K-474

J. Wickes Farm  
Broad Neck  
c. 1850's

# Maryland Historical Trust State Historic Sites Inventory Form

historic J. Wickes House

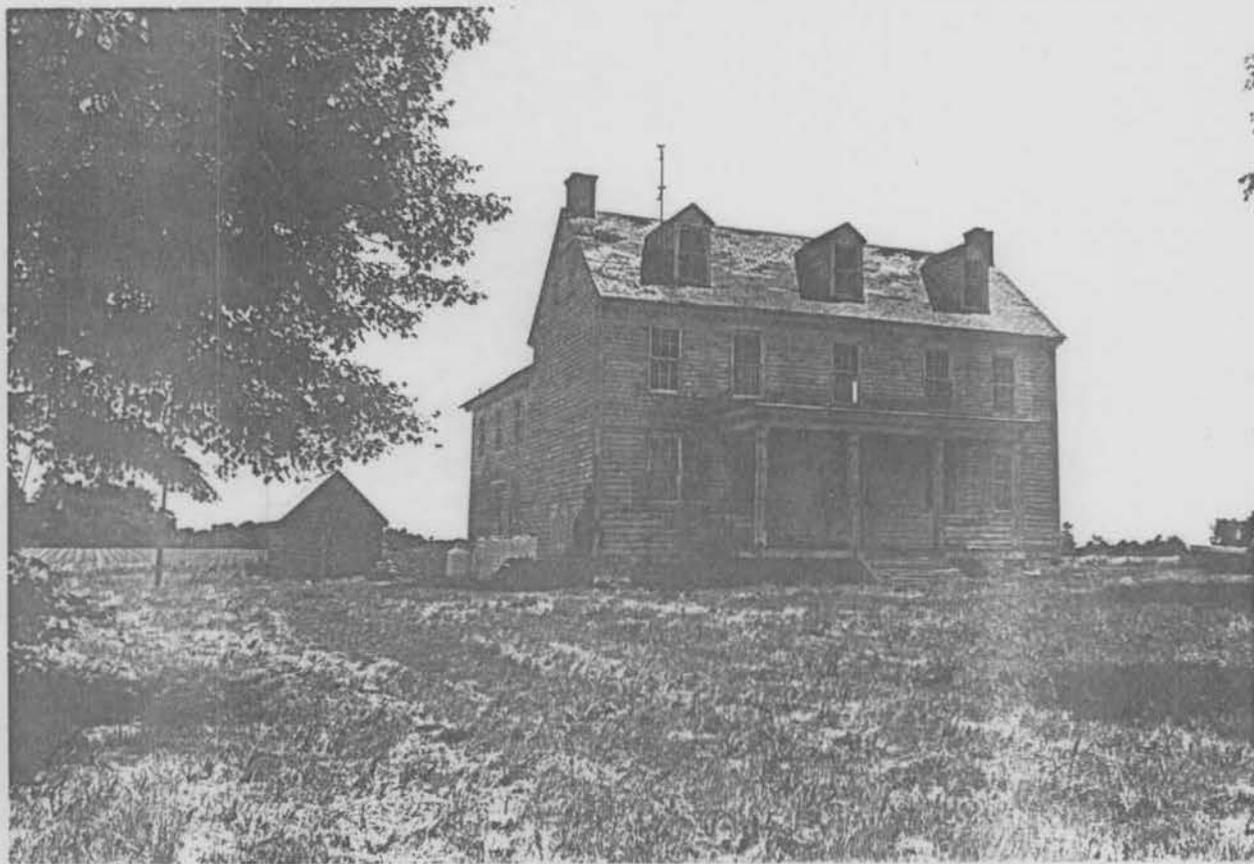
View to North

Facing south with a view of the head of Sinai Cove, this house is 5 bays wide, 2½ stories tall, and one room deep. It is frame. The central hall building has its kitchen in a gable-roofed rear ell. A simple structure, its chief decoration is a bracketed cornice on the main roof and the wide front porch.

ELIASON FARMHOUSE (K-474)
