K-565

Ivingo

Near Locust Grove

Maryland Historical Trust State Historic Sites Inventory Form

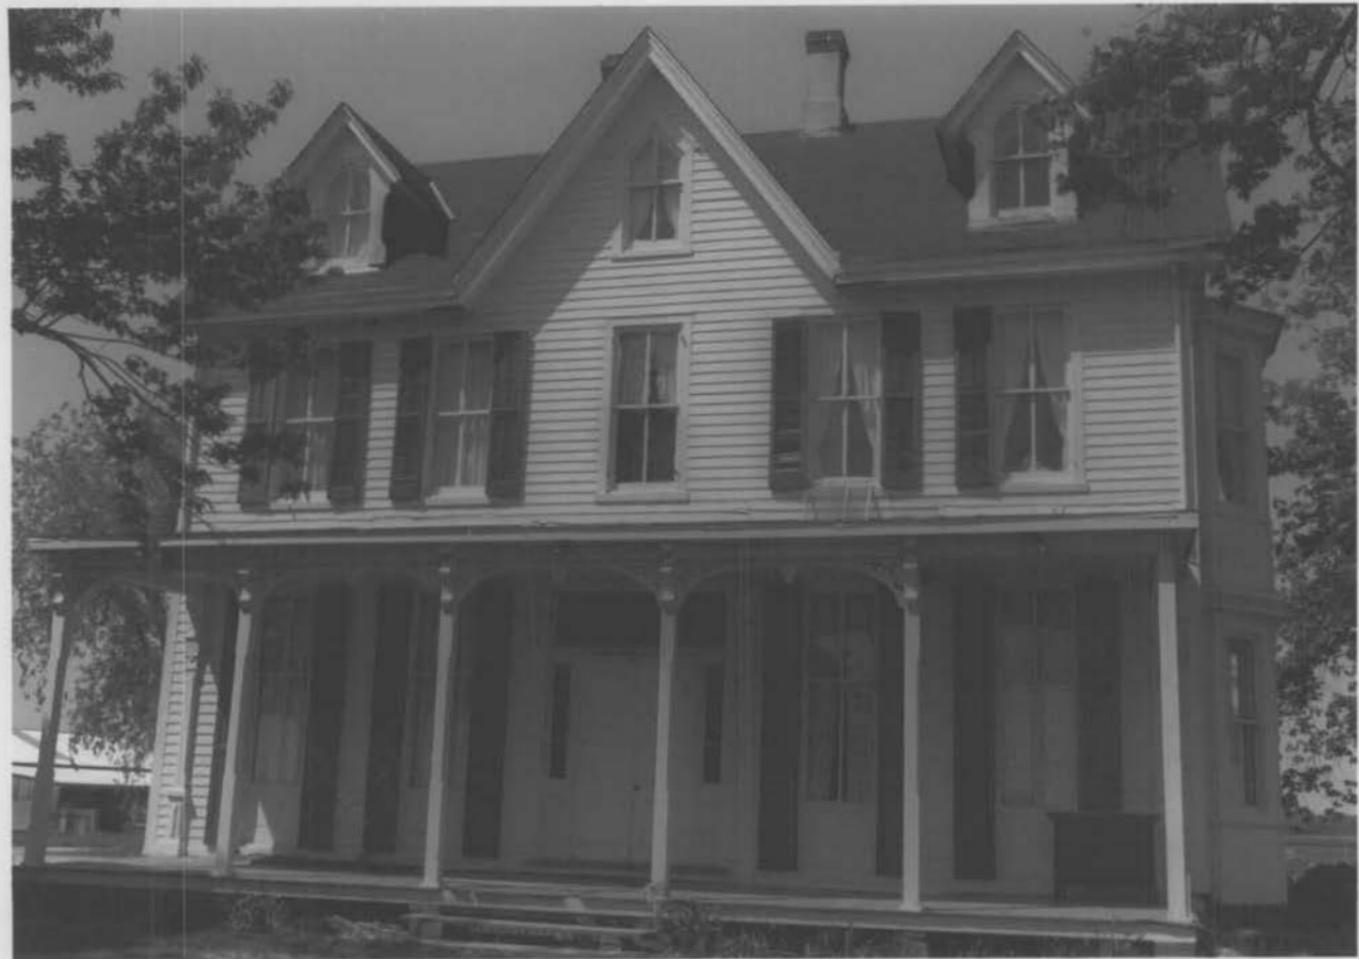
KP565-11A

View to north

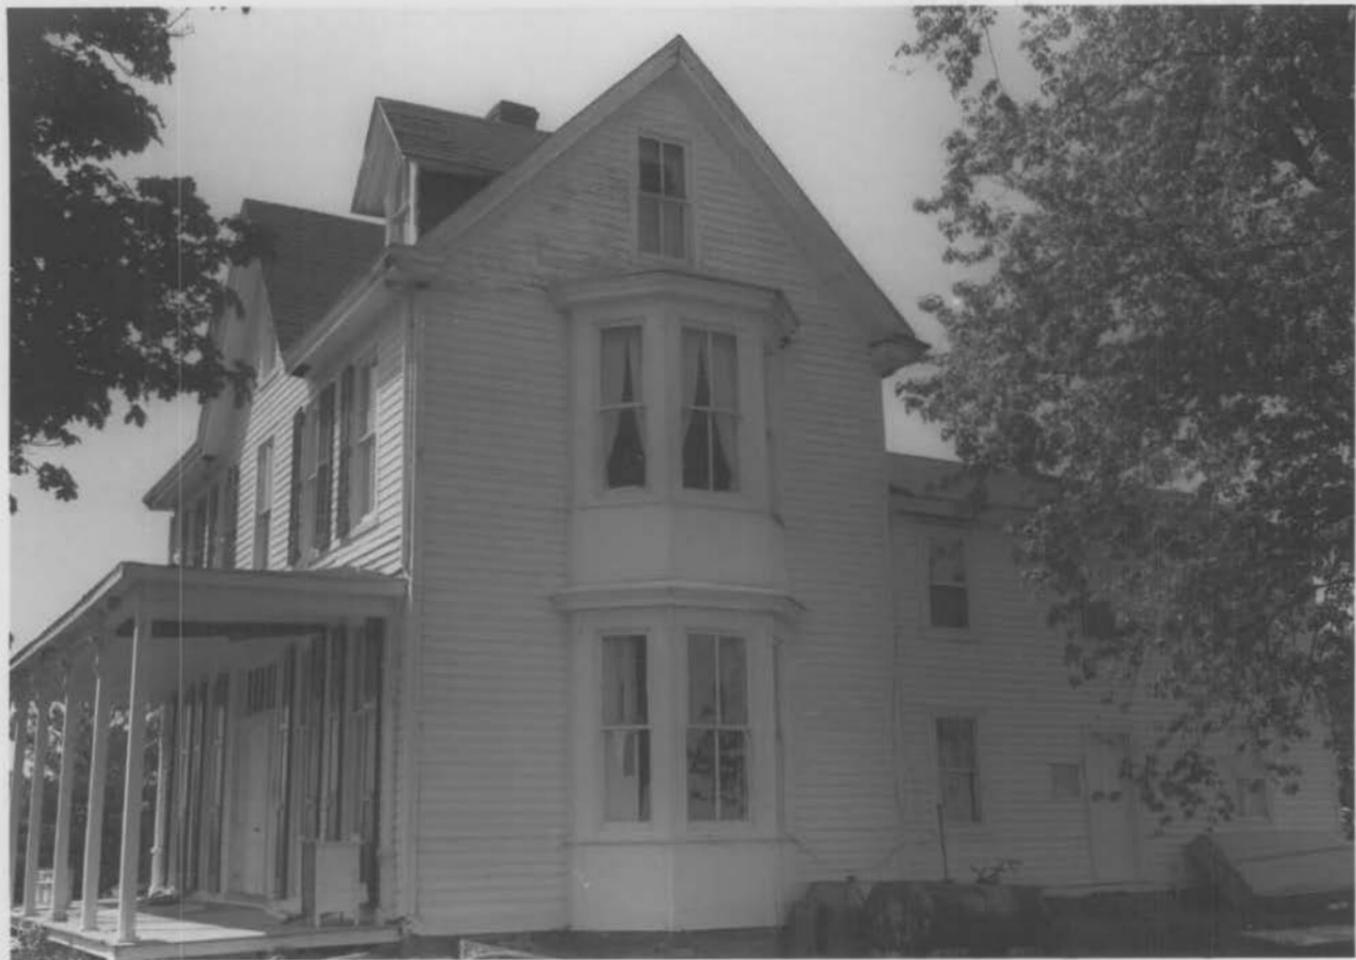
K- 565

View to west
