Maryland Inventory of Historic Properties Number: K-602

Name: MD 299 over Herring Branch of Sassafras River

**SHA Bridge No.** 14017 **Name:** MD 299 over Herring Branch of Sassafras River

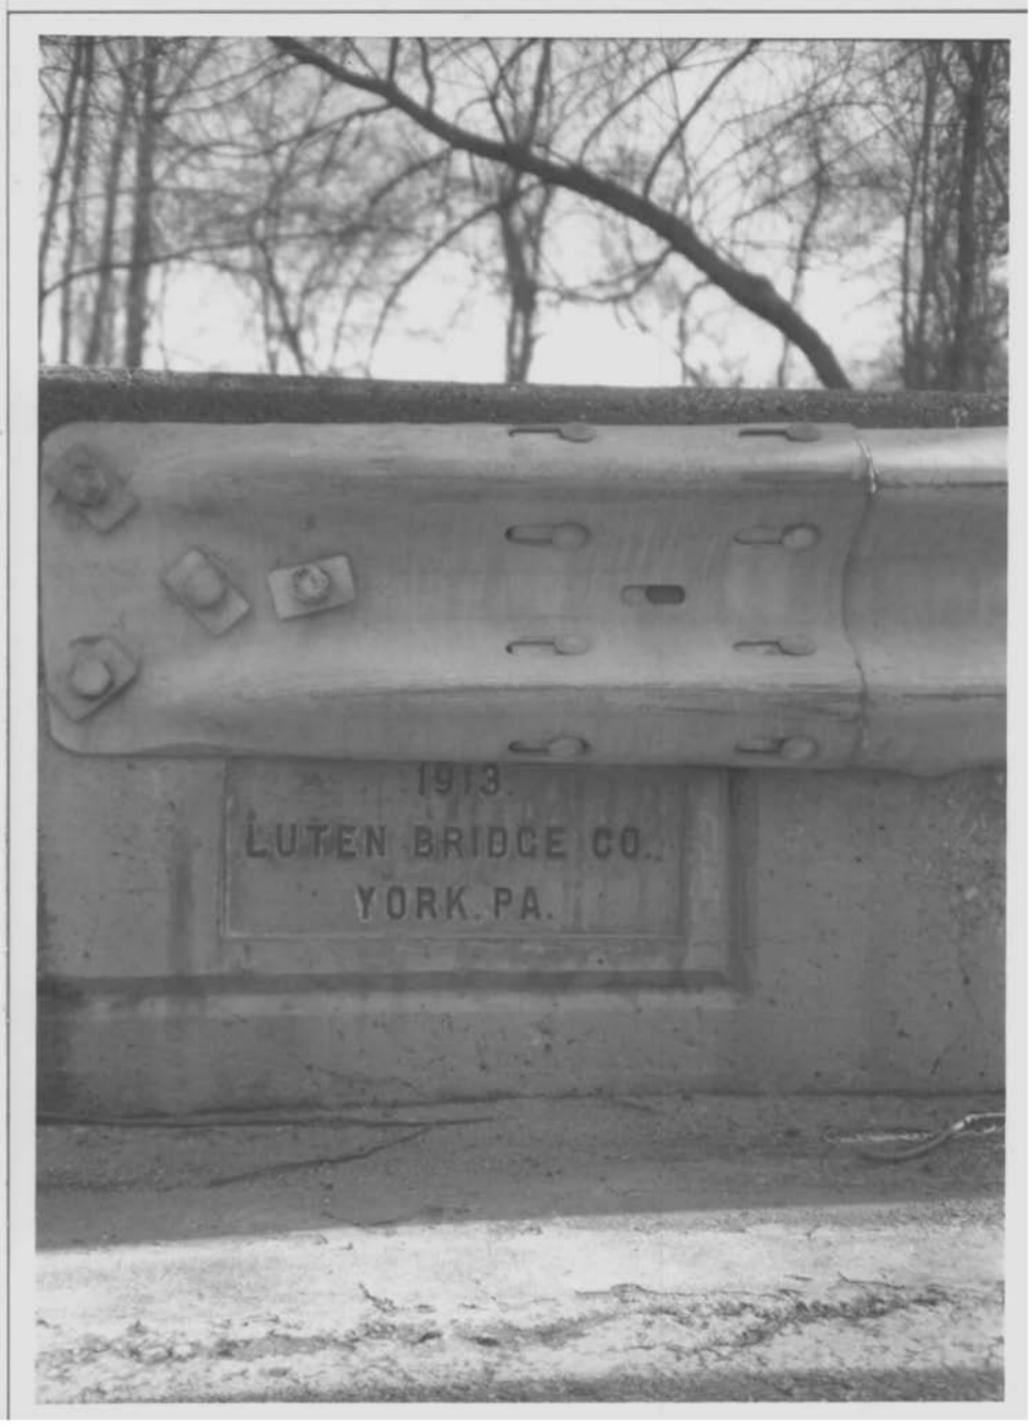
1. K-682
2. HOIT, MD 299 OVER SASSAFRAS RIVER
3. KENT COUNTY, MD
4. WALLACE - MONTGOMERY
5. 12/97
6. MD SHPO
7. PLAQUE
8. 10FS

A black and white photograph showing a close-up of a bridge railing. The railing is made of a heavy, cylindrical metal pipe with several U-bolts and nuts securing it to a concrete base. The concrete base has a rectangular stamp containing the text: 1913.  
LUTEN BRIDGE CO.  
YORK, PA.  
The background shows a line of bare trees, suggesting a winter or late autumn setting. The ground in the foreground is cracked and appears to be asphalt or concrete.

1913.  
LUTEN BRIDGE CO.  
YORK, PA.
