ACHS SUMMARY FORM

1. Name: Stone House Farm (Zeigler Stone House)
2. Planning Area/Site Number: 10/56 3. M-NCPPC Atlas Reference: Map 1
Coordinate J-11
4. Address: Prescott Road
Clarksburg, Md.

INVENTORY FORM FOR STATE HISTORIC SITES SURVEY

Stone House Farm

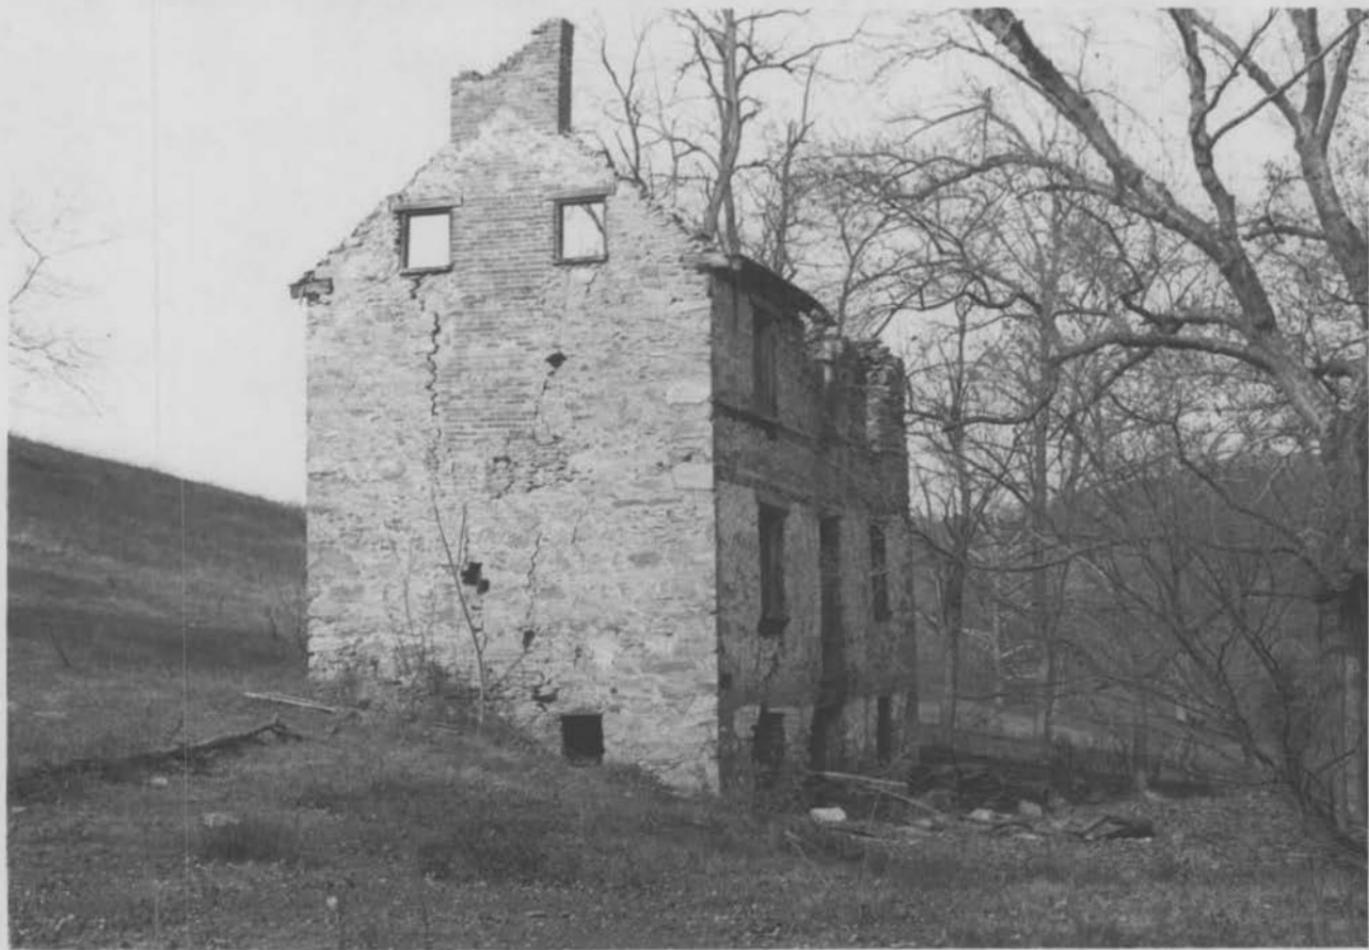
NAME # 10-56 ZEIGER STONE HOUSE (M-NCPPC)

Note: House is presently in ruined condition with exterior walls standing but weakened. West wall bowed inwards.

FACADE SW
