SITE NAME: Pickens Farm

SITE NUMBER: #13/12

APPROXIMATE BUILDING DATE: c. 1865, added to c. 1903

LOCATION: 23701 Shiloh Church Road, Boyds, Maryland 20841

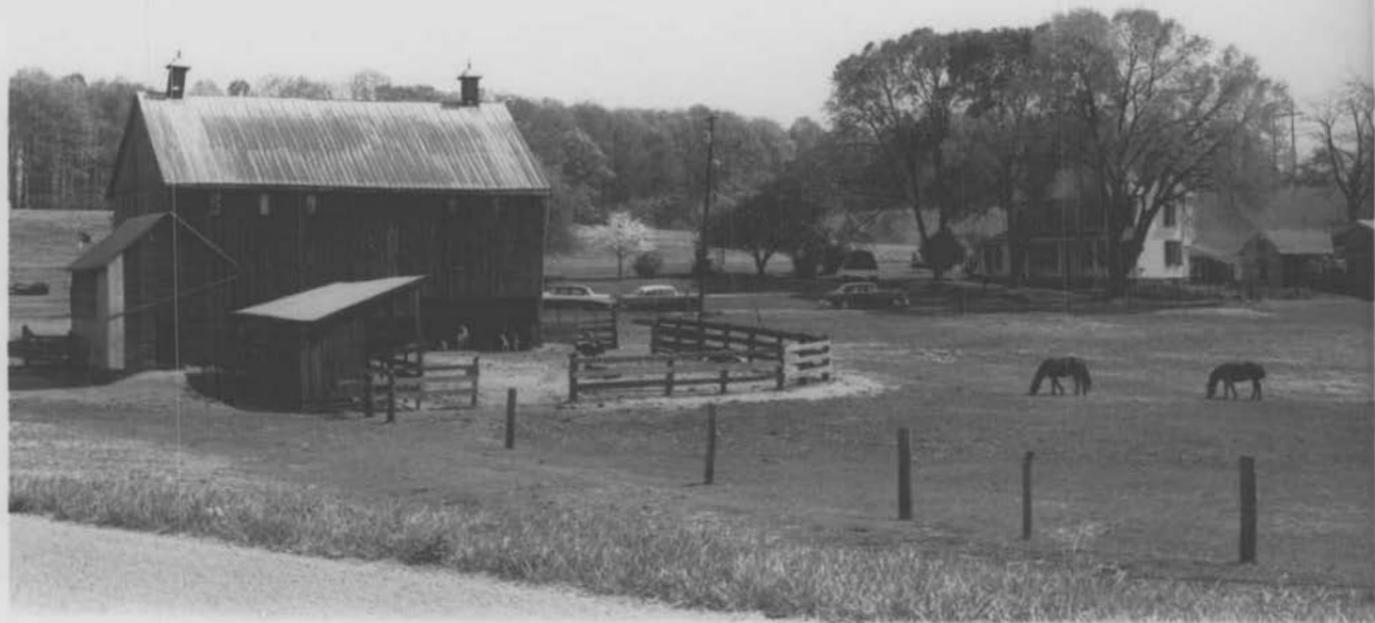
CASCADE SW

The most notable of the outbuildings is the bank barn, which rests on a stone foundation. A 1974 photograph of the barn shows two wooden cupolas, one at each gable end, and painted windows; the cupolas have been removed and the "windows" painted over.

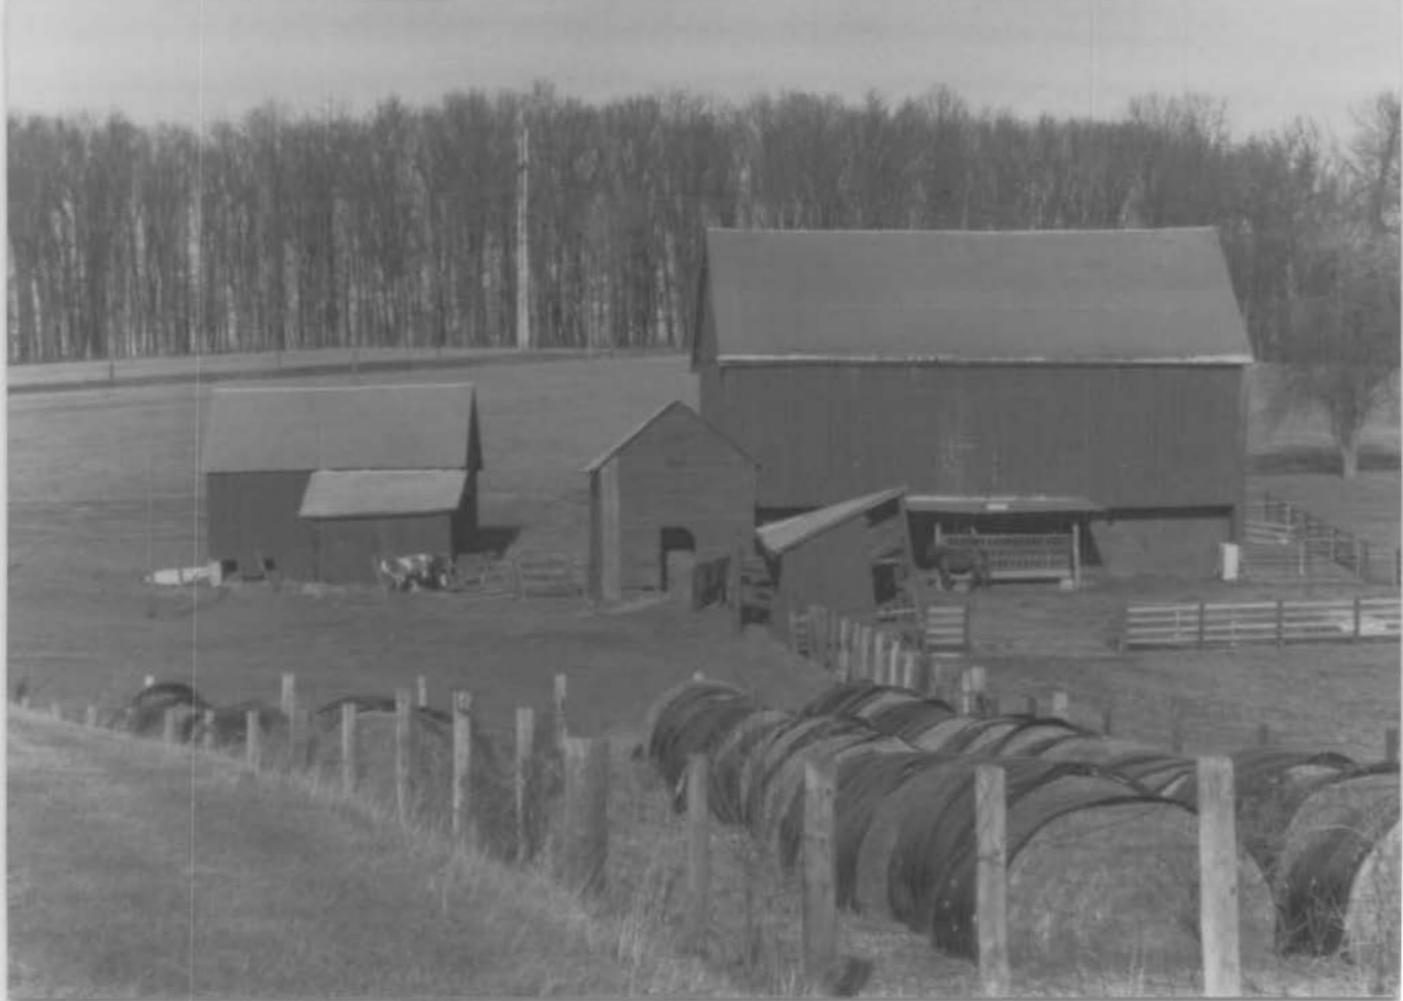
Outbuildings - South

There are several outbuildings on the property, including a small, one-bay, clapboarded, gable-roof structure at the rear of the house which has louvered windows and appears to date from before the turn-of-the-century. Attached to it is a more recent concrete-block, metal-roof equipment storage shed. West of the house, near Shiloh Church Road, are four early outbuildings with vertical or horizontal plank siding and metal roofs; three (including the large bank barn and a double corn crib just to the west of the barn) are gable-roof and the fourth has a shed roof. The corn crib has a small shed-roof addition on its south side.
