INDIVIDUAL PROPERTY/DISTRICT
MARYLAND HISTORICAL TRUST
INTERNAL NR-ELIGIBILITY REVIEW FORM

Property/District Name: George W. Helton Farm Survey Number: M-13-18

George W. Hilton Farmhouse (13-18)
Structural Analysis and Estimate of Costs

INVENTORY FORM FOR STATE HISTORIC SITES SURVEY

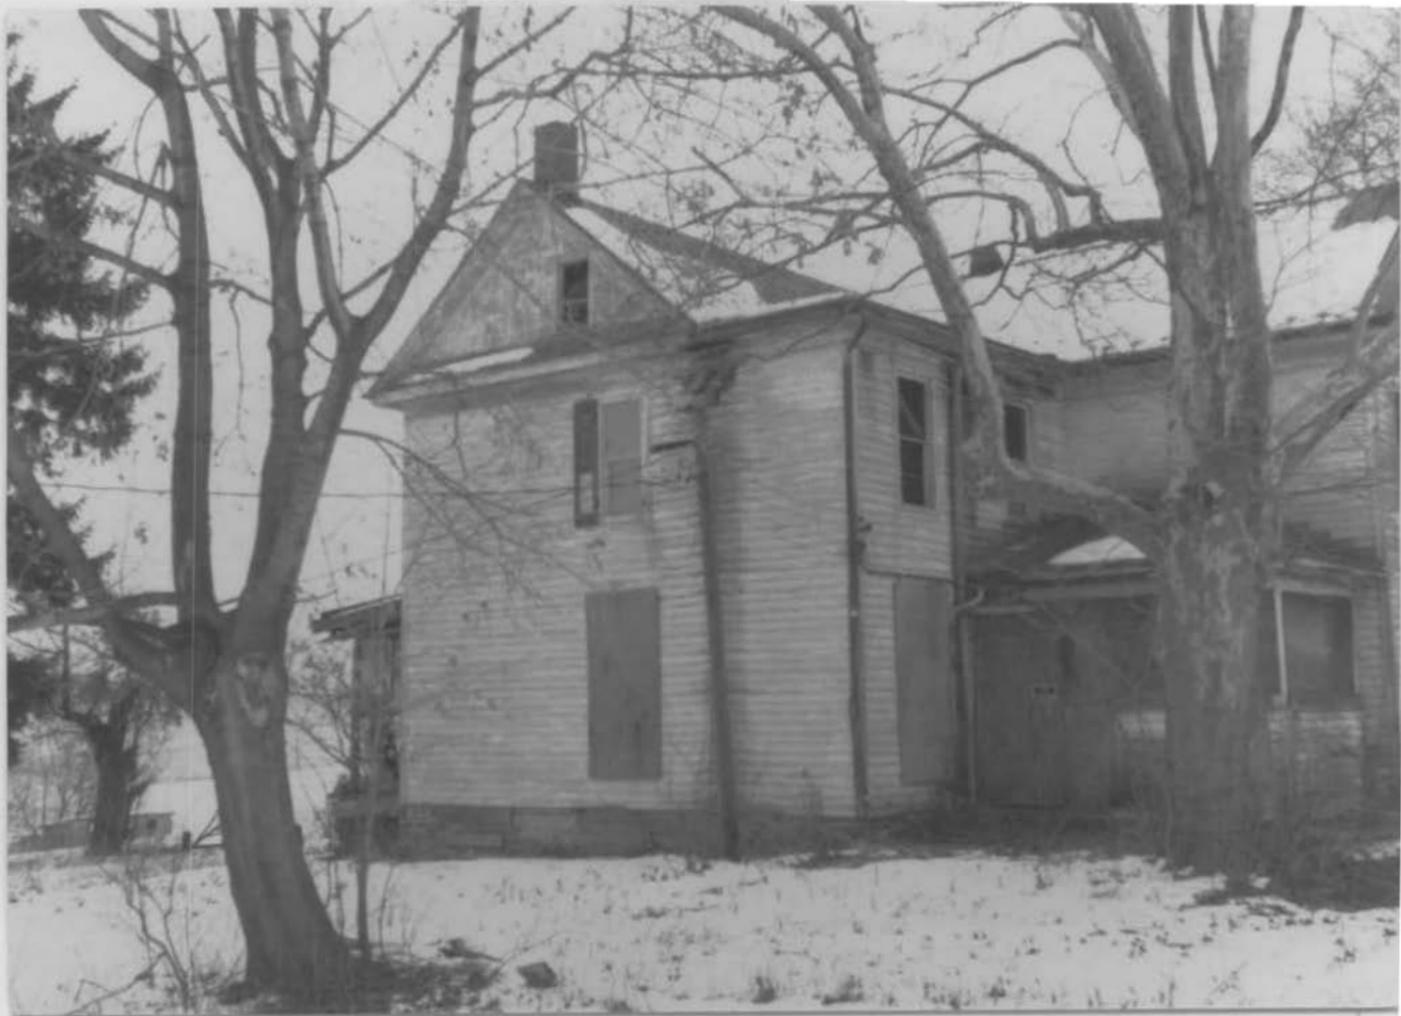
Hilton Farm

West Elevation

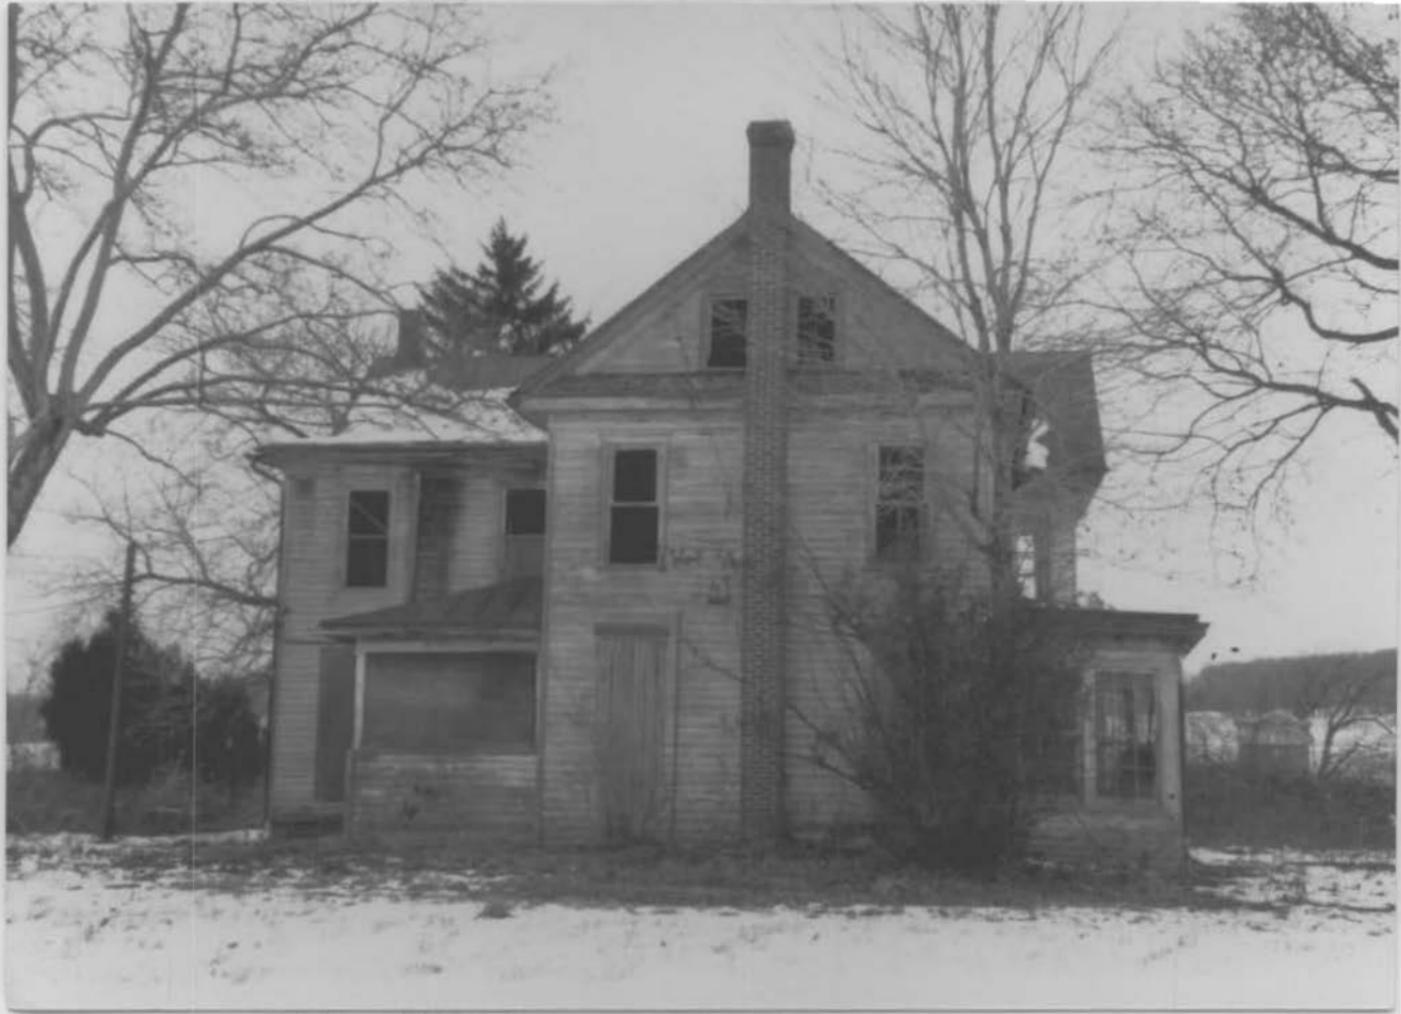
Hilton Farm

At the south elevation there is a 2½ story, two-bay, gable-roof wing extending to the rear from the southeast corner of the main block. The wing has an outside chimney with a corbelled cap, double windows at the gable end, and an entrance in the westernmost bay. There is a shingled overhang at the second story. A one-story, hipped-roof, enclosed porch partially fills in the ell where the main block and the wing meet, at the southwest corner of the house; entrance to the porch is on the west elevation.

South Elevation

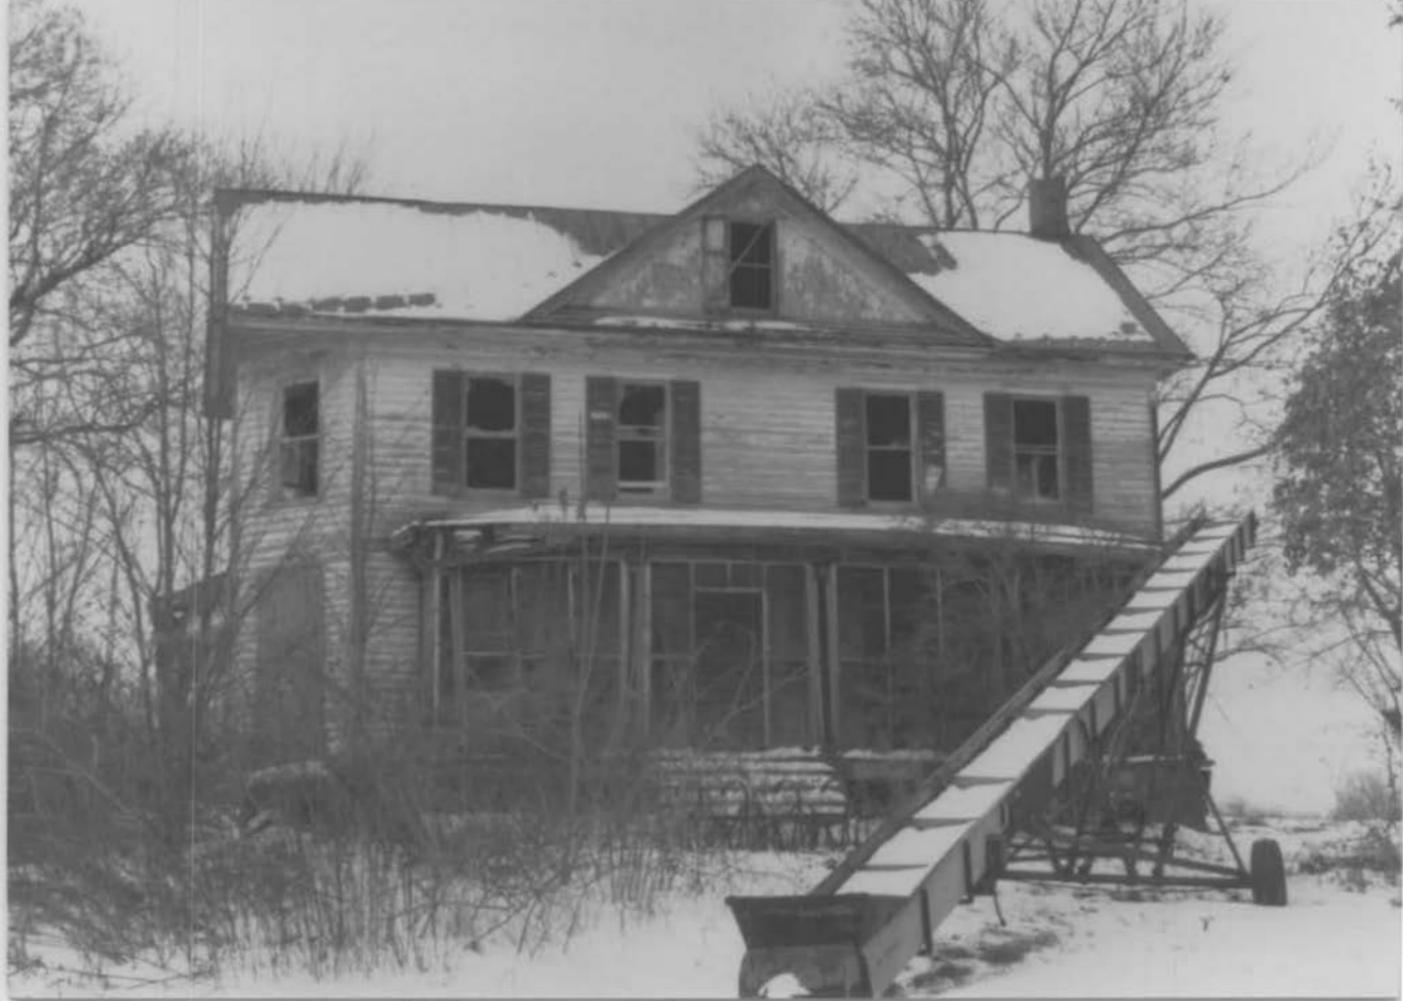
Hilton Farm

The symmetrical main block, which faces north, has a one-story, shed-roof screened porch which covers the full width of the facade; it rests on brick piers with latticework infill. Originally supported by classical columns, most of the columns are now missing. A centered second-story gable features a shuttered window and scalloped shingles, the same shingles decorate all gable ends. There is an interior chimney at the west end of the roof ridge.

The main facade has two entrances, one in the east bay to the dining room and the other in the west bay to the kitchen.

North Elevation

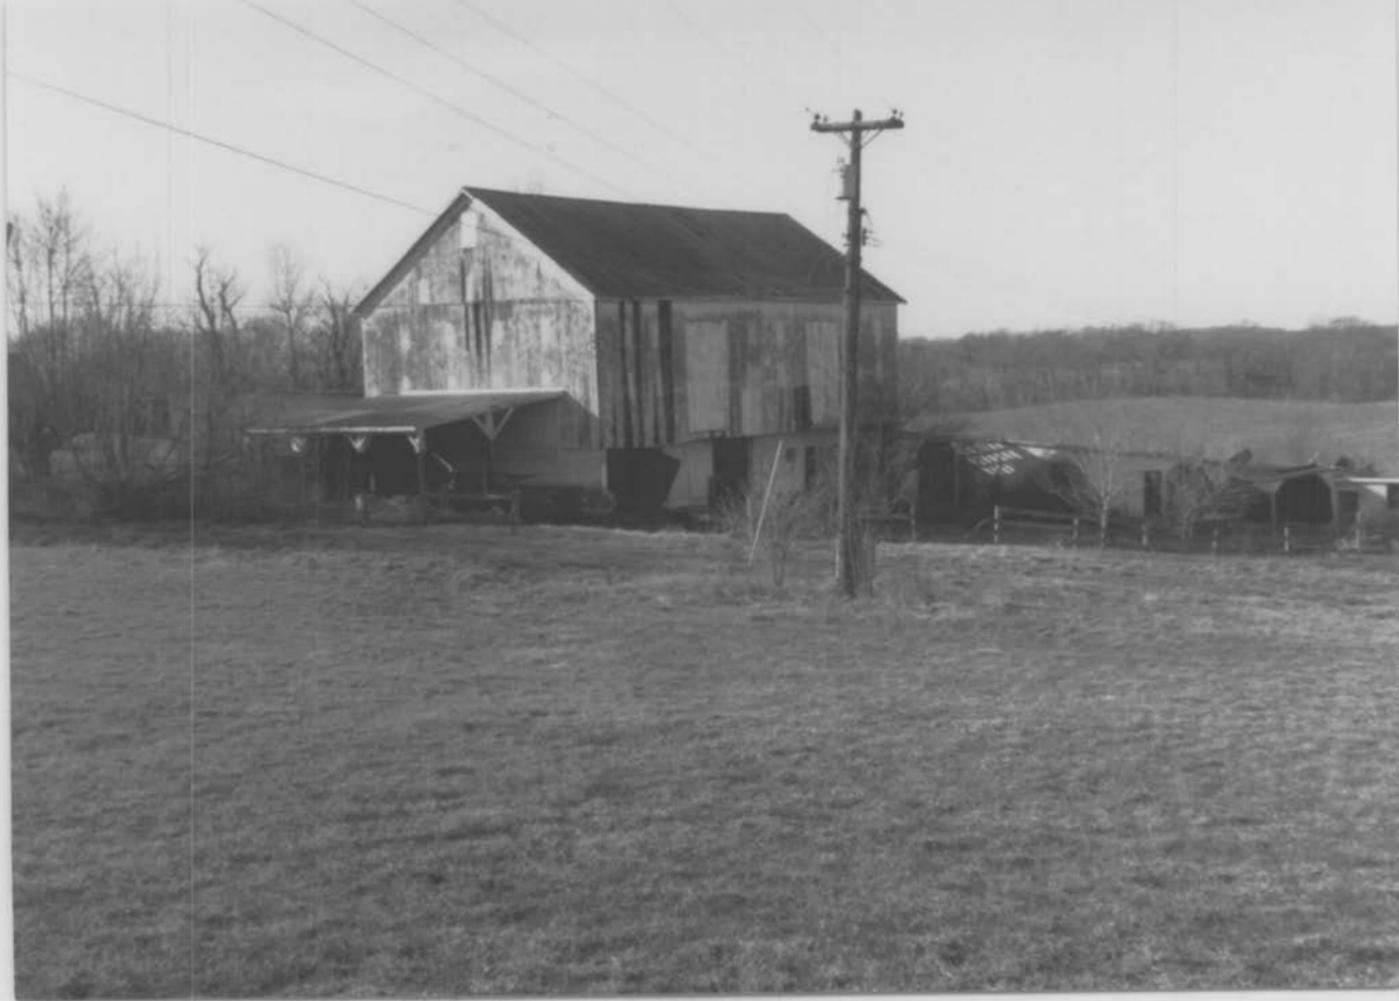
Hilton Farm

There are a number of outbuildings on the site, the most important of which is an early twentieth century metal-roofed bank barn covered with vertical plank siding and resting on a stone foundation; its windows are outlined with paint and there are one-story additions at both gable ends.

Outbuilding - East & North
Bank Barn

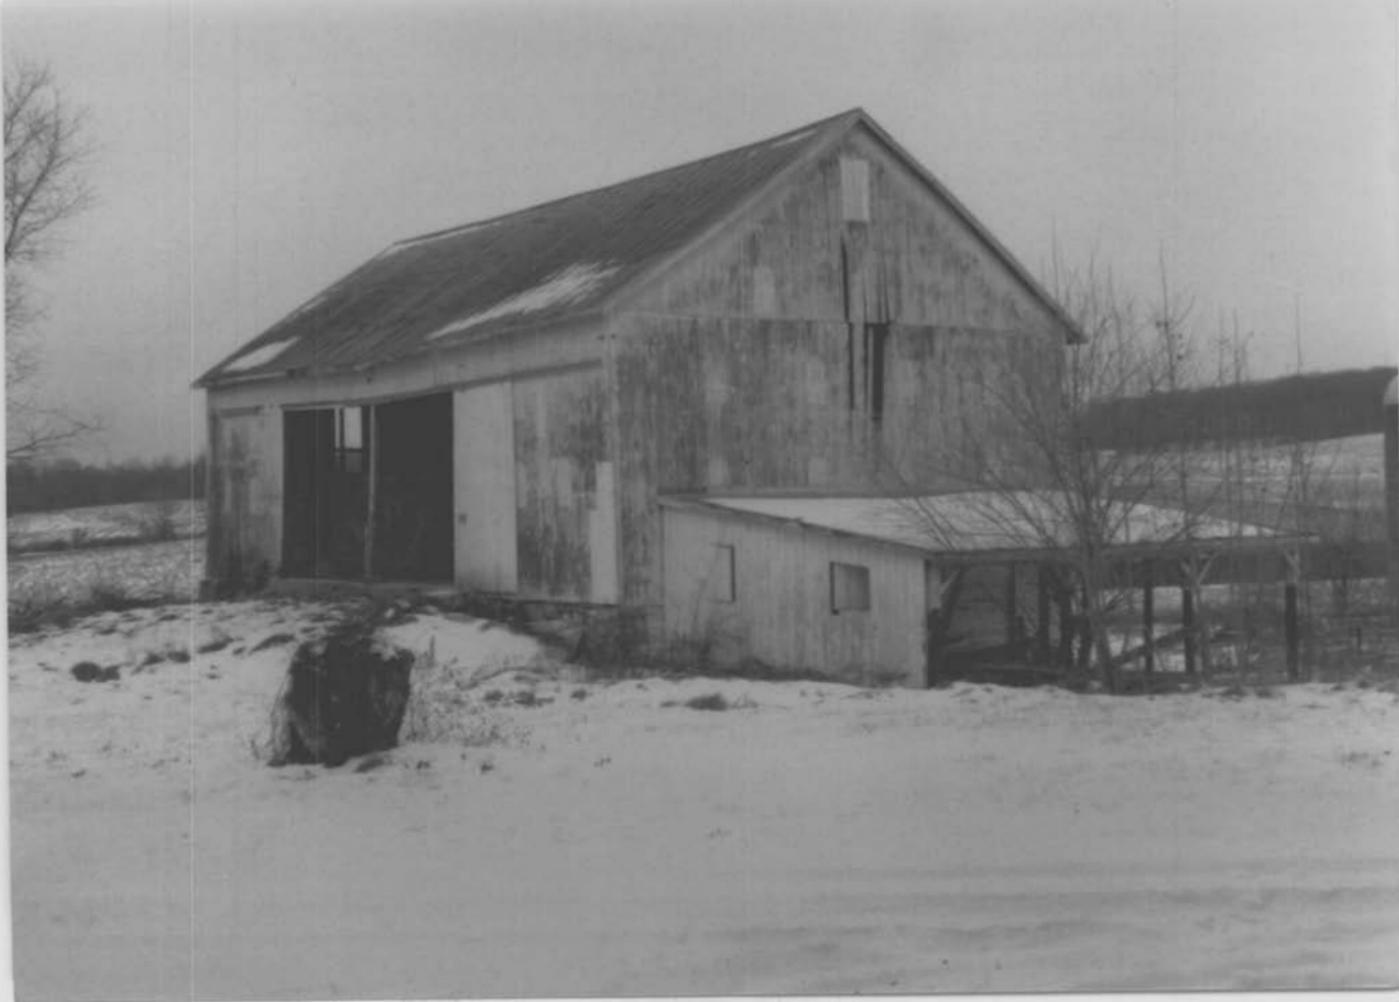
Hilton Farm

Outbuilding (S+E) - Bank Barn

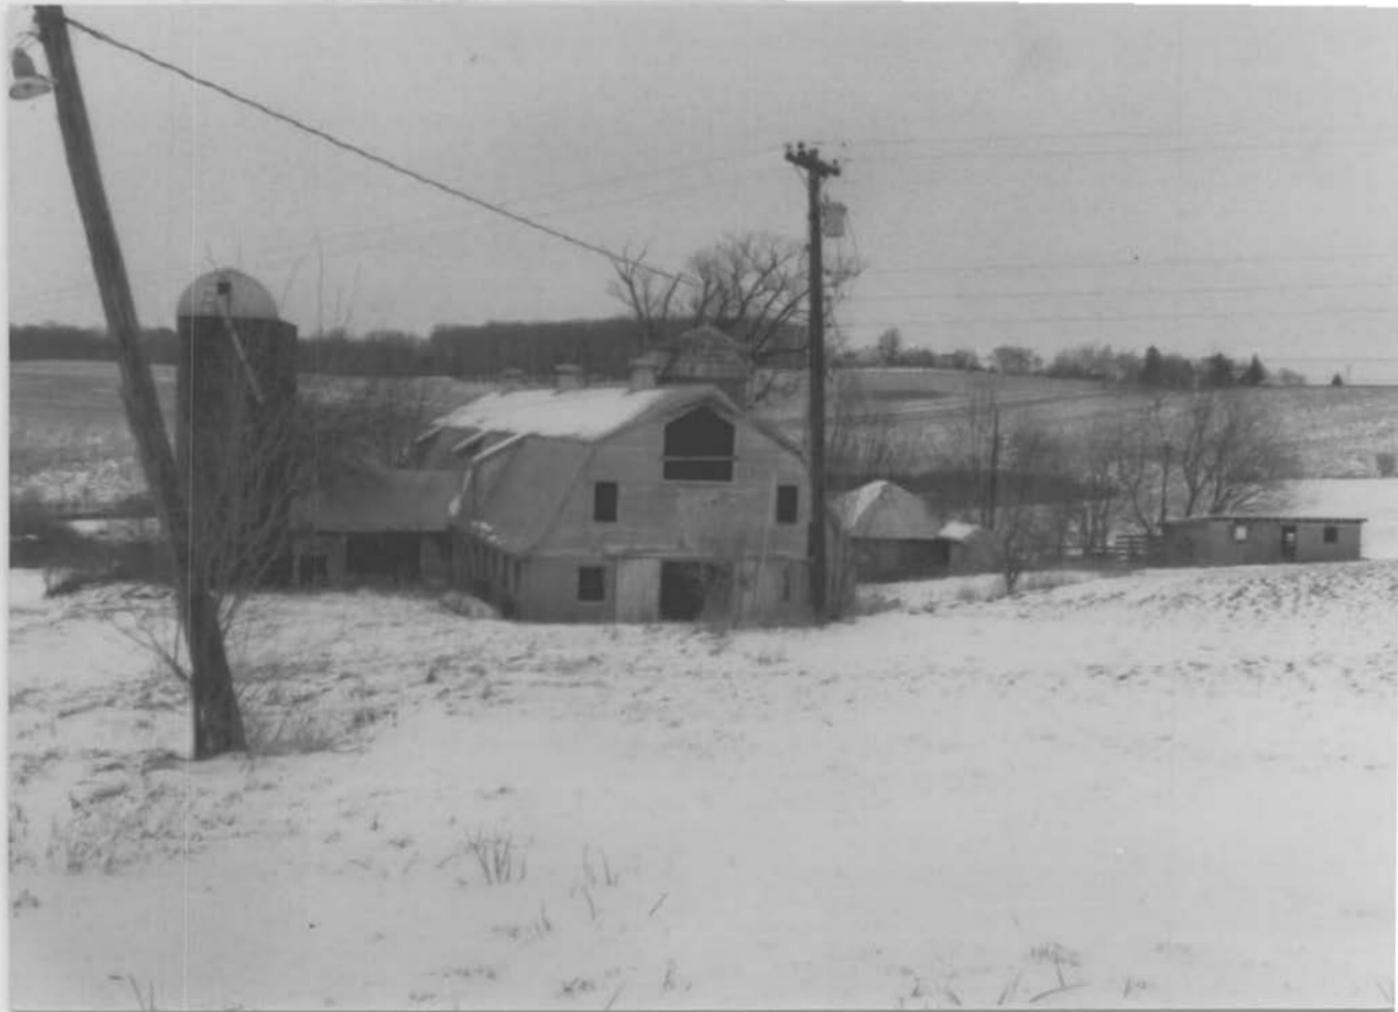
Hilton Farm

The dairying complex on the Hilton farm includes the clapboard-and-concrete-block, metal-roof dairy barn (probably erected about 1923), a tile-covered, hipped-roof equipment building, and twin tile-covered silos, one of which has dormer windows at its peak.

Outbuildings - Dairy Barn,
Silos

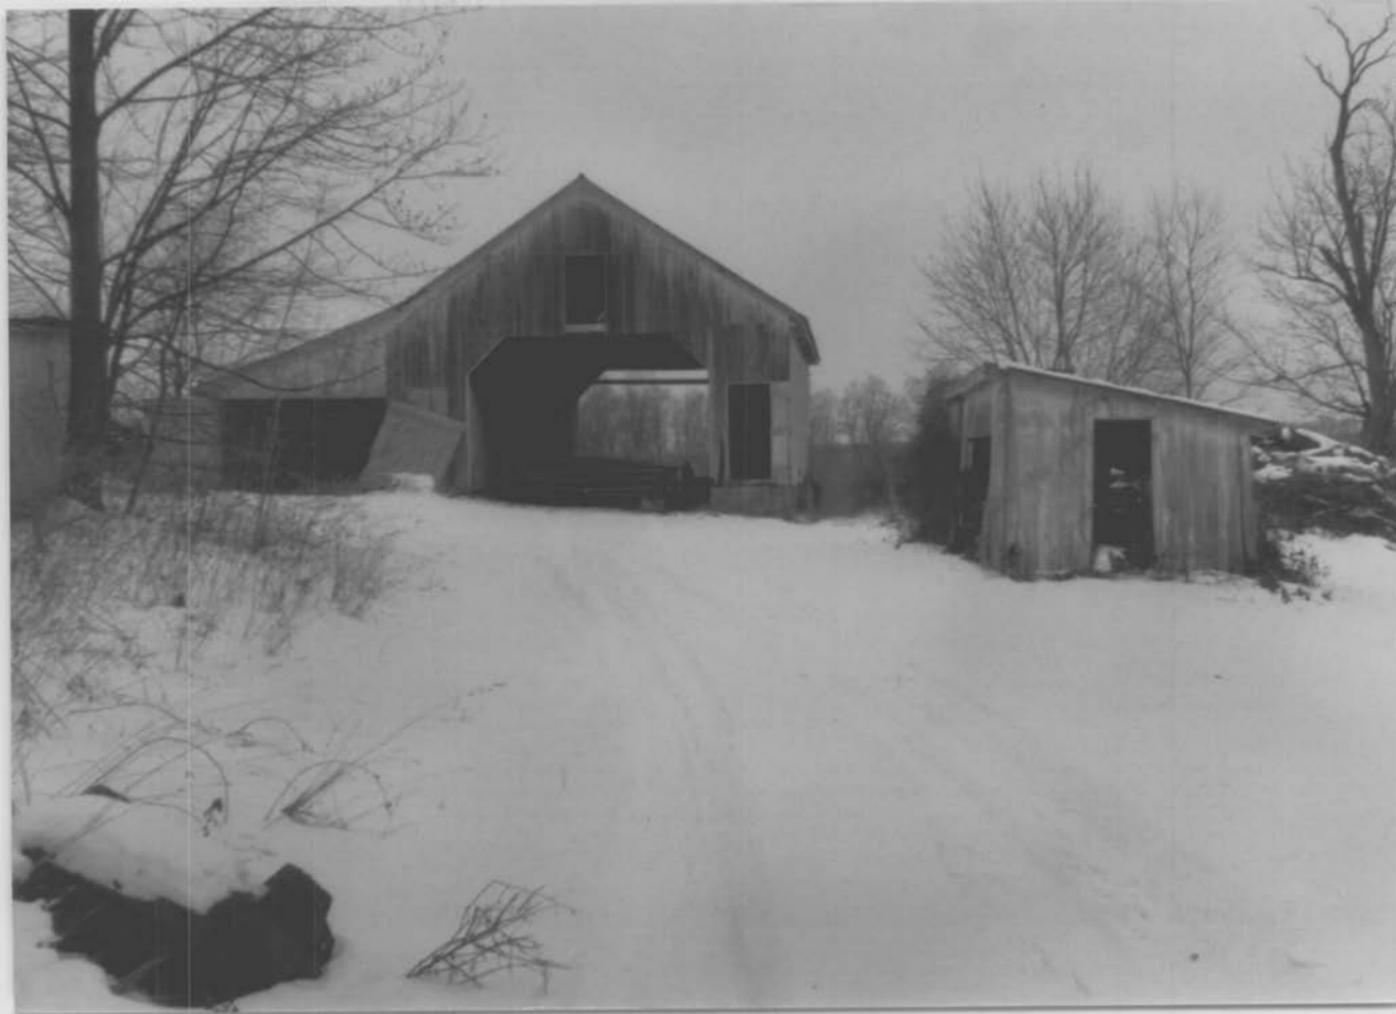
Hilton Farm

Other outbuildings date from the early-mid twentieth century and include a double corn crib and machine storage shed with cat-slide roof, also covered with vertical plank siding; a shed-roof, vertical-sided hen house; and a number of smaller outbuildings (built with vertical plank siding or concrete block, with shed or gable roofs) used for equipment storage or livestock.

Outbuildings (East) Corn Crib,
Machine Storage
Shed

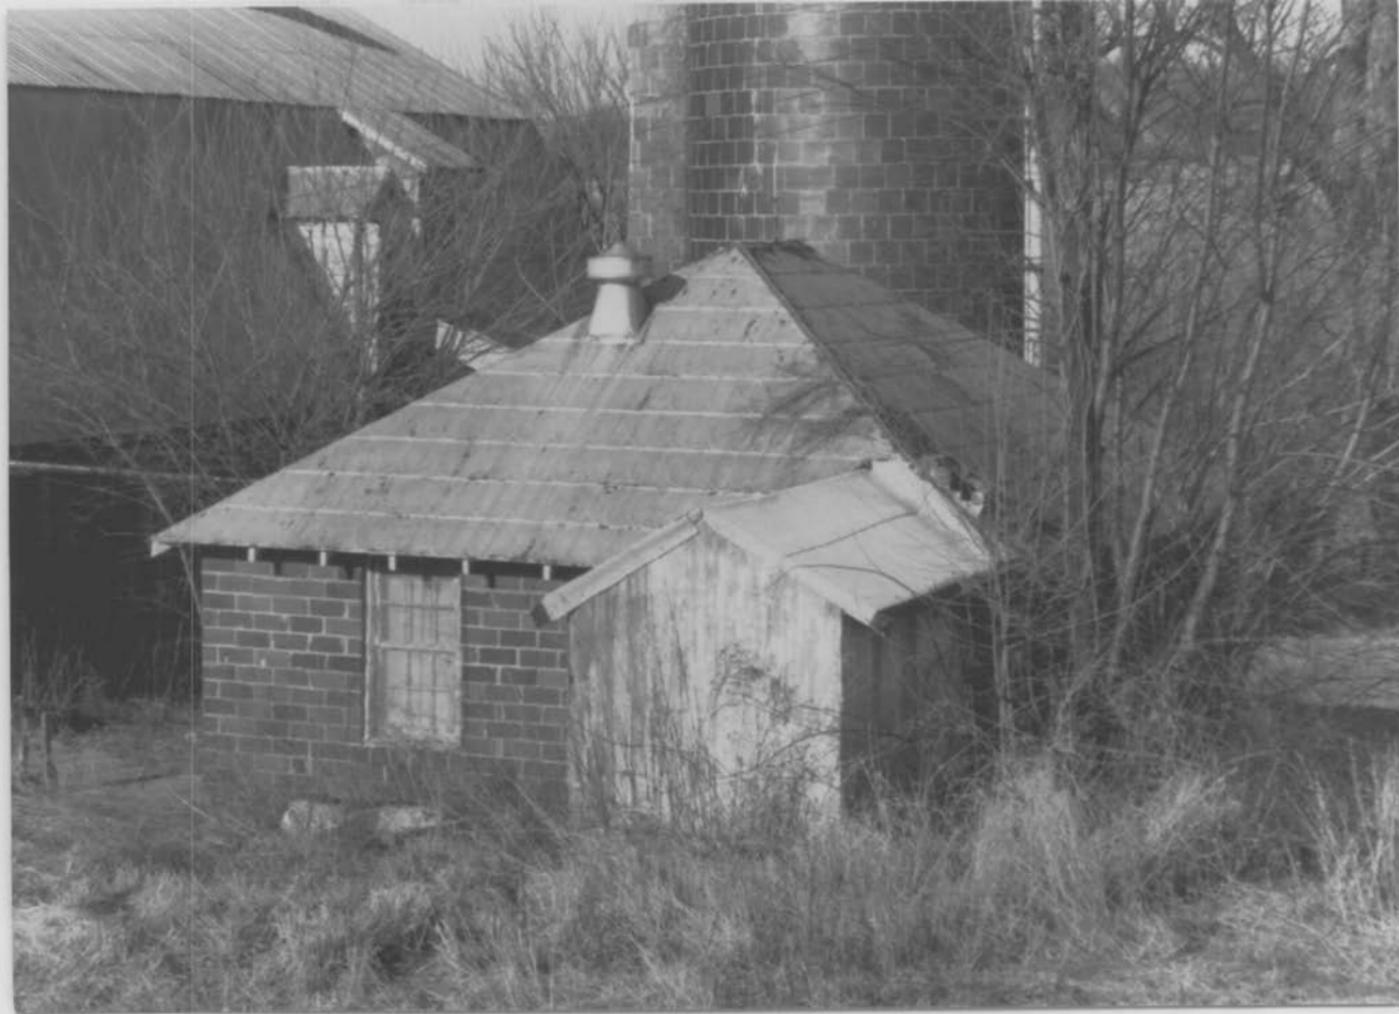
Hilton Farm

Out building - (South) Dairy Equipment
