**MARYLAND HISTORICAL TRUST
DETERMINATION OF ELIGIBILITY FORM**

Property Name: Wildcat Road/Davis Mill Road Rural Historic Distri Inventory Number: M:14-68
 Address: Davis Mill Road Wildcat Road Historic district: yes no
 City: Germantown Zip Code: 20876 County: Montgomery
 USGS Quadrangle(s): Gaithersburg
 Property Owner: multiple Tax Account ID Number: multiple
 Tax Map Parcel Number(s): multiple Tax Map Number: multiple
 Project: Mid County Corridor Study, Montgomery County, Maryland Agency: Montgomery Co. Dept. of Public Works & T
 Agency Prepared By: EAC / Archaeology
 Preparer's Name: Suzanne Stasiulatis Date Prepared: 6/22/2013

ARCHITECTURAL DESCRIPTION

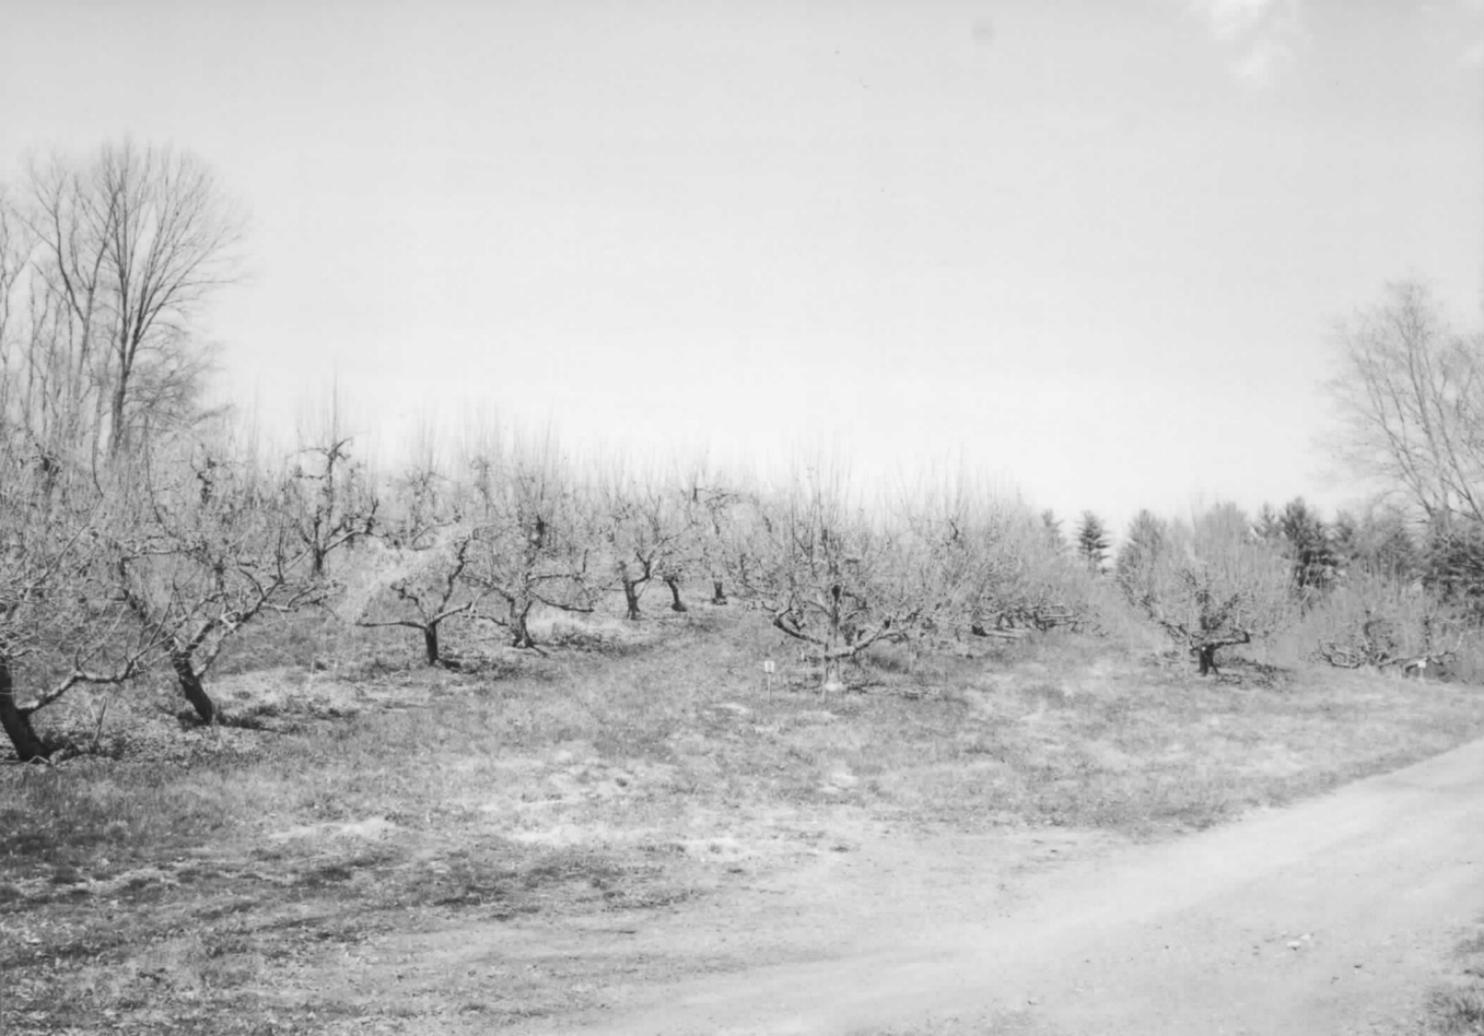
2/8

Facing northwest, viewing orchards along Wildcat
Road.

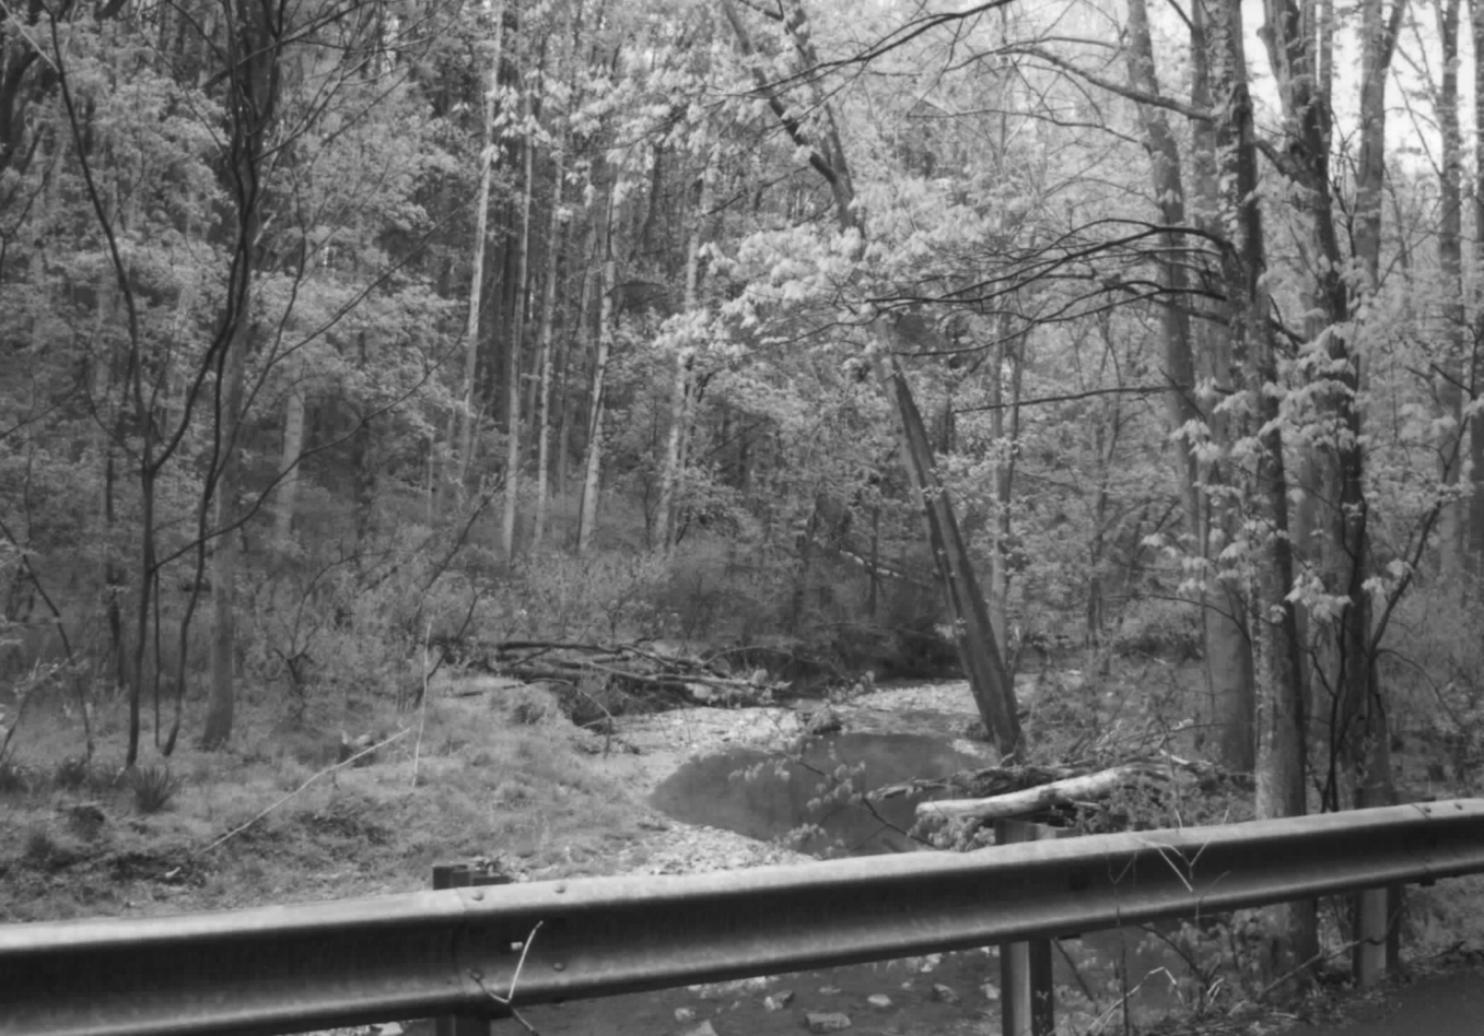
318

Facing east from the Wildcat Road bridge, viewing
the Wildcat Branch of Great Seneca Creek.

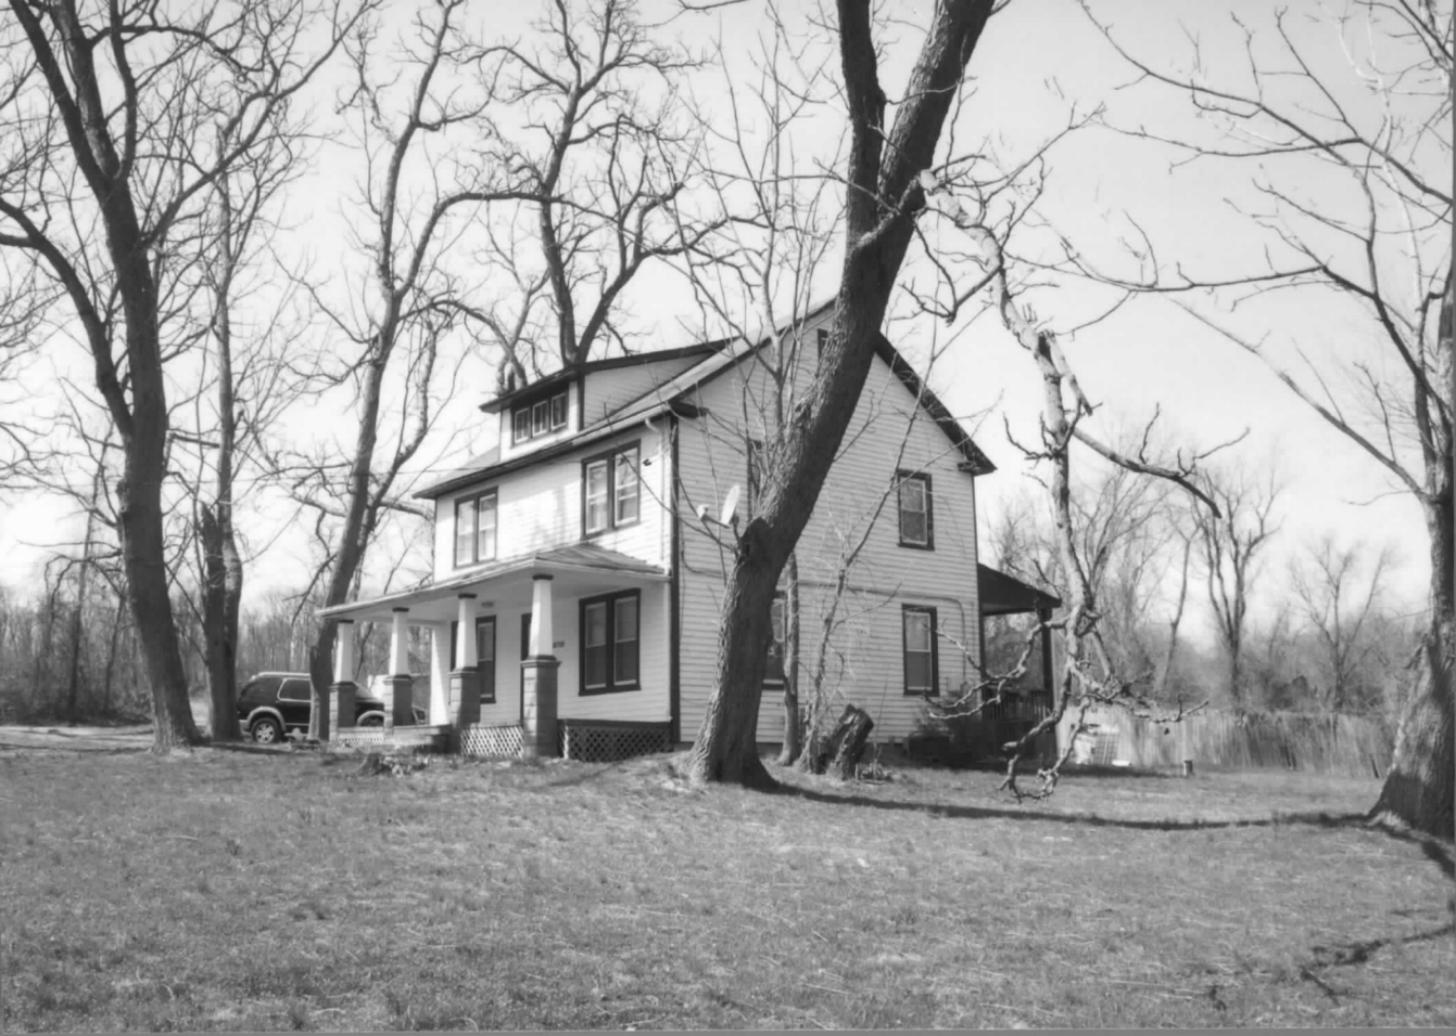
4/8

Facing northwest from the lawn, viewing the
Benson-Sibley Farmhouse.

The Benson-Sibley Farm (M: 14-50) consists of an estimated 120 acre agricultural lot with a farmhouse and a few outbuildings. The farm has a two-story, three-bay, two-pile early 20th century Craftsman farmhouse with a south-facing façade. The low pitched side gable roof is clad in asphalt shingles with overhanging eaves and has a shed roof dormer, which also has overhanging eaves. The dormer has three adjacent four-light, vinyl sash windows with a simple casing. Below the roofline, at the second story level, two sets of paired, two-pane vinyl sash windows are placed on either side of the façade with simple casings. The first story level mimics that of the second story, but a central replacement door with a fixed fanlight is present. A hipped porch roof is set on four simple, tapered square columns with concrete block pedestals. The porch is slightly raised above three steps.

The gable end of the west elevation overhangs and has cornice returns. An attic window is in the peak, and one-over-one sash windows are at the second story level. A pair of low first-story windows is located at the north end, and a high window is located centrally. A protruding square bay is present at the south edge. The bay with hipped roof and overhanging eaves has two paired, one-over-one vinyl sash windows. All windows are one-over-one vinyl sash windows with simple casings.

The rear of the house has three vinyl sash windows at the second story level. The central window is very narrow and surrounded by a wide, simple casing. At the first floor level, a protruding, one-bay wing has a single, smaller, one-over-one vinyl sash window. The other (east) half of the first floor level is occupied by a porch with a one-over-one sash window and a door leading to the protruding bay. The porch is concrete and has two rectangular porch supports, a wooden railing, and three concrete steps. The attic and second story levels of the east elevation mimics the west elevation; the first story has two vinyl sash windows.

The immediate area of the house is surrounded by a large lawn, mature trees and a few shrubs, and is at the southern end of the parcel. A shed is located near the house; the property also has a milk house in poor condition and a collapsed barn. The house is located along Brink Road.

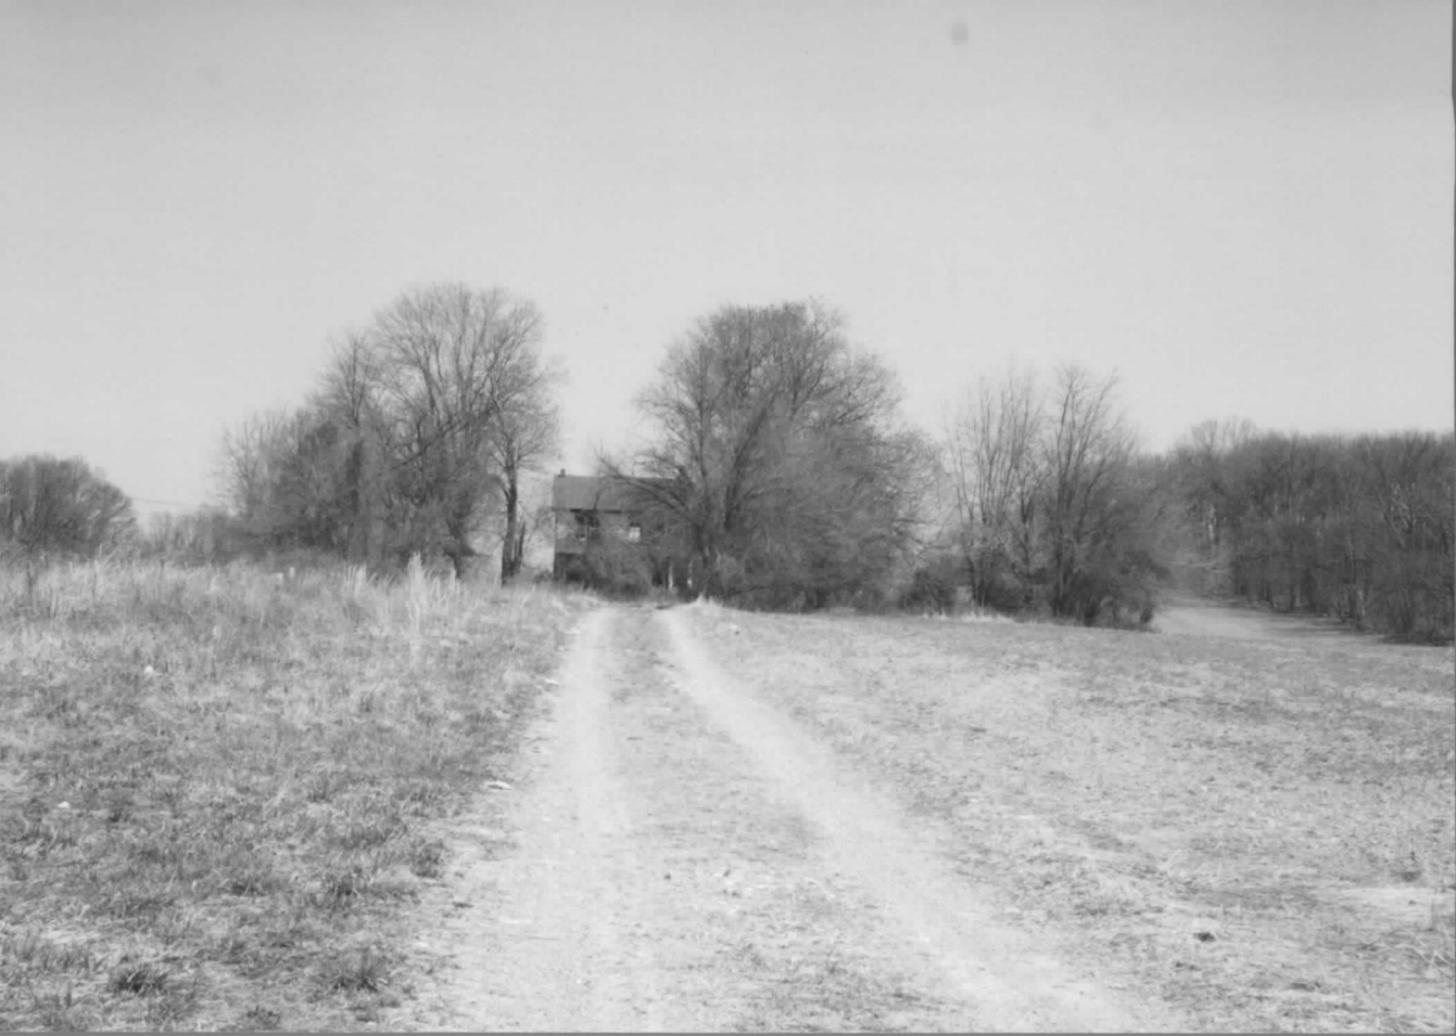
5/8

Facing northeast from Wheat Road, Viewing Woodfield Farm, and surrounding agricultural lands

Woodfield Farm (M: 14-49) is on approximately 105 acres, with a severely deteriorated farmhouse and remnants of outbuildings and accessory structures. The two-and-one-half story farmhouse with a southwest facing façade and cross-gable roof (composed of two wings) is asymmetrical in form. The roof has aluminum cladding, overhanging eaves, and an interior ridge chimney on the west side. The cross-gable meets at the east side, where a canted bay addition protrudes from the façade. Three windows at the façade are located centrally on the bay and on each of the canted sides, at both the first- and second-story levels. The window sashes on the building, when still present, are wood. An opening for an attic window is present within the gable. The second story also has a paired set of windows on the northwest side and a single window on the southeast side. Two single windows are located on the first story, with a door opening to the east. The two windows and door are sheltered by a three-quarter-width, shed porch roof, also clad in aluminum siding and slightly pitched. Two porch supports with bracketed posts hold up the porch roof.

The northwest elevation holds two windows, one on the second story and one on the first story, along the southwest side. A one-story, one-room wing extends off of the main block. A matching wing is located at the anterior of the house, on the other gable. A second-story porch extends across the second story in the anterior and northwest elevations. The porch is sheltered by the primary roof and has wooden railings. Two doors are located at the porch level, with one on each gable block wing. Two doors are located on each gable block at the first-story level, past the one-room wings. The rear of the house has a single window on each story, located on the east side of the elevation. Two attic windows are present in the gable.

The southeast elevation has three evenly spaced sash windows on the second story. Three windows are also present on the first-story level. Present between the middle window and the eastern window, the entryway has a front gable roof clad in aluminum,

Several other outbuildings are located on the property, including a tractor shed, utility shed, and chicken coop. The property around the house is in disrepair. Junk and trash litter the lawns. The farm fields are currently fallow. Trees line the property on three sides, and a forested section within the field is located at the north edge of the property. A driveway leads from Wildcat Road directly to the farmhouse.

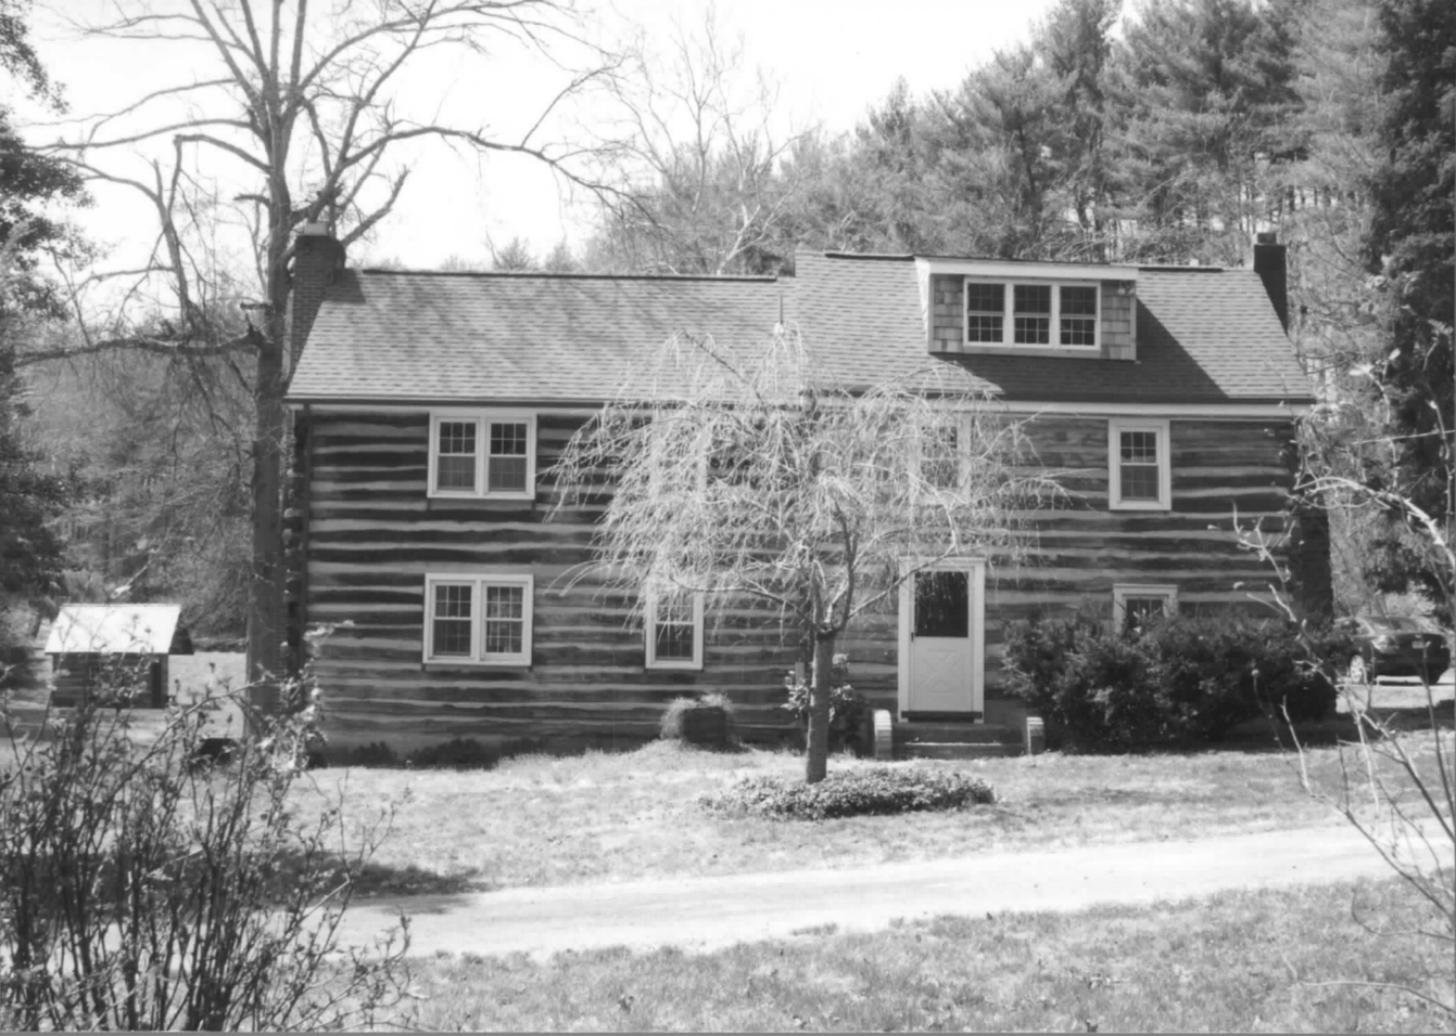
6/8

Facing west from Davis Mill Road, viewing
the Butler's Orchard Log House

Butler's Orchard Log House (M: 14-47) is 36.56 acre agricultural property with farm fields, wooded area, and landscaped lawn. The turn-of-the-eighteenth-century log home, consists of two blocks with an east-facing façade. The side gable roofs are currently clad in asphalt shingles, and two ridge exterior end chimneys with exposed chimney flues are located on each block. The north block has a shed roof dormer with three adjacent six-over-six light windows. All windows are wood. The front and sides of the dormer are clad in wood shingles, and the front has overhanging eaves. The northern block of the house has two six-over-six sash windows on the second story. A southern door and a northern window are located at the first story level. The entryway to the door is raised above two brick course masonry steps. Slightly raised brick masonry is also present on both sides of the entryway. The door has a brick header course sill. A modern storm door is present. The southern block has identical first- and second-story fenestration: each story has two paired, six-over-six sash windows on the southern side and a single six-over-six sash window on the northern side.

A well is noted on the southwestern lawn. A driveway extends from Davis Mill Road to the rear of the house, past the north elevation. The dwelling is immediately surrounded by a lawn landscaped with trees and shrubs. Dense trees border the larger area. Several evergreen trees are within the lawn and the property border. The dwelling is just up the road from the Wildcat Branch and a bridge at Wildcat Road. An accessory orchard store is north of the residence and named, "Butler's Orchard." It supports the active orchard associated with the residence.
