CAPSULE SUMMARY
FOR
FRANK WILSON HOUSE/LINK FARM
2535 LINK ROAD, EDNOR

Montgomery County Survey Prefix & Site Number: M-15/46

Approximate Building Date: circa 1865 & 1894

Maryland Historical Trust State Historic Sites Inventory Form

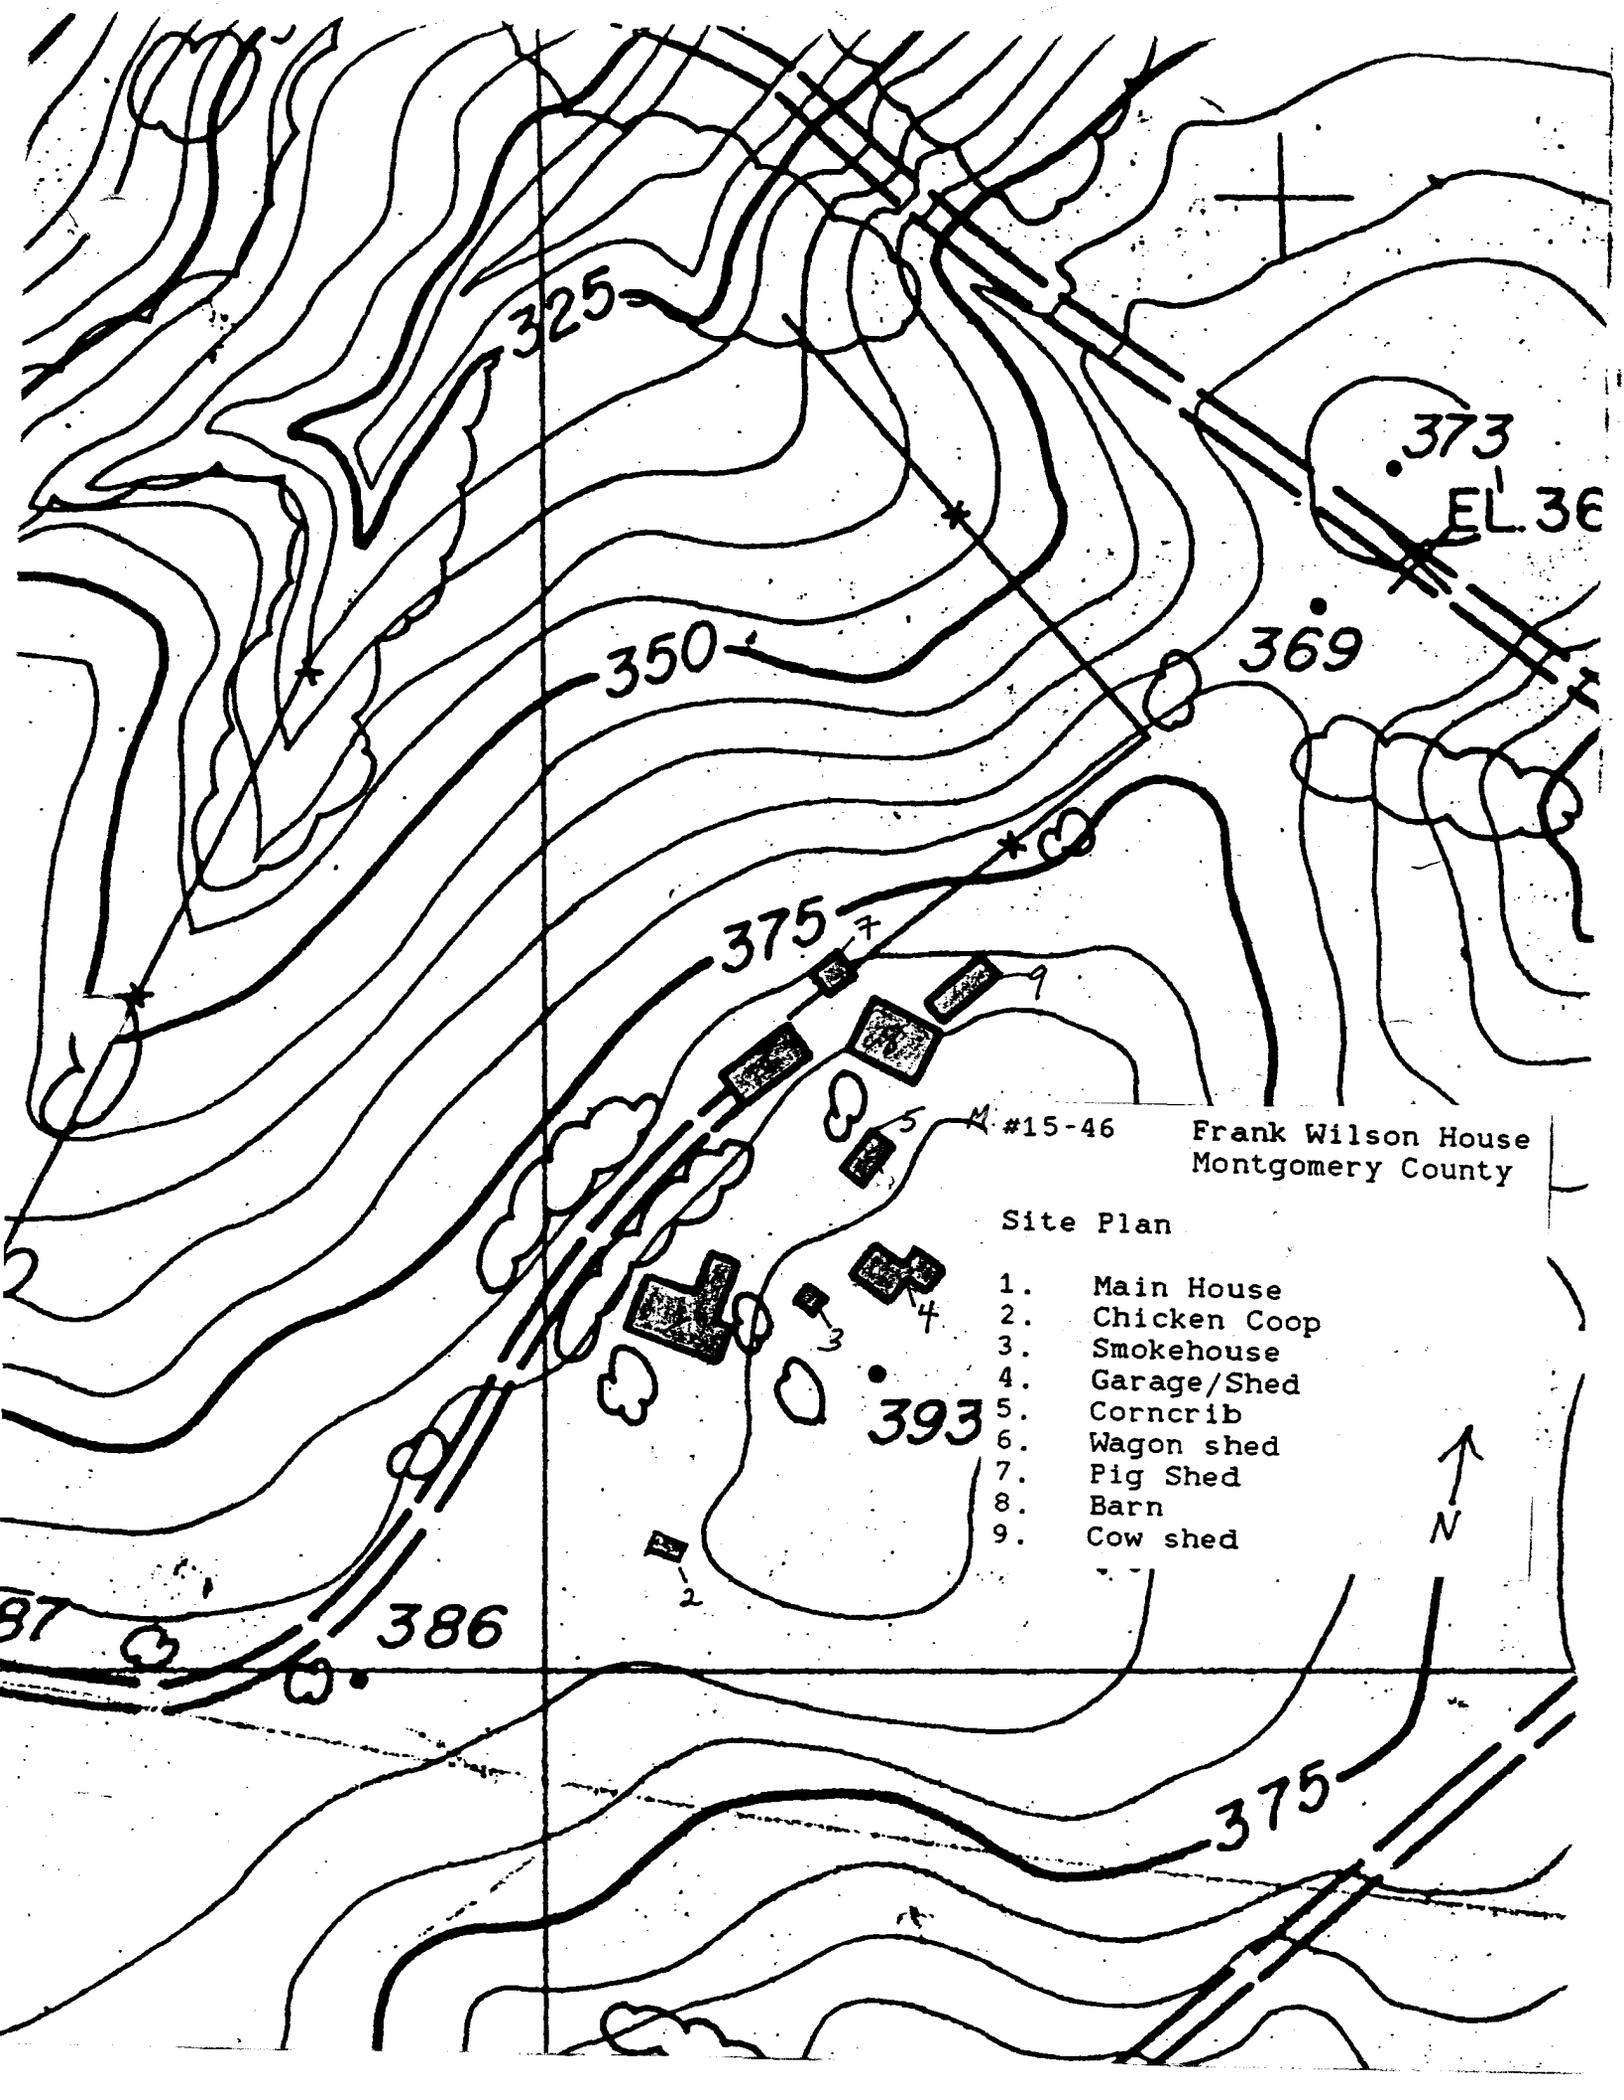
Site Plan

[See site map for location and layout of the farmhouse and outbuildings].

- 1. Main House
- 2. Chicken Coop
- 3. Smokehouse
- 4. Garage/Shed
- 5. Corncrib
- 6. Wagon shed
- 7. Pig Shed
- 8. Barn
- 9. Cow shed

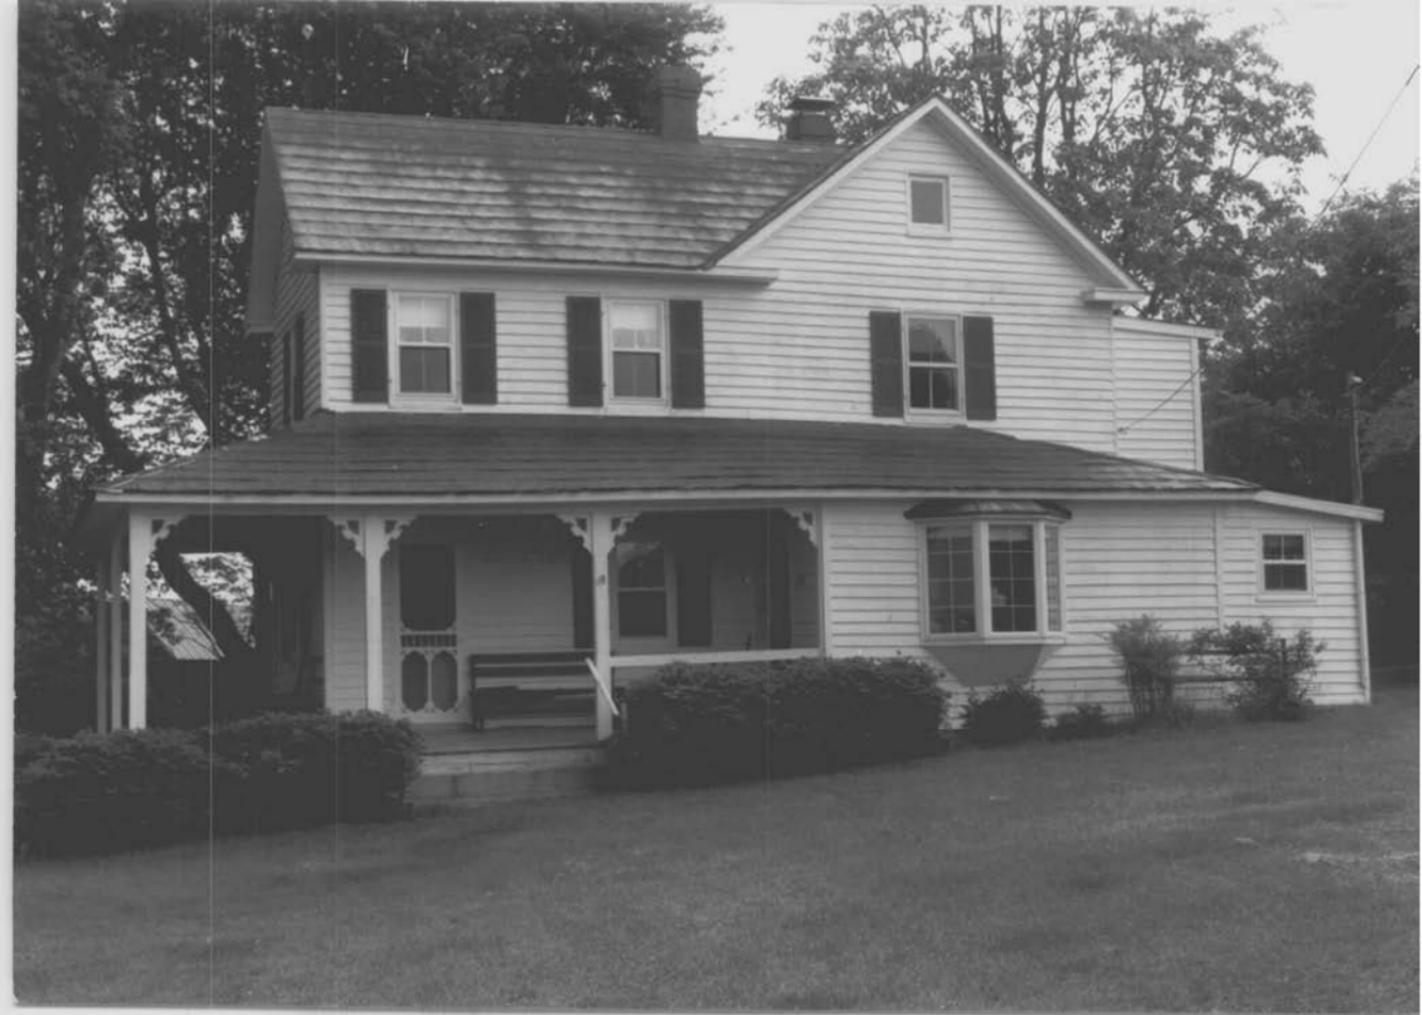
1 OF 8

The Wilson House is a two-story frame gable front and wing building with clapboard walls and a moderate pitched roof covered by metal shingles. The two-story building has a general overall L-plan with a gable and wing core built ca. 1894 with a rear ell that was originally a double-pen log house constructed ca. 1865. The principle elevation of the house faces southwest overlooking a gentle sloping yard and the curvilinear drive that becomes Link Road.

The front of the building has a three-bay facade with a symmetrical rank of two-over-two windows on the second story. The first level has a simple side entry with spindlework screen door and two-over-two window. A one story hipped roofed, L-shaped porch, supported by simple posts ornamented with scrollwork brackets, wraps around the building's south and west elevations. A projecting oriel window with three fixed six pane windows has been added to a porch infill on the main facade's first level, which also has a simple entry off the porch.

VIEW NW

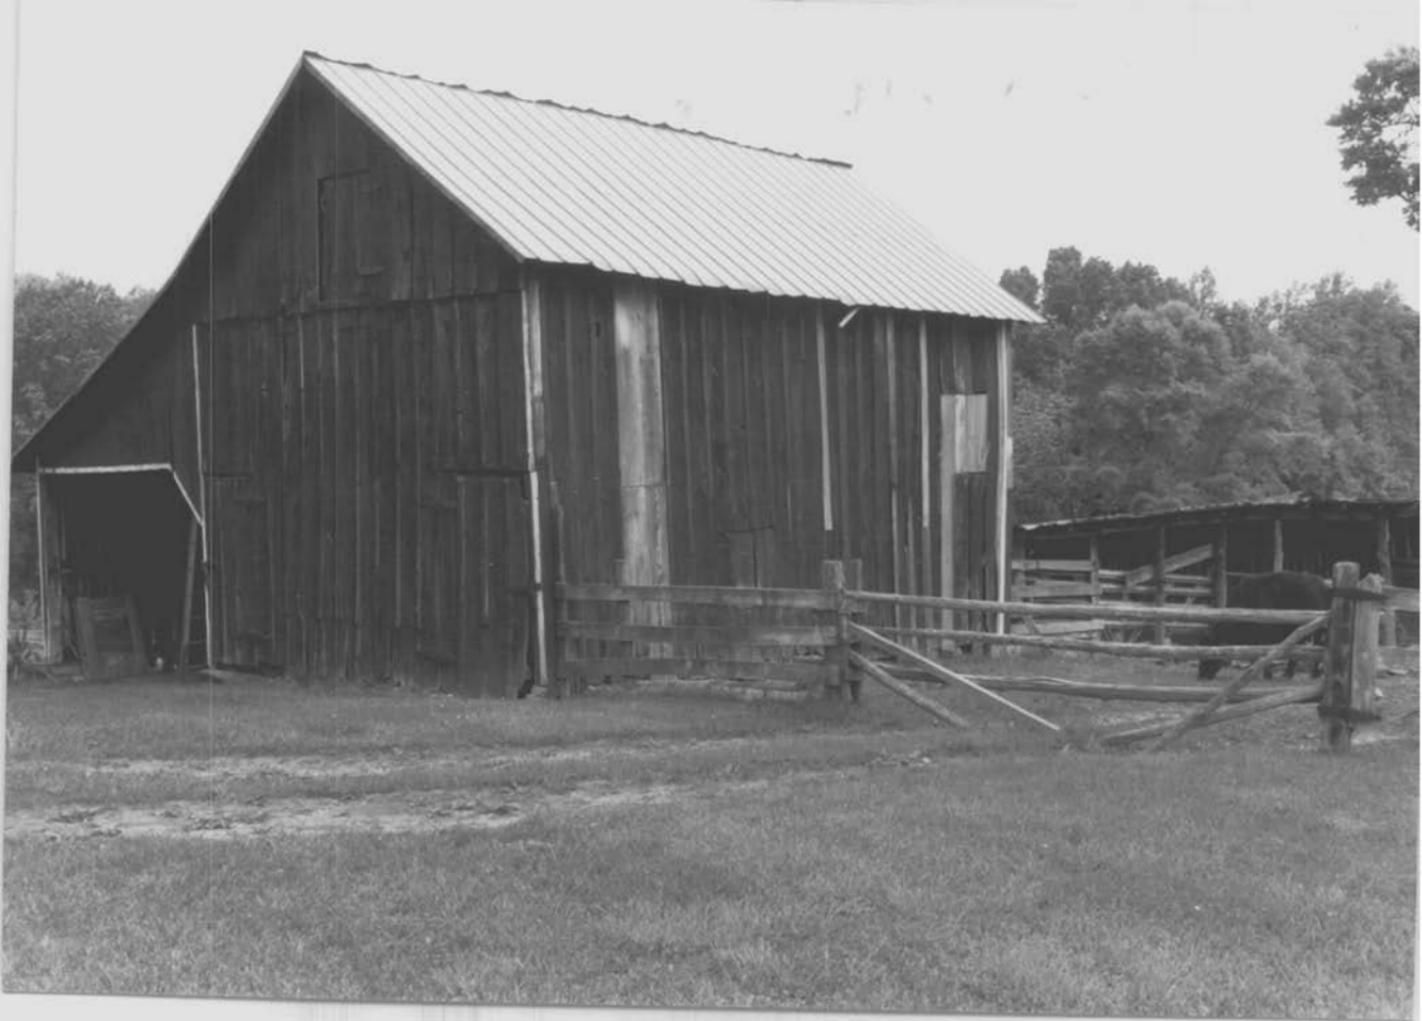
2 OF 8

A gable end single crib barn (ca. 1894) with one side bay used as wagon or harness shed is located to south of main house. The structure has a hand hewn log frame, board and batten siding and a raised tin roof.

BARN

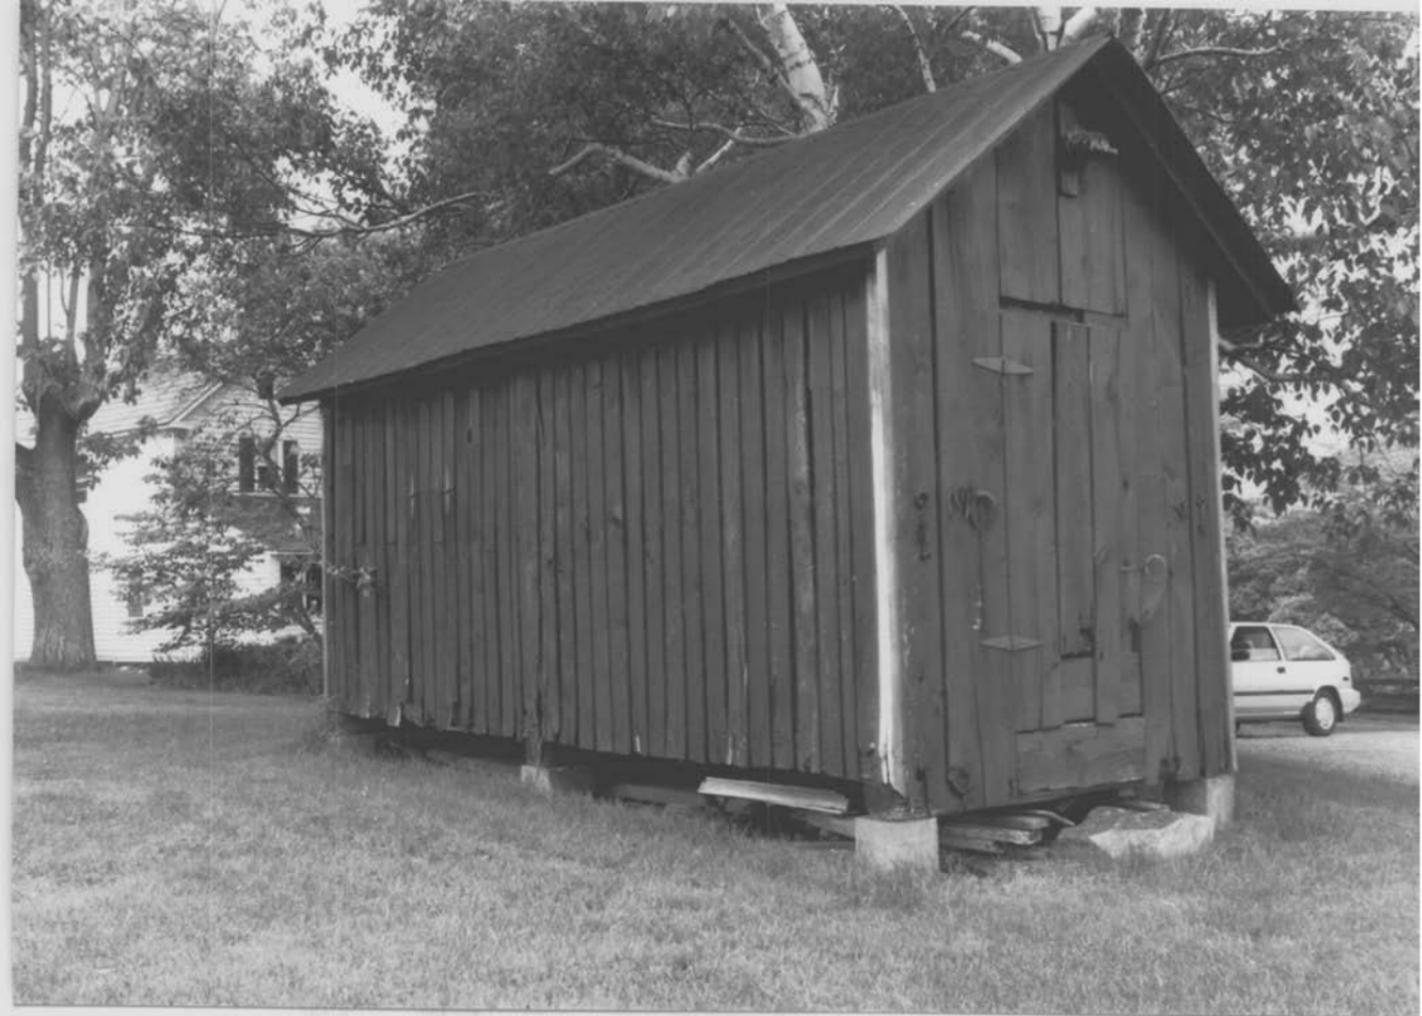
7 OF 8

This corncrib (ca. 1894) is a gable end rectangular structure covered by a metal roof and sided with slats spaced for ventilation. A hinged gable end door allowed entrance to the crib.

CORN CRIS

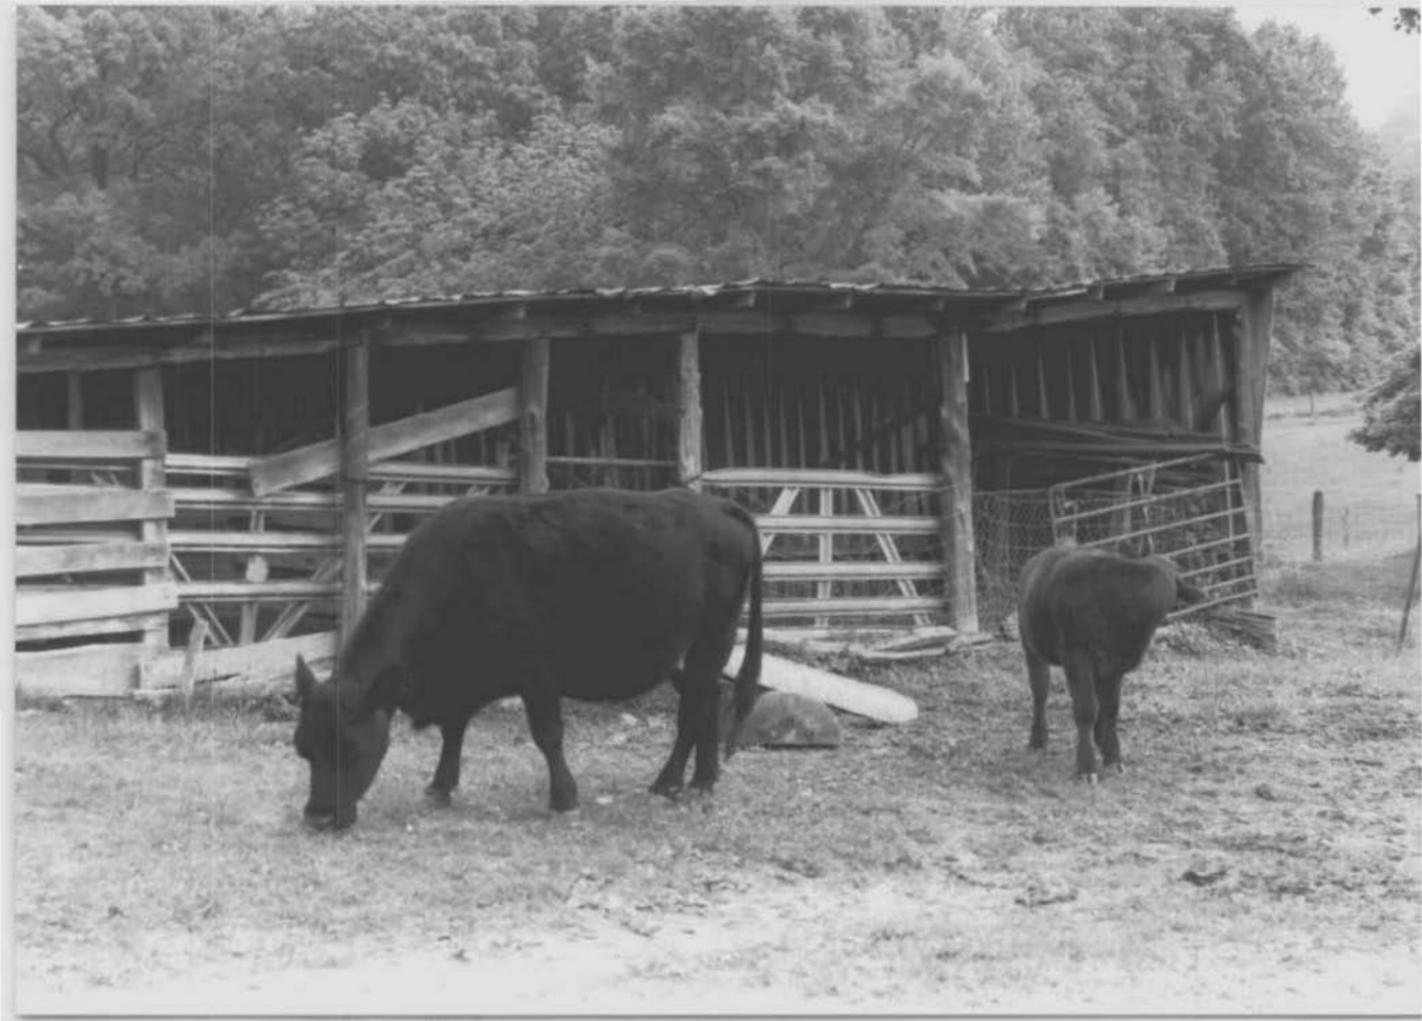
8 OF 8

A deteriorated cowshed (ca. 1894) is located just south of the barn. The structure is crude lumber nailed to a framework of sapling poles covered with a raised tin shed roof.

COW SHED

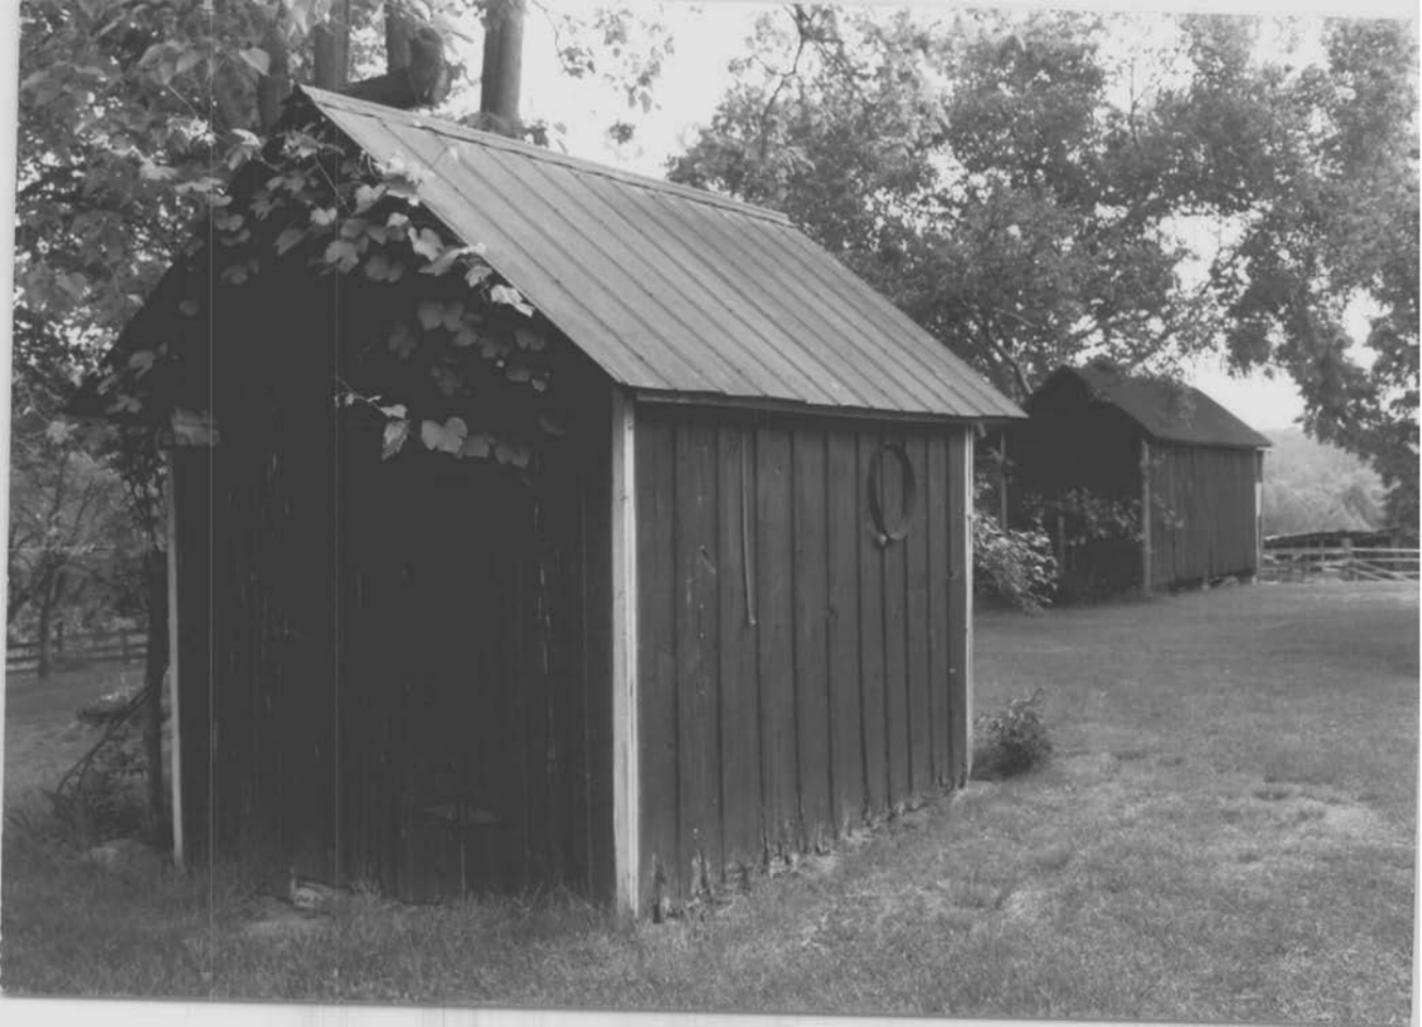
5 OF 8

Just to the northwest of the main house is a one-story gable end rectangular board and batten smokehouse (ca. 1894).

SMOKE HOUSE

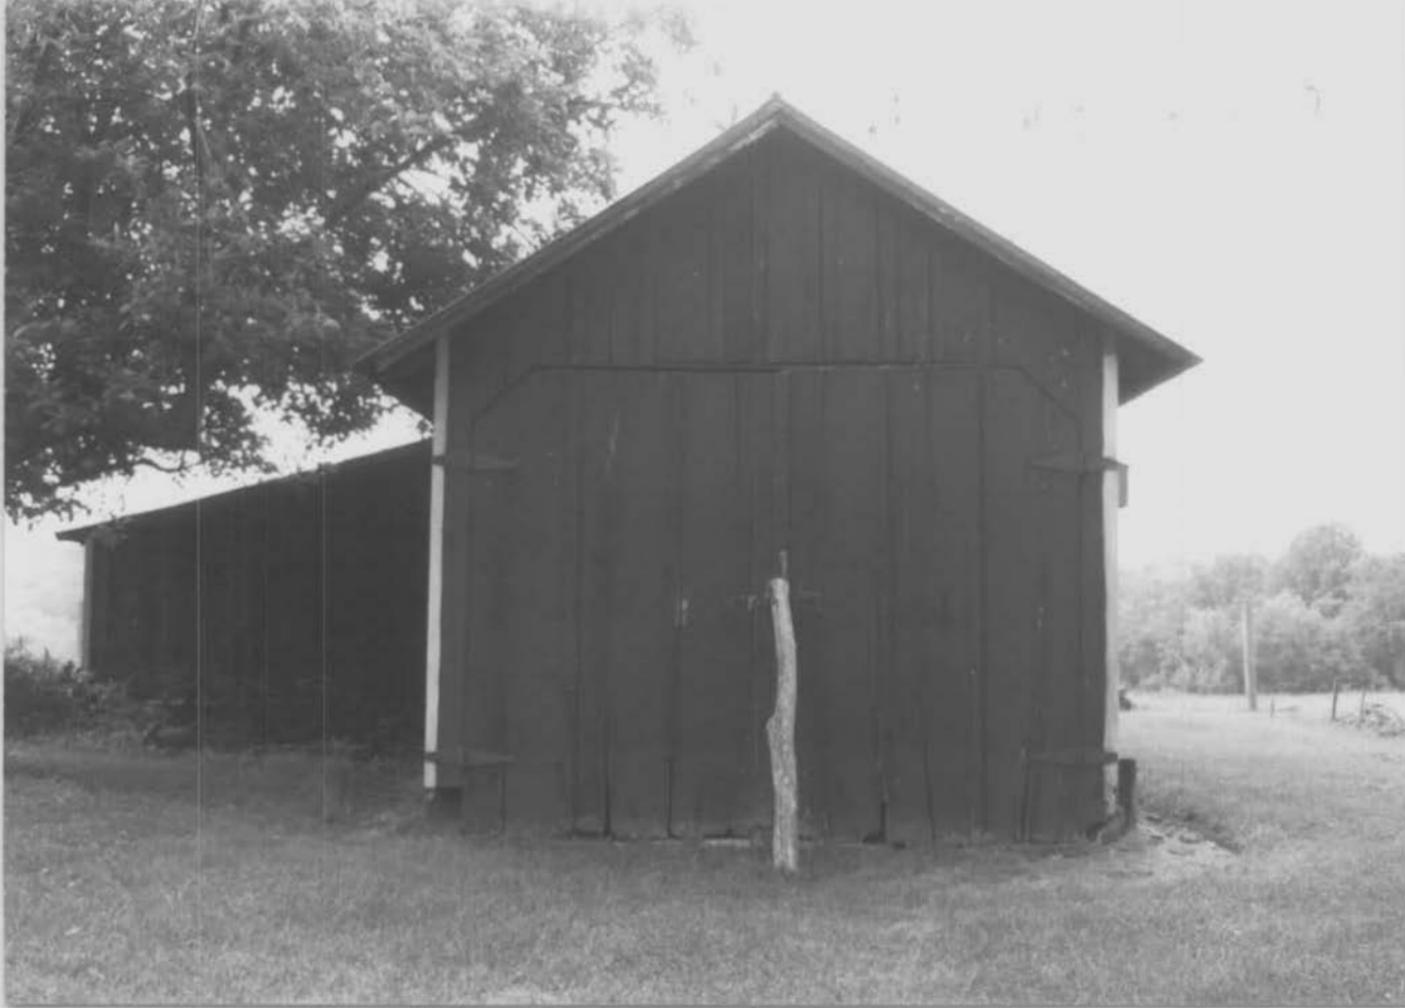
6 OF 8

A gable end rectangular garage/shed with a shed roof addition was erected in the 1920s. It is located just to the northwest of the smokehouse.

GARAGE / SHED

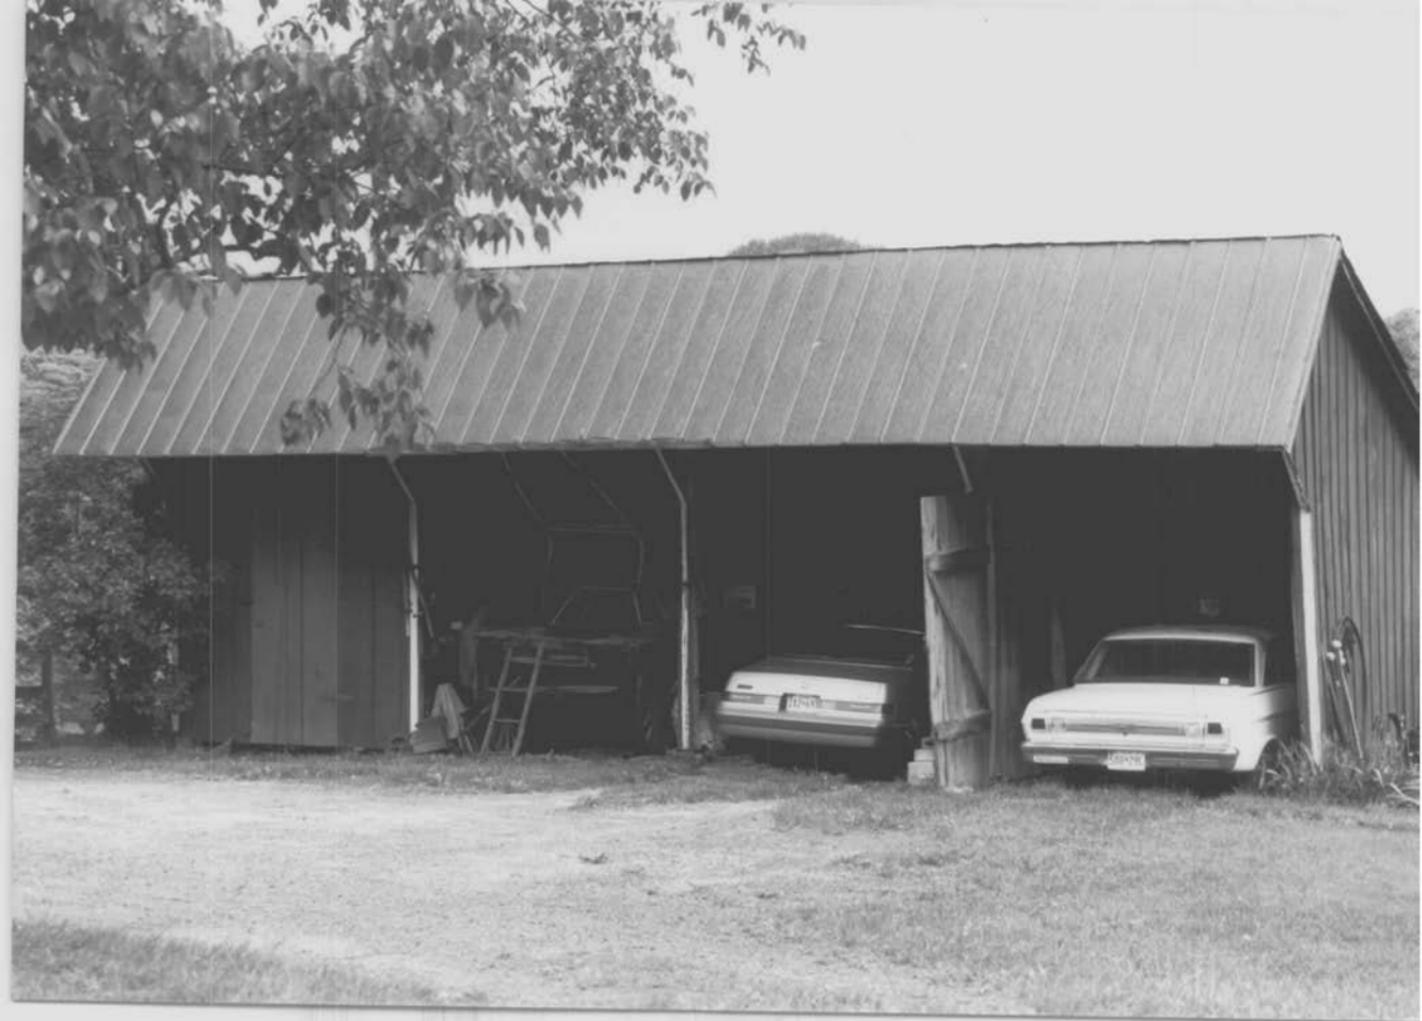
30F 8

A wide one story frame wagon shed (ca. 1894) with three bays and a side wheat bin is located to the southwest of the house. The board and batten structure has a raised tin shed roof with a pent roof built over the wagon bays to create loft space to store implements and tack.

WAGON SHED

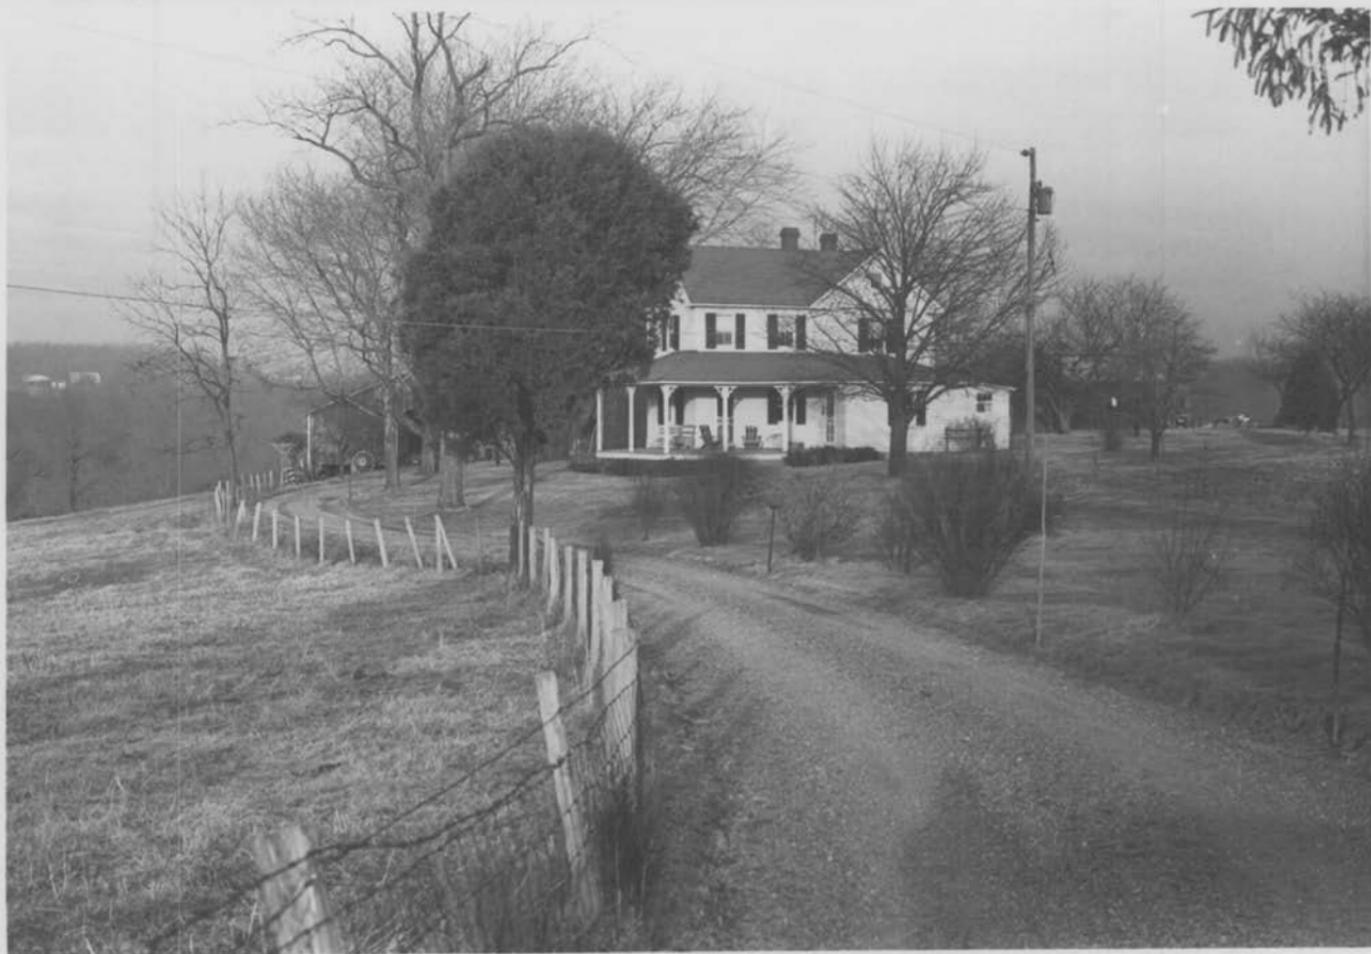
#15-46

The house is a 2-1/2 story L-shaped farm house with a porch running between the legs of the "L" and along the west facade. The porch posts are chamfered and are joined to the boxed cornice with ornamented brackets. The screen doors are in the stick style..

FACADE S.E.
