**Maryland Historical Trust  
State Historic Sites Inventory Form**

Survey No. M: 16-2

historic Edward J. Chiswell Farm Complex

street & number 20130 Wasche Road N/A not for publication

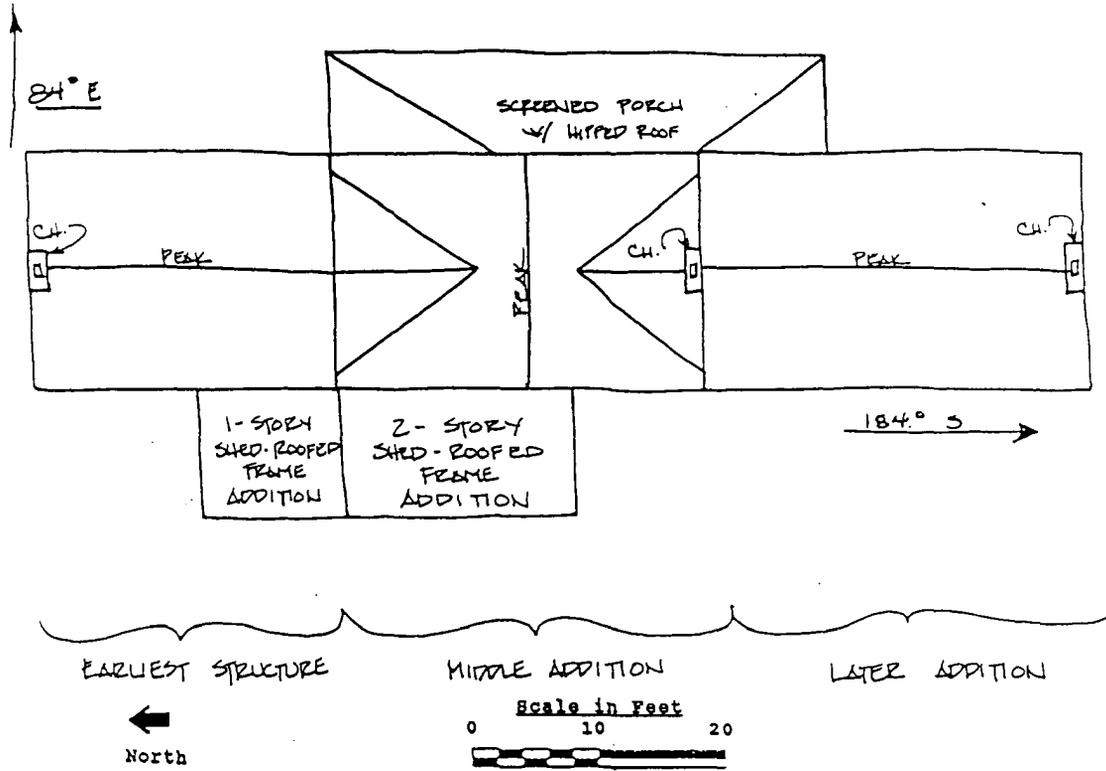
ROOF PLAN  
CHISWELL HOUSE

The Chiswell House sits on an elevated ridge overlooking what appears to be an earlier road bed passing by the property. There is evidence of crude terracing extending down to the former road on the east.<sup>1</sup> The house, constructed of Seneca sandstone, is a long rectangular structure that faces east. Vertical seams clearly indicate that the house was constructed in three distinct parts. These parts include the 23 ft. x 15 ft. two story, three-bay kitchen section on the north constructed ca. 1830; the 30 ft. x 15 ft. two-story addition on the south constructed ca. 1880; and a three-bay, 2-1/2 story middle addition that connects these two parts. The 2nd floor of the middle addition is frame; physical evidence shows that it was added in the late 19th century after the 1st floor of the middle addition was constructed. The building is surmounted by an asphalt shingle roof.<sup>2</sup> Both the kitchen section and south addition have end-gable roofs; the middle addition is surmounted by a cross-gable roof. The cross-gable forms a central element in the composition, unifying the front facade. A long screened porch placed at center of the front of the house further ties the three elements of the front facade together. The porch's position at the center of the front facade, rather than the central section, suggests that its present form dates no earlier than the south addition. There are small, frame shed additions attached to the west facade of the kitchen section and middle addition. The house has interior end chimneys; a third chimney is located at the south end of the cross-gabled section.

The Chiswell House is constructed of load-bearing cut sandstone laid in a coursed pattern. Only the south addition has a basement; the middle addition and kitchen section rest on a crawl space. The 2nd

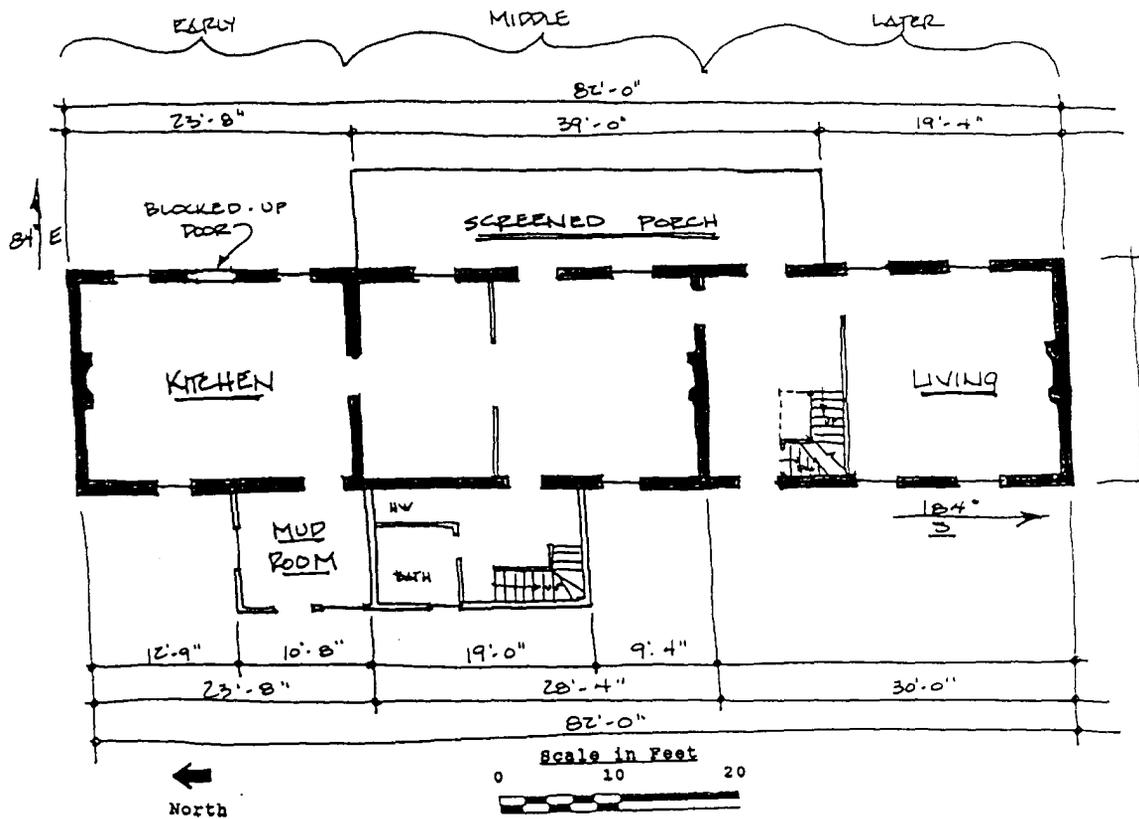
FLOOR PLAN - FIRST FLOOR  
 CHISWELL HOUSE

The proportions, configuration, and exterior appearance of the kitchen section are consistent with an early 19th century date of construction. There is a door opening at the center of the east facade that is now infilled with sandstone. The interior of the kitchen section has been completely altered; there is no visible interior fabric that predates the 20th century. While the exterior reads as a 2-1/2 story building, the interior consists of a single, open space. The original 2nd floor has been removed and a new ceiling has been dropped below the heads of the 2nd floor window openings. The interior end chimney on the north has been enclosed with recent cabinetry and paneling. The floor level of this section is the lowest in the house.

While the 1st floor of the middle section could post-date the southern addition, the existence of the former end chimney along the south wall of the middle section coupled with the visible shoulder within the 2nd floor hall of the southern addition suggest that the middle section was originally a one-story addition to the kitchen section, to which the southern addition was later attached. Also an opening that was probably a former entry has the splayed jambs that characterize the southern addition. The absence of a stair within the older stone portion of the addition adds to the evidence that the frame 2nd floor was constructed after the 1st floor of the middle section.

The 1st floor of the middle addition is a single large room divided by an arched beam. Unlike the southern addition, the interior finishes of the 1st floor of the middle addition vary, suggesting that the 1st floor evolved over time. The middle addition can be accessed from the kitchen section and the south addition. A bead board wainscot extends around the room. The frame mantel along the south wall consists of a shelf supported by simple pilasters and brackets. Some of the window openings have paneled jambs. A narrow stair in the later shed addition at the rear of the middle section provides access to the 2nd floor. Plumbing is also housed within the shed addition.

The interior of the south addition has been little changed. This section has a sidehall plan with the stair located on the north. The stairhall serves as the primary entrance to the house. All openings are splayed and display symmetrically molded trim with bulls-eye corner blocks. The open-string stair features turned balusters and a heavy, turned newel. The ceiling appears to have been replaced; none of the rooms have cornices.

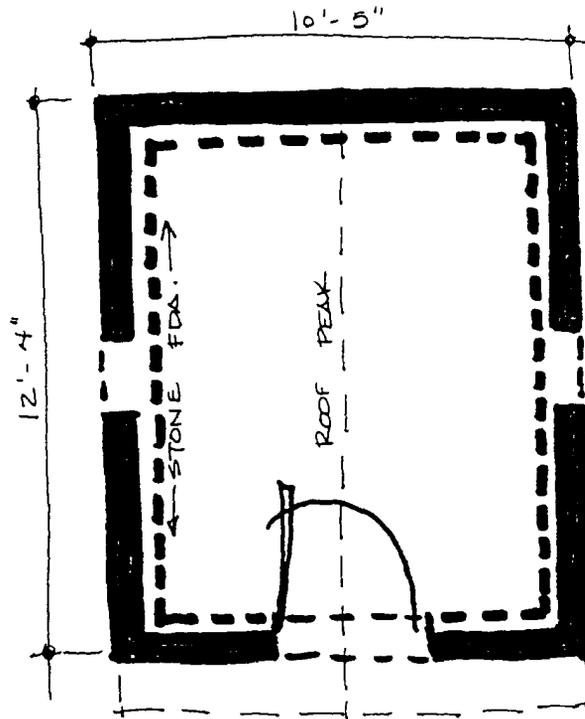
FLOOR PLAN  
STONE OUTBUILDING

A one-story stone outbuilding is situated 20 ft. to the west of the north end of the kitchen section of the Chiswell House. The building is constructed of Seneca sandstone laid in a courses. The axis of the outbuilding, which is in fair condition, corresponds to the axis of the Chiswell House. The approximately 12 ft. x 10 ft. building is surmounted by a sheet metal gable roof. The south gable is detailed with beaded tongue and groove planking. There is a door opening on the south and window openings at ground level in the east and west walls. There is no evidence of a spring presently visible. Because of its 19th century date of construction and functional relationship with the principal residence on the site, this stone outbuilding contributes to the significance of the Chiswell Farm Complex.

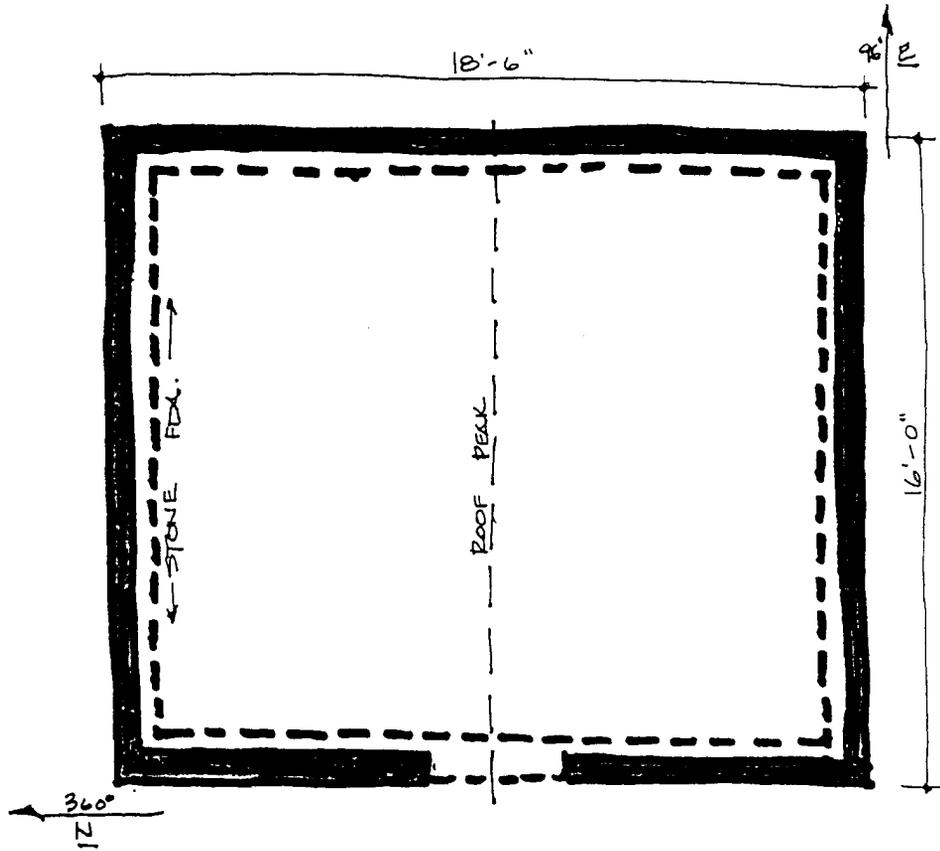
FLOOR PLAN  
STONE OUTBUILDING/ICE HOUSE

A stone structure that appears to have been an ice house is situated below and to the northeast of the Chiswell House. This outbuilding is constructed of Seneca sandstone. The west wall of the outbuilding, which measures approximately 18 ft. x 16 ft., is set into the bank of the ridge. The entrance to the structure is on the west. The building is in deteriorated condition; the south wall of the structure has virtually collapsed. Like the stone outbuilding closer to the house, the original roof of this stone outbuilding also appears to have been replaced. The stone outbuilding (ice house) has a gable roof with tongue-and-groove planking used within the gable.

Because of its 19th century date of construction and functional relationship with the principal residence on the site, the Stone Outbuilding (Ice House) contributes to the significance of the Chiswell Farm Complex despite its deteriorated condition.

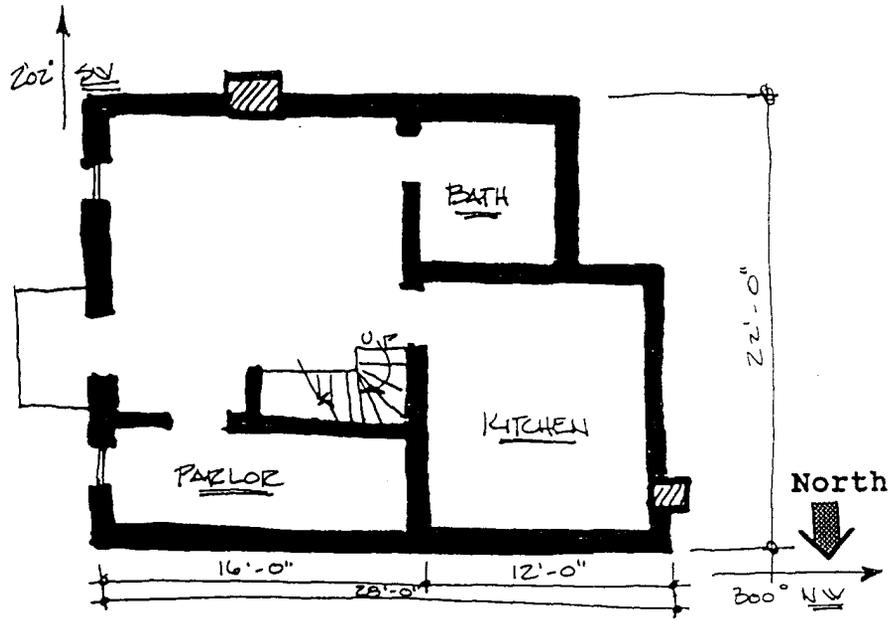
FLOOR PLAN  
TENANT HOUSE

There is a two-story vernacular frame house measuring approximately 20 ft. x 16 ft. situated about 625 ft. northwest of the Chiswell House. Artifactual material found in test pits adjacent to the house suggests that the building was constructed no earlier than the late 19th century. The house, which faces west, is constructed over a crawl space enclosed with a rubble stone foundation of sandstone with cement mortar. There is a major repair to the foundation at the northeast corner of the house. The building is topped with a standing seam metal roof. The exterior of the house is clad with asbestos shingles. There is an exterior end chimney on the south side of the house. The windows have 6-over-6 sash. On the east side of the house, a 20th century one-story shed addition built on a concrete block foundation encloses a kitchen and bathroom. The east wall of the kitchen has a block and brick chimney used to vent stoves. The balloon frame house is constructed with studs 2 ft. on center. The interior of the house is finished with plaster above a bead board wainscot. A well capped with concrete is situated near the kitchen on terrain that slopes up from the house.

The tenant house contributes to the significance of the Chiswell Farm Complex. Although it may date to the early 20th century, the similarity between the finish of the interior of the tenant house and the interior of the 1st floor of the middle addition of the Chiswell House indicate a relationship between the two buildings.

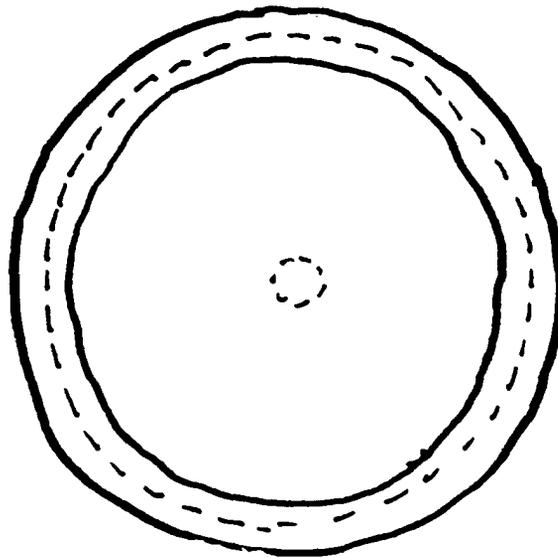
FLOOR PLAN  
IMPROVED SPRING

A natural spring on the west side of the road from the bank barn has been set within a 24 ft. diameter stone basin covered by a brick beehive cone approximately 18 ft. in diameter. The stonework appears to date from the 19th century; the brickwork from the 20th. Because the stonework appears to date from the 19th century and because the spring itself could correspond to the "Still House Spring" mentioned in the 1802 will of Carlton Belt, Sr., the improved spring contributes to the significance of the Chiswell Farm Complex.

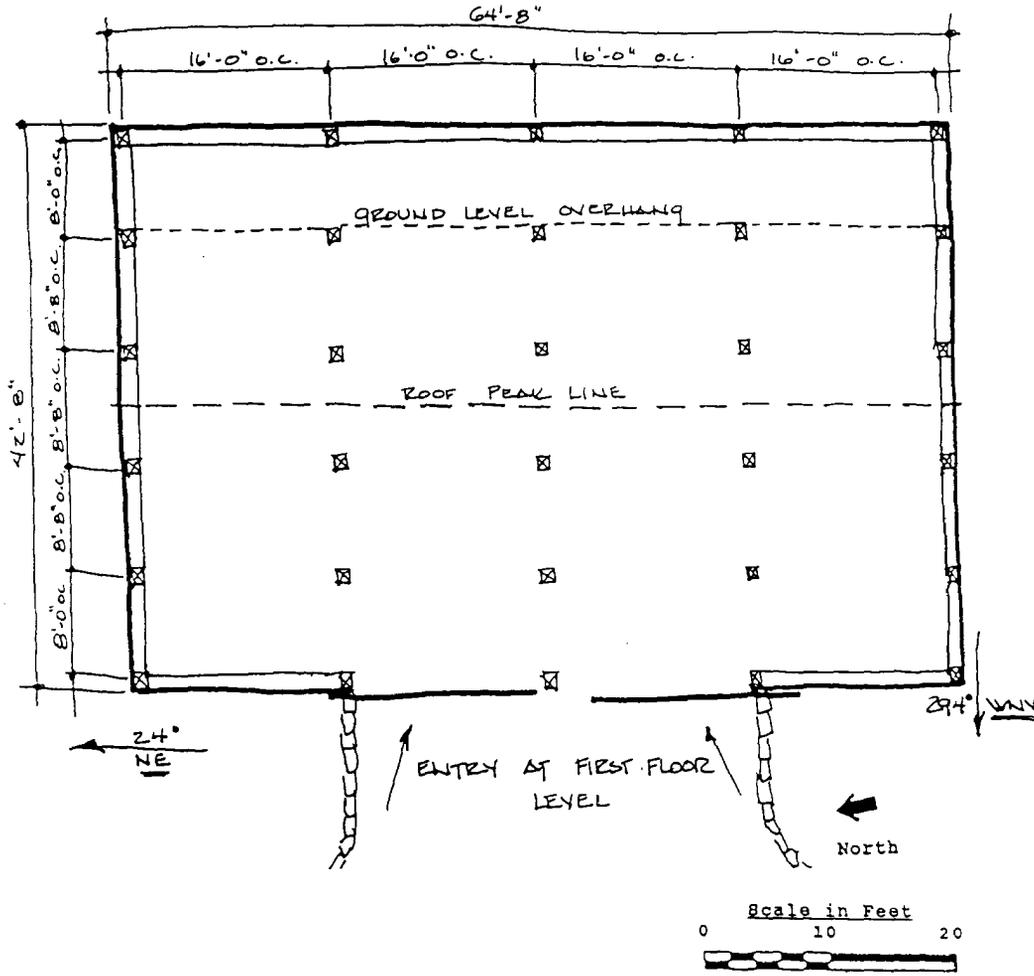
FLOOR PLAN  
BANK BARN

The ca. 1880 four-bay bank barn is of post and beam construction with pegged 8" x 8" posts. The posts are 16 ft. on center on the north and south and 8 ft. on center on the east and west. The building rests on a three-sided coursed stone foundation. The barn is topped by a standing seam metal gable roof with the ridge line running north-south. The eastern side of the barn is open; its western side is built against a banked entrance. Asbestos shingles cover the plank walls. The building's visible fabric and appearance suggest a late 19th century date of construction consistent with the rise in the property's assessments in 1875-1885. The building contributes to the late 19th and early 20th century agricultural character of the Chiswell Farm Complex.

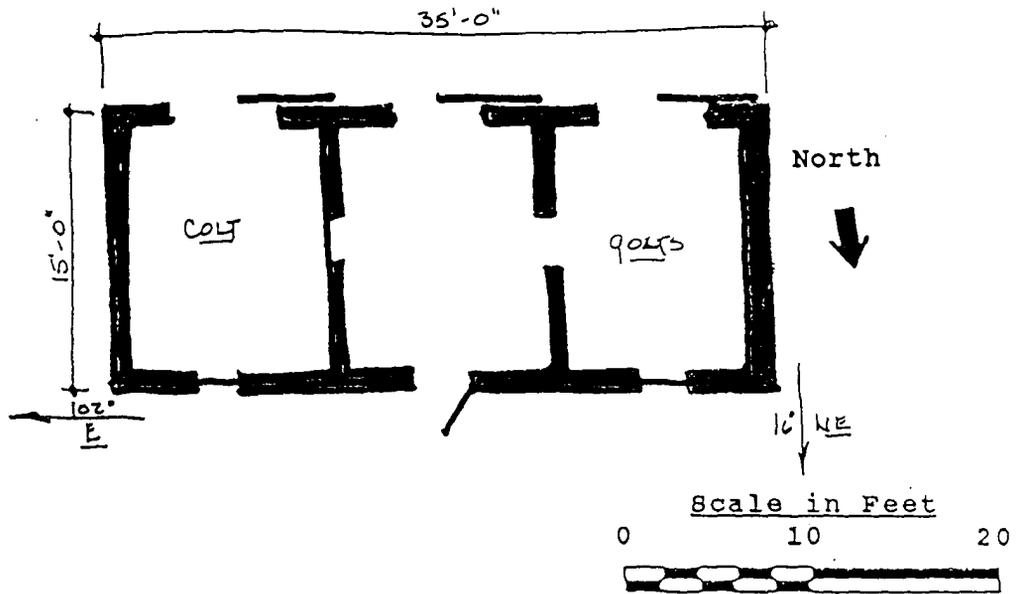
FLOOR PLAN  
STABLE

This timber frame building is located south of the bank barn. The 35 ft. x 15 ft. building rests on an uncoursed sandstone foundation that incorporates cement mortar. The sandstone foundation and timber framing suggest a late 19th or early 20th century date of construction. Both the date and use of the building contribute to the significance of the Chiswell Farm Complex.

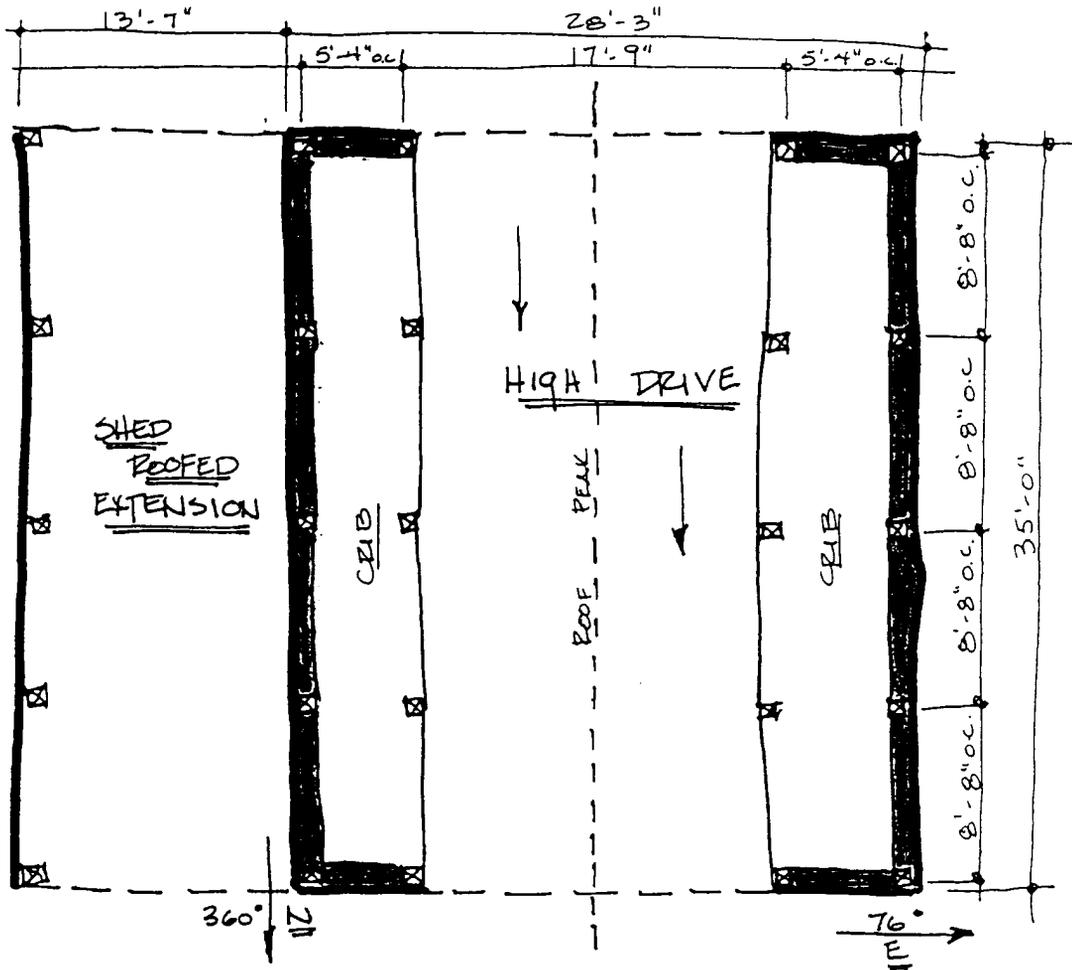
FLOOR PLAN  
WAGON SHED

The four bay Wagon Shed is situated between the Chiswell House and the Bank Barn. The frame structure contains two enclosed corn cribs separated by a longitudinal high drive that runs north-south through the building. Stone piers support pegged post and beam construction. The posts are placed 8 ft. 8 in. on center. Asbestos siding covers the building, which is topped by a tin gable roof. A shed roofed addition is attached to the building on the west.

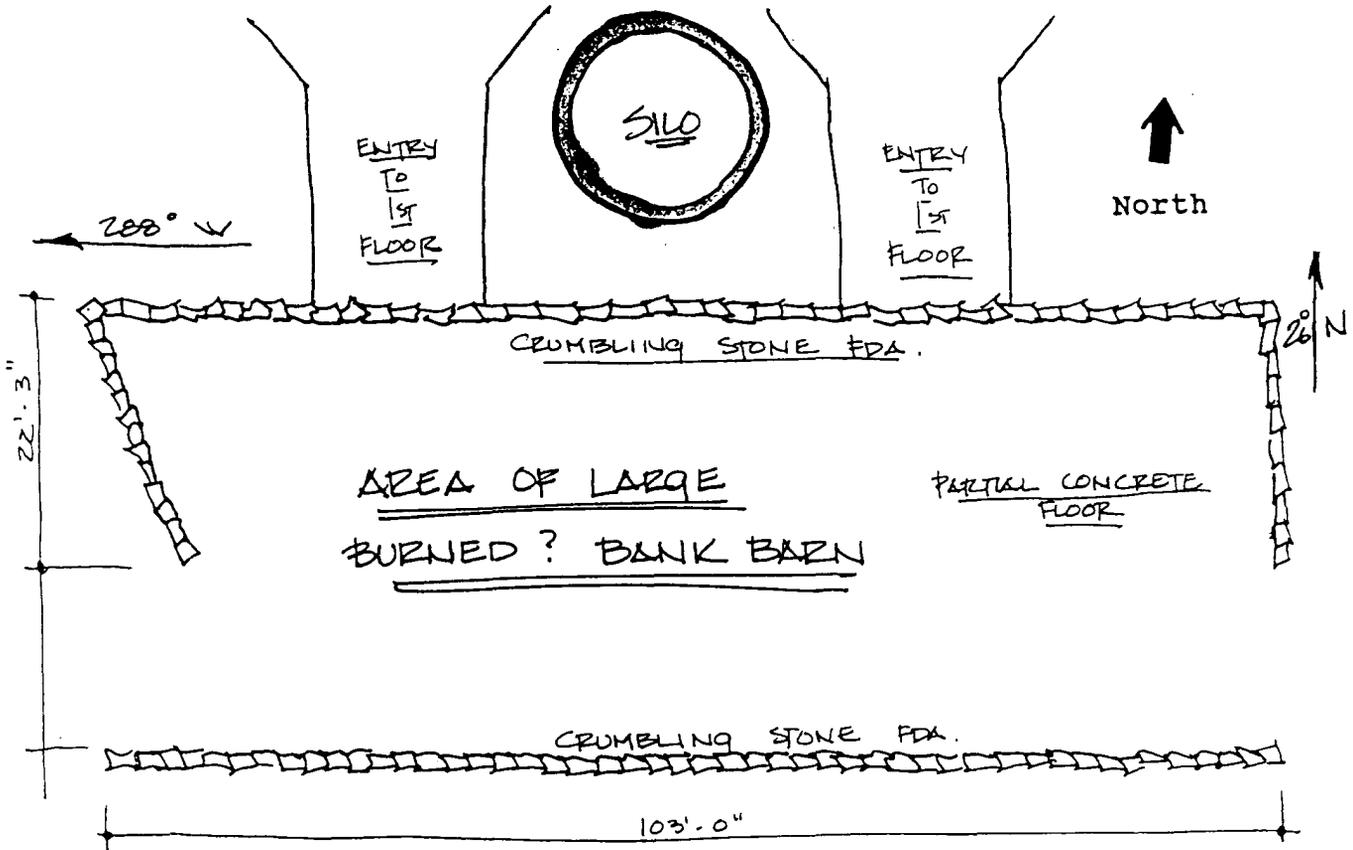
FLOOR PLAN  
BARN RUIN AND SILO

A mid-20th century concrete silo surrounded with steel lattice reinforcing is located at the southwestern corner of the settlement area of the Chiswell Farm Complex. The roof of the silo is missing. The silo is centered adjacent to ruins of a masonry bank barn. Remains of earthen ramps are located on the north side of the barn to either side of the silo. Archeological investigation demonstrated that the barn had been constructed on concrete footings. Steel reinforcing rods extending above the ruins provide

further evidence of a mid-20th century date of construction. While this feature relates to the agricultural use of the property, its late date falls outside the period of significance of the Chiswell Farm Complex.

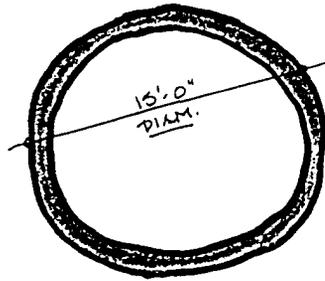
FLOOR PLAN  
SILO (NEXT TO BANK BARN)

A 15 ft. diameter concrete block silo is situated on the eastern side of the south wall of the Bank Barn. The roof of the silo is missing. Because of its 20th century date, the silo does not contribute to the significance of the Chiswell Farm Complex.

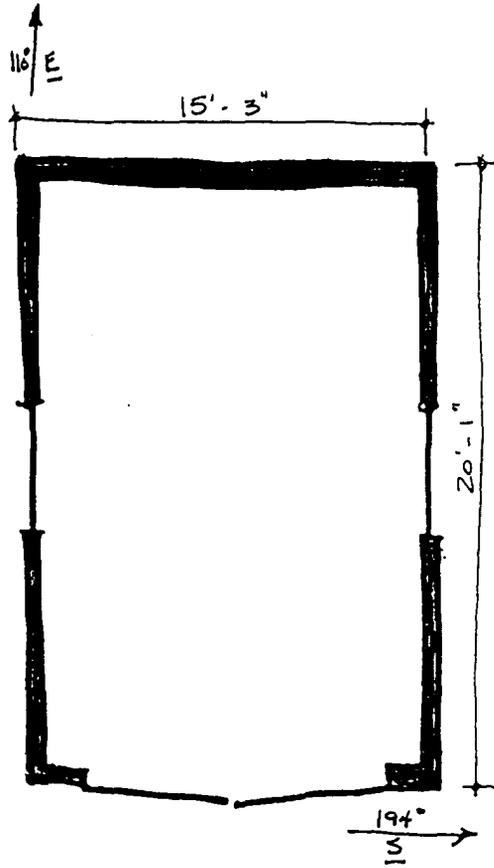
FLOOR PLAN  
GARAGE

The Garage is adjacent to the Tool Shed. Both buildings are located between the Chiswell House and the Wagon Shed. The board-and-batten walls are nailed to a rough dimensioned frame. The structure rests on a poured concrete slab and has a standing seam tin roof. The slab foundation indicates a mid-20th century date of construction. Because of its date, this building does not contribute to the Chiswell Farm Complex.

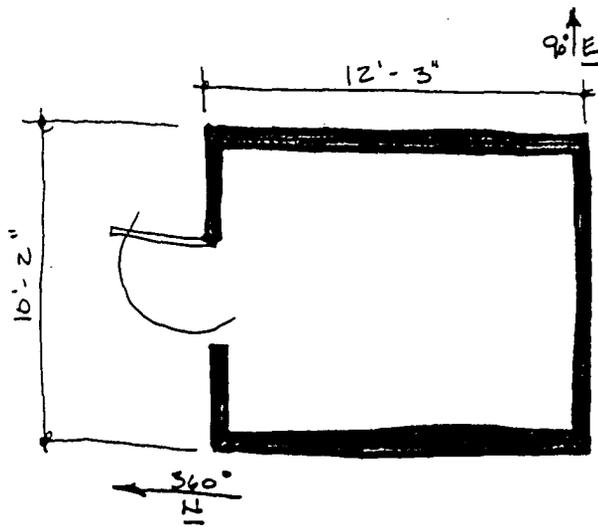
FLOOR PLAN  
TOOL SHED

The Tool Shed is located adjacent to the Garage. The structure has a vertical board exterior. The finish of the vertical boards indicates a mid-20th century date of construction. Because of its date, this building does not contribute to the Chiswell Farm Complex.

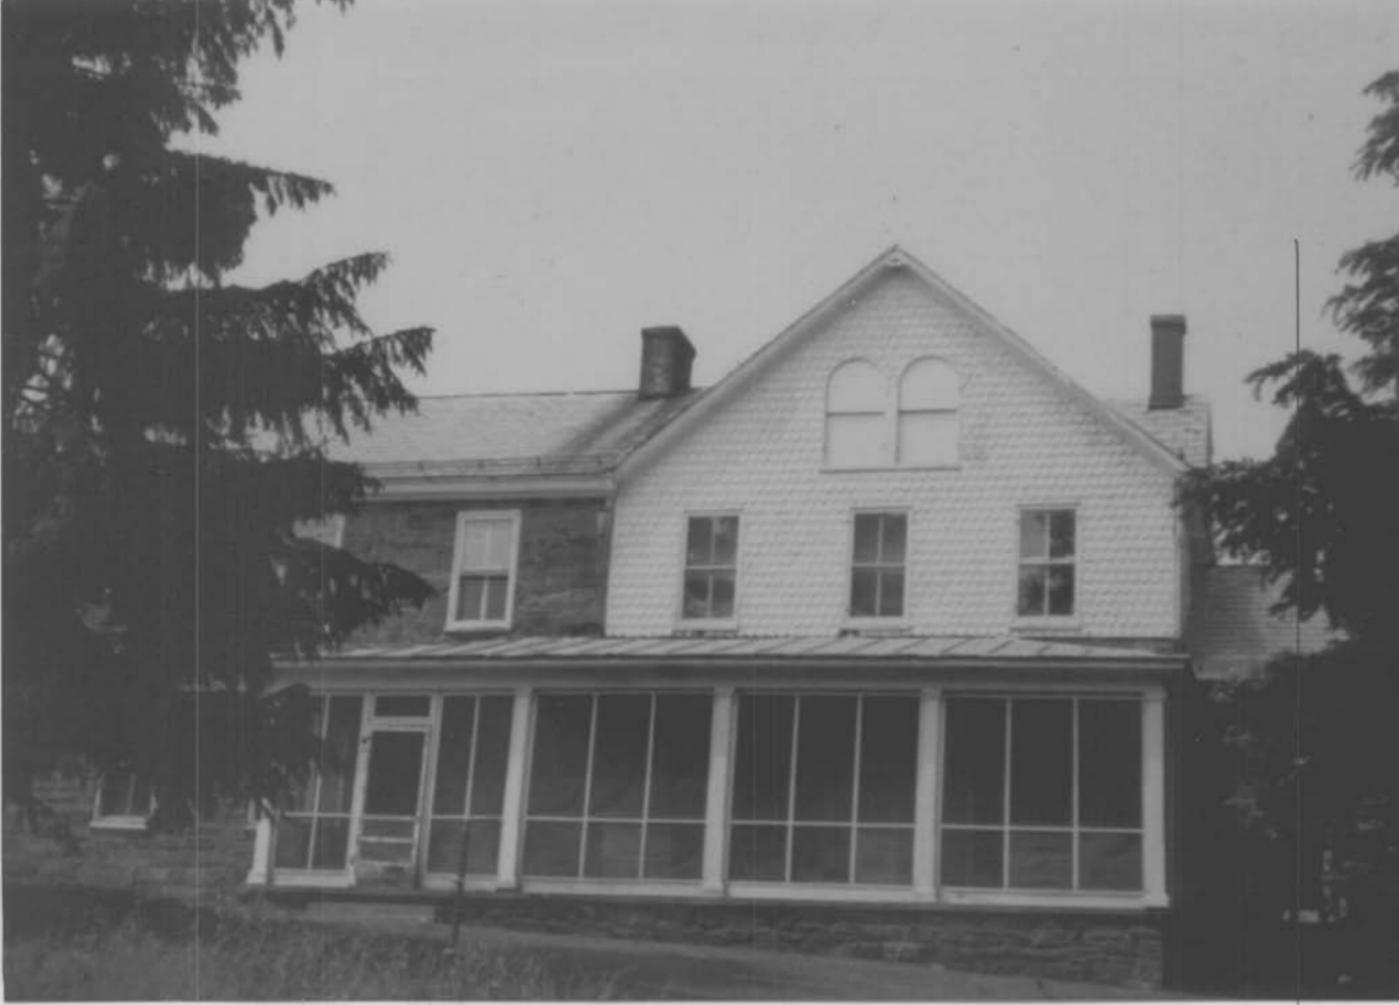
M: 16-Z

West Elevation, Looking East.

Vertical seam between middle section and southern section of house showing masonry of southern section overlapping top of middle section.

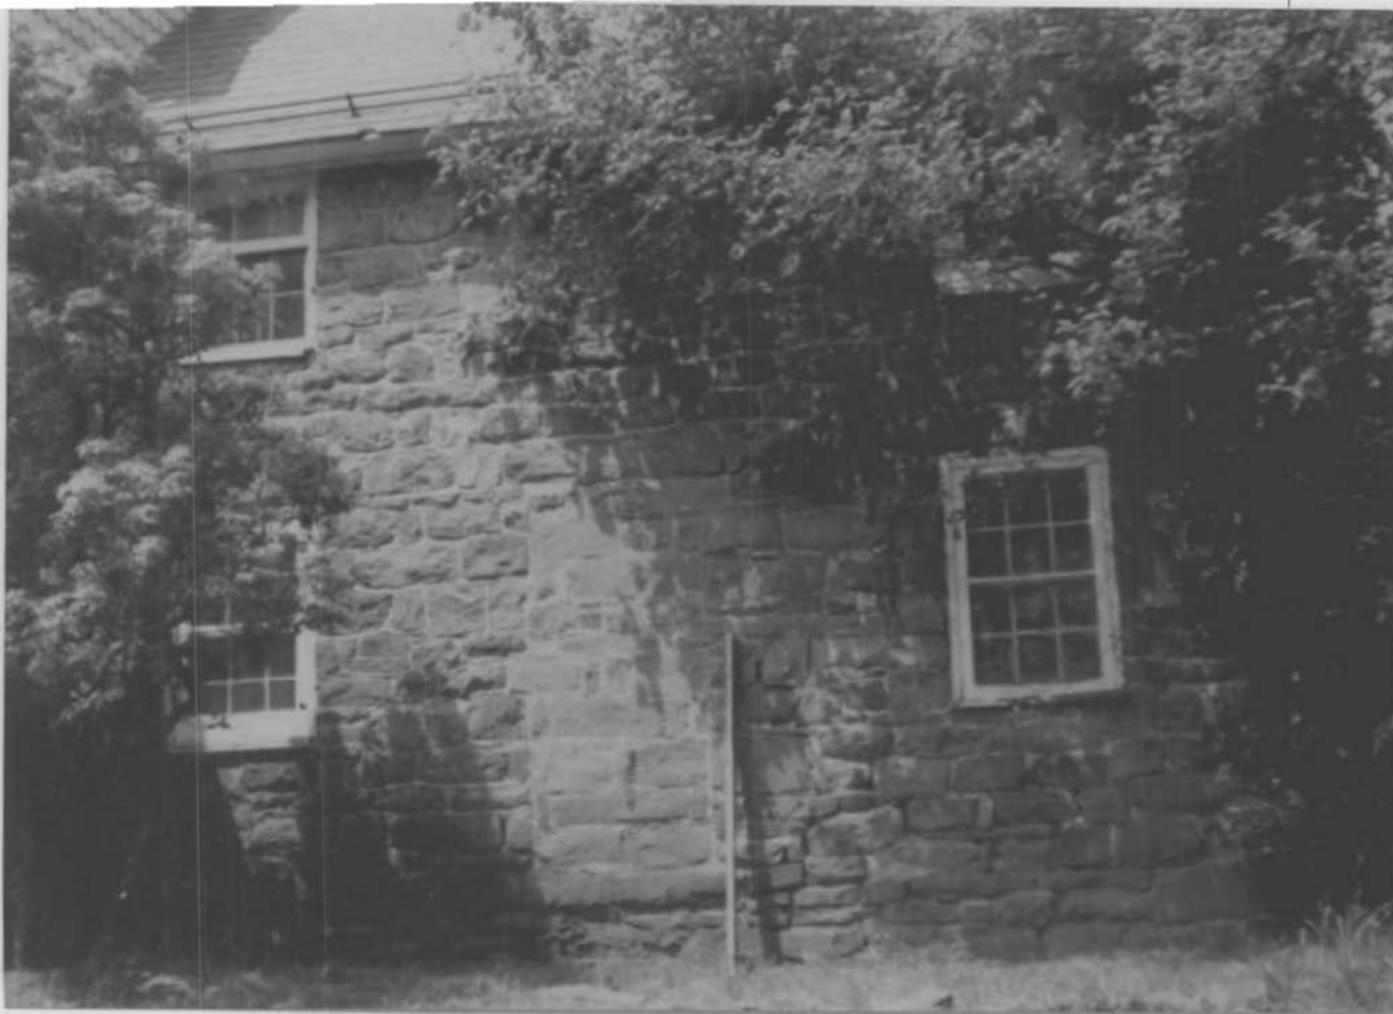
North Sections,

Showing doorway sealed with Masonry.

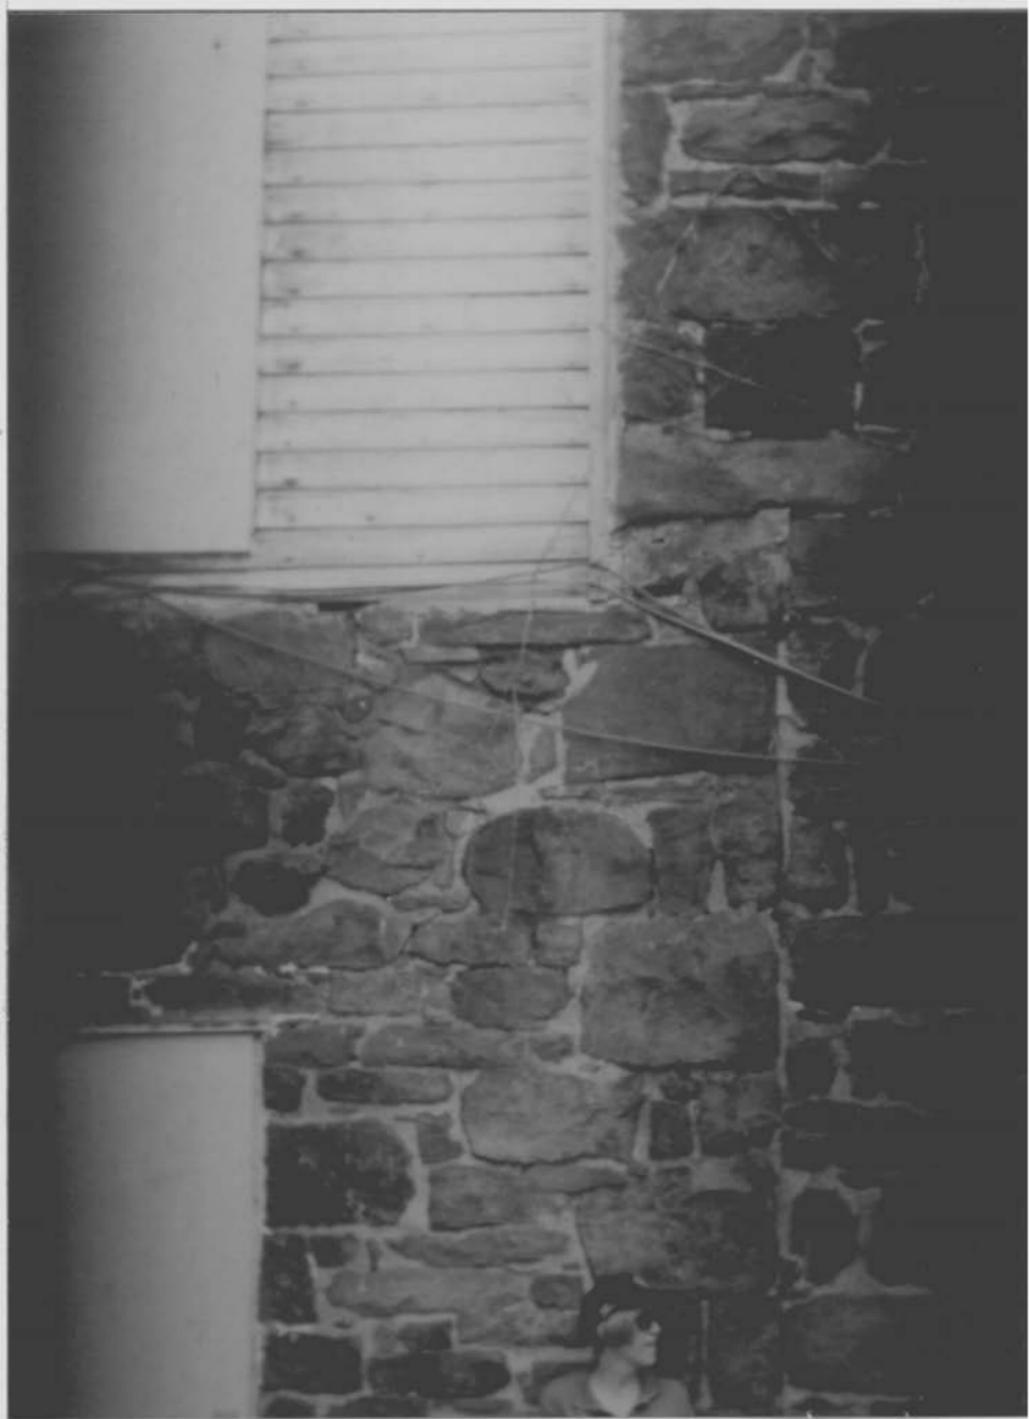
West Elevation, Looking East,

Vertical section between middle section and southern section of house showing masonry of southern section overlapping top of middle section.

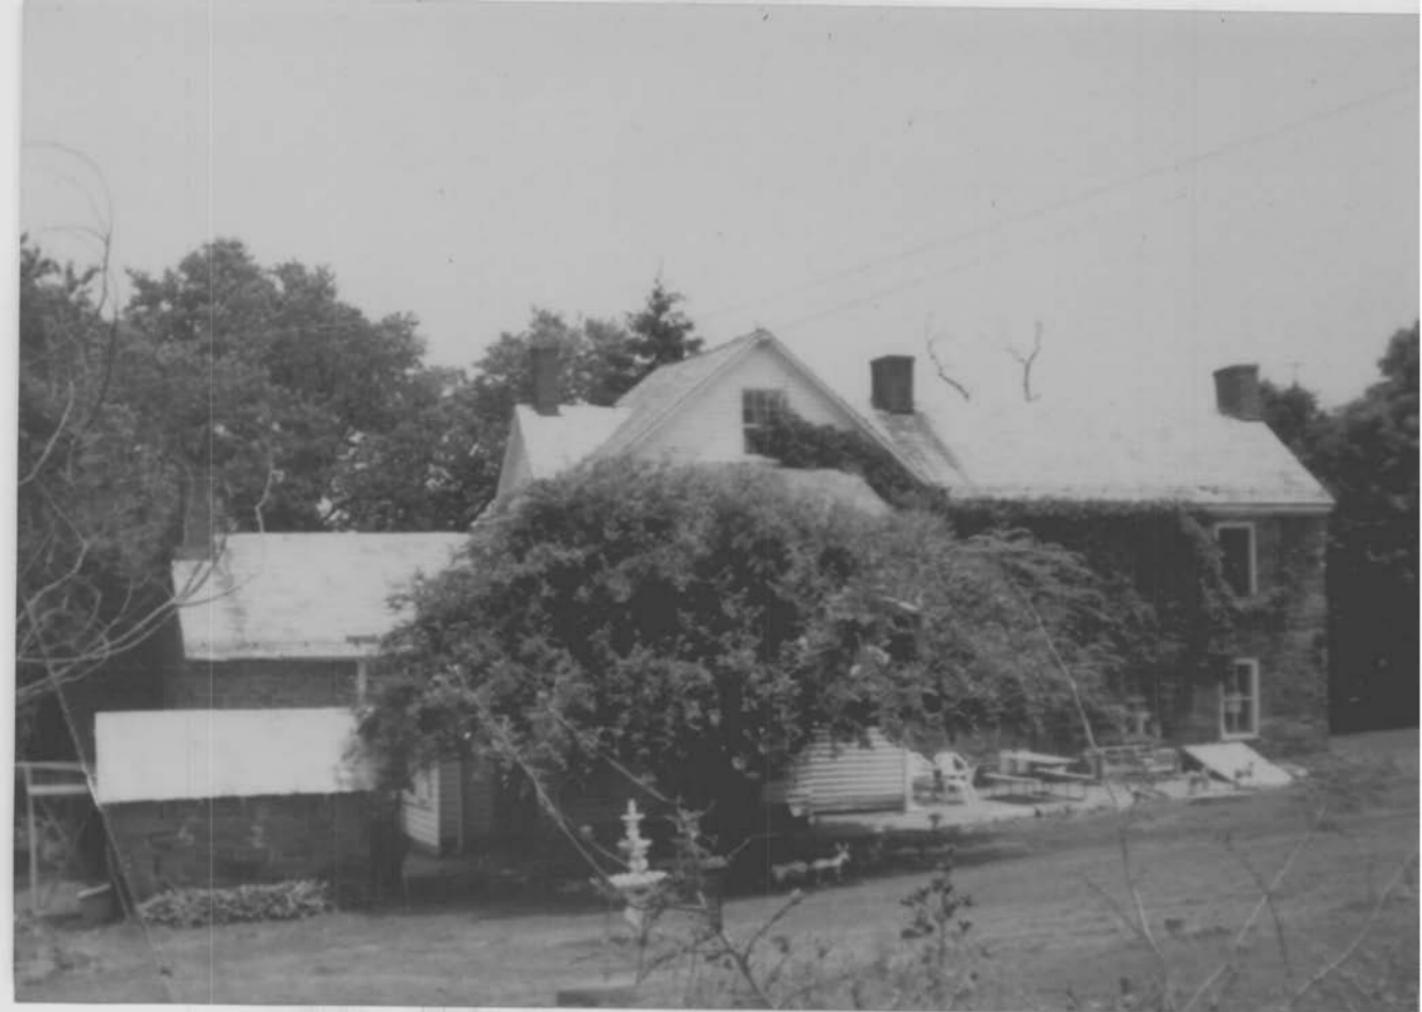
M: 16-2

Chiswell House and Stone Outbuilding

West Elevation, Looking East

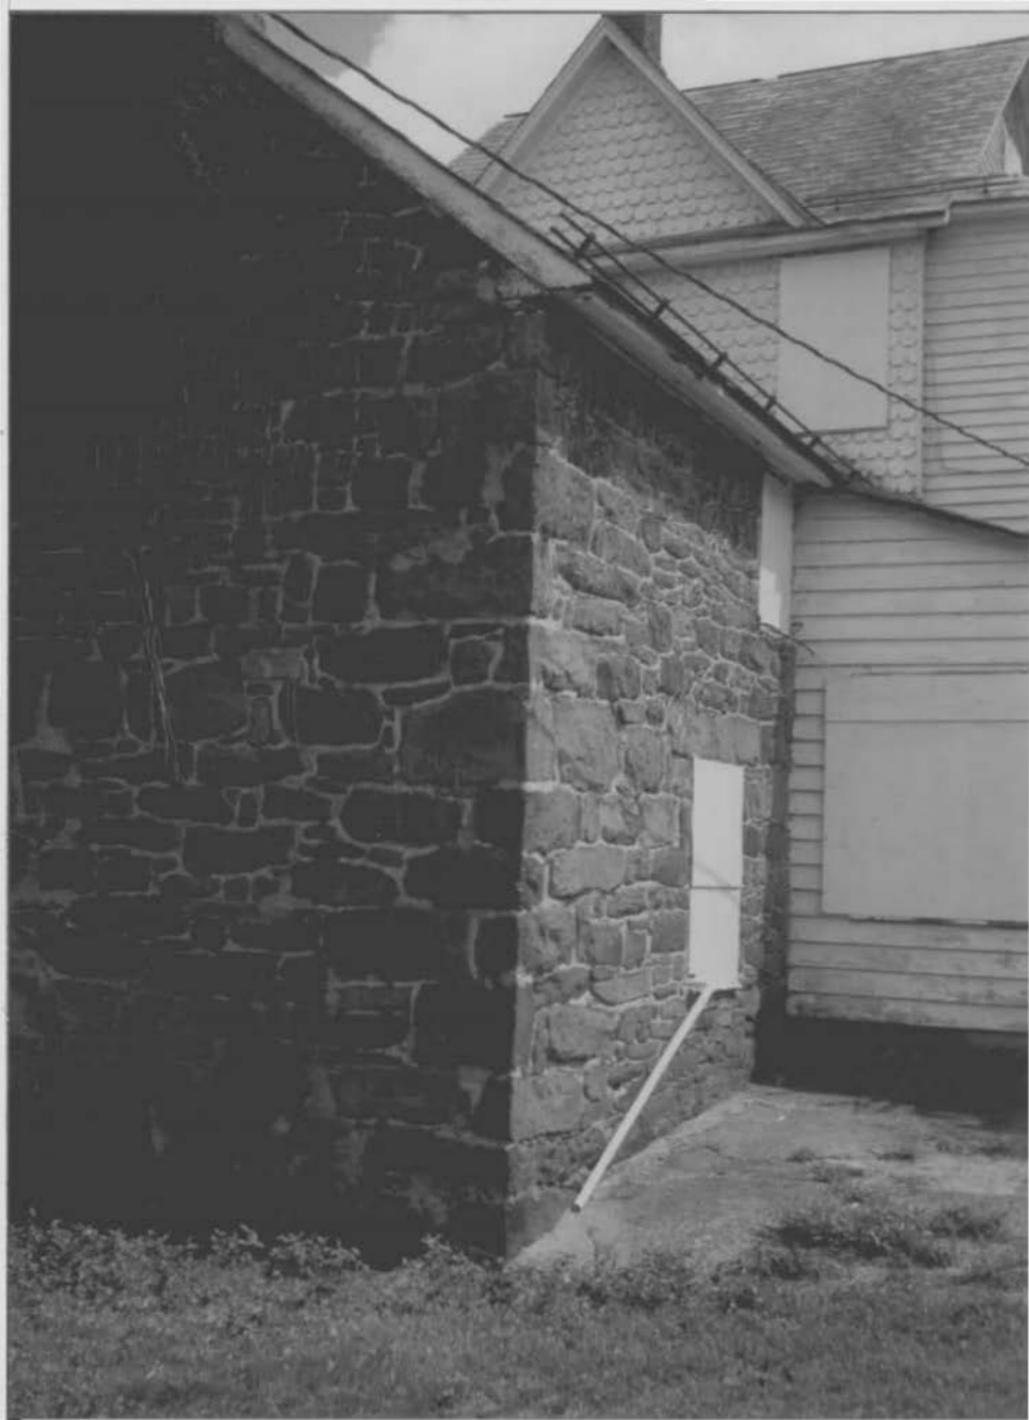
M: 16-2

story and gable of the middle addition are of frame construction. The walls of this frame section are sheathed with fish scale shingles. The south addition displays 2-over-2 sash set within rectangular openings topped with stone lintels. The middle addition also has two-over-two windows. There are paired 1-over-1 arched windows within the central gable of the middle addition. The kitchen section has replacement windows of recent multiple pane sash. The screened porch rests on a sandstone foundation and is articulated by wood pilasters with simple capitals.

Middle section, Second story

North Elevation, Looking South

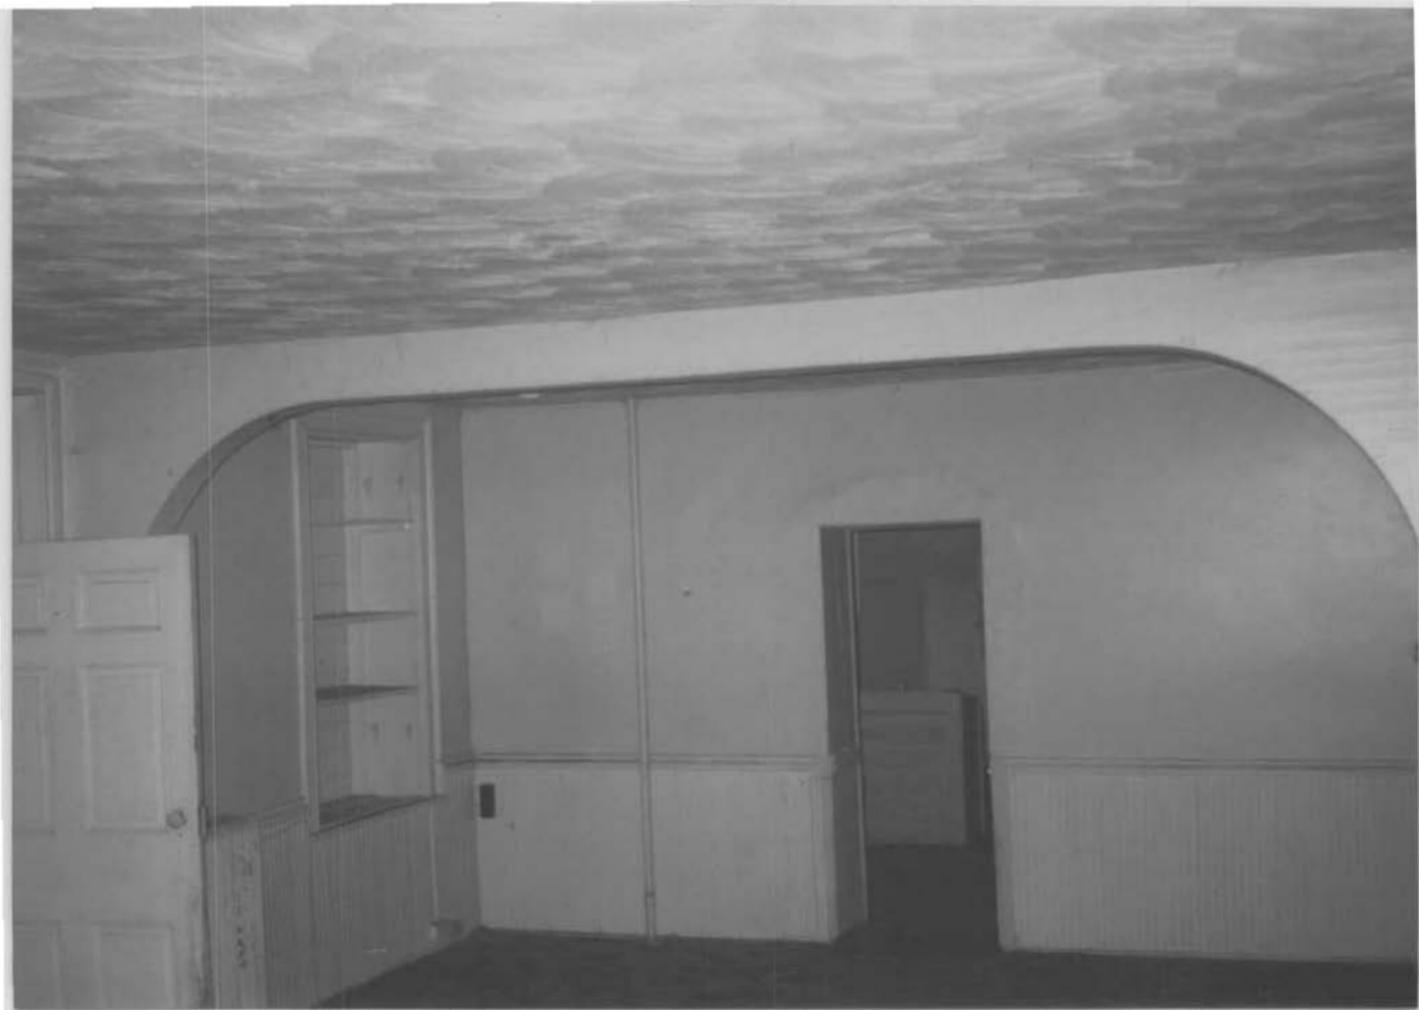
M: 16-2

Doorway to Northern Section

North Elevation, Looking North

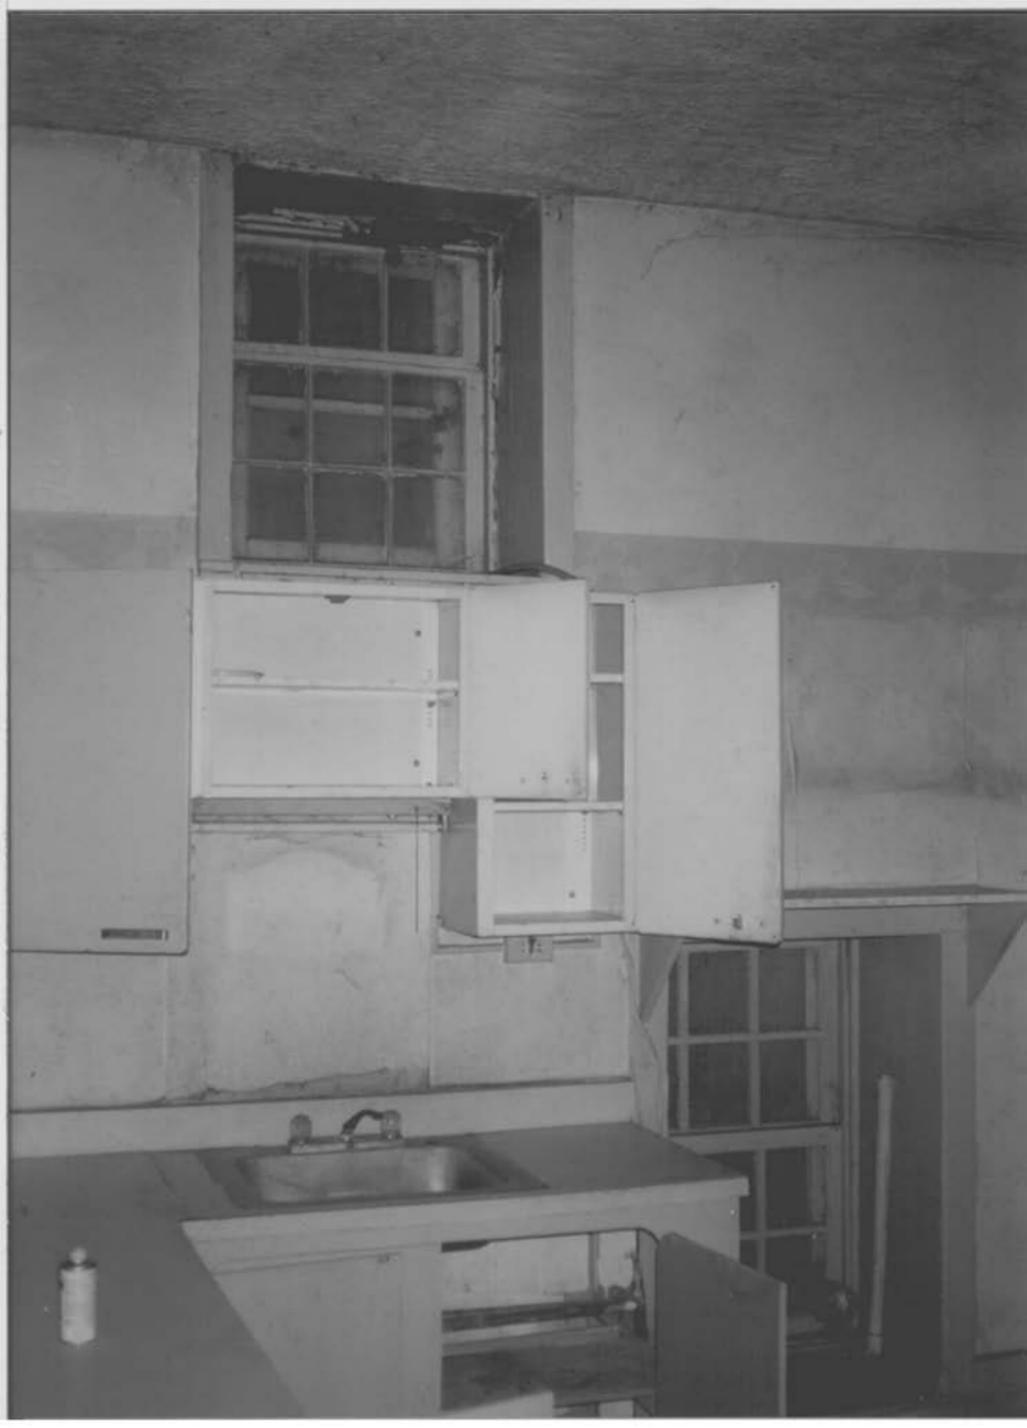
M: 16-2

Northern Section

Interior, West Elevation, Looking West
