**Maryland Historical Trust  
State Historic Sites Inventory Form**

Survey No. M: 16-2

historic Edward J. Chiswell Farm Complex

street & number 20130 Wasche Road N/A not for publication

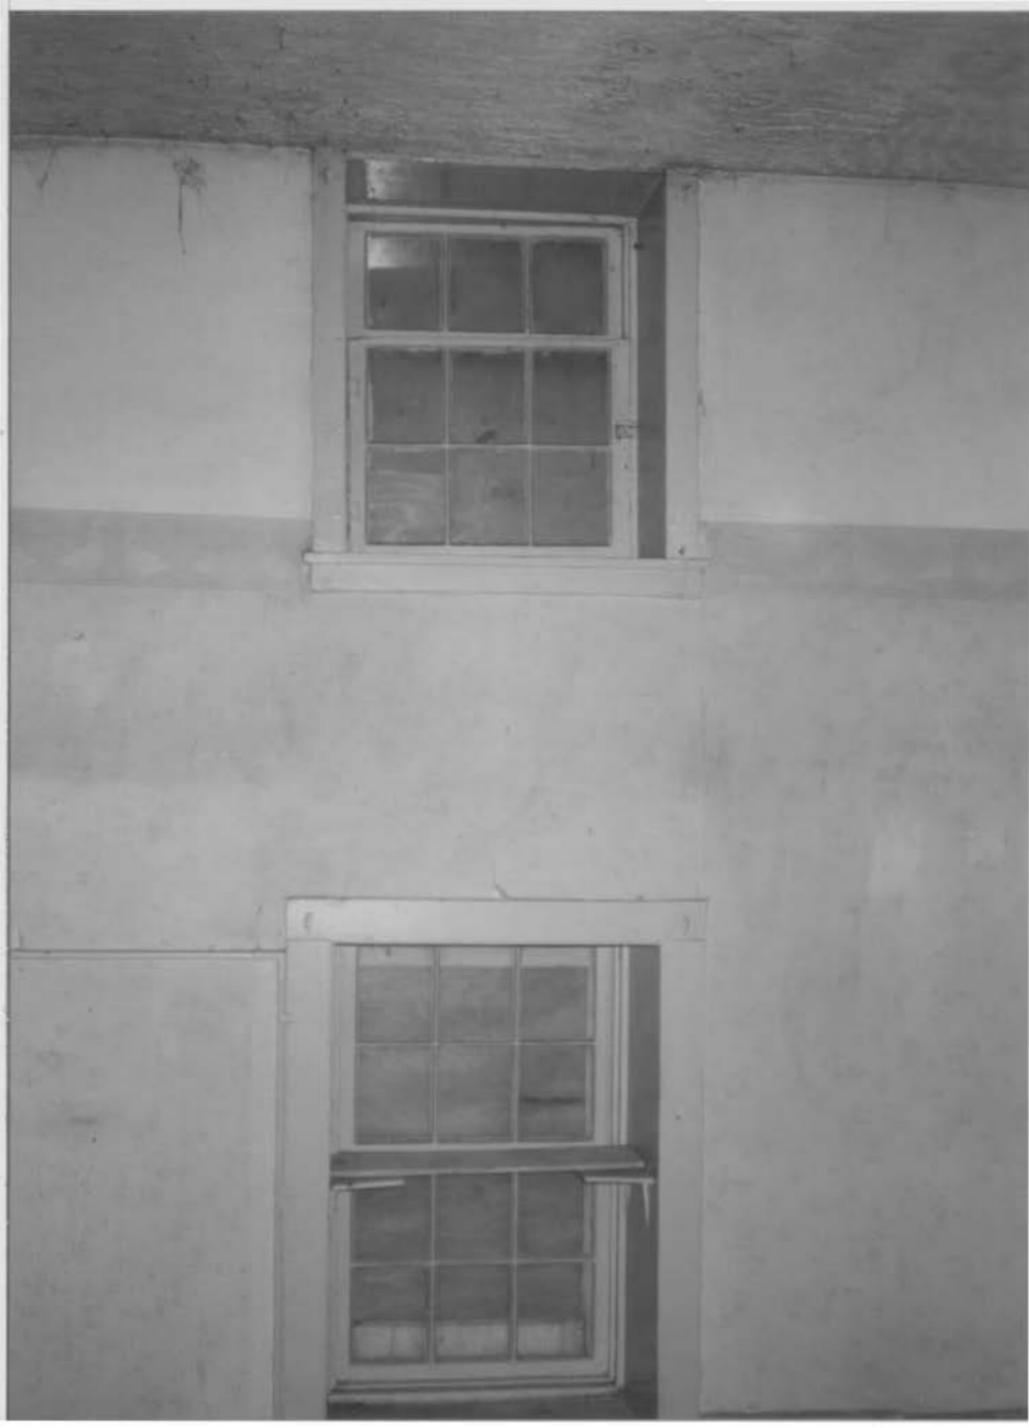
M: 16-2

Northern Section

Interior, East Elevation, Looking East

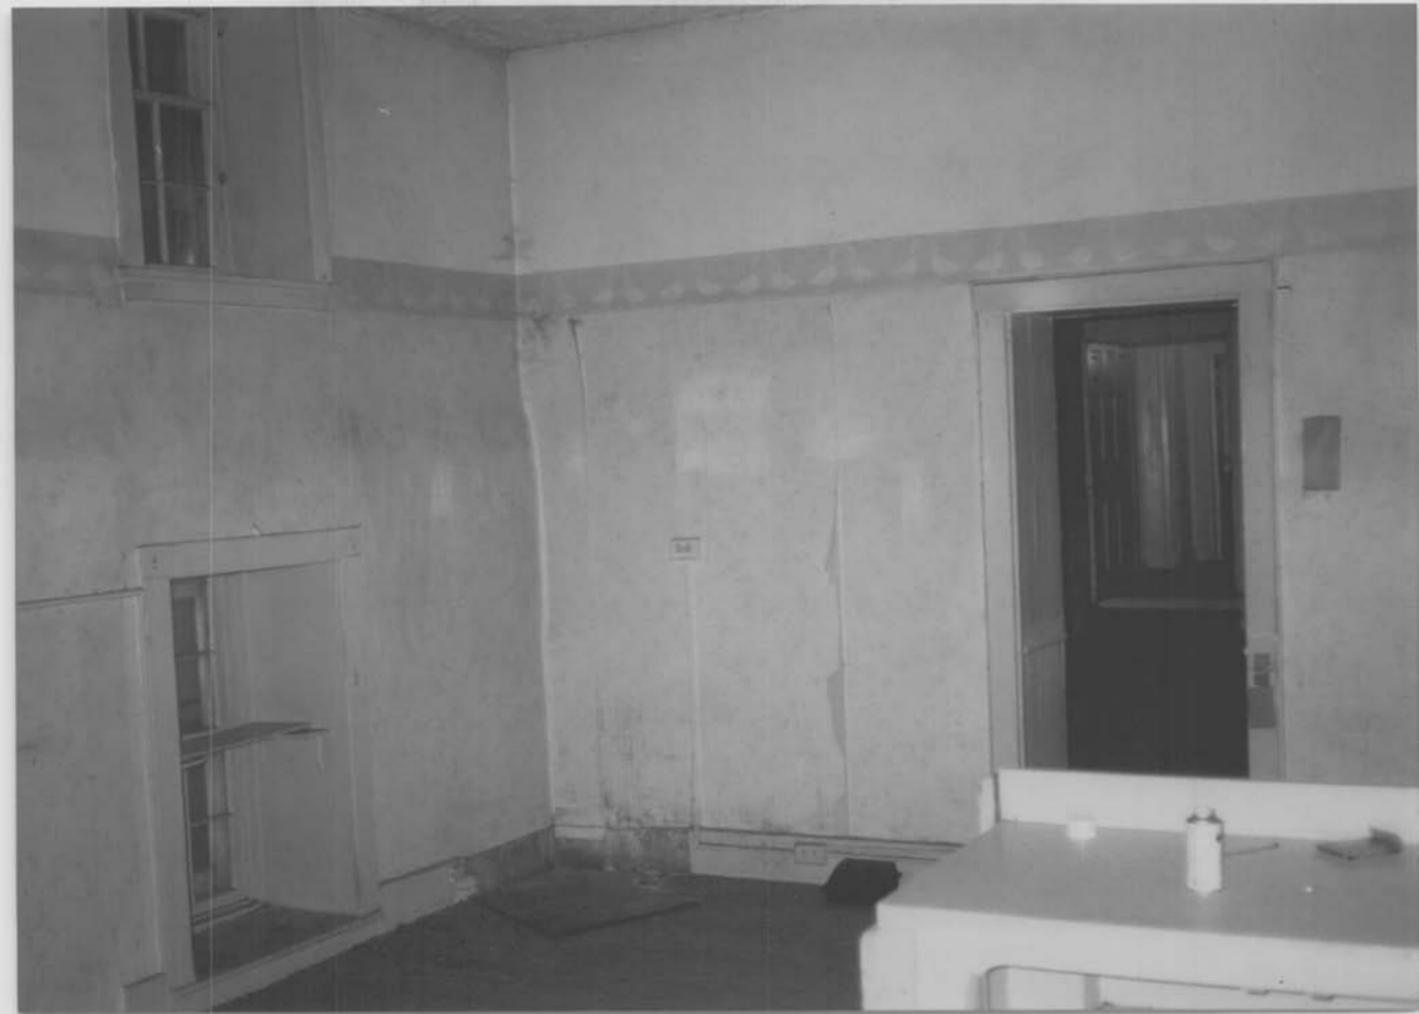
M: 16-2

Northern Section

Interior, North Elevation, Looking North  
Sealed Fireplace

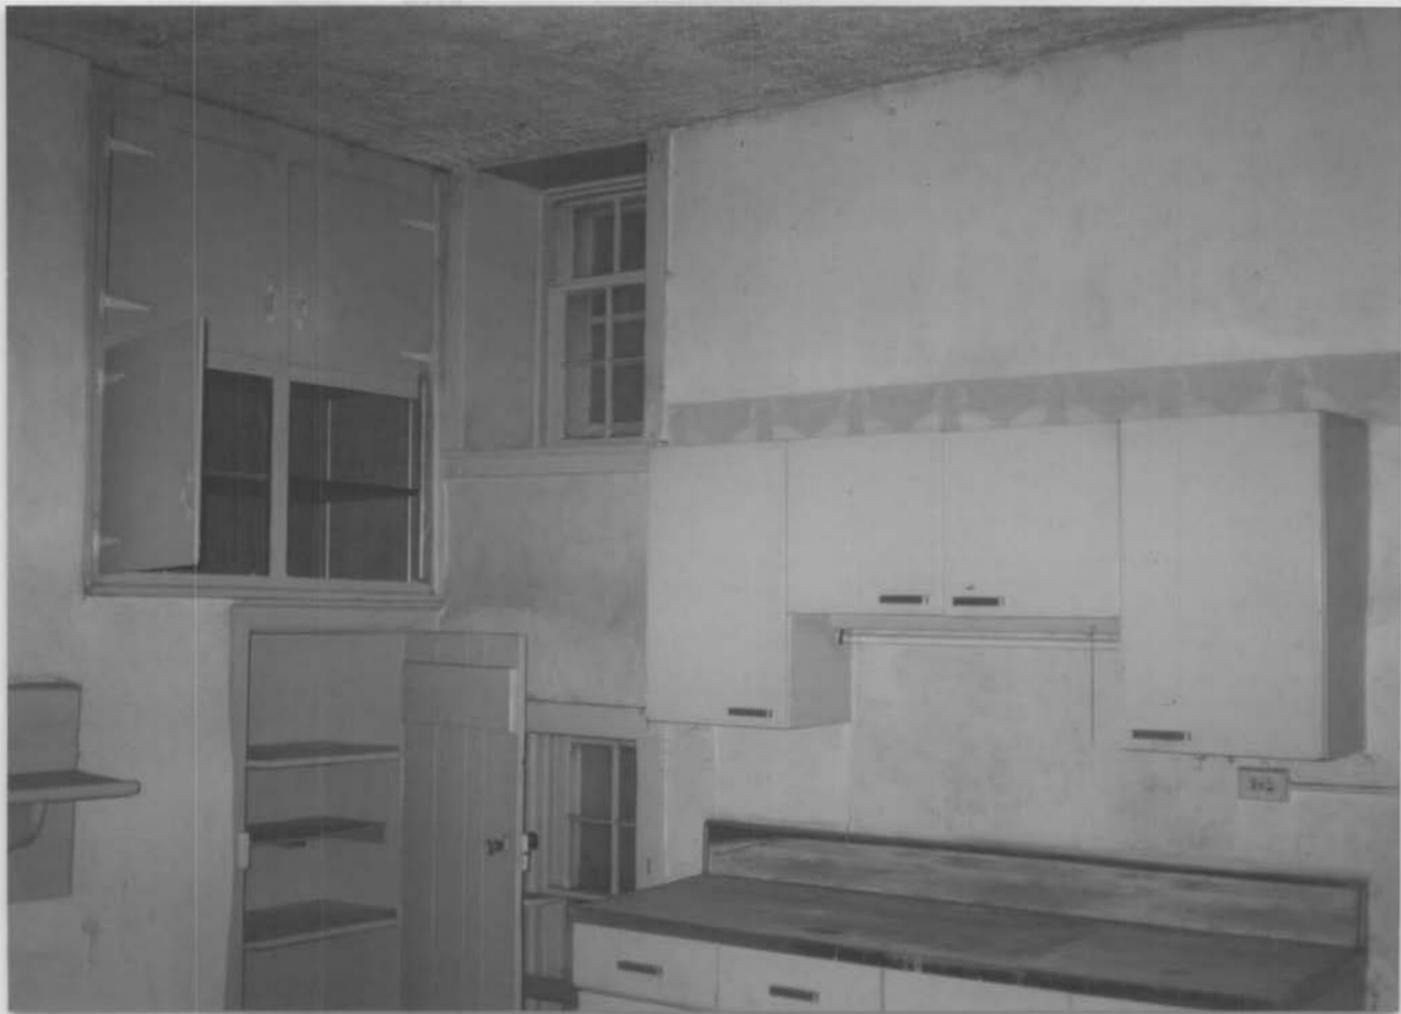
M:16-2

The interior of the south addition has been little changed. This section has a sidehall plan with the stair located on the north. The stairhall serves as the primary entrance to the house. All openings are splayed and display symmetrically molded trim with bulls-eye corner blocks. The open-string stair features turned balusters and a heavy, turned newel. The ceiling appears to have been replaced; none of the rooms have cornices.

Living Room, Southwest Corner

showing splayed window

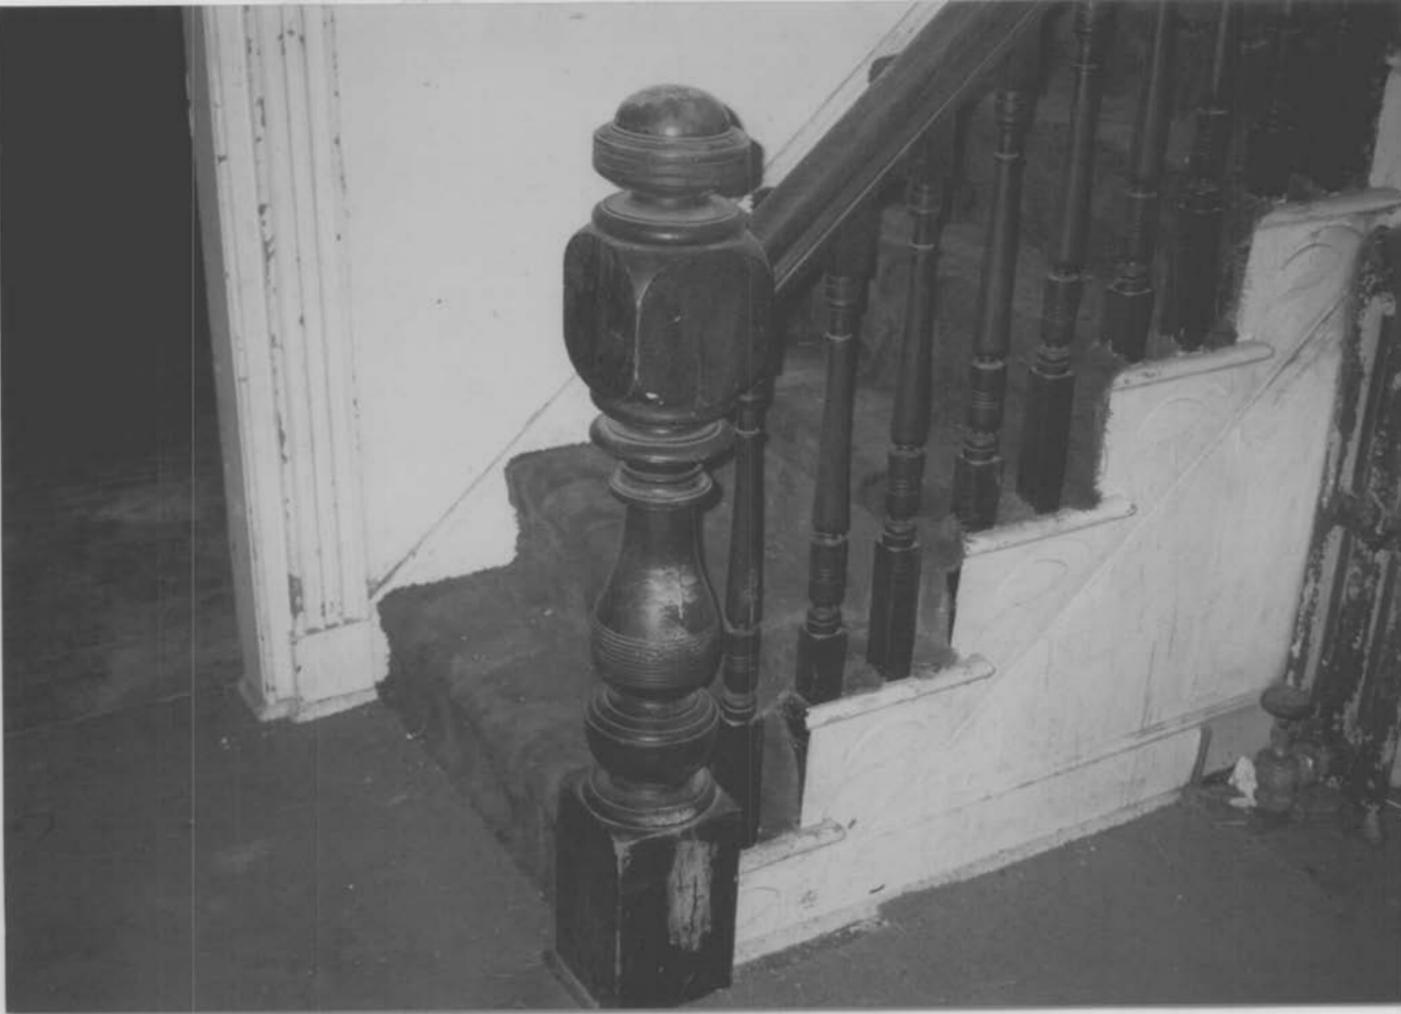
M: 16-2

Chiswell House  
Southern Section

First Floor Hallway  
Foot of Stairway

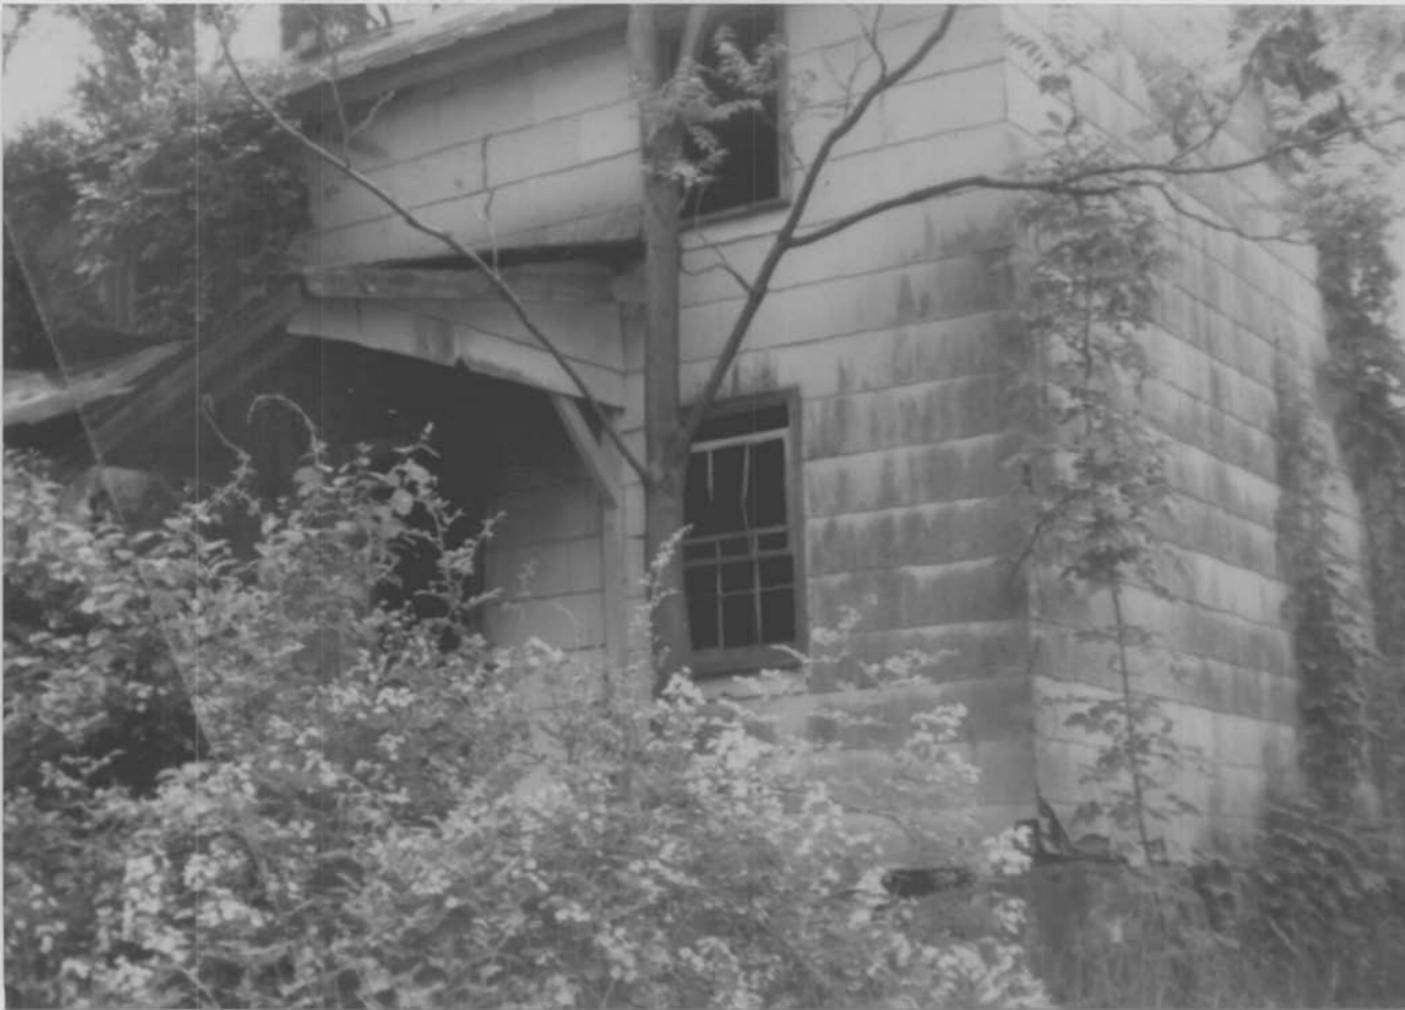
M: 16-2

There is a two-story vernacular frame house measuring approximately 20 ft. x 16 ft. situated about 625 ft. northwest of the Chiswell House. Artifactual material found in test pits adjacent to the house suggests that the building was constructed no earlier than the late 19th century. The house, which faces west, is constructed over a crawl space enclosed with a rubble stone foundation of sandstone with cement mortar. There is a major repair to the foundation at the northeast corner of the house. The building is topped with a standing seam metal roof. The exterior of the house is clad with asbestos shingles. There is an exterior end chimney on the south side of the house. The windows have 6-over-6 sash. On the east side of the house, a 20th century one-story shed addition built on a concrete block foundation encloses a kitchen and bathroom. The east wall of the kitchen has a block and brick chimney used to vent stoves. The balloon frame house is constructed with studs 2 ft. on center. The interior of the house is finished with plaster above a bead board wainscot. A well capped with concrete is situated near the kitchen on terrain that slopes up from the house.

Tenant House

East and North Elevations, Looking Southwest

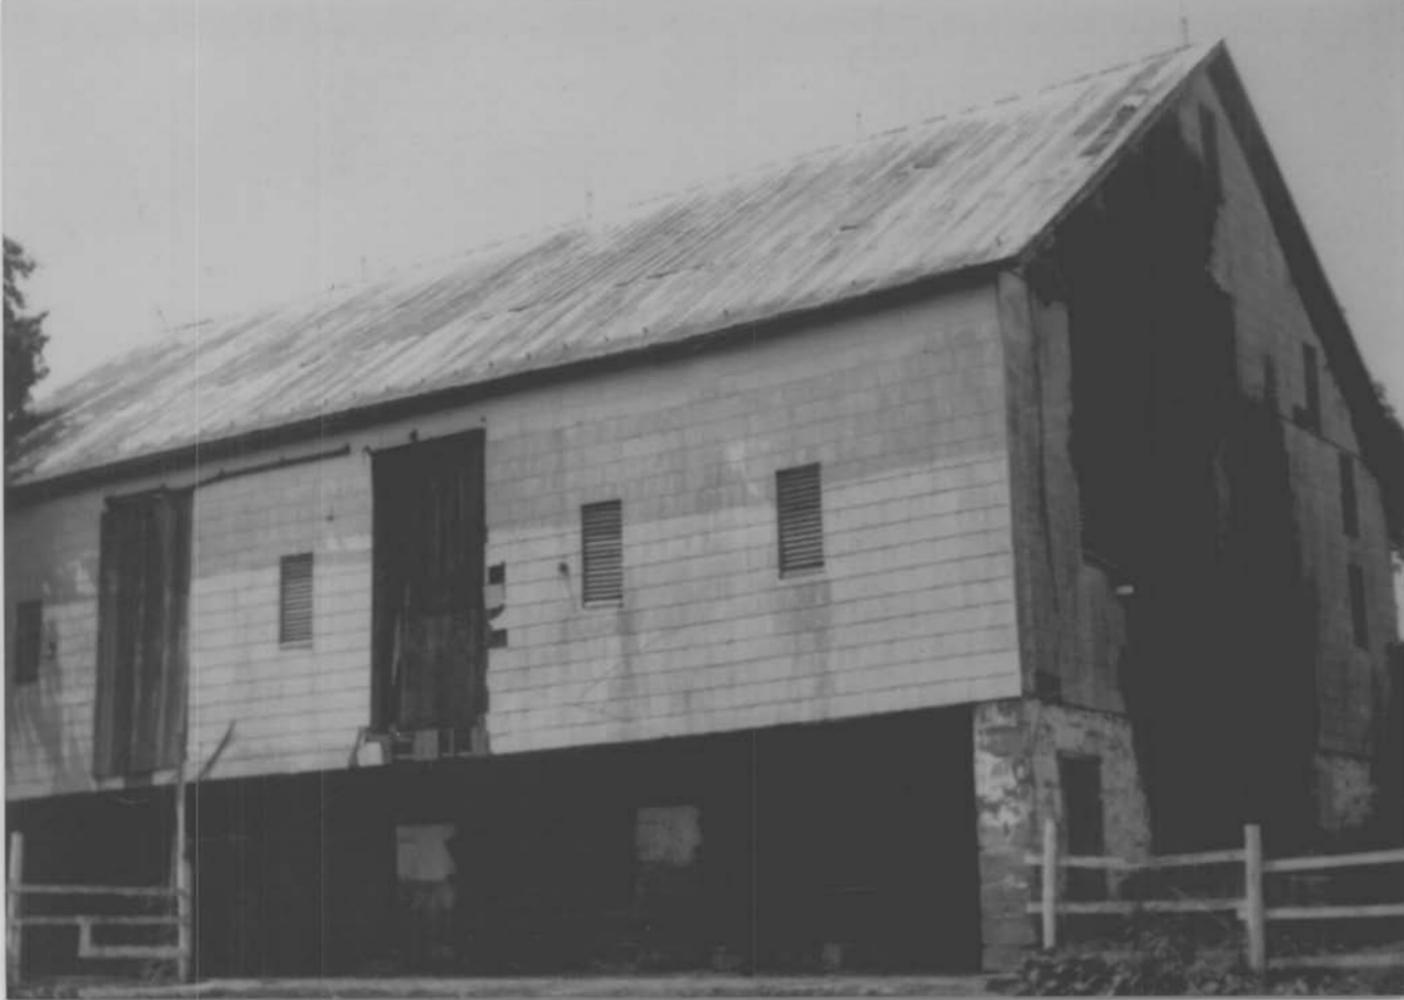
M: 16-2

The ca. 1880 four-bay bank barn is of post and beam construction with pegged 8" x 8" posts. The posts are 16 ft. on center on the north and south and 8 ft. on center on the east and west. The building rests on a three-sided coursed stone foundation. The barn is topped by a standing seam metal gable roof with the ridge line running north-south. The eastern side of the barn is open; its western side is built against a banked entrance. Asbestos shingles cover the plank walls. The building's visible fabric and appearance suggest a late 19th century date of construction consistent with the rise in the property's assessments in 1875-1885. The building contributes to the late 19th and early 20th century agricultural character of the Chiswell Farm Complex.

Bank Barn

East and North Elevations, Looking Southwest

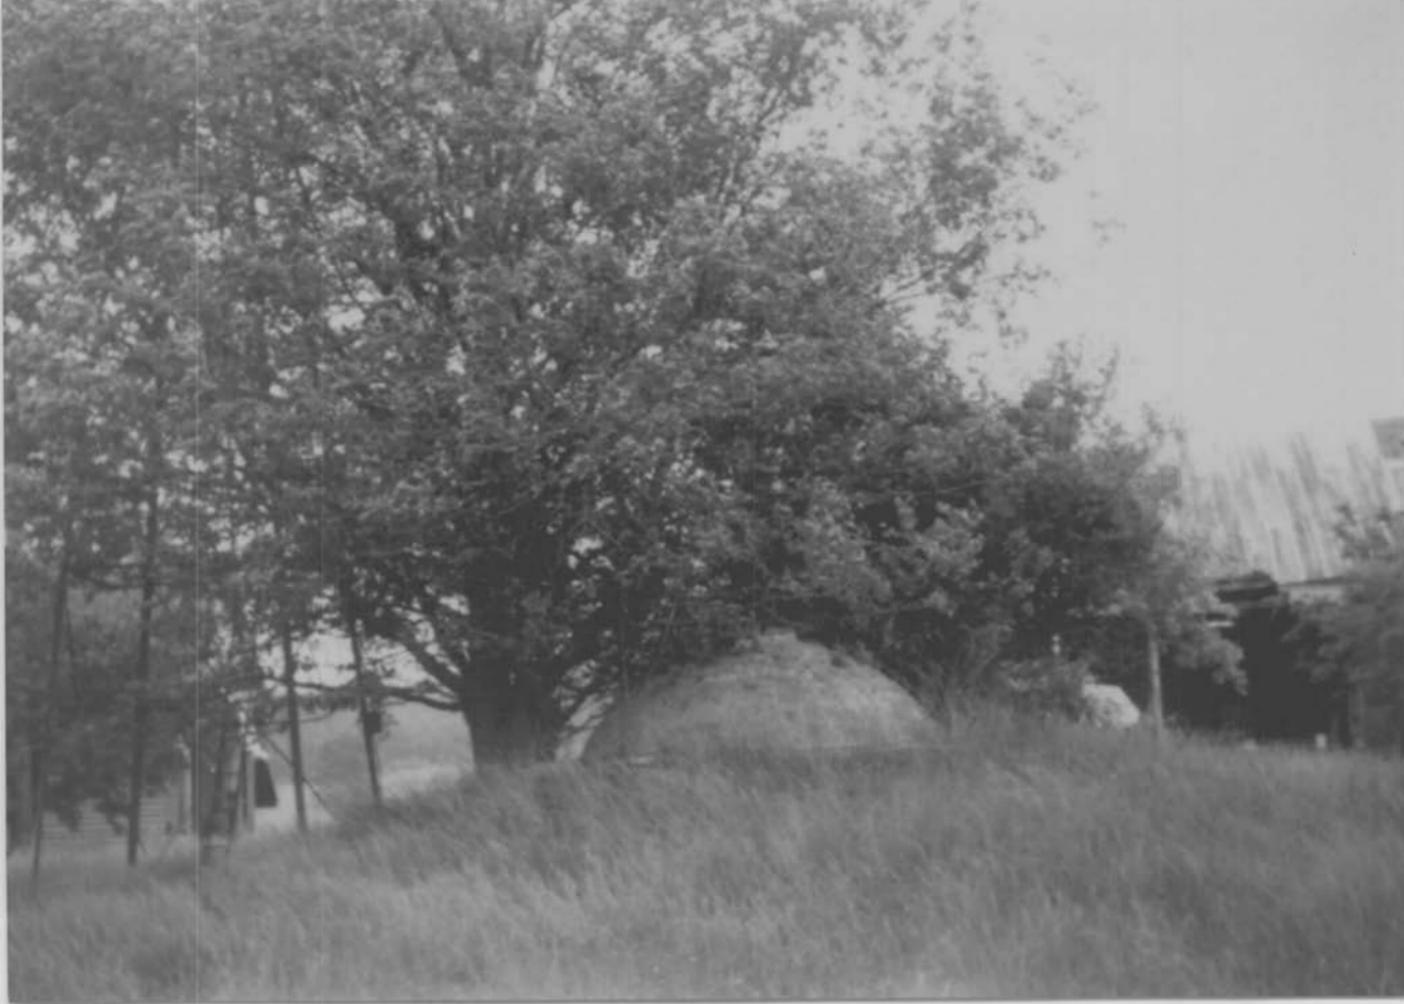
M: 16-2

A stone structure that appears to have been an ice house is situated below and to the northeast of the Chiswell House. This outbuilding is constructed of Seneca sandstone. The west wall of the outbuilding, which measures approximately 18 ft. x 16 ft., is set into the bank of the ridge. The entrance to the structure is on the west. The building is in deteriorated condition; the south wall of the structure has virtually collapsed. Like the stone outbuilding closer to the house, the original roof of this stone outbuilding also appears to have been replaced. The stone outbuilding (ice house) has a gable roof with tongue-and-groove planking used within the gable.

Because of its 19th century date of construction and functional relationship with the principal residence on the site, the Stone Outbuilding (Ice House) contributes to the significance of the Chiswell Farm Complex despite its deteriorated condition.

Stone Outbuilding / Ice House  
West Elevation, Looking East

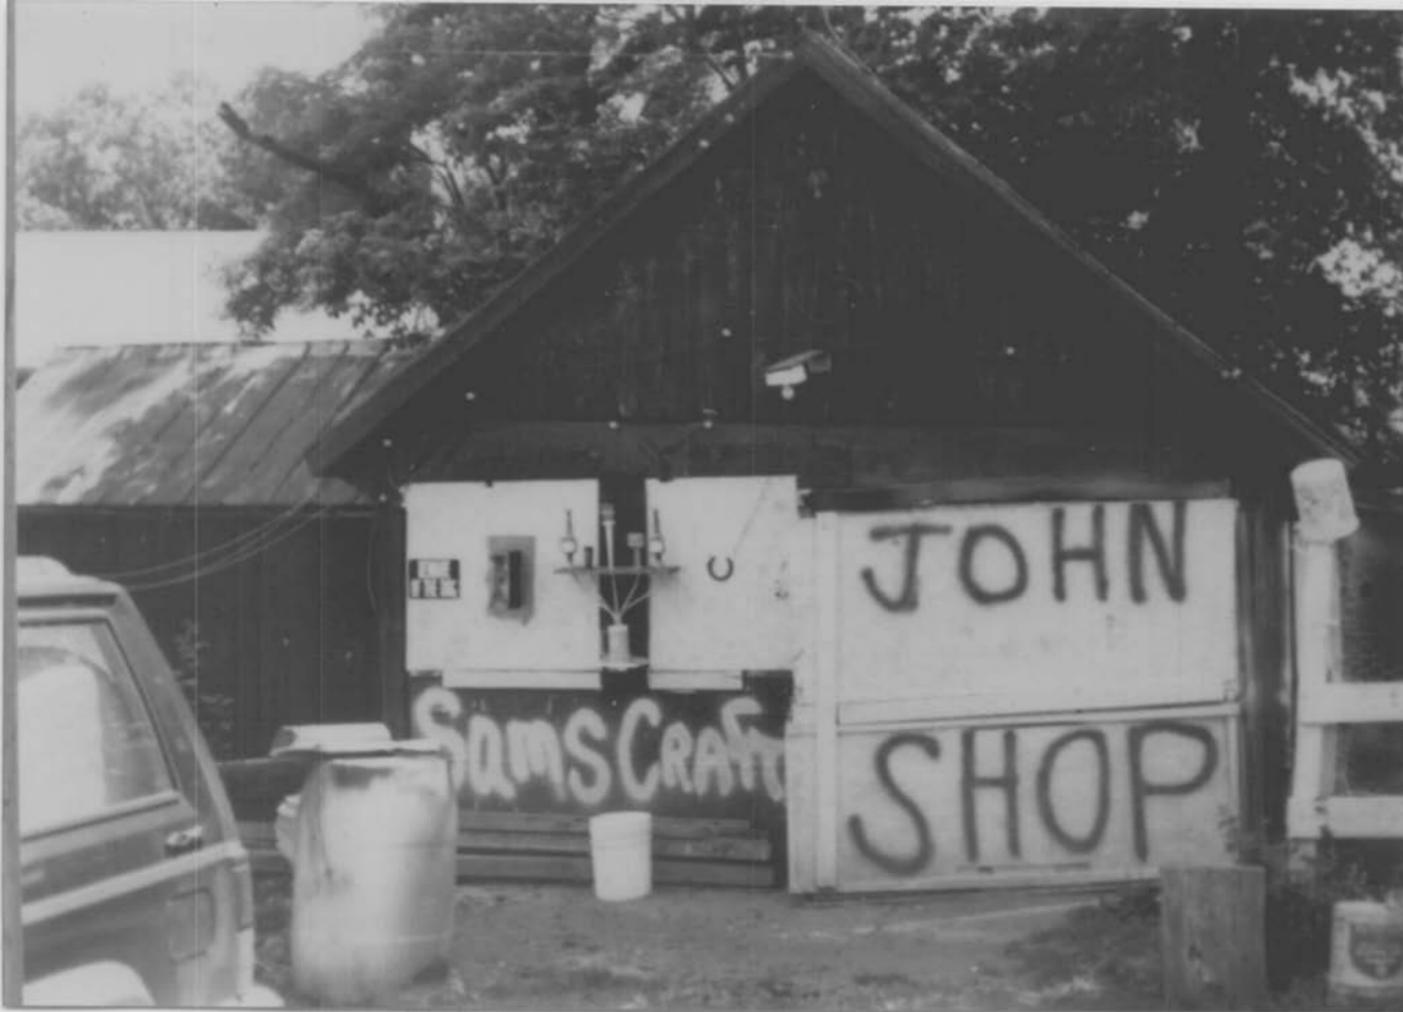
M: 16-2

The Garage is adjacent to the Tool Shed. Both buildings are located between the Chiswell House and the Wagon Shed. The board-and-batten walls are nailed to a rough dimensioned frame. The structure rests on a poured concrete slab and has a standing seam tin roof. The slab foundation indicates a mid-20th century date of construction. Because of its date, this building does not contribute to the Chiswell Farm Complex.

Garage / Tool Shed

West. Elevation, Looking East
