# 7. Description

Survey No. M: 25-24

Charles & Ira Ward Farm

13601 Travilah Road

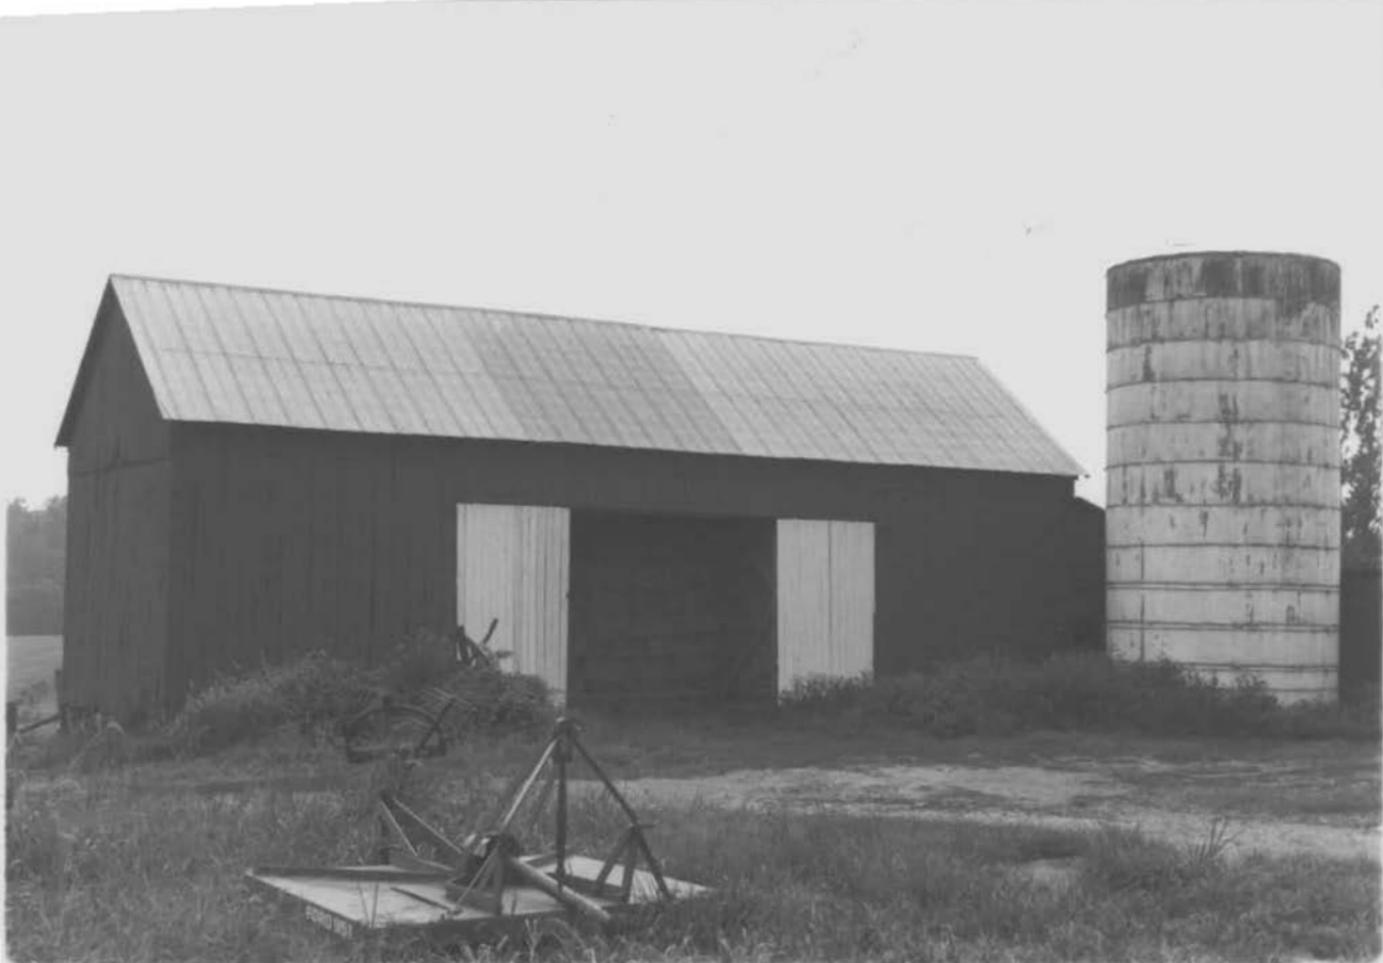
*M: 25-24*

To the west of this barn stands a gable roof barrack barn (built on one level, as opposed to a bank barn). This barn was built in 1942 to store unbaled wheat. Today it is used to store bales of hay. Its structure is heavy sawn oak timbers, with mortise and tenon joints held by locust pegs. The foundation wall is fieldstone, the exterior walls are sheathed in vertical boards, and the roof is covered with sheet metal. Two large pairs of vertical board, horizontally rolling doors - one on the north elevation, the other on the south - give access to the central driveway of the barn. The western end of the barn has a lean-to section attached, which extends well south of the barn to form a gable roof shed open on the east and south. This "run-in" shed, where beef cattle can run in to feed and be sheltered from the weather, is supported by large round timber posts. Running north to south down the center of the shed is a trough along which grain is moved by a rod and paddle device, powered by an electric motor. Moving eight feet at a stroke, the paddles push the grain into feed troughs on either side. A concrete stave silo, built in 1958, stands at the northwest corner of the barn.

1942 barn, north elevation
