Site M:26/10/36

Montgomery Country Club

16 Williams Street

State Historic Sites Inventory Form

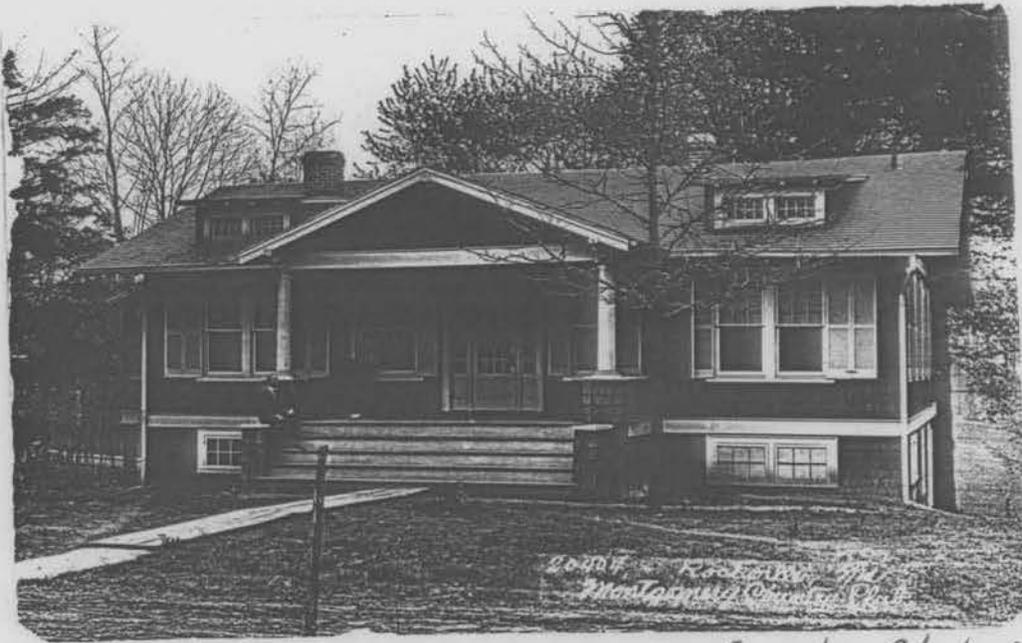
Montgomery Country Club, c. 1920

The accompanying photo shows the clubhouse in the mid-1920's. That there has been little change is a testimonial to the bungalow's endurance as a functional style.

M: 26/10/36
Montgomery Country Club
16 Williams Street
Photo c. 1920
Courtesy of Montgomery County
Historical Society

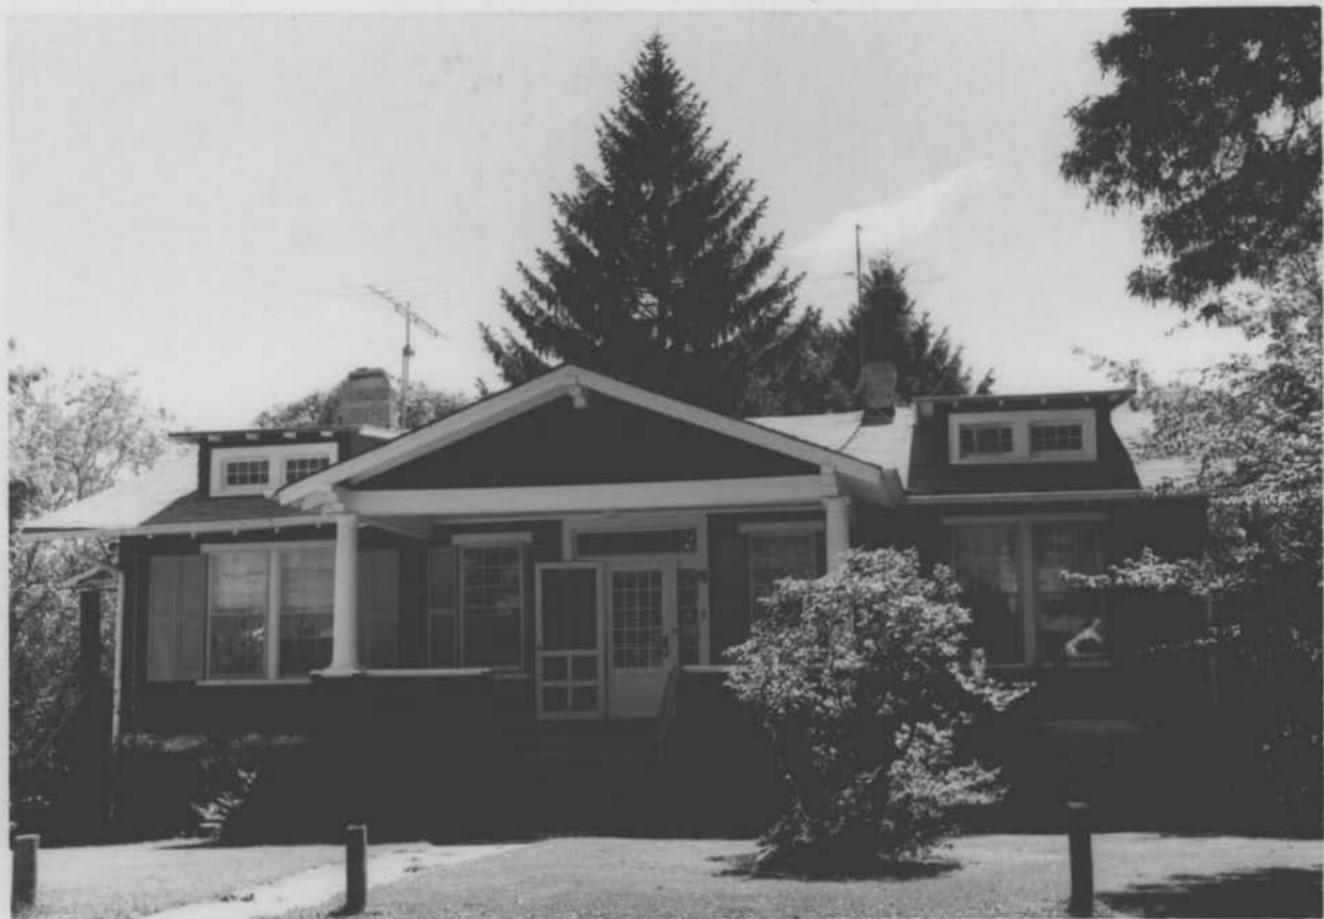
WEST ELEVATION

Steps on the front (west) facade lead to a gabled porch three bays in width. The gable is supported by round tapered columns. A multi-paned door with transom and side lights is present. There are two shed dormers with paired horizontal windows on this facade; these almost flat dormer roofs are also carried out on open rafter end supports. The outer double and inner single windows on the first floor are six over six, the two outer windows having double shutters and the two interior windows in the line having single shutters.

The entire house is covered with dark brown shingles, laid in an imbricated shape on the main block and common square on the dormers, porch piers and supports. On the front facade a wide wooden band above the basement level creates a wooden "stripe" contrasting with the brown shingles.
