Reading/Typhoid House

308 Baltimore Road

State Historic Sites Inventory Form

historic Typhoid House

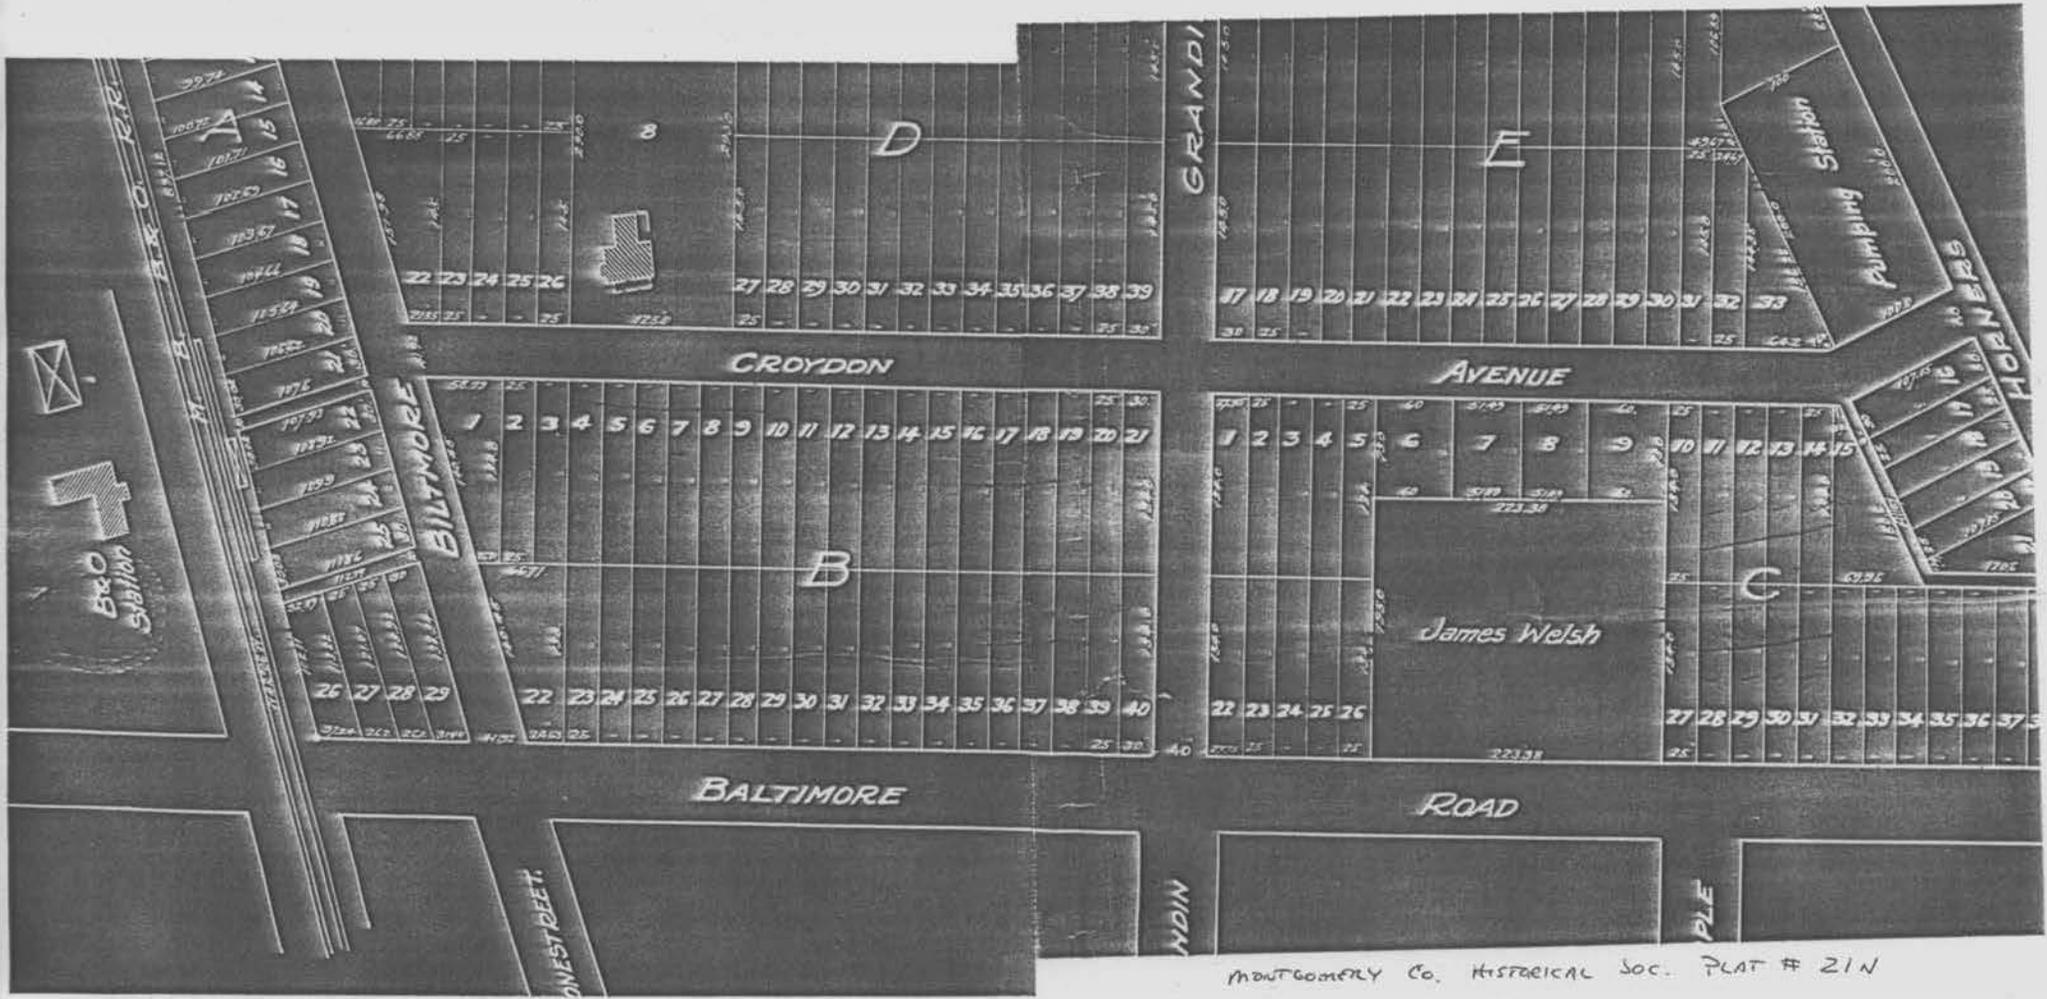
Plat #21N, Plat of Croydon Park, 1924
Montgomery County Historical Society

MONTGOMERY Co. Historical Soc. PLAT # 21N

Rockville water supply

The Reading House and one acre were sold in 1922 to Elizabeth Welsh. When Croydon Park was platted in 1924 "the Welsh Parcel" became lots 6,7,8,9 & 27 of Block C. In 1929 Margaret Ward purchased the property. Porter Ward, her husband, was one of the owners of Rockville Fuel and Feed Company. The Wards owned several properties in various parts of Rockville. The Croydon Park lots were used as a garden plot. The house was rented out, sometimes as a boarding house. During the housing shortage of the 1940s, 308 Baltimore road was divided into three apartment units. In 1963 the Wards replatted the lots for individual sale, and the house became Lot 46 of Block C. 9/

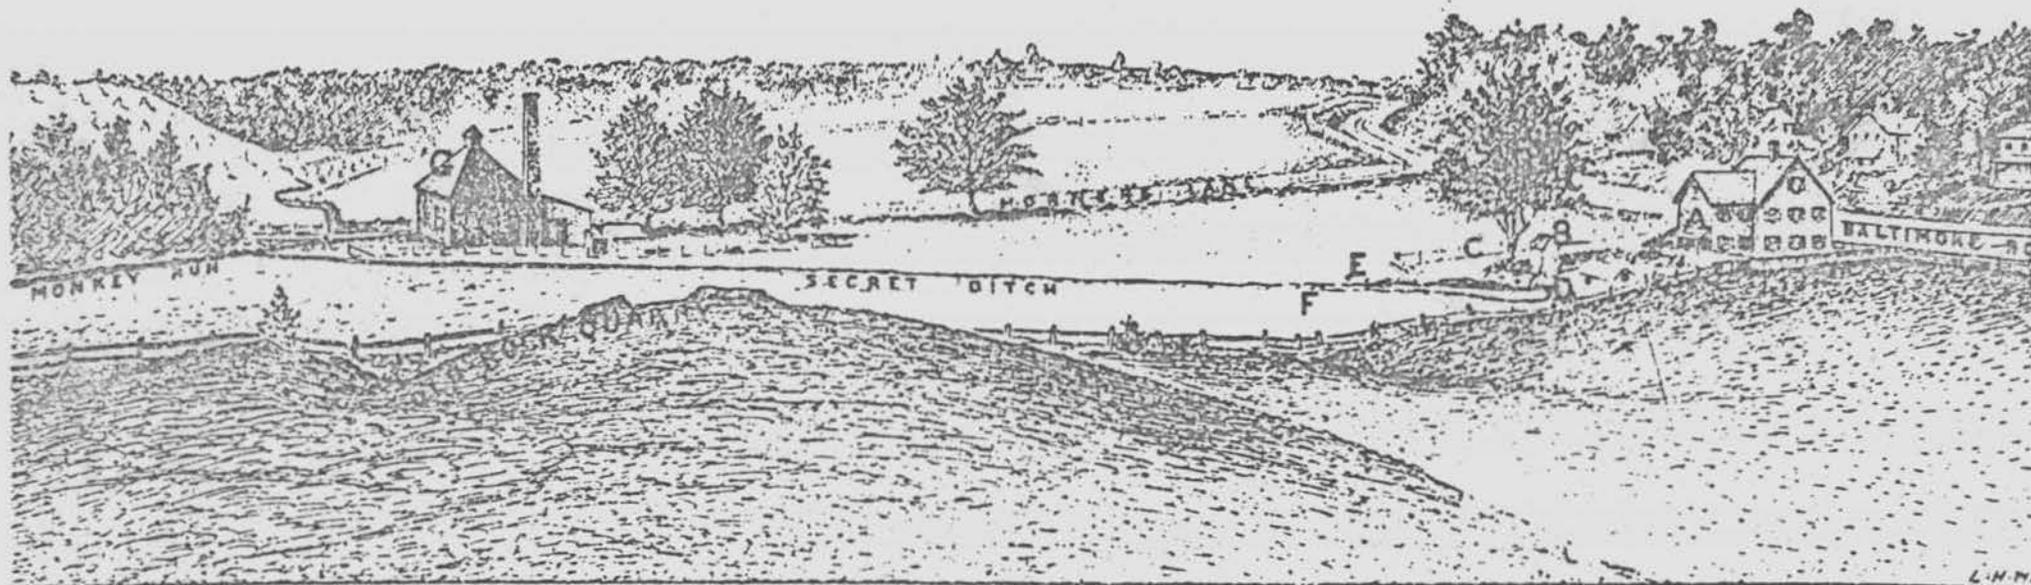
U.S. Public Health Service Bulletin #65
"Typhoid Fever in Rockville, Md."
U.S. Government Printing Office, 1914

U.S. PUBLIC HEALTH BULLETIN 65, MAY 1914, BY COURTESY OF THE UNITED STATES PUBLIC HEALTH SERVICE

G marks the spot where typhoid bacilli entered the water supply of Rockville, Maryland, in the winter of 1913-1914 and spread typhoid fever through the little town. Lumsden of the Public Health Service worked out the story: a sick visitor at house A infected the privy B which drained into the "spring branch" D which at F ran into the "secret ditch" which passed near enough to the pumping station G for foul water to seep at times into an imperfectly protected well

Unusually heavy precipitation fell in the winter of 1913-14. Between January 15 and February 1, 1914 an epidemic of 21 cases of typhoid was reported in Rockville. The Maryland Department of Health requested an investigation by the U.S. Public Health Service. 7/ The results of this investigation pointed to the house at 308 Baltimore Road, located within 400 feet of the town well and pumping station, as the source of contamination. The house was built near an underground spring and seepage from the house's privy had entered the town's water system by way of the "secret ditch" and the inadequately drilled town well. 8/ The Health Service published its investigative methods and techniques nationally in its Bulletin. The City Council immediately installed a central sewerage system. By the end of the year a bond issue was before the Maryland General Assembly, and by 1916 all houses were required to hook up to this main system.

7. U.S. Public Health Service Bulletin #65, "Typhoid Fever in Rockville, Md"; U.S. Government Printing Office, and newspaper of the period.
8. Illustration from the Public Health Service Bulletin. The Bulletin indicated that a guest with undiagnosed typhoid fever stayed in the subject house for several weeks November-January.

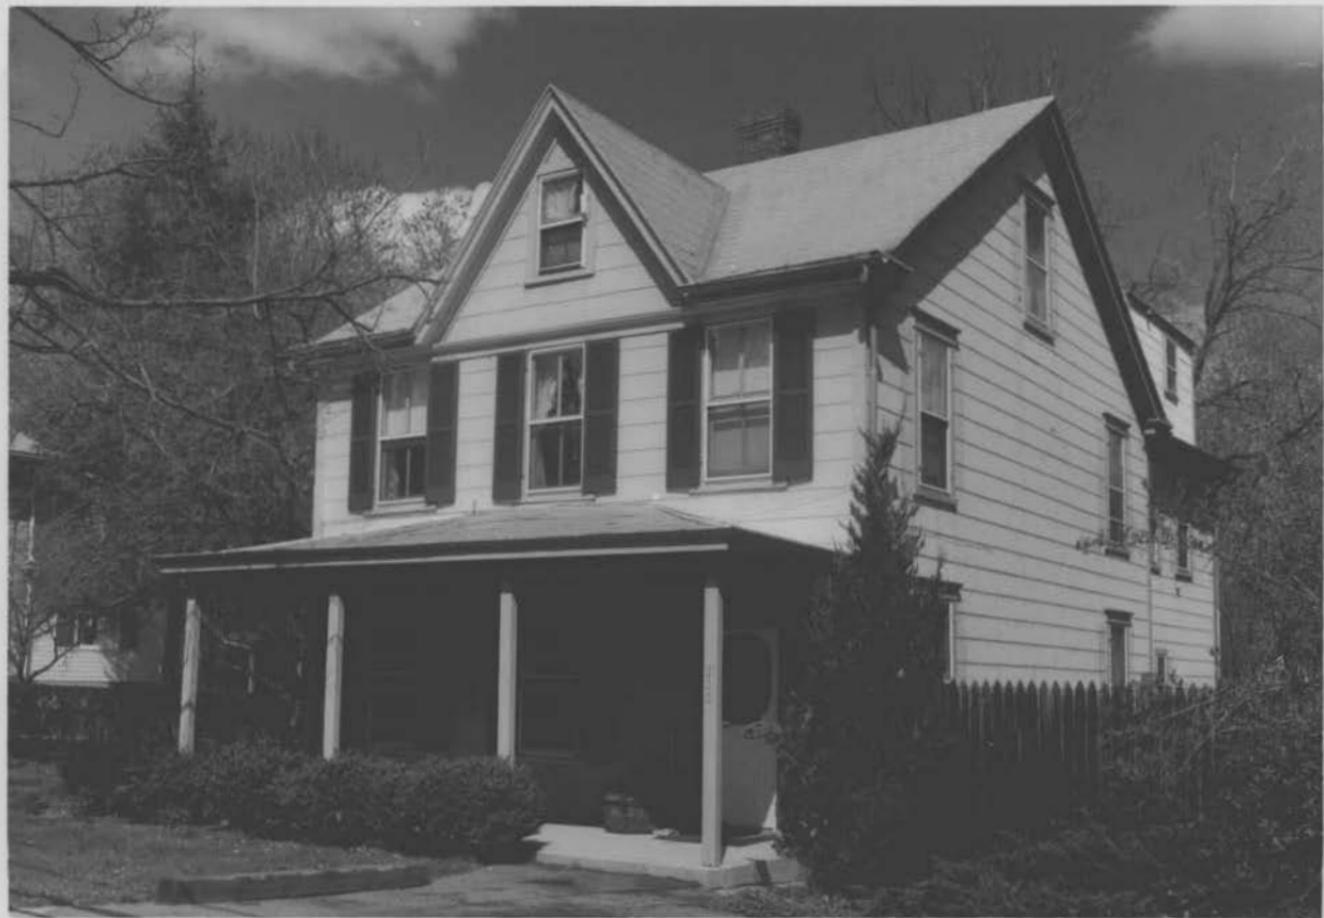
M: 26/13/5

308 Baltimore Rd
Rockville

The three-bay south (front) facade has a front gabled dormer with a central 1/1 window. A corniceboard with crown molding separates the gable from the main block of the house. This gable area was probably originally finished with decorative shingling or another siding variation. One window is in each of the three second story bays. Longer windows are in the two west first story bays. A wood-panelled one-light exterior door topped by a rectangular transom occupies the east bay. The full width front porch has a low-hipped seamed tin roof supported by four square posts, a later replacement. There is no balustrade and the floor is concrete.
