**MARYLAND HISTORICAL TRUST  
DETERMINATION OF ELIGIBILITY FORM**

Property Name: Greenhouse (Building 32) Inventory Number: M: 35-9-16  
 Address: 9000 Rockville Pike City: Bethesda Zip Code: 20892  
 County: Montgomery USGS Topographic Map: Washington West Quadrangle DC-MD-VA  
 Owner: United States of America (National Institutes of Health) Is the property being evaluated a district?  yes  
 Tax Parcel Number: \_\_\_\_\_ Tax Map Number: \_\_\_\_\_ Tax Account ID Number: \_\_\_\_\_  
 Project: NHPA Section 110 compliance Agency: US Dept. HHS/National Institutes of Health  
 Site visit by MHT Staff:  no  yes Name: \_\_\_\_\_ Date: \_\_\_\_\_  
 Is the property located within a historic district?  yes  no

**Greenhouse**  
**National Institutes of Health Bethesda Campus, Bethesda, MD**  
**Montgomery County**  
**Approximate date of construction: 1959**  
**Public access, with restrictions.**

# Maryland Historical Trust Maryland Inventory of Historic Properties Form

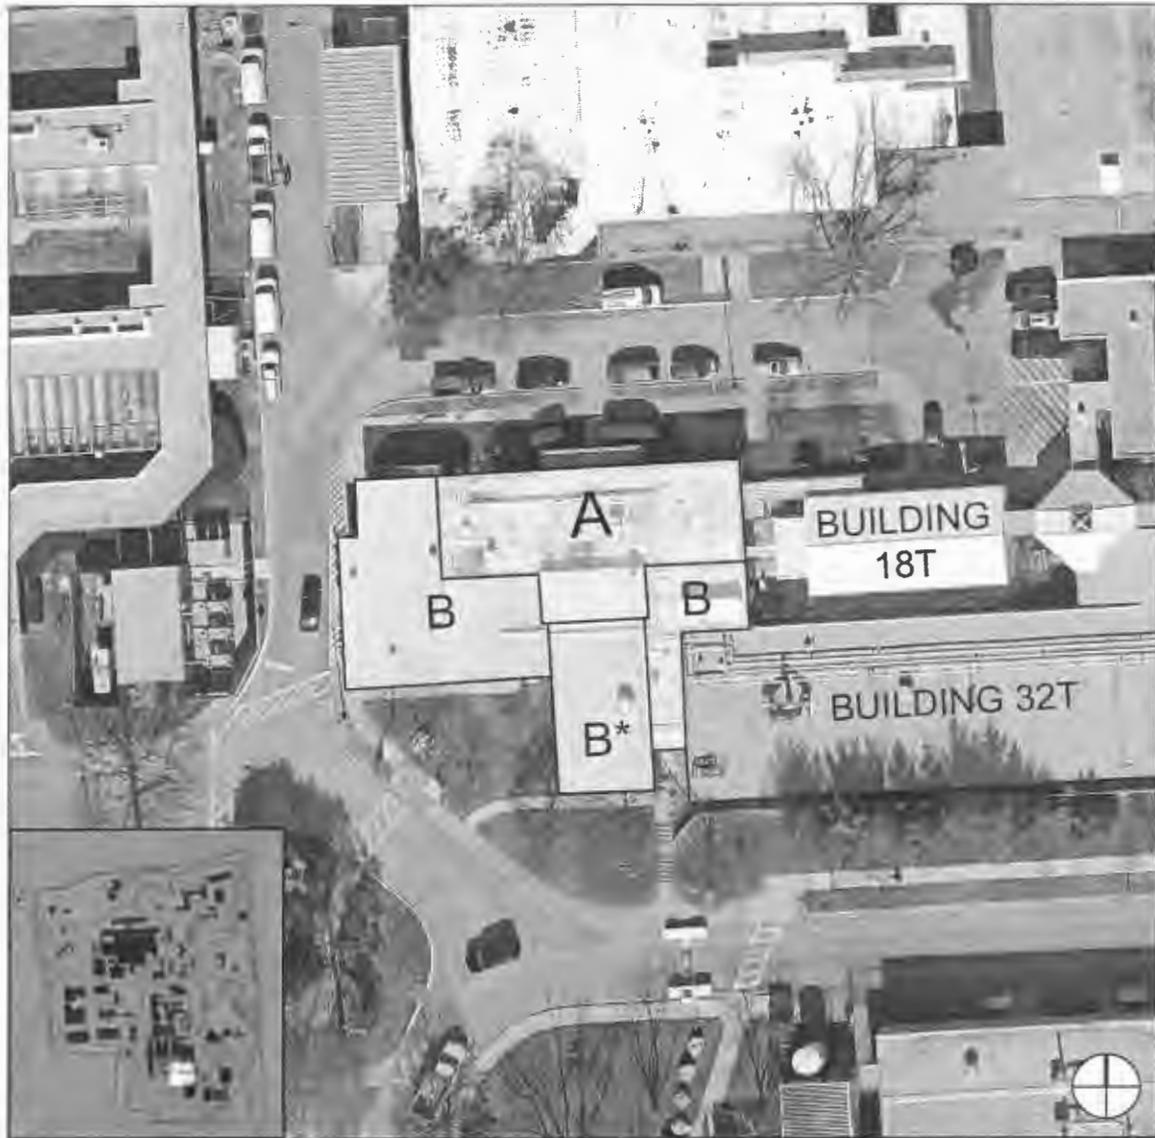
- A The remaining portion of the original building.  
B Later additions. \*Site of original glass greenhouse wing, demolished in the 1990s.

Aerial Photograph of Building 32 at the National Institutes of Health Bethesda Campus, circa 2014, indicating remaining portion of original building and extensive later additions.

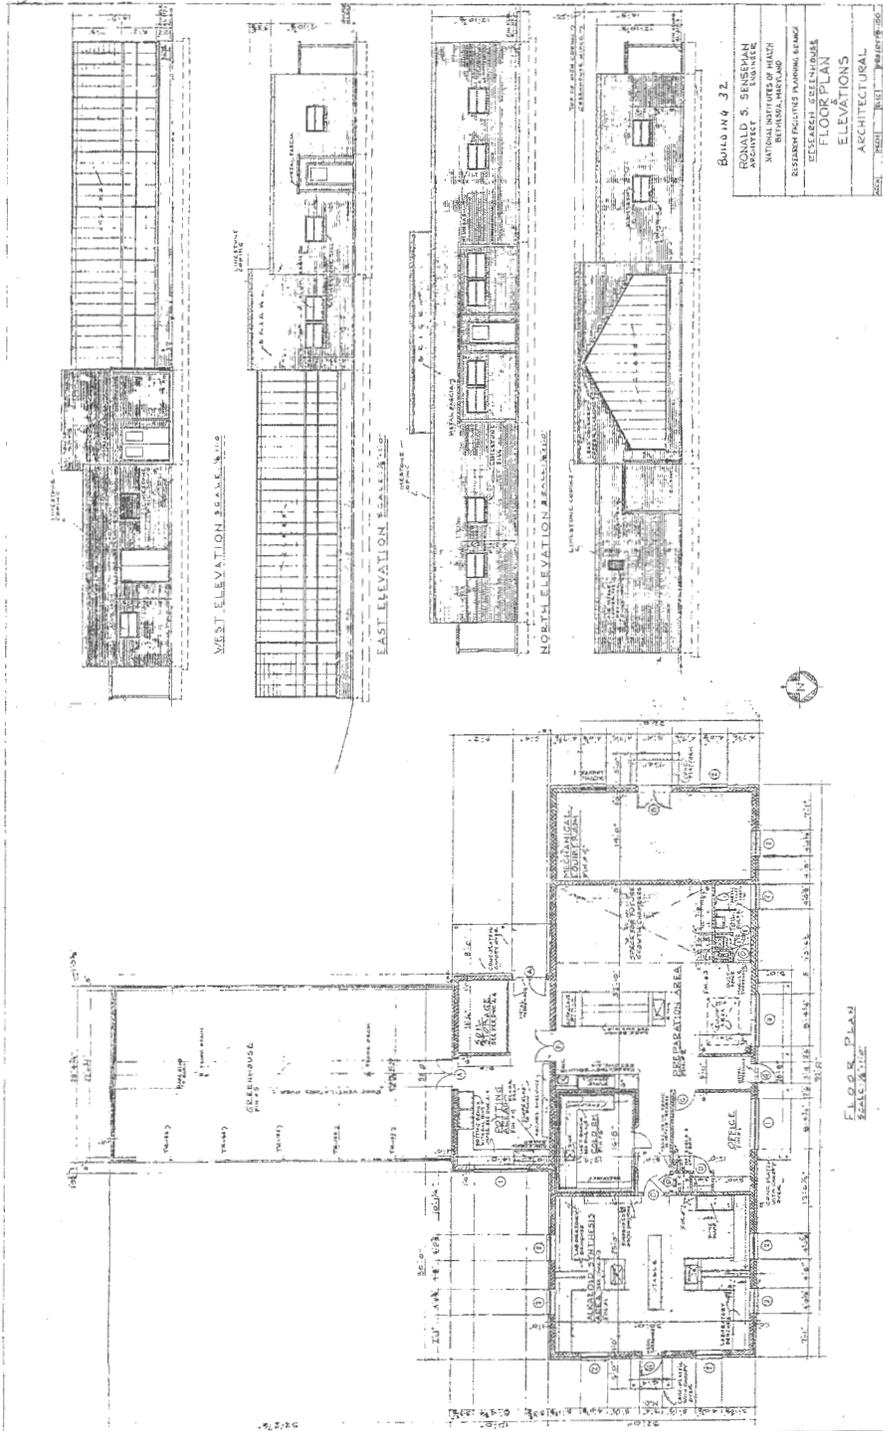
Research Greenhouse Floor Plan & Elevation.

Source: RESEARCH GREENHOUSE dated 5/26/1958, original design furnished to NIH through the Department of Health Education and Welfare, Research Facilities Planning Branch, with Ronald S. Senseman as architect/engineer. Original blueprints on file in the NIH, Office of Research Facilities Plan Room.

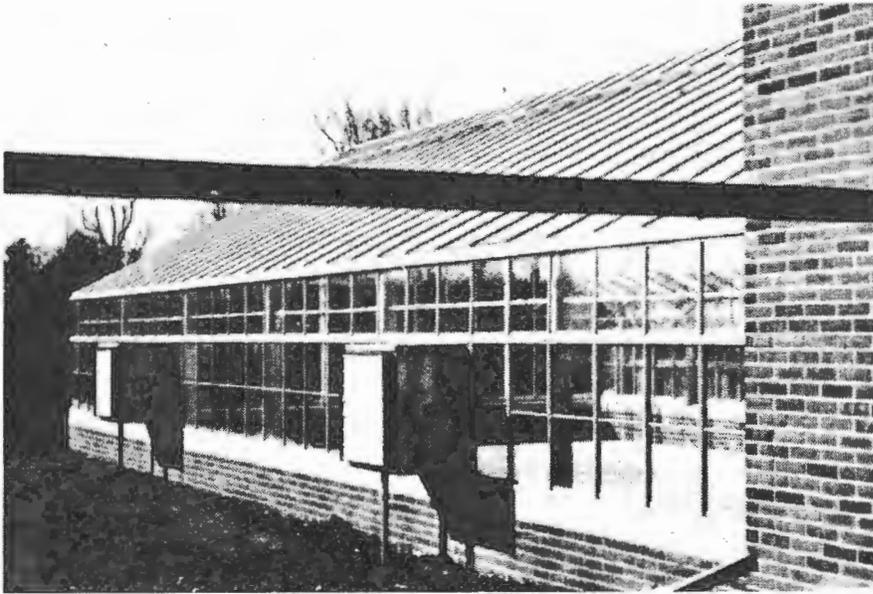
Greenhouse, seen through the window of the adjoining laboratory, c. 1959.

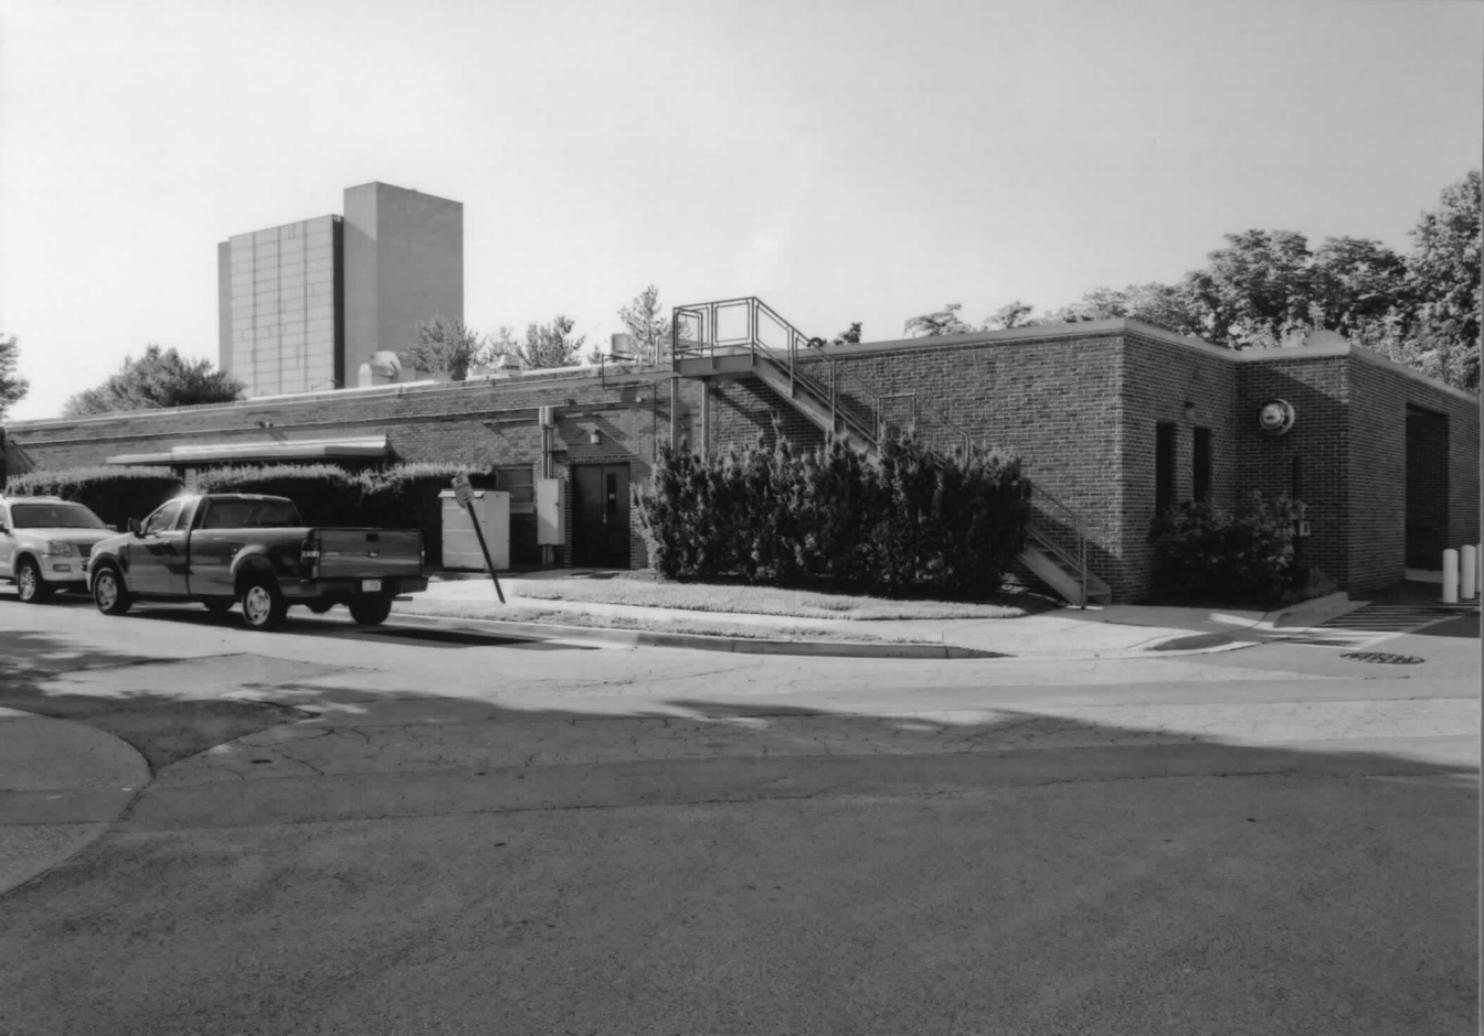
# 1 of 4

| Number | Description | Photographer | Photo Date | Filename |
|---|--|---|---|---|
| 1 | Oblique view of northwest corner. | David A. Derenick | 6/27/2014 | M; 35-9-16_2014-06-27_01.tif |

" OBLIQUE VIEW OF NORTHWEST CORNER."

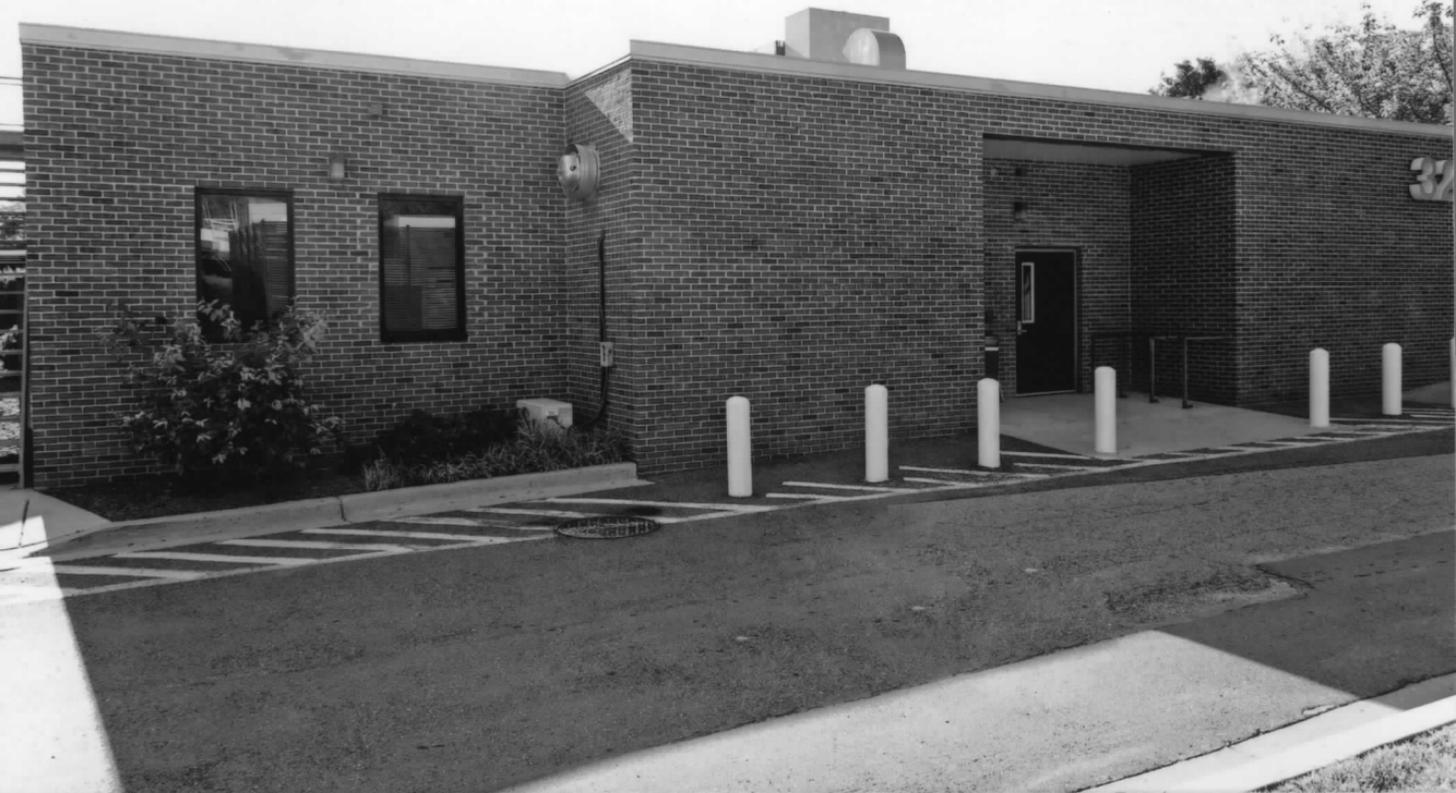
# 2 of 4

| Number | Description | Photographer | Photo Date | Filename |
|---|--|---|---|---|
| 2 | West elevation. | David A. Derenick | 6/27/2014 | M; 35-9-16_2014-06-27_02.tif |

"WEST ELEVATION."

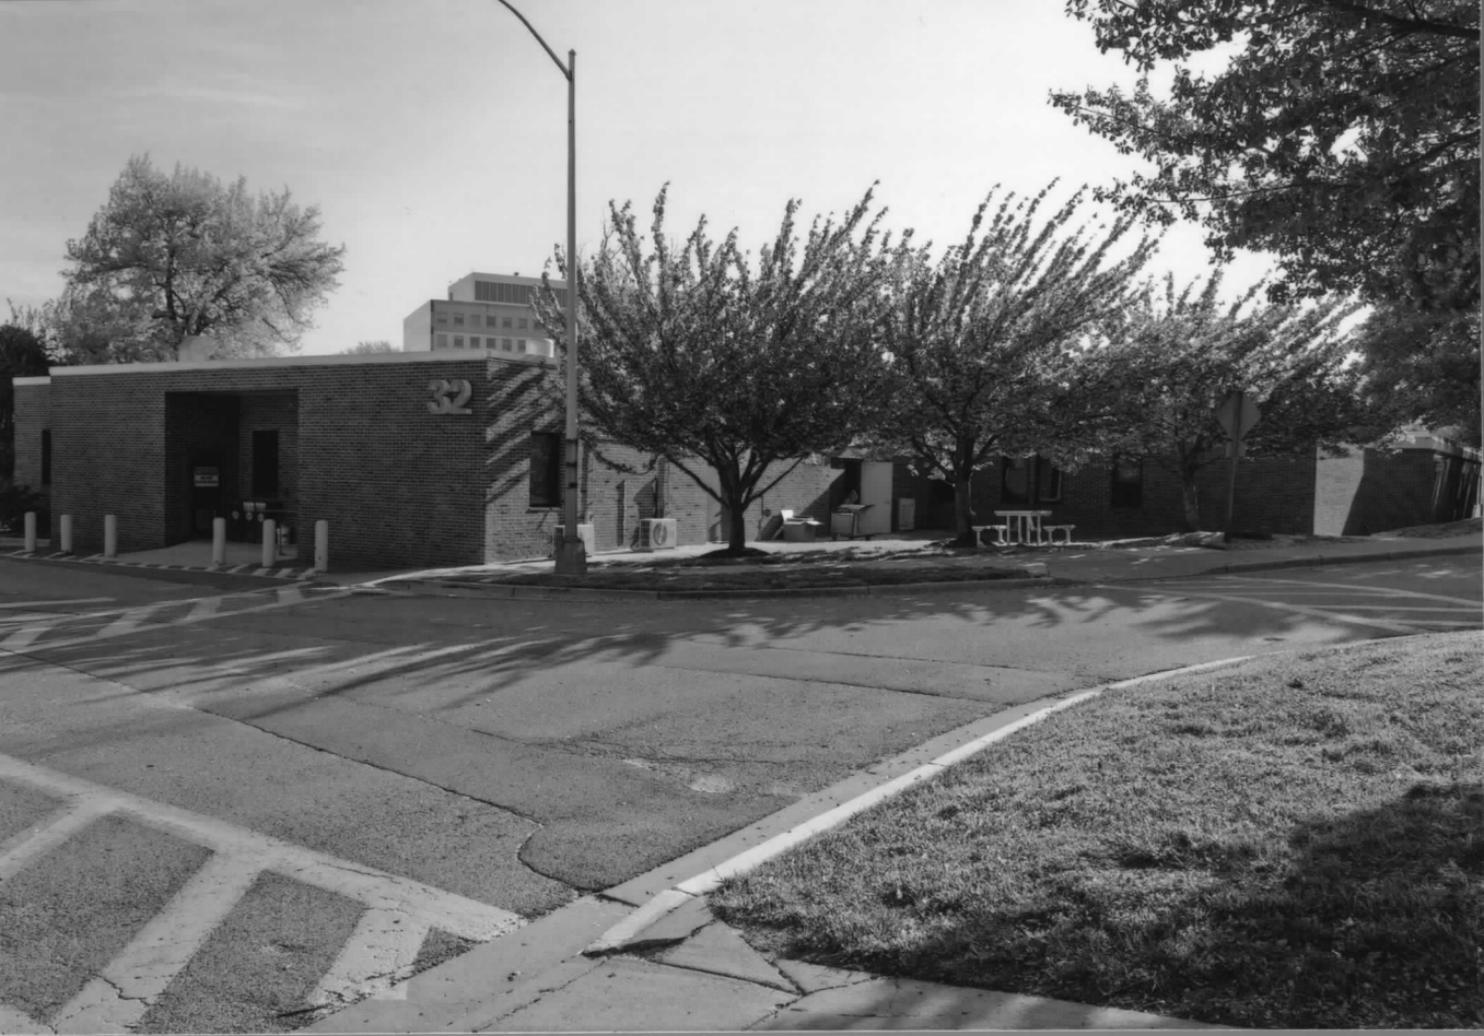
#3 of 4

| Number | Description | Photographer | Photo Date | Filename |
|---|--|---|---|---|
| 3 | Oblique view of southwest corner. | David A. Derenick | 4/25/2013 | M; 35-9-16_2013-04-25_01.tif |

"OBLIQUE VIEW OF SOUTHWEST CORNER."

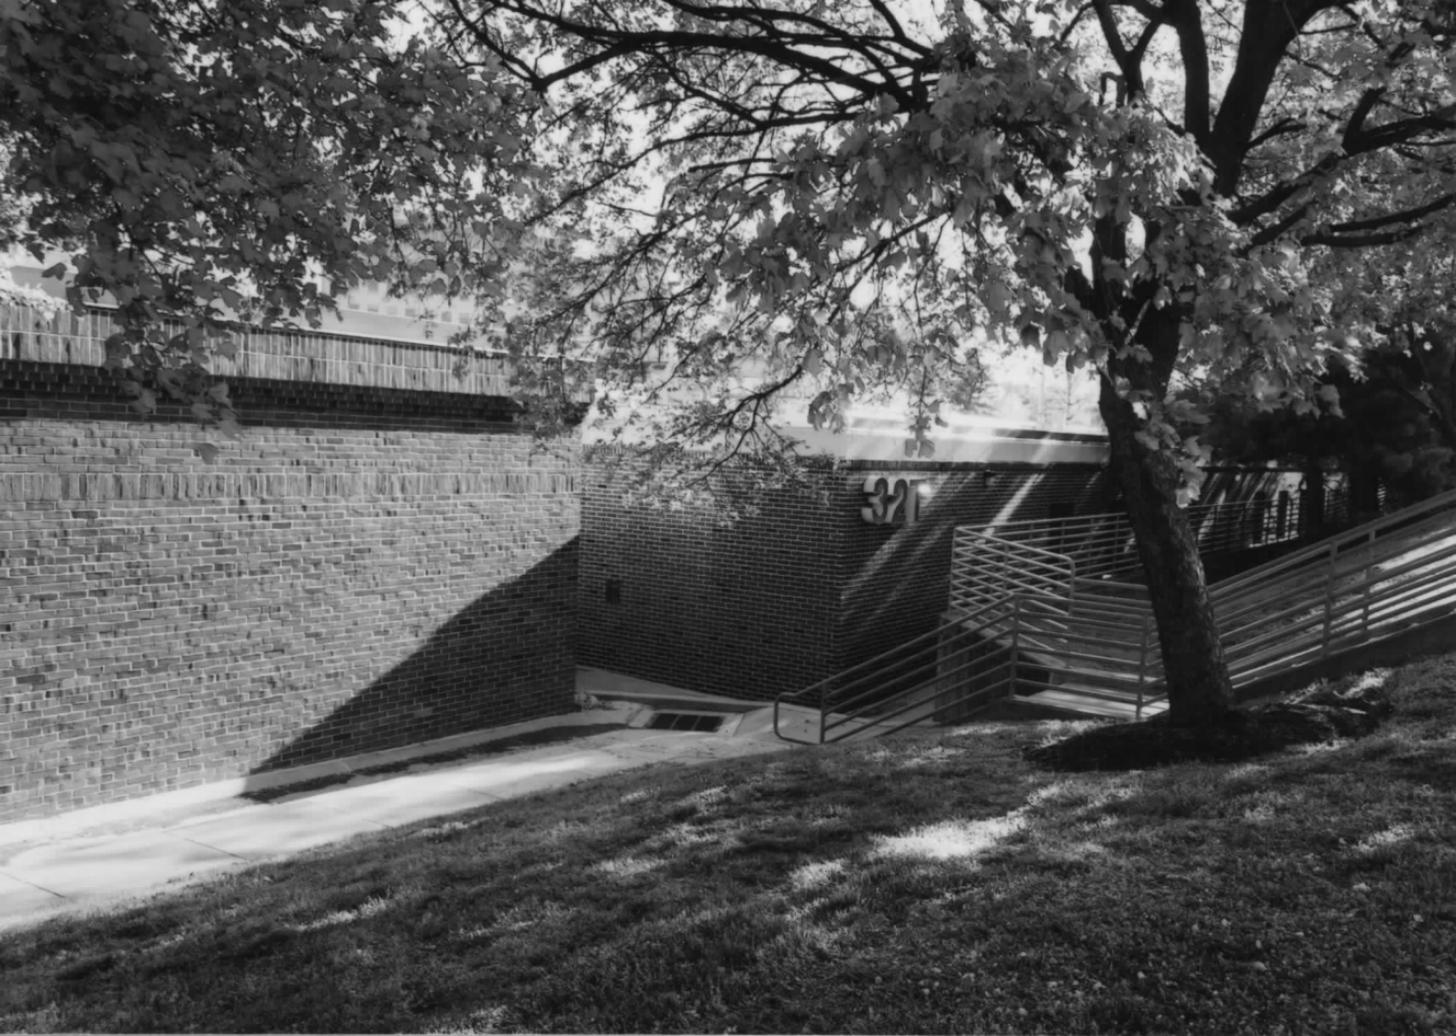
# 4 of 4

| Number | Description | Photographer | Photo Date | Filename |
|---|--|---|---|---|
| 4 | Rear (south) side with Building 32T to the east. | David A. Derenick | 4/25/2013 | M; 35-9-16_2013-04-25_02.tif |

"REAR (SOUTH) SIDE WITH BUILDING 32T  
TO THE EAST."
