National Register of Historic Places Registration Form

historic name WHITE HOUSE FARM
other names/site number K-203

Section number 7 Page 1GENERAL DESCRIPTION:¹

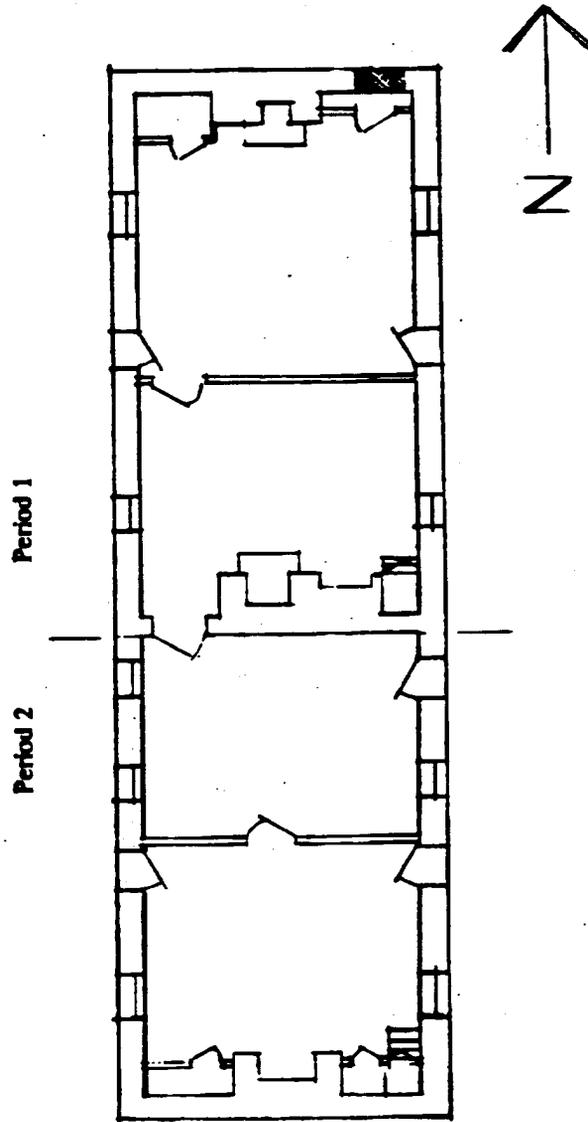
sketch plan
not to scale

WHITE HOUSE FARM (K-203)
Kent County, Maryland

The early brick house on White House Farm was constructed in two principal stages. The original house, dated 1721 with glazed bricks in the north² gable, consists of a 1½-story brick house with a pitched gable roof oriented on a north-south axis. It is three bays long and one room deep, with a traditional hall-parlor plan typical of better built houses of this period in the region. The overall dimensions of the original house are 20 feet deep and 38 feet 9 inches long. This two-room plan house was enlarged at a later date by a brick addition to the south. This addition was the same width, wall height and roof pitch, and extended the house an additional 33 feet 7 inches for an overall length of more than 72 feet. The addition provides an additional two rooms on the first floor and chamber space above.

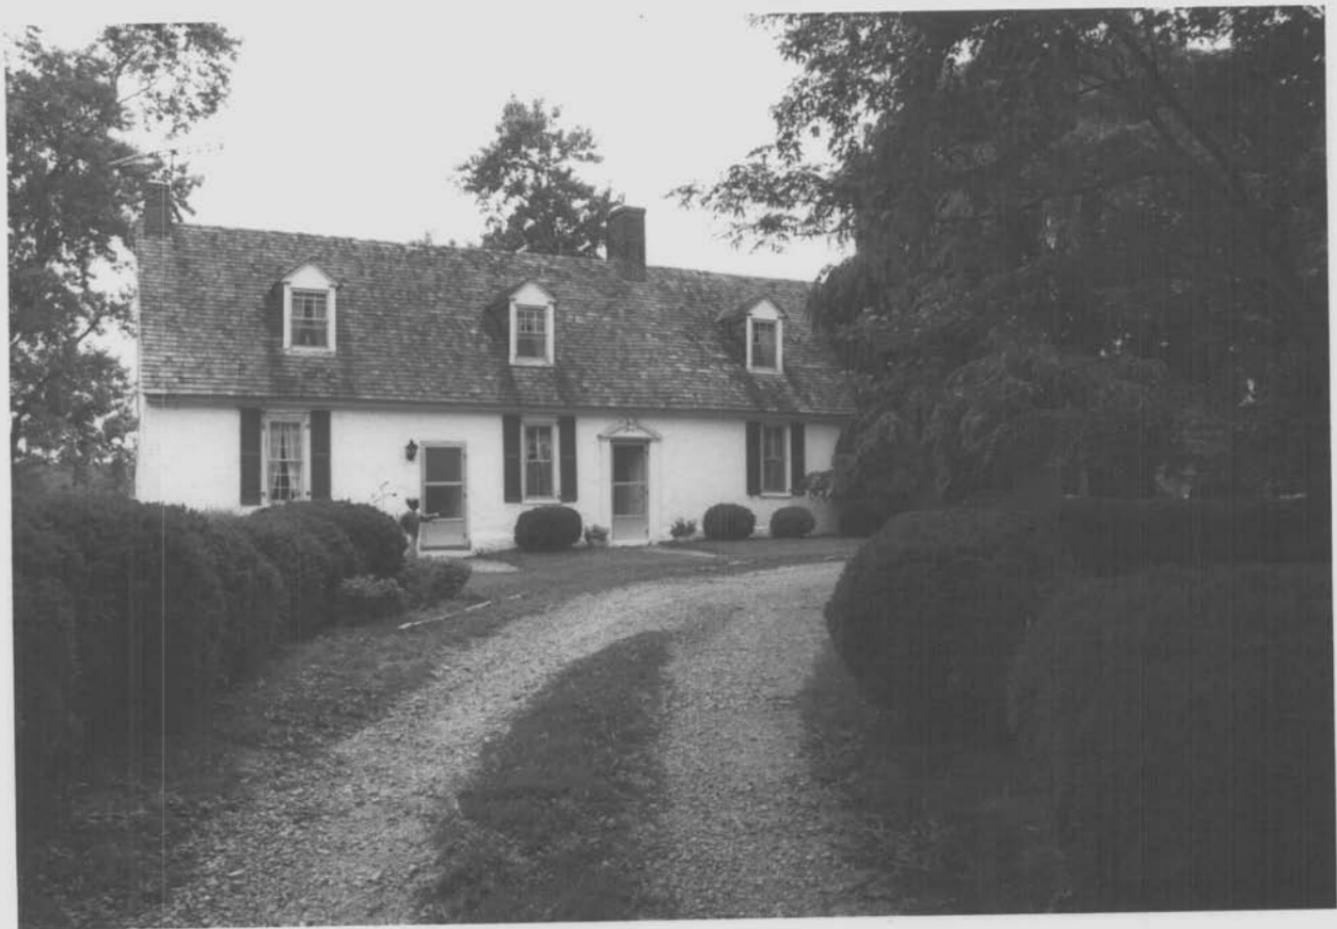
1 OF 8

EAST FACADE

The brickwork of the house is partially obscured by stucco rendering. The entire east facade of both parts is covered in this way, but the plain water table remains evident. Faint traces of rustication are visible in the stucco, largely obscured by thick coats of whitewash, paint, and later plaster. The stucco also provides the outline of a lower gable-roofed wing, approximately 17 feet 6 inches wide, that at one time projected from the north gable of the main house. When this wing was demolished (long ago), it revealed the original Flemish bond brickwork and plain water table of the original north gable, as well as the date 1721 in glazed bricks. A cut-in door that permitted direct access from the original house to the former wing was bricked up but remains visible today.

The fenestration of the original house is typical of early hall-parlor plan houses in this region. The entrance doors are located near the center of the facades, each flanked by a single window to either side. The entrances are fitted with six-panel doors with late Federal or early Greek Revival panel molds. The early window sash was replaced in the 19th century with 4-over-4 sash. There are two pitched dormers on each facade of the main house, each aligned with a first-floor window. The dormers retain 6/6 sash and are decorated with routed pilasters, Greek Revival cap pieces, and cornices that return at the pilasters. Other significant exterior features include a handsome complex cornice with bed mold and crown mold that extends the entire length of both facades, three different periods of shutter dogs including one early hand-wrought rat-tail dog, and a clear outline of the gable-roofed structure that once protected the bulkhead cellar entrance.

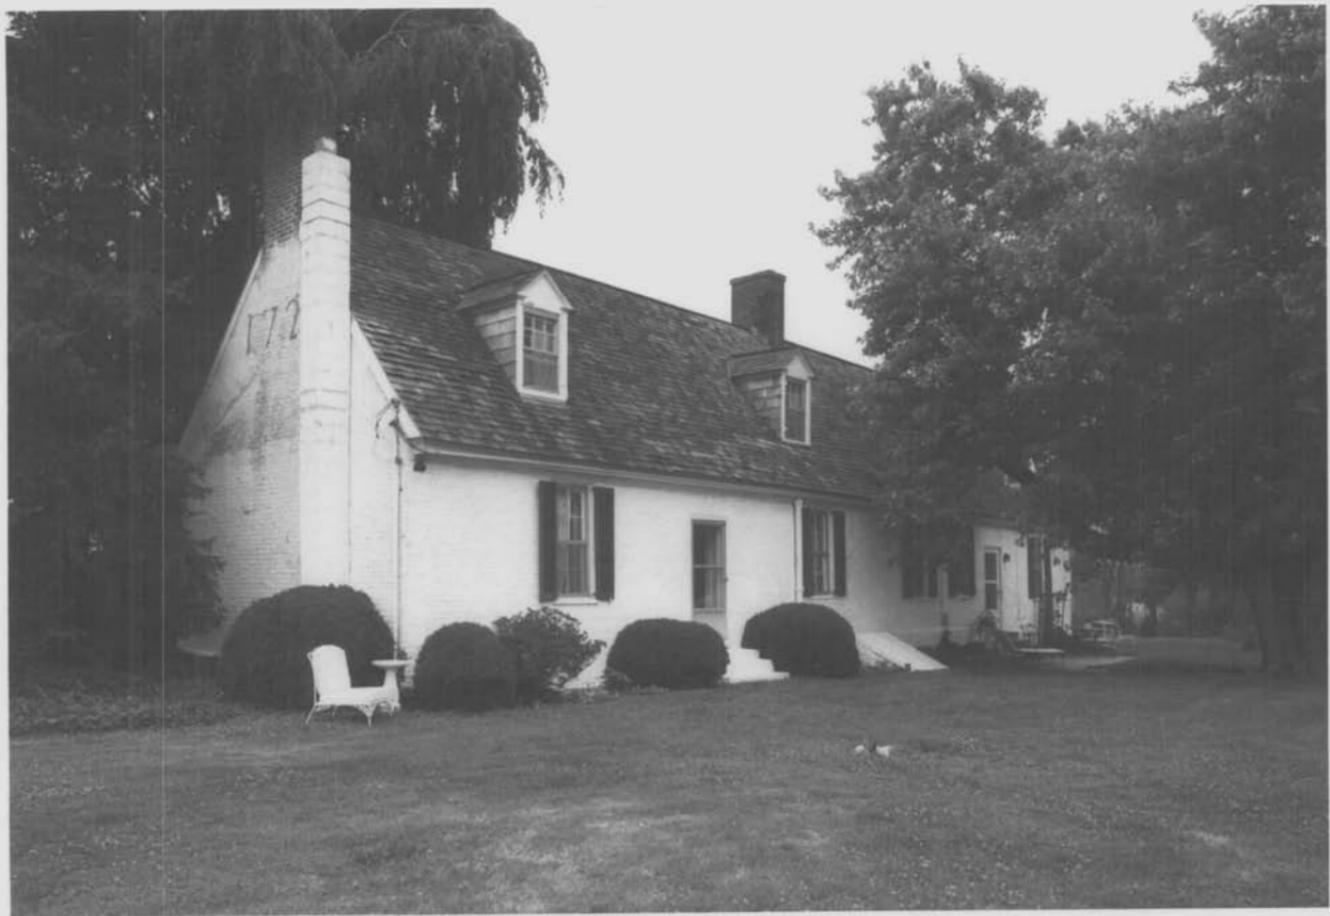
2 OF 8

WEST ELEV. & NORTH GABLE

The rear or west facade of the main house has been partially rebuilt, probably in the second quarter of the 19th century. This rebuilt section is not immediately apparent due to the heavy accumulation of whitewash and paint, but a comparison of original work at the south end of this facade, above the bulkhead cellar entrance, reveals early Flemish bond and a plain water table in contrast to the later work, laid primarily in stretcher bond with occasional header courses.

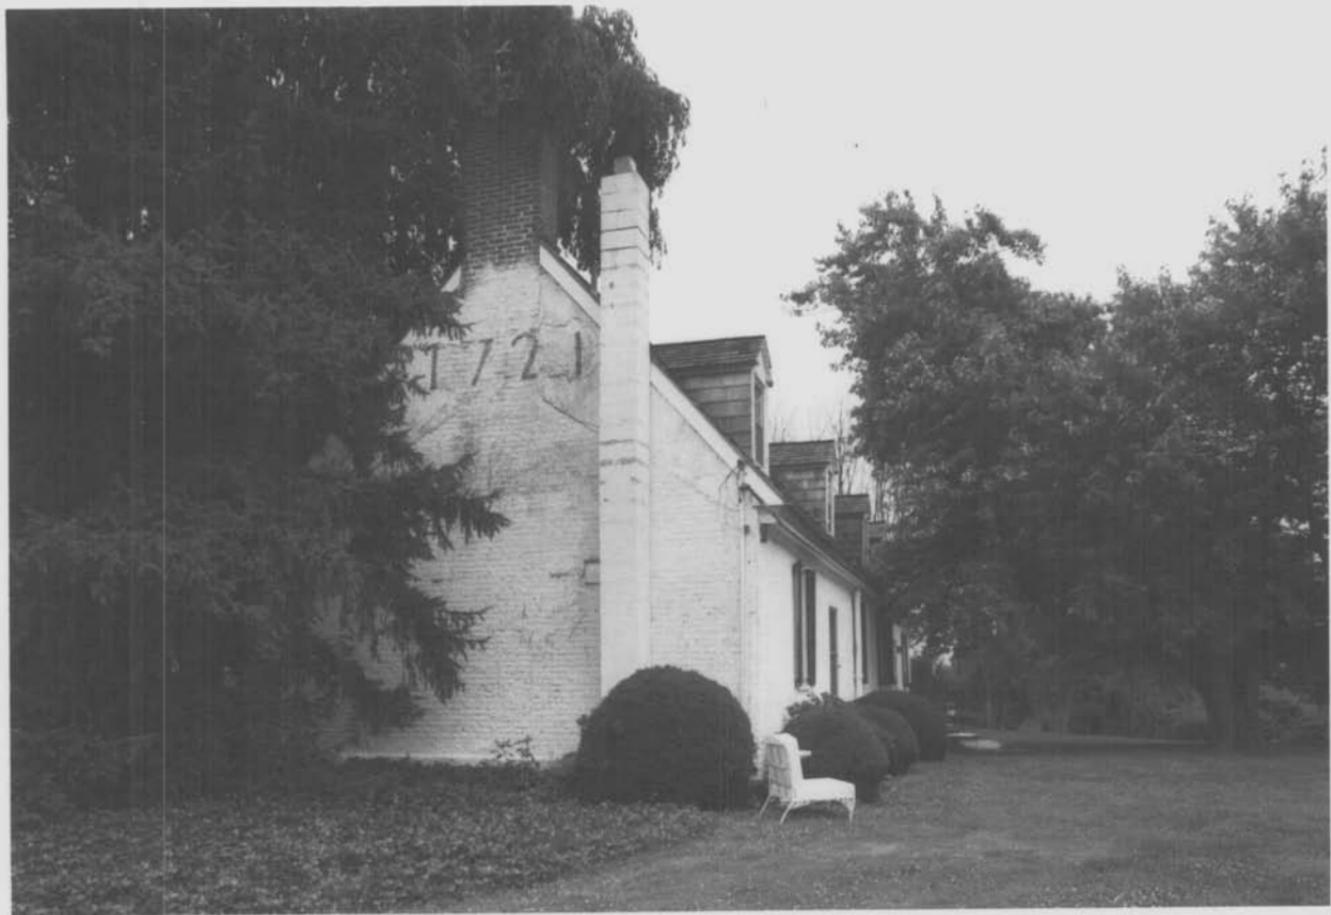
3 OF 8

VIEW FROM NORTHWEST

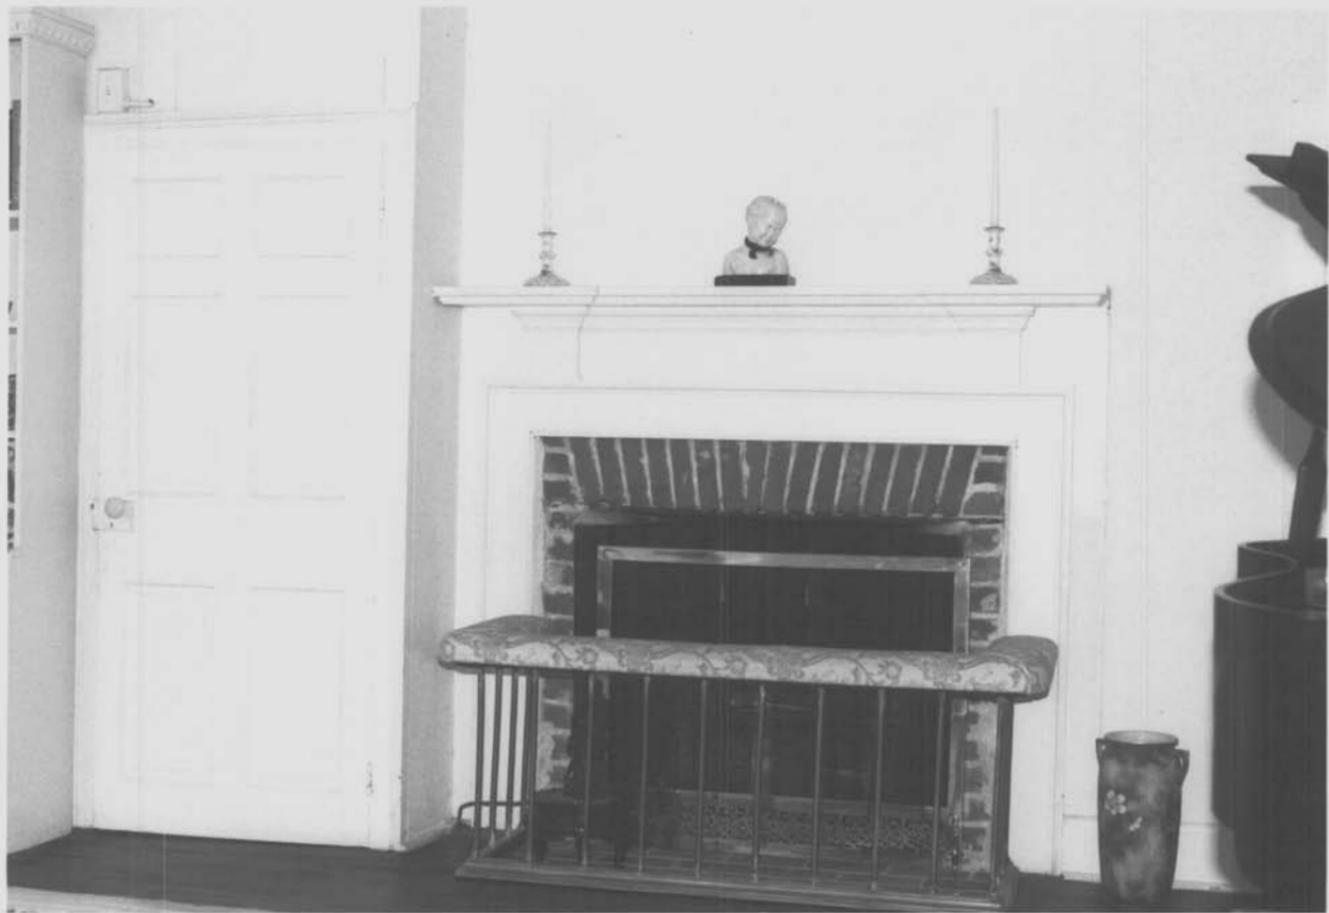
4 OF 8

HALL MANTEL & STAIR ENCLOSURE

The interior of the main house consists of a hall-parlor plan with the larger hall to the north and the parlor, or "inner room," to the south. Fireplaces are centered on the exterior gable wall of each of these rooms, and each room also originally had an enclosed winder stair next to the chimney. The stair in the hall has been removed to accommodate a modern bath, but the stair enclosure, door and door trim have been retained on both the main floor and in the hall chamber above.

The mantel in the hall is the largest and most refined in the house. It consists of a board surround with ogee-astragal backband framing the opening. Plain side blocks frame a plain frieze and support a complex molded shelf with late Federal and early Greek Revival details.

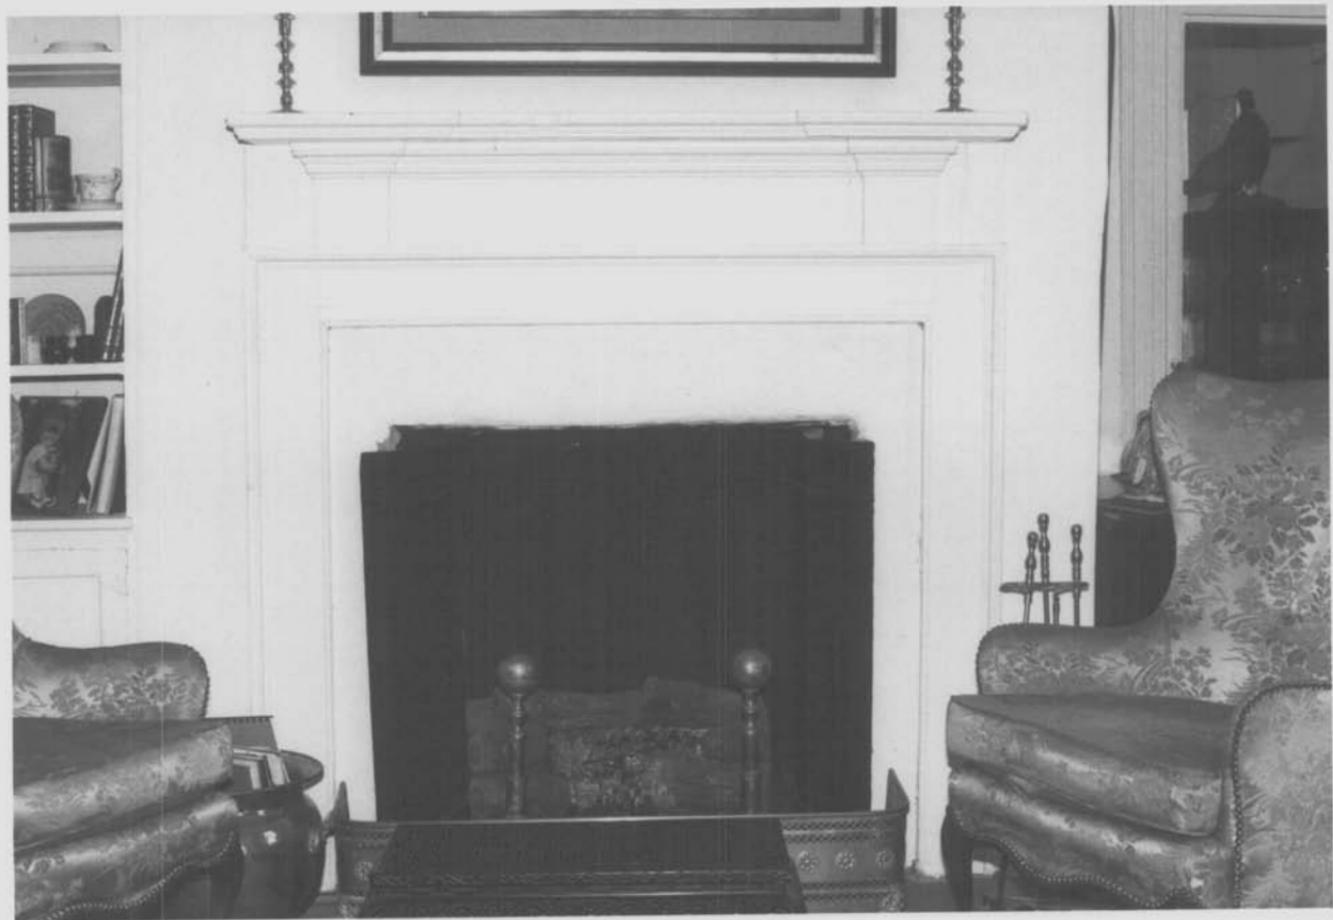
5 OF 8

PARLOR MANTEL

The parlor mantel is virtually identical to that in the hall in form and detail but is several inches narrower. This fireplace opening has been fitted with a handsome cast iron fireback and sidepieces embellished with Classical ornament, including fluted pilasters and acanthus motifs. Cast into the center piece is the inscription, "Thomas Chambers, Southampton Furnace." This fireback was found on the premises and installed during the stabilization and repair of the house by the present owners in the 1940s.

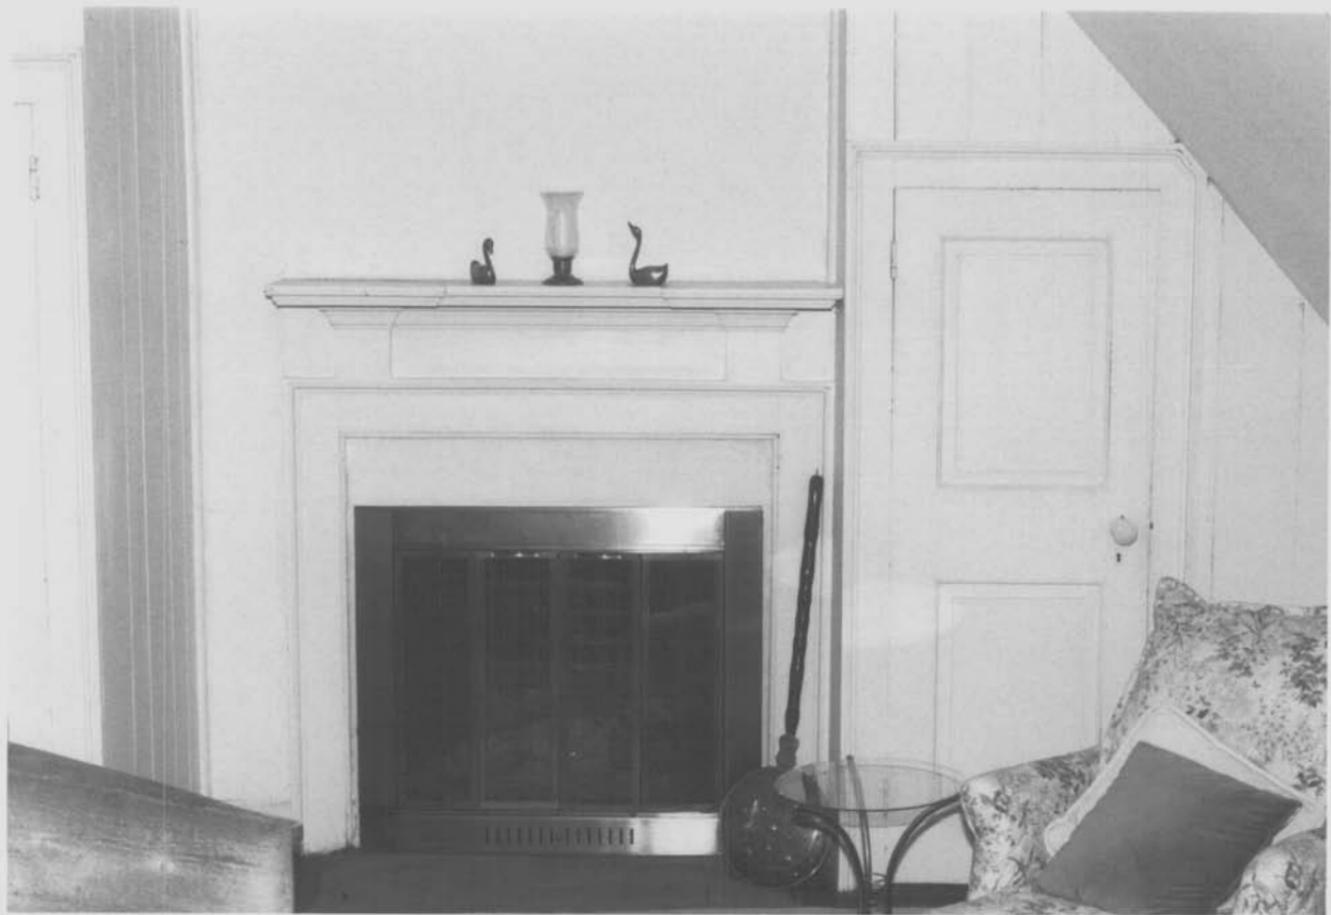
= 6 OF 8

MANTEL & CLOSET DOOR, 2D FL NORTH ROOM

The north chamber fireplace is fitted with a mantel comparable to the first floor mantels but smaller in scale. This fireplace is flanked by the original stair enclosure (now a closet) to the left and a small, early closet to the right. These closets are fitted with doors and architrave trim consistent with the first floor.

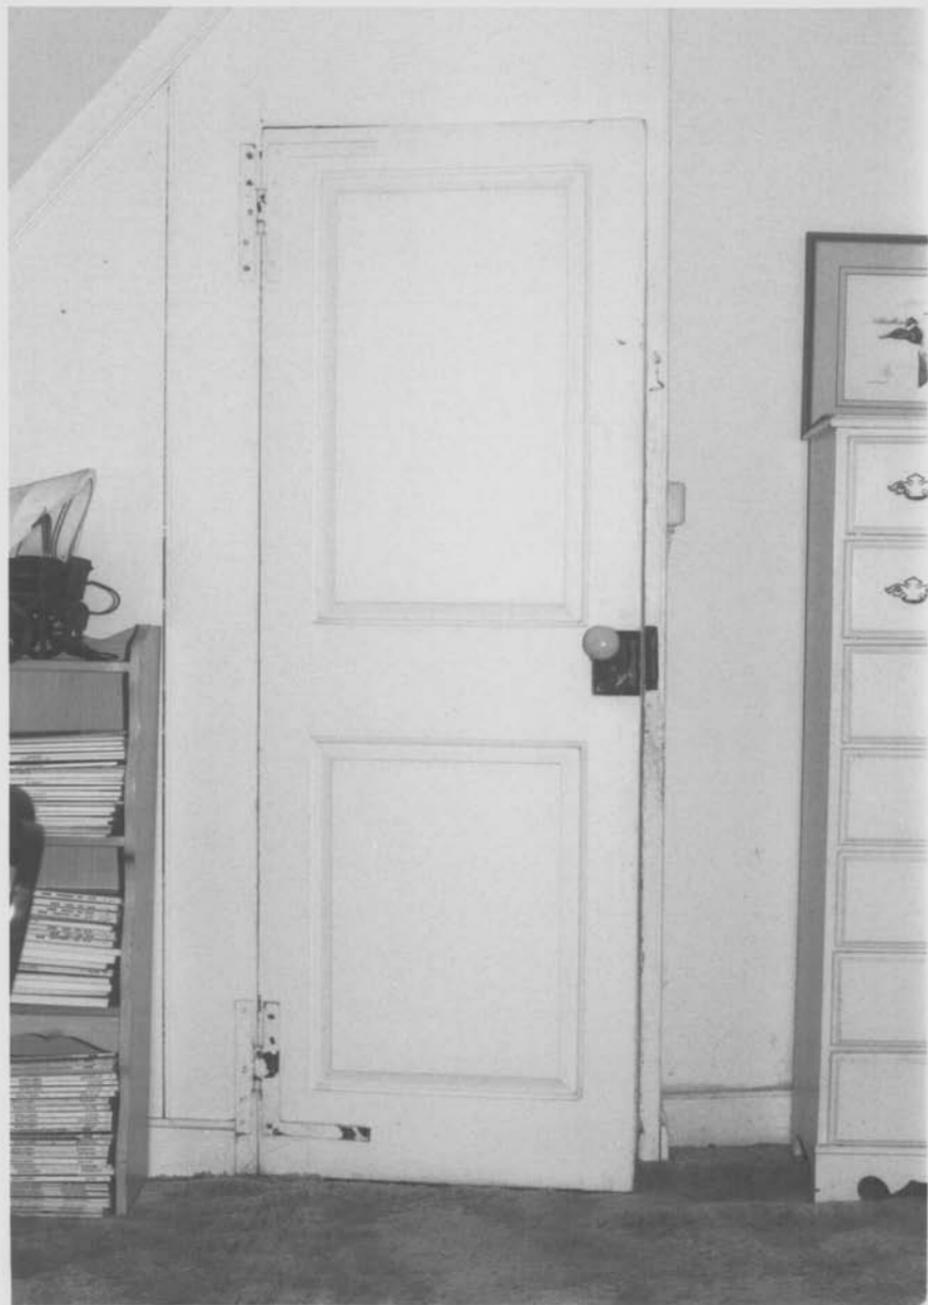
7 OF 8

2-PANEL DOOR, 2D FL

An enclosed winder stair to the left of the parlor fireplace leads up to the second story chambers. The second story was originally divided into two bed chambers, each apparently with a separate stair. The door between the two chambers is framed with the same architrave trim as found on the first floor. A two-panel door with fully raised panels is hung on unusual hand-wrought H hinges with three of the four ends foliated. An early 19th century metal box lock with brass knob remains in use.

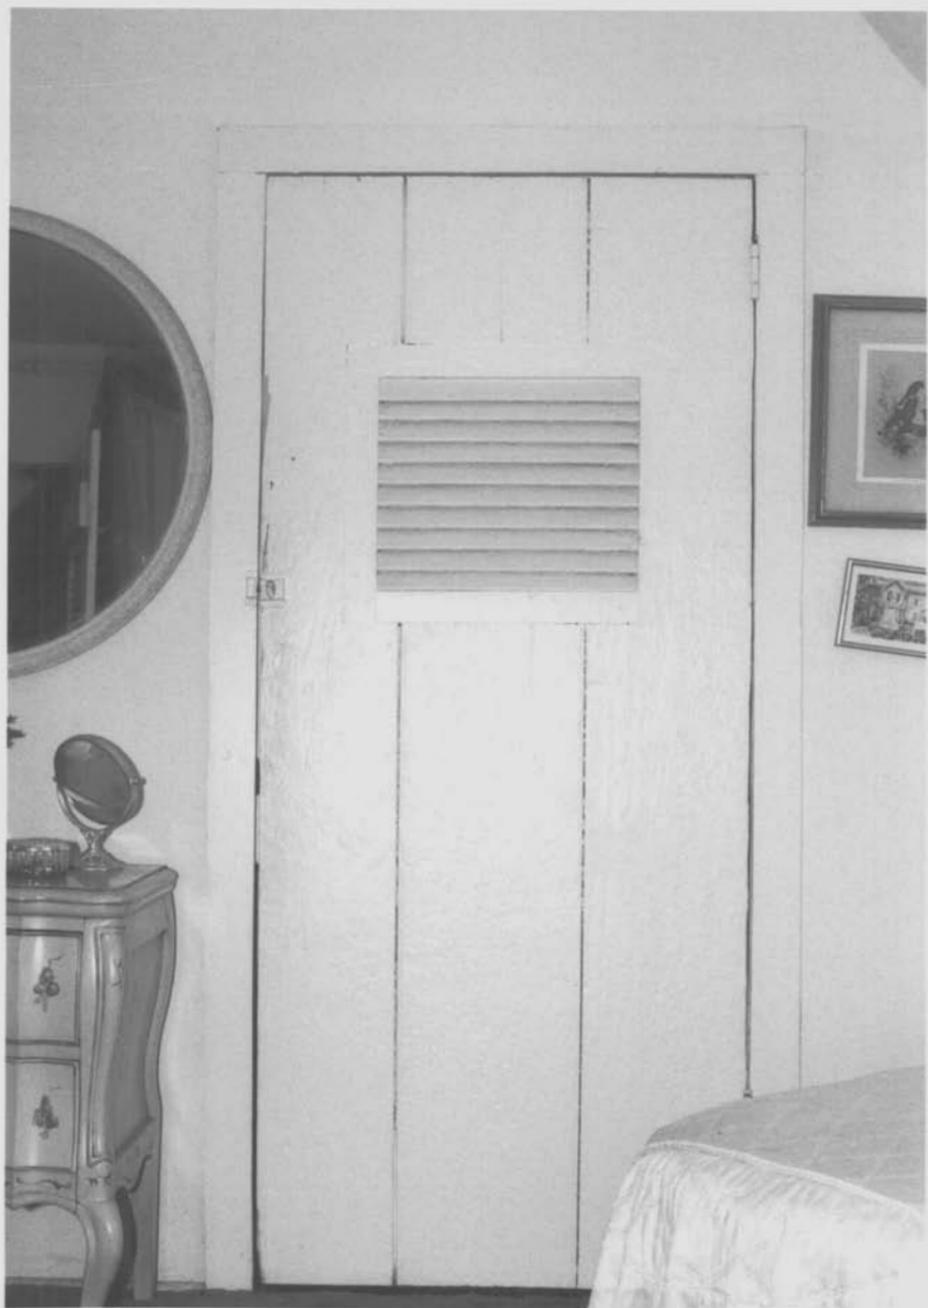
8 OF 8

LOUVERED BATTEN DOOR, 2D FL

An enclosed winder stair to the left of the kitchen chimney leads up to a room above the kitchen. This space is partitioned off from the room above the dining room by a beaded board partition. Originally, it was divided into two rather plain chambers for the kitchen servants. The ghost of the original partition remains visible on the ceiling. An interesting feature of the servants' rooms are the doors, which are of beaded batten construction with louvered vent panels fitted into the upper portion of each door.
