National Register of Historic Places Registration Form

historic name UPTON
other names/site number Stewart, David, Residence; Dammann Mansion

street & number 811 West Lanvale Street N/A not for publication
city, town Baltimore N/A vicinity
state Maryland code MD county Independent City code 510 zip code 21217

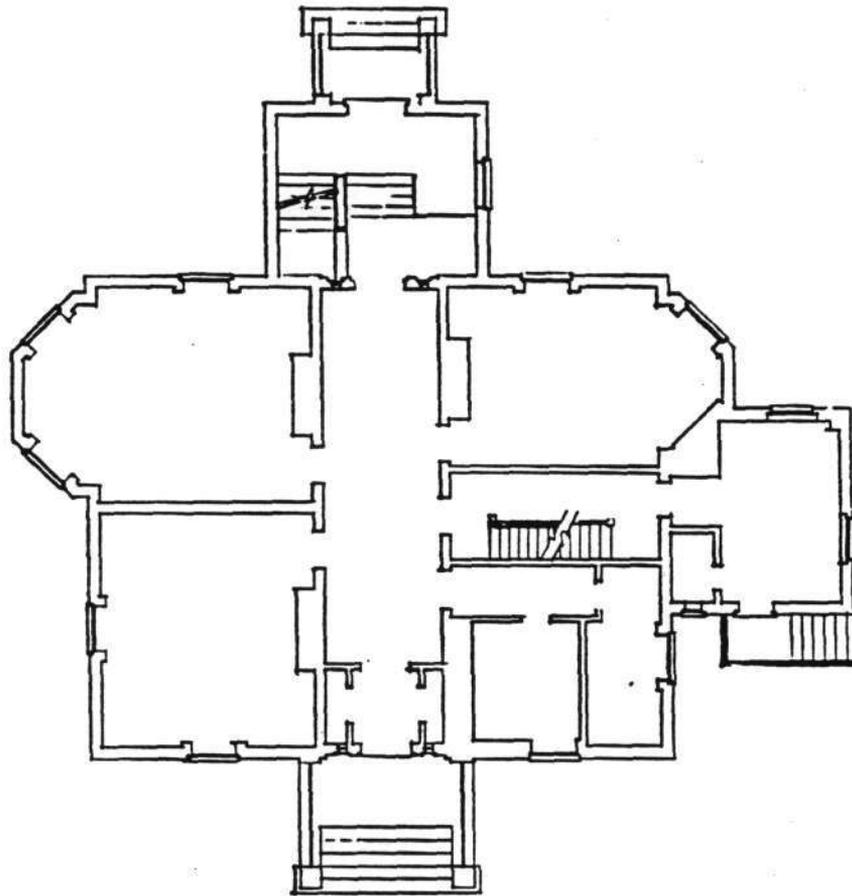
FIRST FLOOR PLAN
0 10 20 30 40
UPTON

The interior is organized in a center-passage, double-pile plan; the main hall runs through the building from north to south, and the stair is located in a secondary passage perpendicular to the main hall on the west. Two rooms open off the passage on either side. David Stewart's inventory indicates that the first-floor spaces originally functioned as "parlours" (the two east rooms), "library" (probably the southwest room), and "dining room" (the northwest room, which now contains two toilet rooms and a short passage), in addition to the "main hall." A small vestibule at the north end of the hall has a closet on either side; these closets are lighted by the sidelights which flank the north entrance.

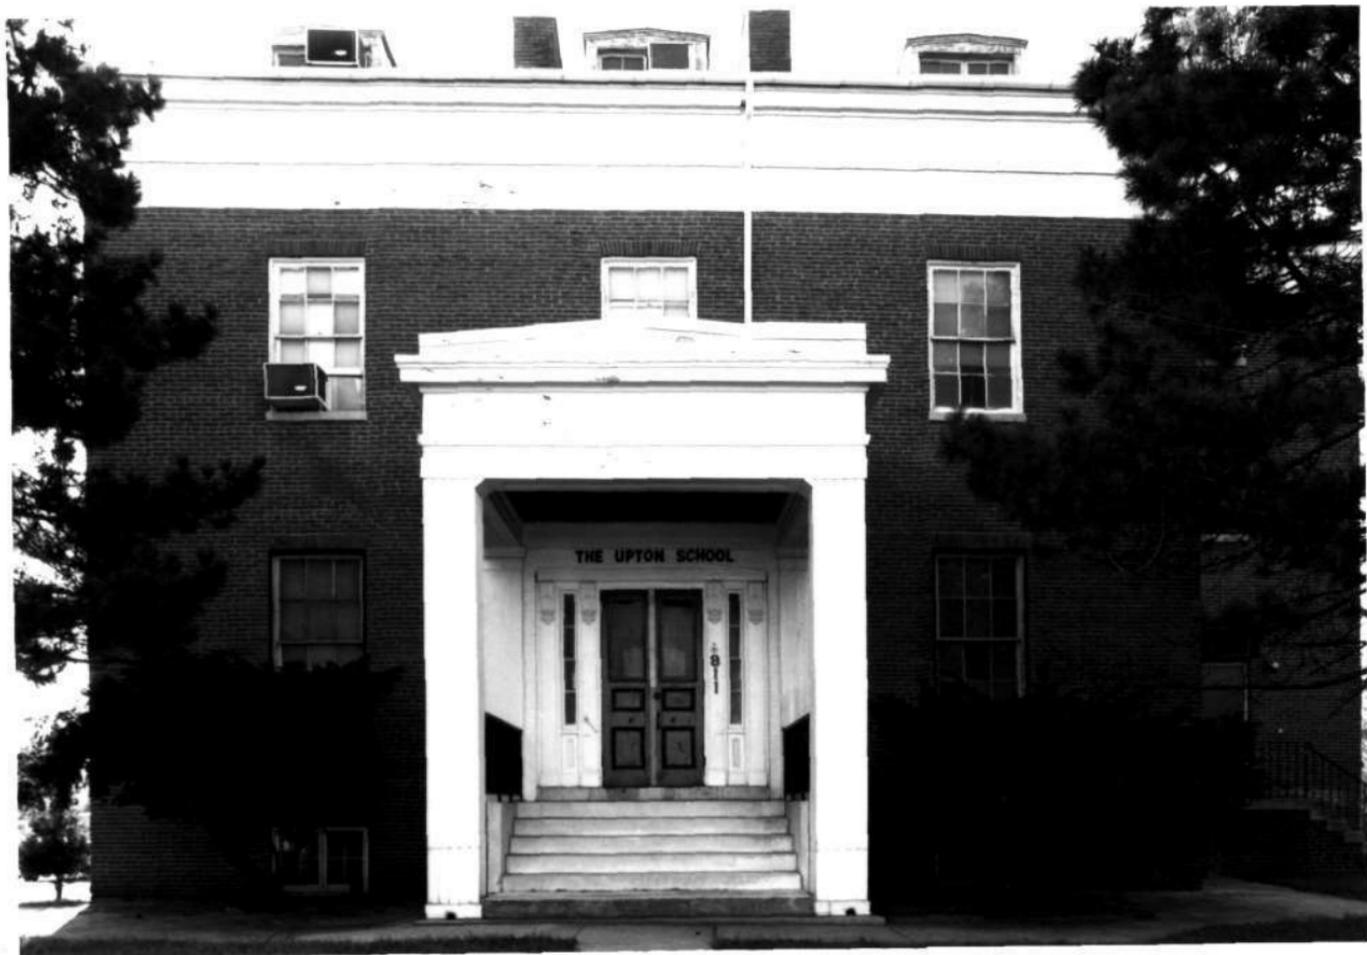
1 / 8

NORTH FACADE

The north facade faces West Lanvale Street, and is three bays wide. A portico shelters the central entrance; square columns (encased in grooved plywood) support an entablature and cornice employing Classical molding profiles surmounted by a shallow pediment. Above a granite apron, a flight of five marble steps rises to a marble platform with an iron rail featuring a rose and thistle motif derived from the Stewart family arms. The cheek walls flanking the steps are carved on their outer faces, each with a large stylized flower centered in a stepped recessed panel. The entrance comprises double-leaf doors with three flat fielded panels framed with quirk ogee panel molds (the upper panels have been replaced with glazing). The doors are flanked by four-pane sidelights above a paneled spandrel. The doors and sidelights are defined by four pilasters with stepped plinths and richly carved consoles with acanthus leaves at the capitals. The frontispiece is slightly recessed within a segmental-arched opening. The portico has a paneled ceiling.

The entrance bay is flanked by large 9/6 windows on the first floor; at the second floor level, the three bays are defined by 6/6 sash. The basement is lighted by paired casement windows; three shallow gabled dormers with paired casements light the attic on the north slope of the roof. The window sash throughout the building was replaced in the 1957-58 rehabilitation, but the original frames were retained. Windows on the first and second stories throughout the building have splayed jack arches and marble sills. The first-floor windows have cast iron grilles with rose-and-thistle decoration. This window configuration and detailing is consistent throughout the building.

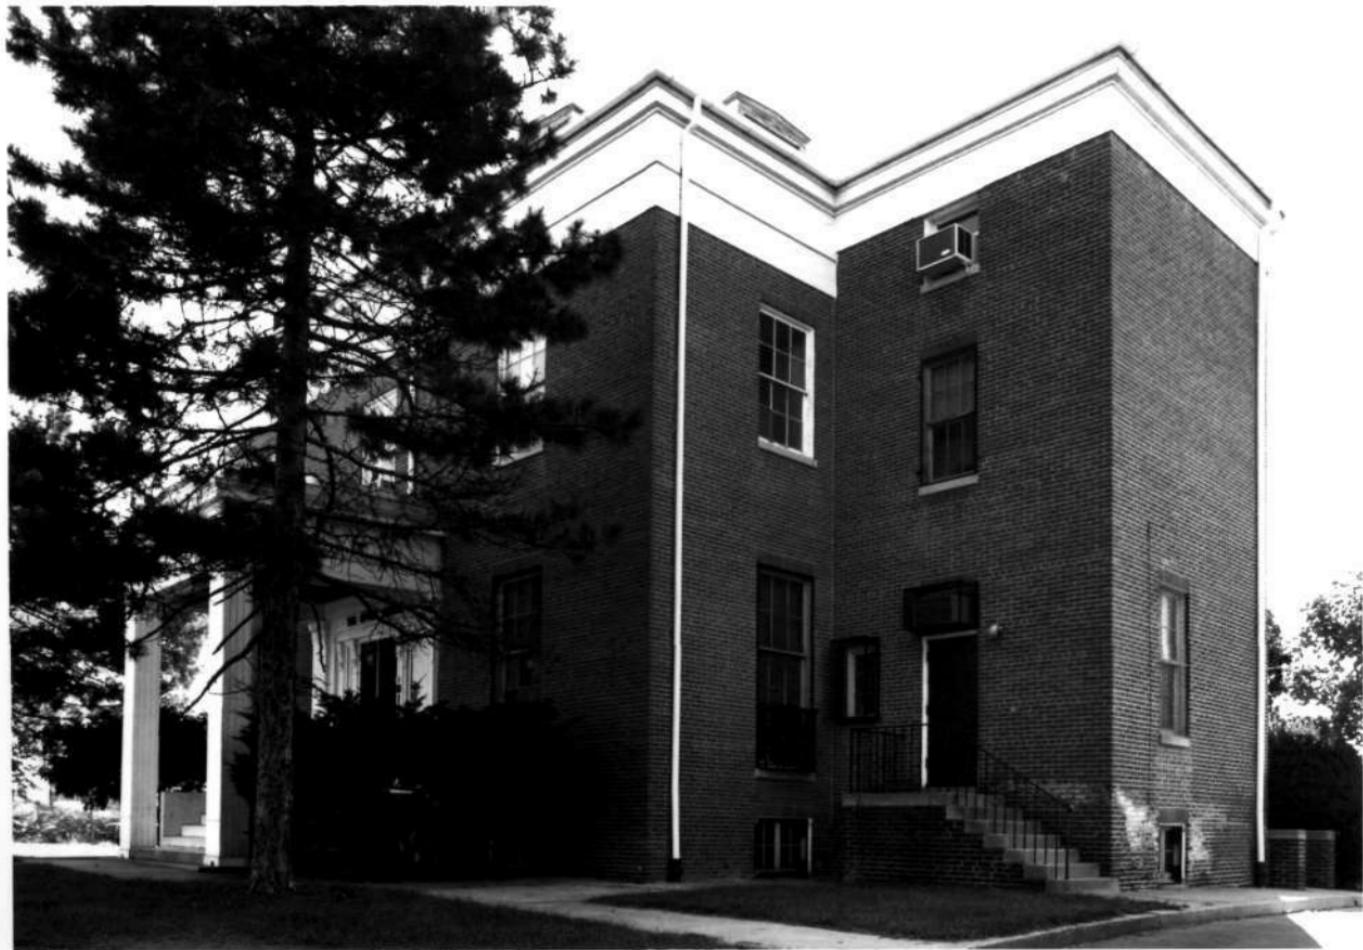
2/8

VIEW FROM NORTHWEST

The west elevation originally mirrored the east, with a three-sided projecting bay on its southern half. A service wing one bay wide by one bay deep and rising the full height of the building was added in the third quarter of the 19th century; it is not mentioned

in a room-by-room inventory prepared after David Stewart's death in 1858, but appears in a photograph taken before ca. 1880; it was probably constructed shortly after the Dammann family acquired the property in 1868. The wing is centered on the west facade, and engages the north facet of the projecting bay. It originally had an entrance in its west wall, facing the drive and carriage house; this entrance was relocated to the north side of the wing in 1957-58.

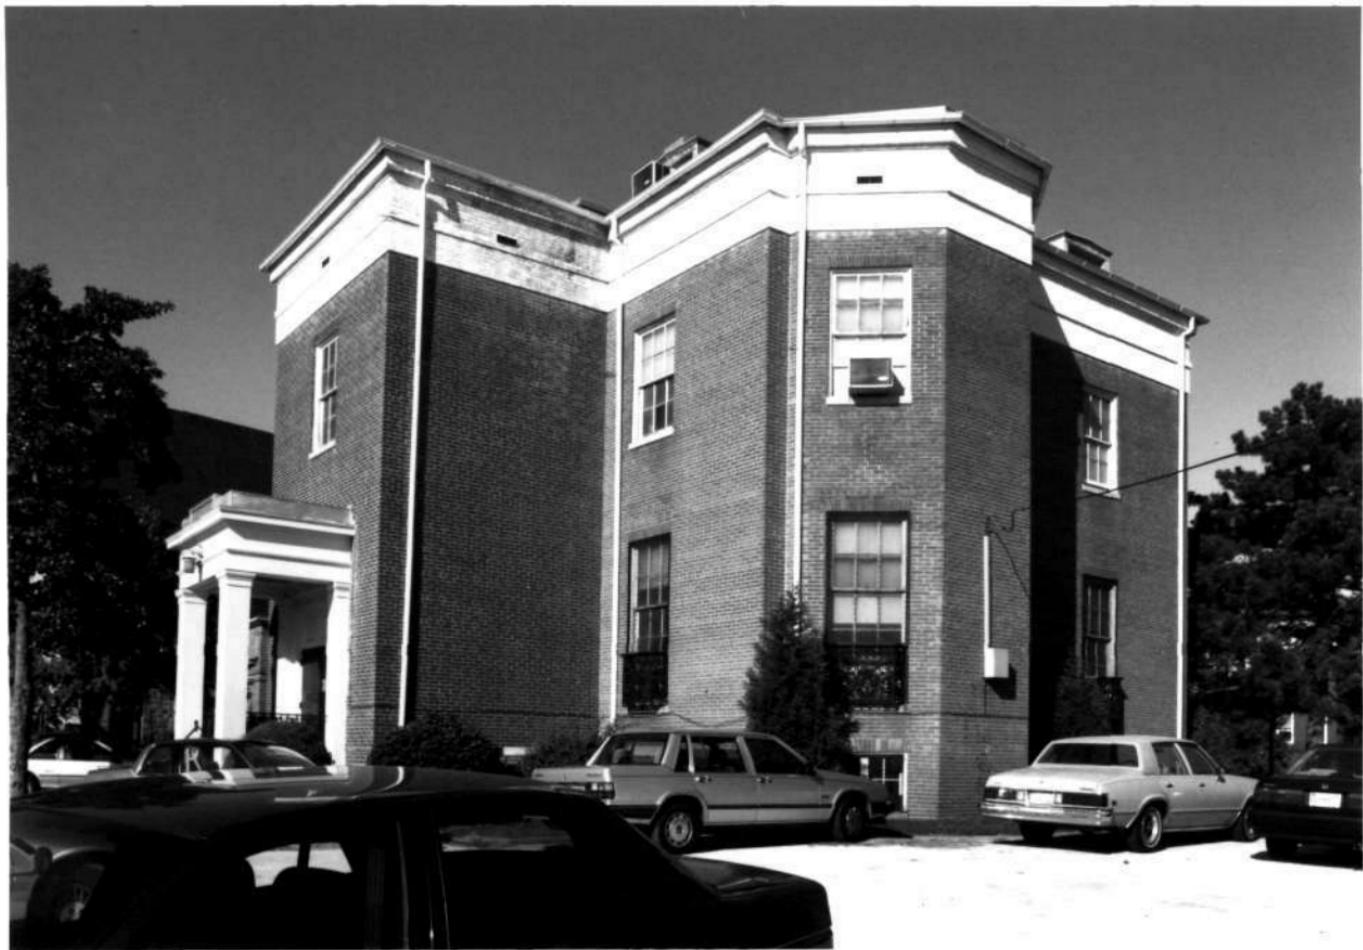
3/8

VIEW FROM SOUTHEAST

On the east elevation, a three-sided projecting bay occupies the southern half of the facade; there are windows in the angled facets of the projecting bay, and a single window centered in the northern portion of the facade, on both the first and second stories.

The south elevation originally was the garden facade; its symmetrical three-bay composition and detailing mirror the north elevation with the exception of a two-story porch which formerly occupied the central bay and which was replaced with a brick stair tower in the 1957-58 rehabilitation. This tower is constructed of concrete block faced in brick laid in running bond, with a two-brick belt course at the level of the entrance. A Classically-detailed portico serves the entrance, which comprises double-leaf, three panel doors. The granite steps and cheek wall bases of the original south porch were reused in the new portico. Original entrance enframements, similar to that described on the north facade, survive in the south wall within the stair tower. The basement on the south side is lighted by 6/6 windows opening into an areaway. In the 1957-58 rehabilitation, the cast iron railing with rose-and-thistle decoration was salvaged from the first level of the south porch and incorporated into a new brick wall protecting this areaway (historic photographs show a simpler geometrical railing in this location).

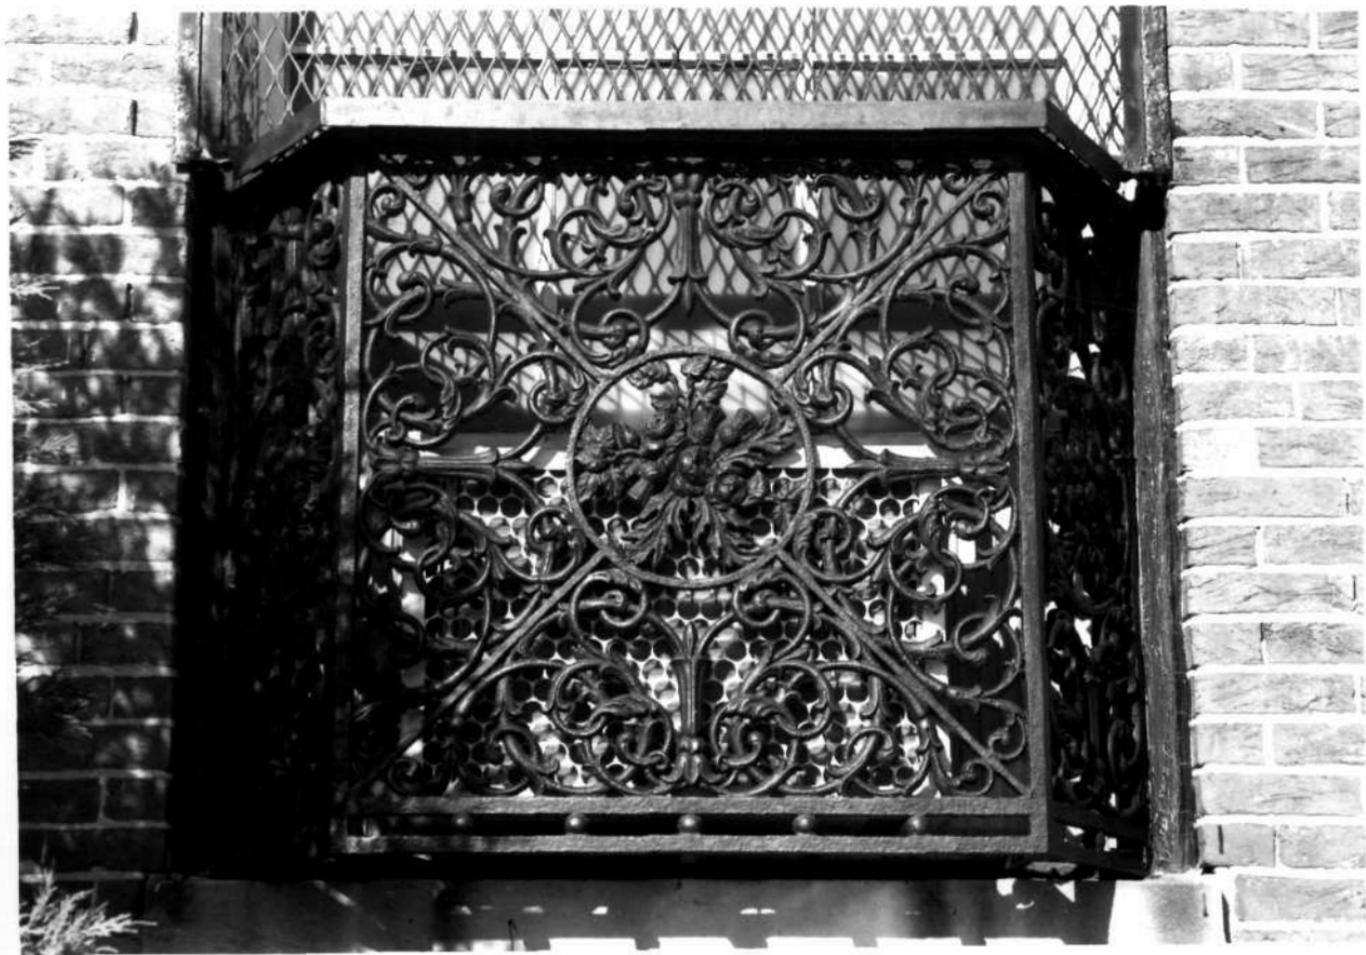
#4/8

DETAIL, TYPICAL WINDOW GRILLE

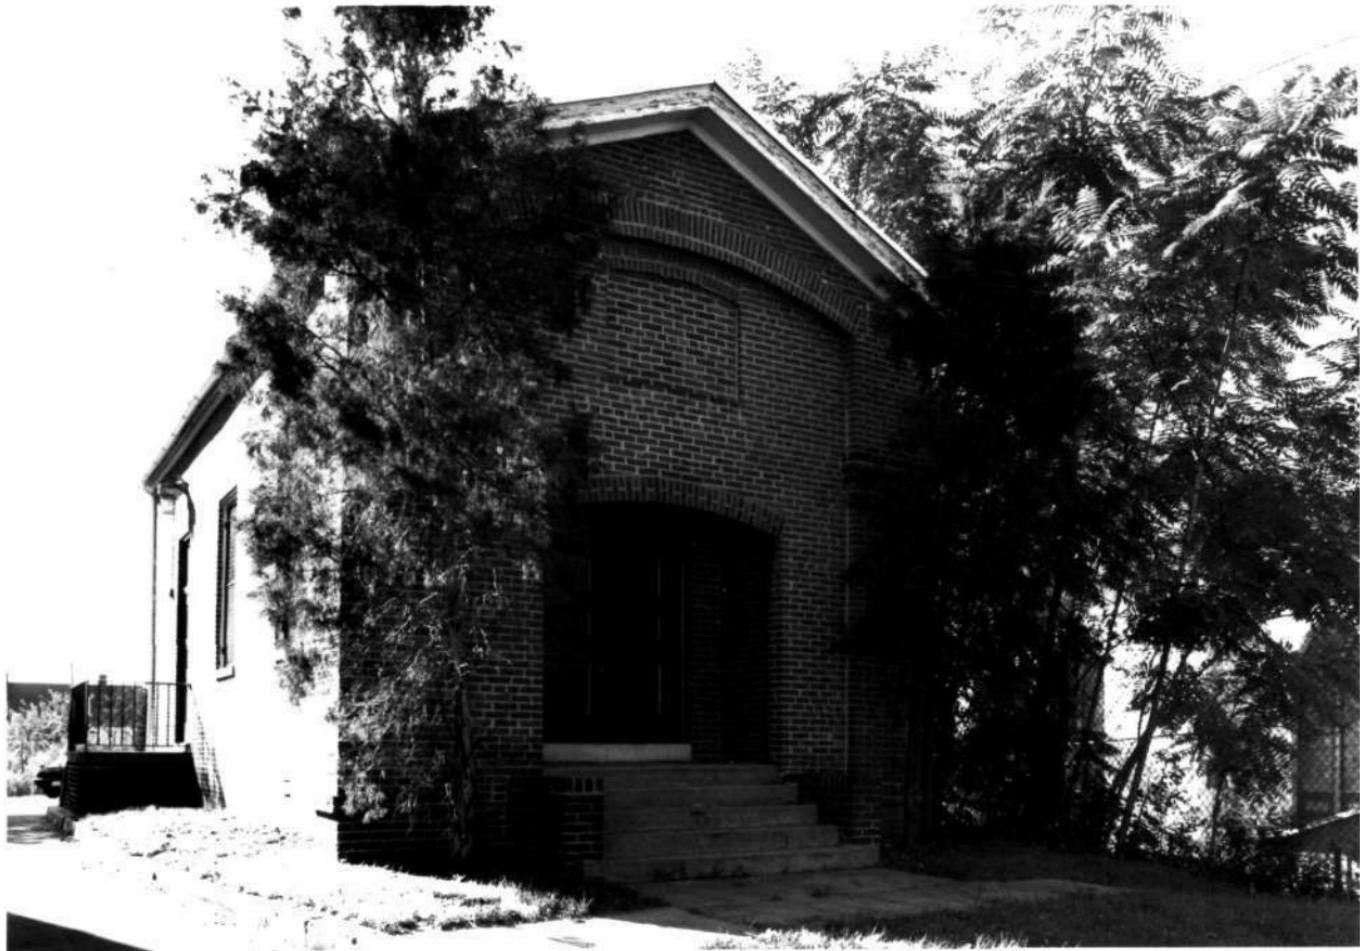
5/8

CARRIAGE HOUSE, VIEW FROM NORTHEAST

The carriage house is located to the west of the building; this is a rectangular, one-story brick building with a broad segmental arched opening in its north gable end. It was remodeled extensively in 1957-58 to serve as a school assembly room. A 19th-century photograph shows a one-story, hip-roofed building located to the west of the existing carriage house; this presumably was the stable mentioned in David Stewart's inventory, and was demolished in the late 19th century for the construction of the church at the corner of Lanvale and Fremont streets. According to the inventory, the stable and carriage house accommodated two family carriages (one large, one small) and tack, a pair of carriage horses, a red-and-white cow, and a stepladder.

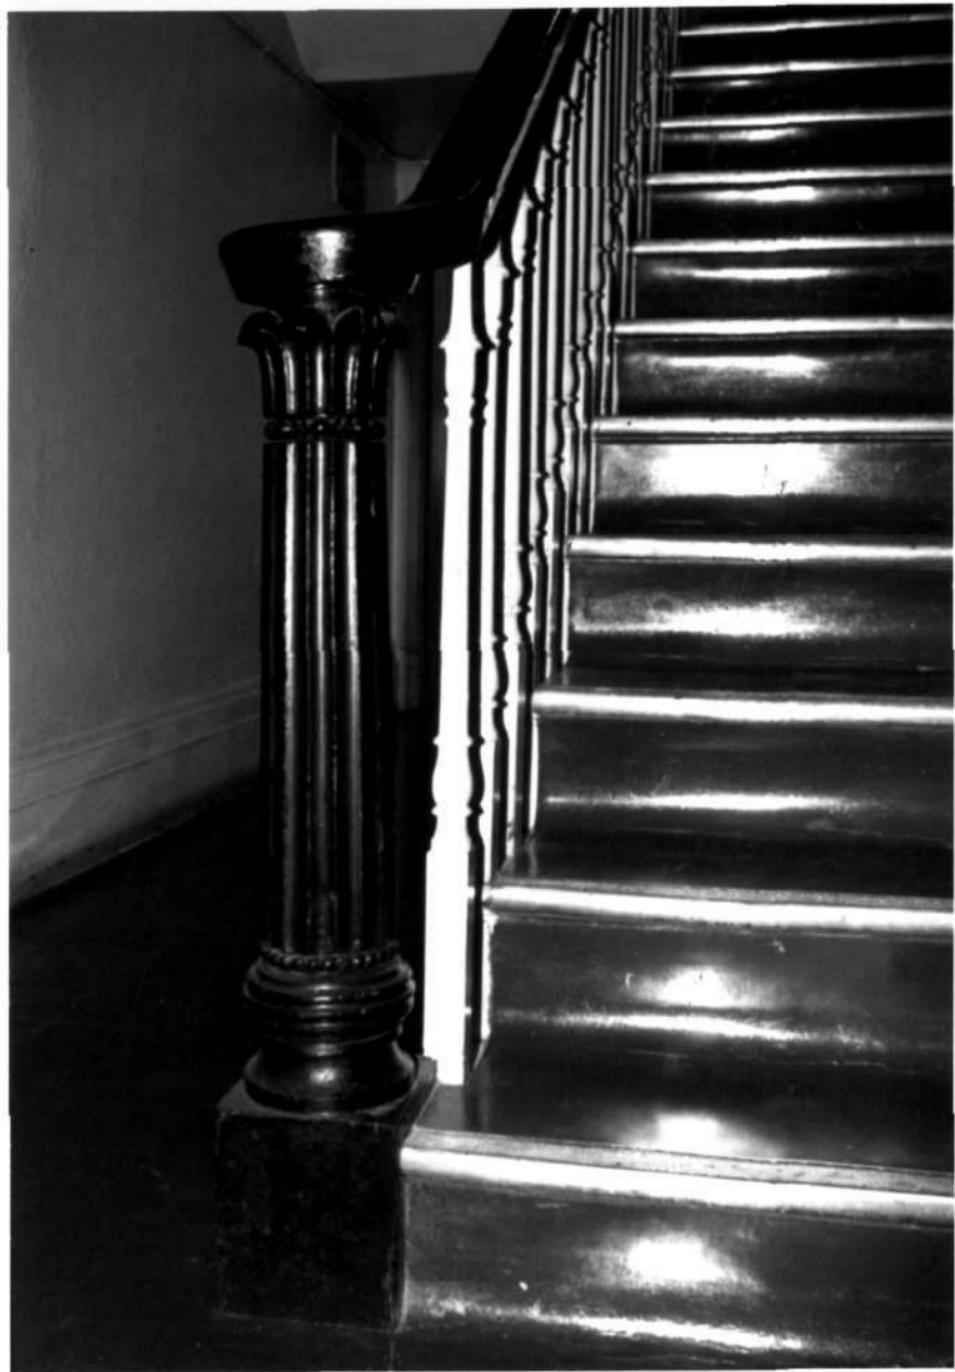
6/8

STAIR DETAIL

The open-string stair has a fluted mahogany newel, turned balusters (two per tread), and scrolled step ends. At the landing between the first and second floors, an opening provides access to the second level of the service wing. The detailing of this opening is consistent with that in the main hall. As described in a newspaper article of 1929, the wing housed a service stair which joined the main stair at this landing. The landing between the second and third floors has an entrance to the upper level of the wing, detailed in a manner similar to the second floor of the main block.

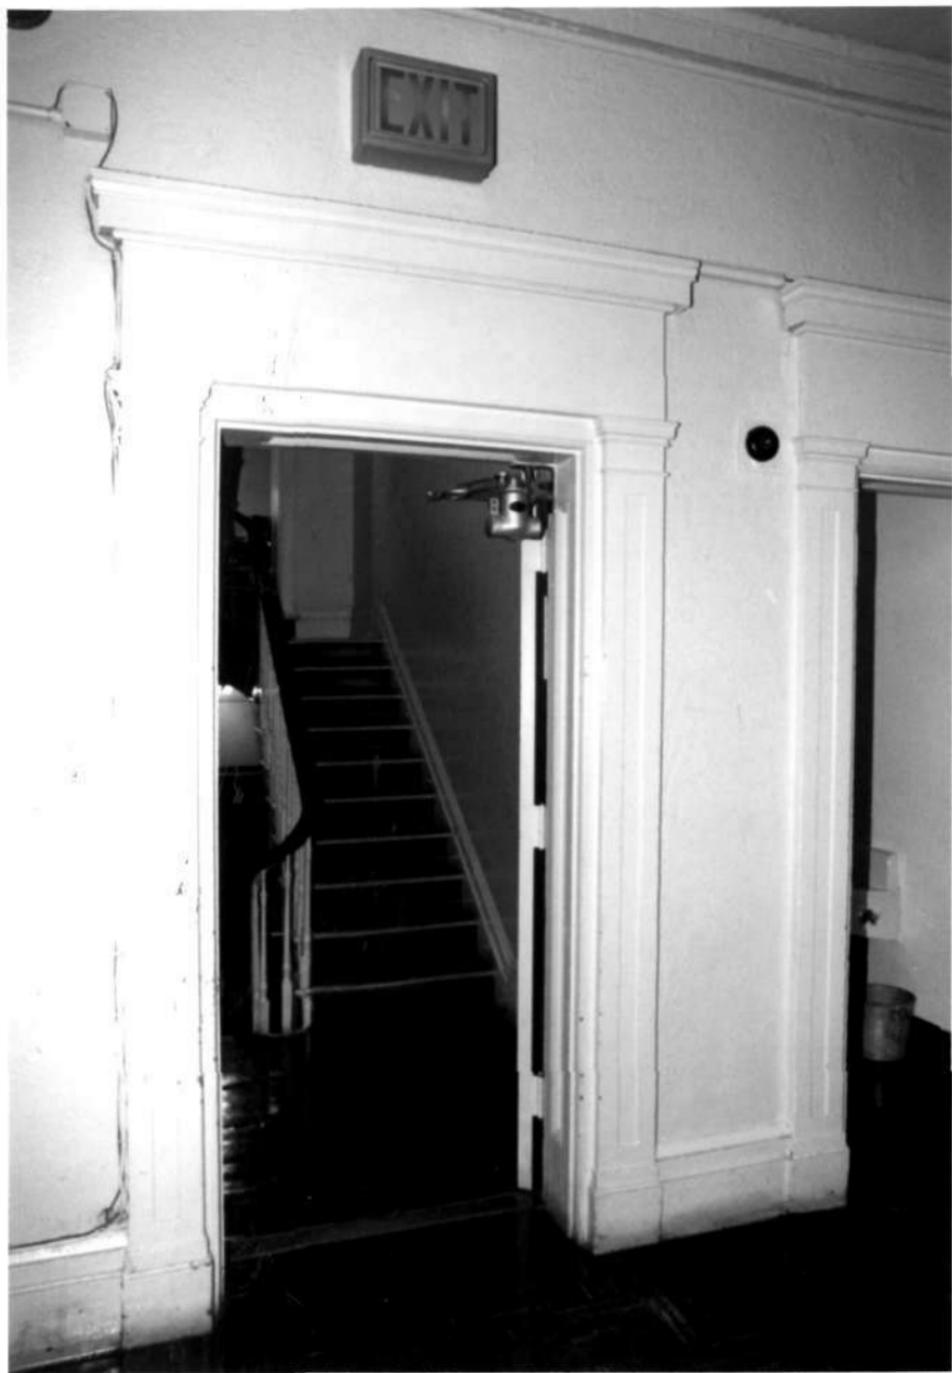
#7/8

TYPICAL TRIM, 2ND FL. HALL

On the interior, Upton retains the vast majority of original door, window, and baseboard trim intact. A clear hierarchy of finish is evident in this decorative detailing. In the most formal, public areas of the first floor--the entrance hall, stair passage, and east parlors--door and window openings are framed by stepped-paneled pilasters with carved capitals incorporating greek key and patera motifs; these support a plain entablature, with architrave and cornice outlined by egg-and-dart and bead-and-reel moldings. Door jambs are paneled, and windows have paneled blinds which fold flush with the openings. The southwest room, presumably the library, is treated similarly, but the greek key and patera elements are absent from the window frames. [Trim in the northwest room was removed in the conversion of this space to toilet facilities.] A complex baseboard with multiple Classical molding profiles is found throughout the first floor and continues the full height of the stair to the attic. On the second-floor openings, the pilasters have a simpler recessed panel without a step, and the architraves are less bold and lack the egg-and-dart and bead-and-reel moldings; baseboards are also less elaborate, with a beaded step and a quirk ovolo cap. On the third floor, openings have beaded casings, plain frames with a single step near the inner edge, and plain corner blocks; baseboards are treated with a single step.

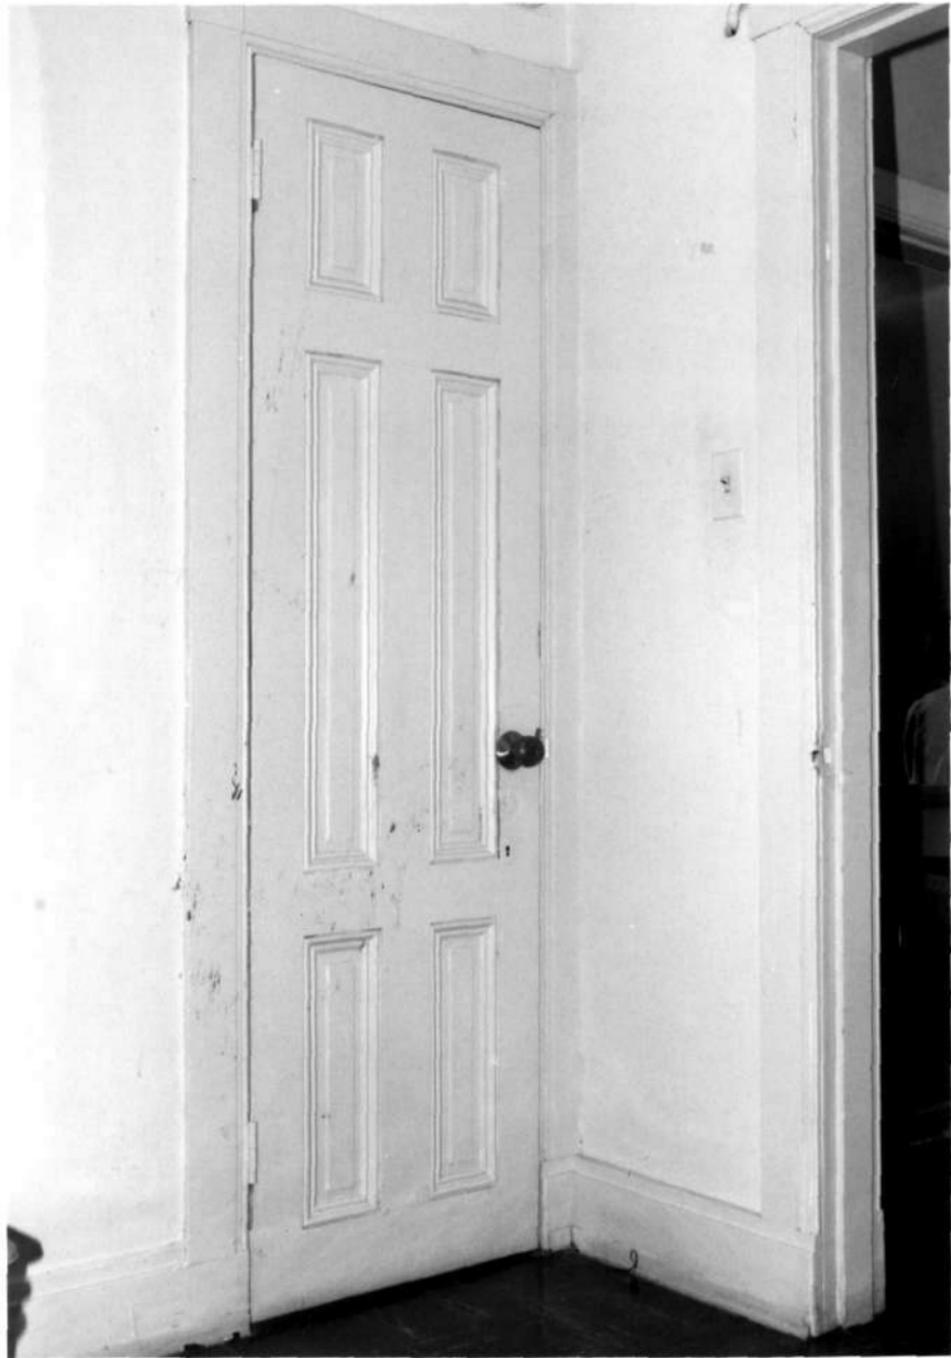
8/8

DOOR AND TRIM, 3RD FL.

The west service wing has a single room on each of its three levels. As described in a newspaper article of 1929, the first level of the wing housed a service stair which joined the main stair at the landing between the first and second stories. On the second and third stories, the floor levels in the wing occur below the corresponding floors of the main block; these rooms are entered from the landings of the main stair. The room on the second level of the wing communicates with the southwest room on the second story of the main block. Architrave trim throughout the wing consists of a beaded casing with quirk ovolo and bead backband.
