historic name Oxon Cove Farm, Godding Croft, Mount Welby
other names/site number Oxon Hill Children's Farm/ P.G. 76A-13

National Register of Historic Places Continuation Sheet

Oxon Cove Farm (Godding Croft)
name of property

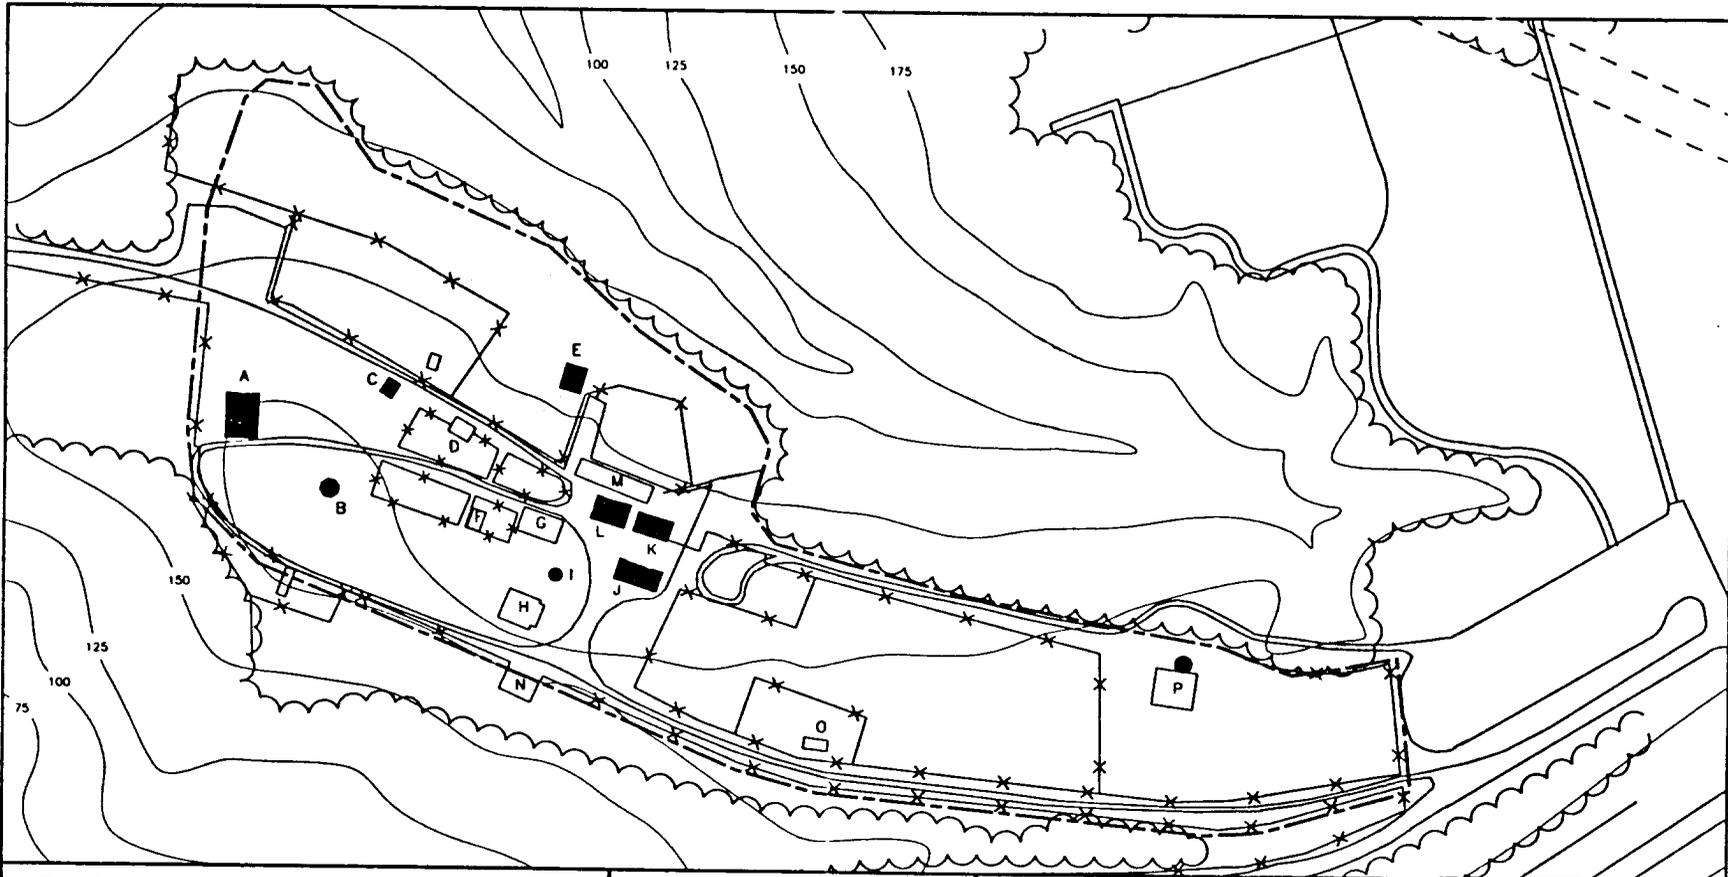
BUILDING KEY

The following building and structure descriptions are keyed to the accompanying district map. This map also identifies land-use areas. The contributing elements in the district are:
