**NATIONAL REGISTER OF HISTORIC PLACES  
INVENTORY -- NOMINATION FORM**

River View

NATIONAL REGISTER OF HISTORIC PLACES  
INVENTORY -- NOMINATION FORMRiver View  
St. Mary's County  
Maryland

MARYLAND HISTORICAL TRUST WORKSHEET

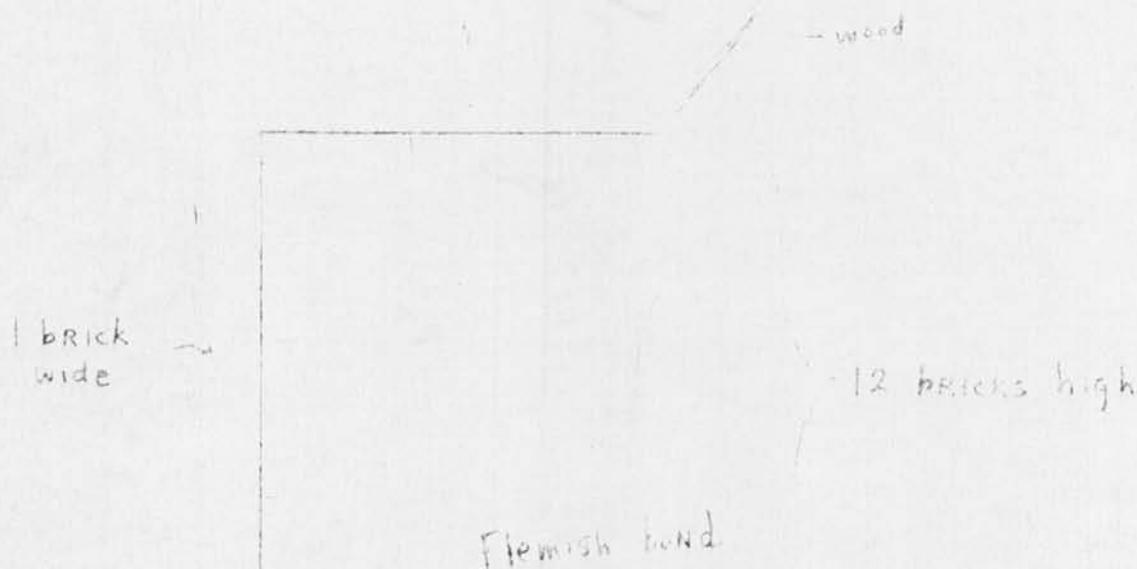
corbeled parapets at the eaves on the land side  
(#51 p.45)

These projections are very striking from the side view. Somehow, the end board of the cornice sticks out and shows.

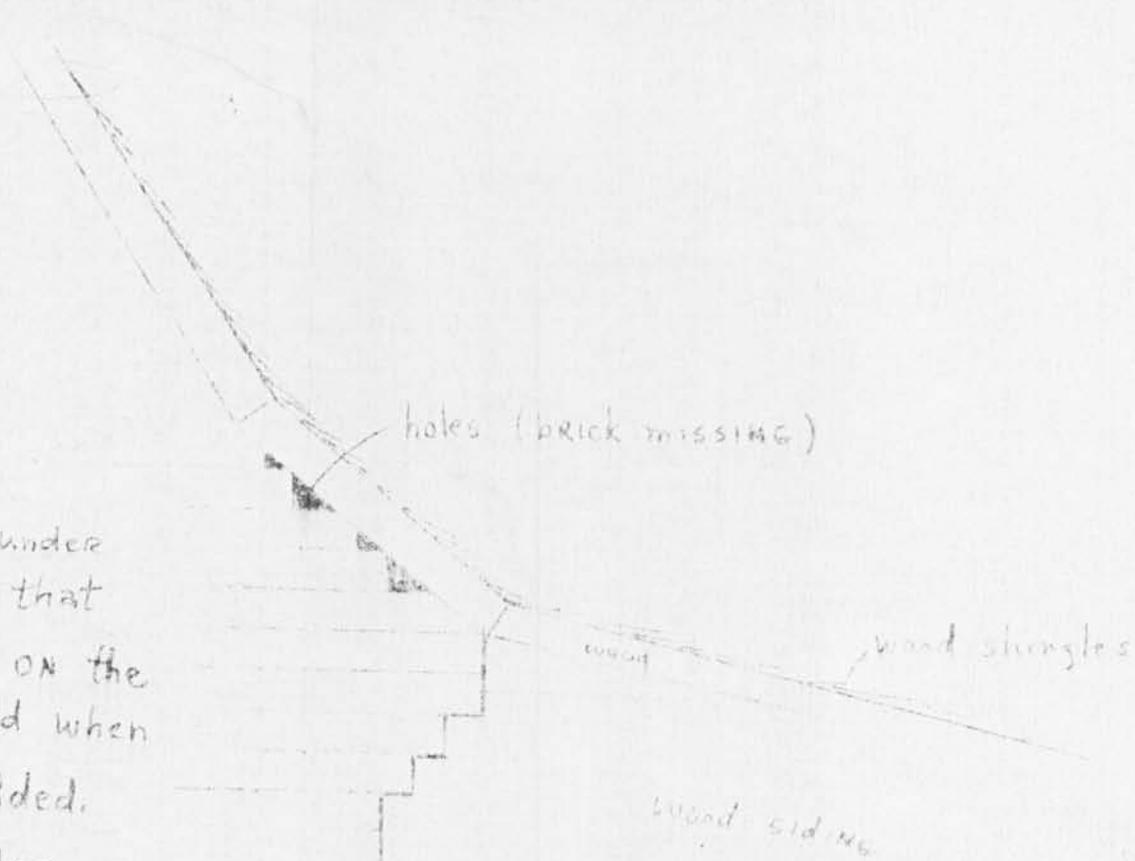
(H) The eaves on the RIVER side are splayed and the brick under them is corbeled.

The missing brick under the splay suggests that the arapets like those on the north were removed when the porch was added.

There is no similar deterioration (?) along the steeper parts of the gables.

The splay is a sort of bridge that makes the main roof continuous with the porch roof. (I think the splay is larger than I have shown.)

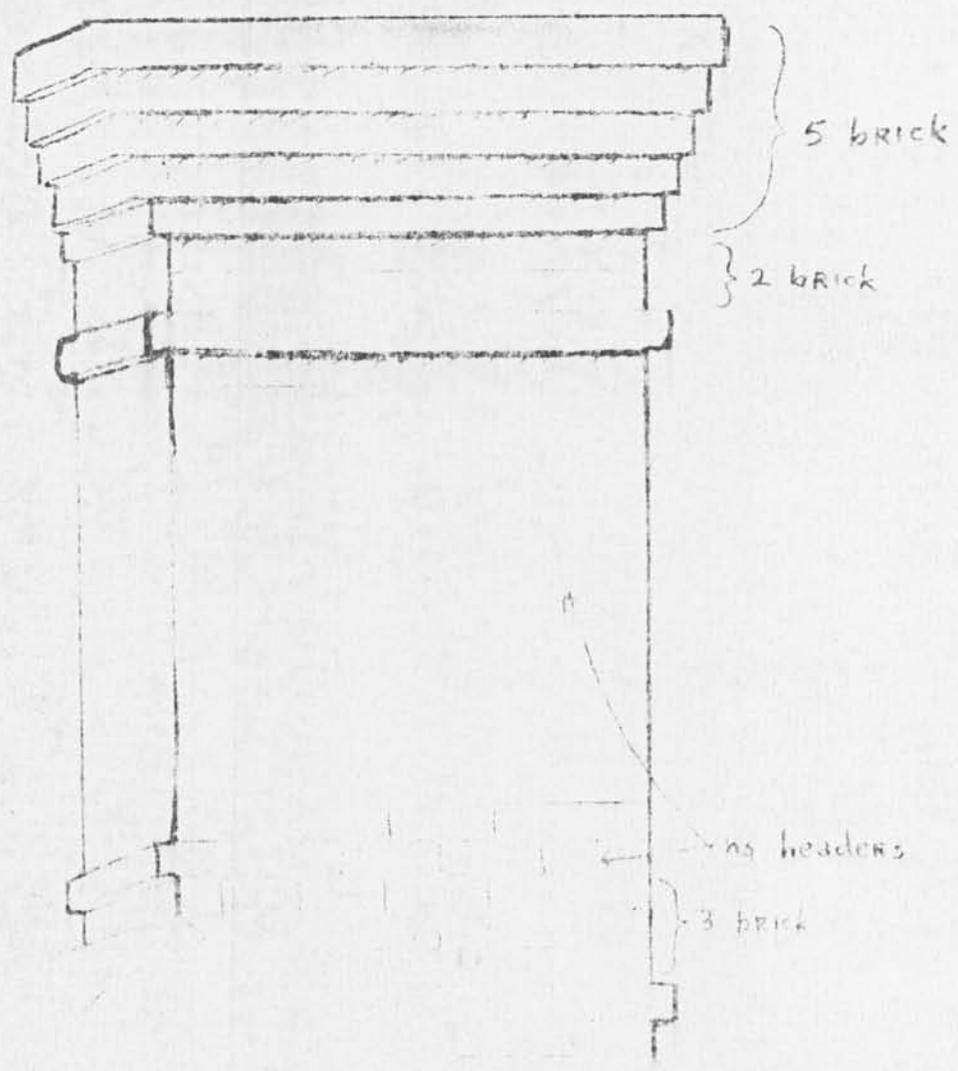
Chimneys (identical on each end).

lemish bond

glazed headers

no headers  
3 brick

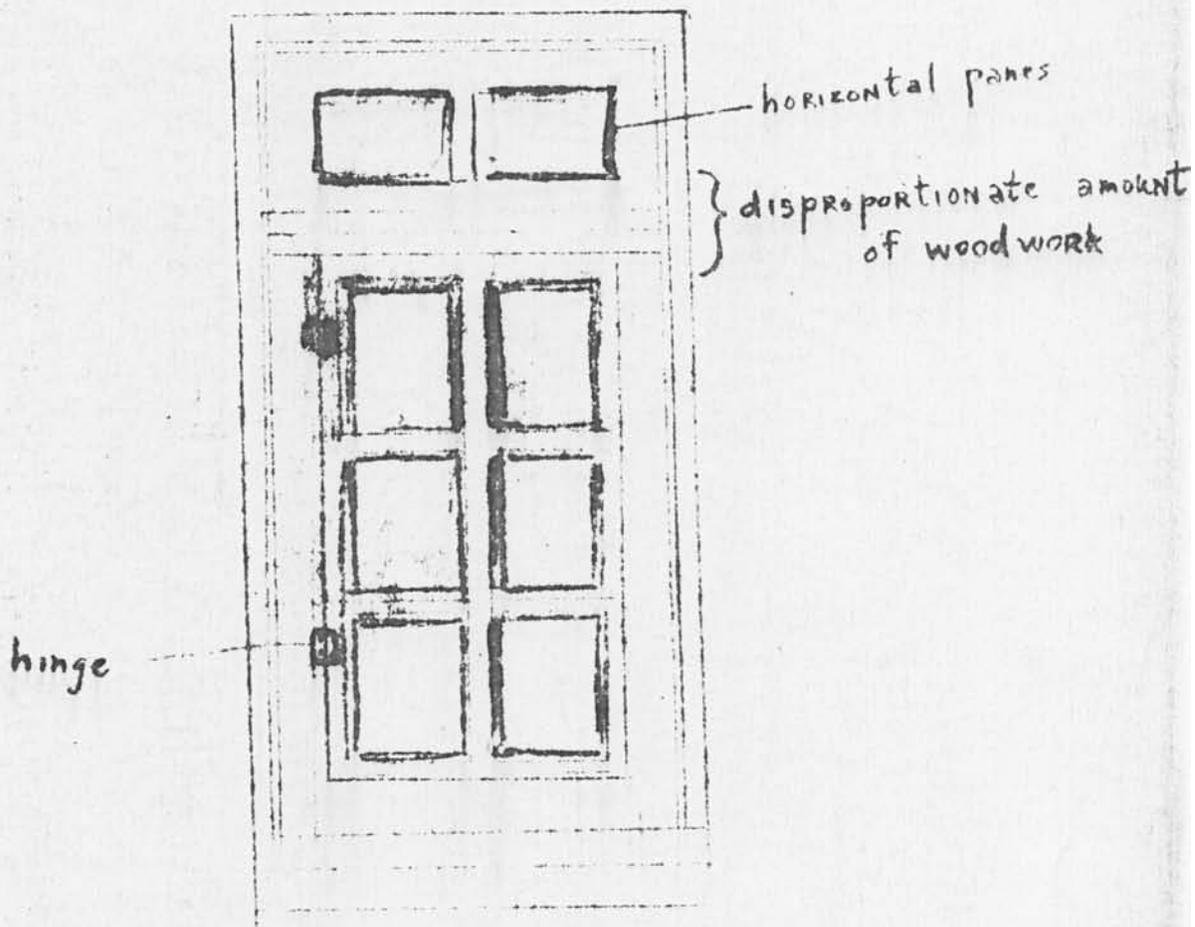
3 small gable windows (very rough sketch)

(The top part looked like a transom, but I couldn't tell if it is hinged. I couldn't make out the detail of the hinges. The effect of these little windows is quite odd. They suggest a medieval window made over to sash.)

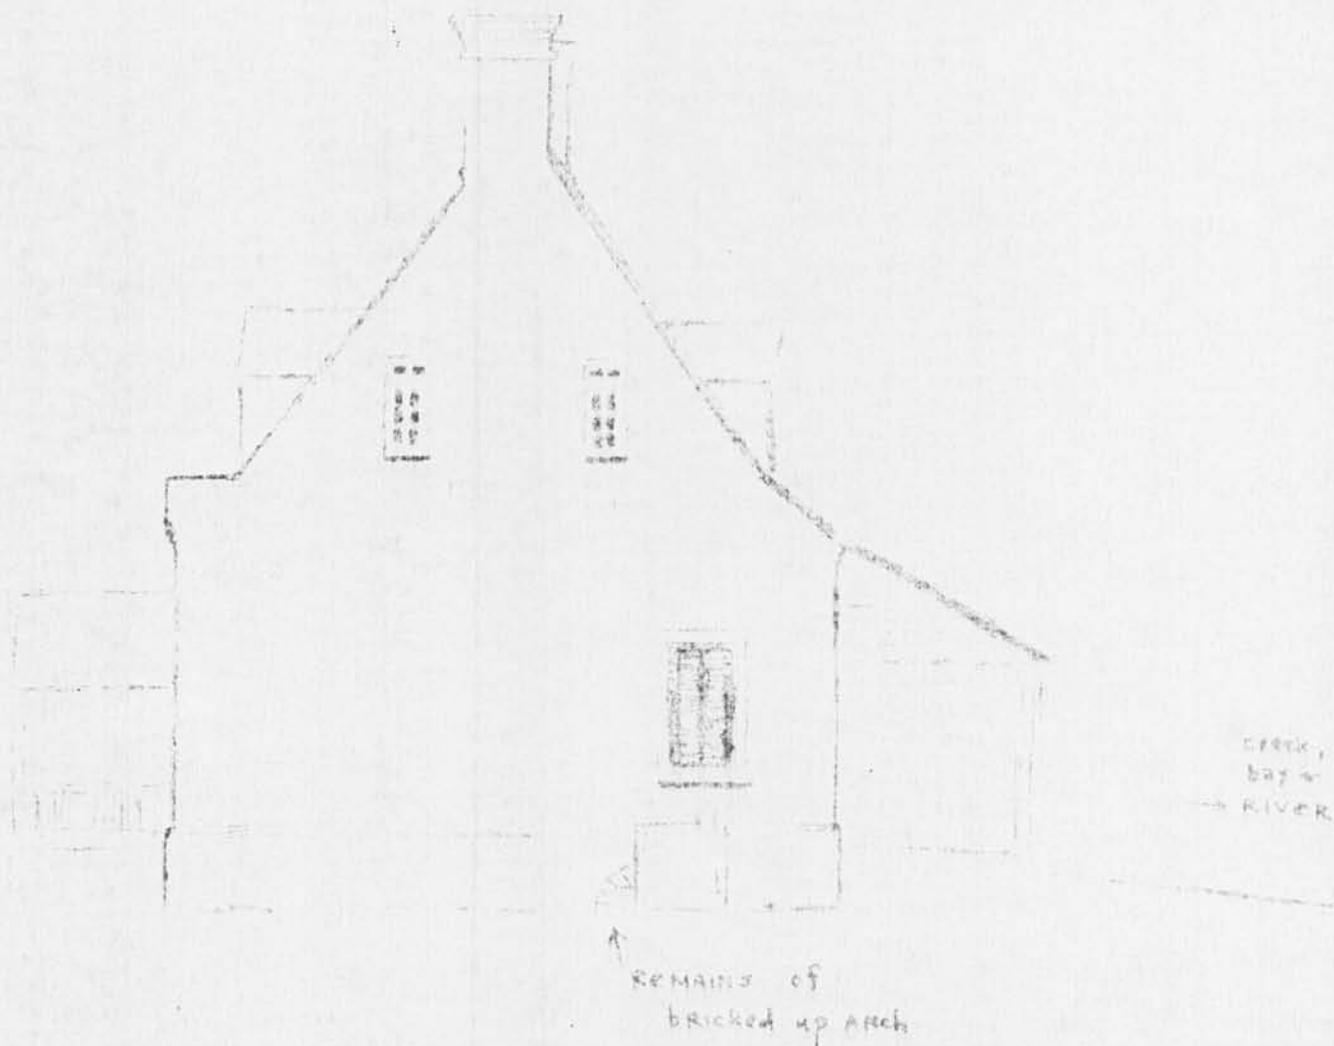
Free sketch of Gable end

All windows seem to have wood sills.

(ON the opposite Gable end extend three attached, low, extremely narrow outshuts of wood.

New shutters on the first floor window seen in this end seem to conceal the wide woodwork (?). Also, this window lacks the curvilinear rubbed brick head. Headers on this end do not seem to be glazed as on opposite end.
