**National Register of Historic Places
Inventory—Nomination Form**

historic Old Bloomfield

Old Bloomfield
Talbot County
Maryland

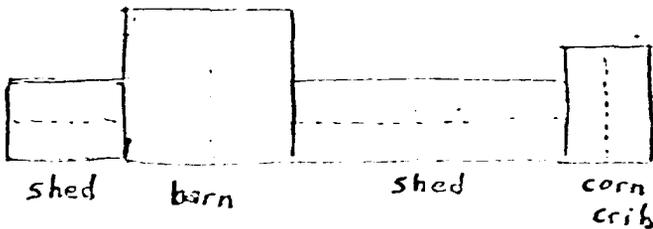
SITE PLAN, OLD BLOOMFIELD

31' long, 11' to 12' (incl. to wall)

Several notable farmbuildings have survived. A small frame diary dating to the late 19th century is located to the rear of the house. A row of farmbuildings along the northeast side of the driveway includes a heavy timber frame crib 10 feet by 22 feet and a barn 47 feet wide and 30 feet deep. Both buildings are constructed of circular sawn timber, and probably date to the third quarter of the 19th century, but are similar in form and construction to much earlier buildings. A handsome pale fence enclosed the yard to the northeast and northwest of the house.
