**National Register of Historic Places
Inventory—Nomination Form**

historic Rieman Block

street & number 617-631 West Lexington Street n/a not for publication

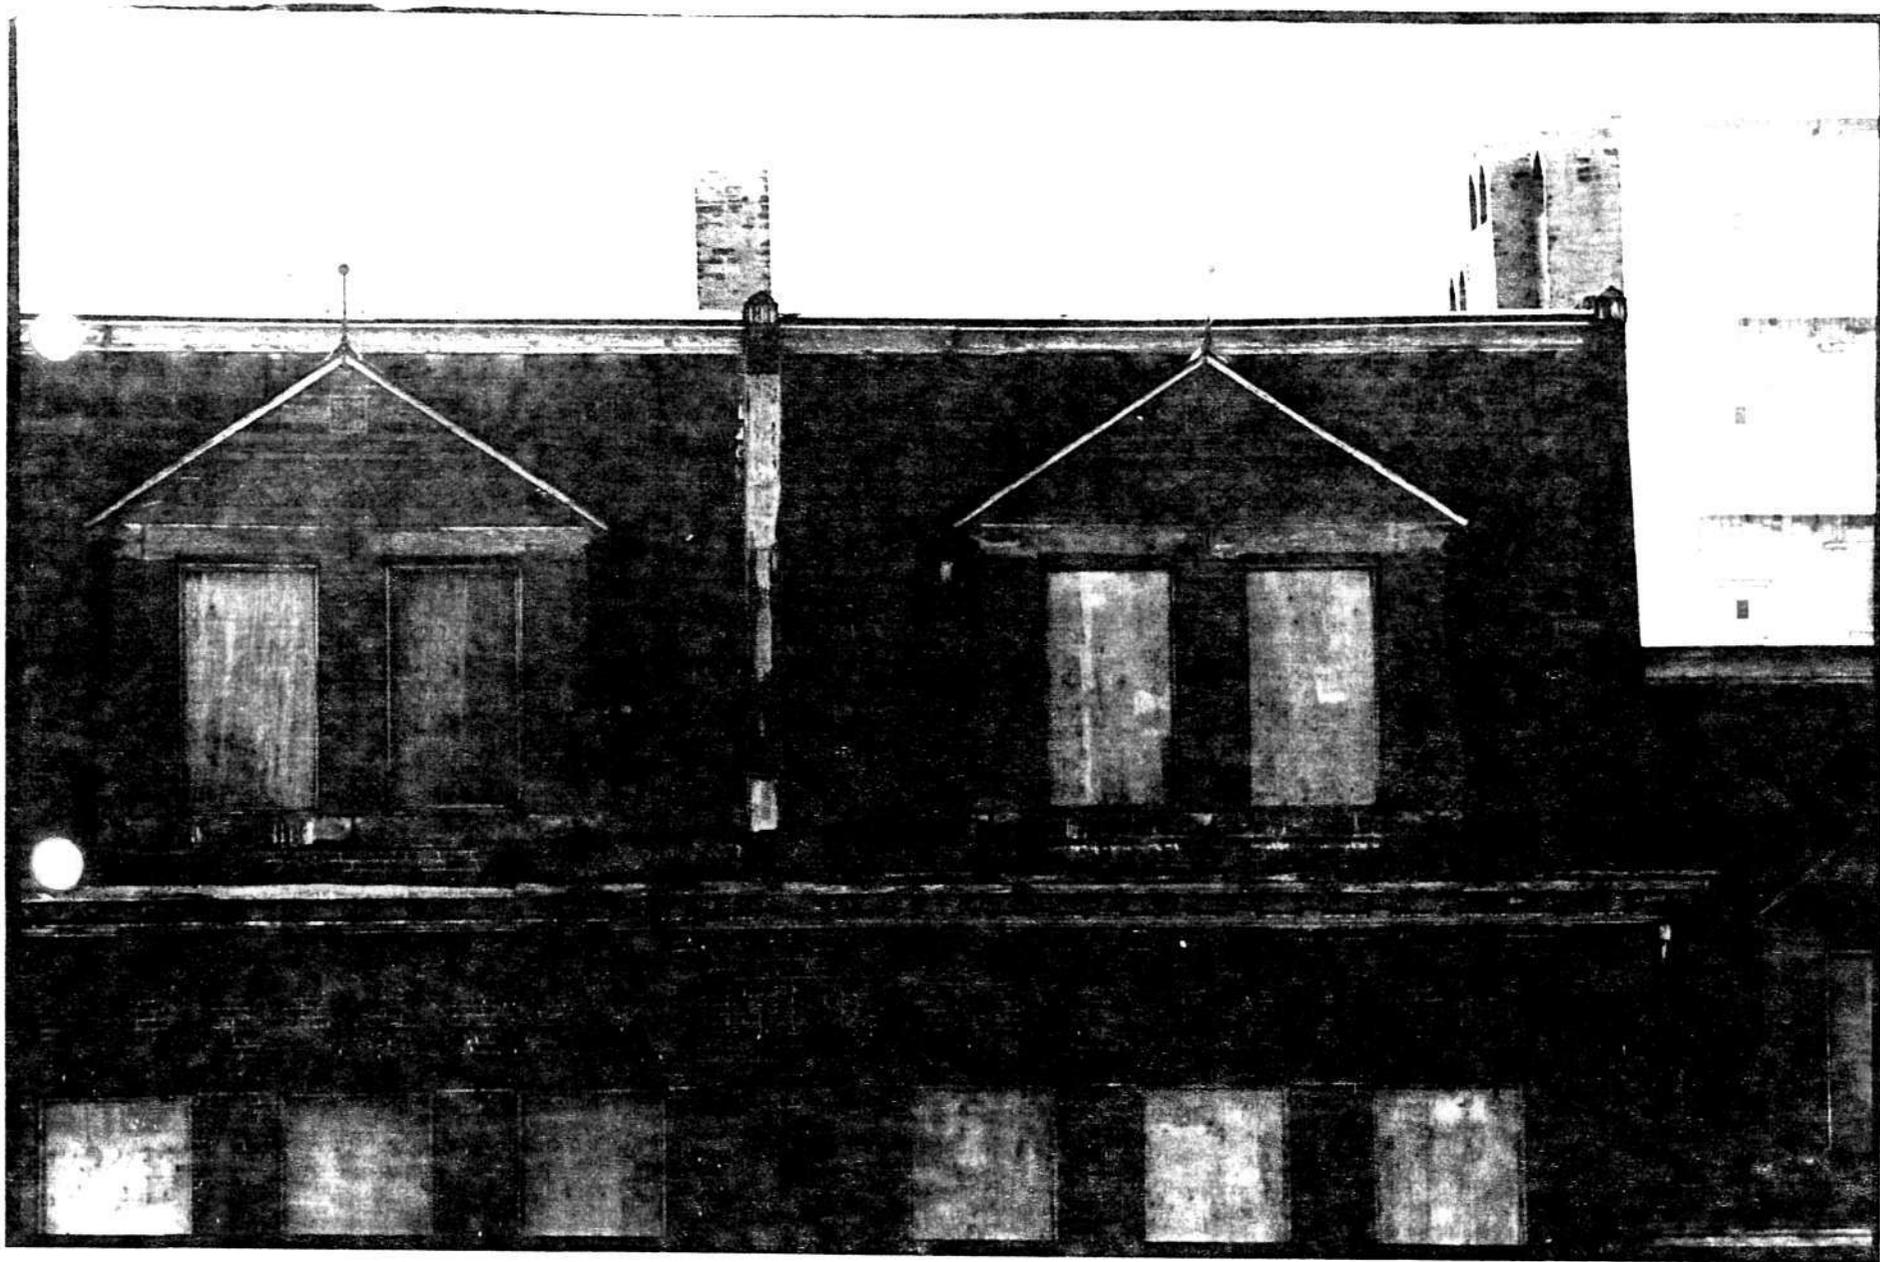
1 RIEMAN BLOCK *B-3995*
2 617-631 West Lexington Street
Baltimore, Maryland
3 Photographer - Tom Miller
4 December 14, 1983
5 Negatives held by Paul McKean
6 North elevation of Dormers at #621 & #623
7 Roll 1 #10

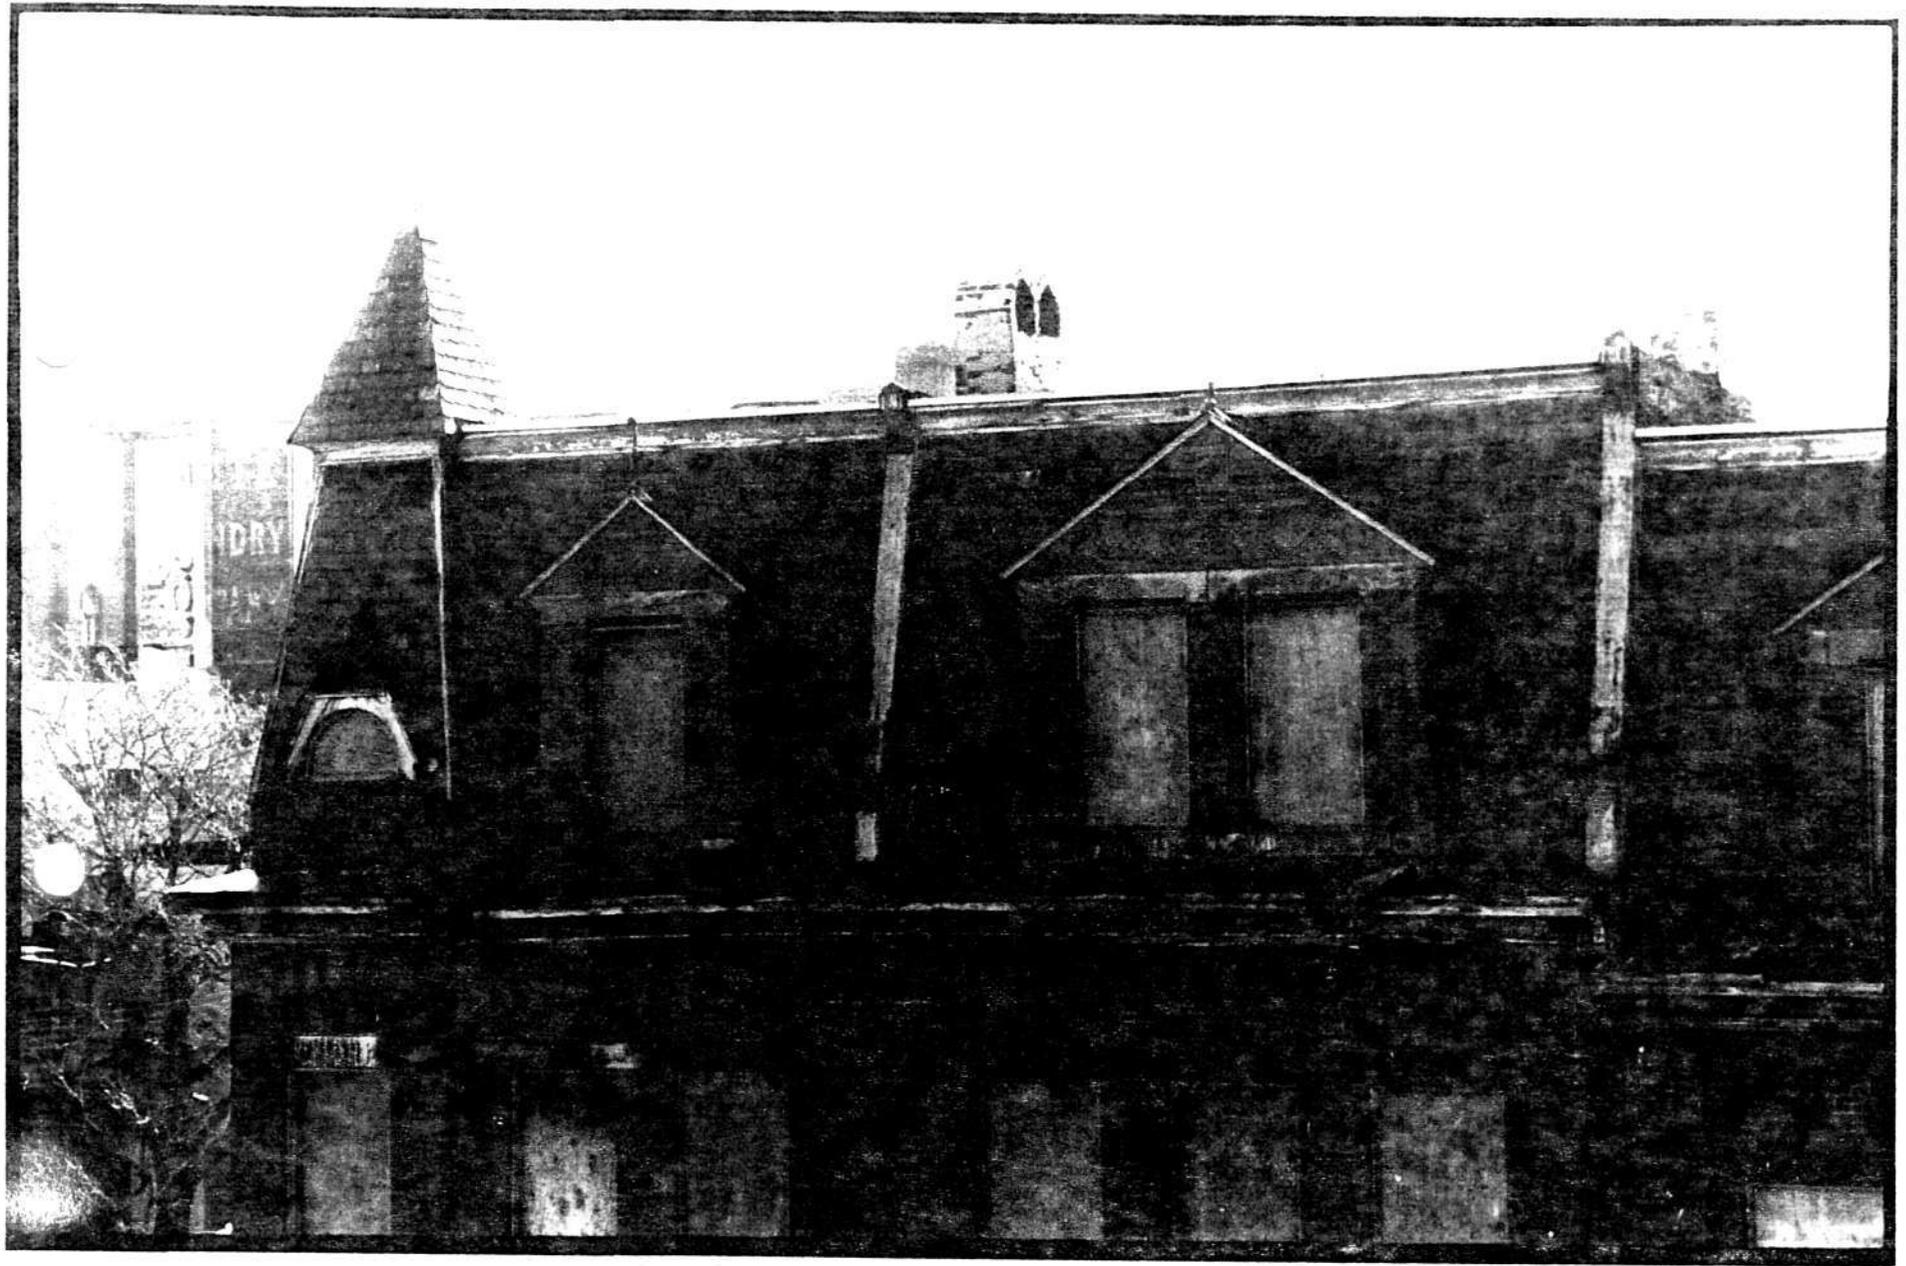
1 RIEMAN BLOCK *B-3995*
2 617-631 West Lexington Street
Baltimore, Maryland
3 Photographer - Tom Miller
4 December 14, 1983
5 Negatives held by Paul McKean
6 North elevation of Dormers at #617 & #619
7 Roll 1 #11

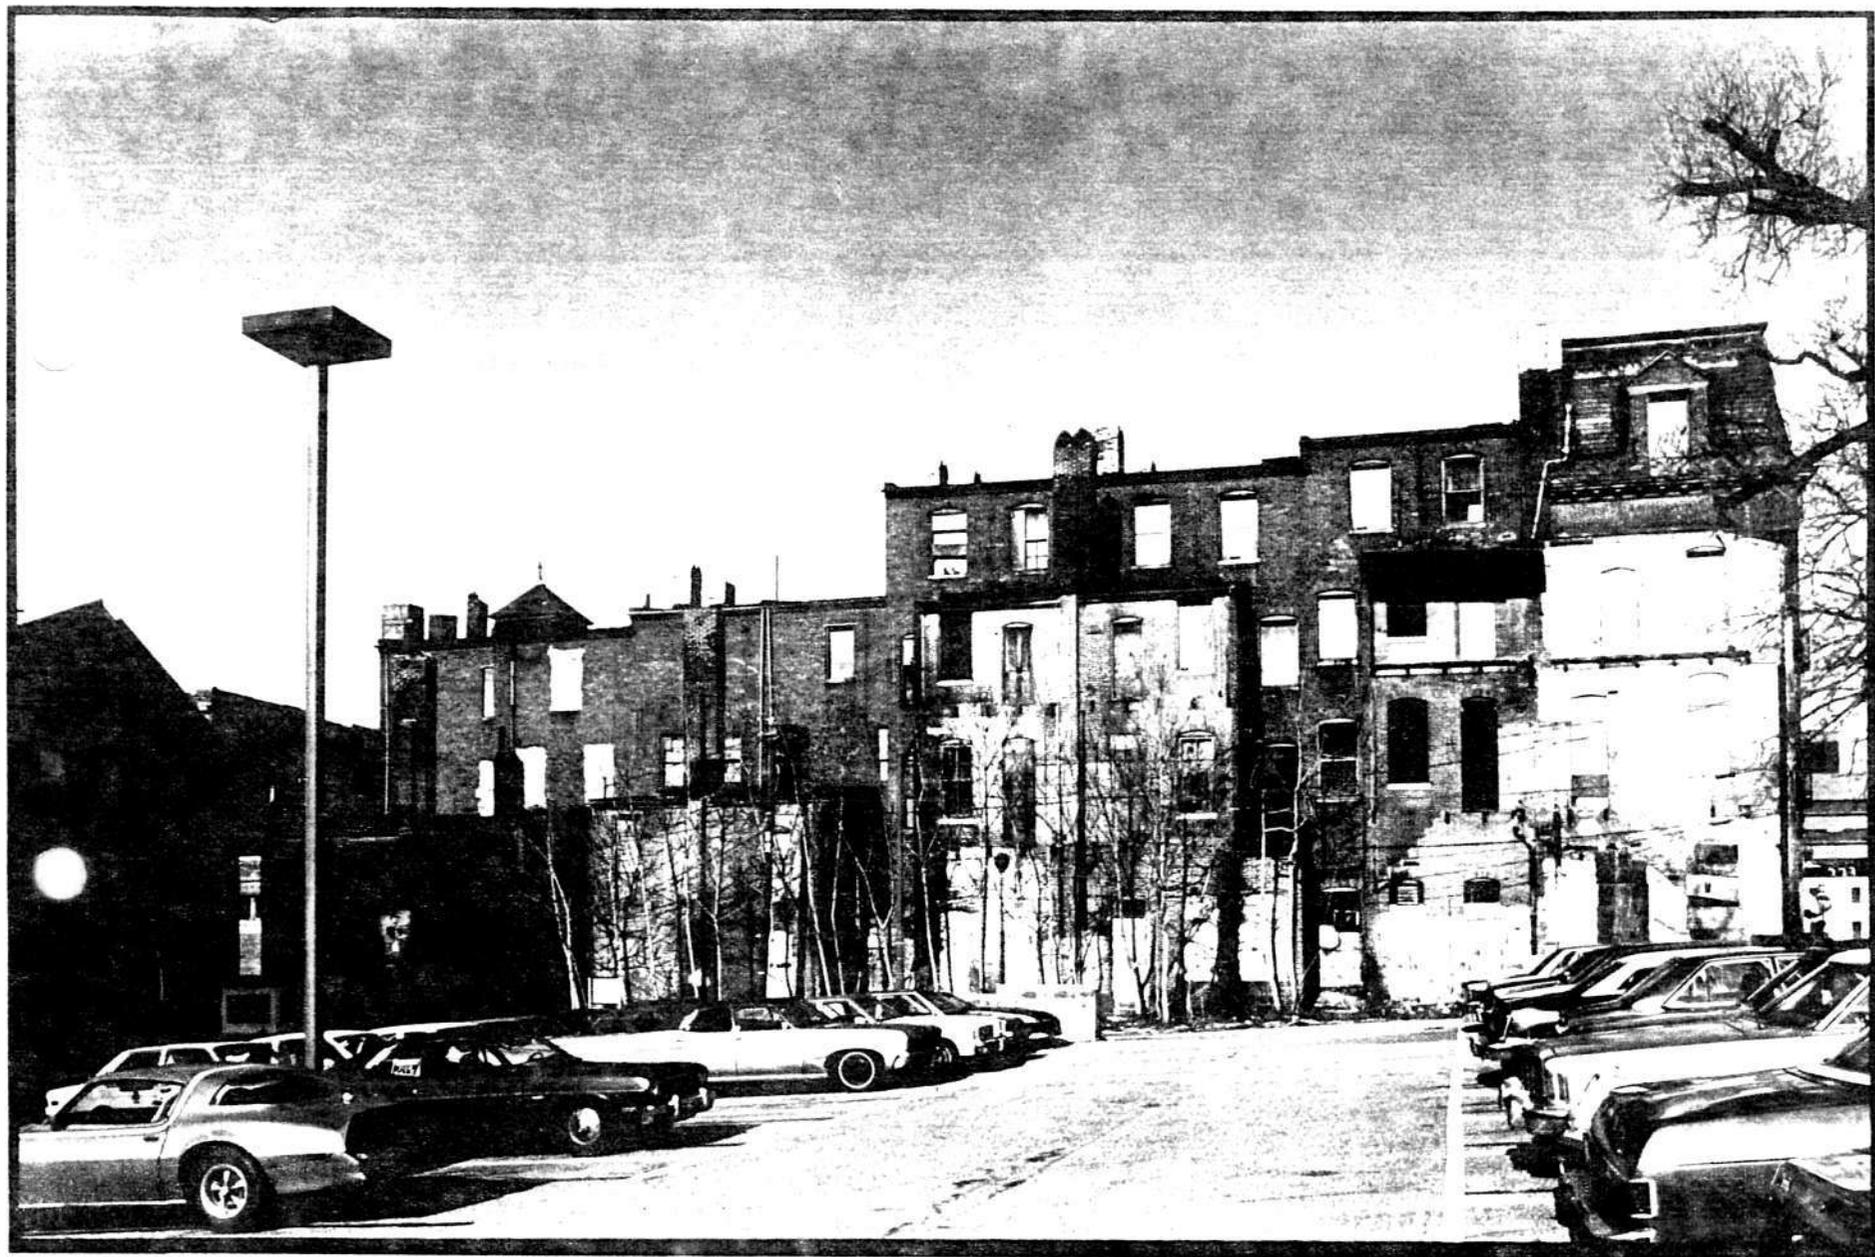
The south or back elevation is a full four stories with two and three story els for the units except the easternmost unit which has the mansard roof effect and decoration that denote the street elevations. This elevation has a fairly regular placement of windows and doors. The openings in the 1880 sections have segmental arches. The window and door openings in the earlier sections are varied. On the first and second floors, the openings have segmental arches. The top two floors have rectangular openings with brick lintels on the third and wood lintels on the fourth. The fenestration arrangement of the fourth floor has one window per unit and the third floor has two windows per unit. A seam in the brick work separates 625-627 from 629-631 but only on the first, second and third stories.

1 RIEMAN BLOCK *B-3995*
2 617-631 West Lexington Street
Baltimore, Maryland
3 Photographer - Tom Miller
4 December 14, 1983
5 Negatives held by Paul McKean
6 South elevation
7 Roll 1 #20

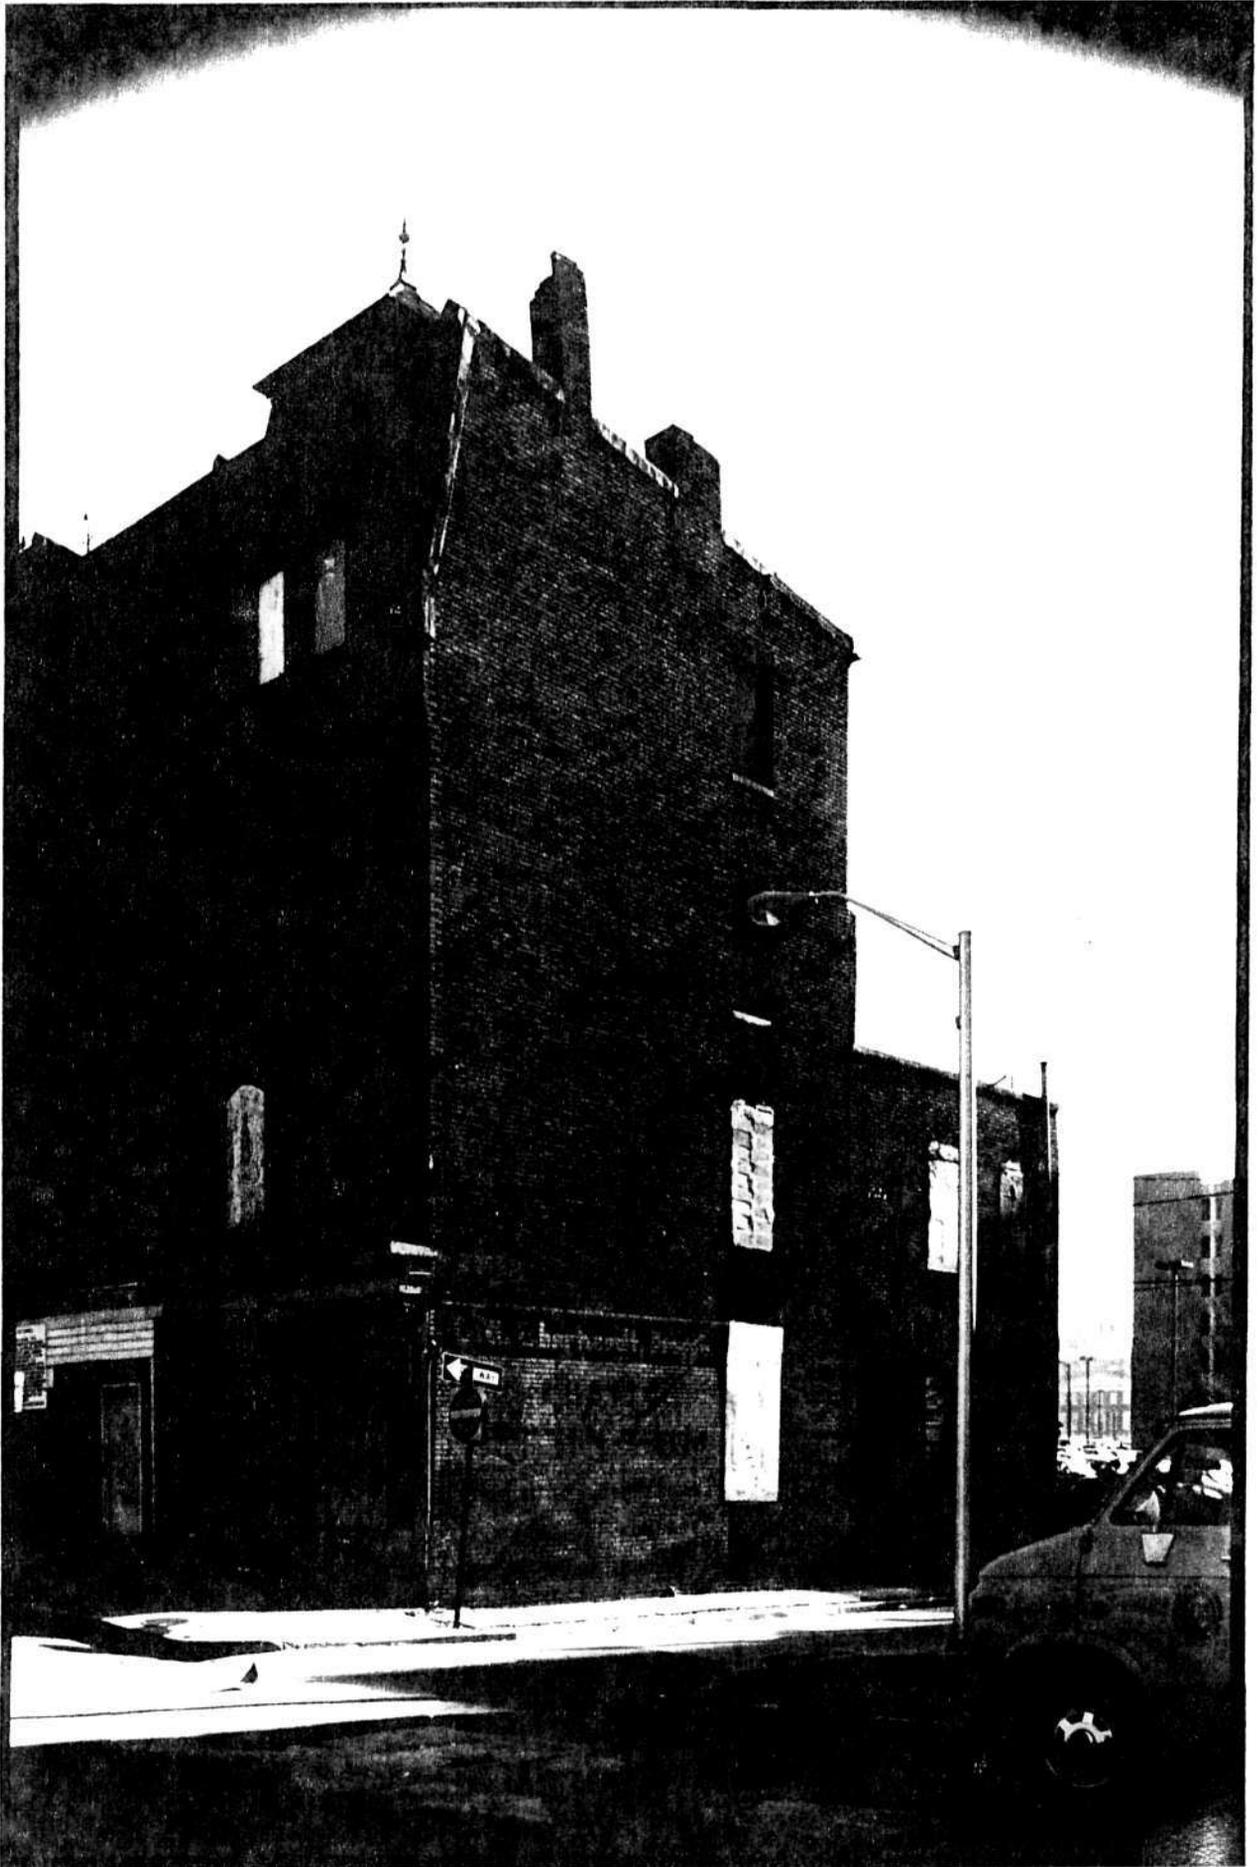
The west end of the block along Arch Street, which is essentially an alley, is devoid of decoration except for the remains of a painted advertisement for a druggist. The bricks are laid in common bond.

1 RIEMAN BLOCK *B-3995*
2 617-631 West Lexington Street
Baltimore, Maryland
3 Photographer - Tom Miller
4 December 14, 1983
5 Negatives held by Paul McKean
6 West elevation of #631
7 Roll 1 #29

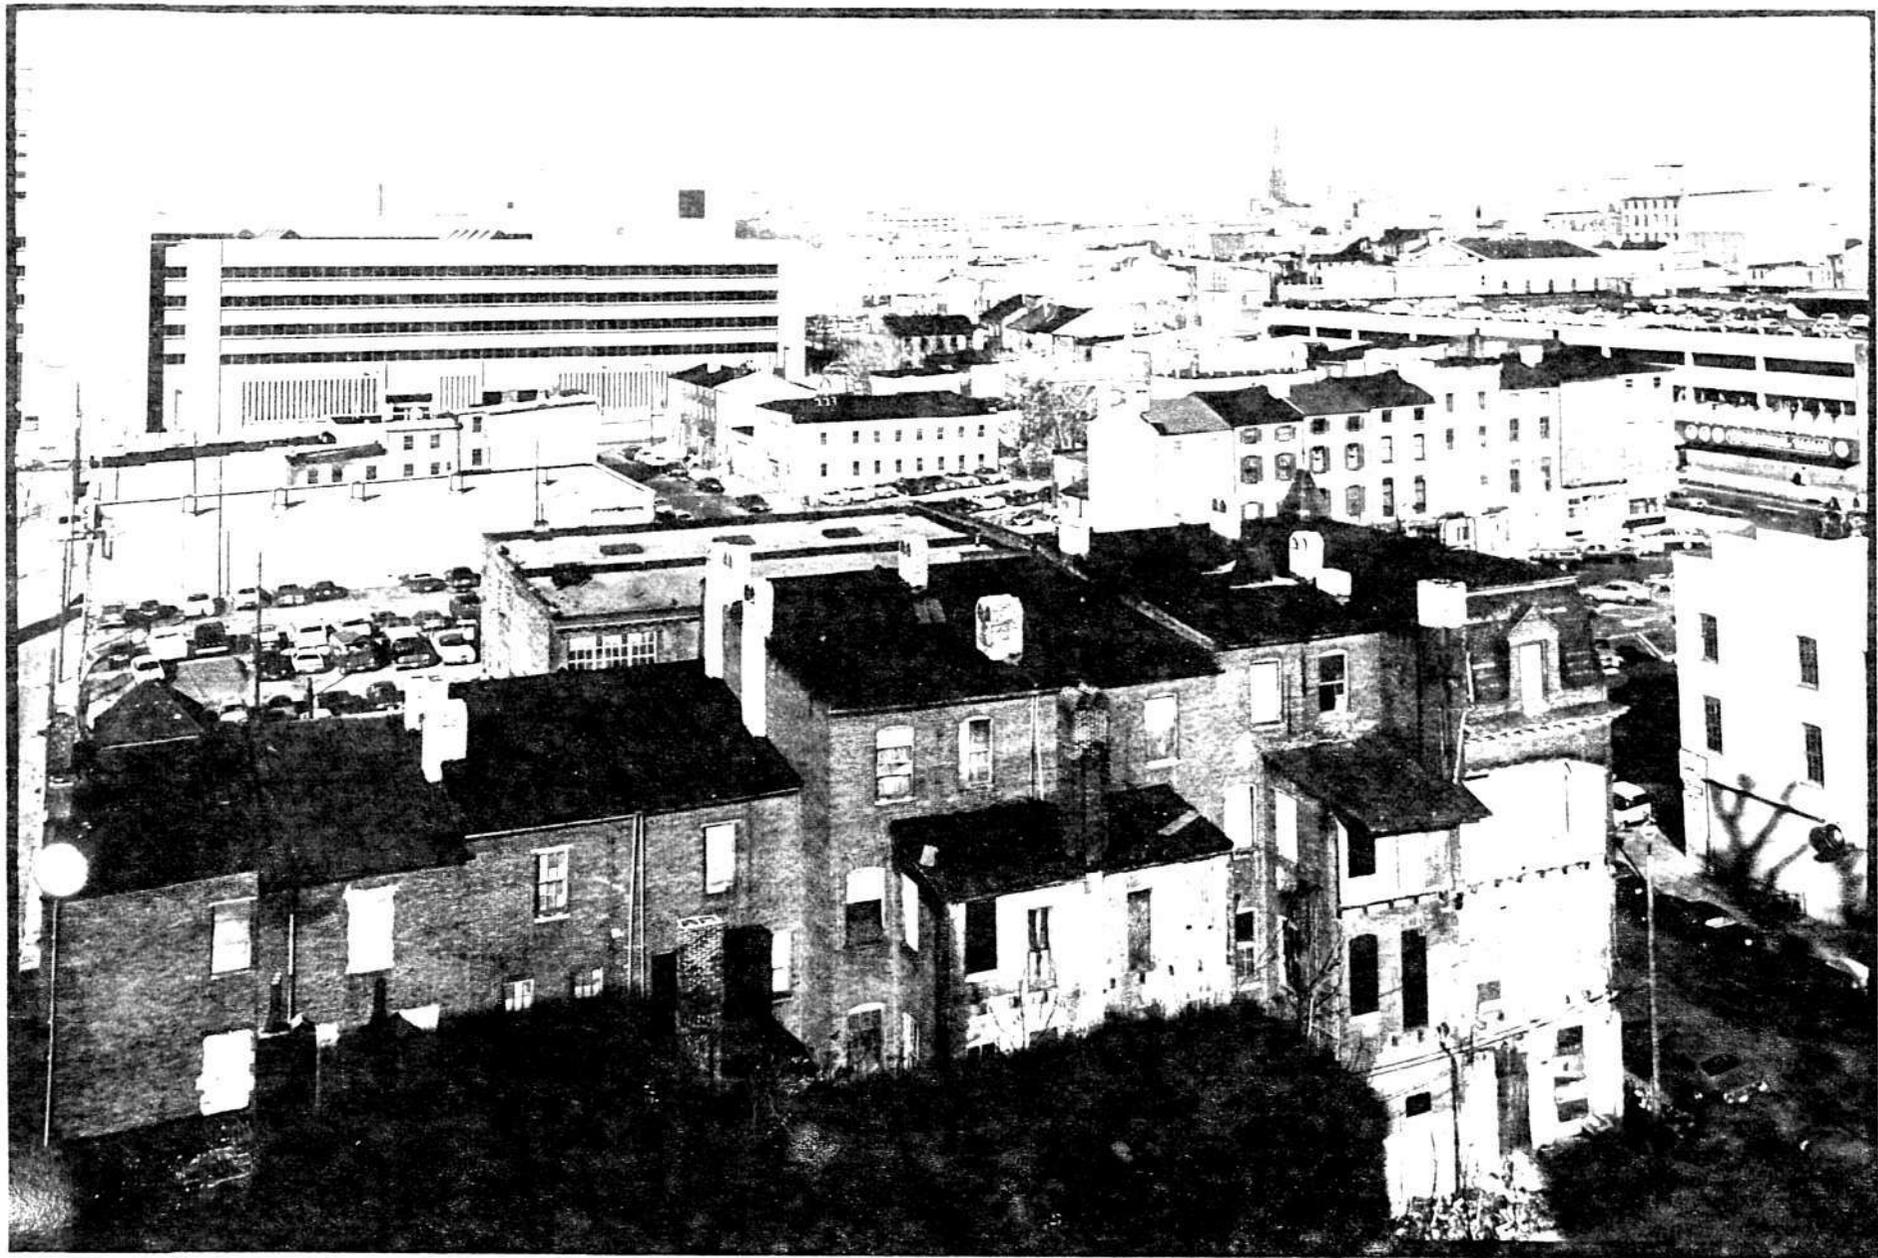
The mansard roof which ties the units into one block is covered with slate shingles with decorative bands of decorative shingles.

1 RIEMAN BLOCK 0-3995
2 617-631 West Lexington Street
Baltimore, Maryland
3 Photographer - Tom Miller
4 December 14, 1983
5 Negatives held by Paul McKean
6 View of the roofs from the South
7 Roll 2 #5

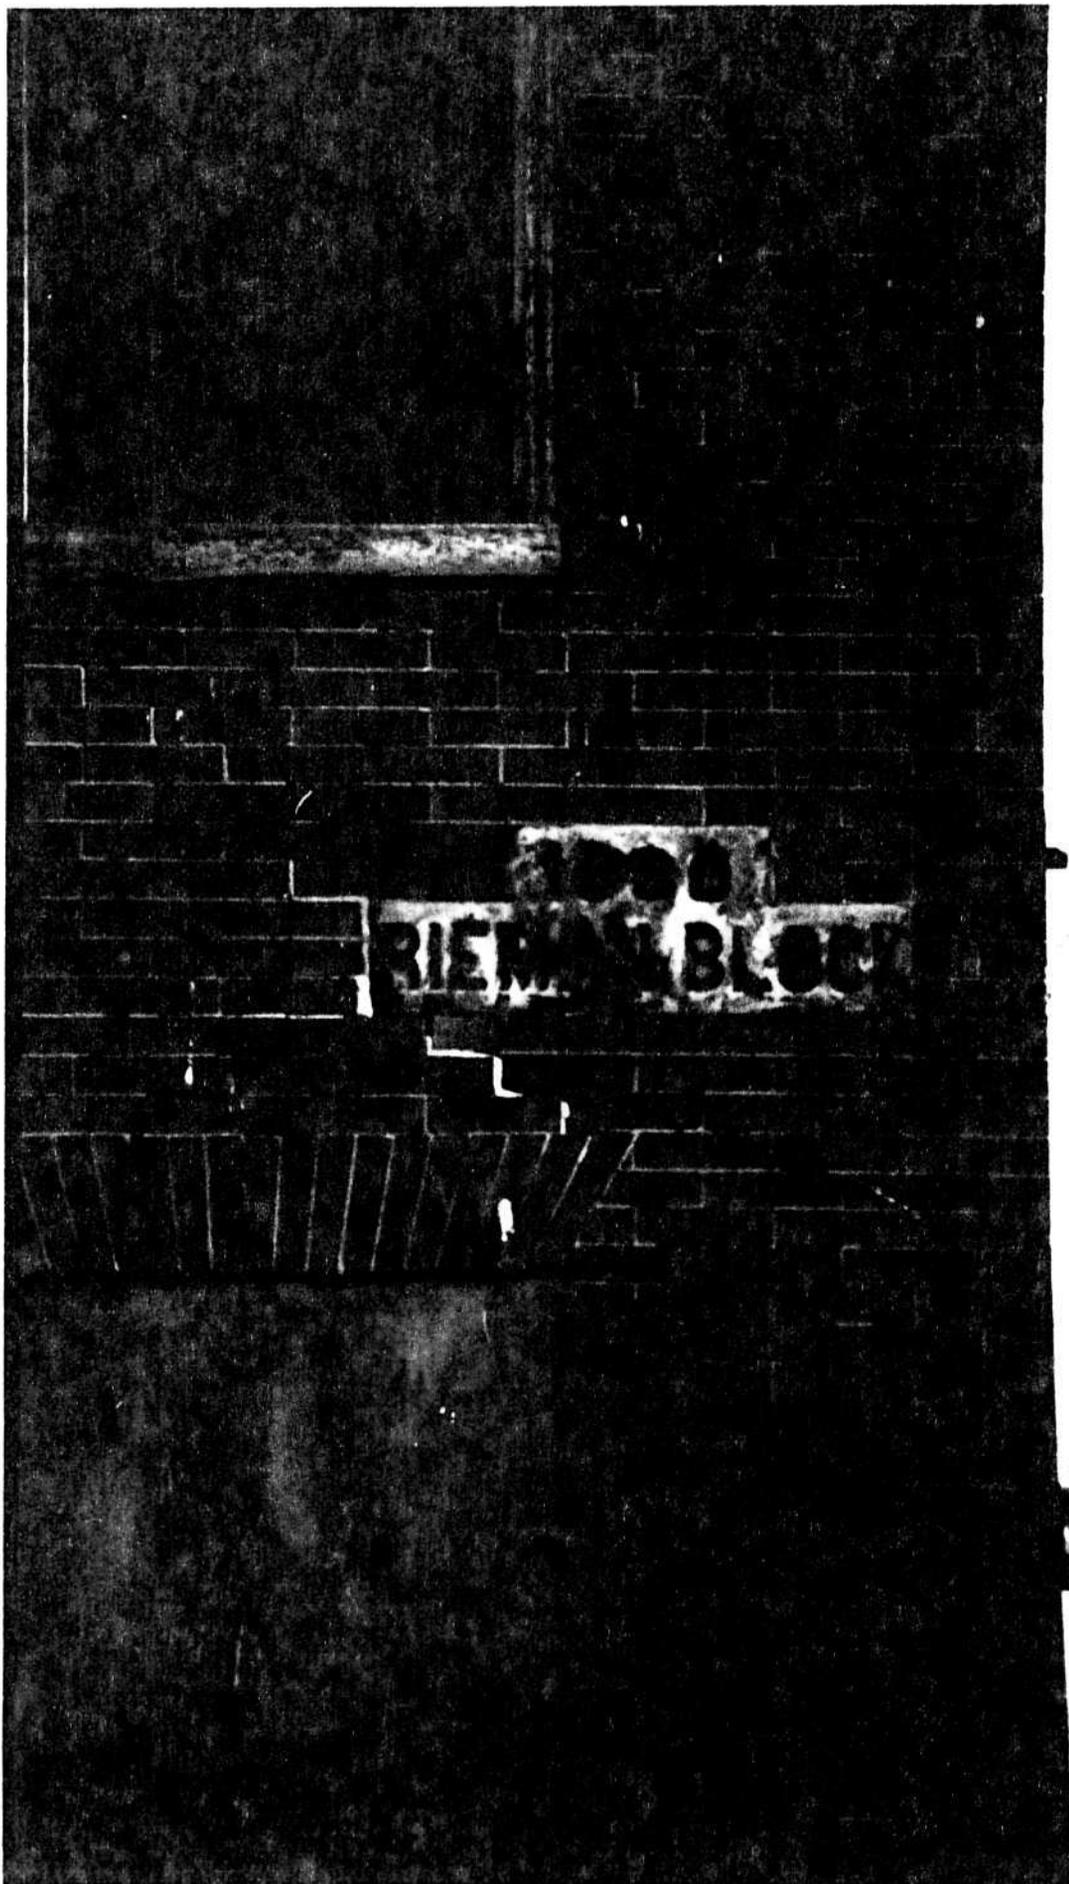
- 1 RIEMAN BLOCK *B-3995*
- 2 617-631 West Lexington Street
Baltimore, Maryland
- 3 Photographer - Paul McKean
- 4 Negatives held by Paul McKean
- 5 May, 1931
- 6 Cornerstone at Northwest corner of #631
- 7 Roll 7 #32

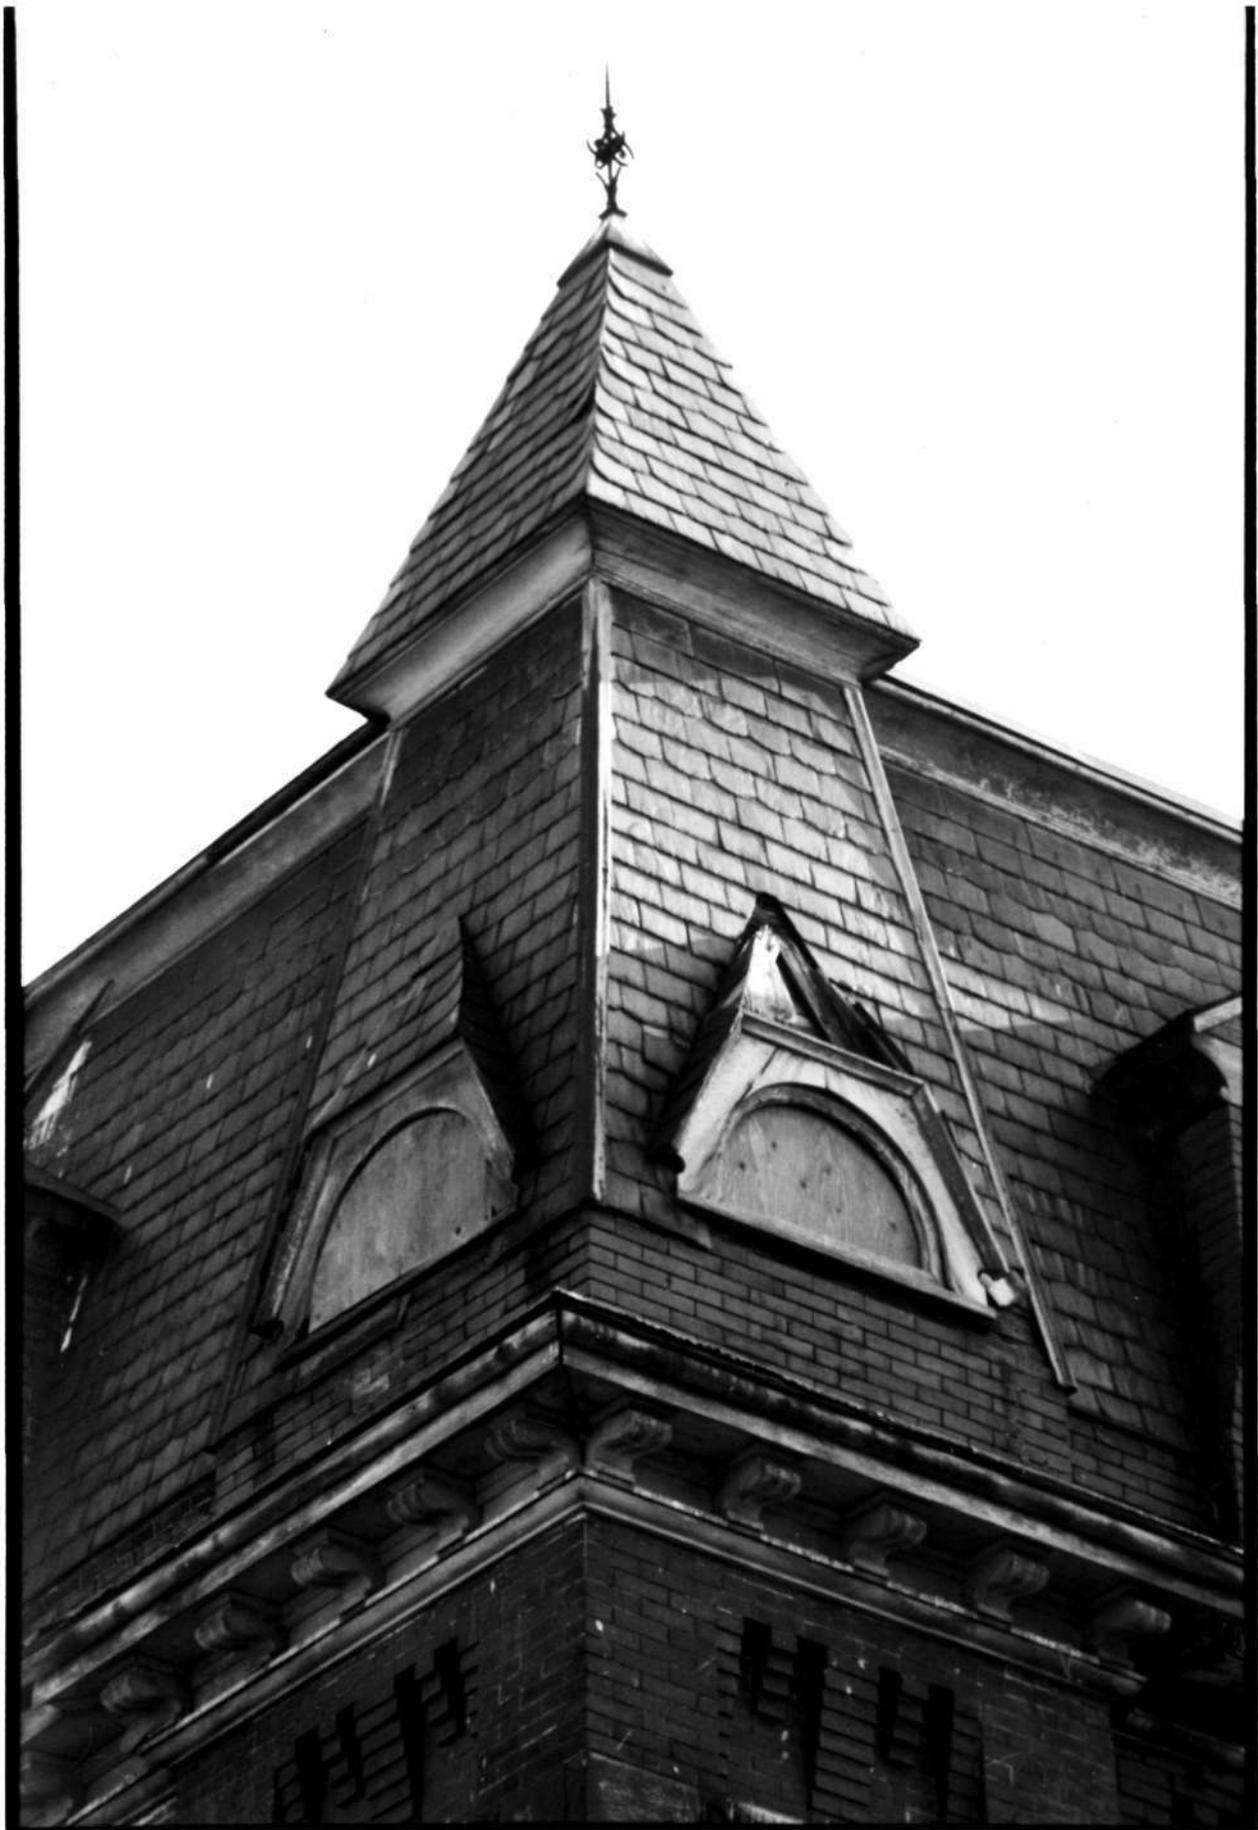
21 of 68

- 1 RIEMAN BLOCK
- 2 617-631 West Lexington Street
Baltimore, Maryland
- 3 Photographer - Paul McKean
- 4 Negatives held by Paul McKean
- 5 May, 1981
- 6 Northeast elevation of Turret at #617
- 7 Roll 7 #33

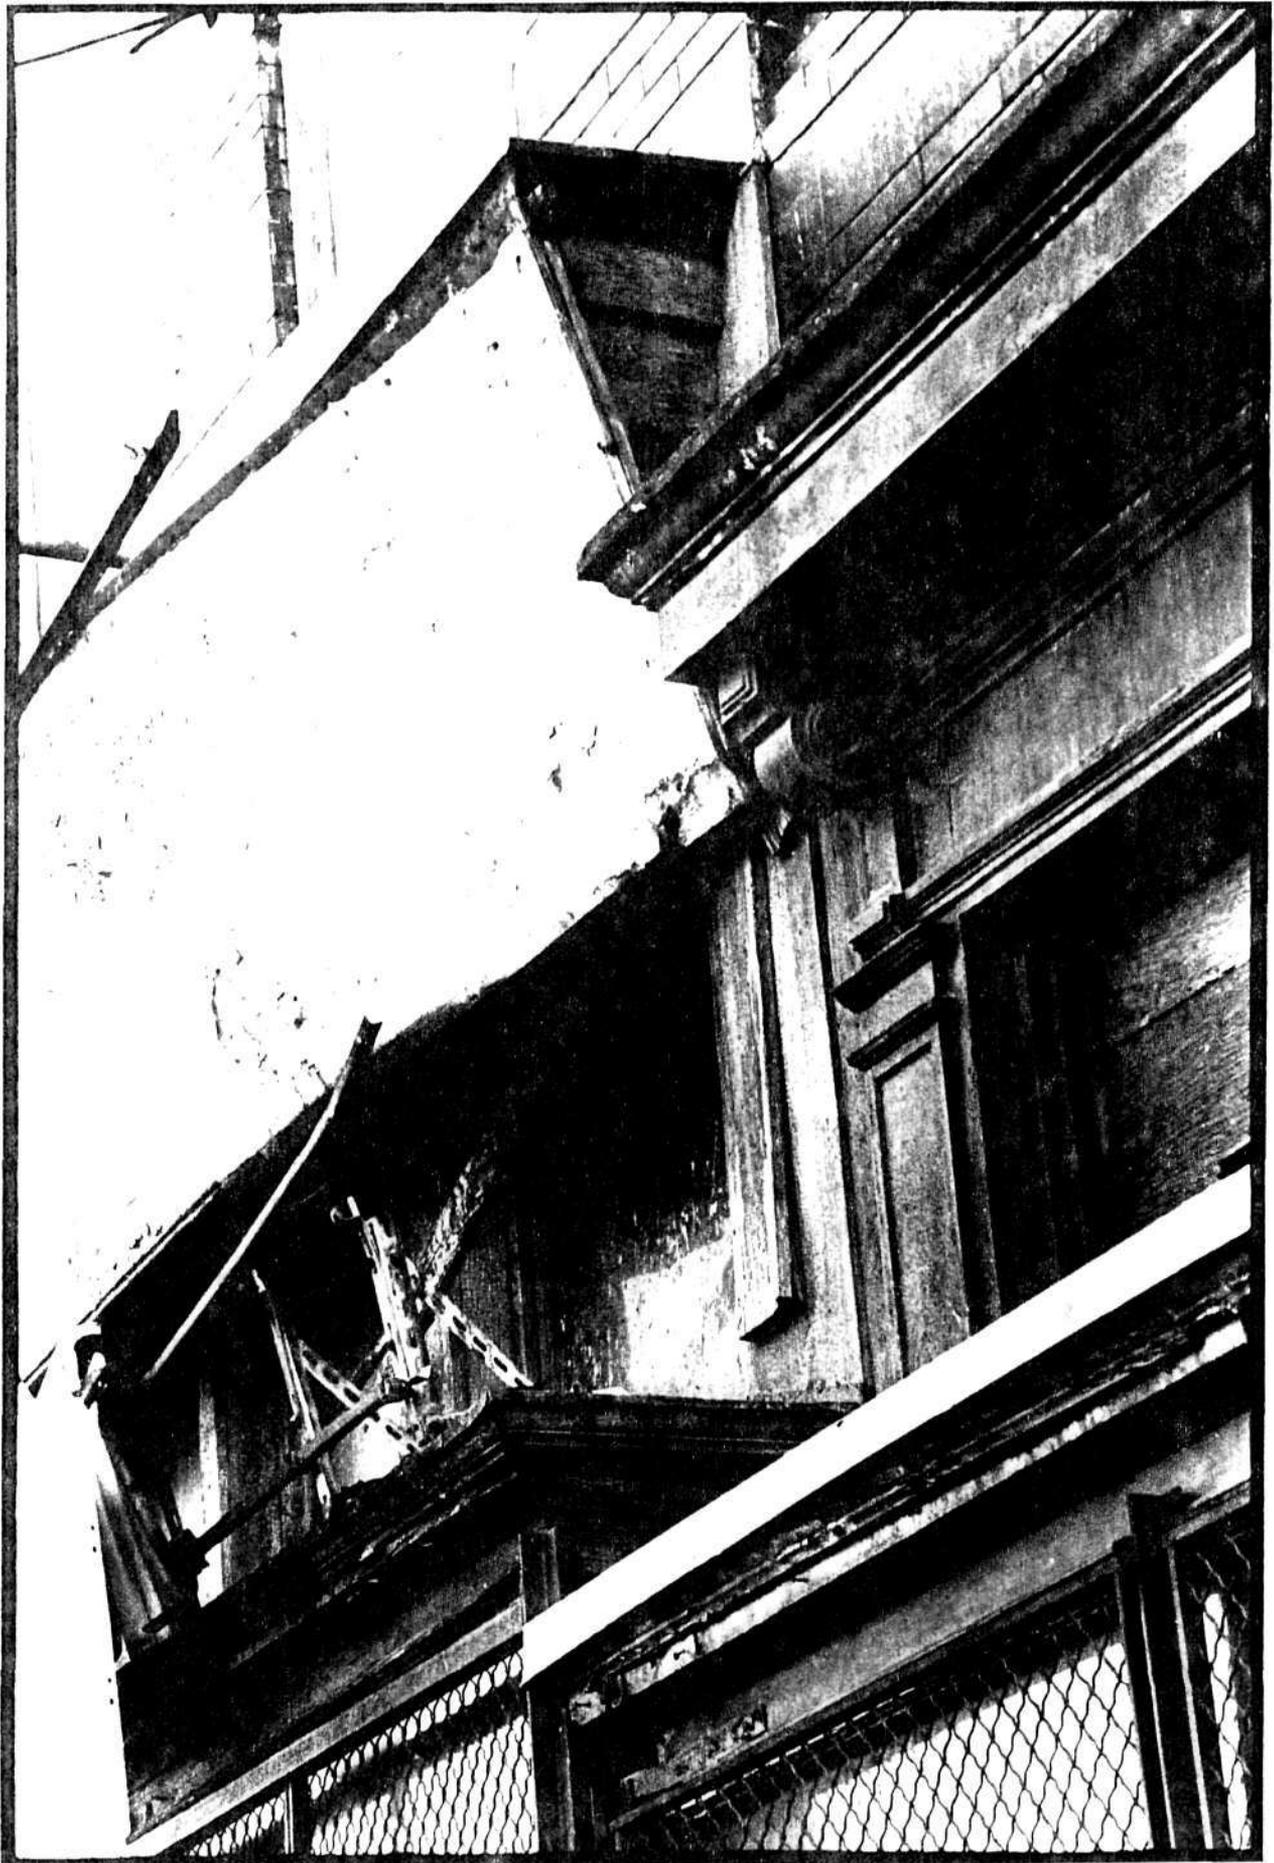
1) The storefronts: In the northeast corner of 617, the outline still remains of the original corner entrance. Most of the entrance vestibule tile is still evident. In units 619-623, the original storefronts are clearly visible from the interiors. In each case, the raised platform portions of the store window is still present. In unit 623, the original interior glass doors from the store window into the shop behind are still in working condition. The storefronts in the smaller 2-bay buildings, 625-631 have undergone more adjustments over the years. The storefront to 627 is, in fact, all but gone. The supporting column for it and the adjacent structure, 629, have been removed and replaced with a different structural system.

1 RIEMAN BLOCK *B-3995*
2 617-631 West Lexington Street
Baltimore, Maryland
3 Photographer - Tom Miller
4 Negatives held by Paul McKean
5 December 16, 1983
6 Storefront trim details, #619/621
7 Roll 3 #12 of 68

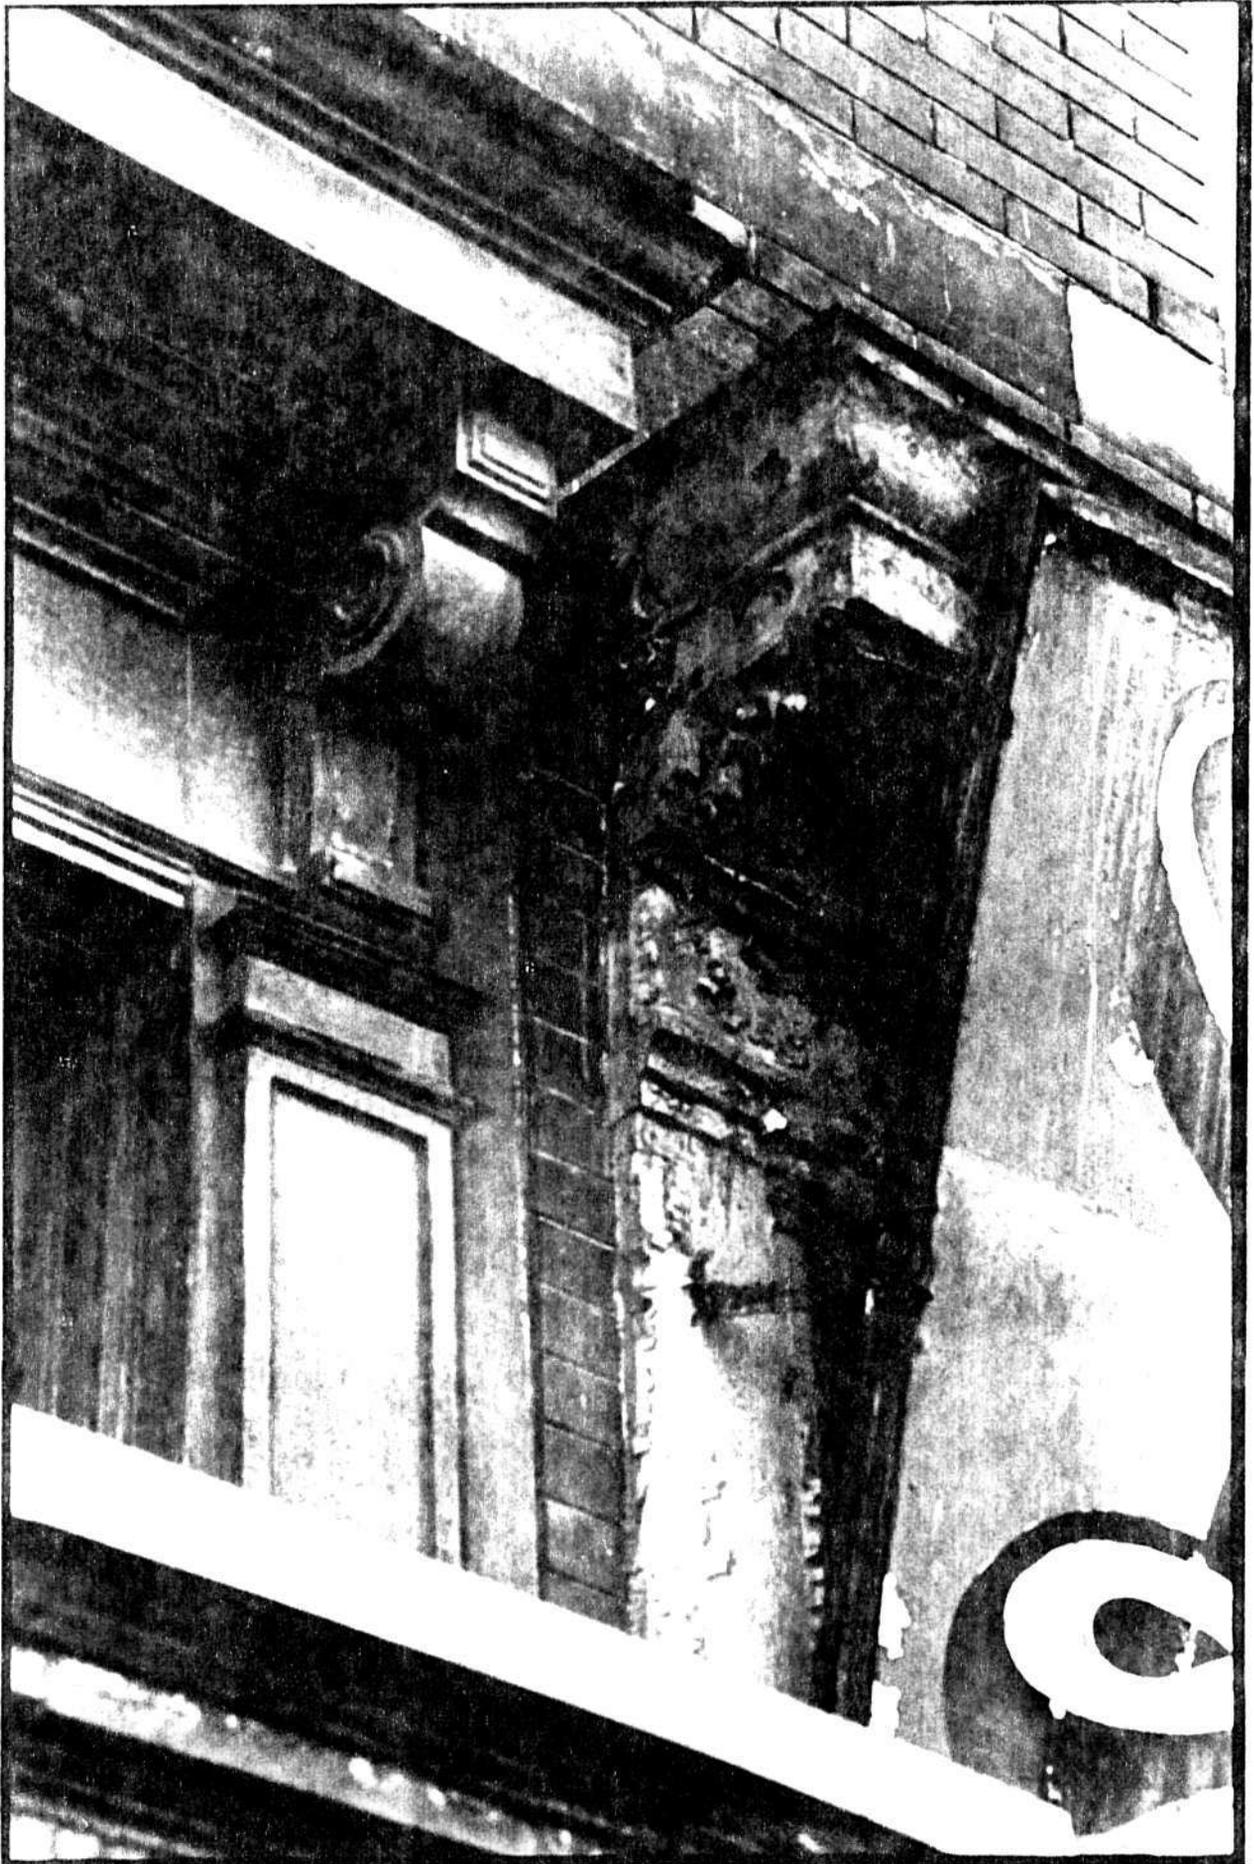
1 RIEMAN BLOCK B-3995
2 617-631 West Lexington Street
Baltimore, Maryland
3 Photographer - Tom Miller
4 Negatives held by Paul McKean
5 December 16, 1983
6 Trim details, over storefronts #621/623
7 Roll 3 #14 of 68
