**National Register of Historic Places
Inventory—Nomination Form**

historic Rieman Block

street & number 617-631 West Lexington Street n/a not for publication

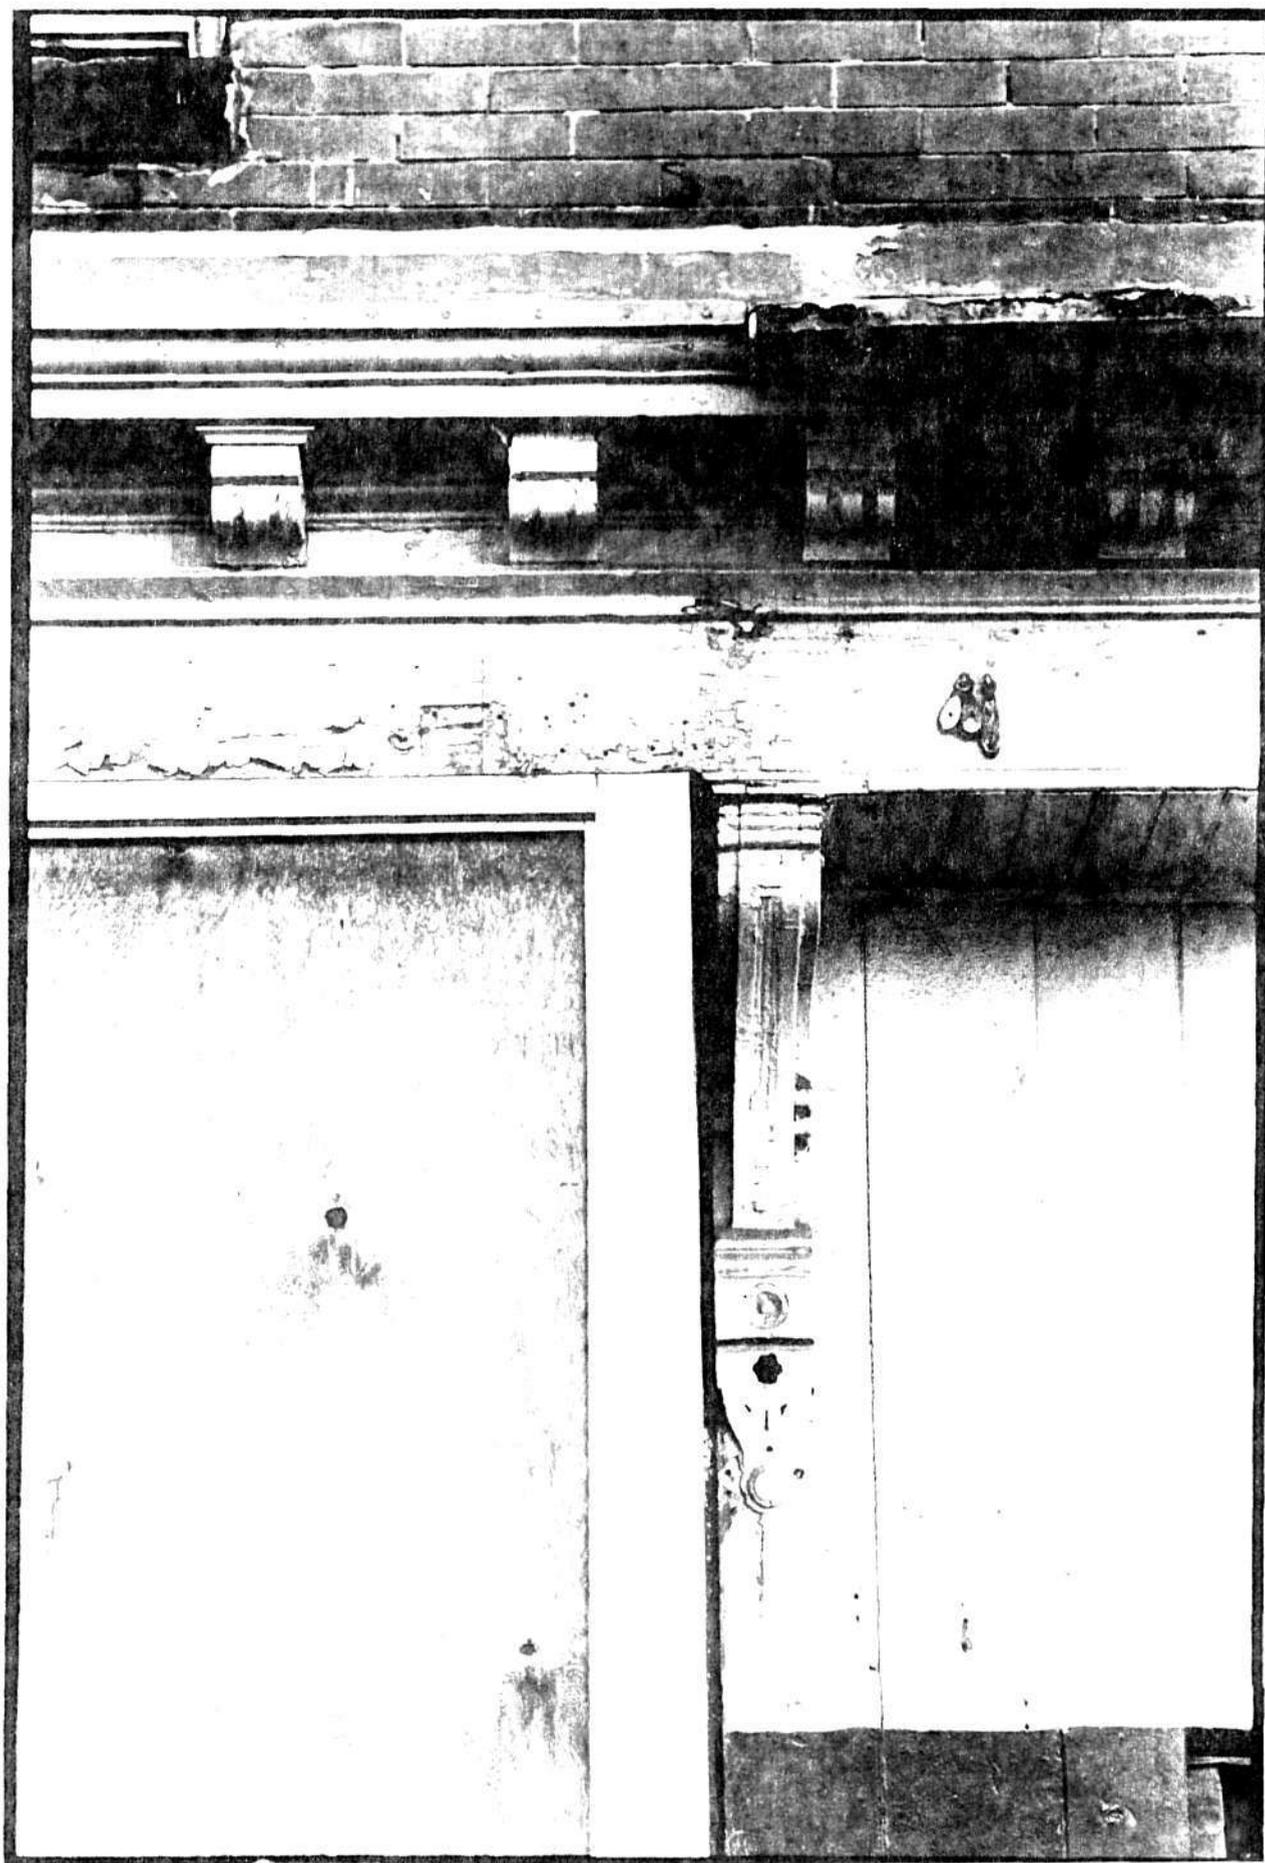
1 RIEMAN BLOCK *B-3995*
2 617-631 West Lexington Street
Baltimore, Maryland
3 Photographer - Tom Miller
4 Negatives held by Paul McKean
5 December 16, 1983
6 Storefront trim details # *625/627*
7 Roll 3 #17 of 68

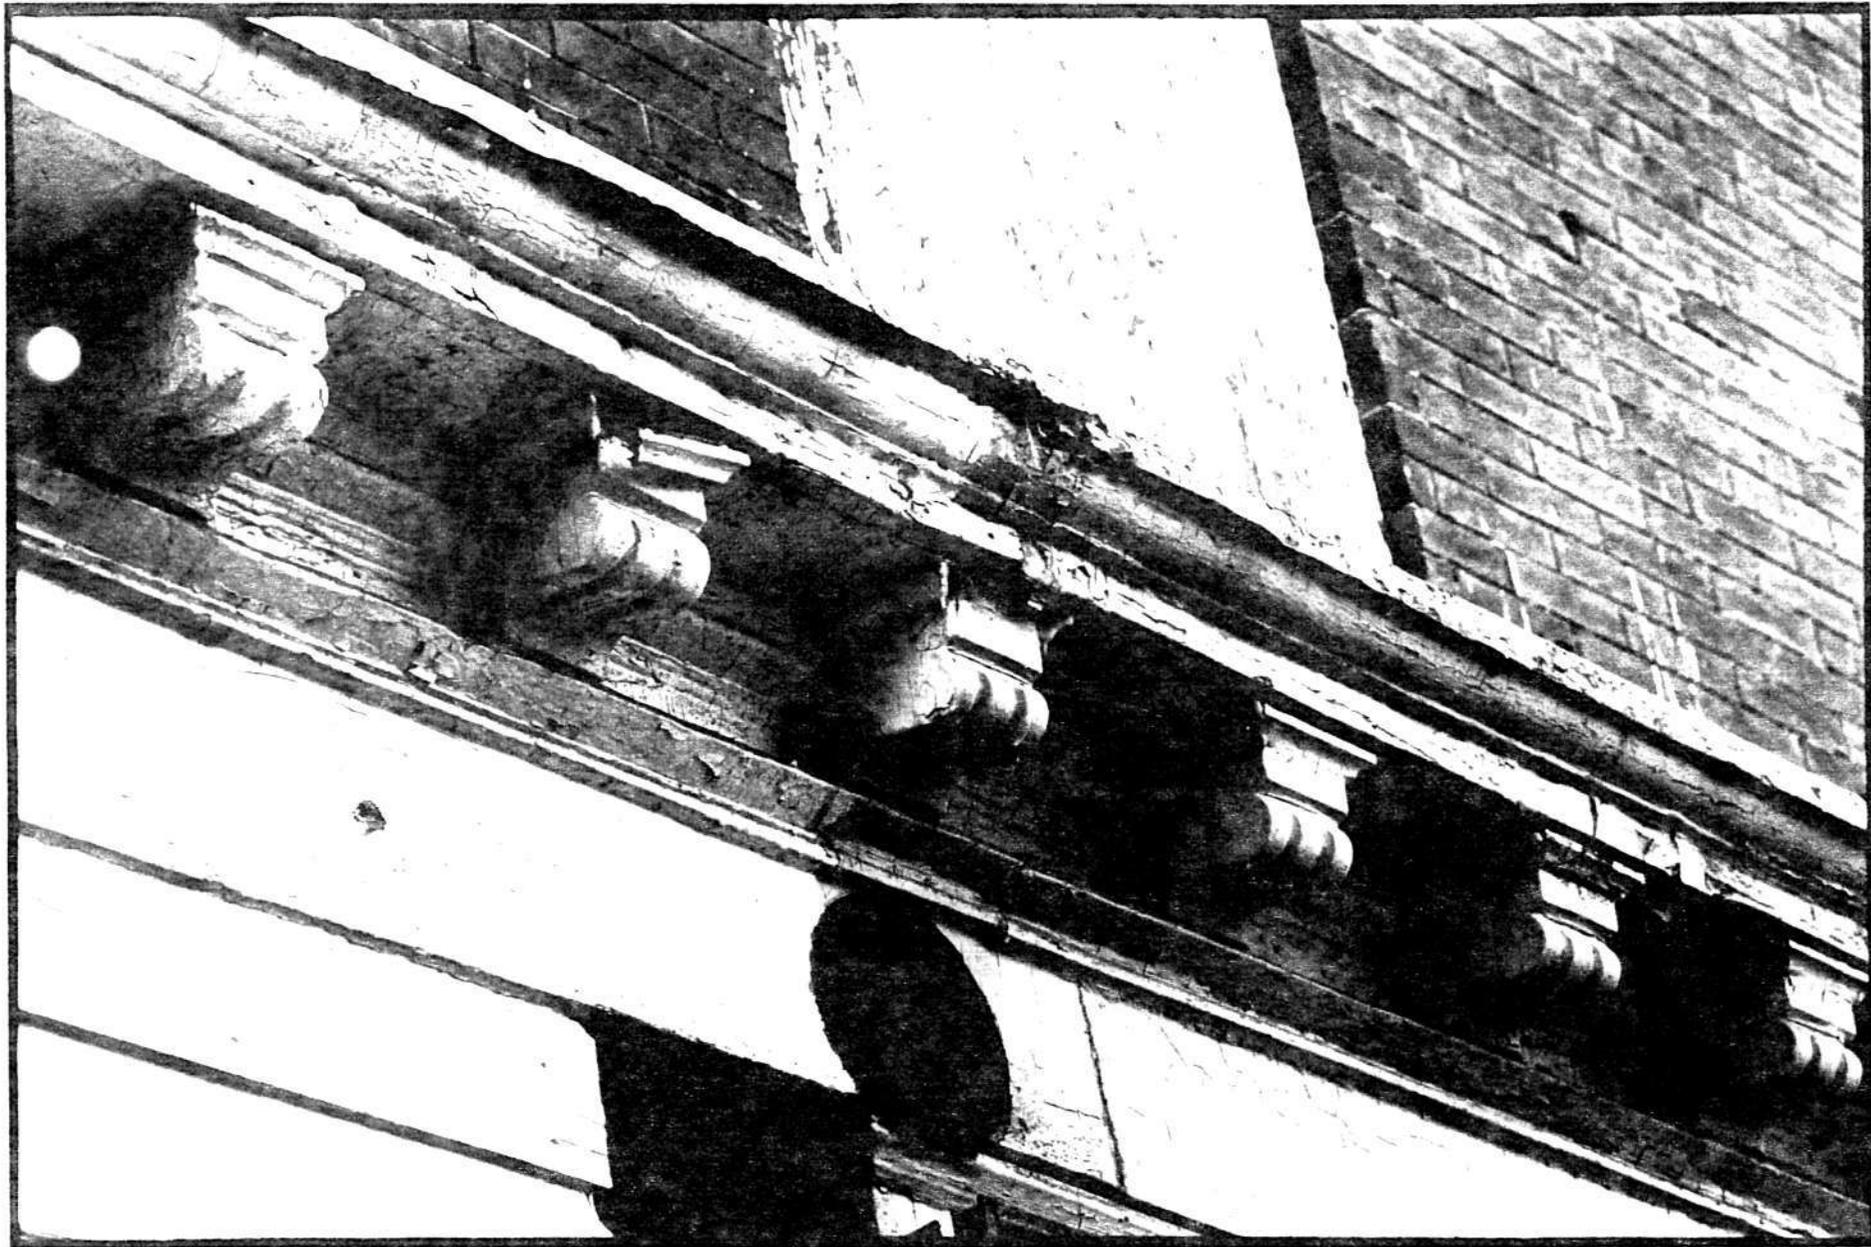
1 RIEMAN BLOCK B-3995
2 617-631 West Lexington Street
Baltimore, Maryland
3 Photographer - Tom Miller
4 Negatives held by Paul McKean
5 December 16, 1983
6 Storefront trim details. #629/631
7 Roll 3 #18 of 68

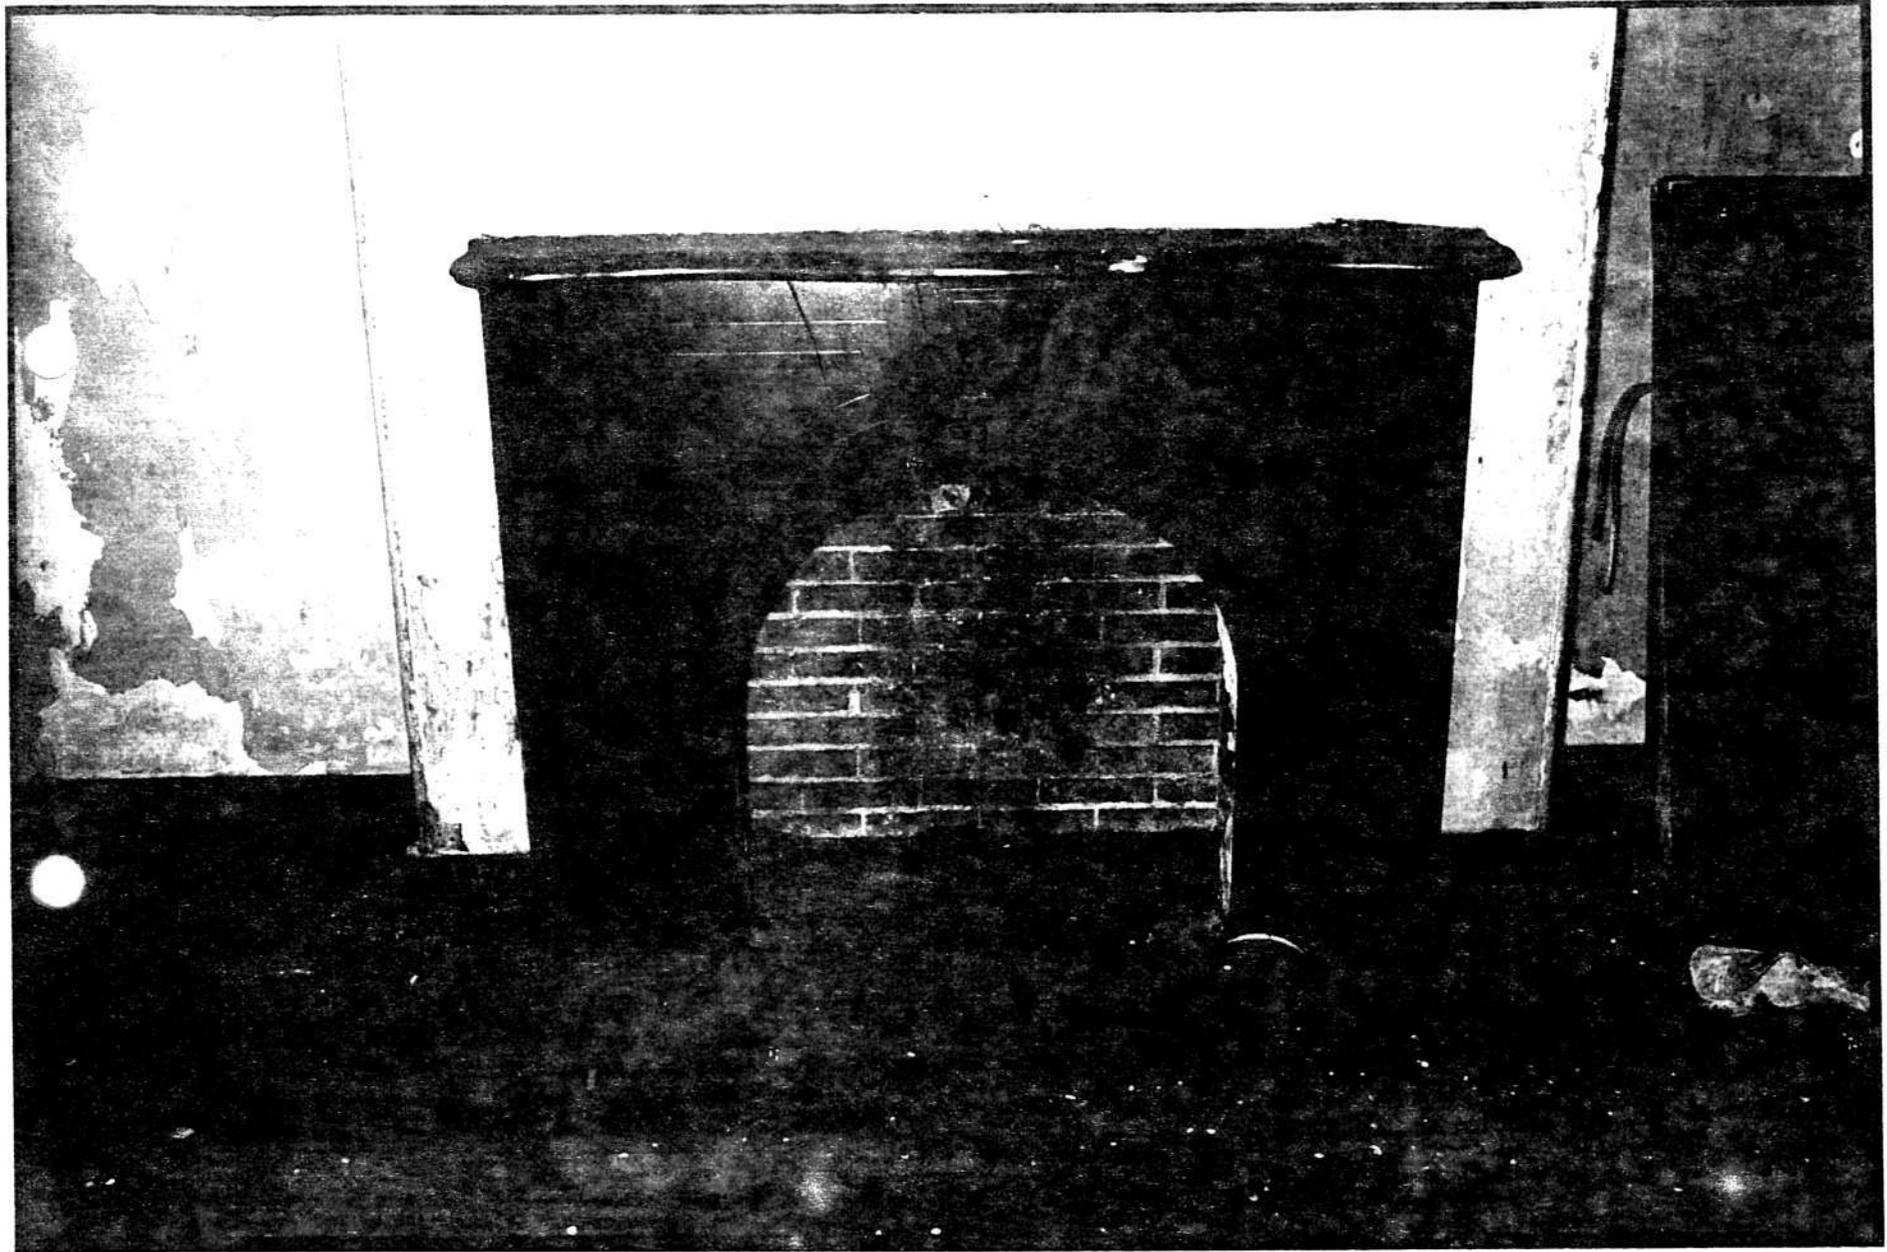
2) Fireplaces: On the upper floors of the buildings there are several existing fireplaces. In the larger units, 617-623, the fireplaces in the main front room (or living room) on the second floor all have existing stone hearths. Although several of the mantels and surrounds are missing, those that remain are typical of the period, i.e., black slate mantel with marbelized slate surround. The slate surround forms an arch over the fireplace masonry opening. On the third and fourth floor of the building there are no full fireplaces, evidence exists of openings into the flue where wood or coal stoves were probably connected. There are several existing fireplaces in buildings 625-631 on the second and third floors. In these buildings, however, the fireplaces are less ornate as they have a single brick hearth (in running bond) and plain wood surround and mantel.

1 RIEMAN BLOCK B-3995
2 617-631 West Lexington Street
Baltimore, Maryland
3 Photographer - Tom Miller
4 Negatives held by Paul McKean
5 December 14, 1983
6 Fireplace, Second floor front #617
7 Roll 2 #21 of 68

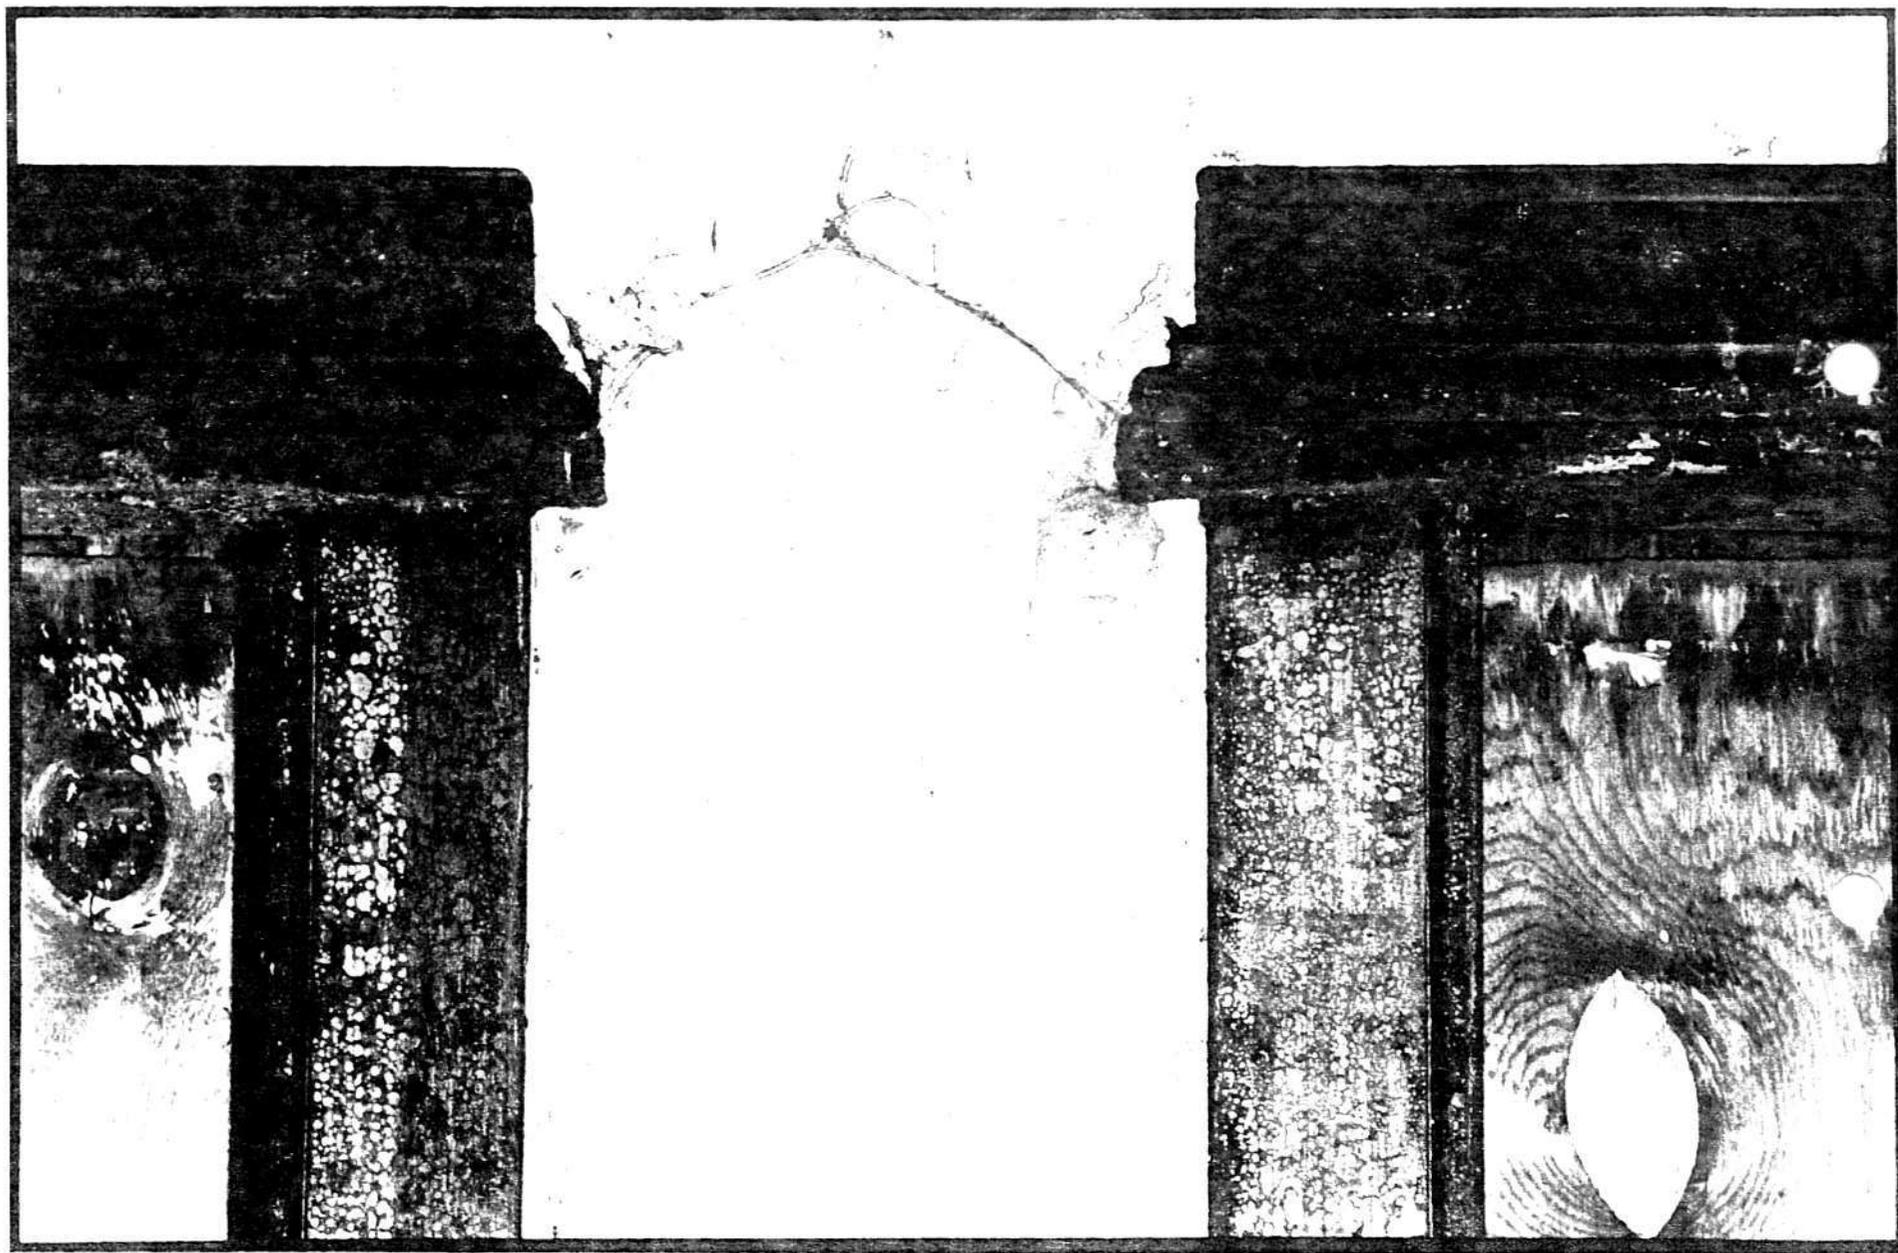
- 1 RIEMAN BLOCK *B-3995*
- 2 617-631 West Lexington Street
Baltimore, Maryland
- 3 Photographer - Tom Miller
- 4 Negatives held by Paul McKean
- 5 December 14, 1983
- 6 Close-up of window trim at bottom, North wall
Second floor front #617 (typical)
- 7 Roll 2 #23 of 68

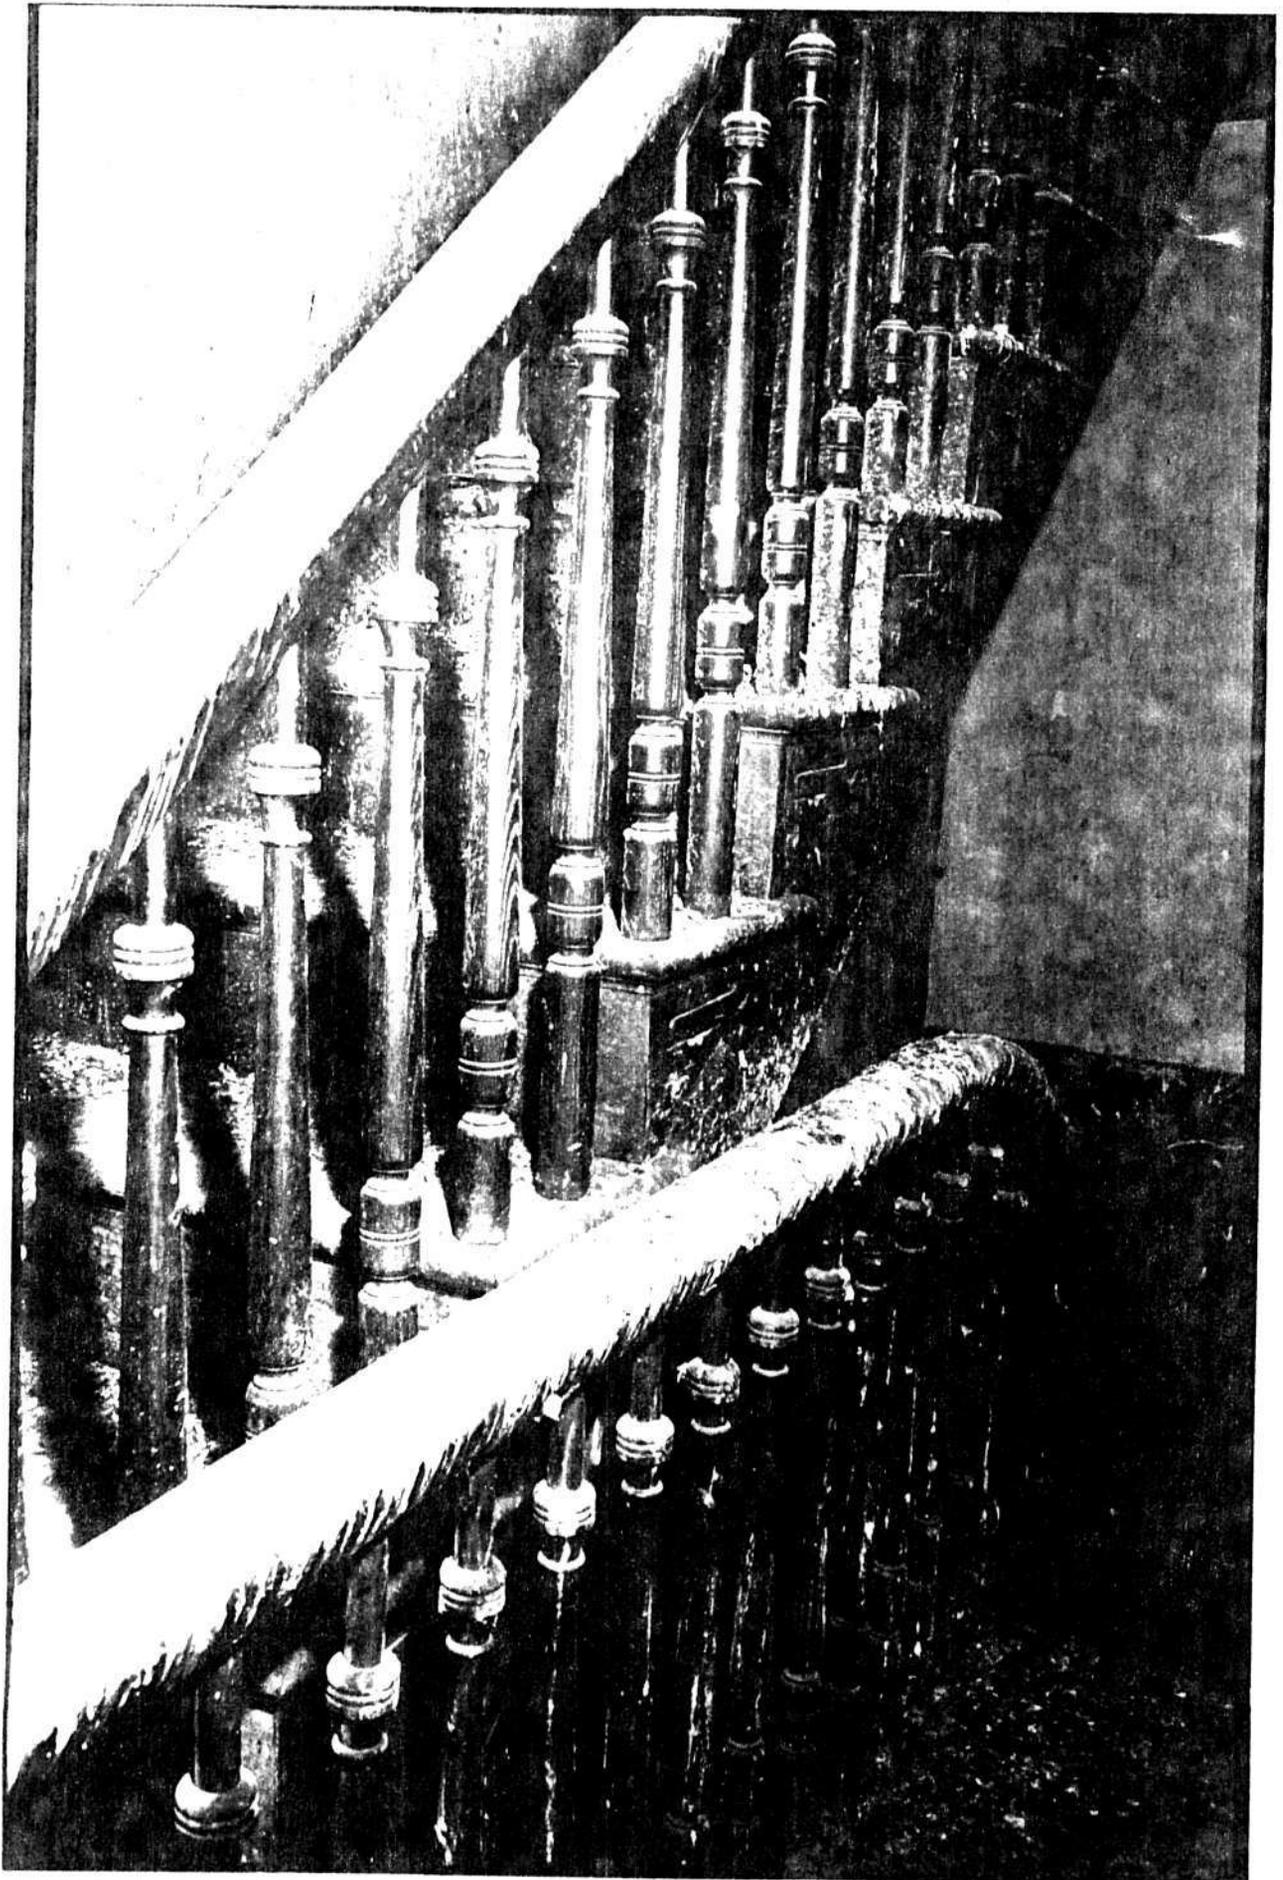
6) Stairways: The existing stairways in the 4 larger units, 617-623 are in excellent condition. The stairs are solid with only minimal wear evident. The first to second floor stair is missing in building 617, however, in 619-623 this stair is present and extends from directly behind the storefront, along the east wall, through a section of three winder treads, to the second floor. From this point on up to the fourth floor, the stair changes directions to a 'switch-back' stair with landing. The stair rail is unpainted mahogany, with turned-spindle pickets and decorative round newell. In general, all stair elements are in good condition and all intact in units 619-623. The stairways in building 625-631 are less grand, and certainly less prominent than those in the 4 larger buildings. In buildings 625-631, all stairs from the first to the second floor are in the rear section of the building. The stairs to the upper levels become more narrow as they continue to the top floor. These upper level stairs are quite steep, with narrow wooden tread.

1 RIEMAN BLOCK B-3995
2 617-631 West Lexington Street
Baltimore, Maryland
3 Photographer - Tom Miller
4 Negatives held by Paul McKean
5 December 14, 1983
6 Detail of Center Stair, Third floor #617
7 Roll 2 #26 of 68

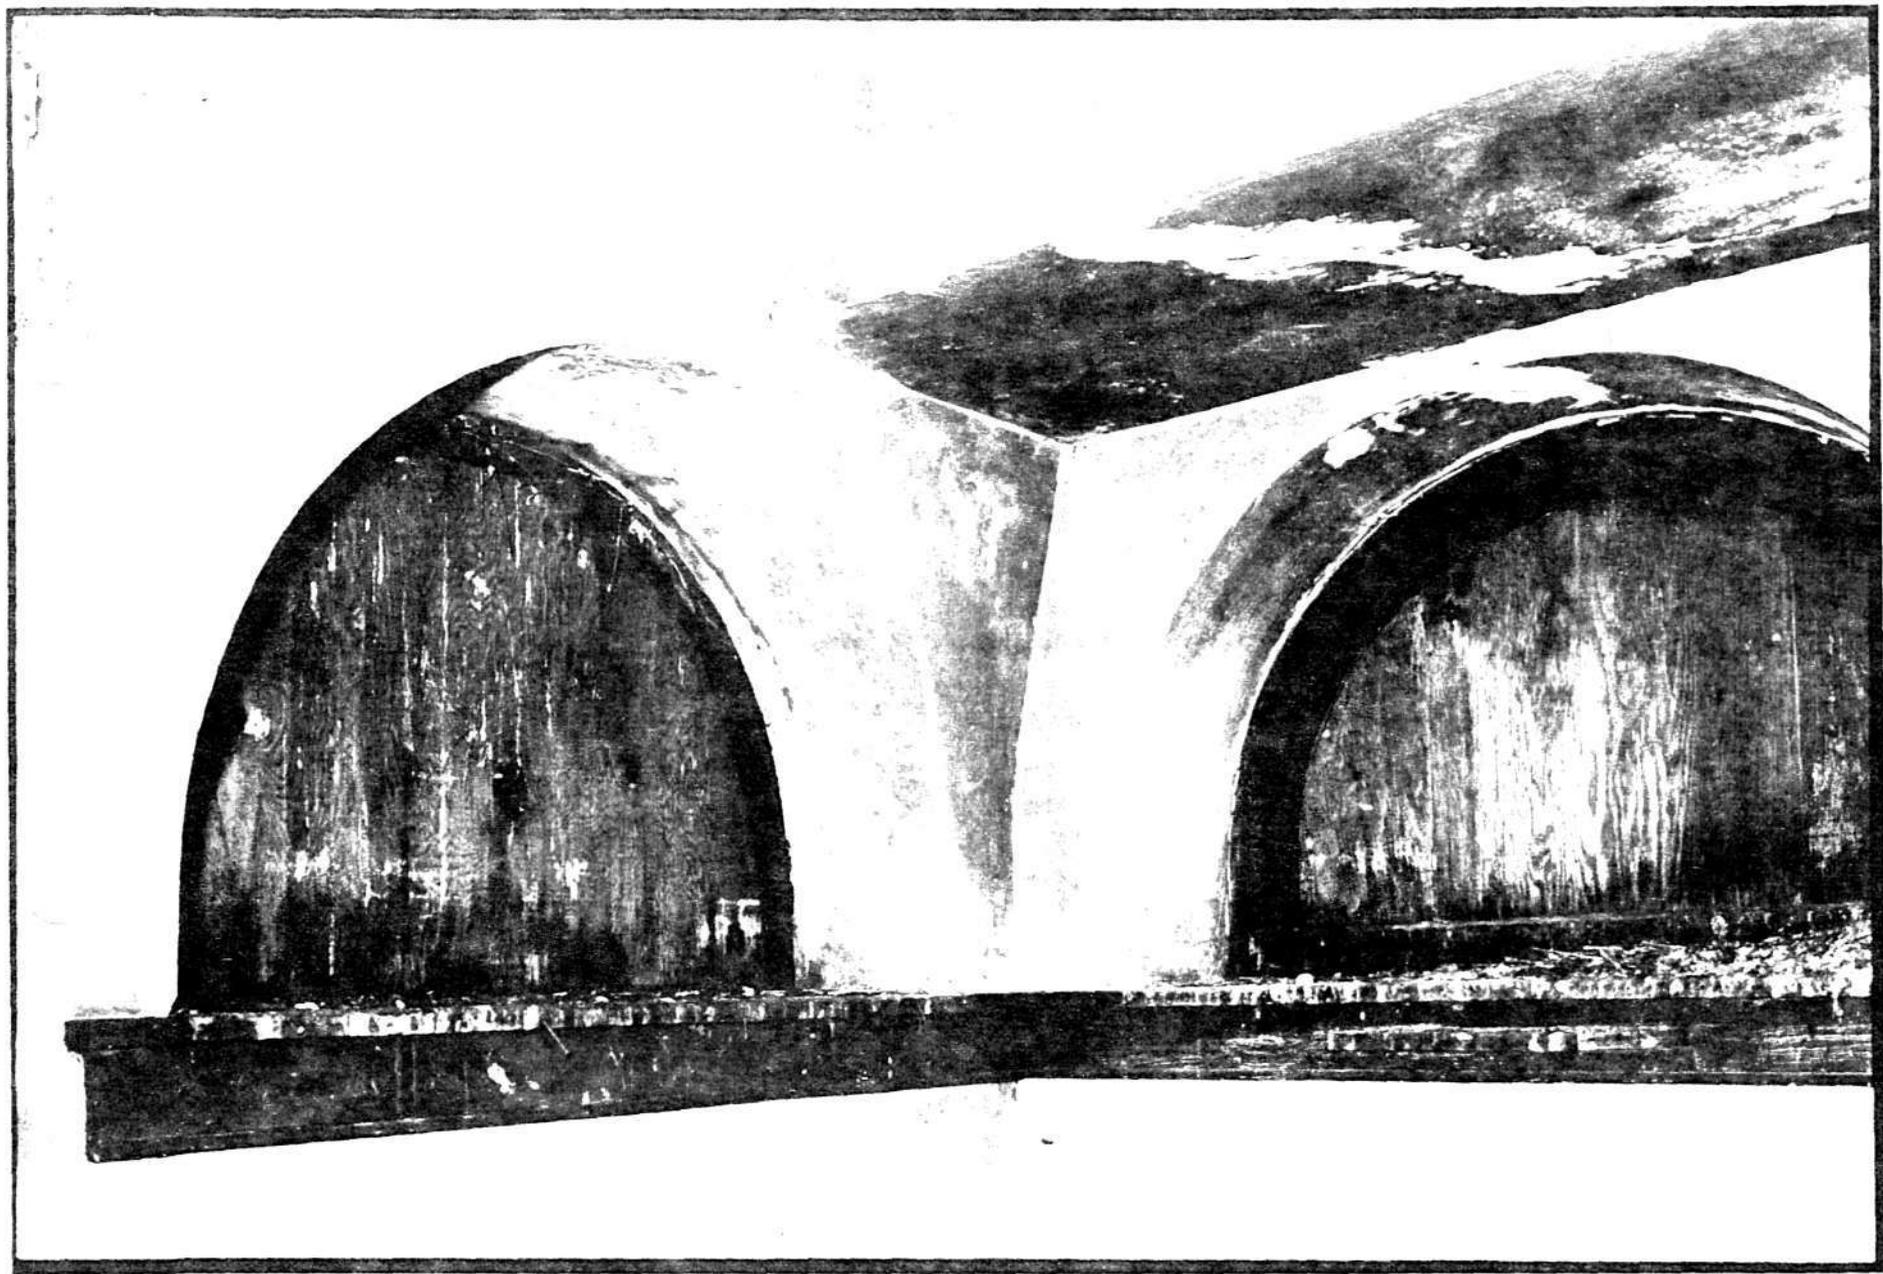
35

- 1 RIEMAN BLOCK 8-3995
- 2 617-631 West Lexington Street
Baltimore, Maryland
- 3 Photographer - Tom Miller
- 4 Negatives held by Paul McKean
- 5 December 14, 1983
- 6 Arched windows, Northeast corner,
Third floor #617
- 7 Roll 2 #29 of 68

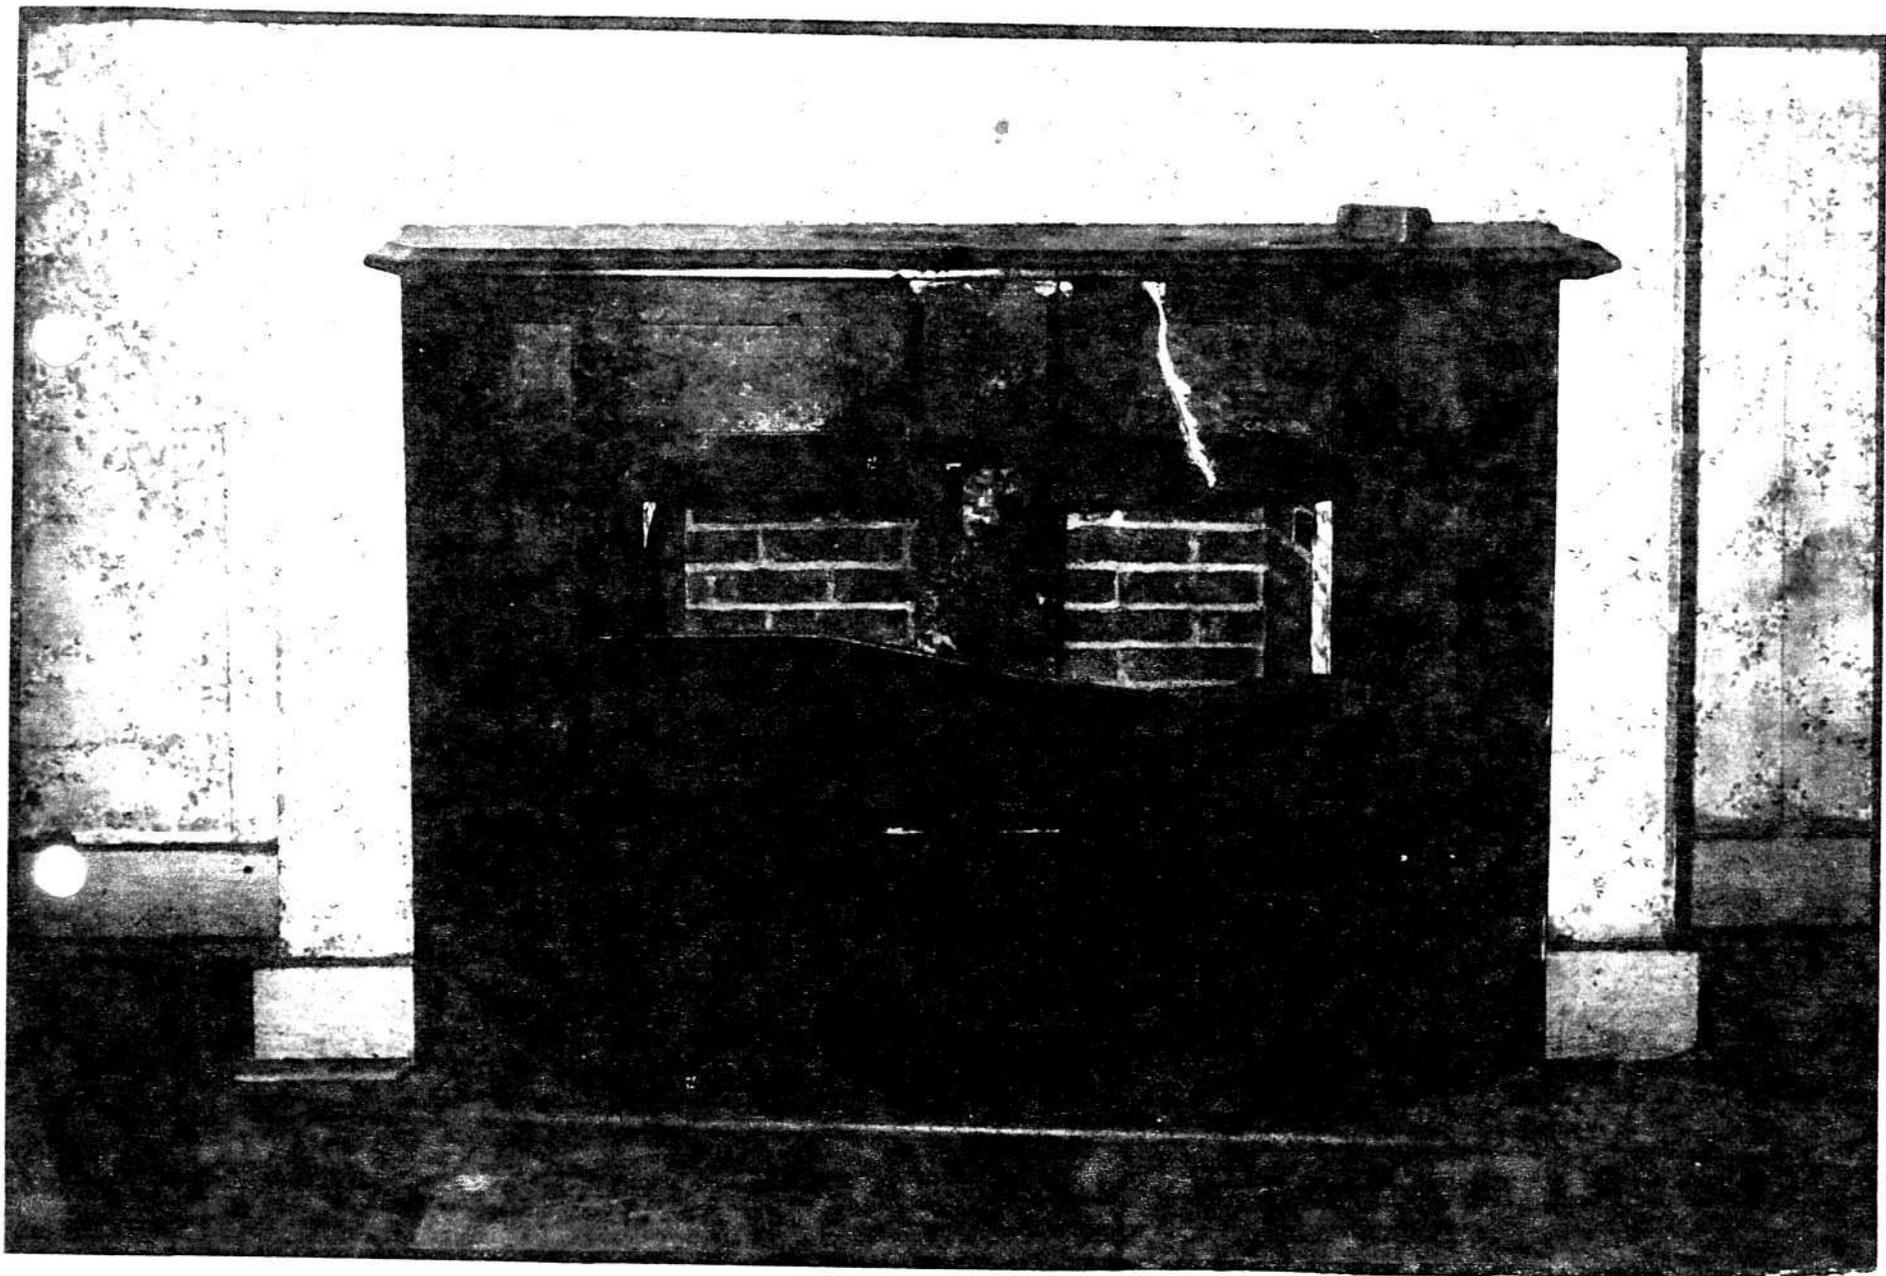
1 RIEMAN BLOCK B-3995
2 617-631 West Lexington Street
Baltimore, Maryland
3 Photographer - Tom Miller
4 Negatives held by Paul McKean
5 December 14, 1983
6 Fireplace, Front room, Second floor #619
7 Roll 2 #34 of 68

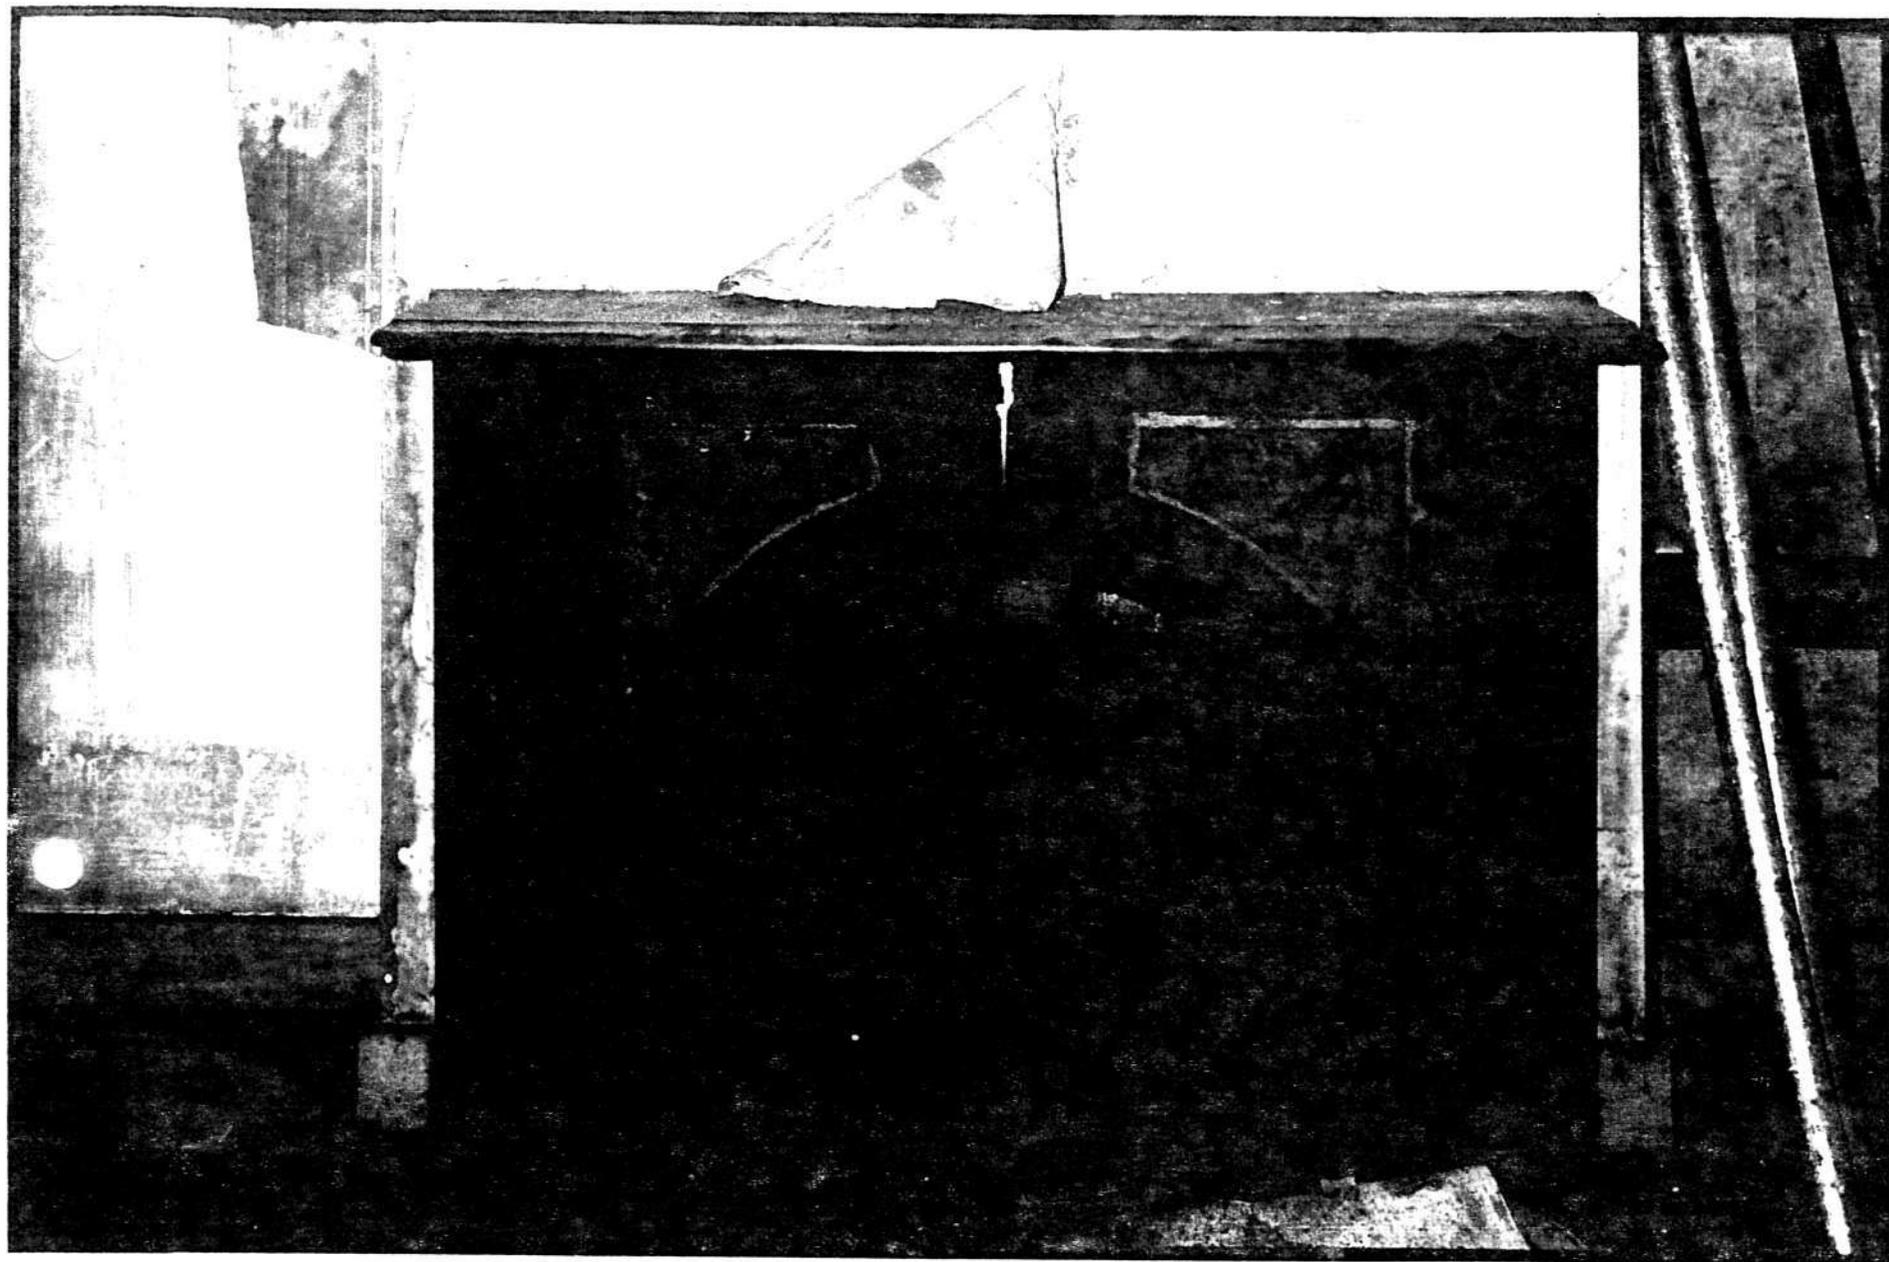
1 RIEMAN BLOCK B-3995
2 617-631 West Lexington Street
Baltimore, Maryland
3 Photographer - Tom Miller
4 Negatives held by Paul McKean
5 December 14, 1983
6 Fireplace, Middle room, Second floor #619
7 Roll 2 #35 of 68

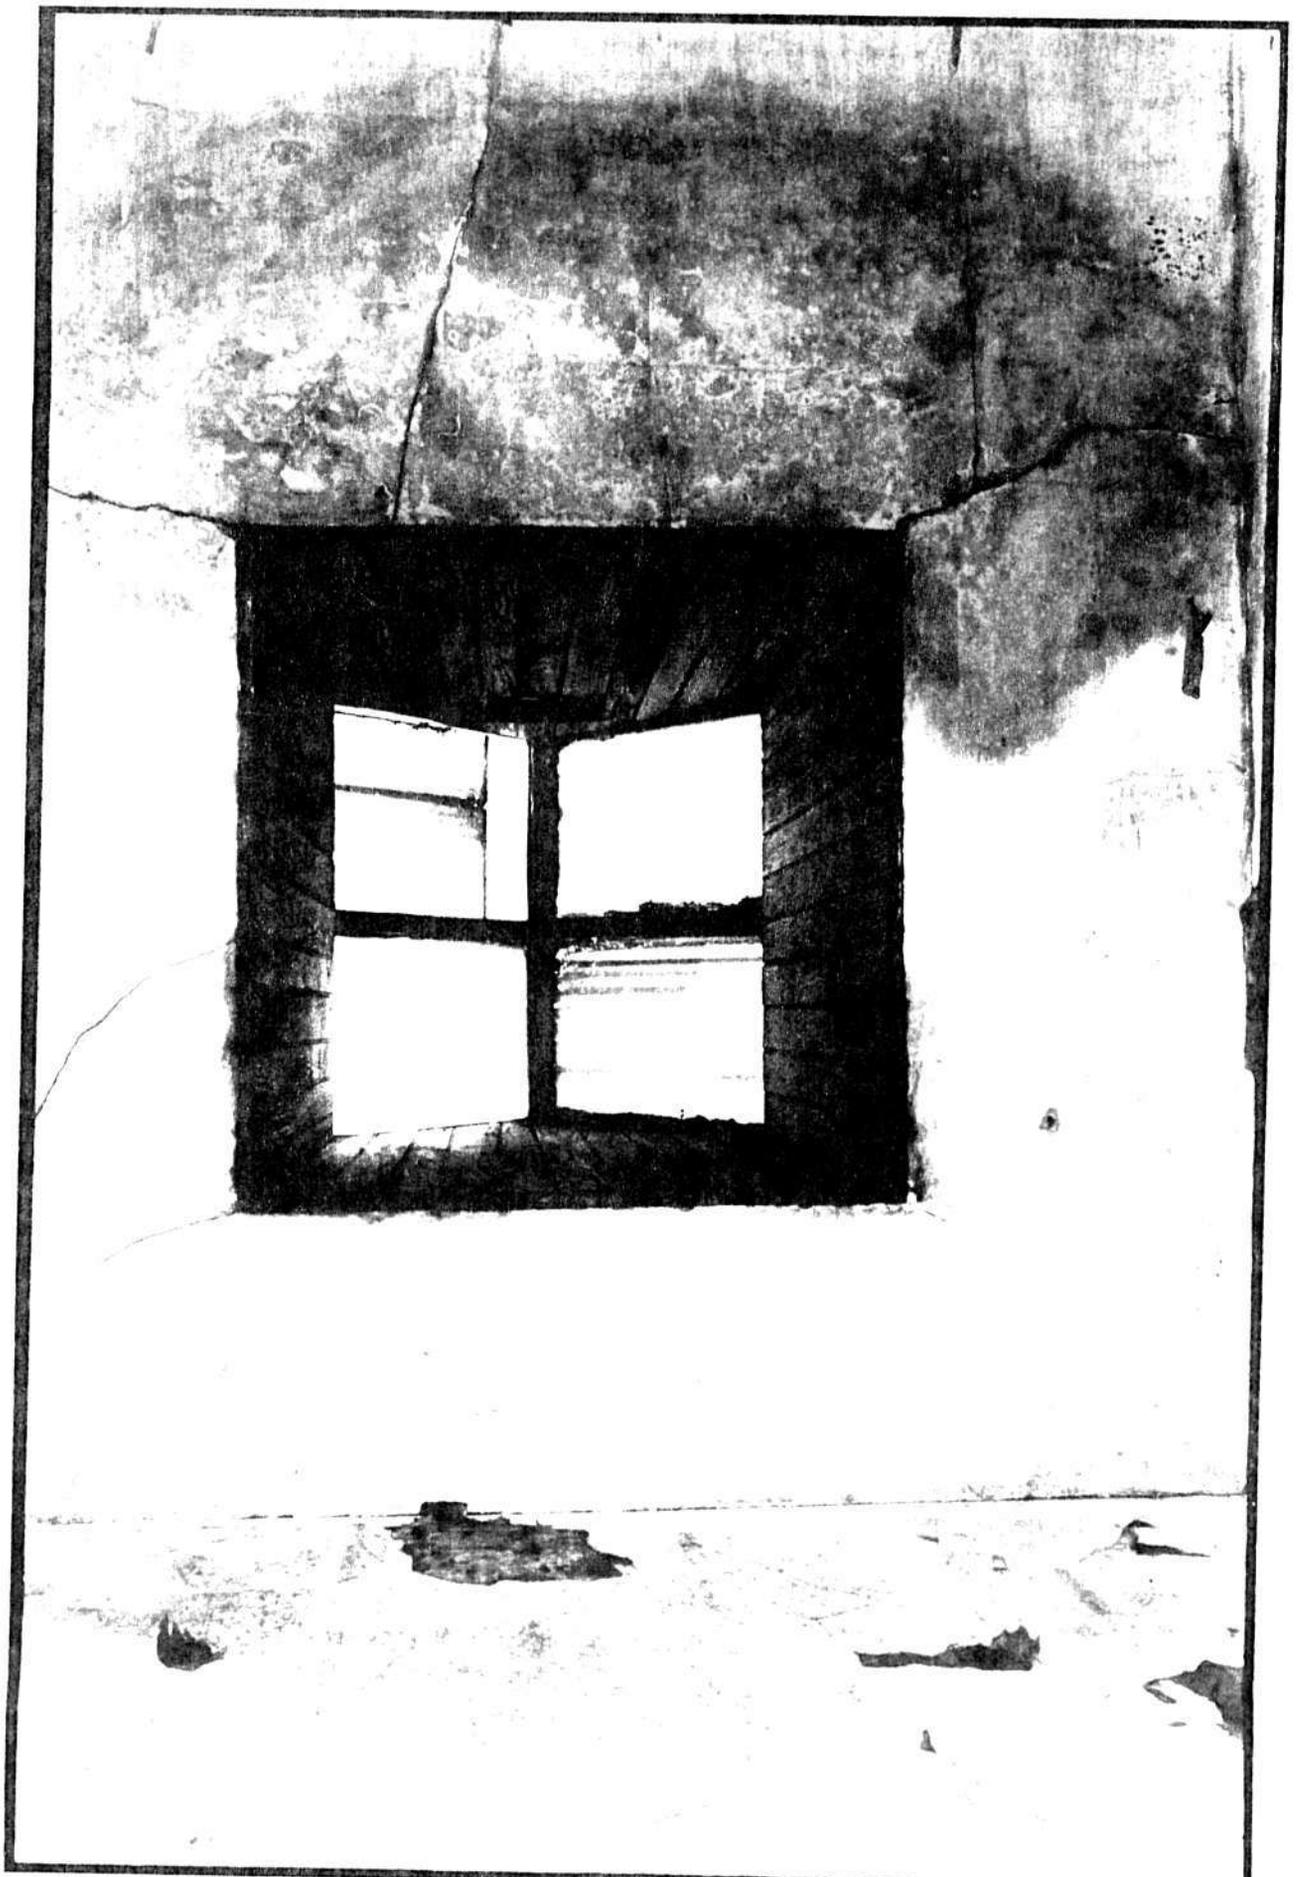
4) Skylights: There are three existing light monitors or skylights, one each above the main stair in 619, 623 and 625 respectively. They appear to be in good condition, fully glazed and watertight. The skylights are approximately 3' square and have two sloping sides of glass. The inside face of the light-well directly below each skylight is finished in a beaded board, set vertically.

1 RIEMAN BLOCK B-3995
2 617-631 West Lexington Street
Baltimore, Maryland
3 Photographer - Tom Miller
4 Negatives held by Paul McKean
5 December 16, 1983
6 Stair skylight, Fourth floor, #619
7 Roll 3 #7 of 68
