**National Register of Historic Places
Inventory—Nomination Form**

historic Rieman Block

street & number 617-631 West Lexington Street n/a not for publication

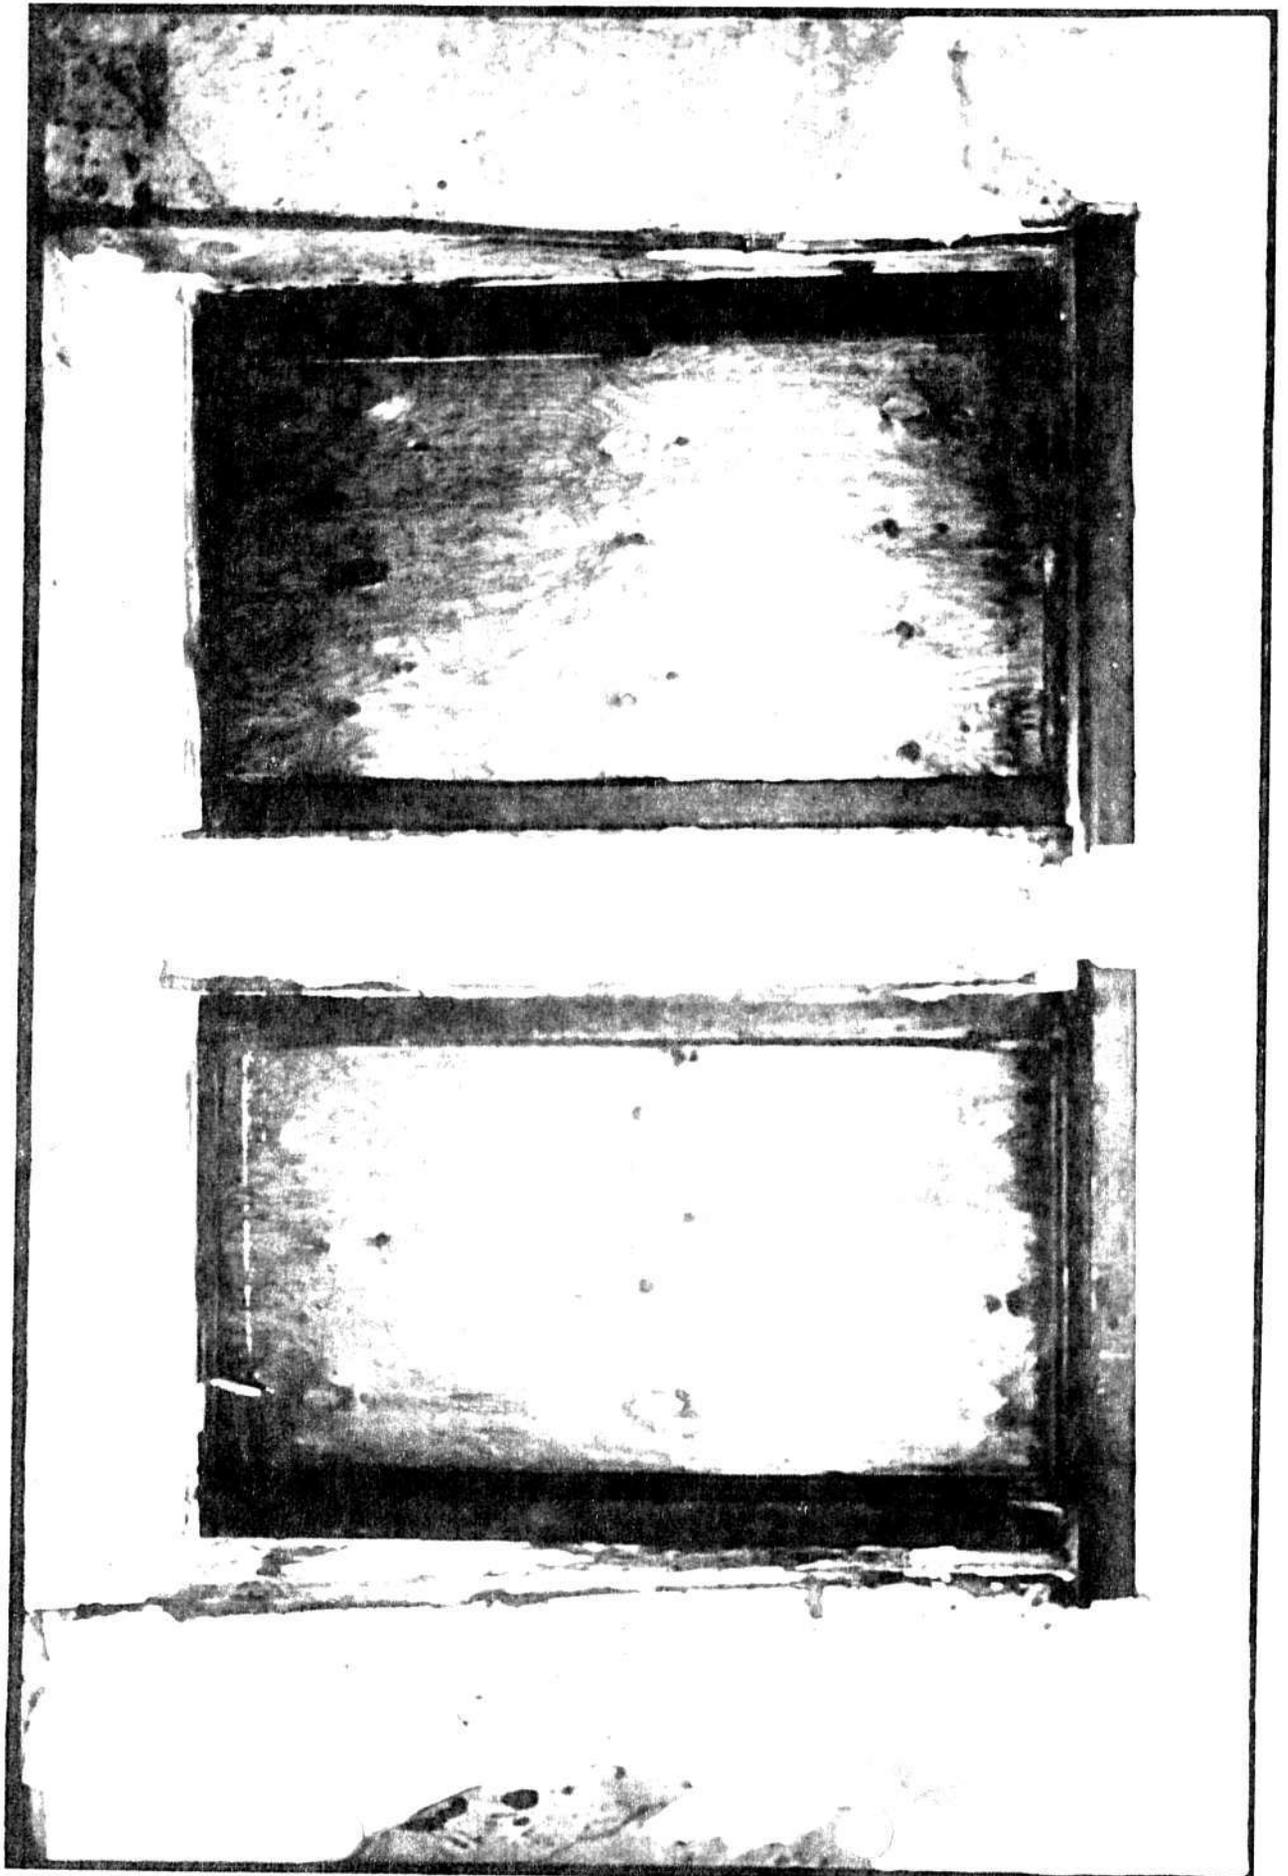
42

1 RIEMAN BLOCK B-3995
2 617-631 West Lexington Street
Baltimore, Maryland
3 Photographer - Tom Miller
4 Negatives held by Paul McKean
5 December 16, 1983
6 North dormer windows, Fourth floor, #619
7 Roll 3 #8 of 68

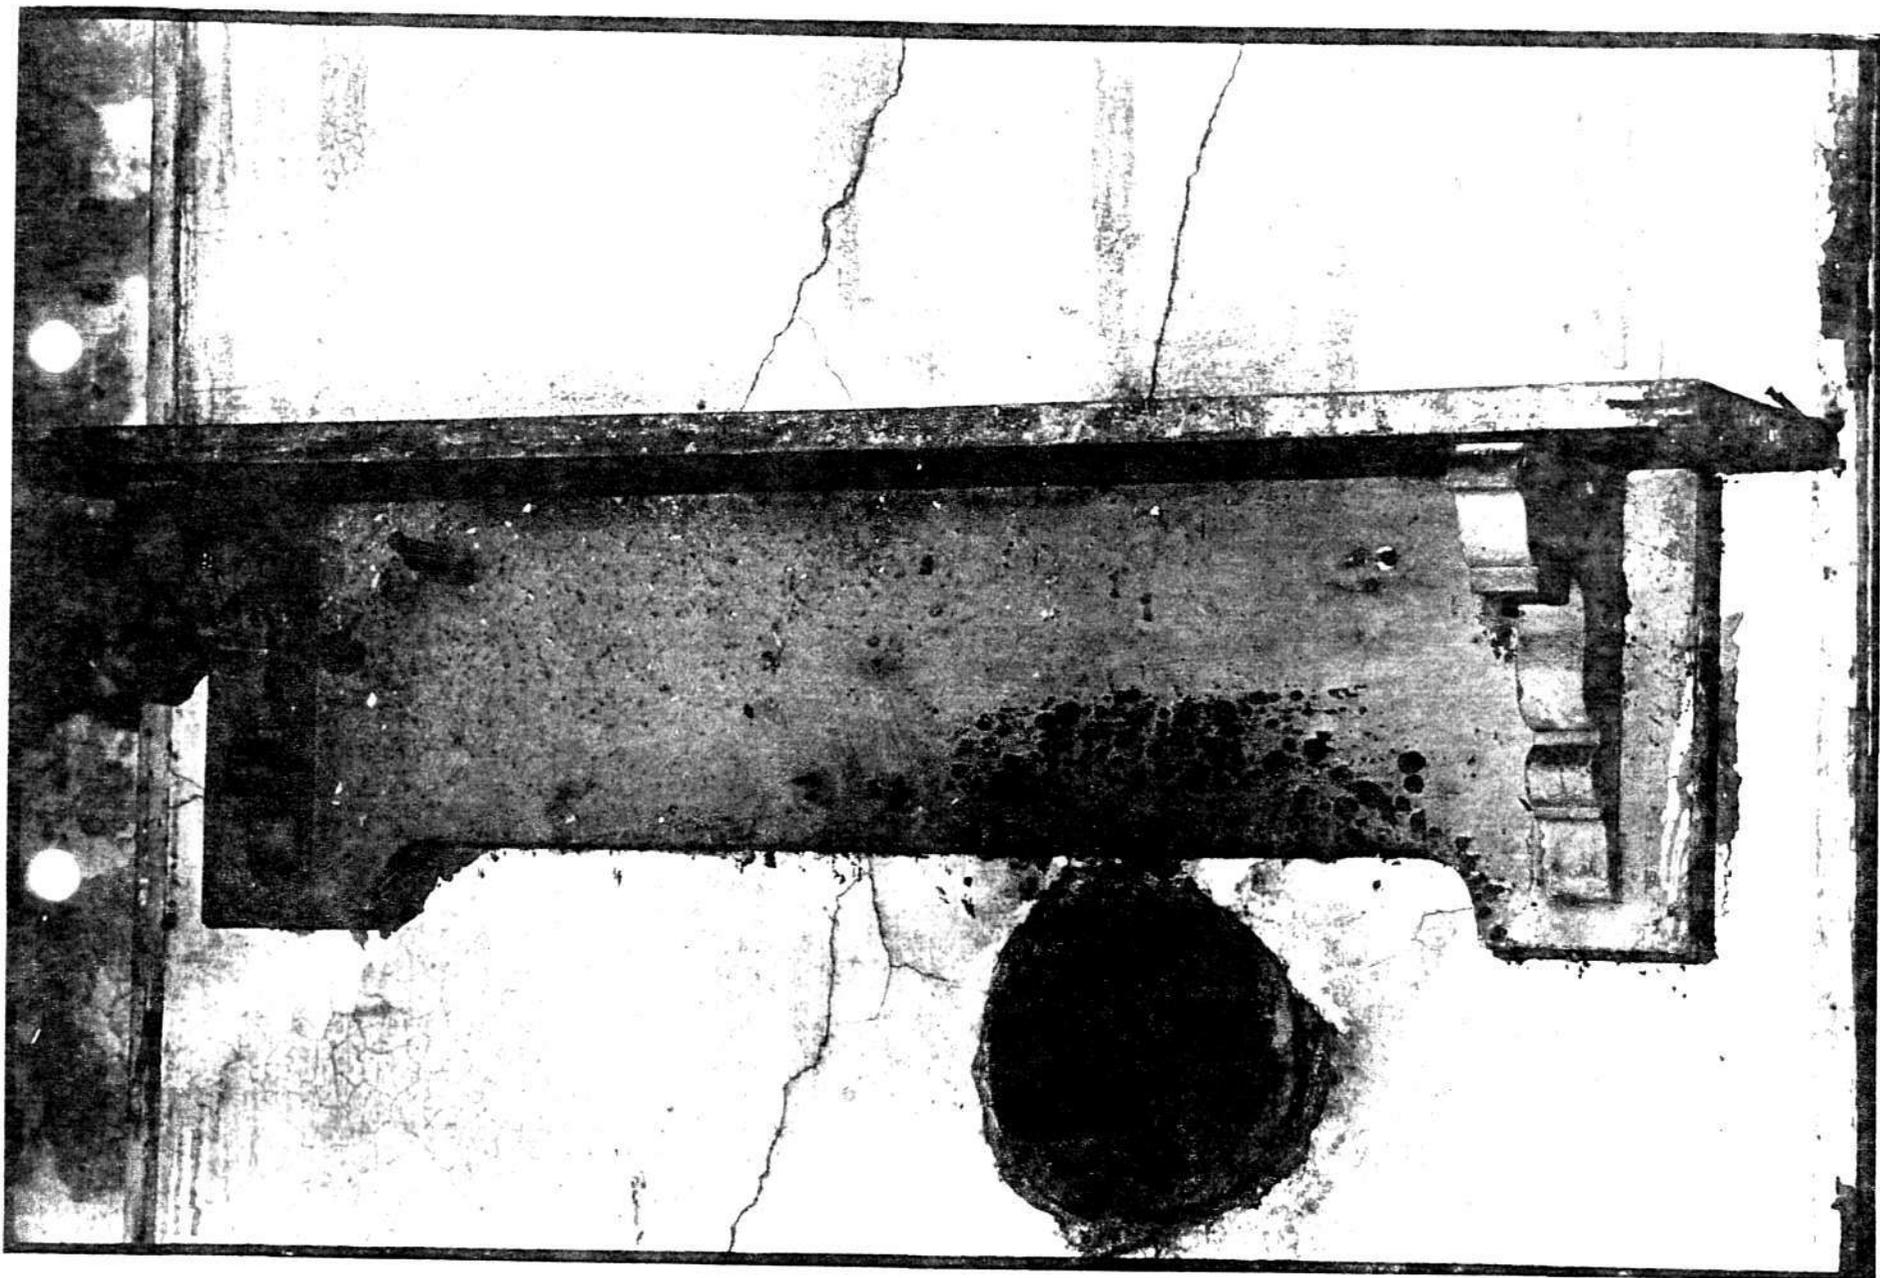
45

1 RIEMAN BLOCK B-3995
2 617-631 West Lexington Street
Baltimore, Maryland
3 Photographer - Tom Miller
4 Negatives held by Paul McKean
5 December 16, 1983
6 Chimney shelf (typical), Fourth floor
rear, #621
7 Roll 3 #32 of 68

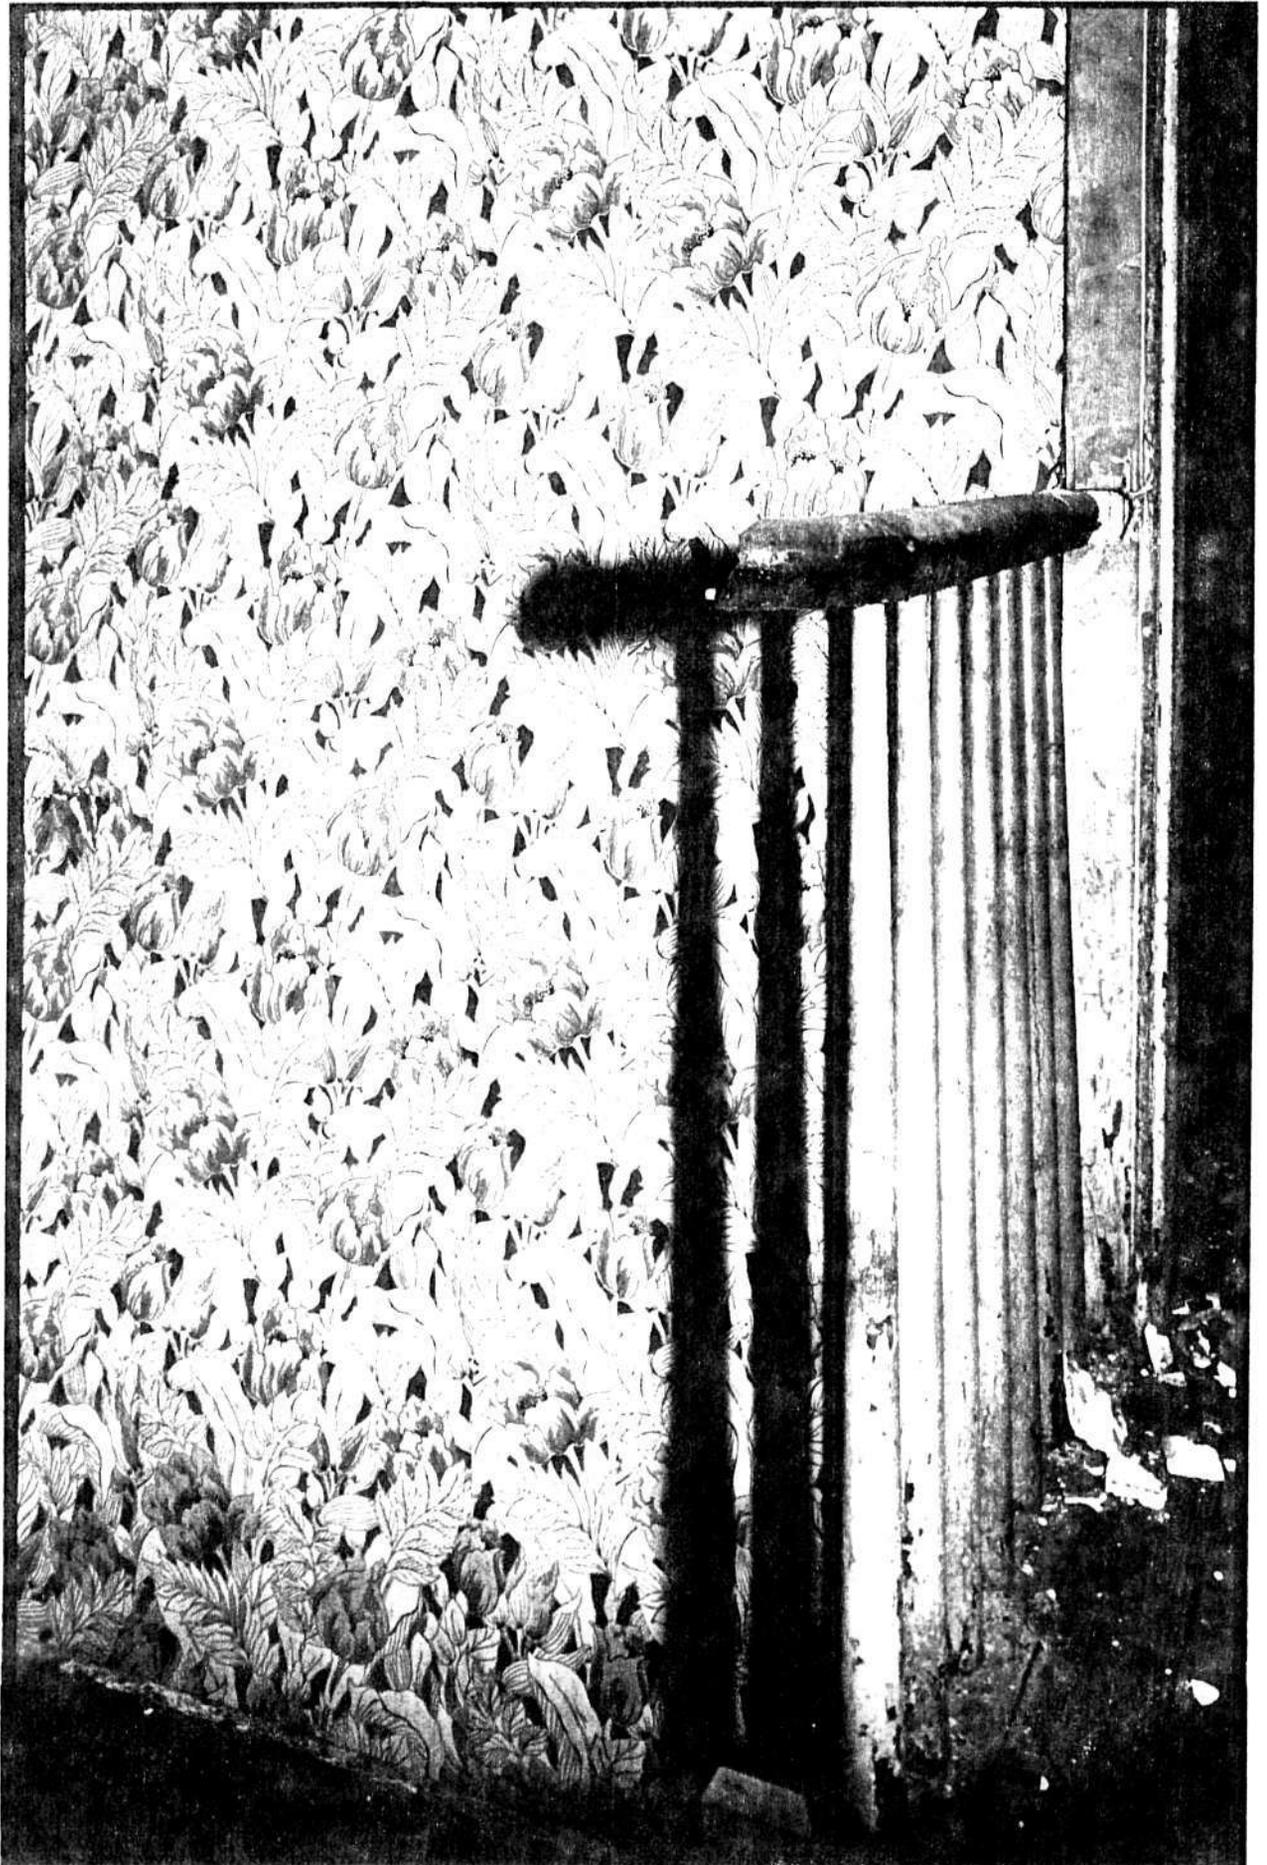
46

- 1 RIEMAN BLOCK *B-3995*
- 2 617-631 West Lexington Street
Baltimore, Maryland
- 3 Photographer - Tom Miller
- 4 Negatives held by Paul McKean
- 5 December 16, 1983
- 6 Stair rail, Second floor, #625
- 7 Roll 4 #7 of 68

6) Stairways: The existing stairways in the 4 larger units, 617-623 are in excellent condition. The stairs are solid with only minimal wear evident. The first to second floor stair is missing in building 617, however, in 619-623 this stair is present and extends from directly behind the storefront, along the east wall, through a section of three winder treads, to the second floor. From this point on up to the fourth floor, the stair changes directions to a 'switch-back' stair with landing. The stair rail is unpainted mahogany, with turned-spindle pickets and decorative round newell. In general, all stair elements are in good condition and all intact in units 619-623. The stairways in building 625-631 are less grand, and certainly less prominent than those in the 4 larger buildings. In buildings 625-631, all stairs from the first to the second floor are in the rear section of the building. The stairs to the upper levels become more narrow as they continue to the top floor. These upper level stairs are quite steep, with narrow wooden tread.

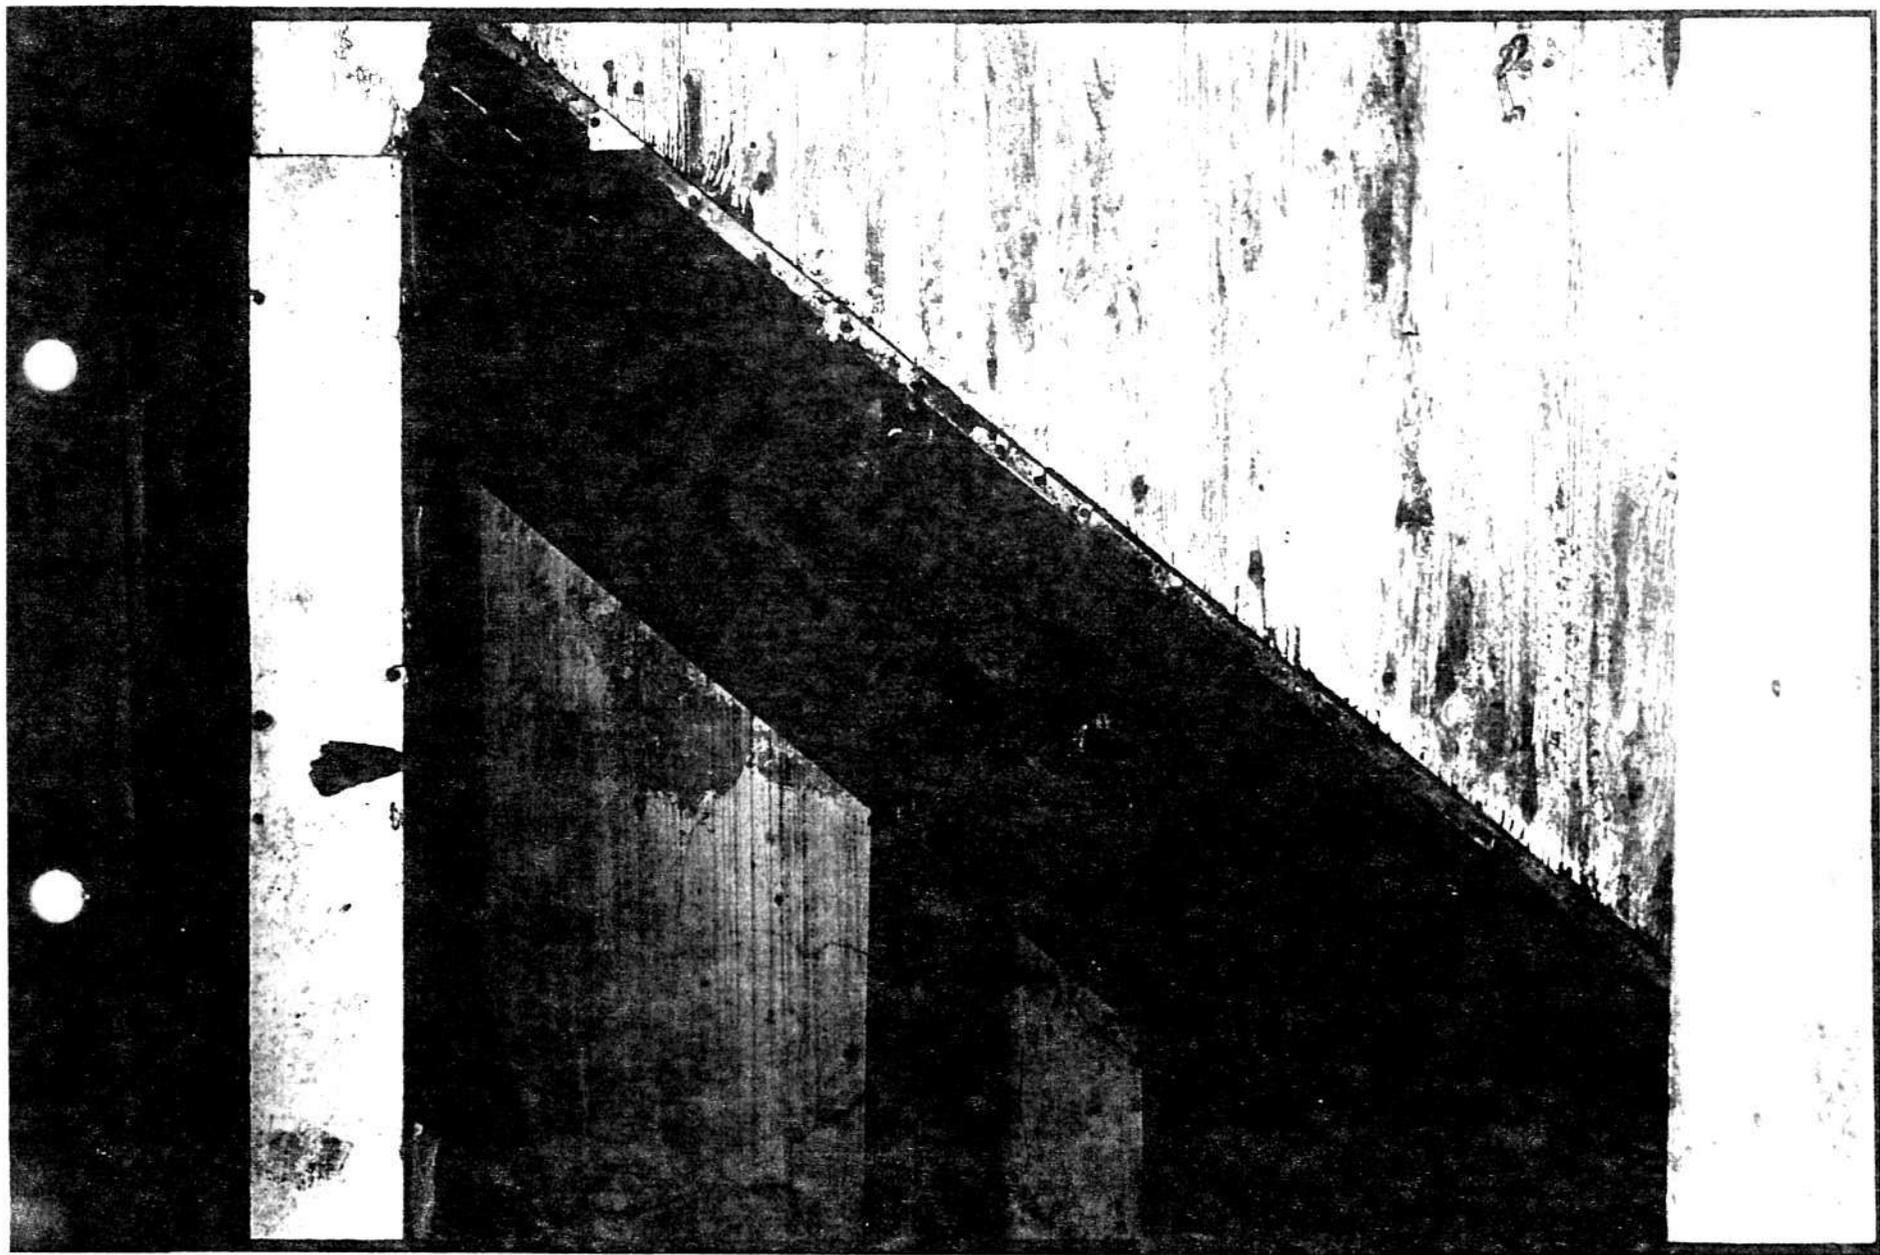
51

1 RIEMAN BLOCK B-3995
2 617-631 West Lexington Street
Baltimore, Maryland
3 Photographer - Tom Miller
4 Negatives held by Paul McKean
5 December 16, 1983
6 Rotted stair carriage, First floor, #627
7 Roll 4 #17 of 68

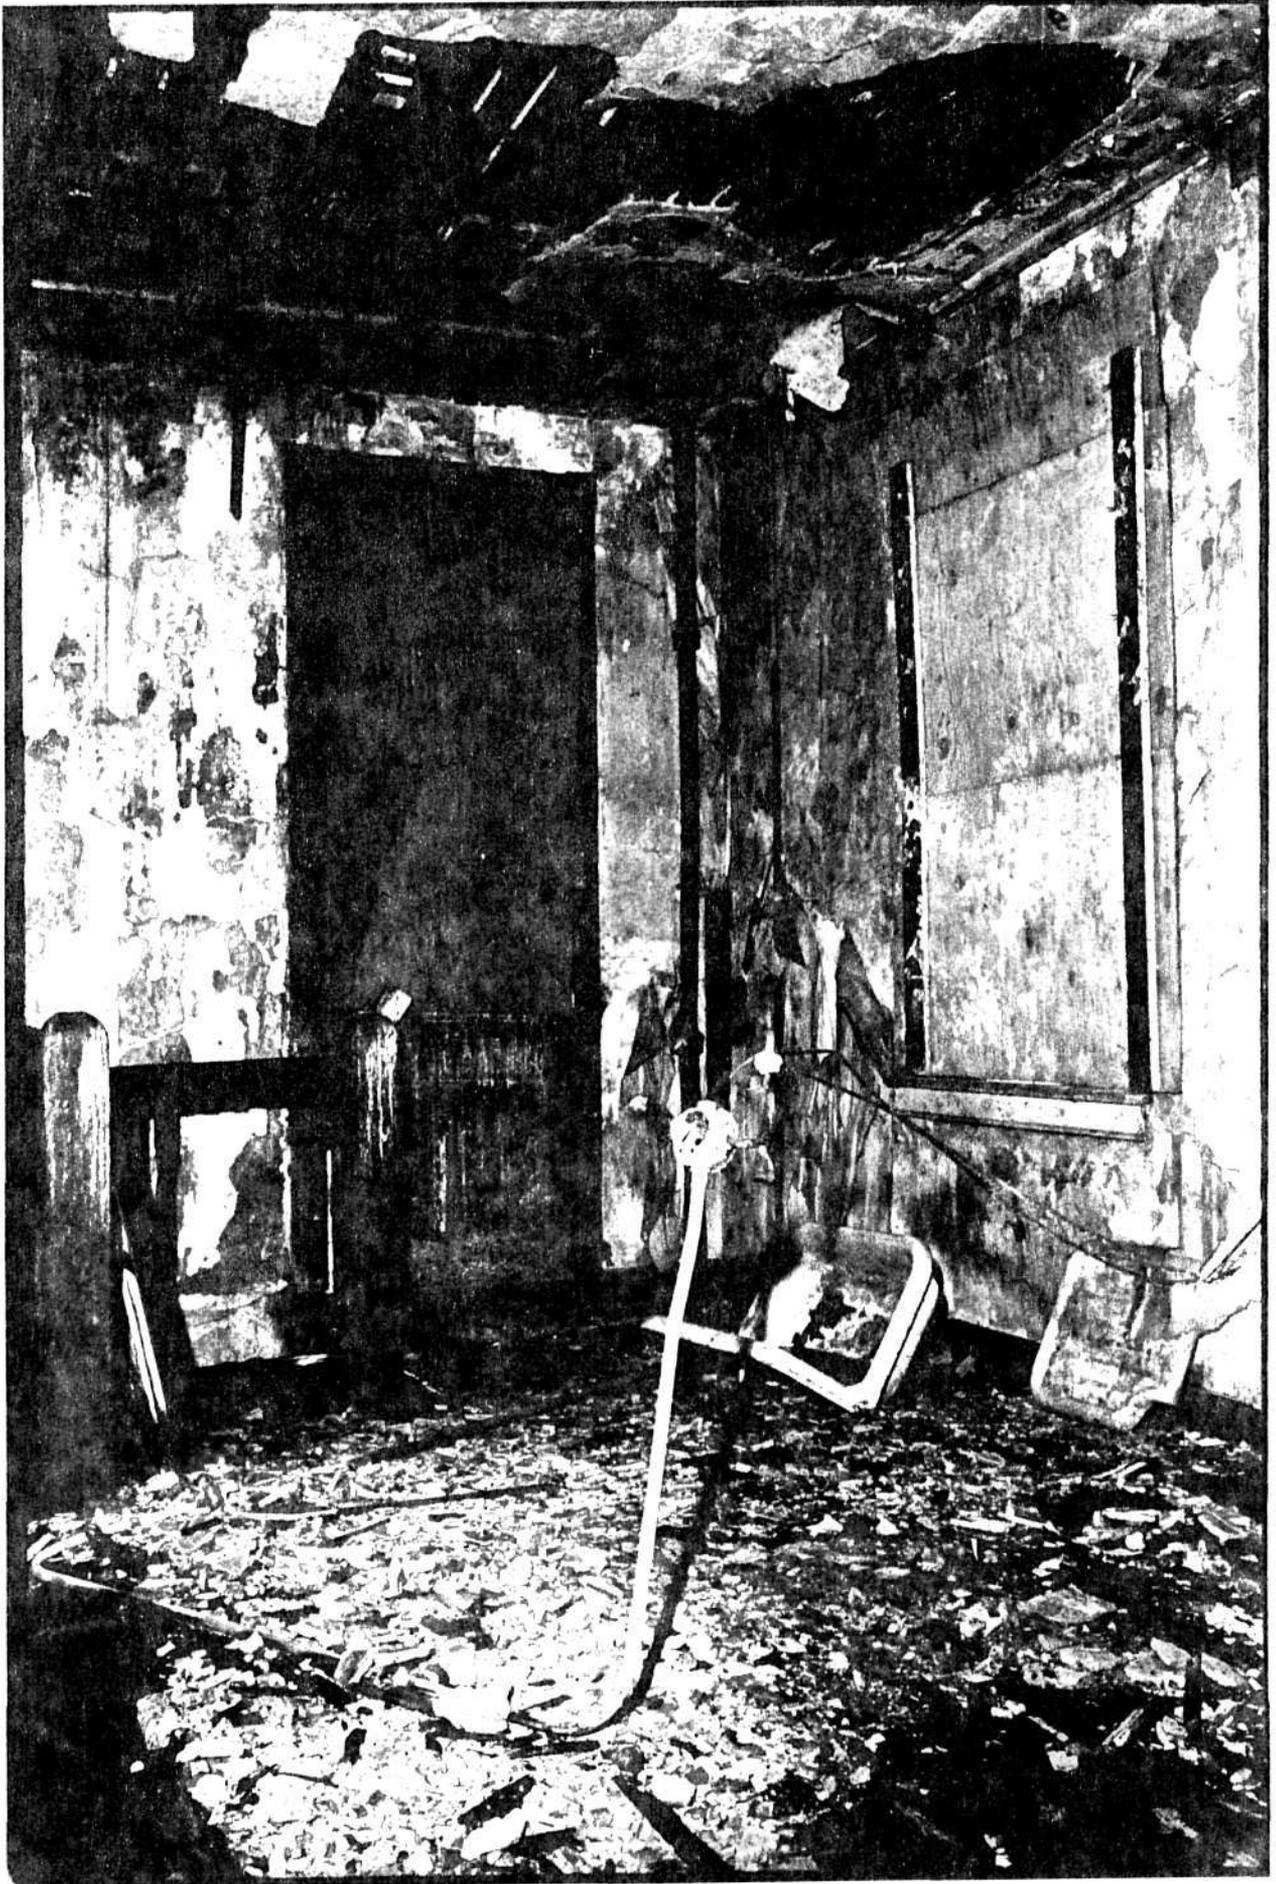
3) Wall Finish: All the interior walls and ceilings in the Rieman Block are plaster on wood lath. In most cases, when the plaster is on an interior wall it is in fair condition. There is cracking evident and some deterioration, however most of the plaster is still firmly held to the supporting wall. Exterior wall conditions, however, are less stable and there is much greater evidence of the plaster cracking and coming loose from the wall. Almost all of the ceiling plaster has extensive cracks or noticeable damage. As the existing roof is in poor condition, much of the ceiling plaster on the upper floors and on the ceilings of the second and third story rear portions show some rear damage. In some cases, entire ceilings have fallen.

- 1 RIEMAN BLOCK *B-3995*
- 2 617-631 West Lexington Street
Baltimore, Maryland
- 3 Photographer - Tom Miller
- 4 Negatives held by Paul McKean
- 5 December 16, 1983
- 6 Severe water damage - Middle & Rear
Second floor, #627
- 7 Roll 4 #19 of 68

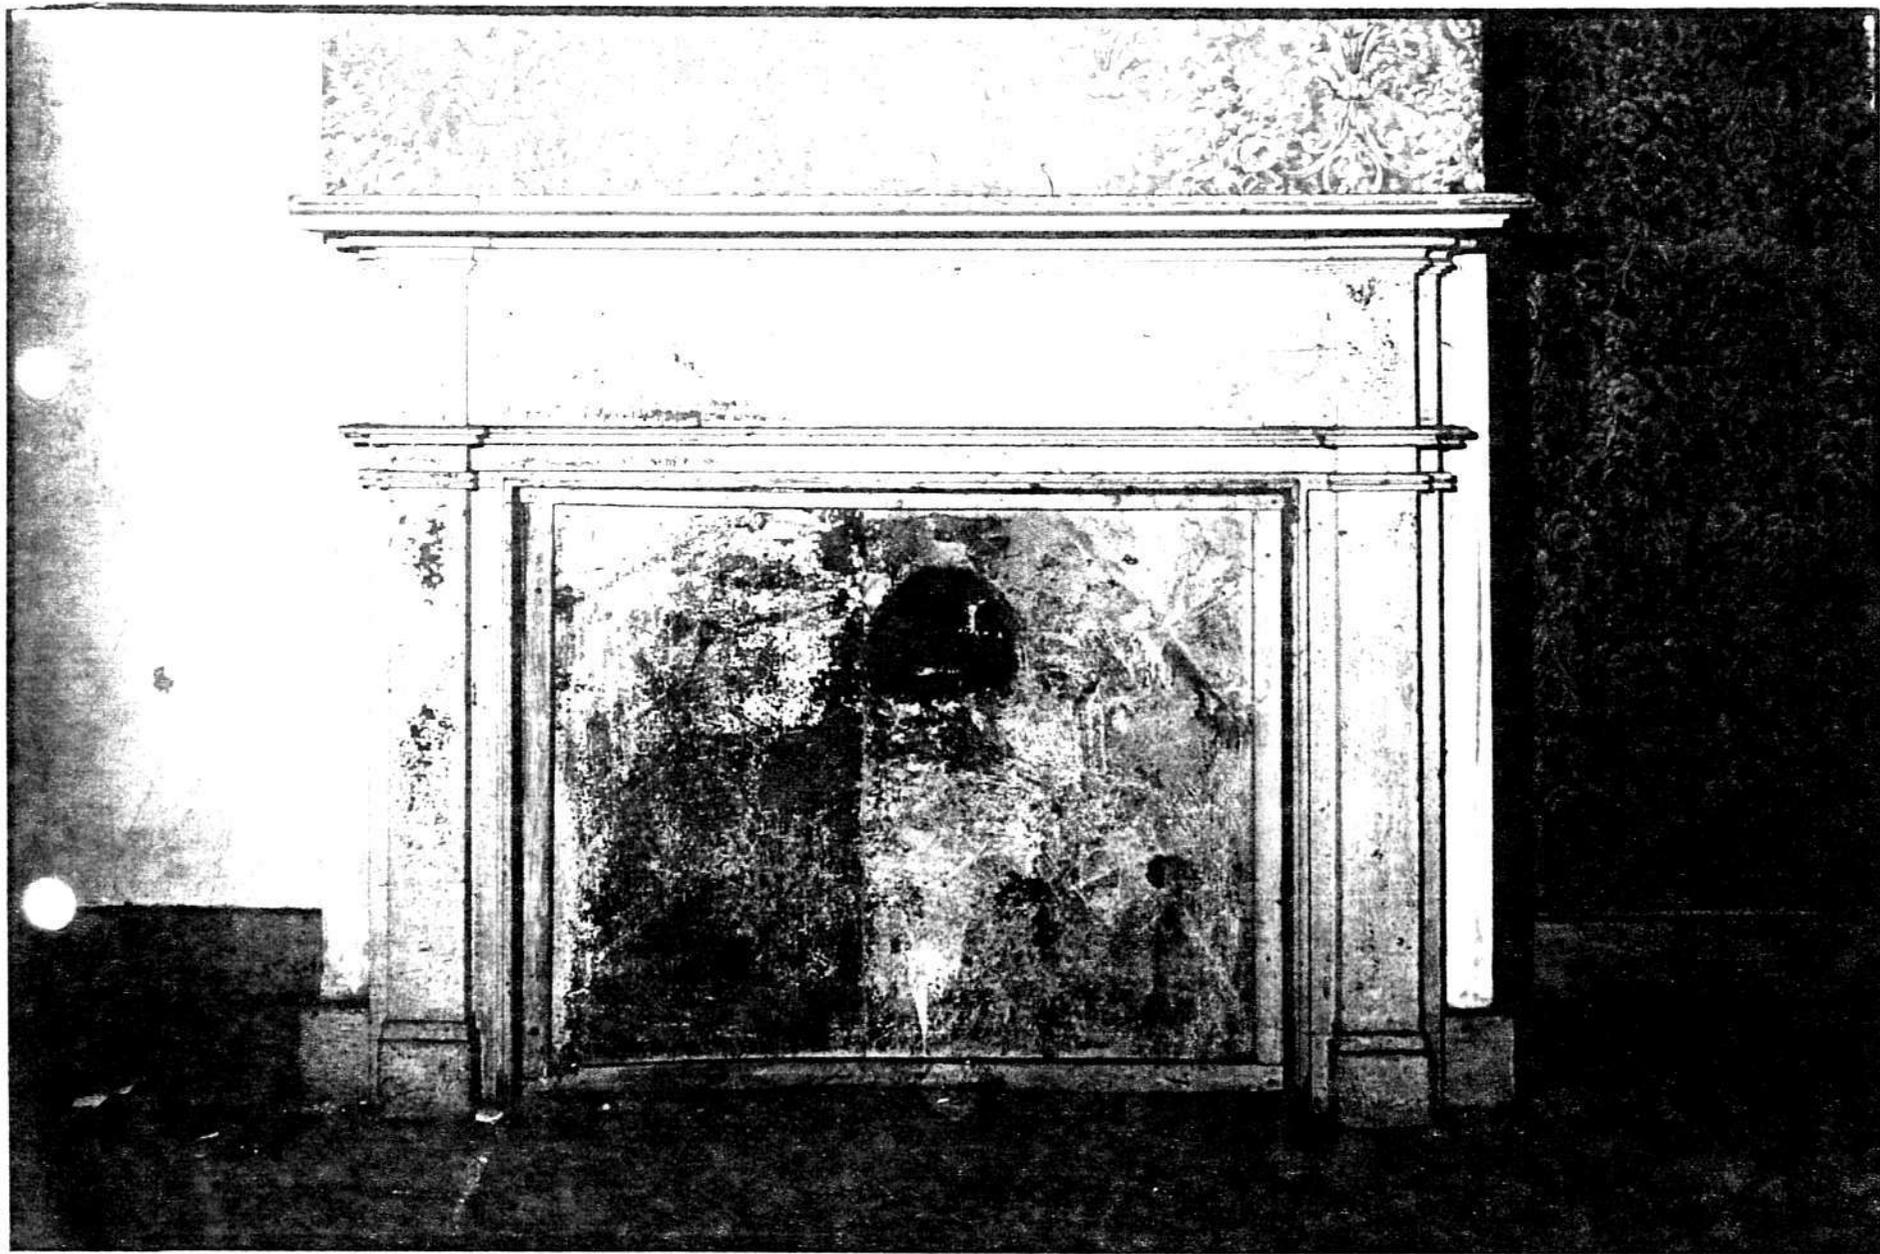
2) Fireplaces: On the upper floors of the buildings there are several existing fireplaces. In the larger units, 617-623, the fireplaces in the main front room (or living room) on the second floor all have existing stone hearths. Although several of the mantels and surrounds are missing, those that remain are typical of the period, i.e., black slate mantel with marbelized slate surround. The slate surround forms an arch over the fireplace masonry opening. On the third and fourth floor of the building there are no full fireplaces, evidence exists of openings into the flue where wood or coal stoves were probably connected. There are several existing fireplaces in buildings 625-631 on the second and third floors. In these buildings, however, the fireplaces are less ornate as they have a single brick hearth (in running bond) and plain wood surround and mantel.

1 RIEMAN BLOCK B-3995
2 617-631 West Lexington Street
Baltimore, Maryland
3 Photographer - Tom Miller
4 Negatives held by Paul McKean
5 December 16, 1983
6 Fireplace, Second floor front room, #627
7 Roll 4 #20 of 68

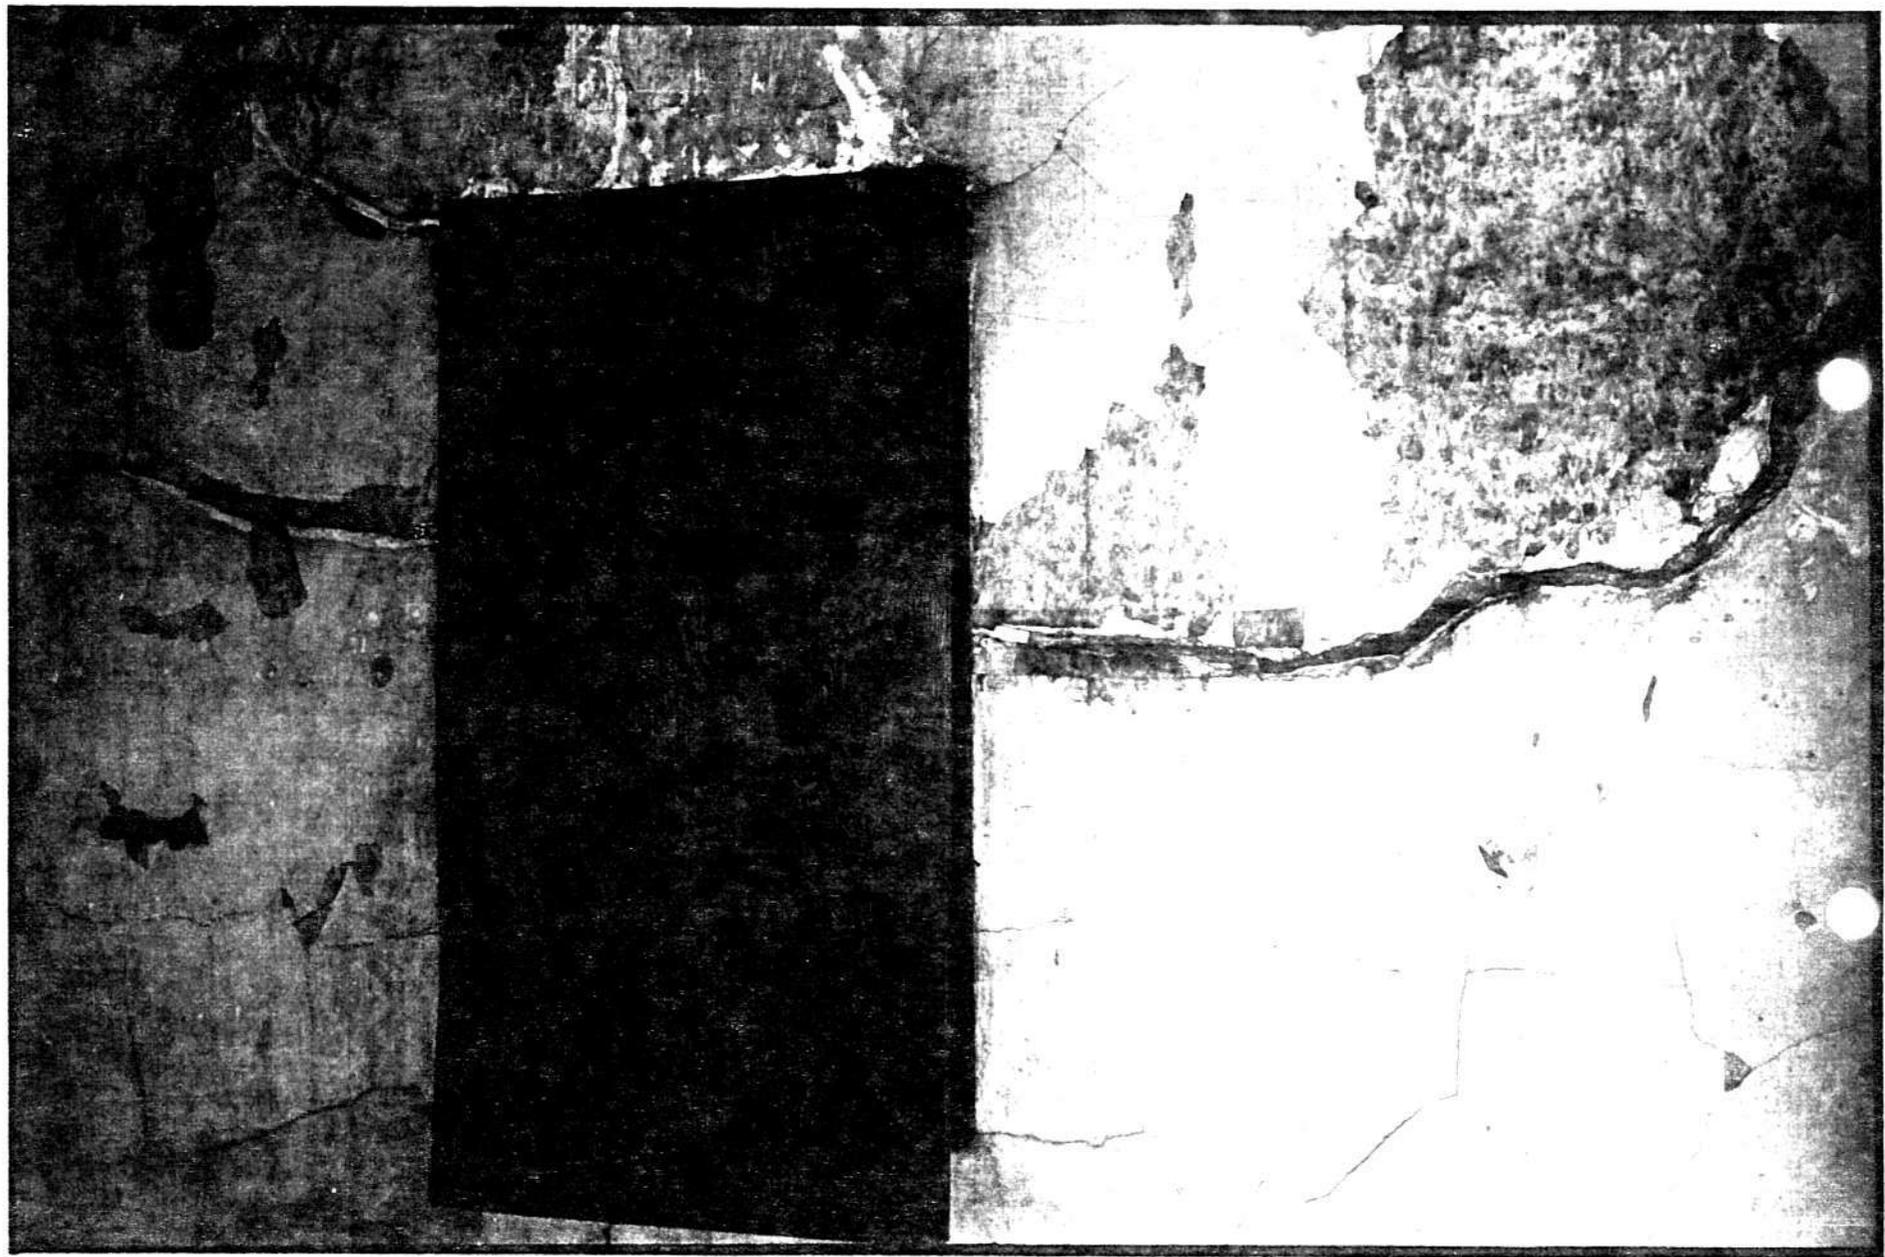
1 RIEMAN BLOCK *B-3995*
2 617-631 West Lexington Street
Baltimore, Maryland
3 Photographer - Tom Miller
4 Negatives held by Paul McKean
5 December 16, 1983
6 Structural crack, rear wall, Fourth floor #627
7 Roll 4 #23 of 68

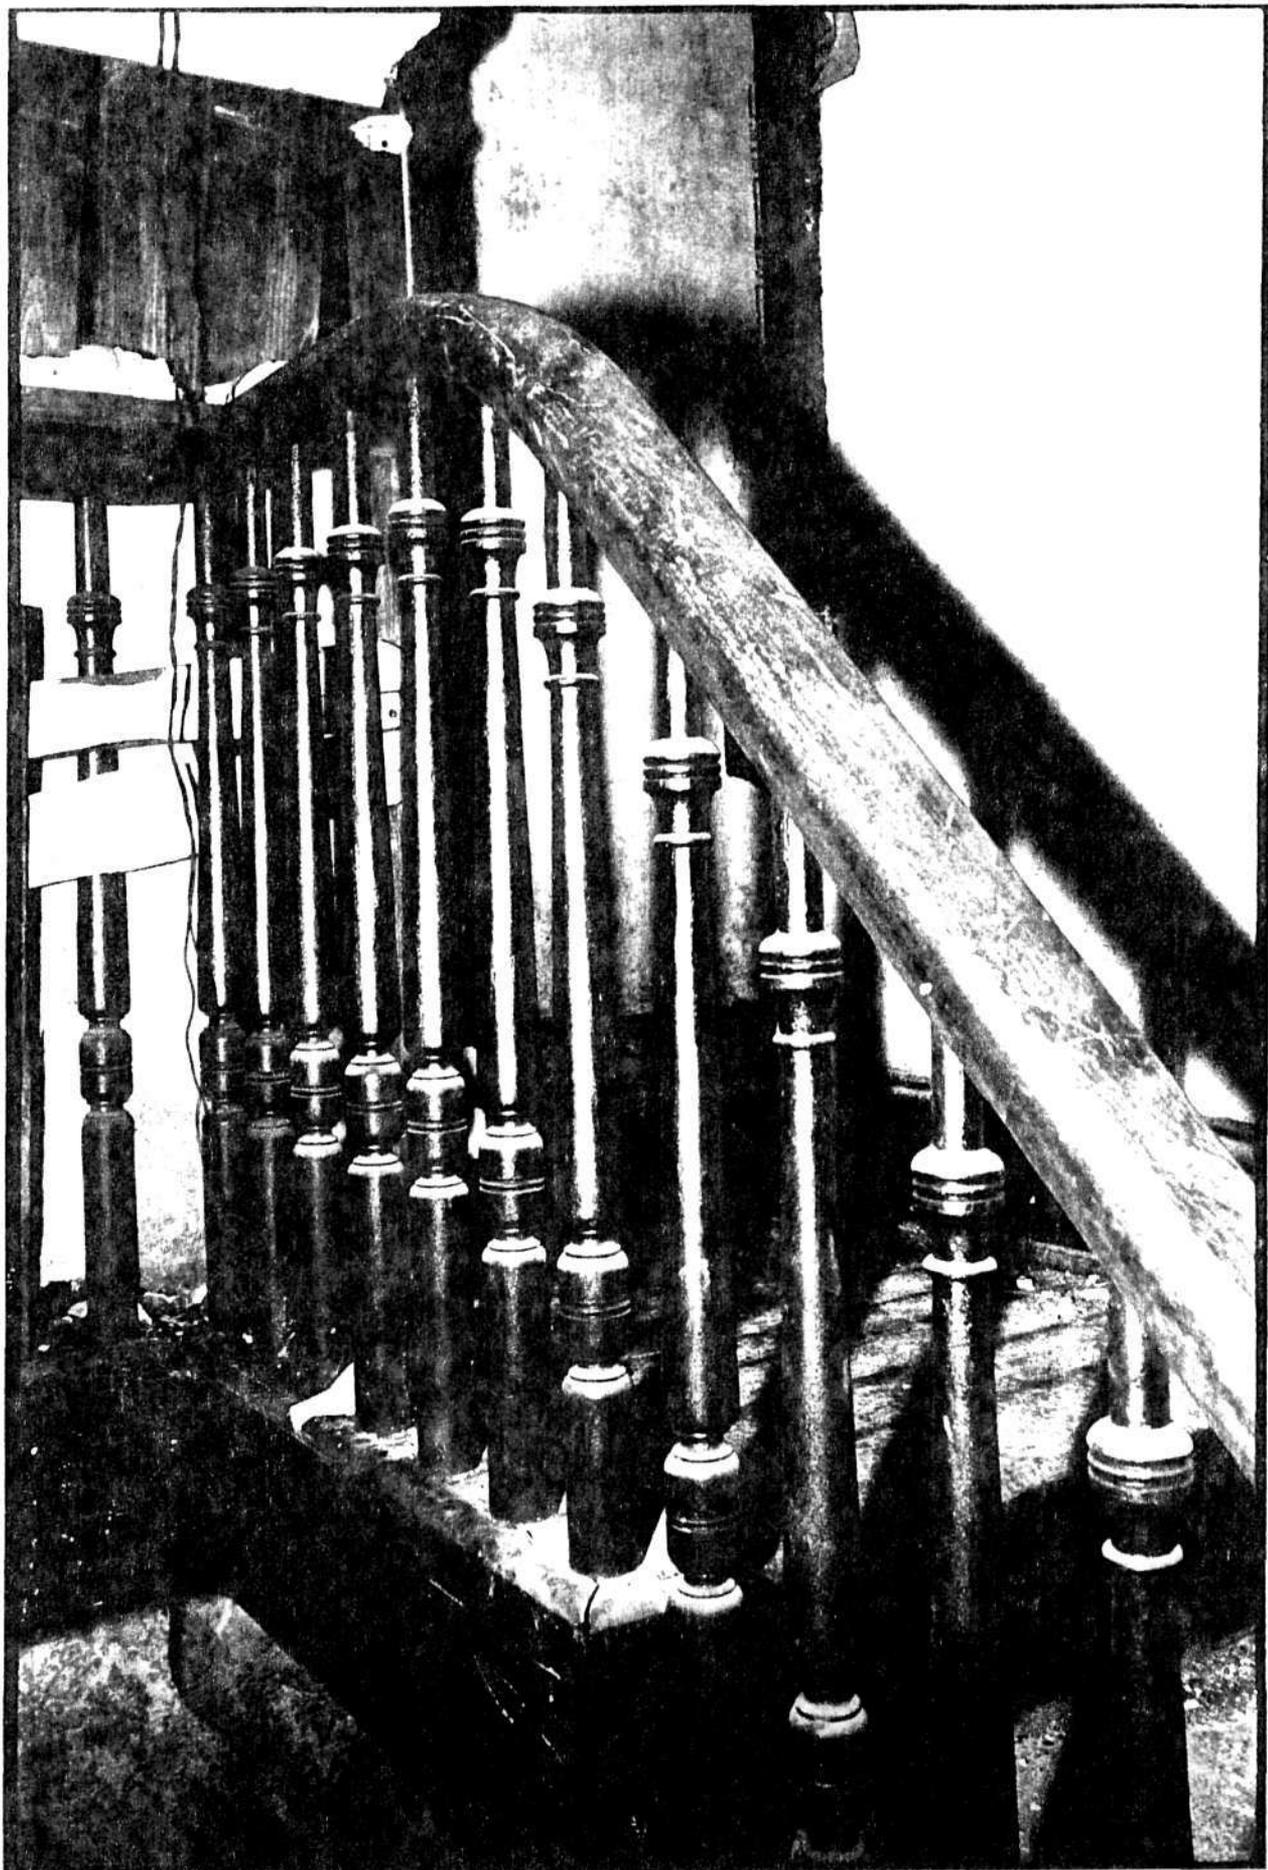
57 of 68

1 RIEMAN BLOCK B-3995
2 617-631 West Lexington Street
Baltimore, Maryland
3 Photographer - Tom Miller
4 Negatives held by Paul McKean
5 December 16, 1983
6 Stair detail, First to Second floor #629
7 Roll 4 #29 of 68

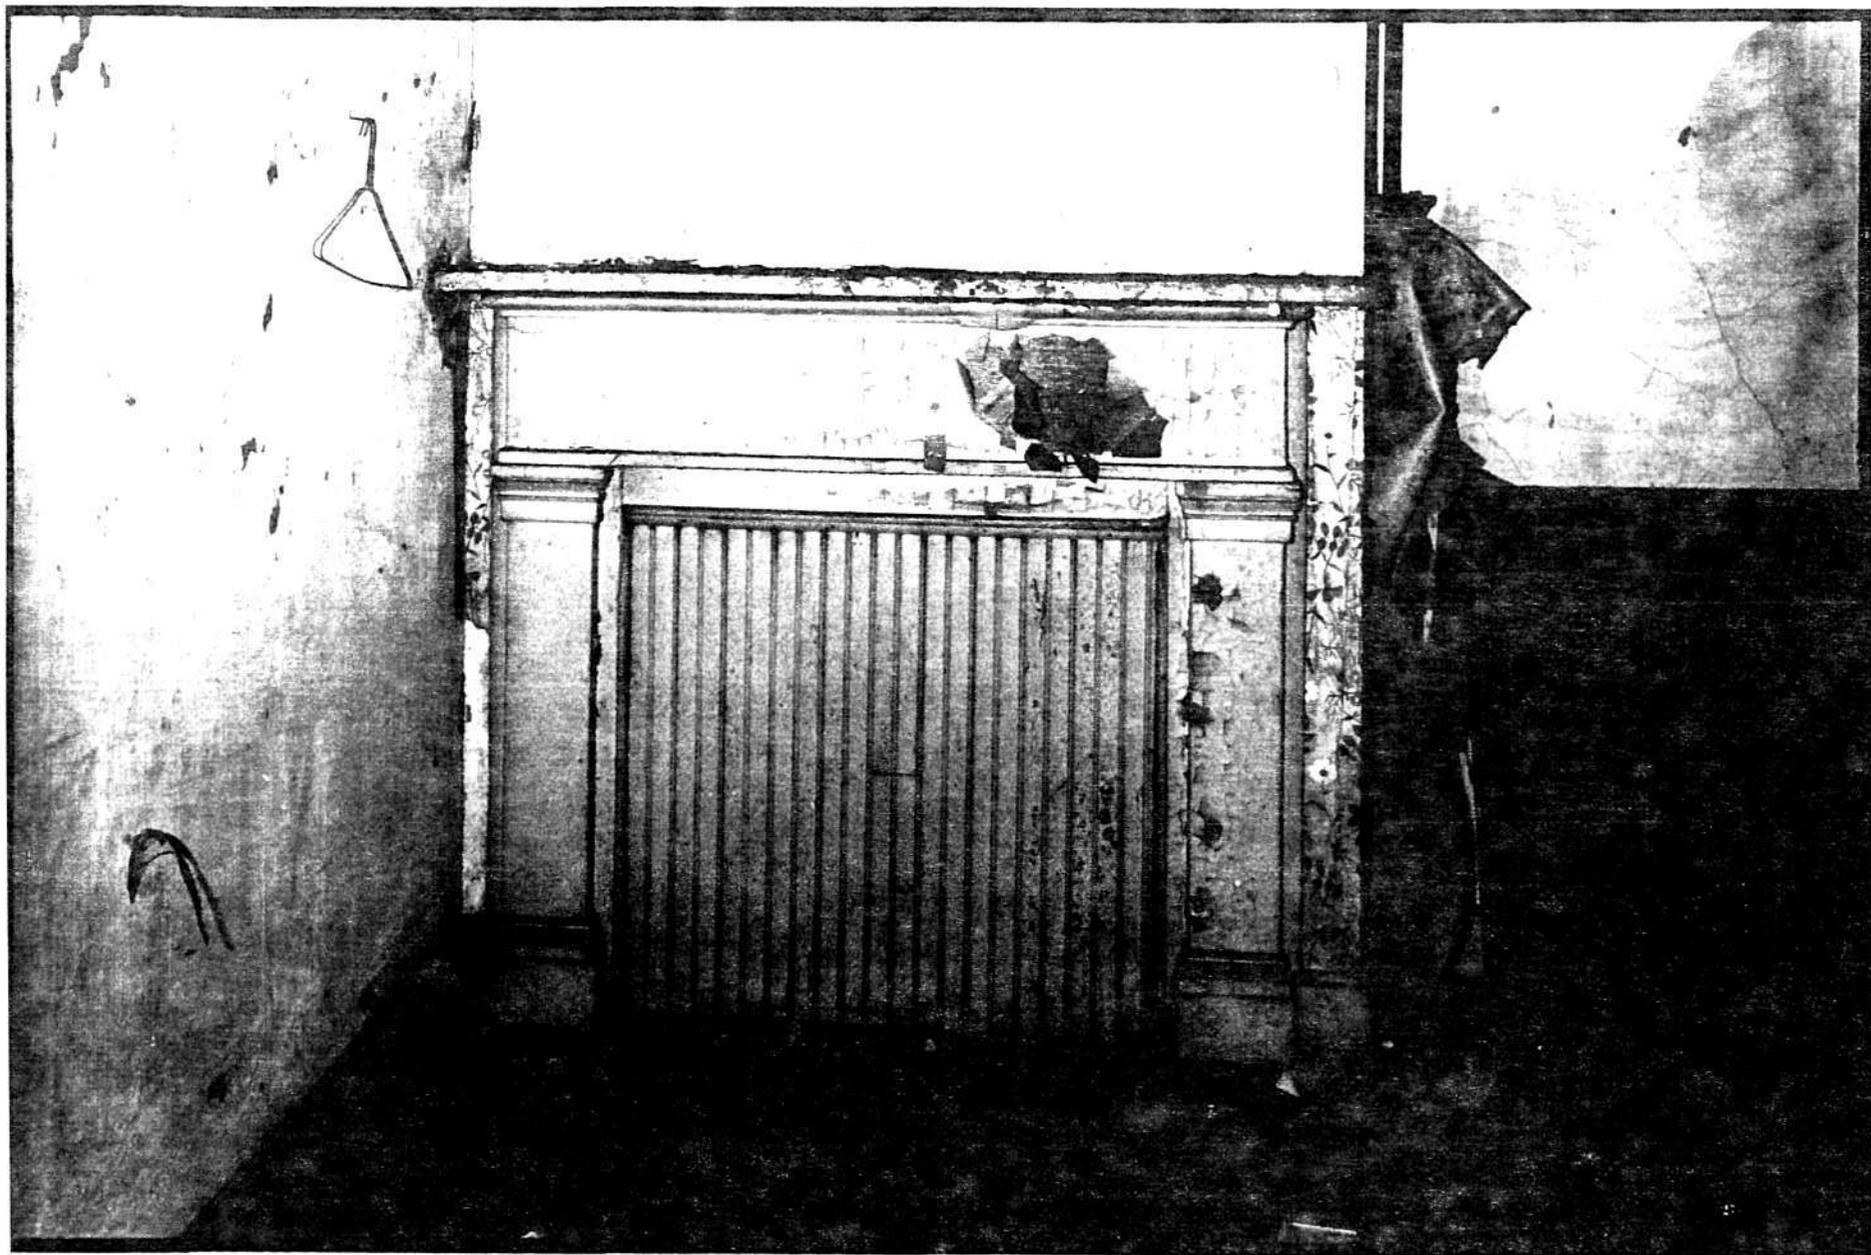
1 RIEMAN BLOCK 8-3995
2 617-631 West Lexington Street
Baltimore, Maryland
3 Photographer - Tom Miller
4 Negatives held by Paul McKean
5 December 16, 1983
6 Fireplace, Second floor Middle room #629
7 Roll 4 #31 of 68
