**National Register of Historic Places
Inventory—Nomination Form**

historic Rieman Block

street & number 617-631 West Lexington Street n/a not for publication

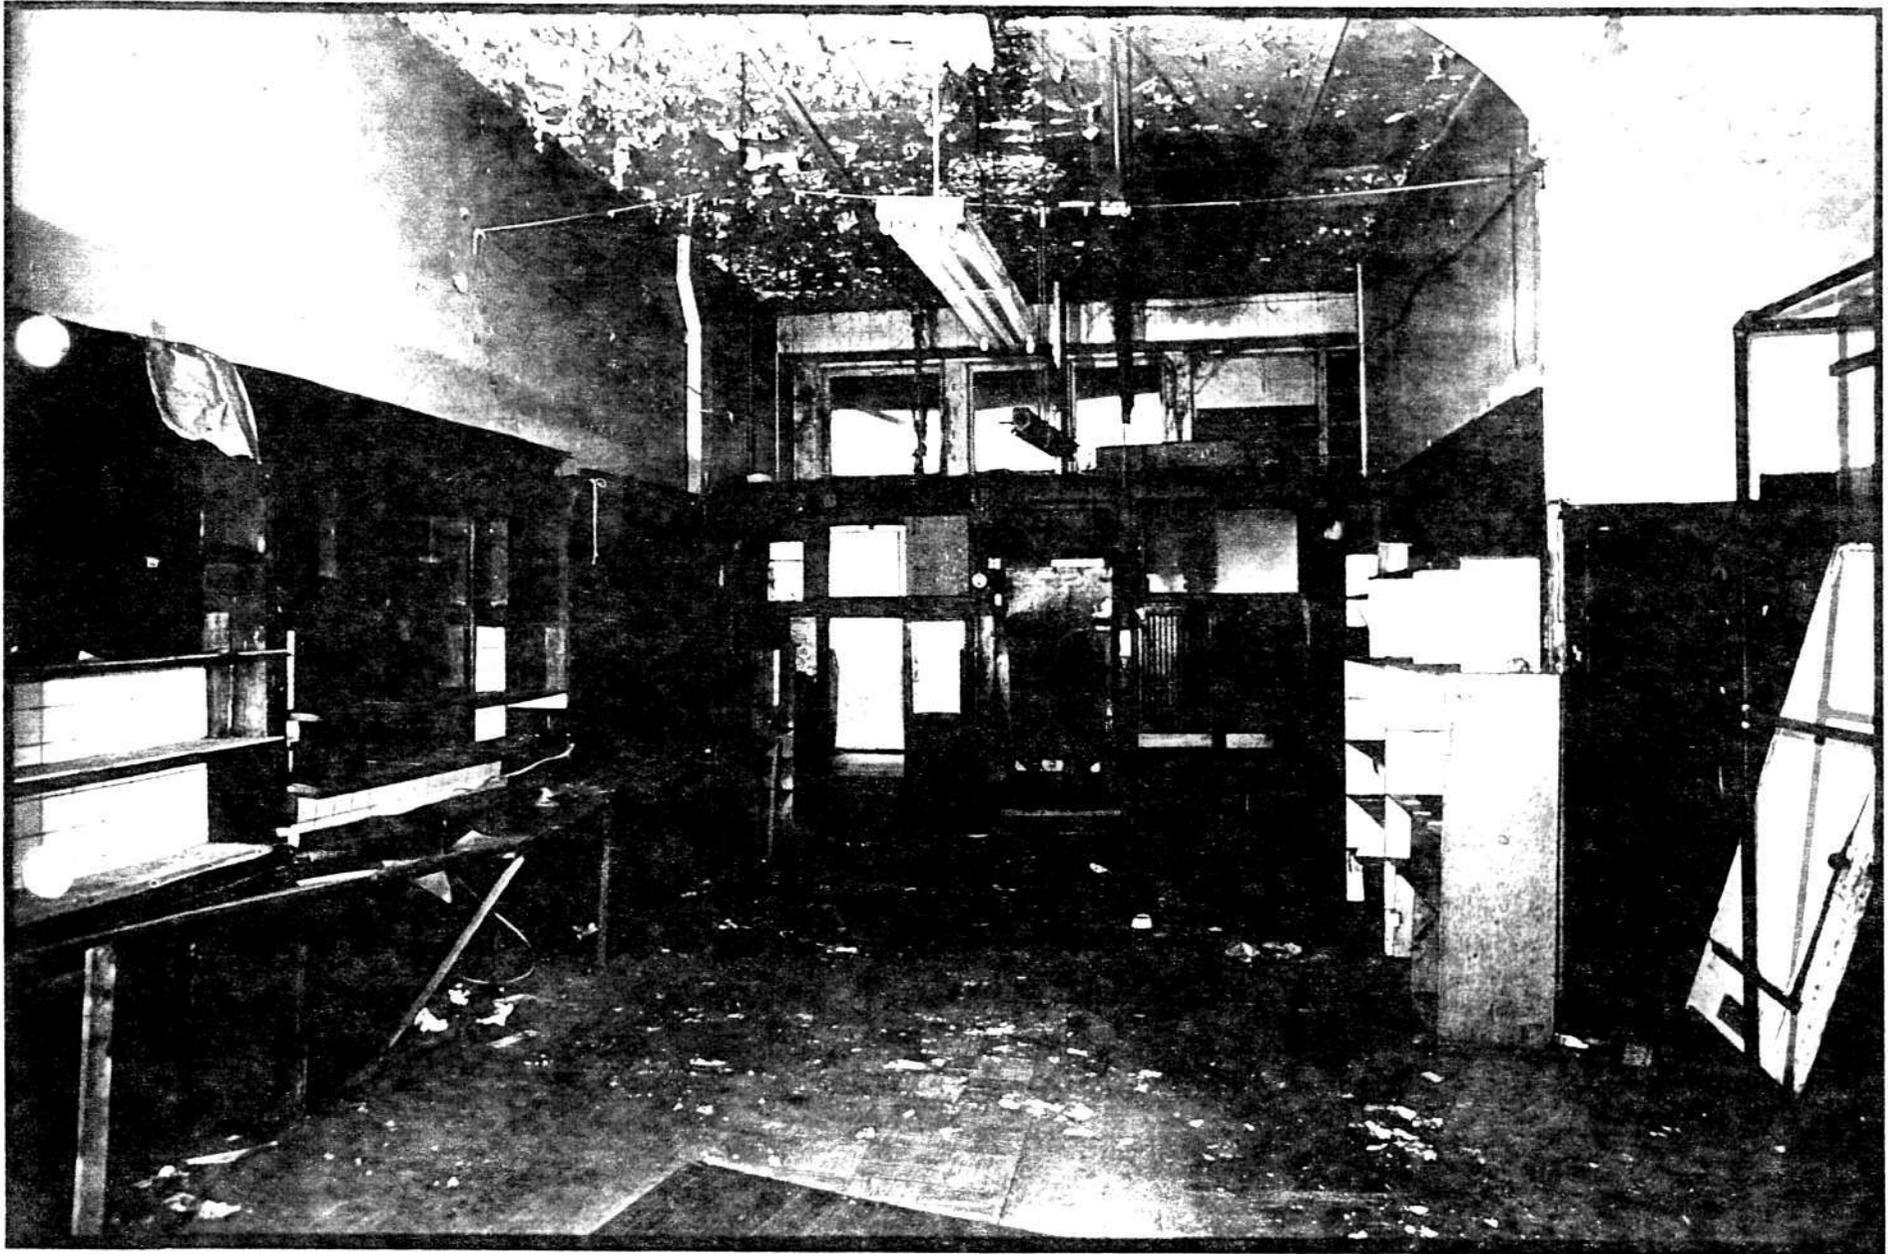
60 of 68

- 1 RIEMAN BLOCK B-3995
- 2 617-631 West Lexington Street
Baltimore, Maryland
- 3 Photographer - Tom Miller
- 4 Negatives held by Paul McKean
- 5 January 14, 1984
- 6 General view looking North - First
floor of #619
- 7 Roll 6 #9

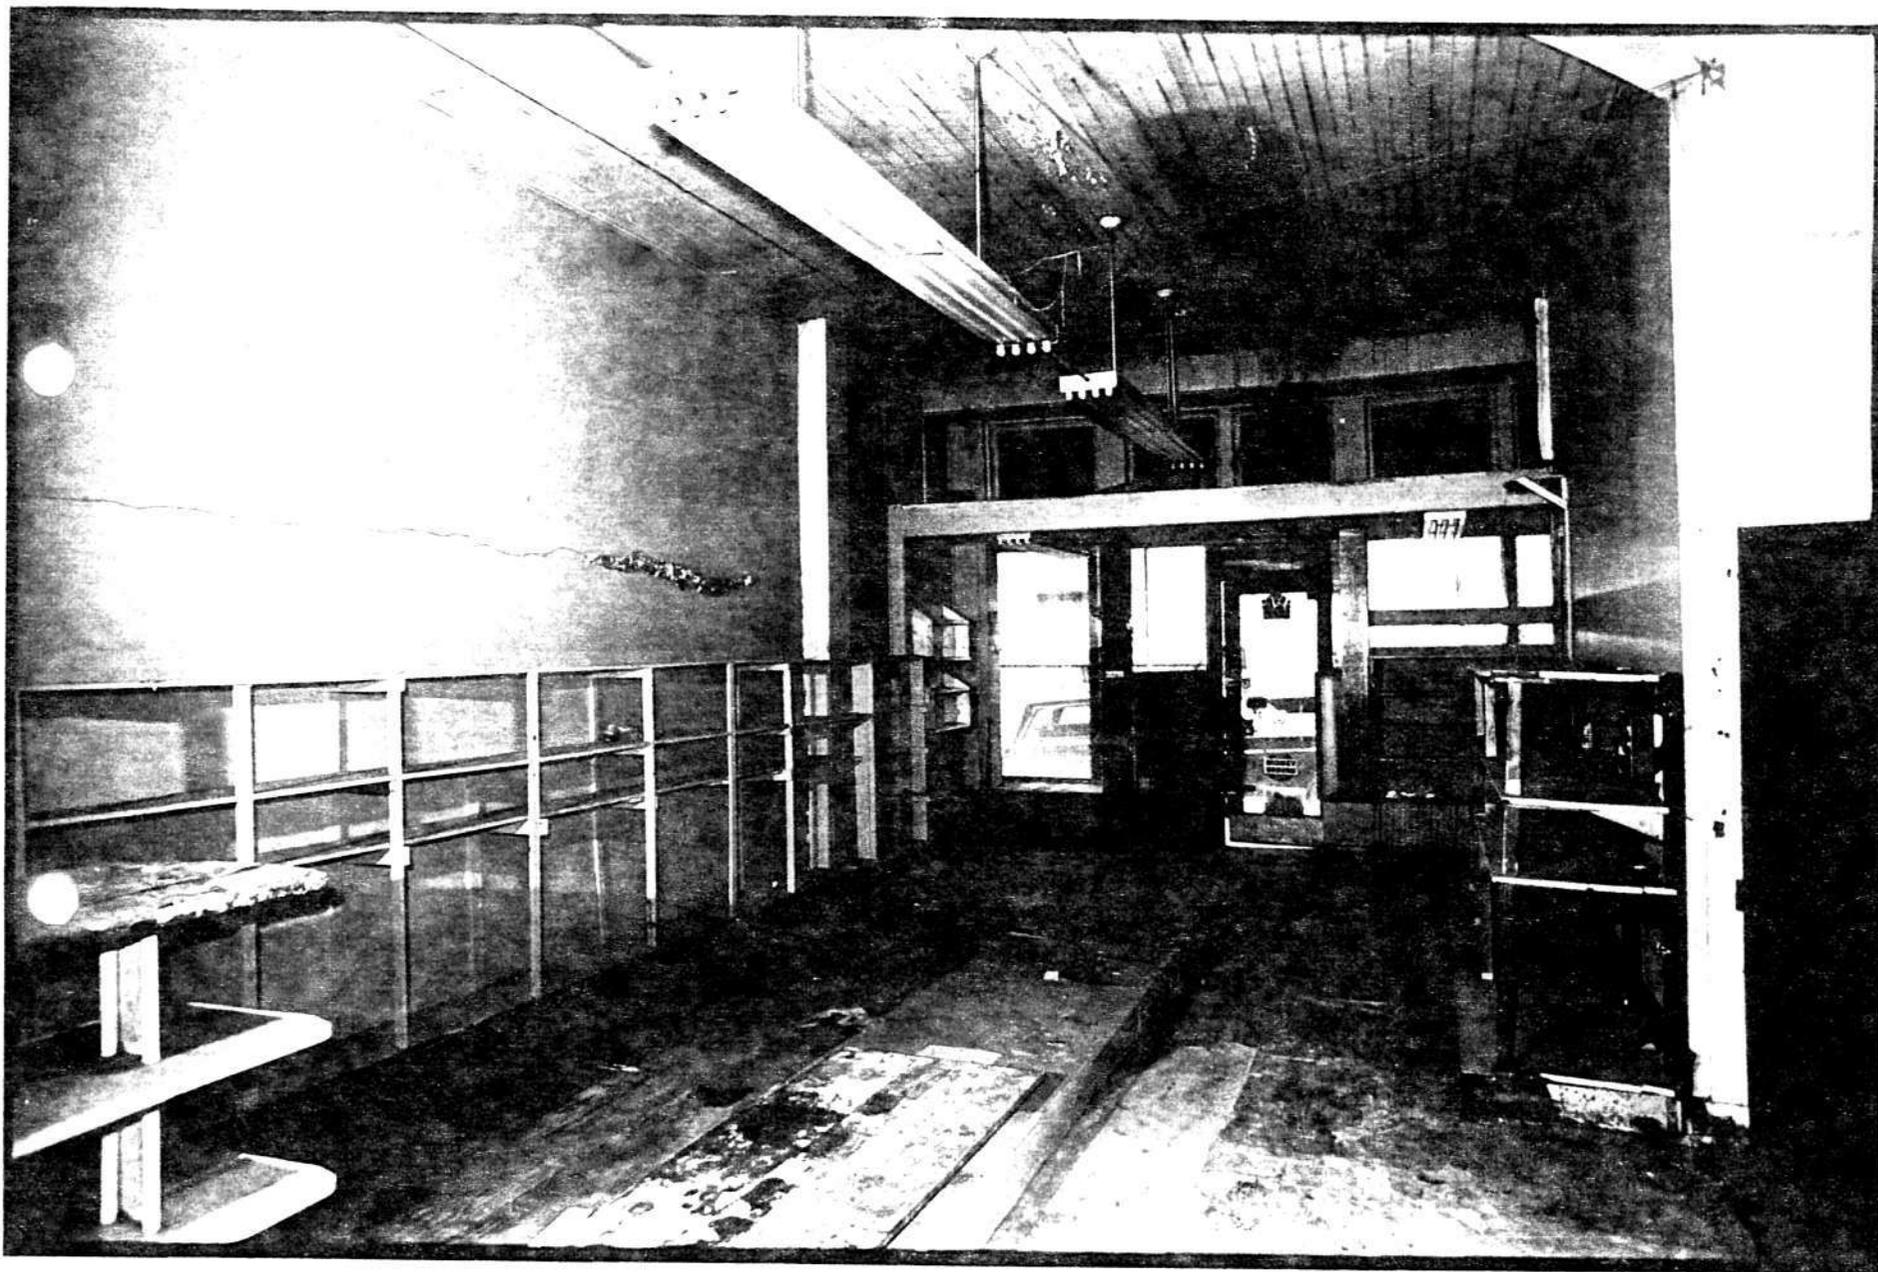
61 of 68

1 RIEMAN BLOCK B-3995
2 617-631 West Lexington Street
Baltimore, Maryland
3 Photographer - Tom Miller
4 Negatives held by Paul F. McKean
5 January 14, 1984
6 North view of first floor of #621
7 Roll 6 #16

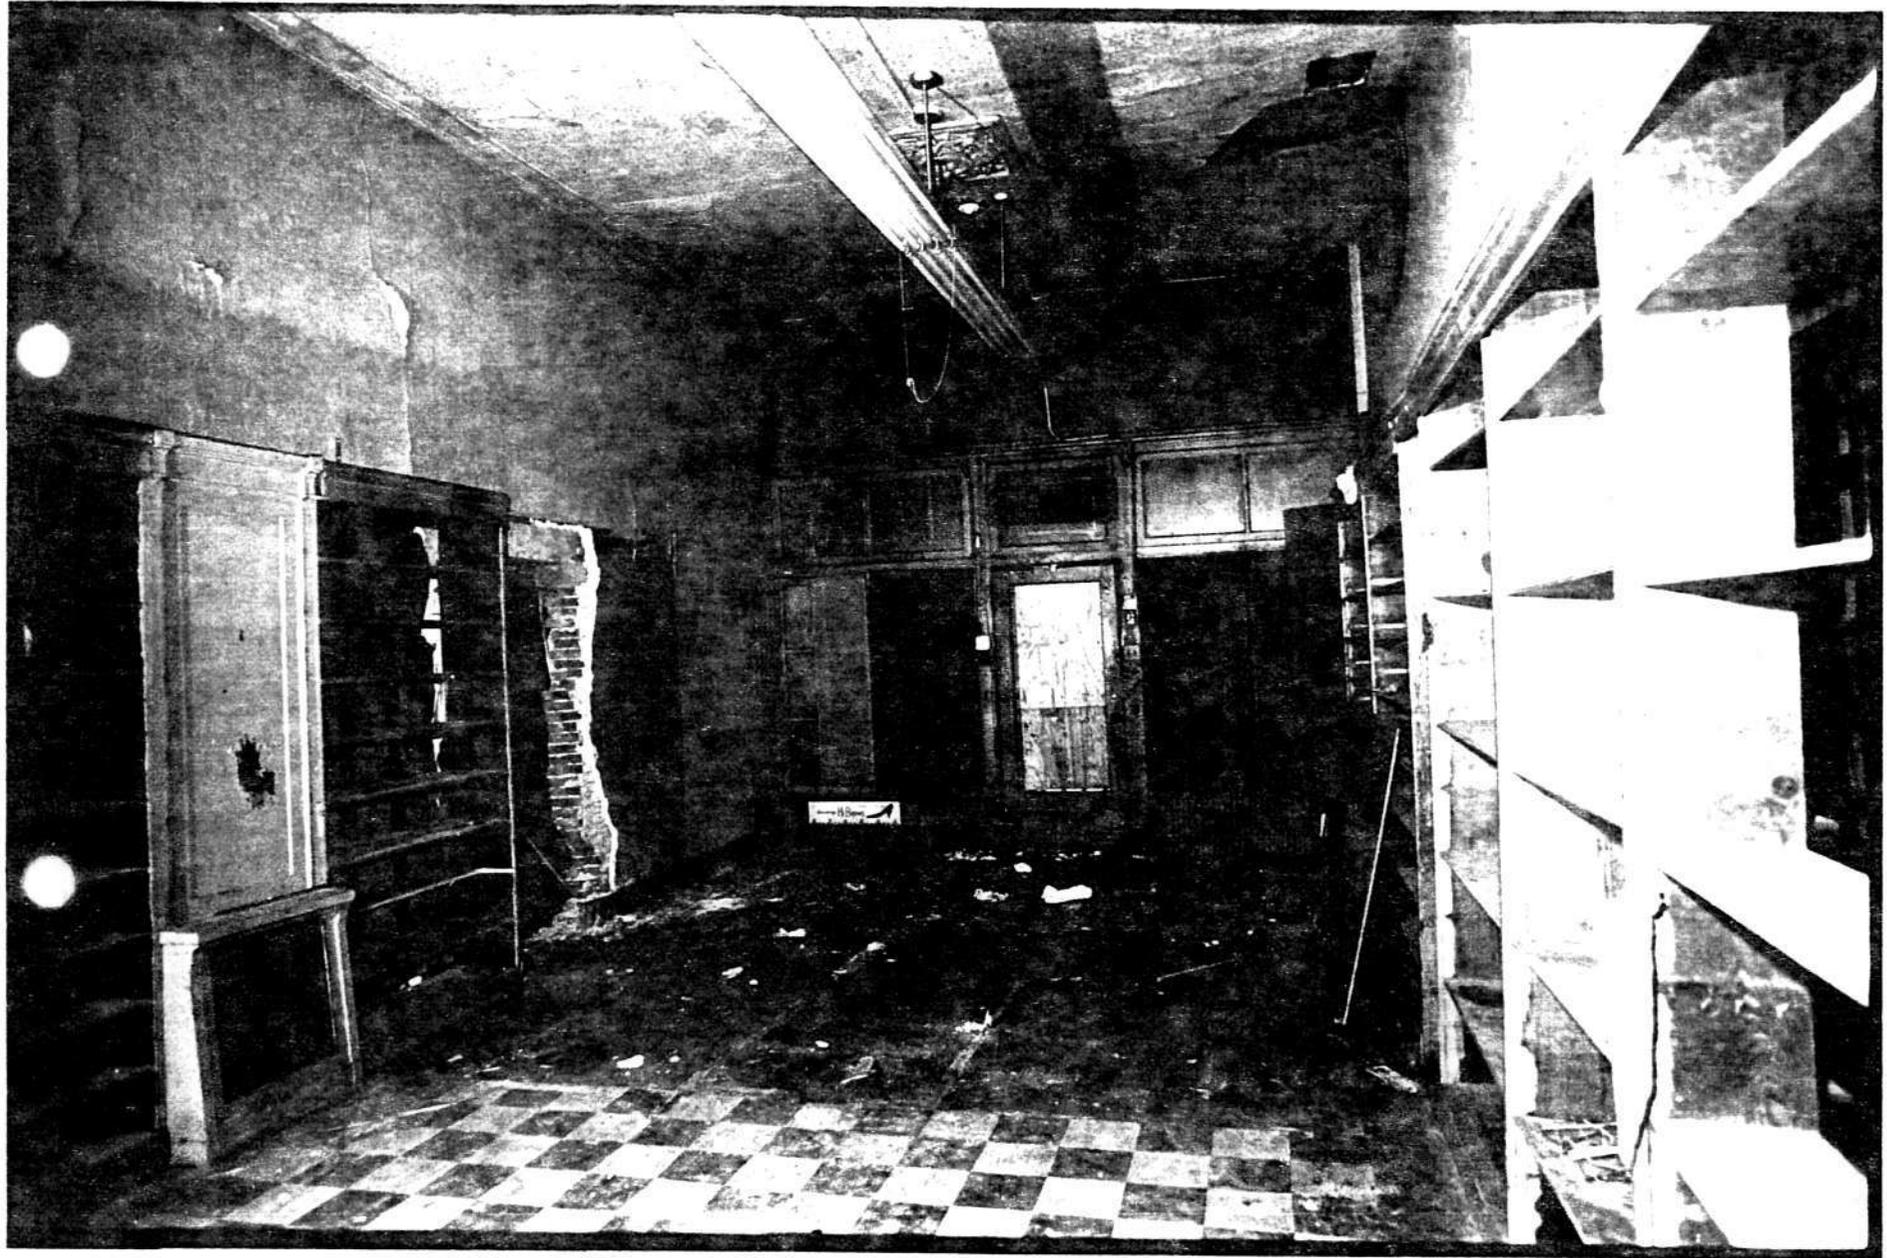
62 of 68

- 1 RIEMAN BLOCK B-3995
- 2 617-631 West Lexington Street
Baltimore, Maryland
- 3 Photographer - Tom Miller
- 4 Negatives held by Paul McKean
- 5 January 14, 1984
- 6 General view looking North - First
floor #623
- 7 Roll 6 #23

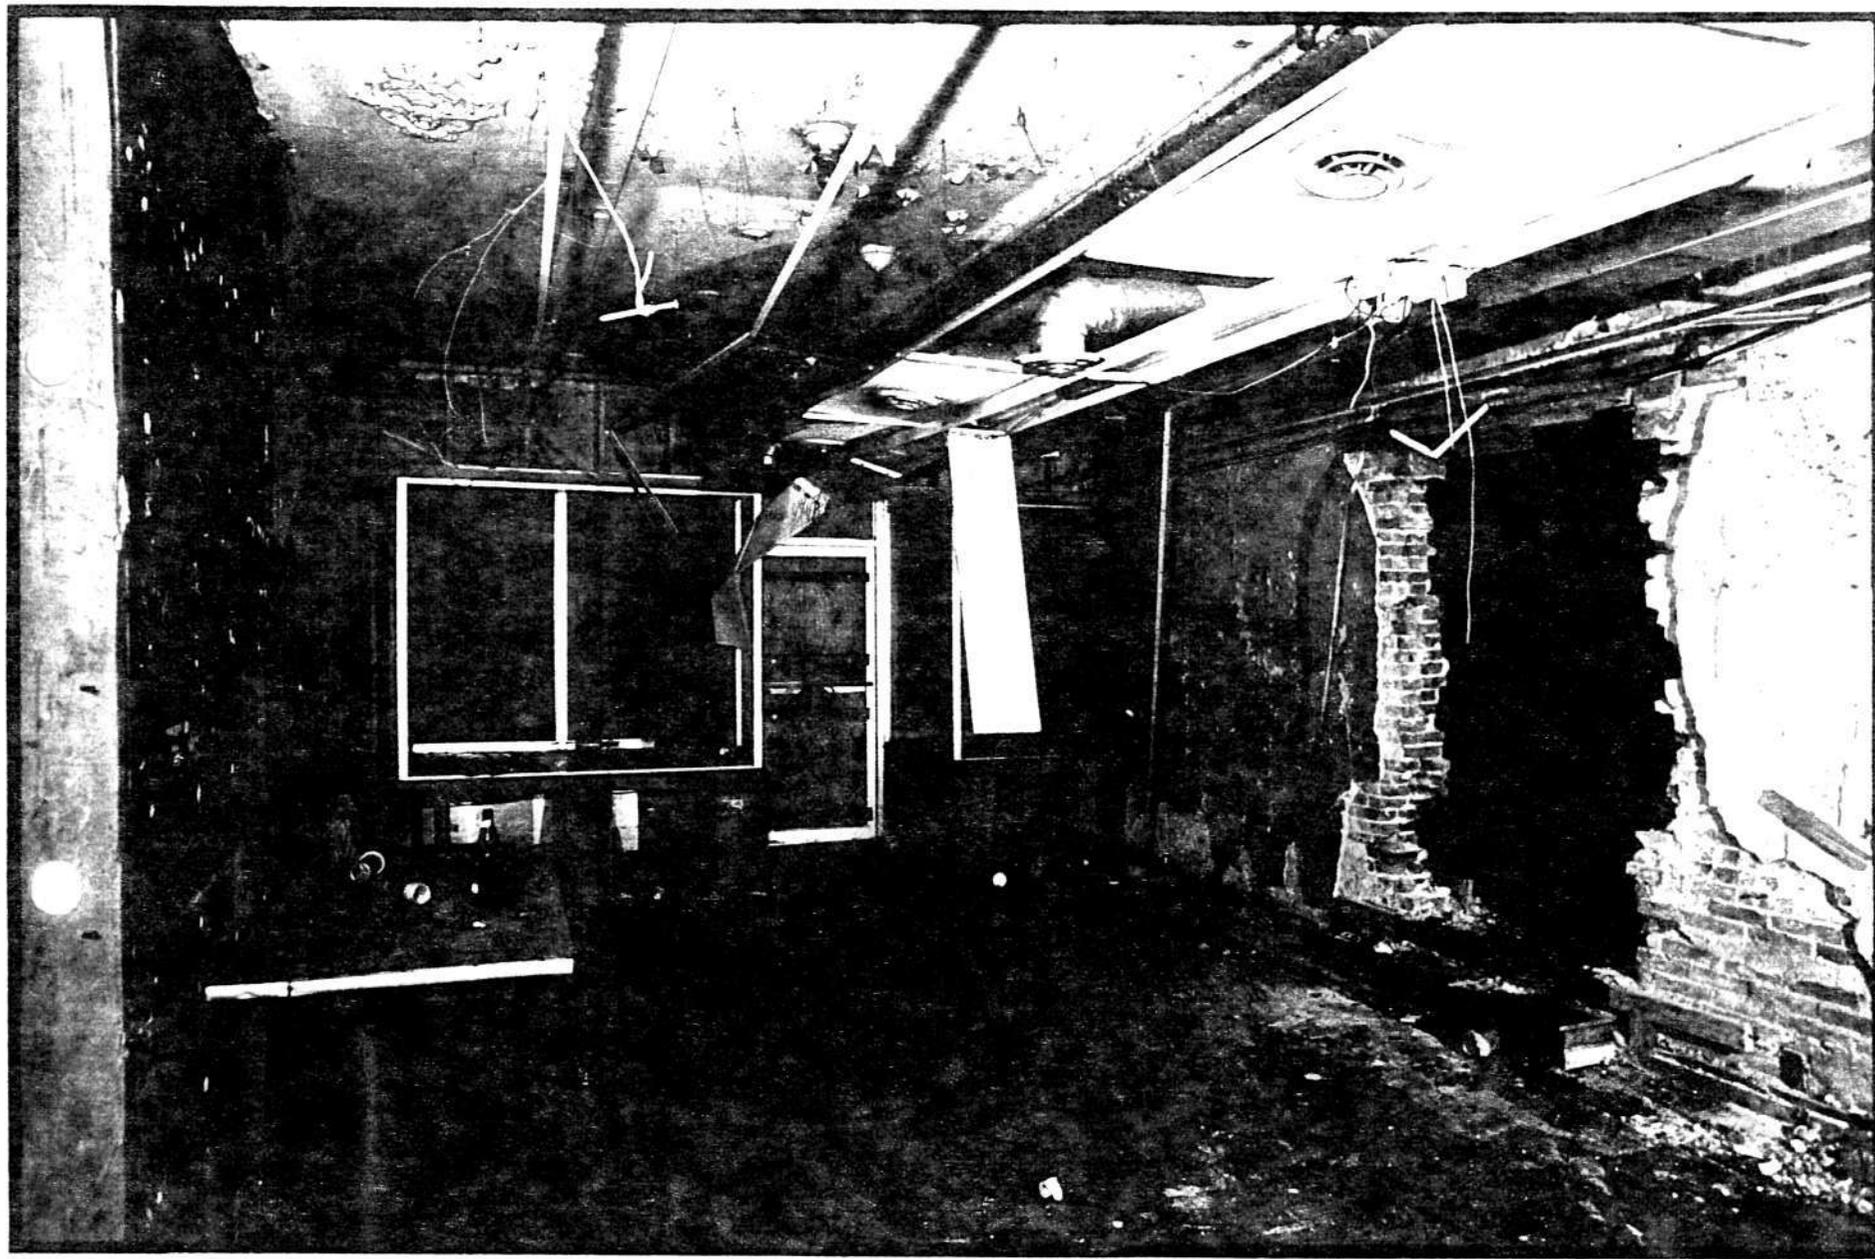
63 of 68

- 1 RIEMAN BLOCK B-3995
- 2 617-631 West Lexington Street
Baltimore, Maryland
- 3 Photographer - Tom Miller
- 4 Negatives held by Paul McKean
- 5 January 14, 1984
- 6 General view looking North - First
floor #625
- 7 Roll 6 #21

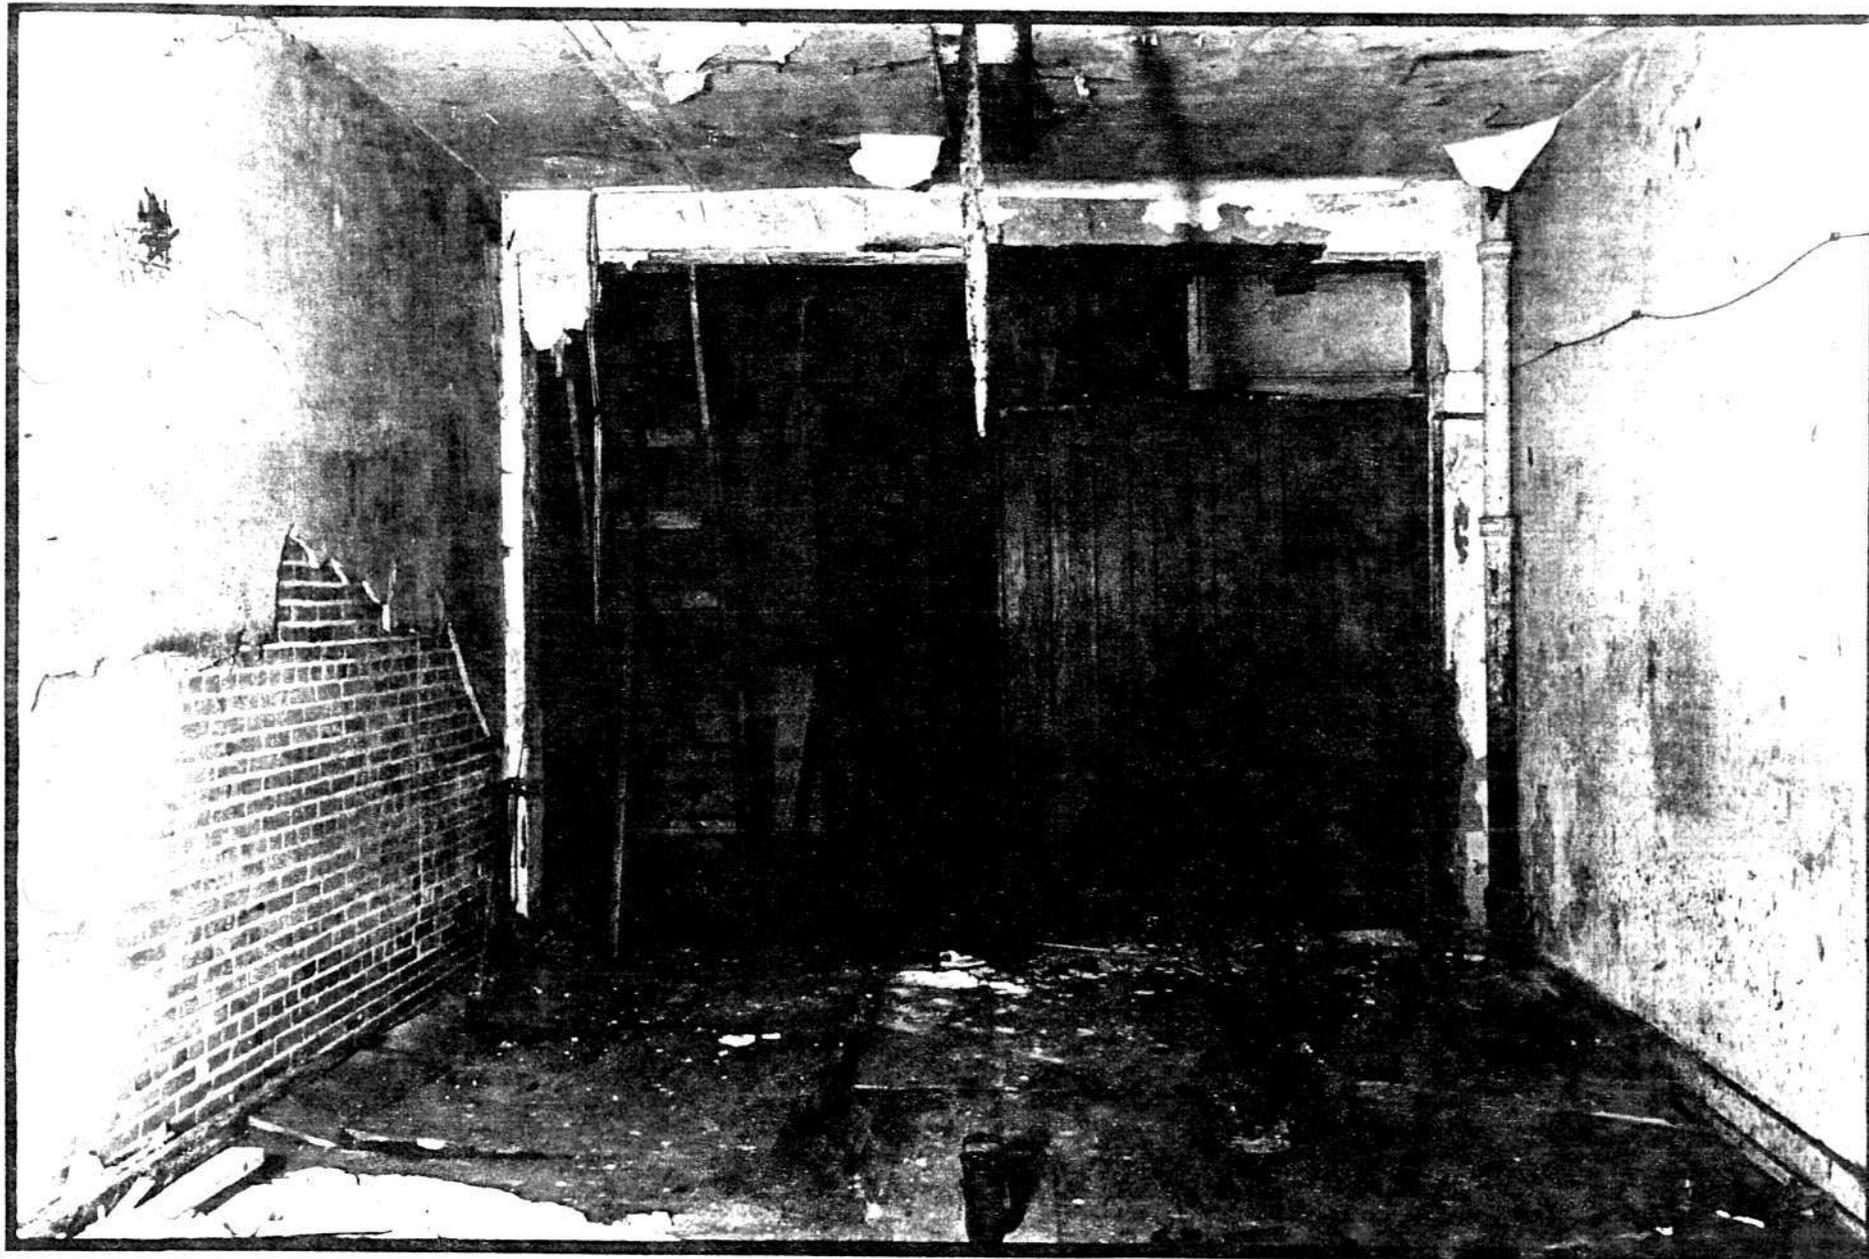
64 of 68

1 RIEMAN BLOCK B-3995
2 617-631 West Lexington Street
Baltimore, Maryland
3 Photographer - Tom Miller
4 Negatives held by Paul McKean
5 December 16, 1983
6 North view, First floor, #627
7 Roll 4 #15 of 68

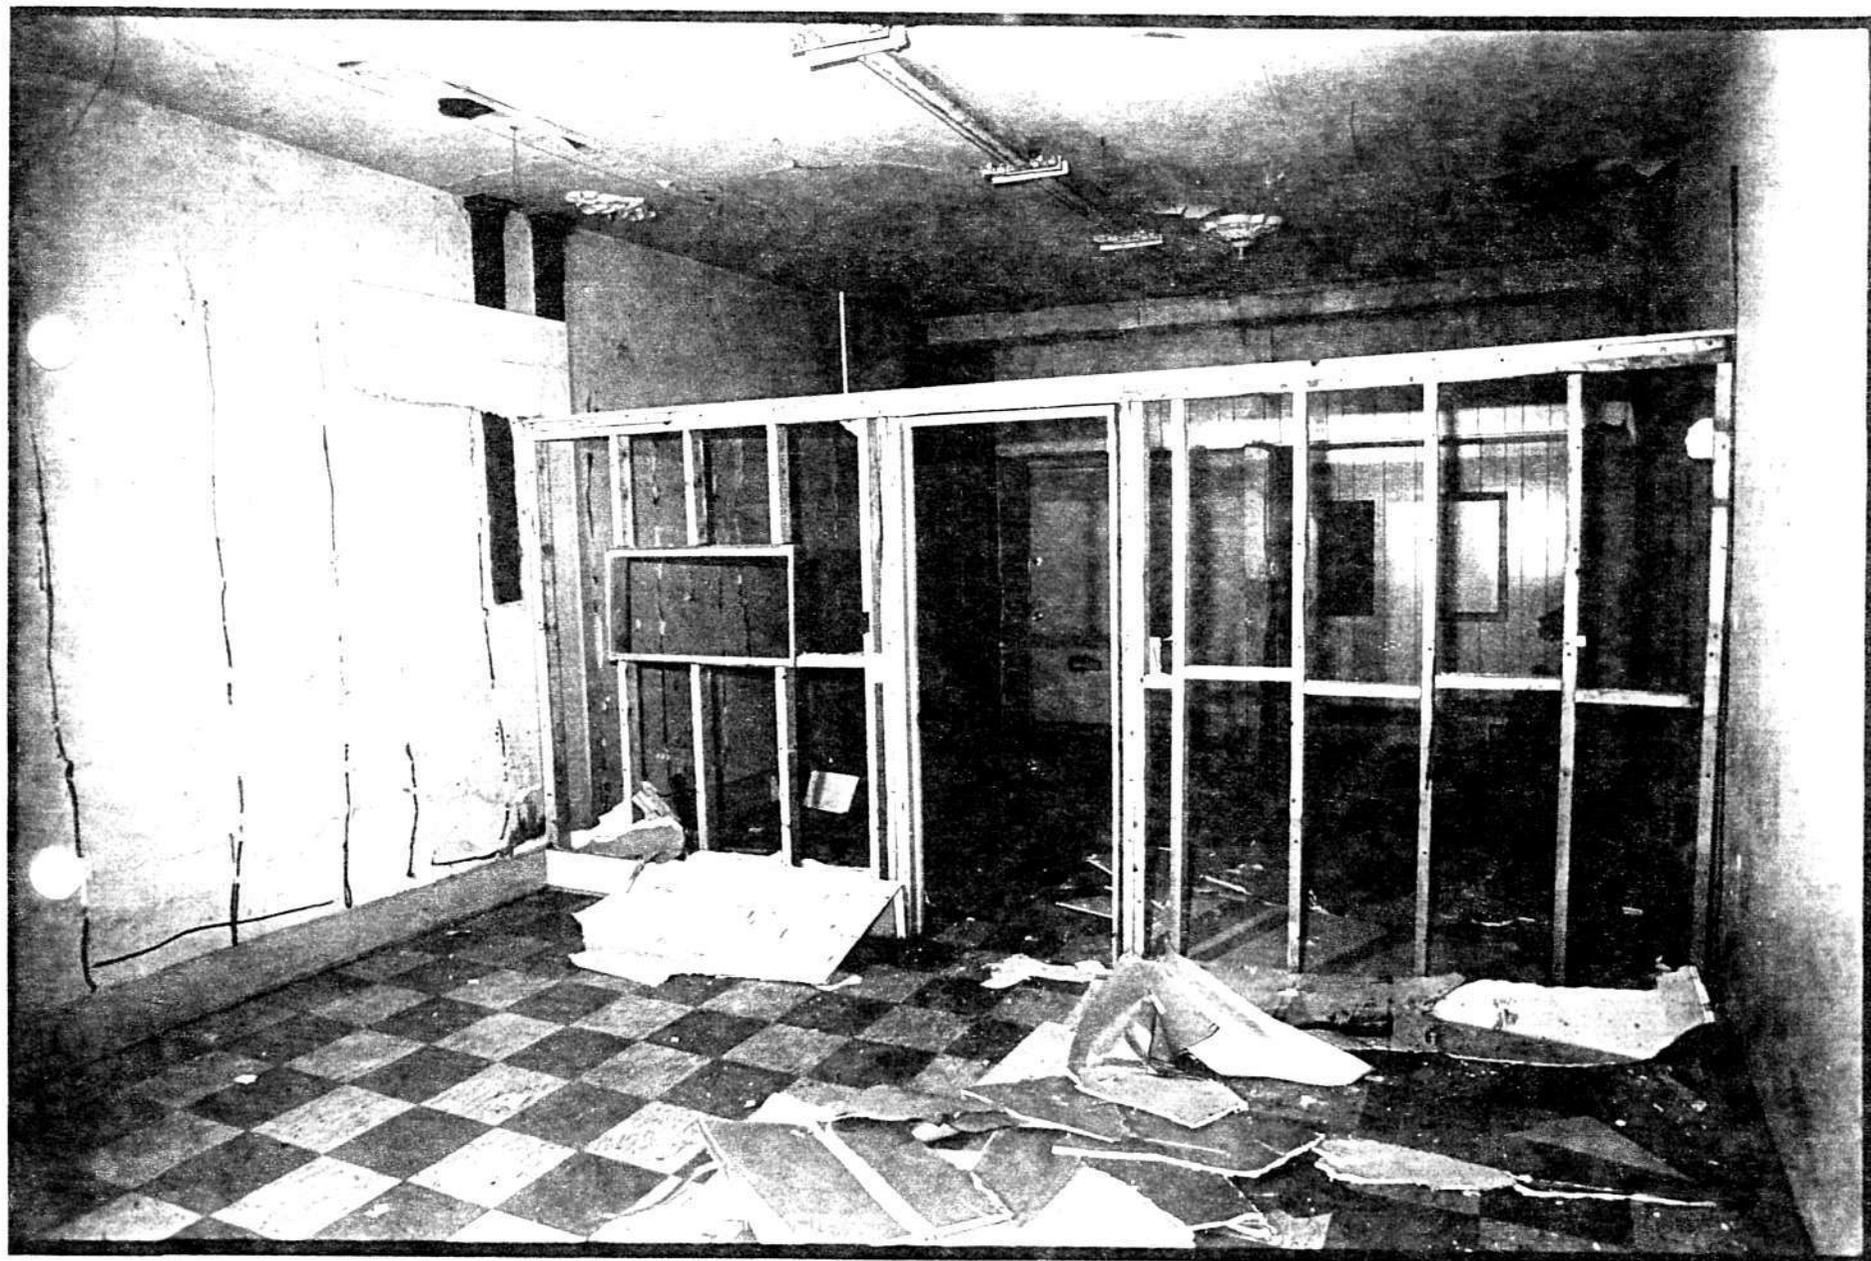
65 of 68

1 RIEMAN BLOCK B-3995
2 617-631 West Lexington Street
Baltimore, Maryland
3 Photographer - Tom Miller
4 Negatives held by Paul McKean
5 January 14, 1984
6 North view of first floor of #629
7 Roll 6 #29

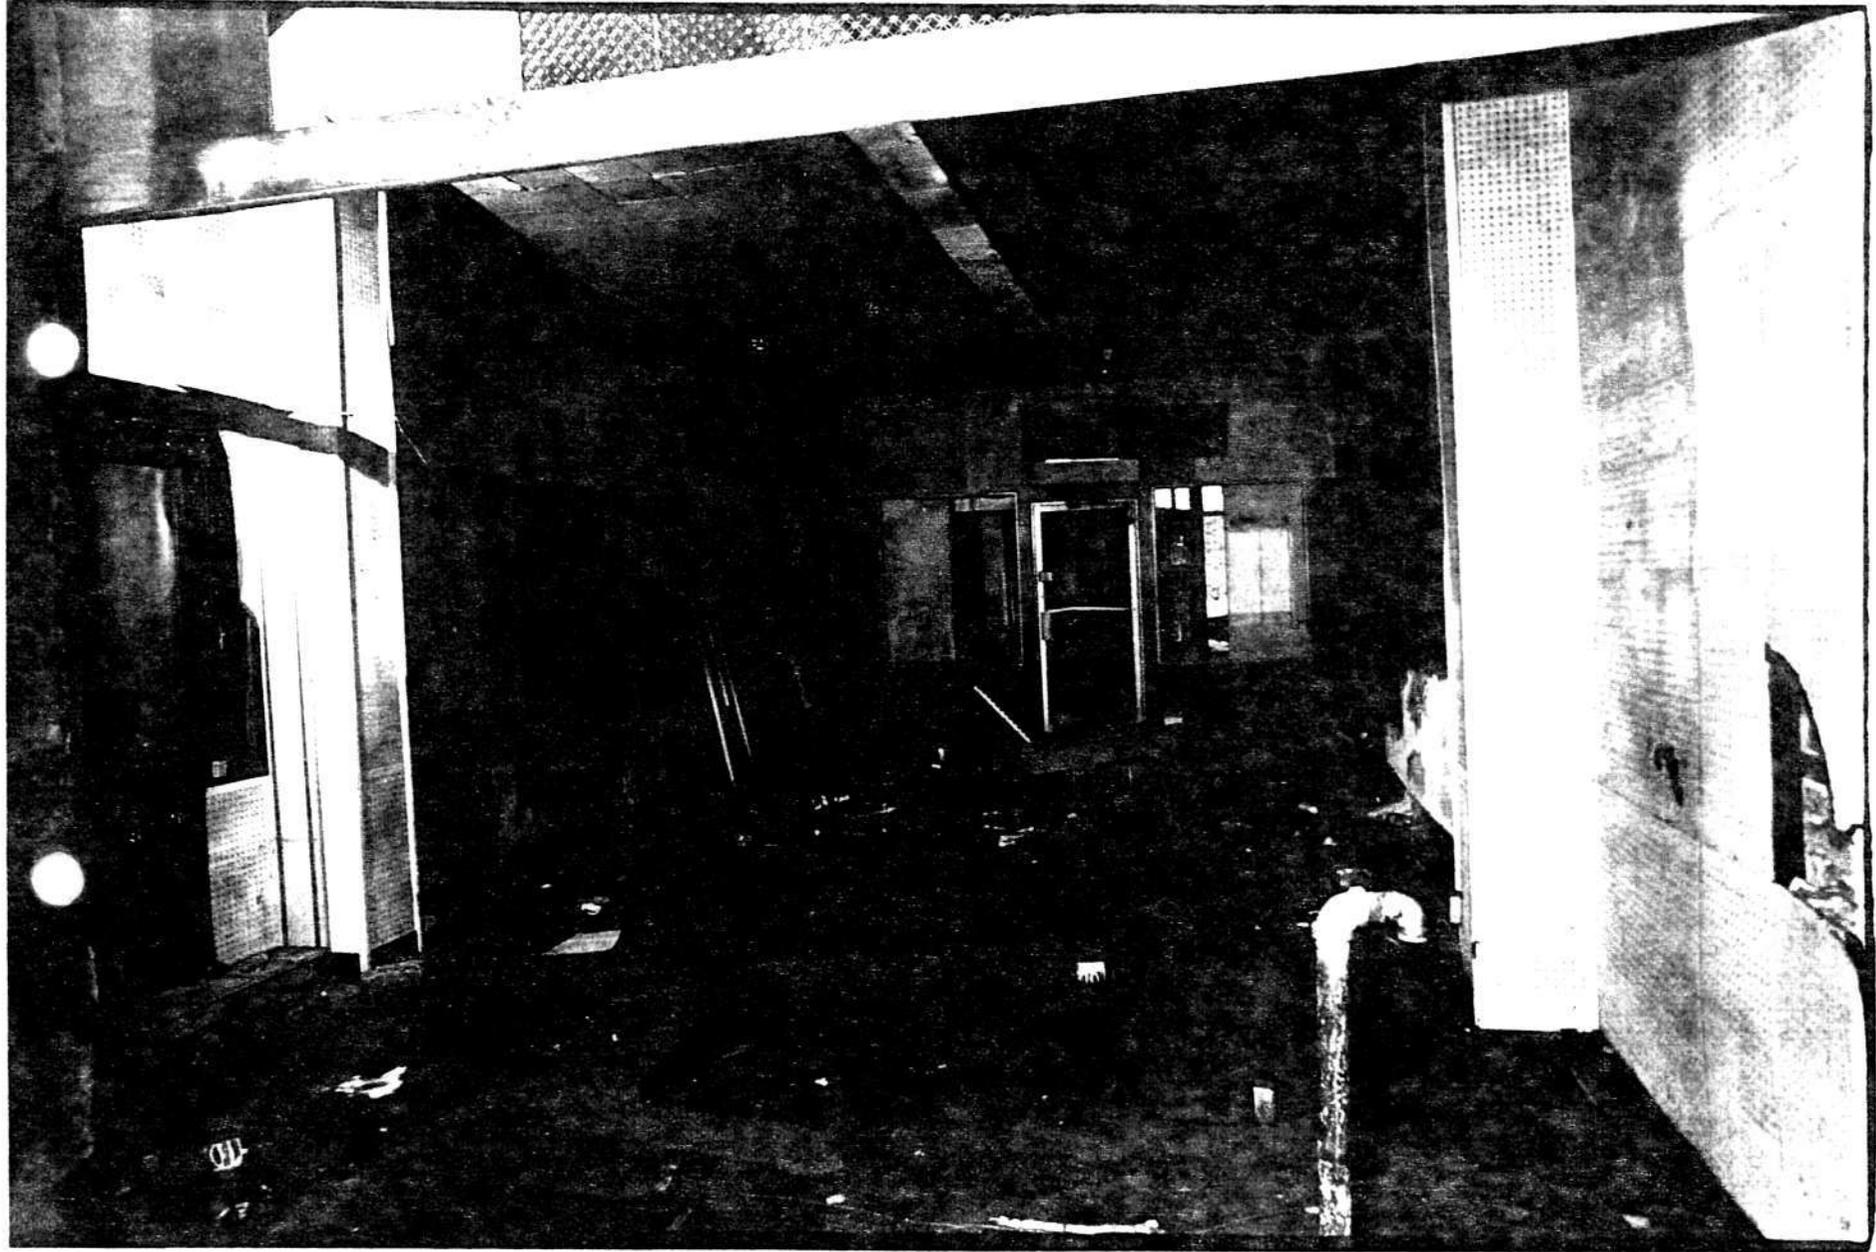
66 of 68

-
- 1 RIEMAN BLOCK B-3995
 - 2 617-631 West Lexington Street
Baltimore, Maryland
 - 3 Photographer - Tom Miller
 - 4 Negatives held by Paul F. McKean
 - 5 January 14, 1984
 - 6 North view of first floor of # 631
 - 7 Roll 6 #31

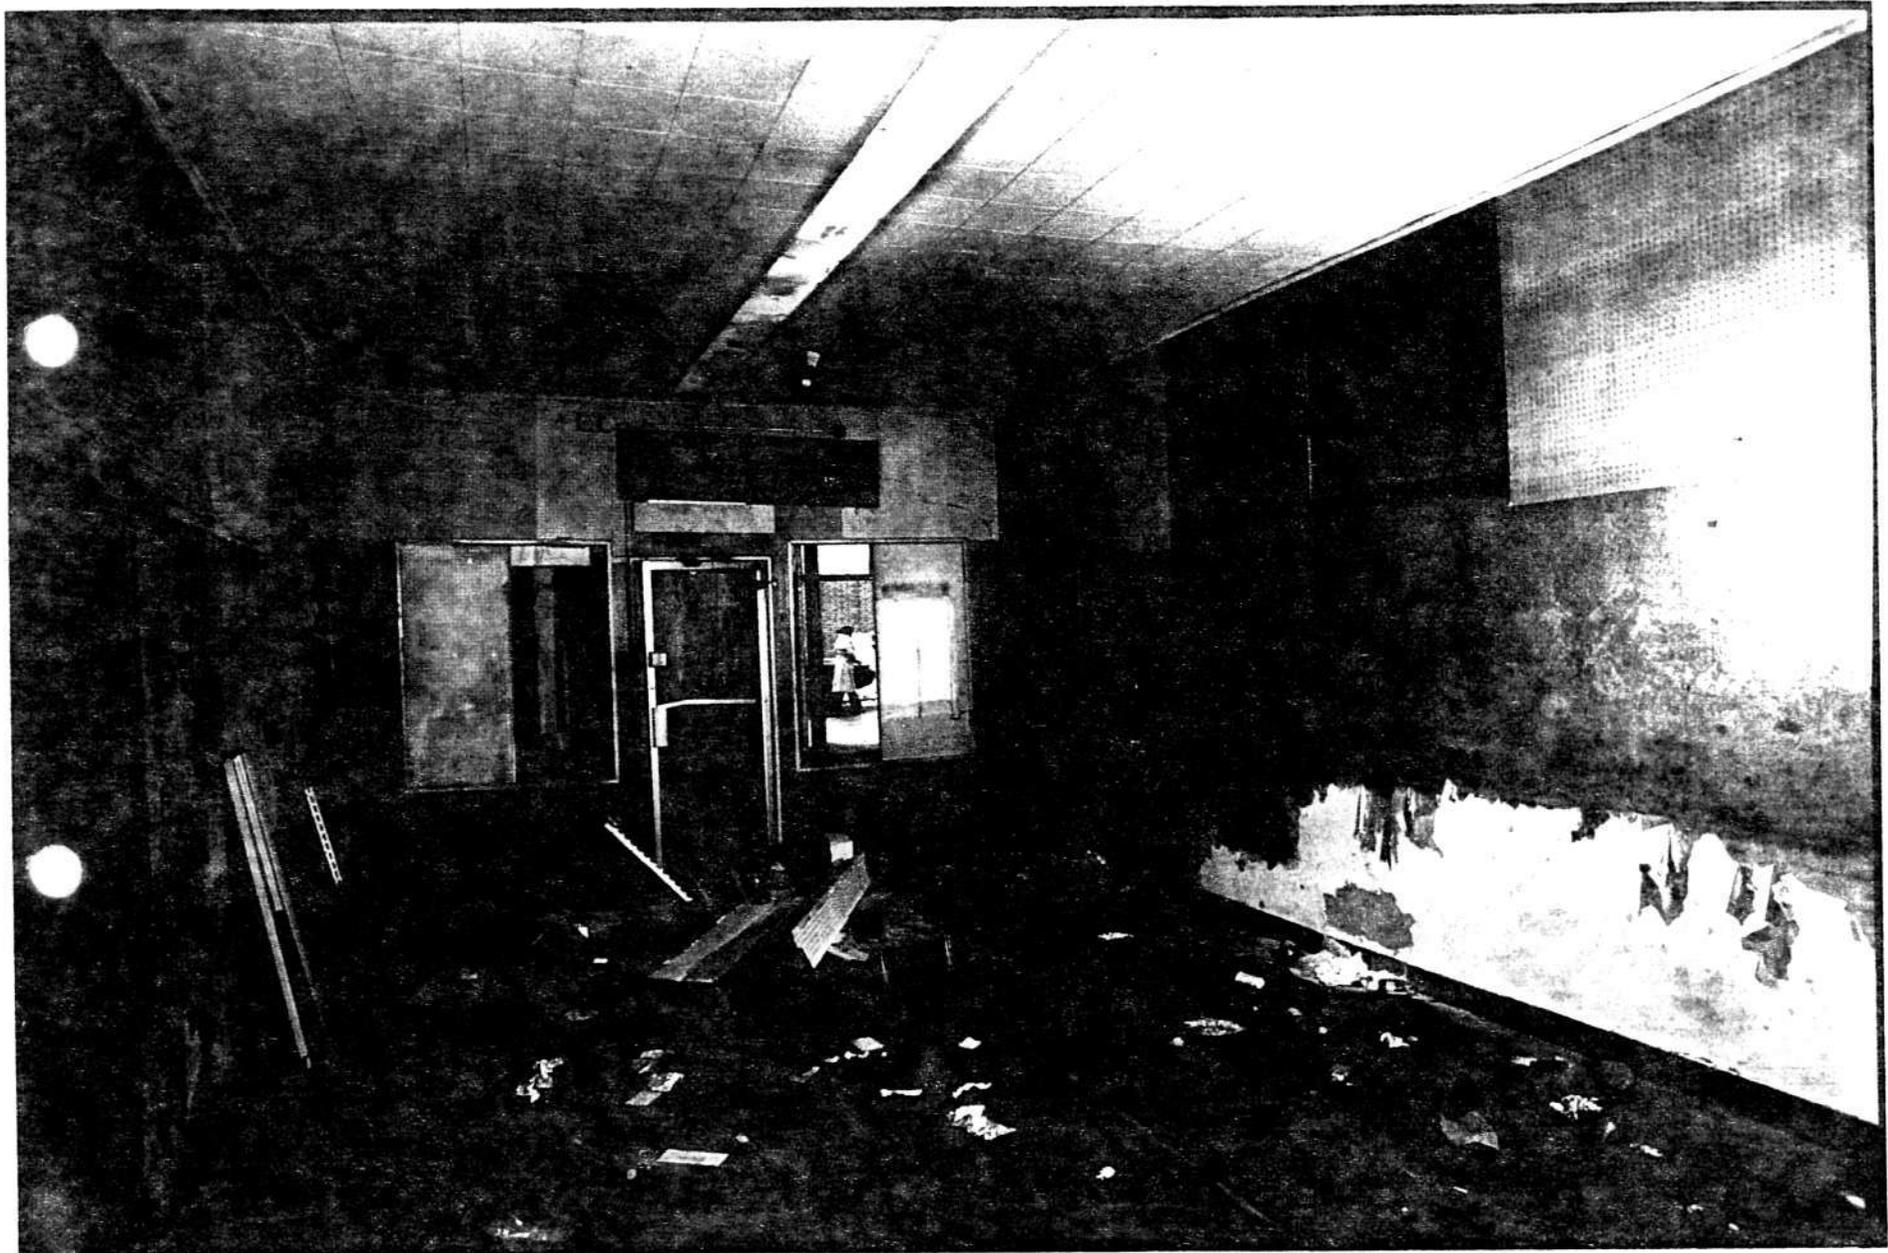
67 of 68

1 RIEMAN BLOCK B-3995
2 617-631 West Lexington Street
Baltimore, Maryland
3 Photographer - Tom Miller
4 Negatives held by Paul McKean
5 January 14, 1984
6 North view of first floor of #631
7 Roll 6 #33

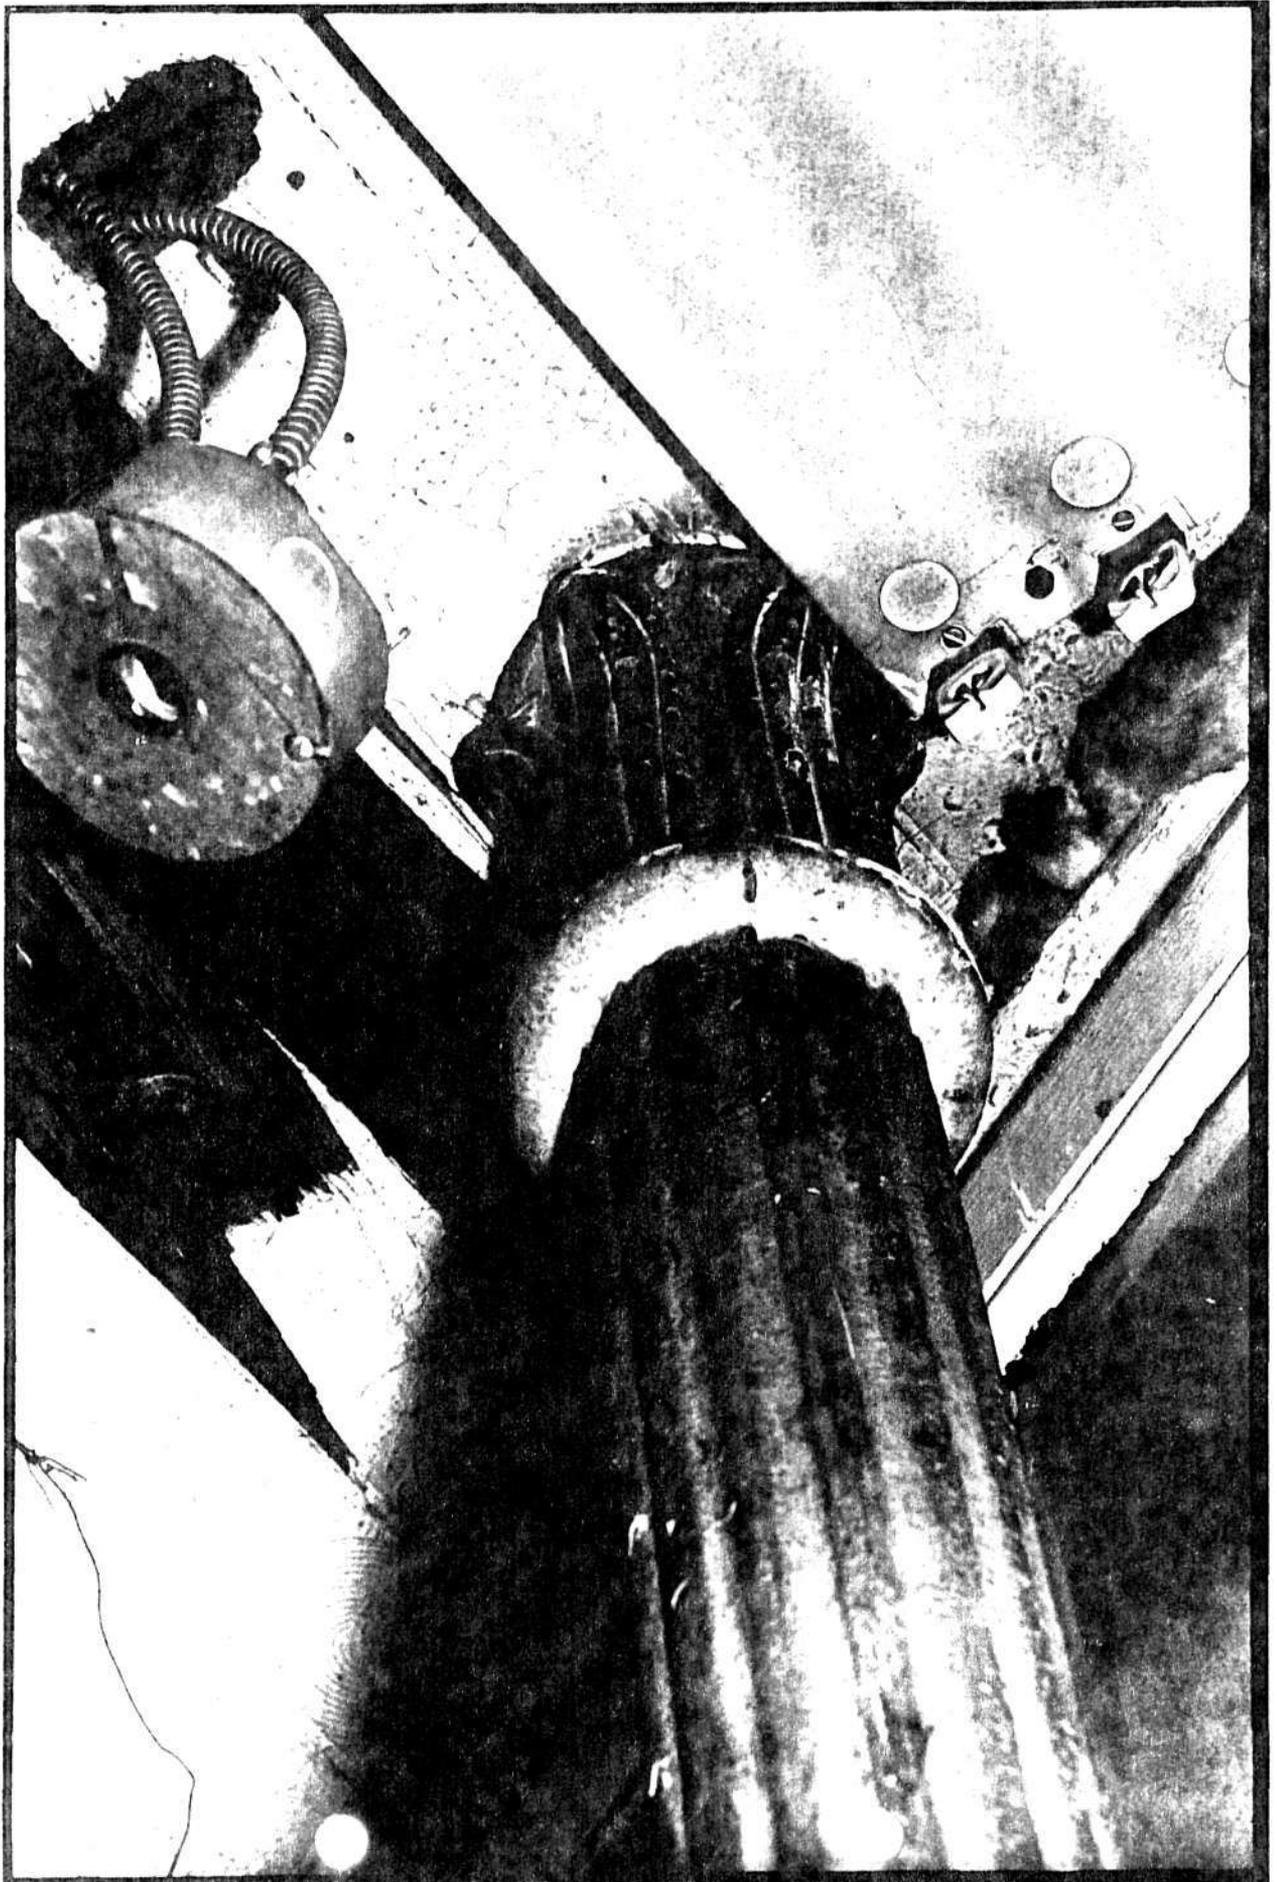
68 of 68

1 RIEMAN BLOCK " B-3995
2 617-631 West Lexington Street
Baltimore, Maryland
3 Photographer - Tom Miller
4 Negatives held by Paul McKean
5 December 16, 1983
6 View of top of storefront column #631
7 Roll 5 #9 of 68
