National Register of Historic Places
Inventory—Nomination Form

historic Arter, Solomon, House (preferred)

and or common Arter-Davidson House

Arter, Solomon, House
Carroll County, Maryland

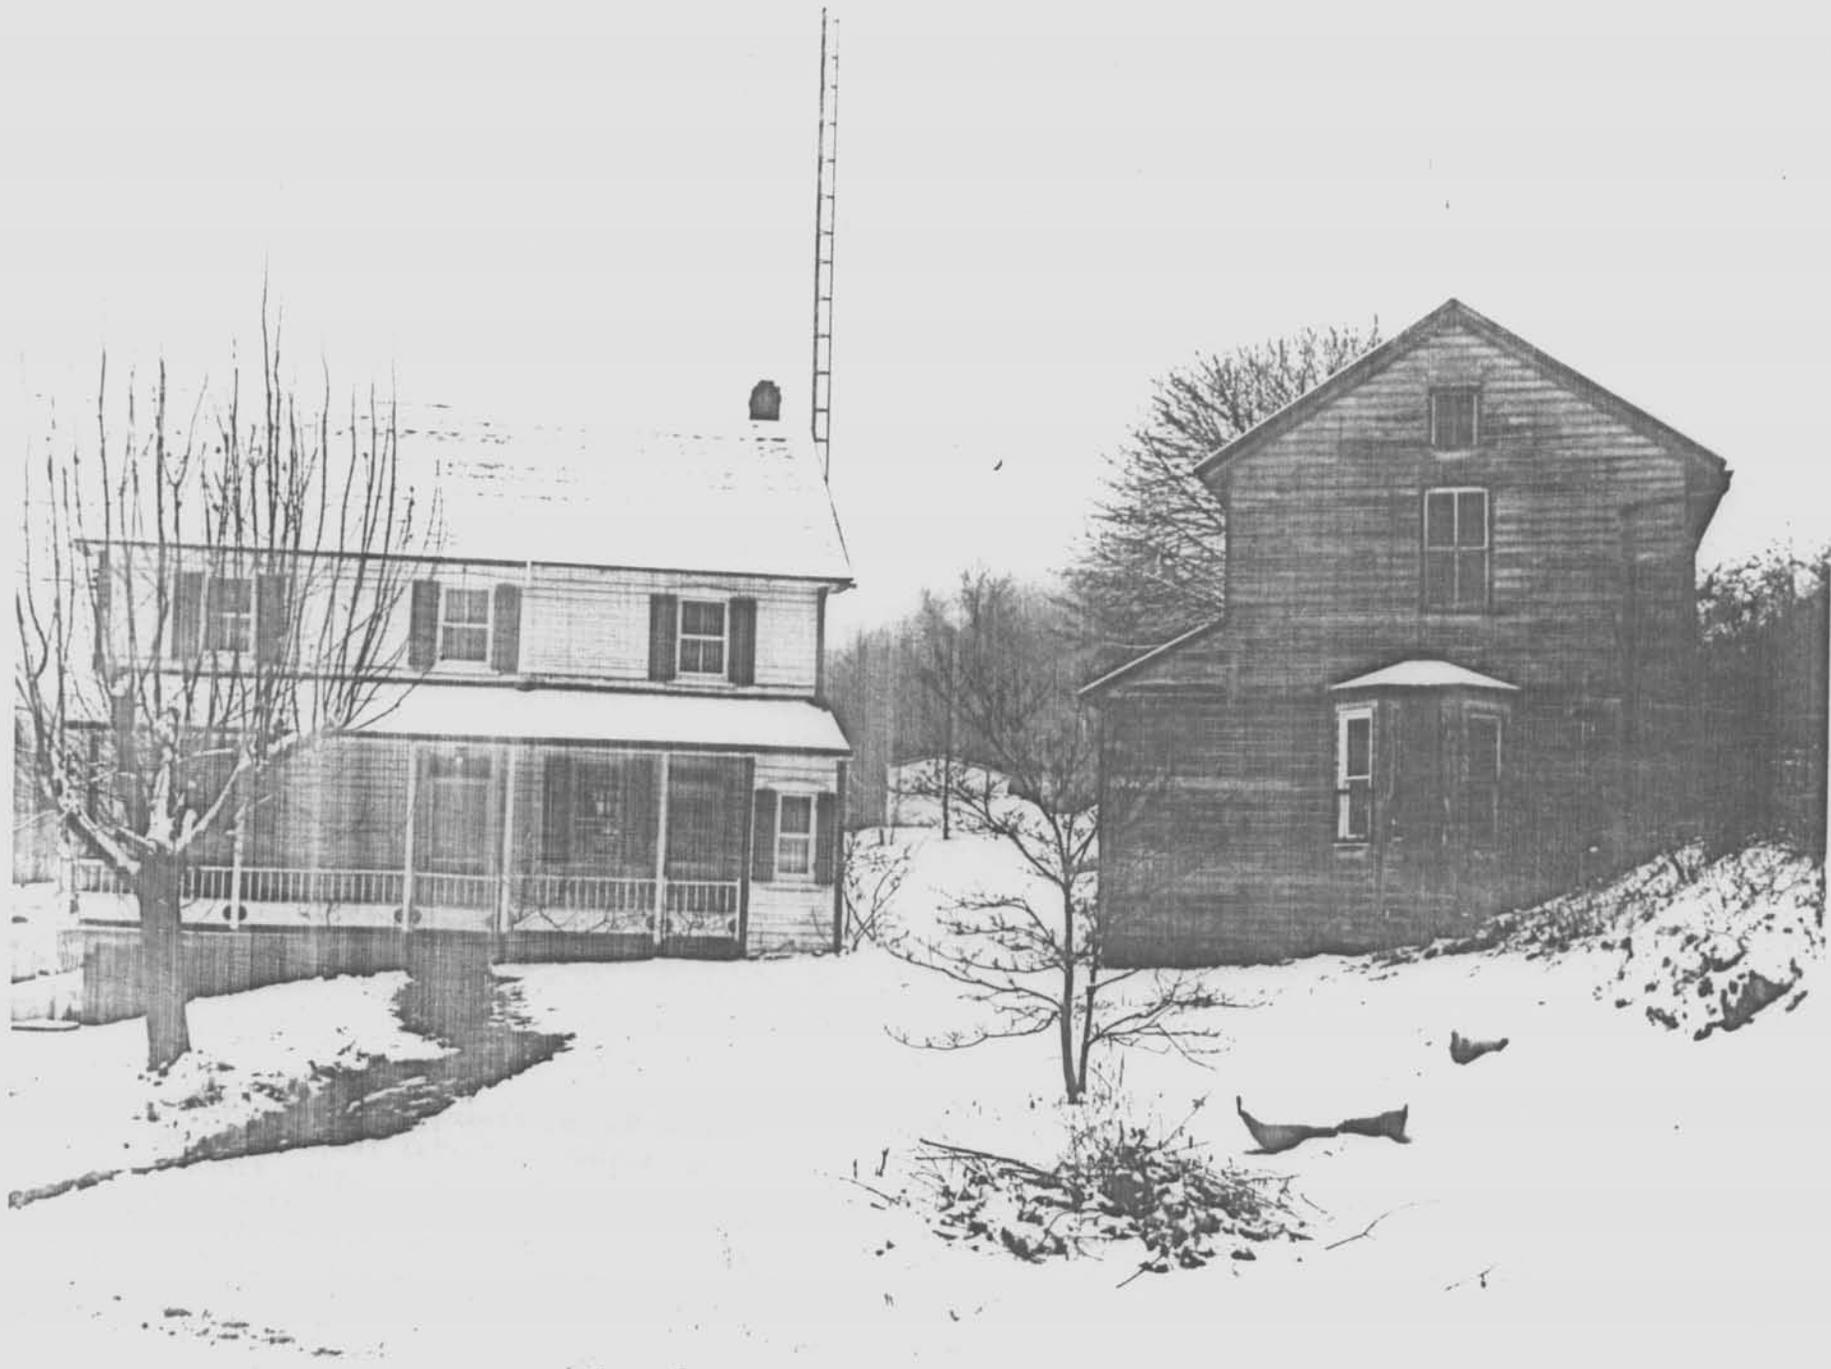
1. CARR-824 Arter-Davidson House
2. Carroll County, Maryland
3. Joe Getty
4. January 1985
5. Md. Historical Trust, Annapolis, MD
6. South elevation (camera facing north)
7. 1/19

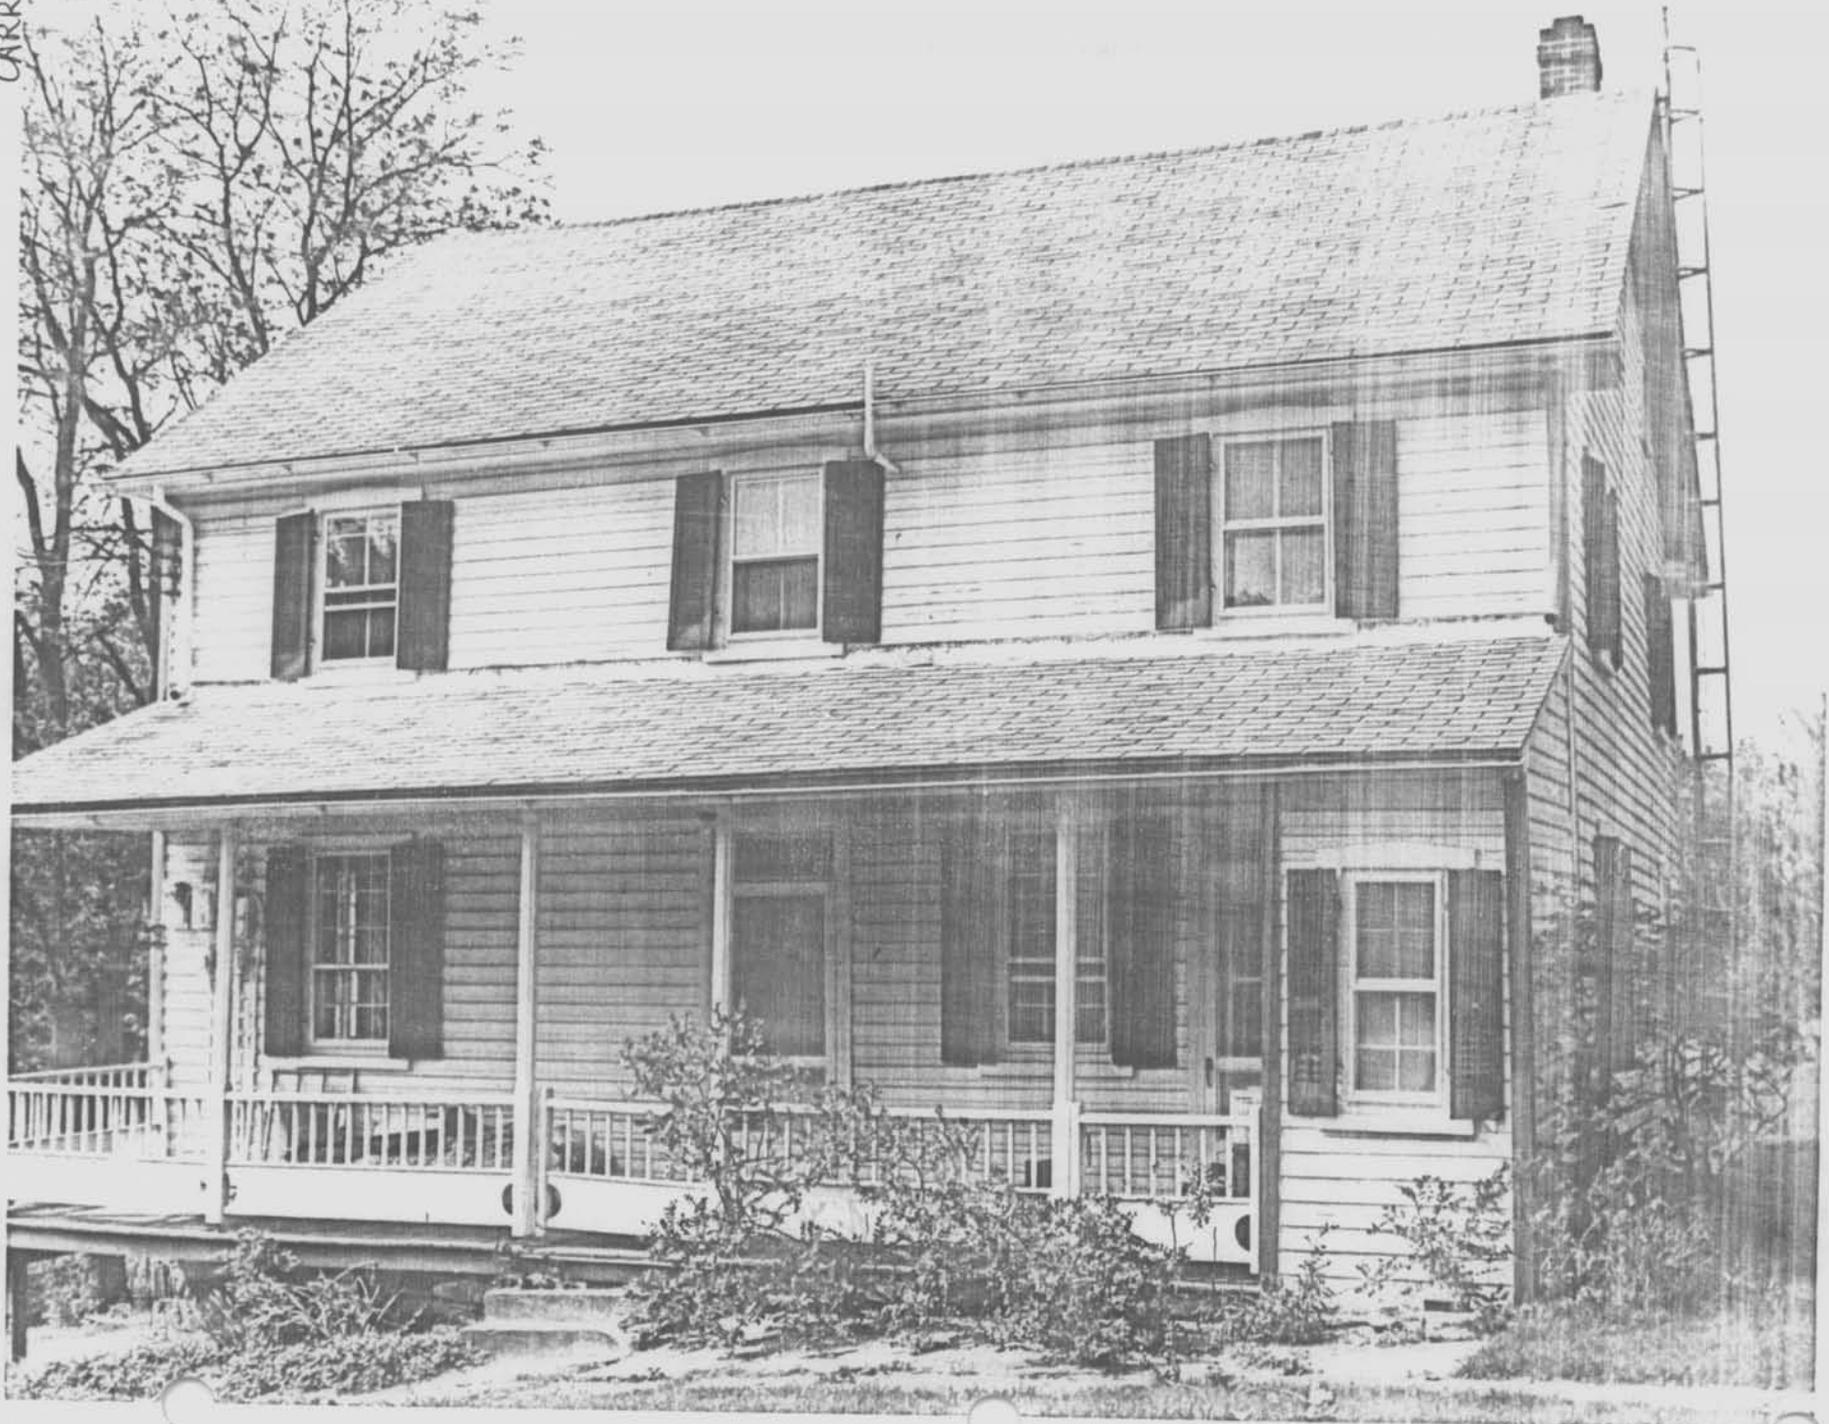
1. CARR-824 Arter-Davidson House
2. Carroll County, Maryland
3. Joe Getty
4. May, 1985
5. Md. Historical Trust, Annapolis, MD
6. South elevation (camera facing north)
7. 2/19

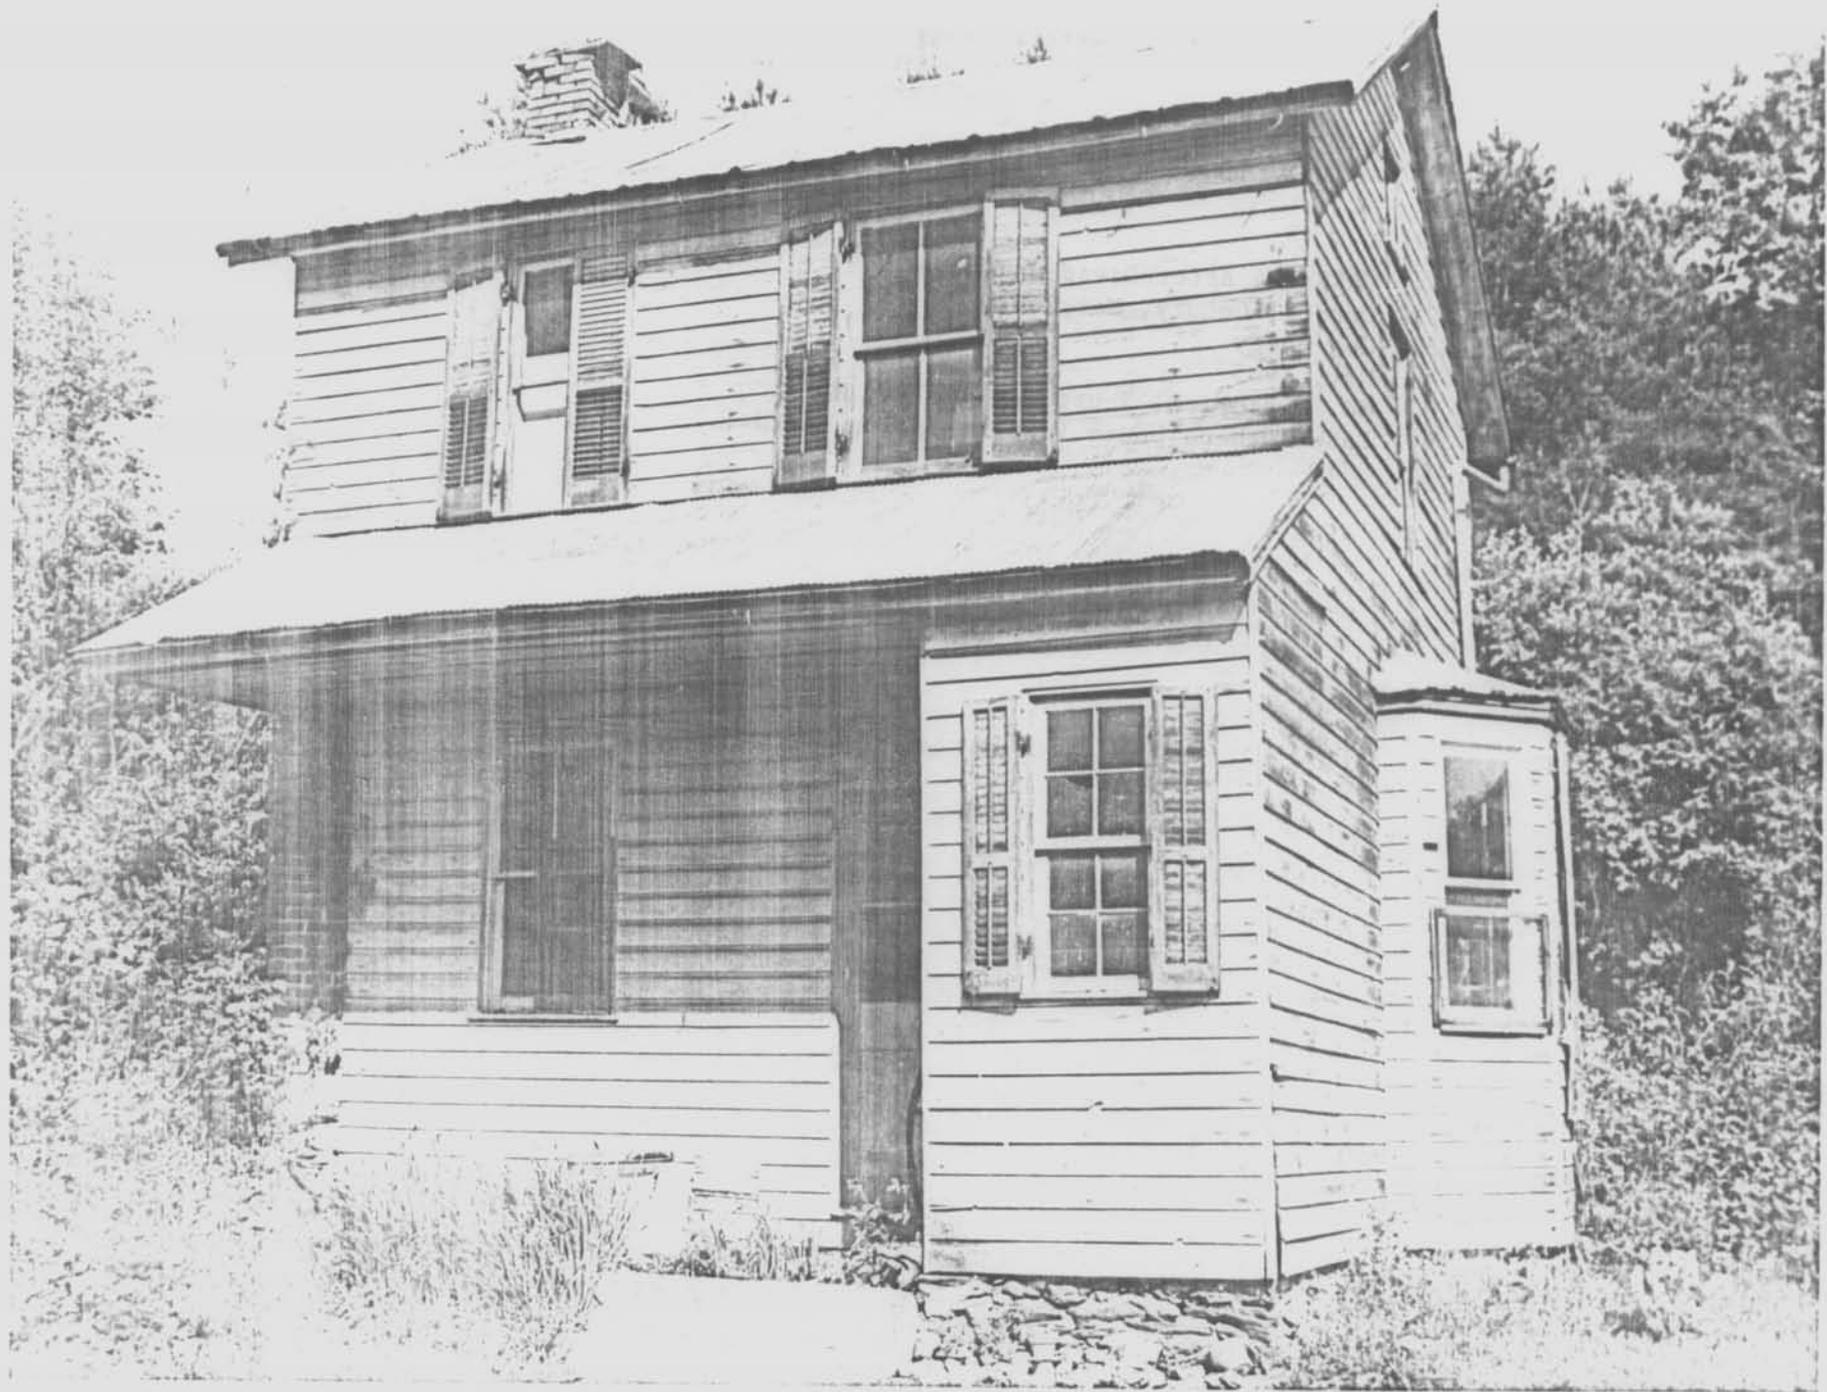
1. CARR-824 Arter-Davidson House
2. Carroll County, Maryland
3. Joe Getty
4. May, 1985
5. Md. Historical Trust, Annapolis, MD
6. Late 19th c. house (camera facing east)
7. 3/19

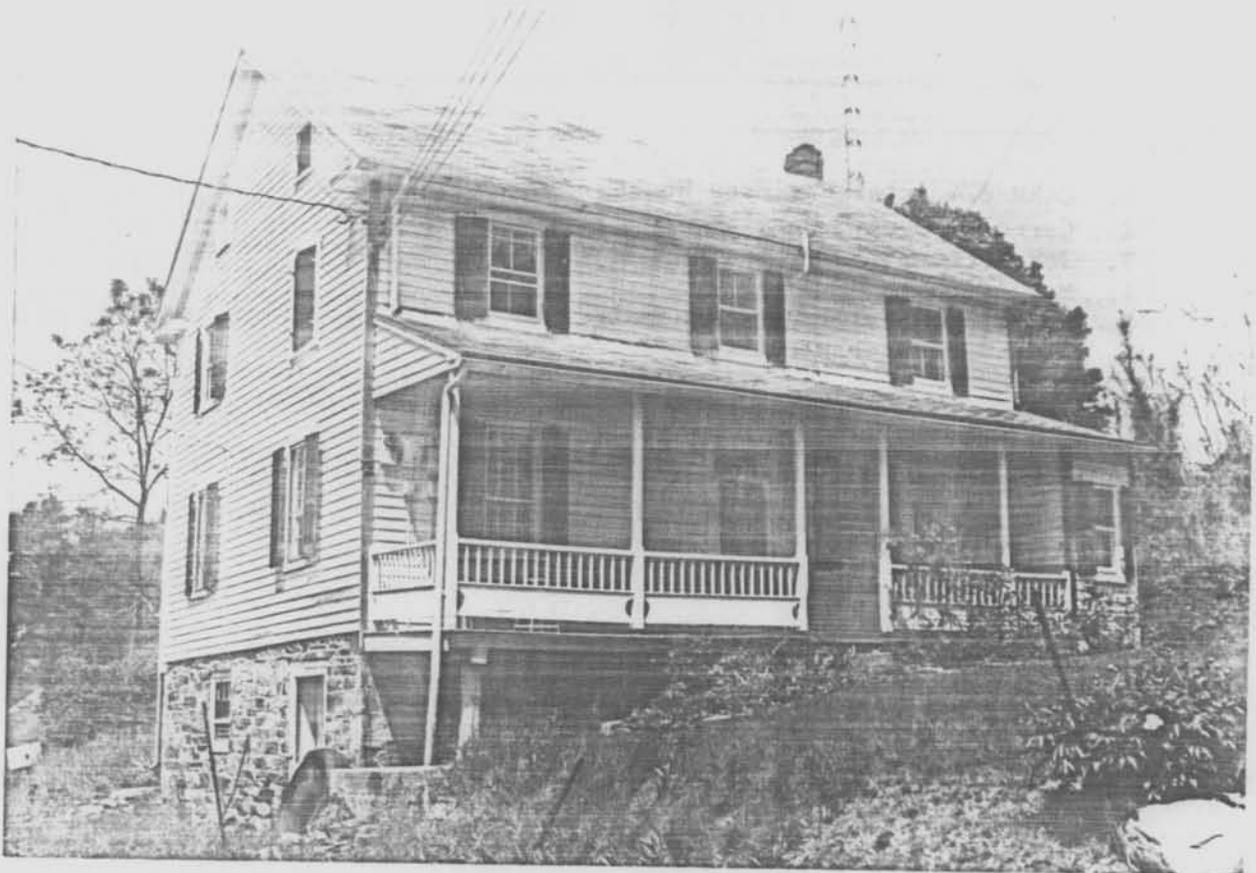
1. CARR-824 Arter-Davidson House
2. Carroll County, Maryland
3. Joe Getty
4. May, 1985
5. Md. Historical Trust, Annapolis, MD
6. South and West Elev. (camera facing n.e.)
7. 4/19

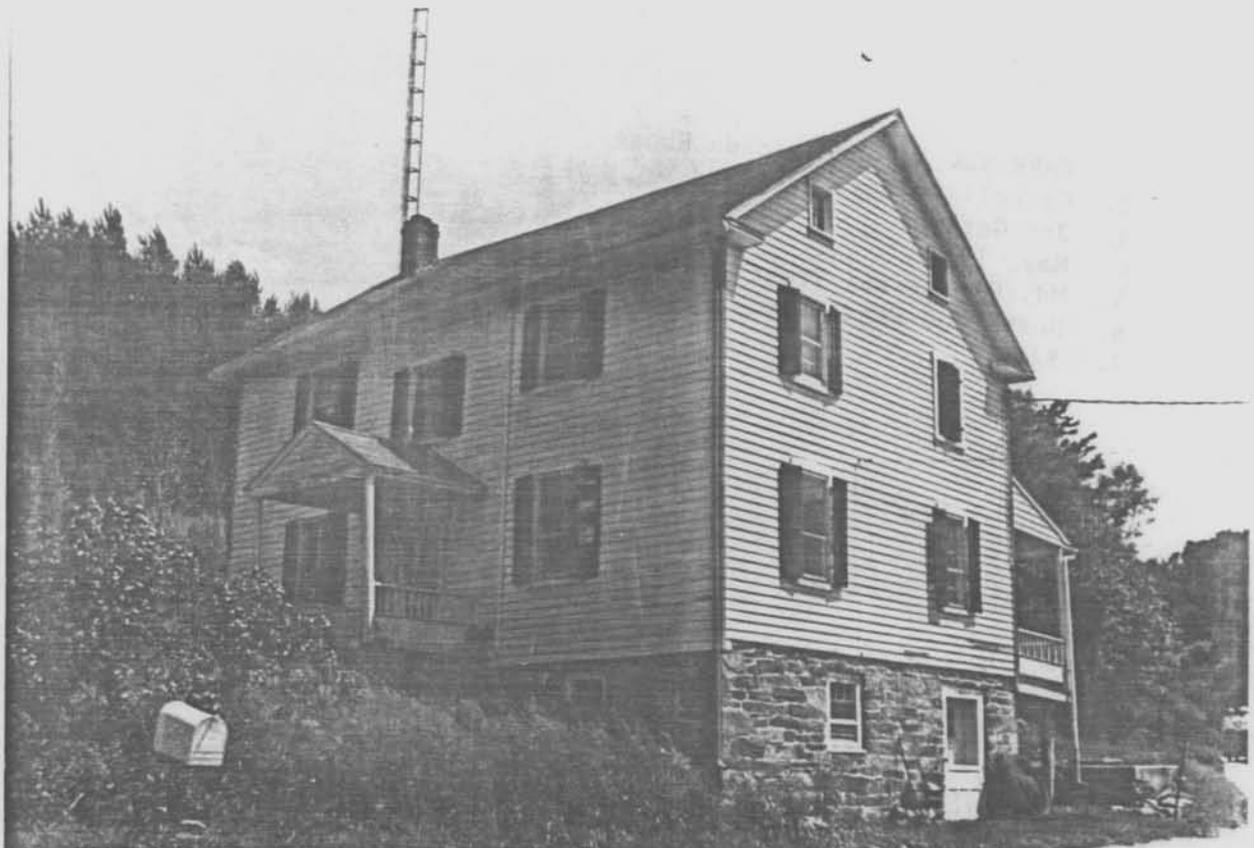
1. CARR-824 Arter-Davidson House
2. Carroll County, Maryland
3. Joe Getty
4. May, 1985
5. Md. Historical Trust, Annapolis, MD
6. North and West elev. (camera facing s.e.)
7. 5/19

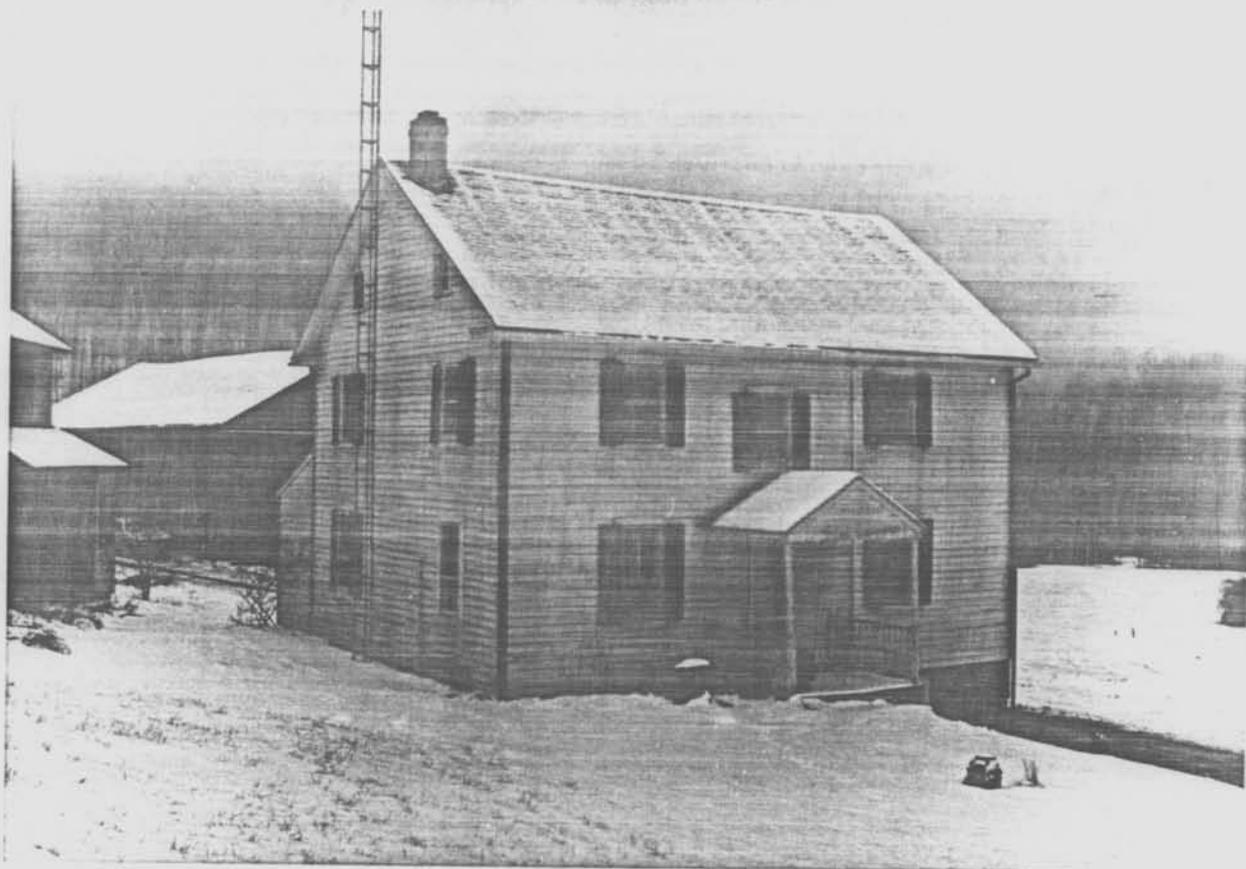
1. CARR-824 Arter-Davidson House
2. Carroll County, Maryland
3. Joe Getty
4. January, 1985
5. Md. Historical Trust, Annapolis, MD
6. North and east elev. (camera facing S.W.)
7. 6/19

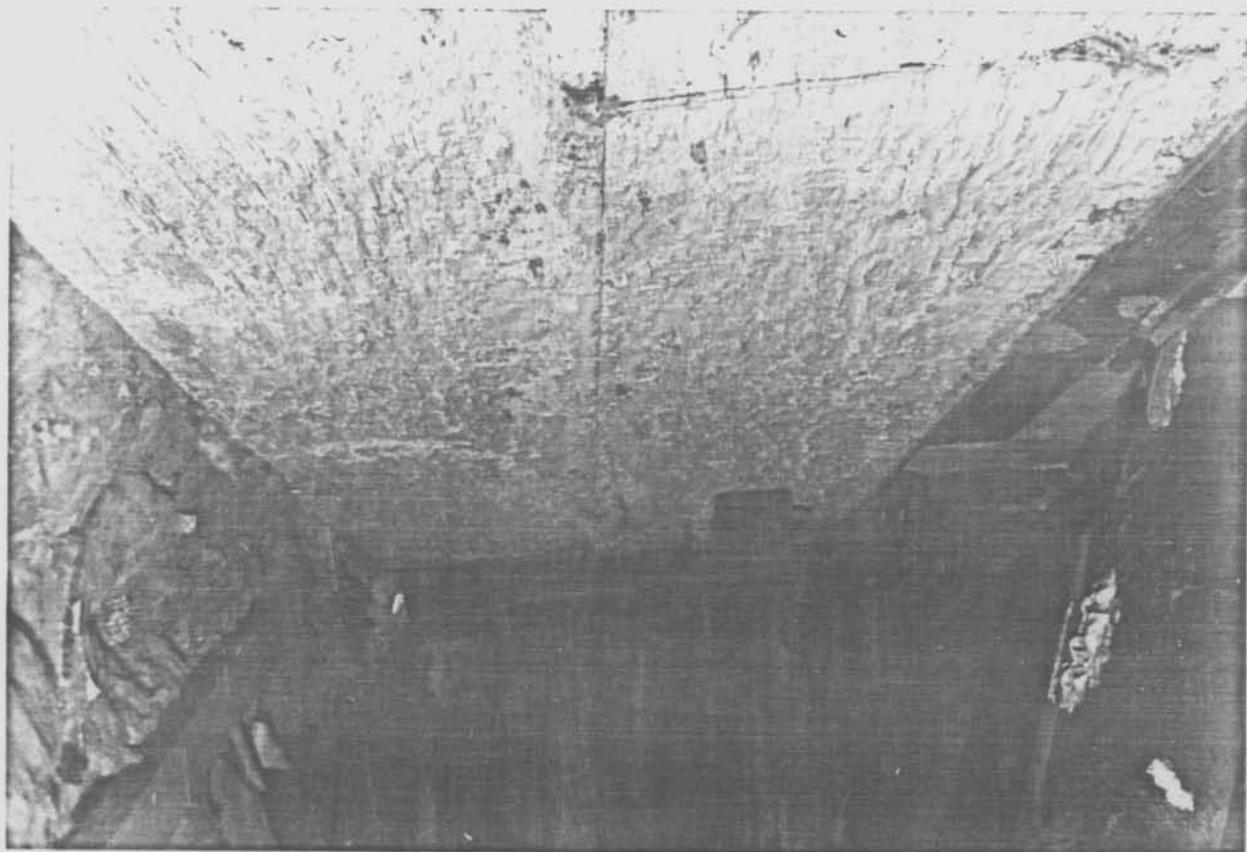
1. CARR-824 Arter-Davidson House
2. Carroll County, Maryland
3. Joe Getty
4. May, 1985
5. Md. Historical Trust, Annapolis, MD
6. Original siding under south elev. porch
roof
7. 7/19

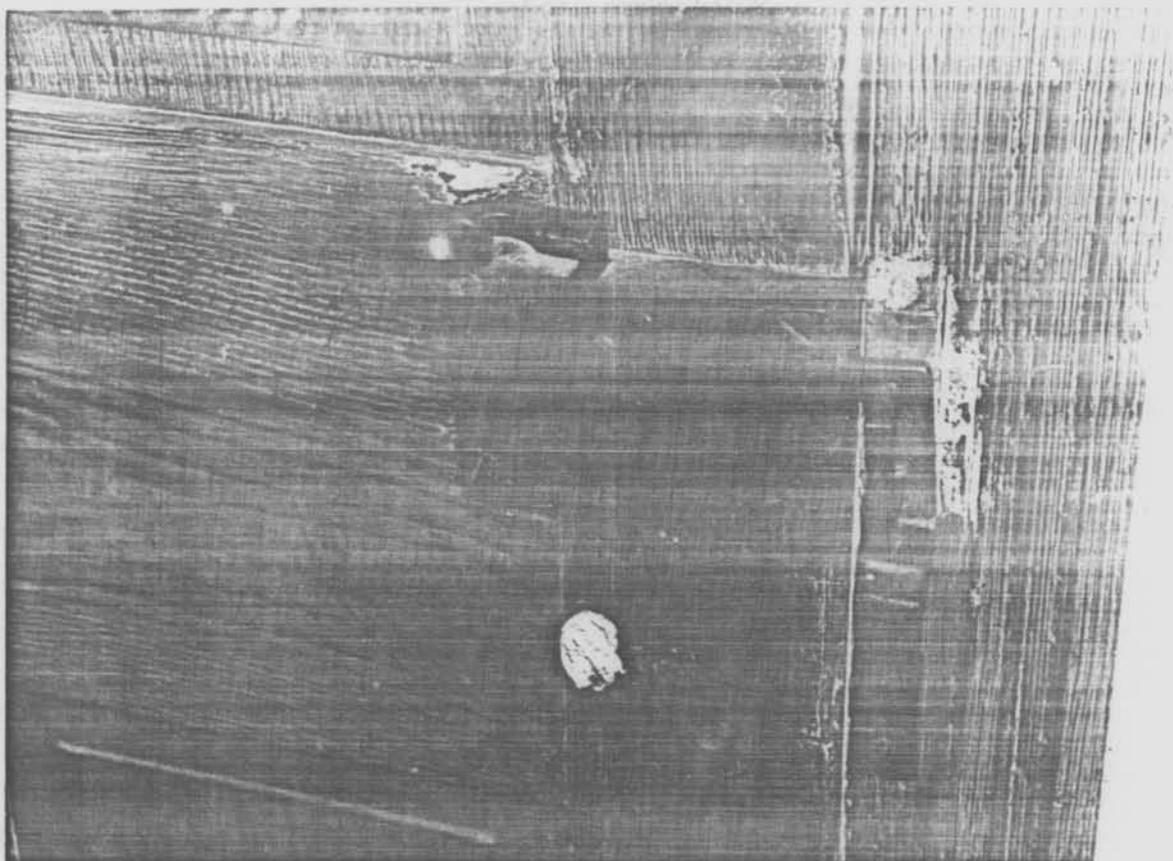
1. CARR-824 Arter-Davidson House
2. Carroll County, Maryland
3. Joe Getty
4. January, 1985
5. Md. Historical Trust, Annapolis, MD
6. Original boxloc;grained door 1st storyhall
7. 8/19

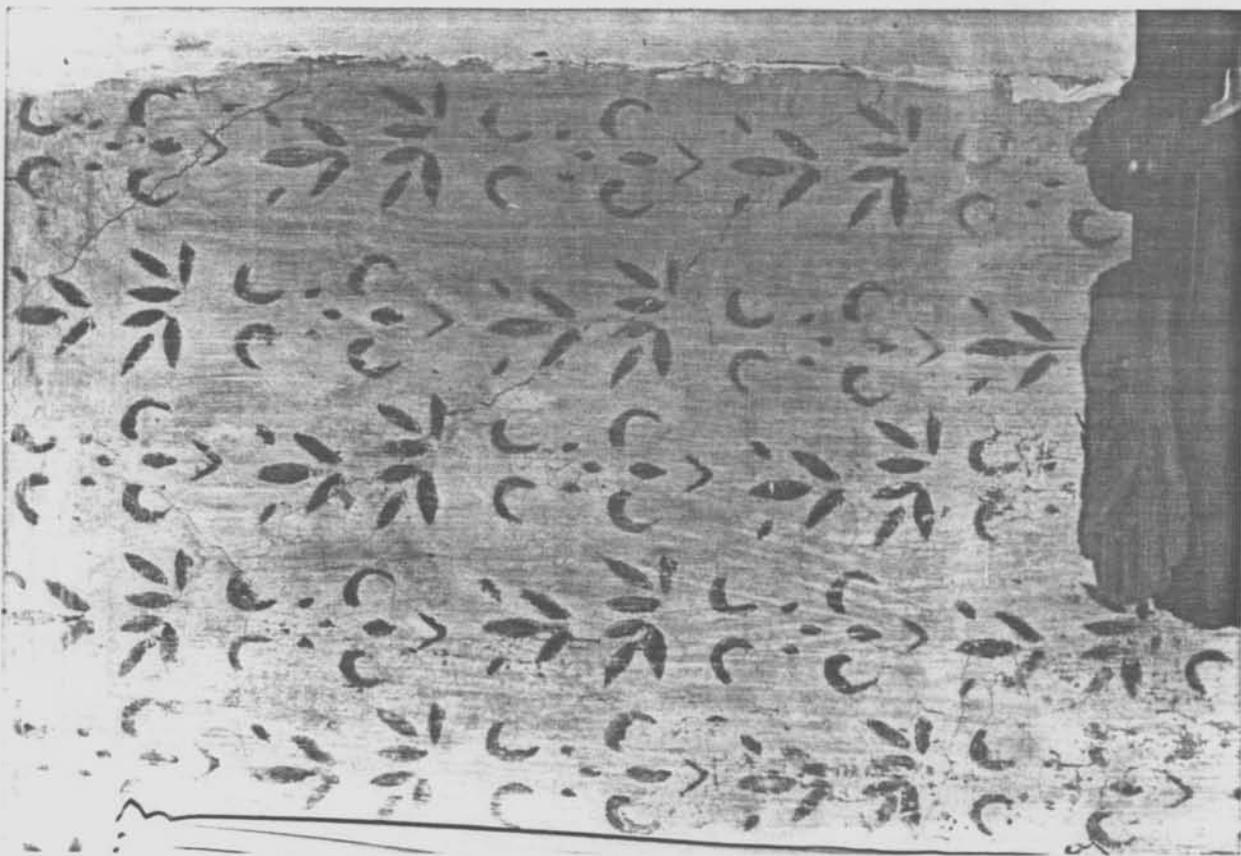
The walls of the northeast bedroom retain two sections of original stenciling. One section runs floor-to-ceiling and the other runs part of the way up the wall before it is painted over. The stenciling pattern of both sections is identical consisting of two large motifs, a red tulip rising from a heart and a green abstract leaf. The motifs run alternately in both a horizontal and vertical pattern. The heart and tulip motif was a popular design in Pennsylvania German decorative arts. It is possibly a reference to scripture (Matthew 7:17, 18; Matthew 12:3-25; and Luke 6:43-45) where it is stated that from the heart rose good deeds, and the tulip frequently represents good things or good fruit in the Pennsylvania German culture. This section of stenciling was revealed by the current owners in the late 1940s, when they removed a layer of wallpaper. They left these panels exposed, and while the light has probably faded the colors to some extent, the stencils and their colors are still quite vivid. The red color is deep and the green on one wall is dark, while on the other wall it is a blue-green.

1. CARR-824 Arter-Davidson House
2. Carroll County, Maryland
3. Joe Getty
4. January, 1985
5. Md. Historical Trust, Annapolis, MD
6. Stenciled wall in northeast bedroom
7. 9/19

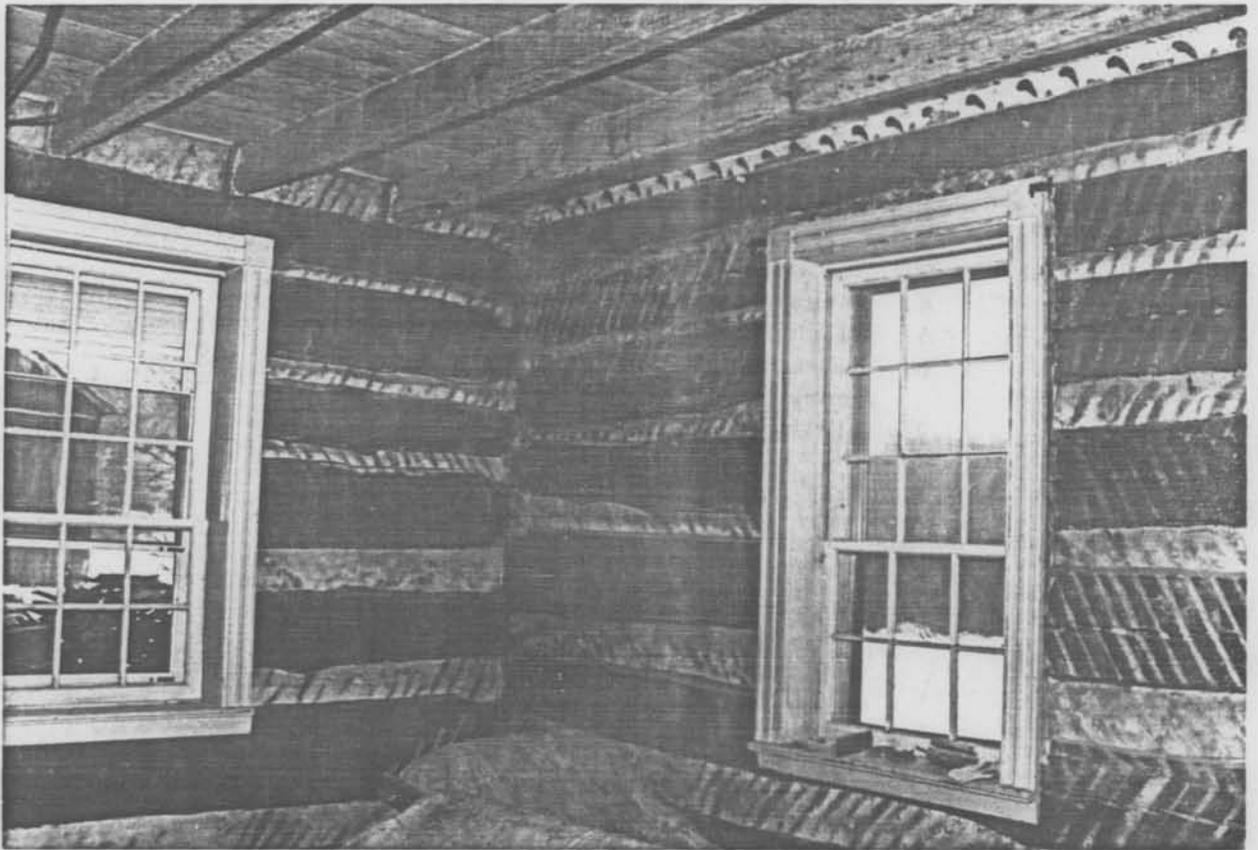
On the first story, the west interior walls were exposed during a remodeling in January 1985. With the ceiling and wall plaster dating from the early 20th century removed, the location of the former partition between the two rooms became evident. Further, the ceiling joists and underside of the second story floor boards were found to have been painted a pink color in the southwest room and whitewashed in the northwest room. Apparently, the ceilings were covered with lath and plaster in the mid 19th century and in the early 20th century the walls of both rooms were completely replastered. When this new plaster was removed during the 1985 remodeling, the only original plaster that was found was a 7 to 8 inch strip at the cornice level, which had been concealed by the earlier plastering job. This preserved strip revealed two different stencil patterns, both consisting of floral motifs. In the southwest room, the pattern had two different designs. It begins in the southeast corner of the room with a green maple leaf pattern above blue swirls, but becomes more abstract along that wall changing to a leaf pattern

1. CARR-824 Arter-Davidson House
2. Carroll County, Maryland
3. Joe Getty
4. January, 1985
5. Md. Historical Trust, Annapolis, MD
6. Remnants of southwest room stenciling, 1st story
7. 11/19

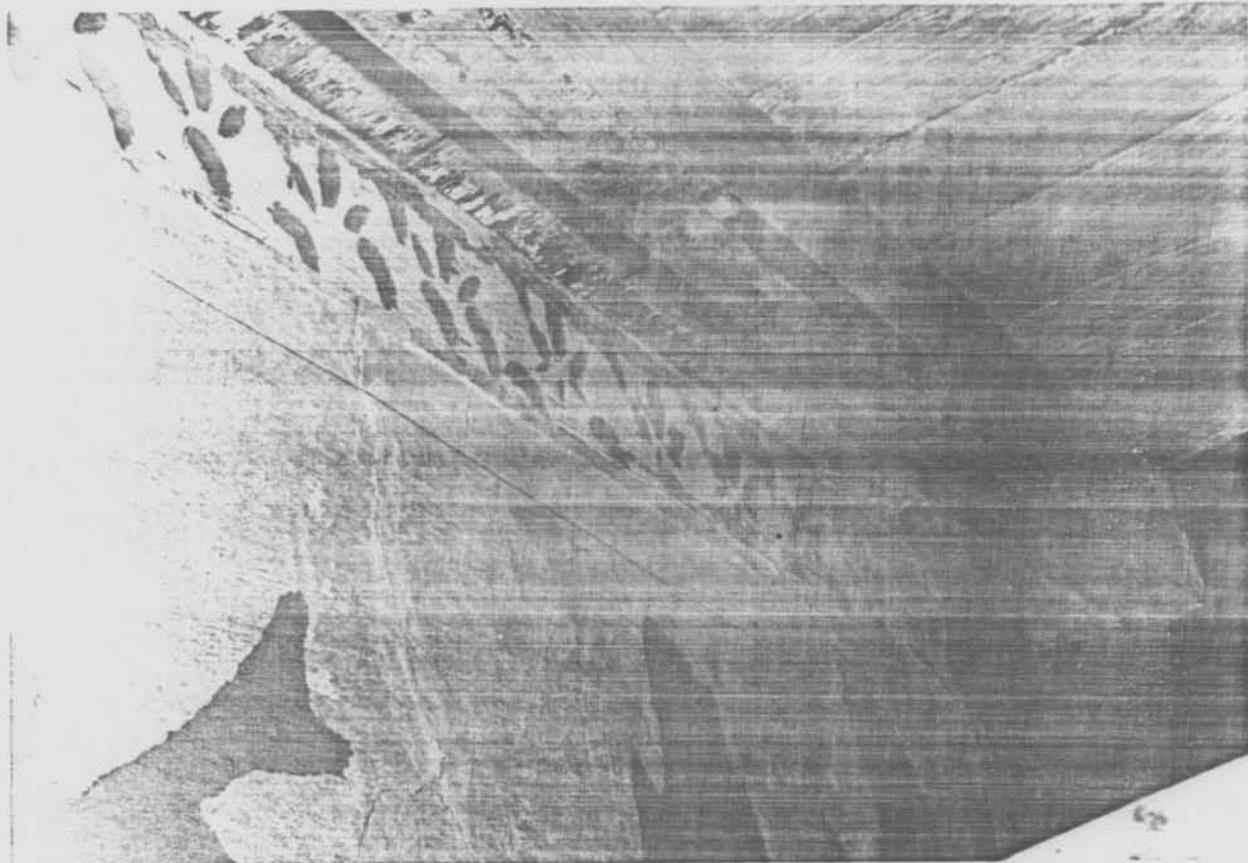
1. CARR-824 Arter-Davidson House
2. Carroll County, Maryland
3. Joe Getty
4. January, 1985
5. Md. Historical Trust, Annapolis, MD
6. \ 1st story, southwest room stenciling
(southeast corner)
7. 12/19

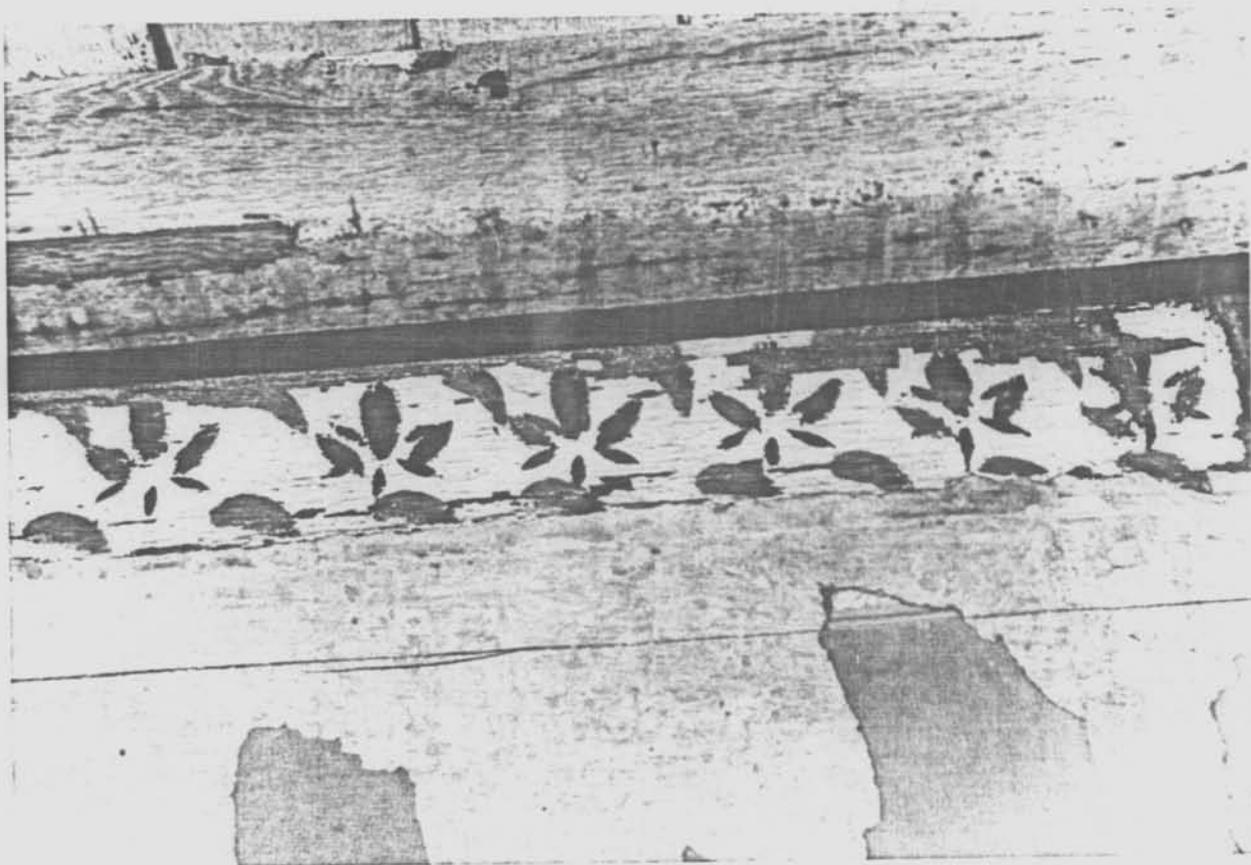
1. CARR-824 Arter-Davidson House
2. Carroll County, Maryland
3. Joe Getty
4. January, 1985
5. Md. Historical Trust, Annapolis, MD
6. 1st story, detail of southwest room
stenciling
7. 13/19

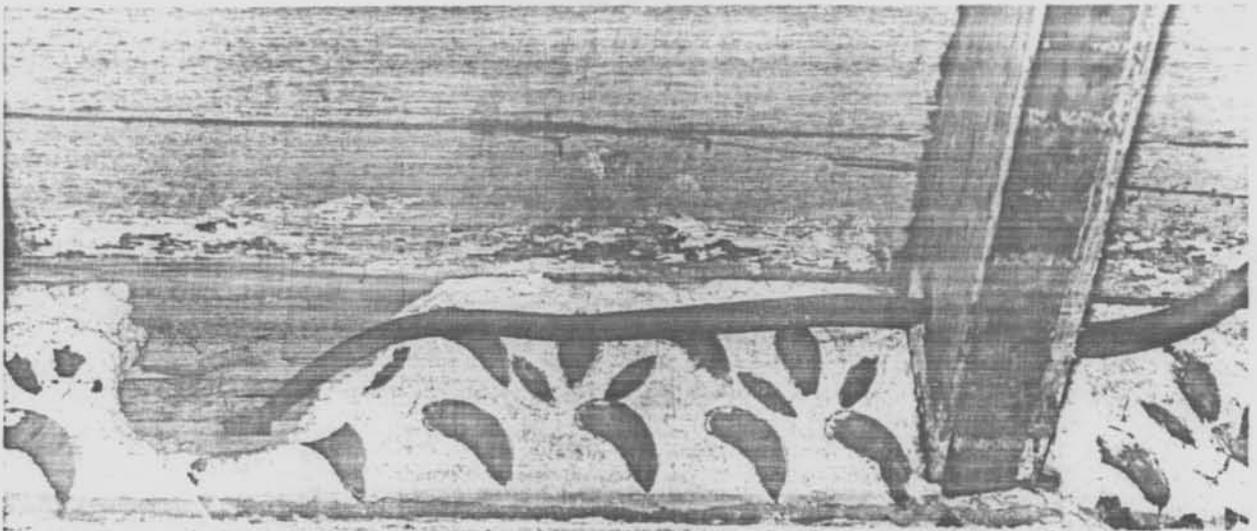
1. CARR-824 Arter-Davidson House
2. Carroll County, Maryland
3. Joe Getty
4. January, 1985
5. Md. Historical Trust, Annapolis, MD
6. 1st story, detail of southwest room
stenciling (northeast corner)
7. 14/19 <

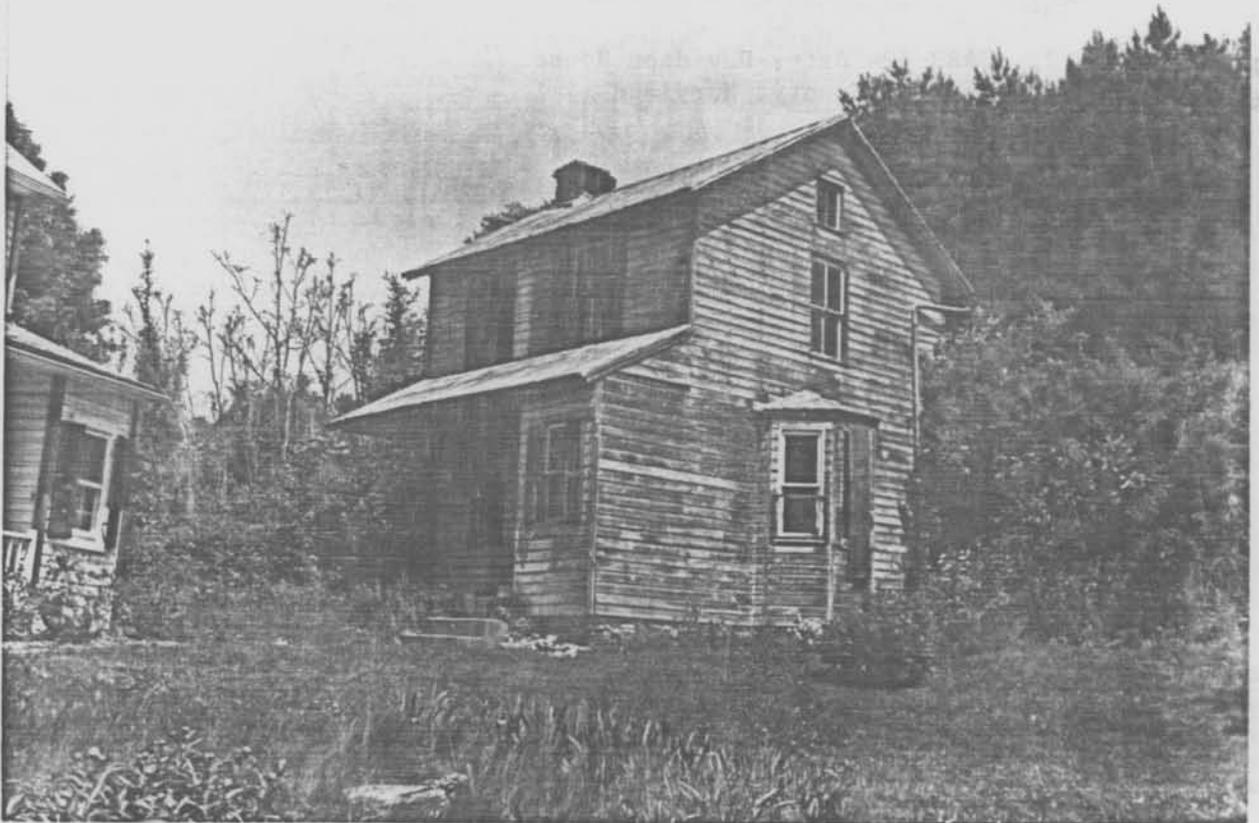
1. CARR-824 Arter-Davidson House
2. Carroll County, Maryland
3. Joe Getty
4. May, 1985
5. Md. Historical Trust, Annapolis, MD
6. Late 19th c. house, South and West elev.
7. 15/19

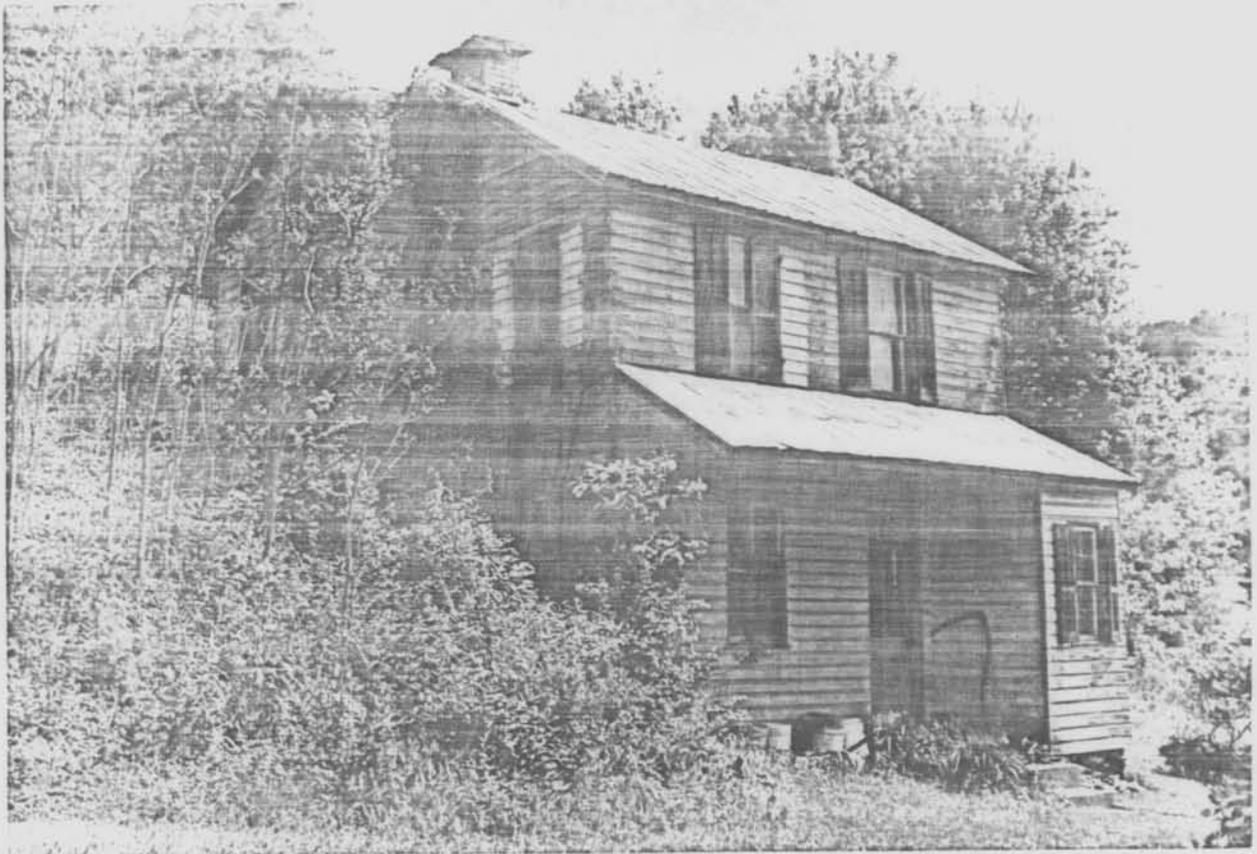
1. CARR-824 Arter-Davidson House
2. Carroll County, Maryland
3. Joe Getty
4. May, 1985
5. Md. Historical Trust, Annapolis, MD
6. Late 19th c. house, north and west elev.
7. 16/19

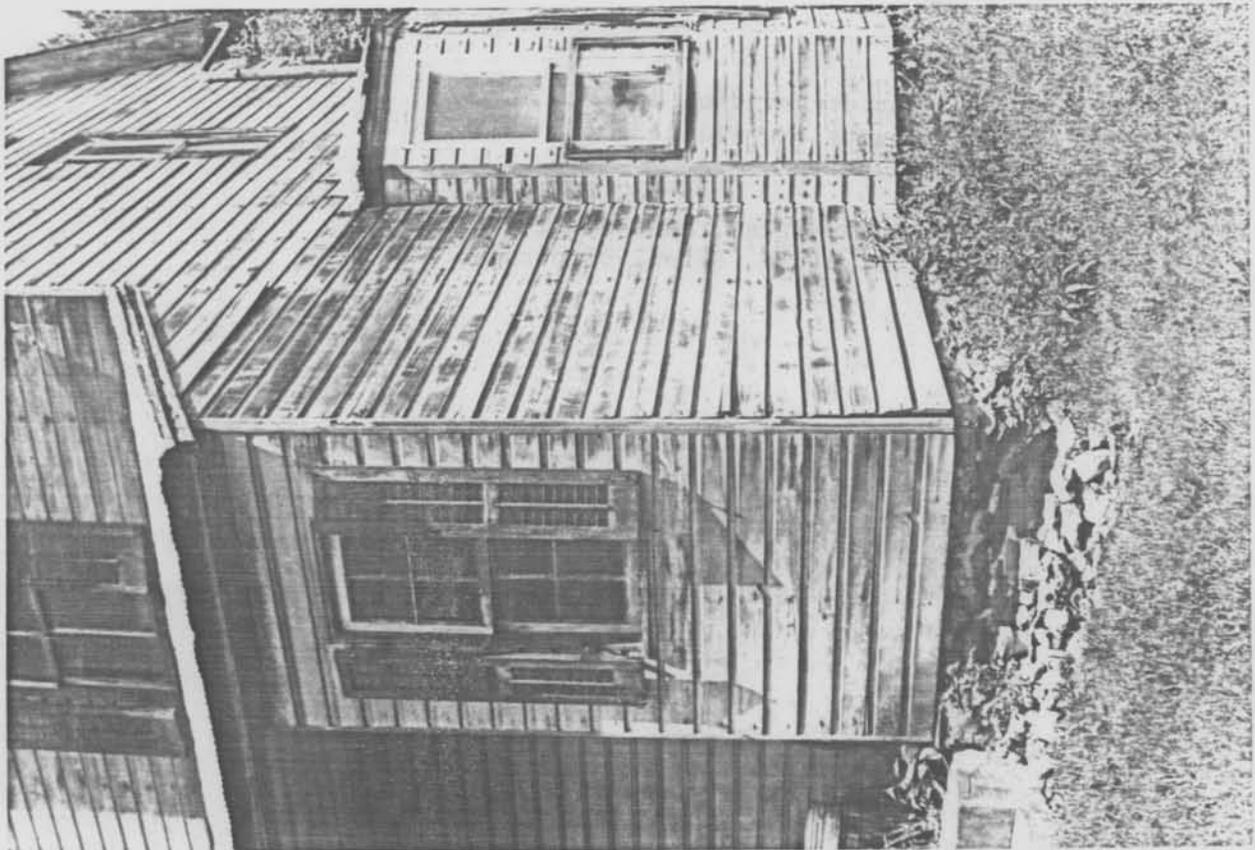
1. CARR-824 Arter-Davidson House
2. Carroll County, Maryland
3. Joe Getty
4. May, 1985
5. Md. Historical Trust, Annapolis, MD
6. Late 19th c. house, detail of porch
feature
7. 17/19
