National Register of Historic Places
Inventory—Nomination Form

historic Arter, Solomon, House (preferred)

and or common Arter-Davidson House

Arter, Solomon, House
Carroll County, Maryland

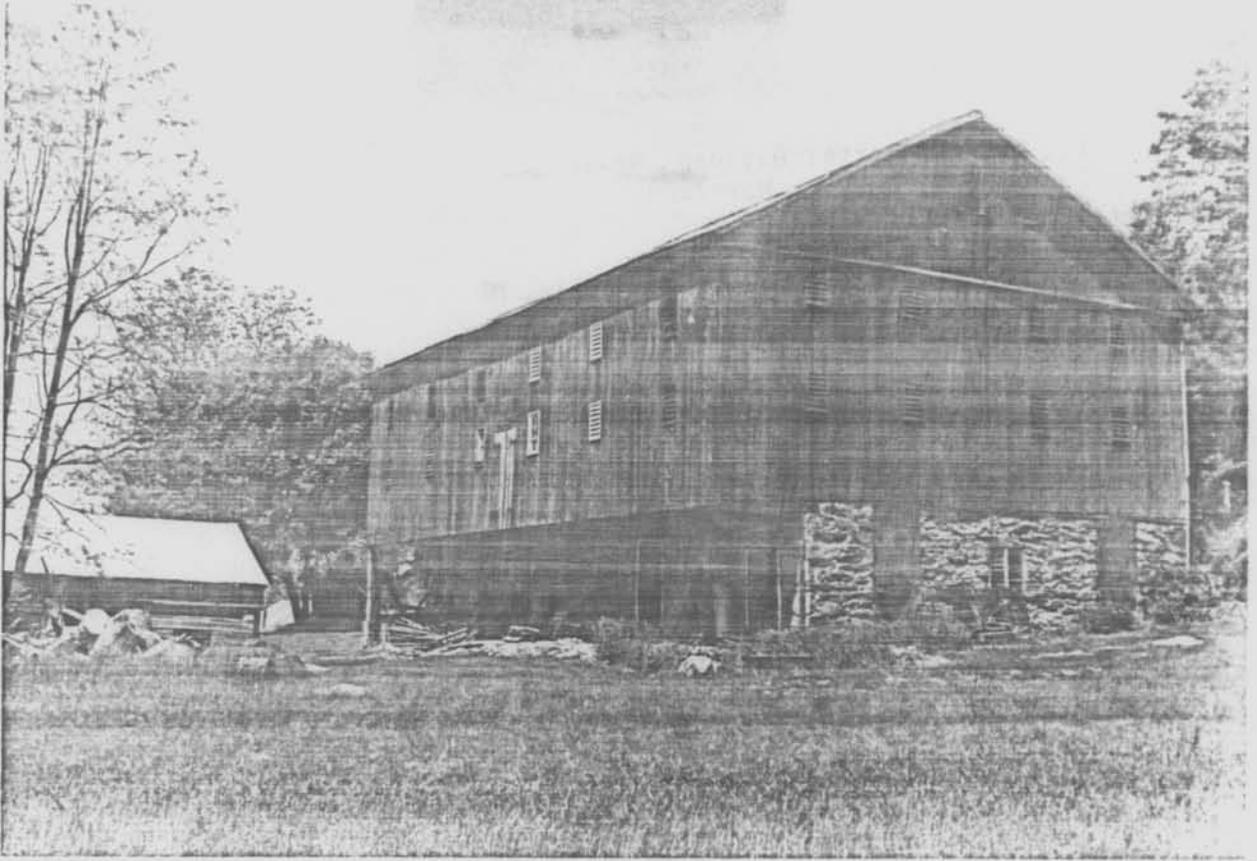
The frame bank barn was constructed in 1872. It is a large structure constructed in the regional style with a stone foundation built into a slope so that the east side has ground level entrance to the threshing floor. The west side has a projecting forebay with doors leading into the stalls. The foundation is constructed of uncoursed fieldstone. The frame section is covered in vertical boards and has louvered openings in two rows (four in each row on the gable ends). In the gables are a pattern of round-arched central-louvered windows flanked on each side by a square louvered window. The west facade forebay section has a row of six louvered windows on the

1. CARR-824 Arter-Davidson House
2. Carroll County, Maryland
3. Joe Getty
4. May, 1985
5. Md. Historical Trust, Annapolis, MD
6. Bank barn, South and West elev.
7. 18/19

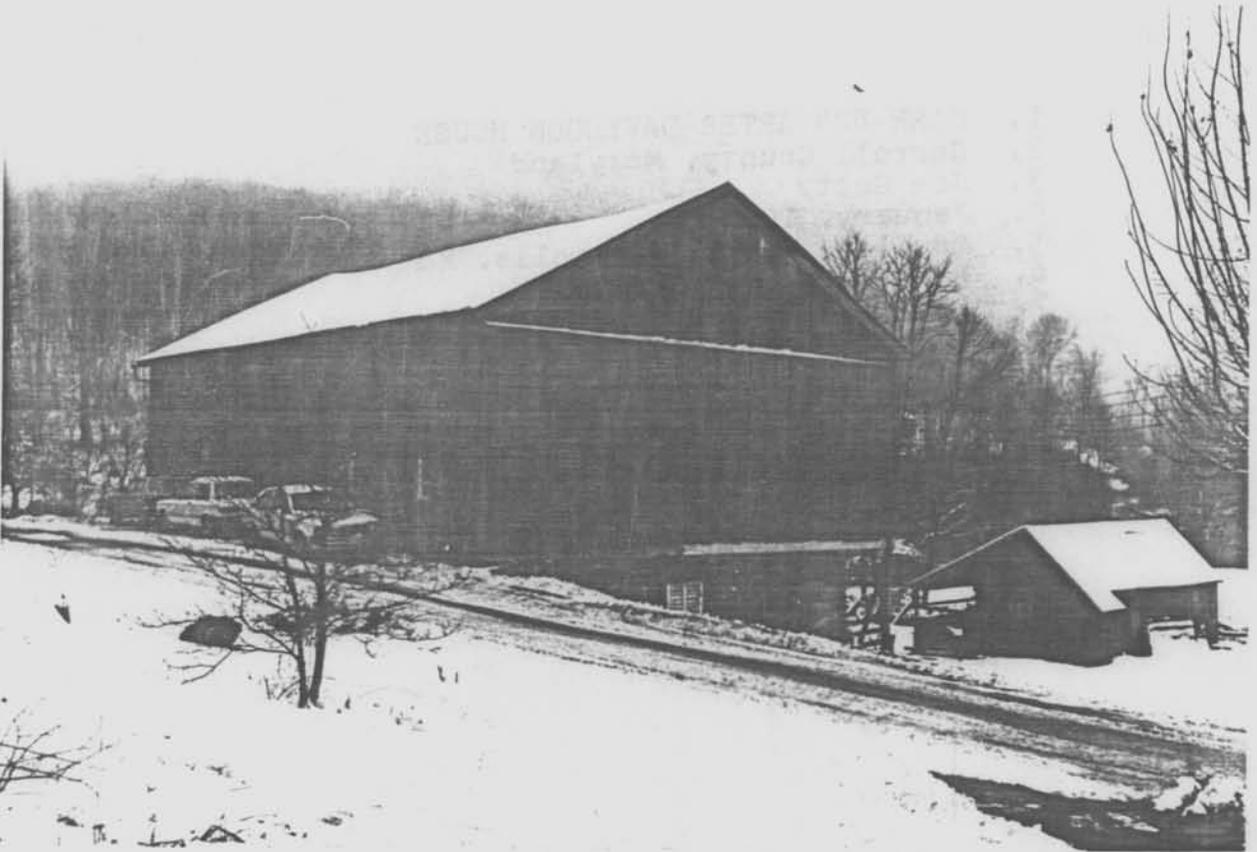
second level and four (in the outer two bays on each side) on the first level with the center bay containing two four-over-two sash windows in a central doorway of double doors. The east elevation (bank side) contains two large double doors in the center of the elevation, four louvered openings on the top level and two four-over-two sash windows on the first level on the northern side of the elevation. A man-door within the large wagon doors contains Pennsylvania German style hardware with a strap hinge that is connected to a double-flange patterned pintle.

1. CARR-824 ARTER-DAVIDSON HOUSE
2. Carroll County, Maryland
3. Joe Getty
4. January, 1985
5. Md Hist. Trust, Annapolis, Md
6. Bank barn, N & E elev.
7. 19/19
