National Register of Historic Places
Inventory—Nomination Form

and or common Linden Grove

Linden Grove
Frederick County, Maryland

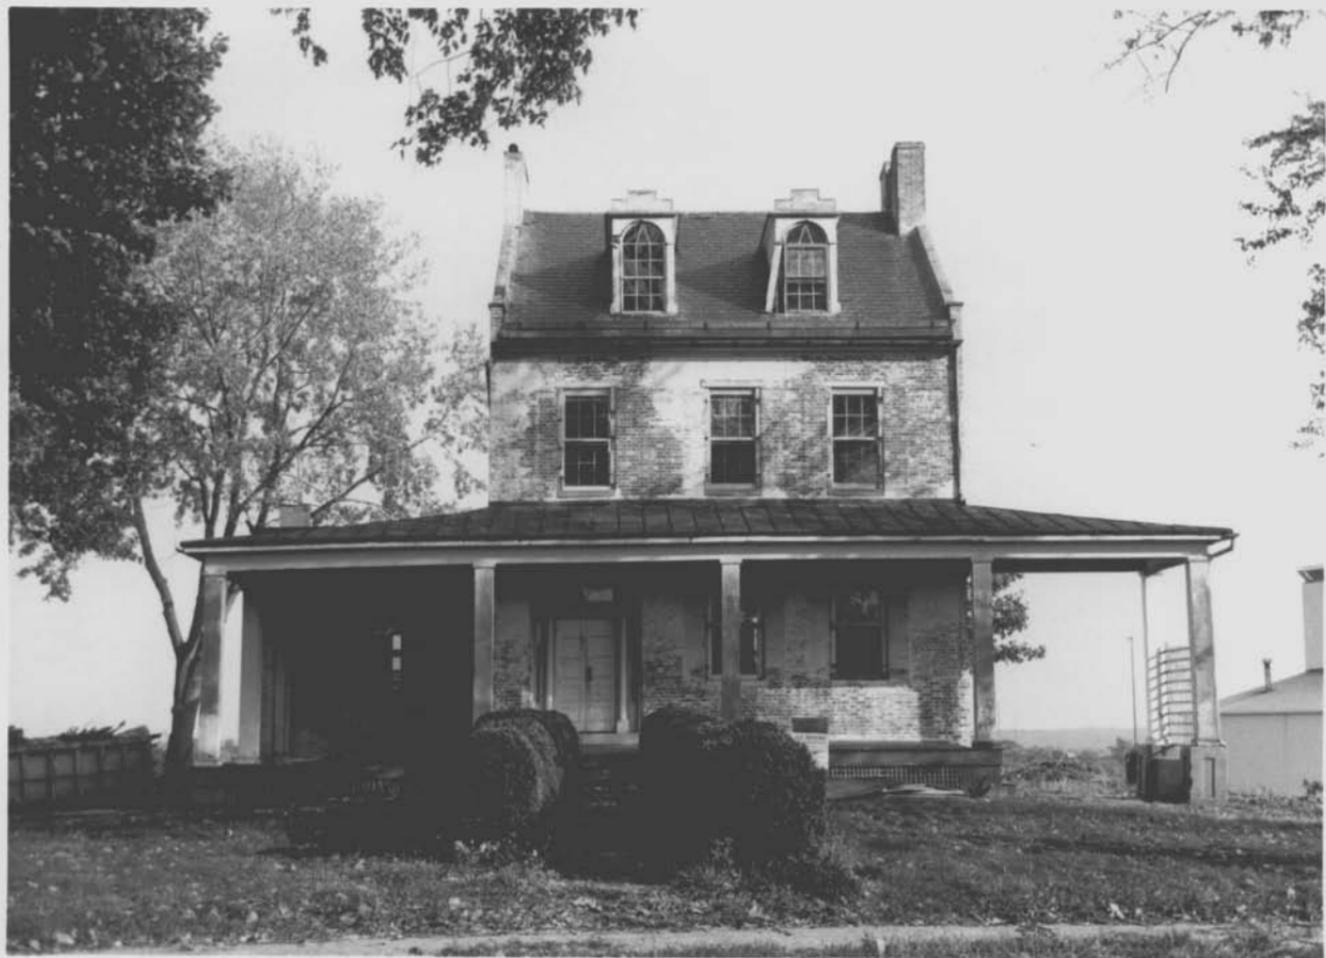
1. LINDEN GROVE
2. Frederick, Frederick Co., MD
3. Photo Date: October 1986
4. Photo by Ronald Peck
5. Neg. Location: Hagerstown, MD
Preservation Associates, Inc.
6. View: E. view, W. elevation
7. Photo #3

The front elevation of Linden Grove is very formal with a vertical orientation giving the house a tall, narrow appearance. Prominent features of the facade include Flemish bond brickwork once covered with yellowish buff paint, perhaps an original finish, beneath the present coat of white paint. Another significant feature is the entrance consisting of a two-leafed door surround by a transom and sidelights. An integral part of the entrance treatment are Doric colonettes on either side of the door. A third significant facade feature is the pair of dormers projecting from the west slope of the roof. They are gable roofed structures finished with parapets and have nine over six light arched-topped sashes. On either side of the sash are simple pilasters. Although not unique, dormers are certainly not typical in Frederick County farmhouses.

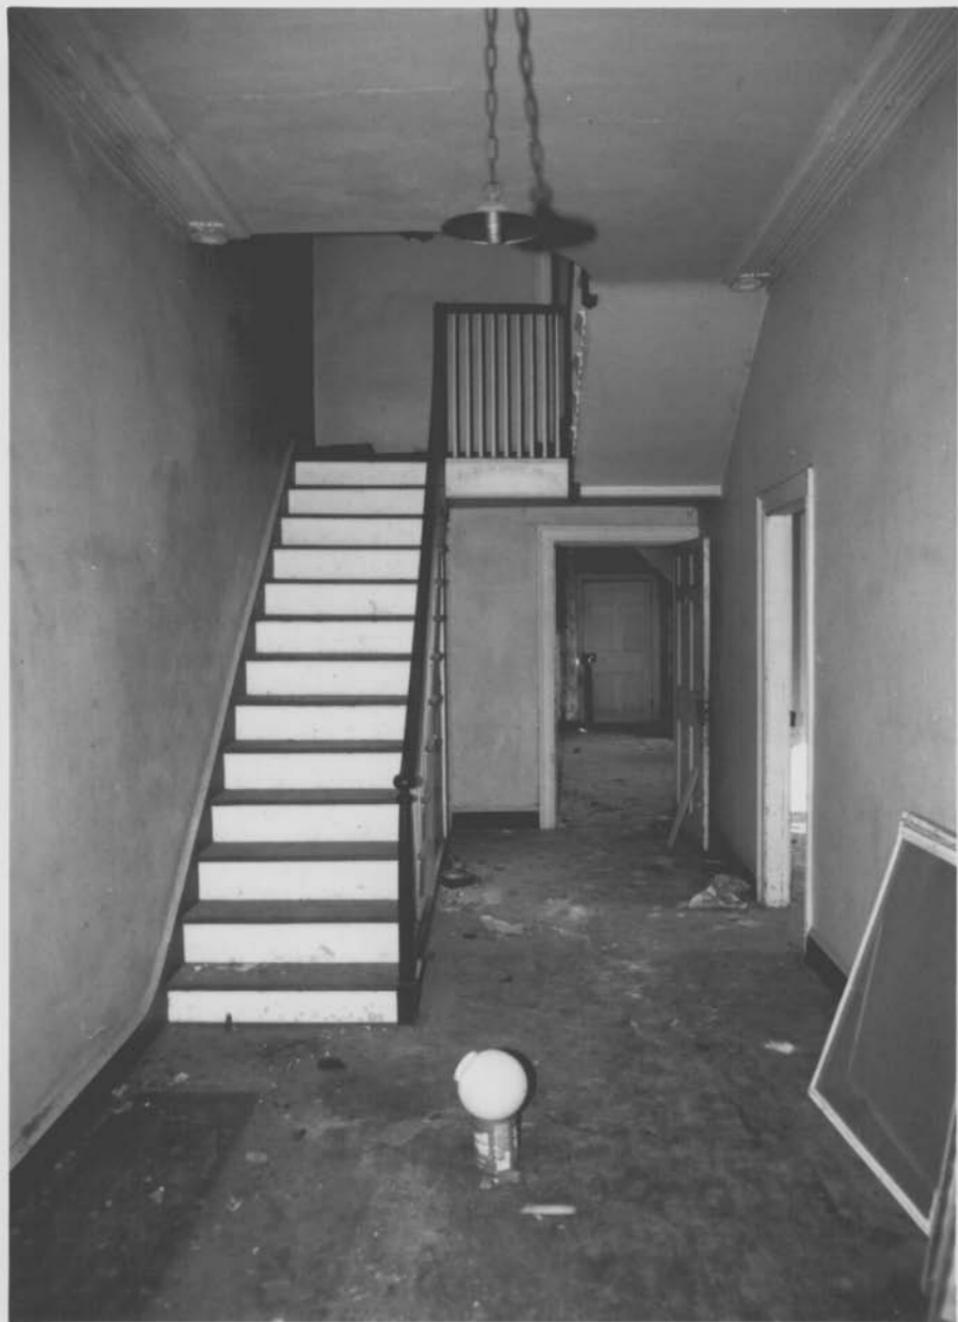
1. LINDEN GROVE
2. Frederick, Frederick Co., MD
3. Photo Date: October 1986
4. Photo by Ronald Peck
5. Neg. Location: Hagerstown, MD
Preservation Associates, Inc.
6. View: *Mam House Entrance Hall*
7. Photo # *16*

The main entrance opens into a formal stair hall which retains most of its original features, including the paint on the baseboard. Perhaps the most significant feature of the entrance hall is the molded plaster ceiling trim including rosettes and a round medallion surrounding a ceiling fixture. The staircase is Federal in appearance with an attenuated newel and balusters and delicate carving on the ends of the risers and on the spandrels.

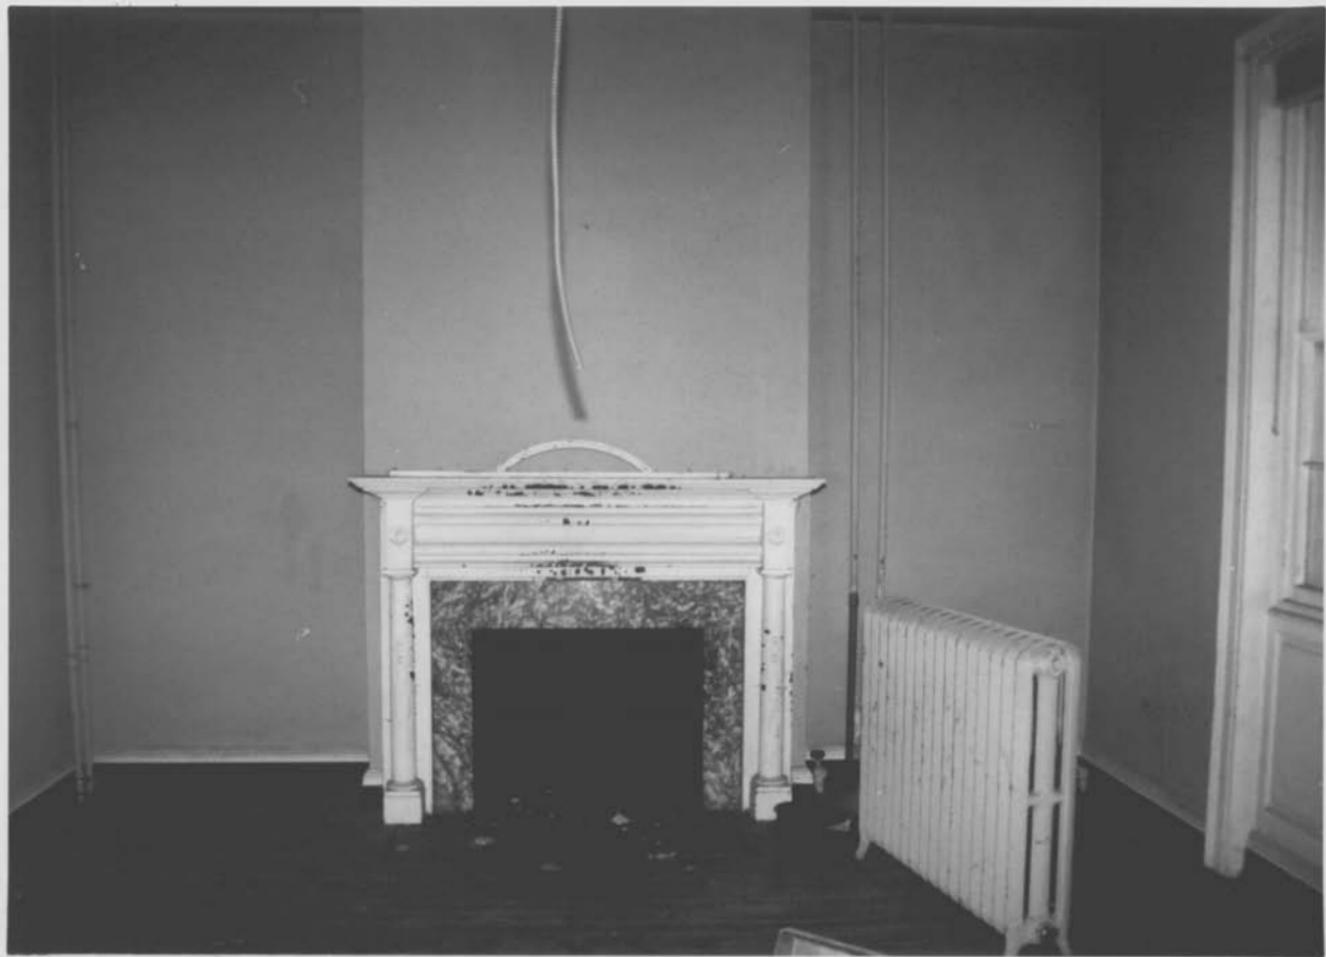
1. LINDEN GROVE
2. Frederick, Frederick Co., MD
3. Photo Date: October 1986
4. Photo by Ronald Peck
5. Neg. Location: Hagerstown, MD
Preservation Associates, Inc.
6. View: SW Parlor, Main House
7. Photo #17

Doors from the hallway open into two formal parlors, both of which retain their original trim. Prominent features of the two parlors are matching fireplaces with marble surrounds and late Federal style (with some Greek Revival style feeling) mantelpieces with Doric colonettes and bolection moldings. Windows are finished with paneled jambs and dados. The two rooms of the first story kitchen wing are much more simply appointed. The kitchen has an enclosed corner stair winding to the second floor.

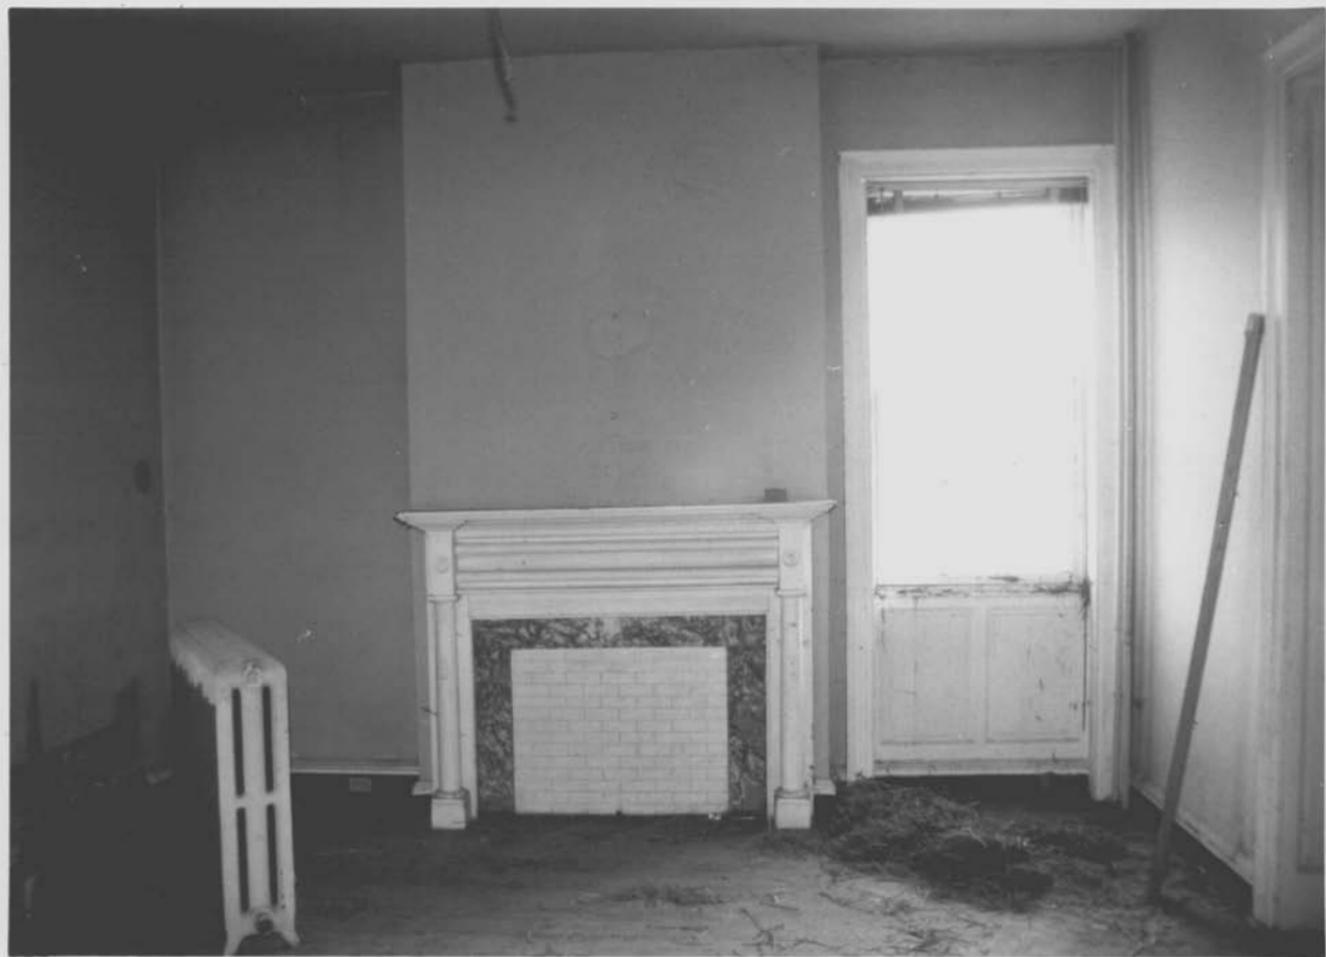
- F-3-102
1. LINDEN GROVE
 2. Frederick, Frederick Co., MD
 3. Photo Date: October 1986
 4. Photo by Ronald Peck
 5. Neg. Location: Hagerstown, MD
Preservation Associates, Inc.
 6. View: SE Parlor, Main House
 7. Photo #18

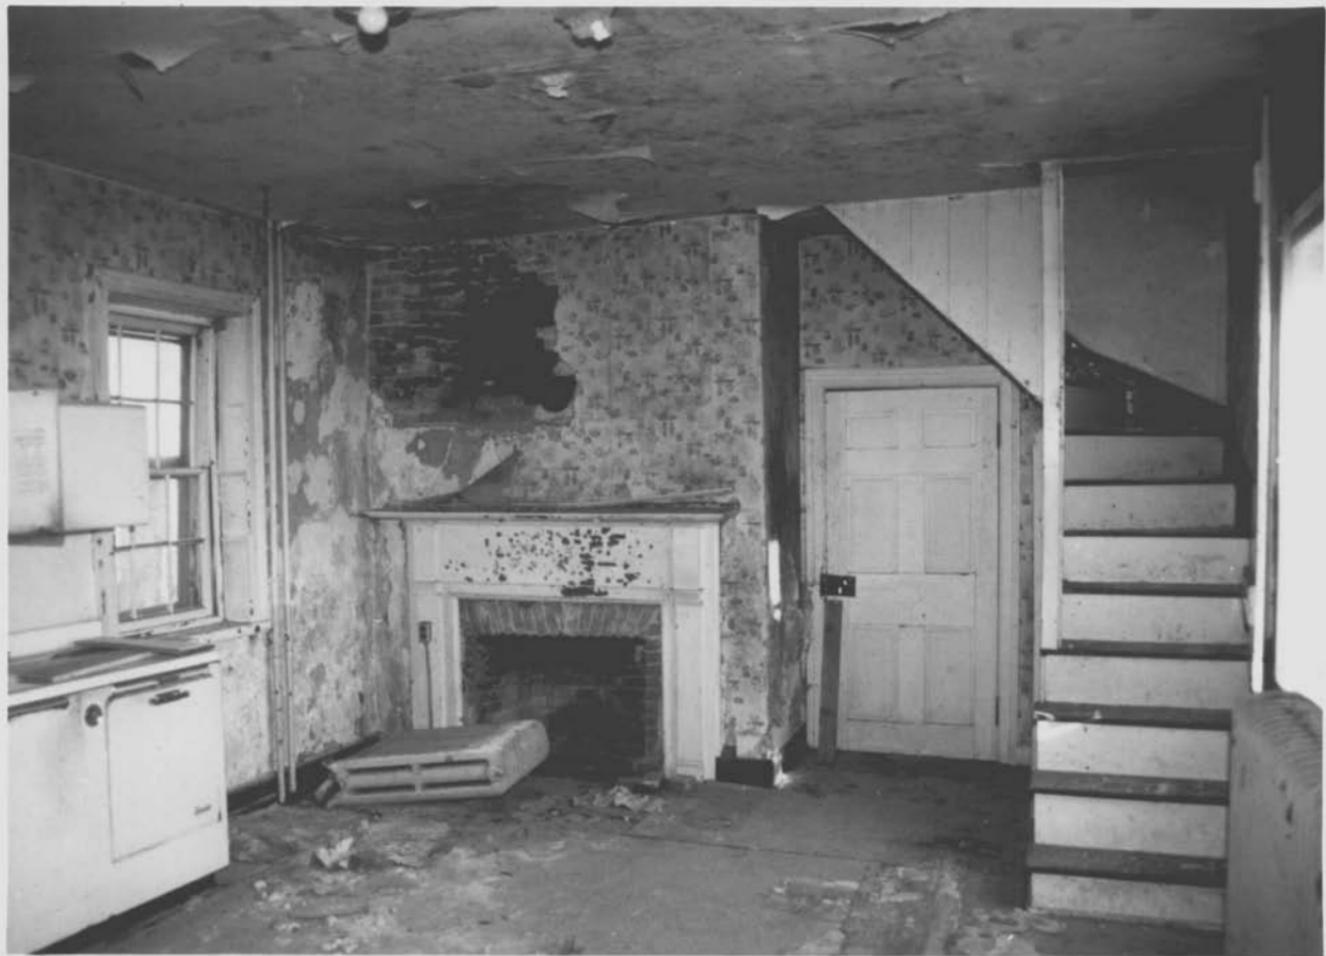
1. LINDEN GROVE
2. Frederick, Frederick Co., MD
3. Photo Date: October 1986
4. Photo by Ronald Peck
5. Neg. Location: Hagerstown, MD
Preservation Associates, Inc.
6. View: Mam House Kitchen
7. Photo #19

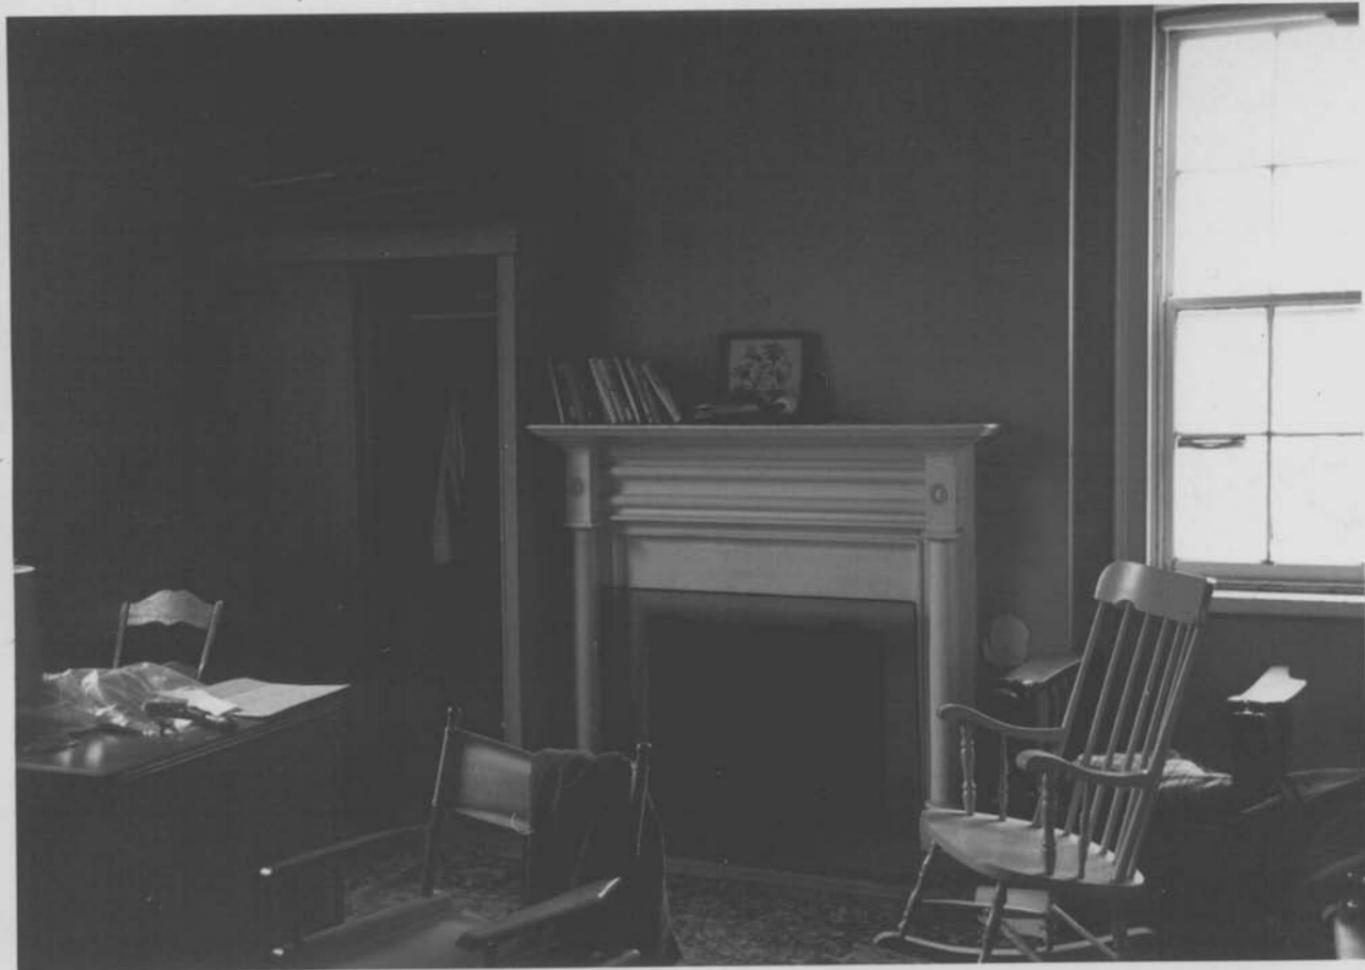
matel: 2nd floor, east chamber

The upper level has originally painted graining on the hallway floors and mantelpieces and trim similar to that of the first floor with less decorative elaboration. The attic level is finished with plastered walls and baseboards.

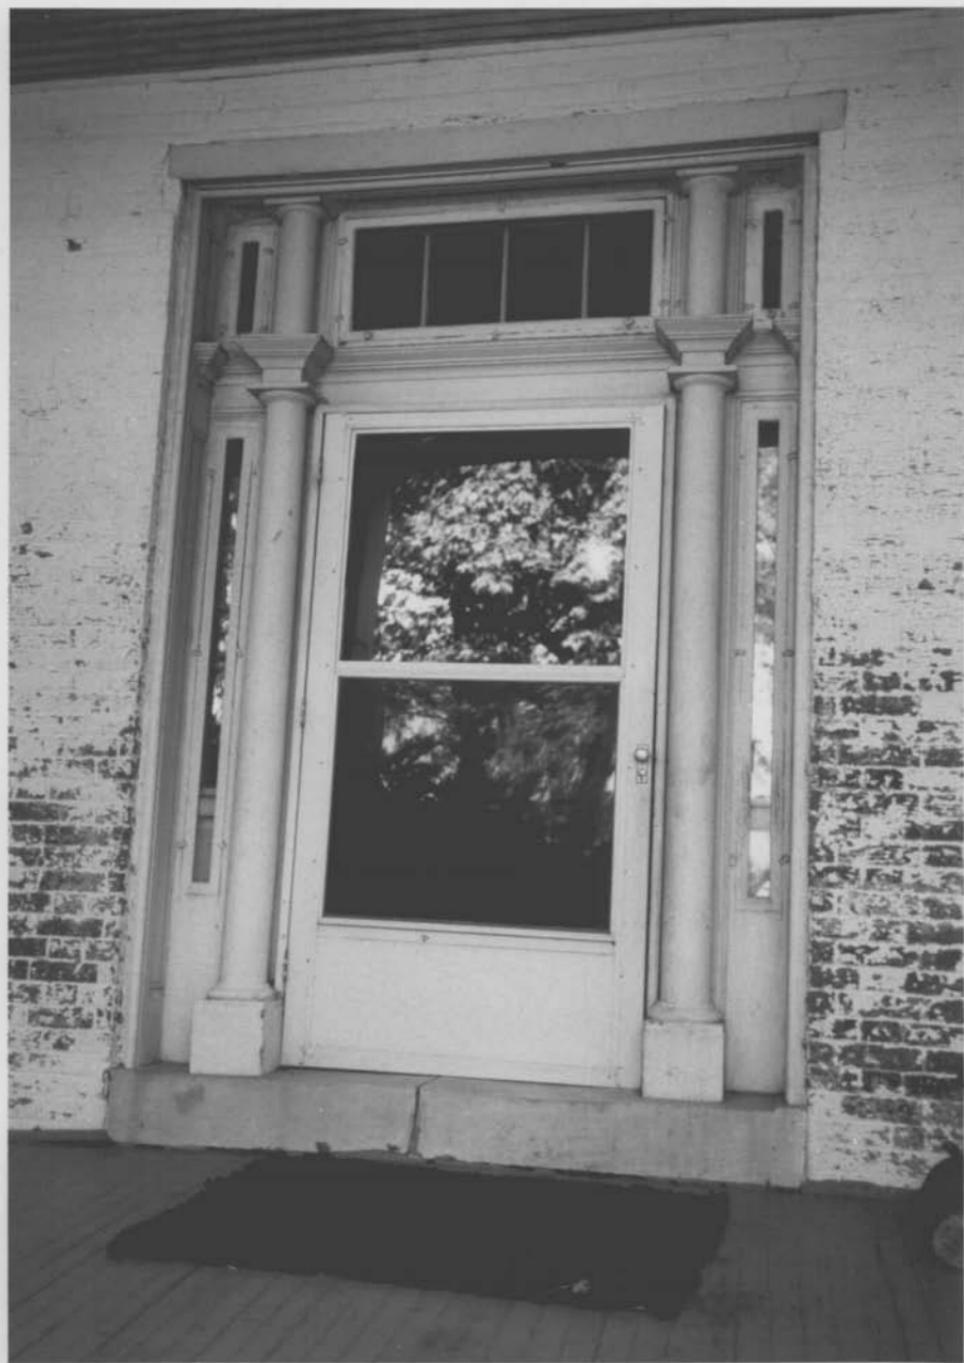
detail, main entrance

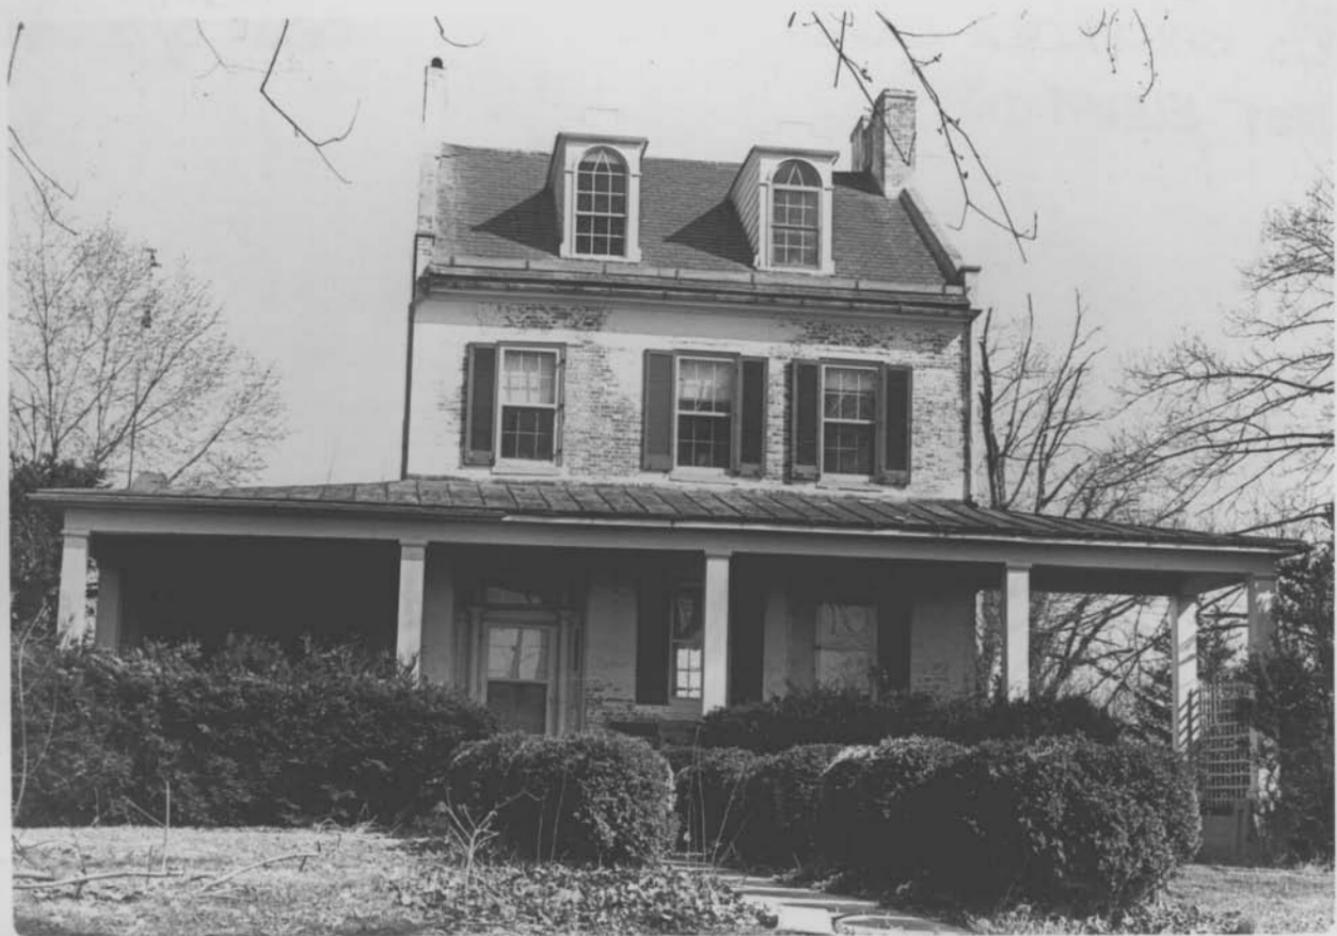
~~F-80~~ EDWARD HOWARD FARM
E/S BALLENGER CREEK PIKE
WEST ELEVATION

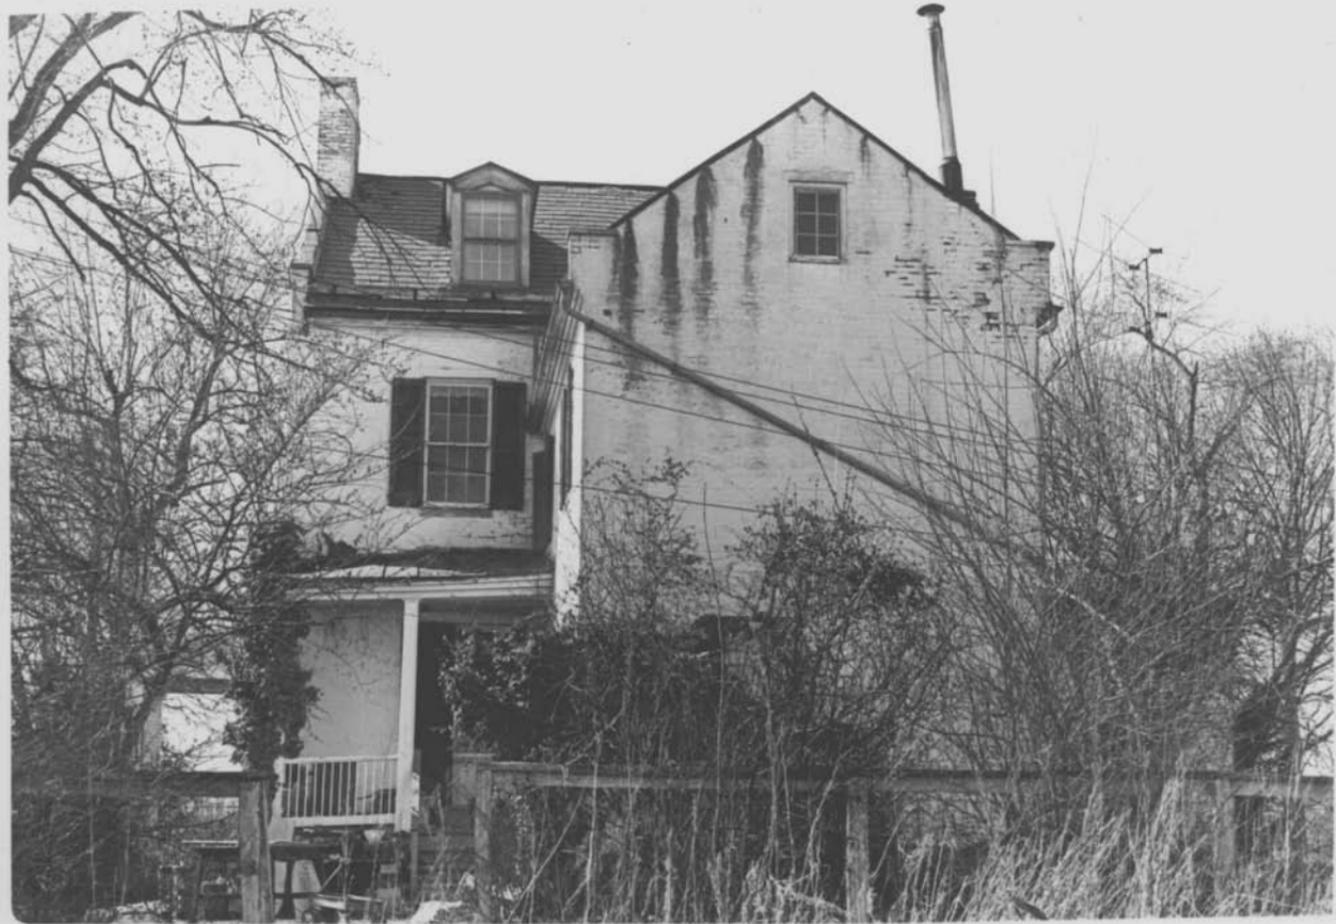
~~F-180~~ EDWARD HOWARD FARM
E/S BALENGER CREEK PIKE
EAST ELEVATION

The other elevations are much less formal in their appearance. Extending to the rear is a two story kitchen wing which is part of the original construction, but lower in height and thus less vertical in orientation. This is the service wing which contains the kitchen on the first story with secondary bedrooms above. The east slope of the main house roof has a single gabled dormer, an original structure but much simpler than those on the front elevation. Added to the rear of the house is a small early 20th century porch and an original window in the main house was enlarged to include sidelights and a jib door beneath.
