INDIVIDUAL PROPERTY/DISTRICT  
MARYLAND HISTORICAL TRUST  
INTERNAL NR-ELIGIBILITY REVIEW FORM

Property/District Name: BARC Potable Water System Survey Number: PG-61-23

Project: Proposed Demolition of Well Houses Agency: F/USDA

Beltsville Agricultural Research Center Water System

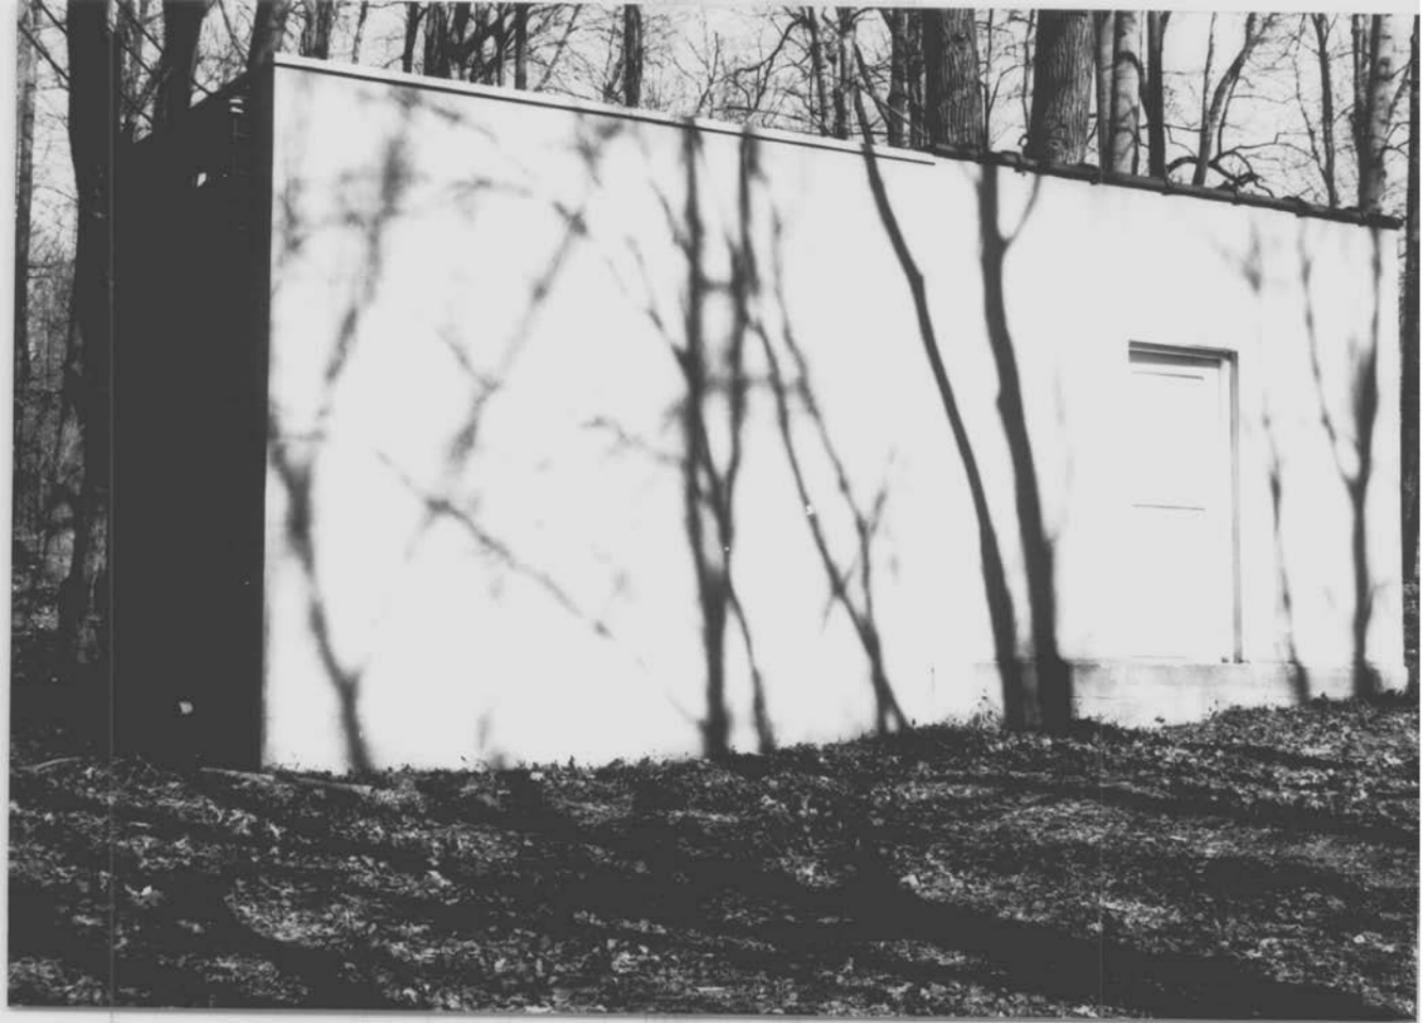
2/25

PG 61-23  
WATER SYSTEM BARC EAST  
PRINCE GEORGE, MARYLAND  
CAROL HOOPER, FEBRUARY  
NEGATIVE AT MD SHPO  
FRONT VIEW OF WELL HOUSE B 240  
(WELL #5)

Well House B 240 is similar to B 157A in its concrete construction. Constructed in 1938, it was roughly doubled in size in 1977. Located southeast of Building 254 in the Poultry Area, its closest major road is Poultry Road. One side of this well house appears to have had stucco applied to its facade, while the other sides show concrete block construction. This well house appears to be divided into two distinct sections. The original section rests solidly on a concrete base and has a flat metal roof with turned edges and a wooden door on the main facade and a six-over-six window in the rear. The other section, a 1977 addition/extension, sits directly on the ground, with no apparent subfloor. This addition maintains the same roof line as the original structure on the front, but in the back, a slight drop illustrates the break between the two sections before it returns to its previous height. The addition has a window on the rear side which consists of two-over-two horizontal panes of glass with a small brick sill. This well house is abandoned.

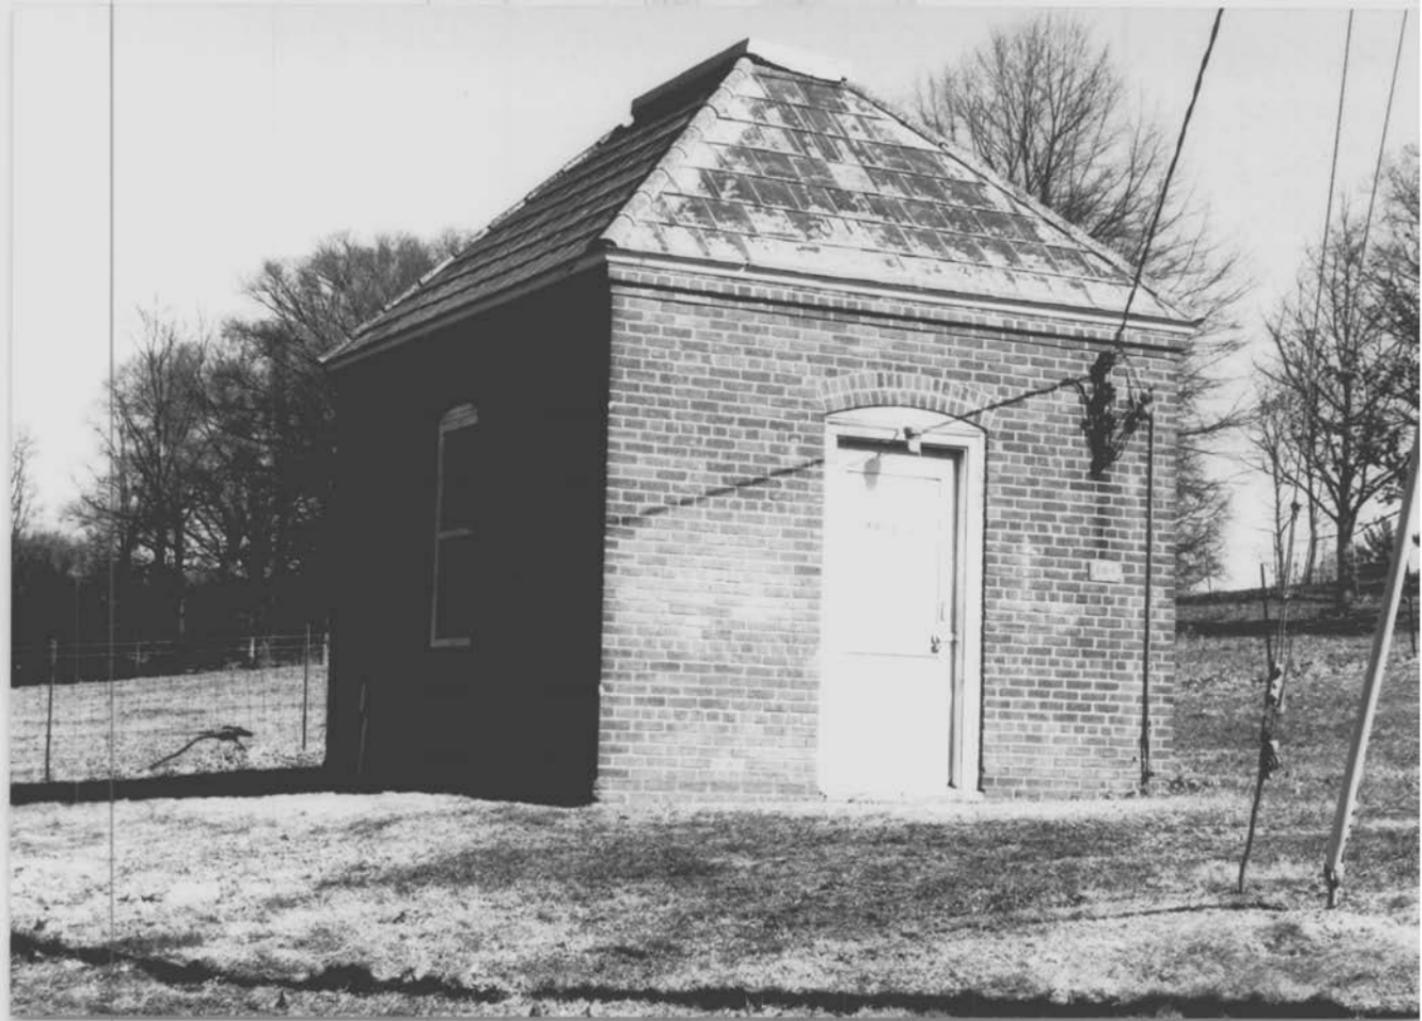
WATER SYSTEM BARC EAST  
PRINCE GEORGE, MARYLAND  
CAROL HOOPER, FEBRUARY 1996  
NEGATIVE AT MD SHPO  
FRONT VIEW OF WELL HOUSE  
B 305 (WELL #2)

Well house B 305 is a nicely detailed, simple, brick structure erected in 1938. Located northeast of the intersection of Powder Mill and Research Roads, it has a moderately pitched, hipped pyramidal roof with brick coping in the eave. The roof is sheathed in asbestos shingles and is capped with a box-like opening which was used to access the pumps inside, similar to B 287. Each corner joint on the roof is covered with a curved shingle which acts as flashing, protecting the joint from water damage. The brick, segmentally arched windows have brick sills and nine-over-six glass panes. The wooden door is set in a wooden frame with a segmental arch in the brickwork above the door. The entire structure is set on a brick base. The brick is laid in five-course American bond and appears to be in fairly good condition.

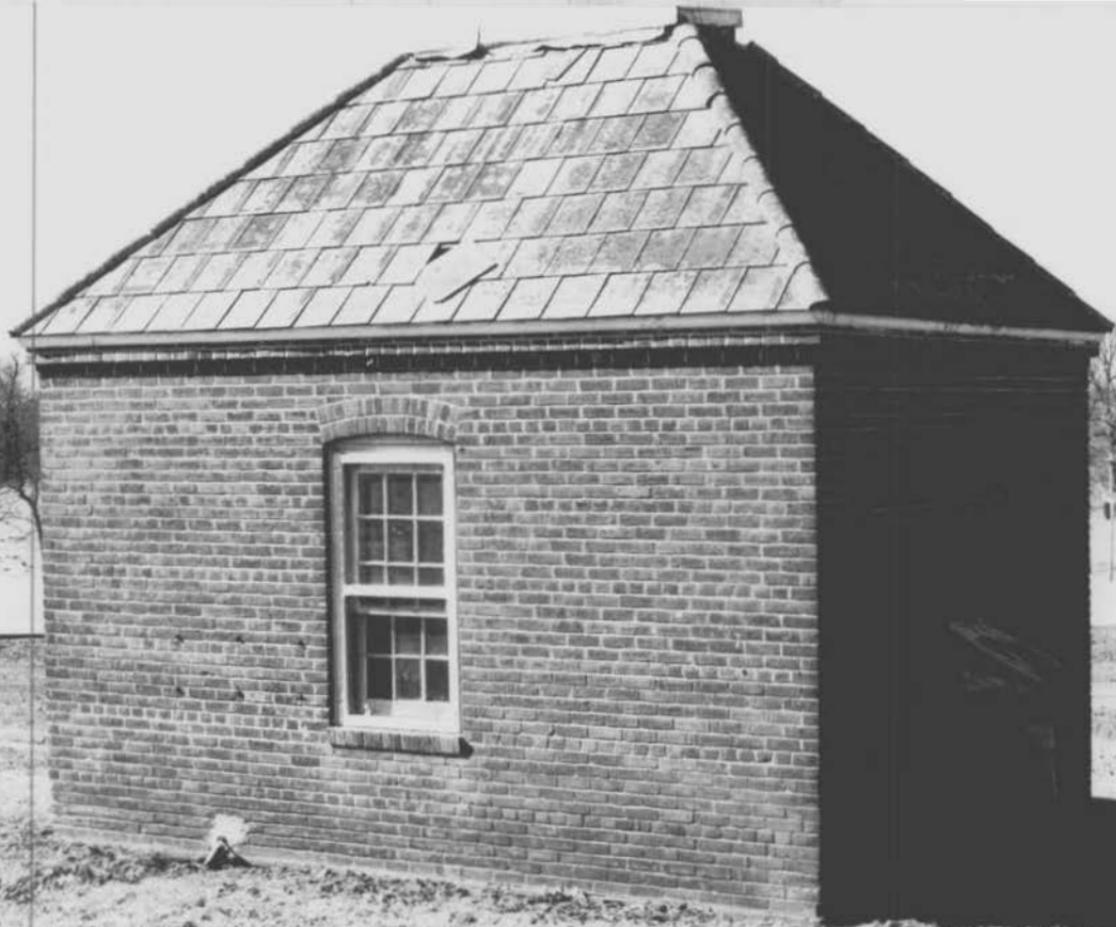
WATER SYSTEM BARC EAST  
PRINCE GEORGE, MARYLAND  
CAROL HOOPER, FEBRUARY 1996  
NEGATIVE AT MD SHFO  
REAR VIEW OF WELL B 305 (WELL #2)

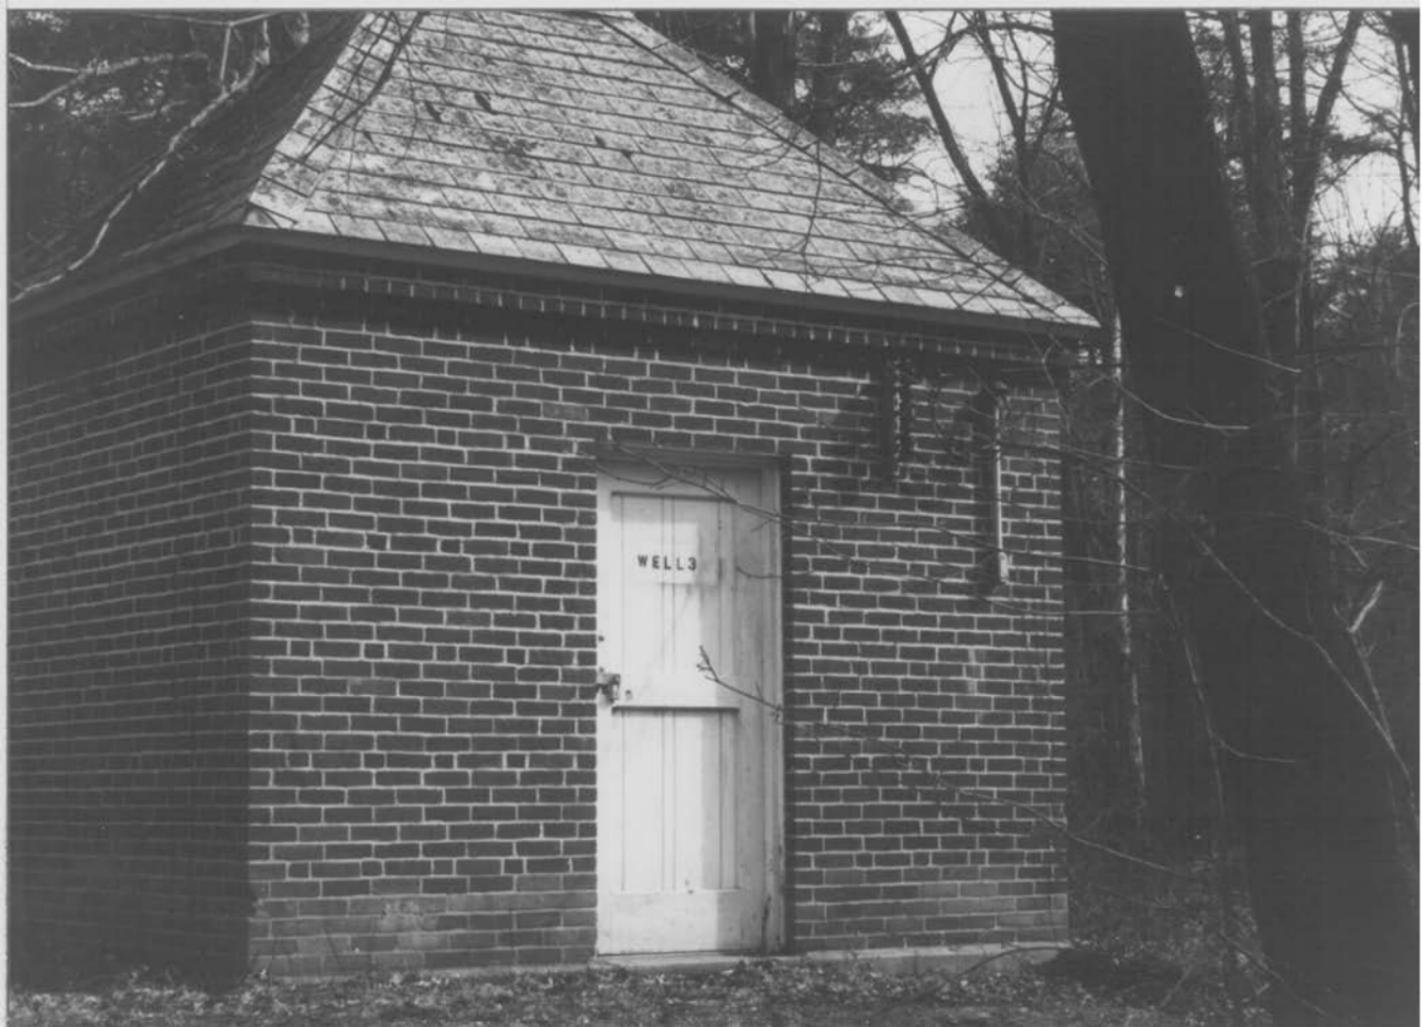
13/25

PG 61-23  
WATER SYSTEM BARC EAST  
PRINCE GEORGE, MARYLAND  
CAROL HOOPER, FEBRUARY 1996  
NEGATIVE AT MD SHPD  
FRONT FACADE OF WELL HOUSE B 314 (WELL #3)

Well House B 314 is located just off the access road, which branches off Entomology Road as it forks off to the west. This well house is an exact duplicate of Well House B 313; it features the same brick and bonding pattern, concrete base, asbestos shingle roof, access cap on side, and wooden door and window. Other than location, there are no distinguishing features to differentiate between Well House B 313 and B 314. These well houses also share the same construction date (1938.)

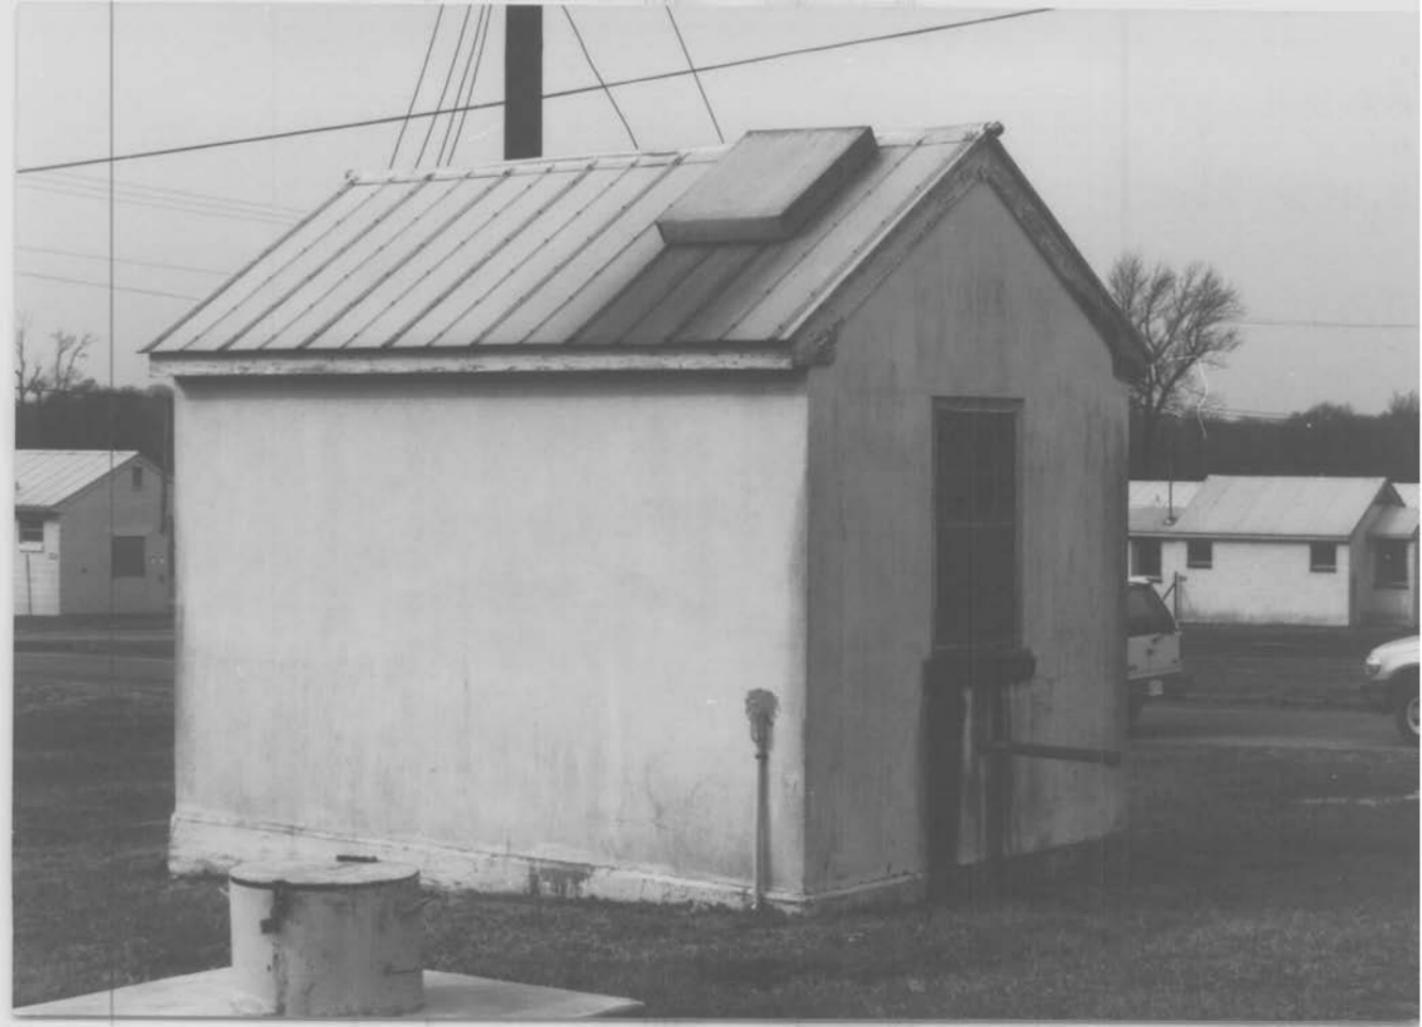
15/  
25

PG 61-23  
WATER SYSTEM BARC EAST  
PRINCE GEORGE, MARYLAND  
CAROL HOOPER, FEBRUARY 1996  
NEGATIVE AT MD SHPO  
REAR VIEW OF WELL HOUSE B 1168 (WELL #9)

Located in the Animal Parasitology Unit off Research Road, Well House B 1168 was part of the well construction that took place during 1938. This well house is set on a concrete floor with a side gabled roof and has a common wood paneled door in a wooden frame. The six-over-six window has a brick sill (perhaps a vestige of its original design) and this too is set in a wooden frame. The wooden gable has been painted and appears to be in a serious state of peeling and rotting wood. The pump access is located on the rear side of the roof.

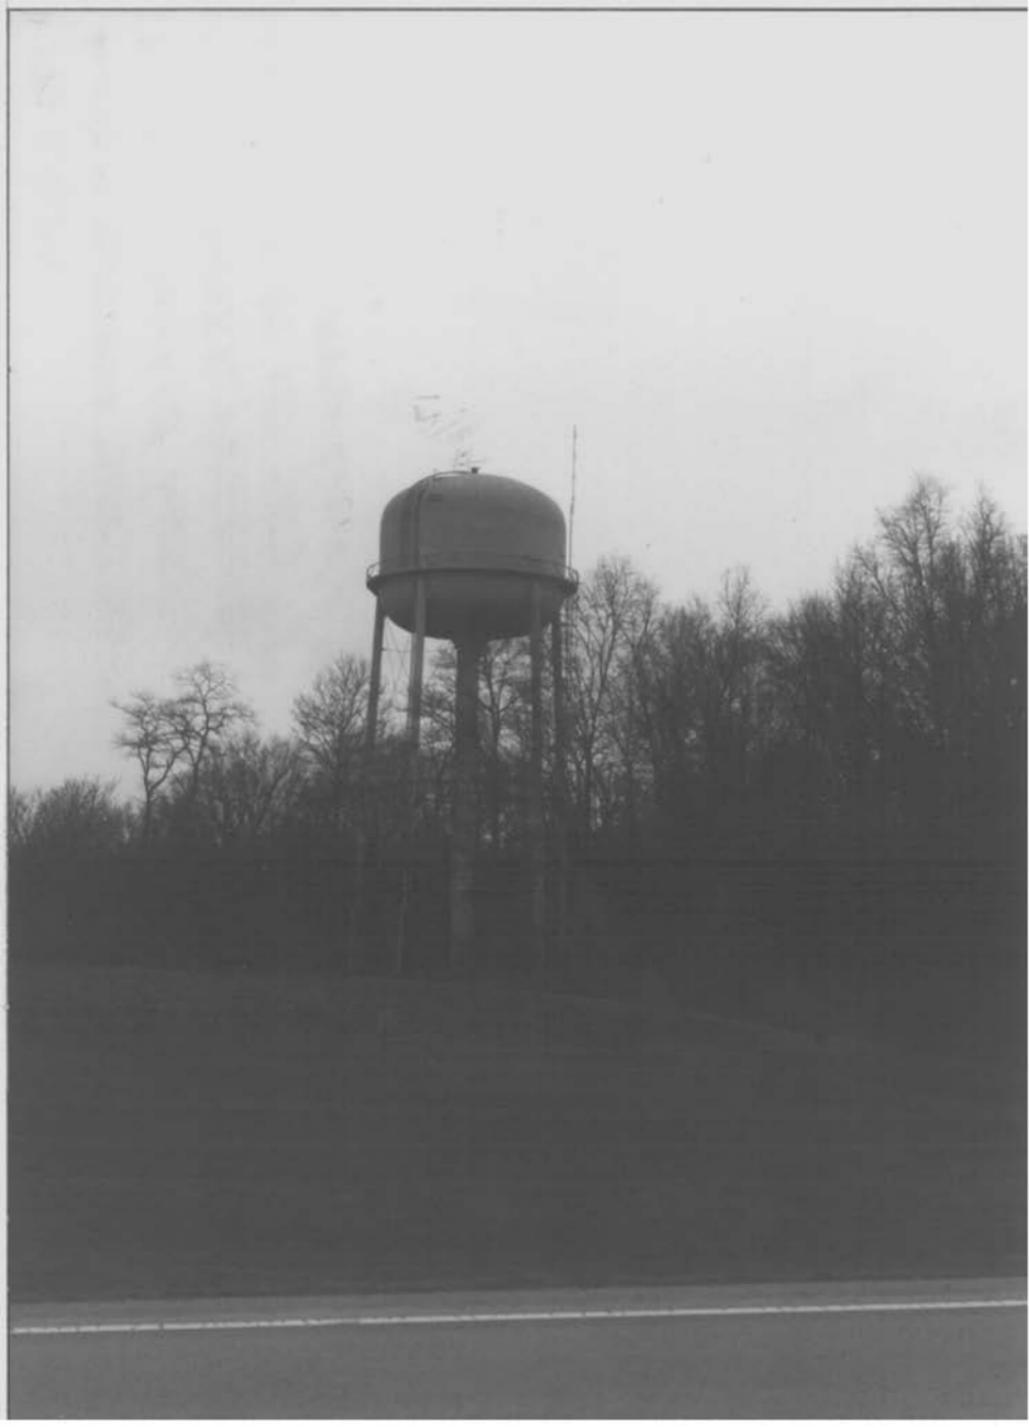
18/25

PG 61-23  
WATER SYSTEM BARC EAST  
PRINCE GEORGE, MARYLAND  
CAROL HOOPER, FEBRUARY 1996  
NEGATIVE AT MD SHPO  
ELEVATED RESERVOIR #1

Elevated Reservoirs # 1, 2, 3, 4, and 5 exhibit close similarities in their configuration. All are elevated water towers constructed of steel and raised on four iron supports with a central pipe beneath the tank and an overflow pipe. Reservoirs # 2, 3, 4, and 5 are variations of an ellipsoidal shape with slightly peaked roofs rising to a small ball finial. All four of these water towers were erected between 1935 and 1940. Elevated Reservoir # 1 was constructed in 1966 and its shape differs more substantially from those mentioned previously. Capacity of the Elevated Reservoirs varies from 25,000 gallons (Elevated Reservoir #2) to 150,000 ("Center Tower" #3) to 250,000 (Elevated Reservoir #1). The majority of the structures are in poor repair.

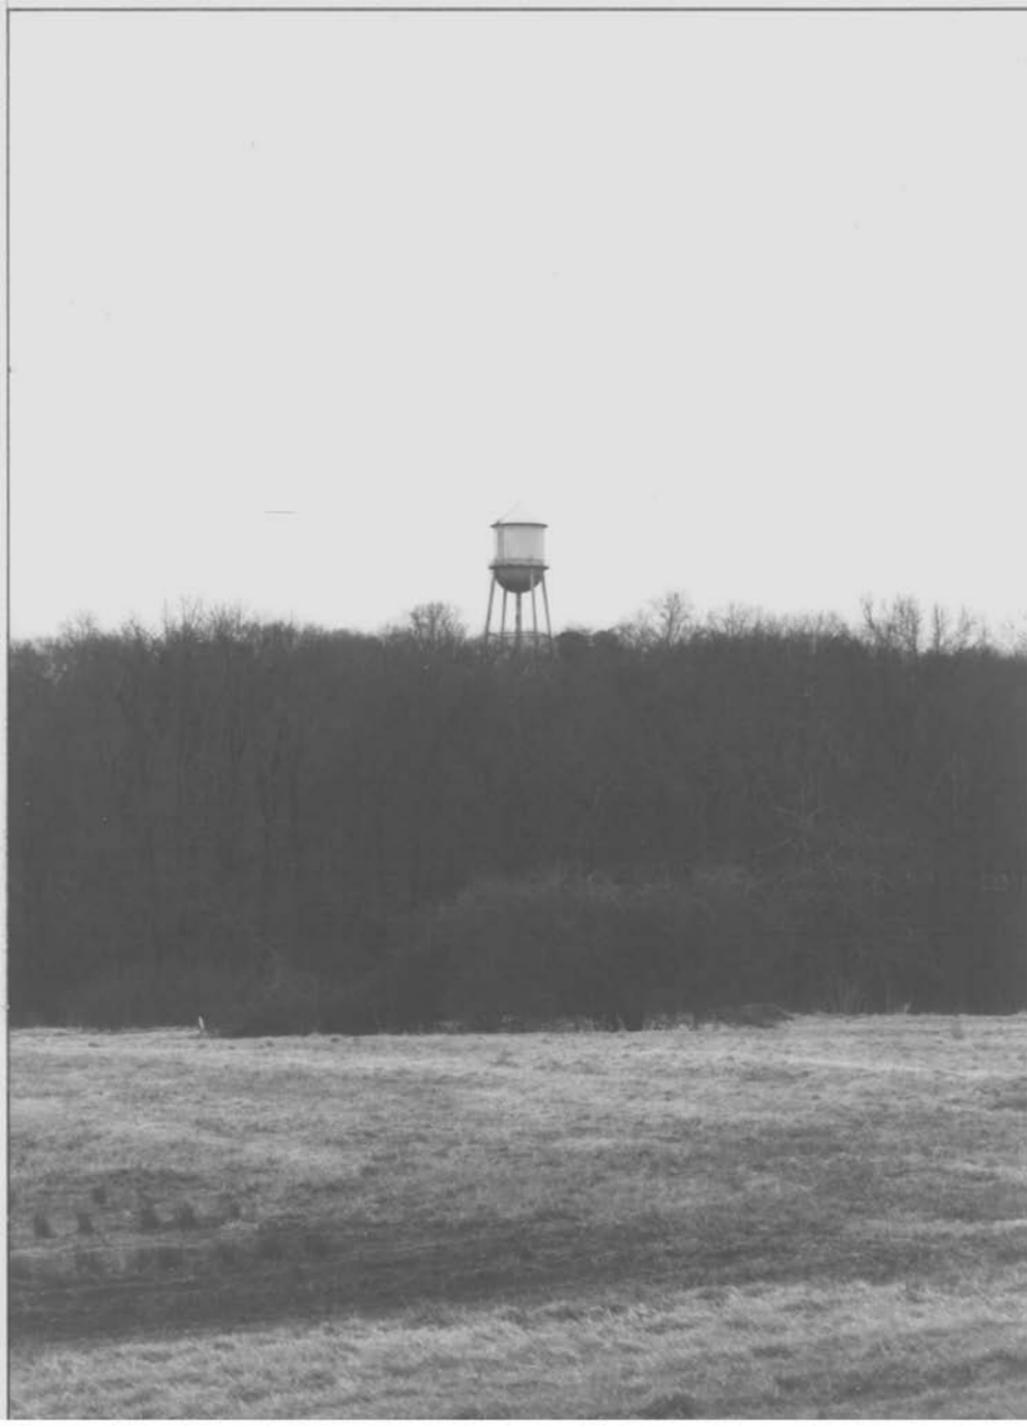
19/  
2.5

PG 61-23  
WATER SYSTEM BARC EAST  
PRINCE GEORGE, MARYLAND  
CAROL HOOPER, FEBRUARY 1996  
NEGATIVE AT MD SHPO  
ELEVATED RESERVOIR #2

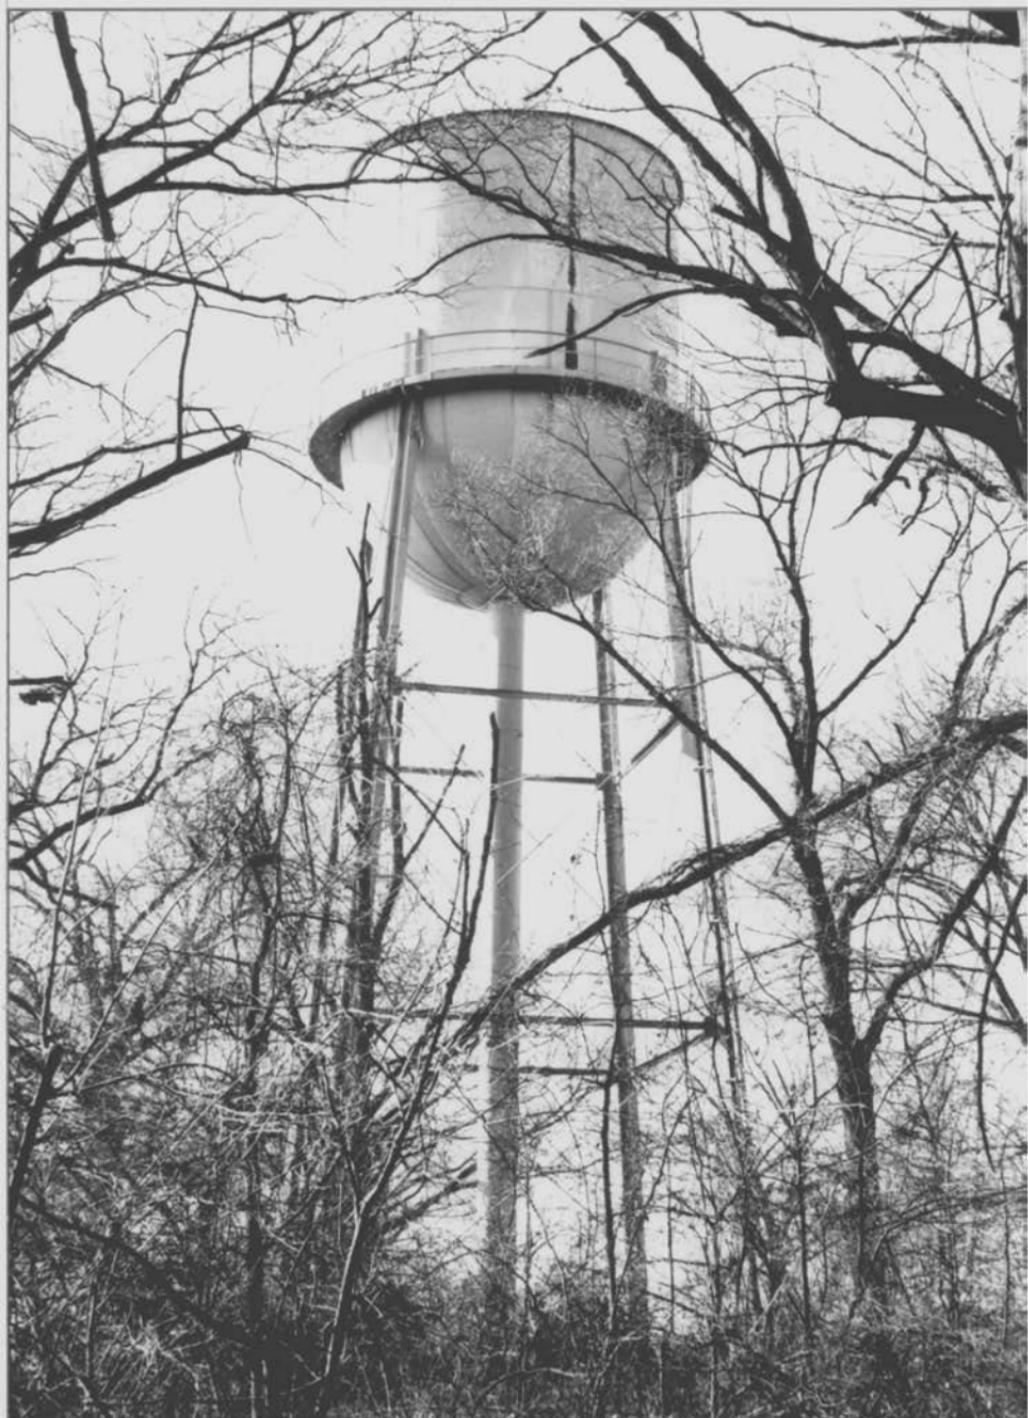
20/25

PG 61-23  
WATER SYSTEM BARC EAST  
PRINCE GEORGE, MARYLAND  
CAROL HOOPER, FEBRUARY 1996  
NEGATIVE AT MD SHPO  
ELEVATED RESERVOIR #3

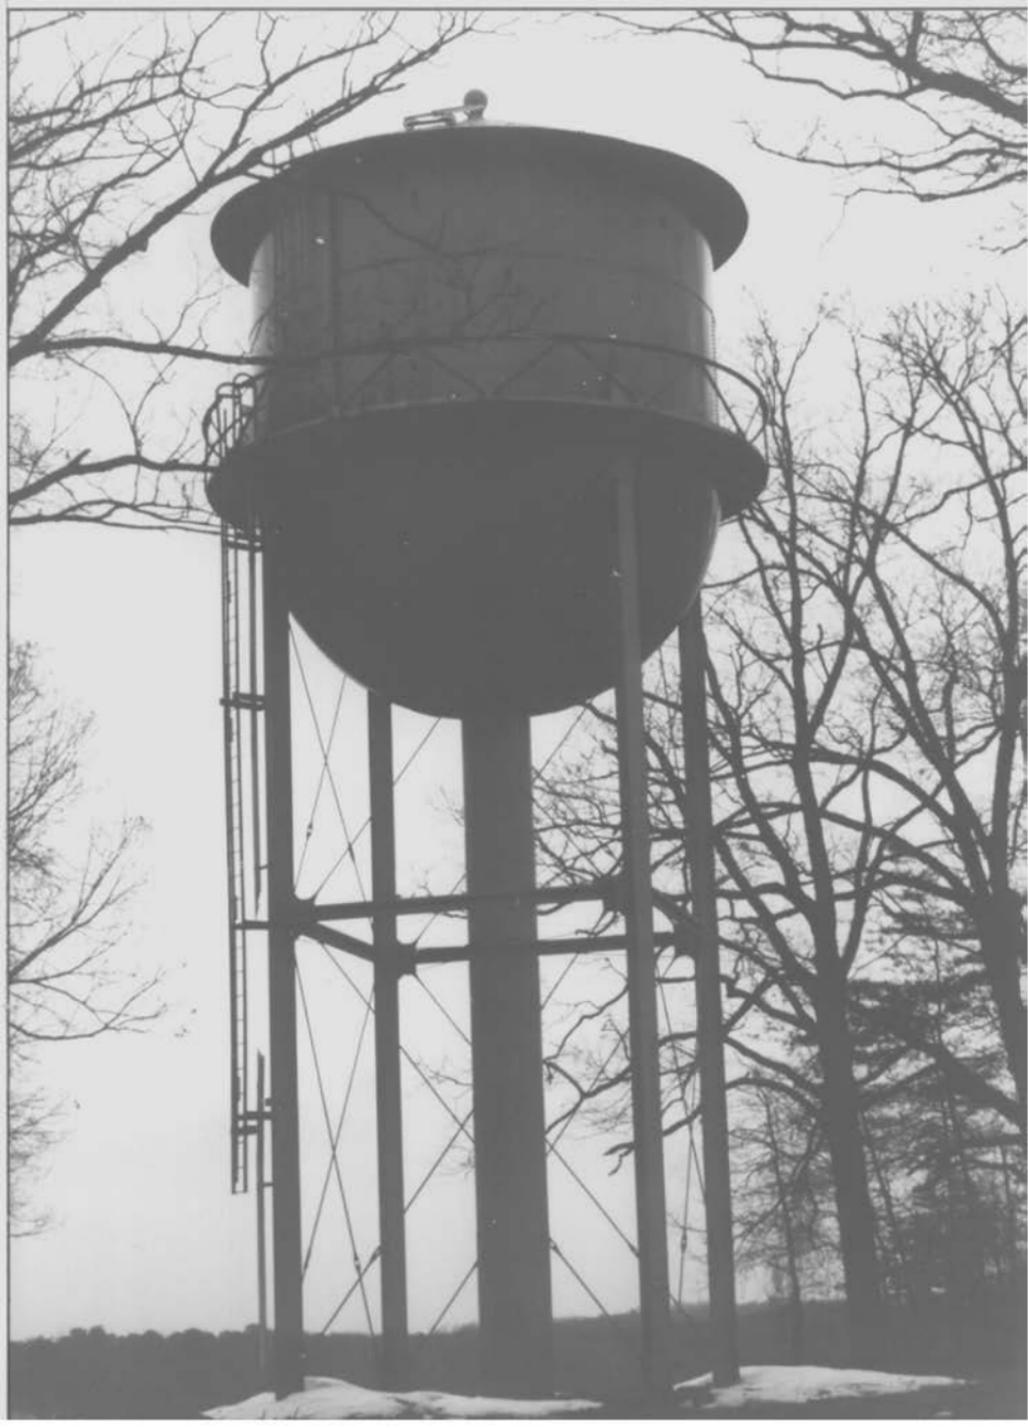
21/  
25

ELEVATED RESERVOIR #4

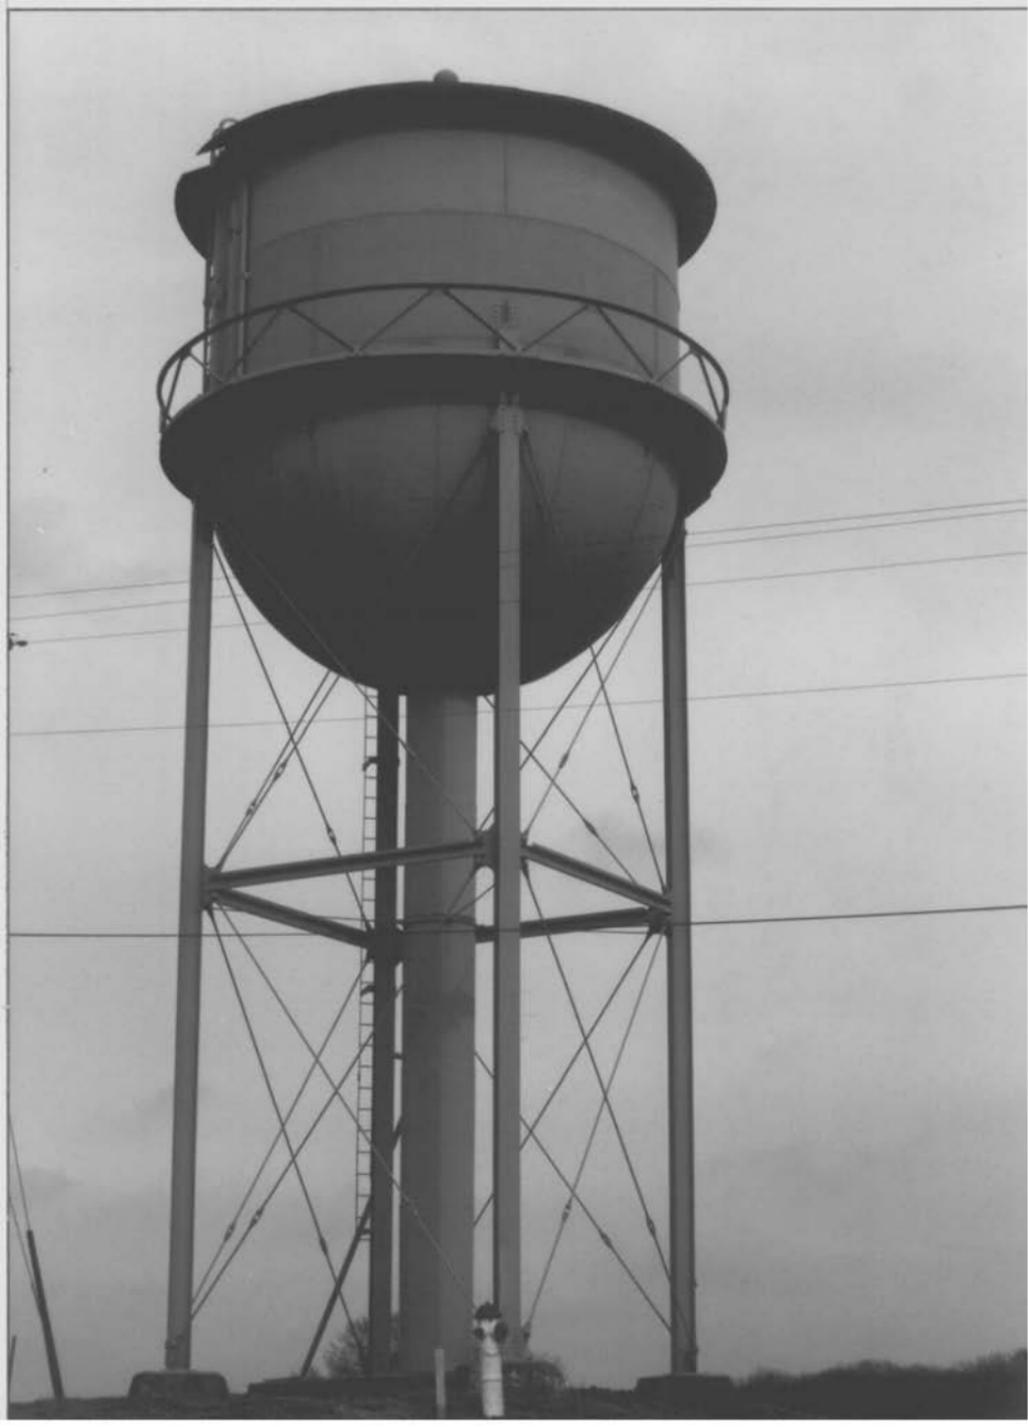
22/25

PG 61-23  
WATER SYSTEM BARC EAST  
PRINCE GEORGE, MARYLAND  
CAROL HOOPER, FEBRUARY 1996  
NEGATIVE AT MD SHPO  
ELEVATED RESERVOIR #5

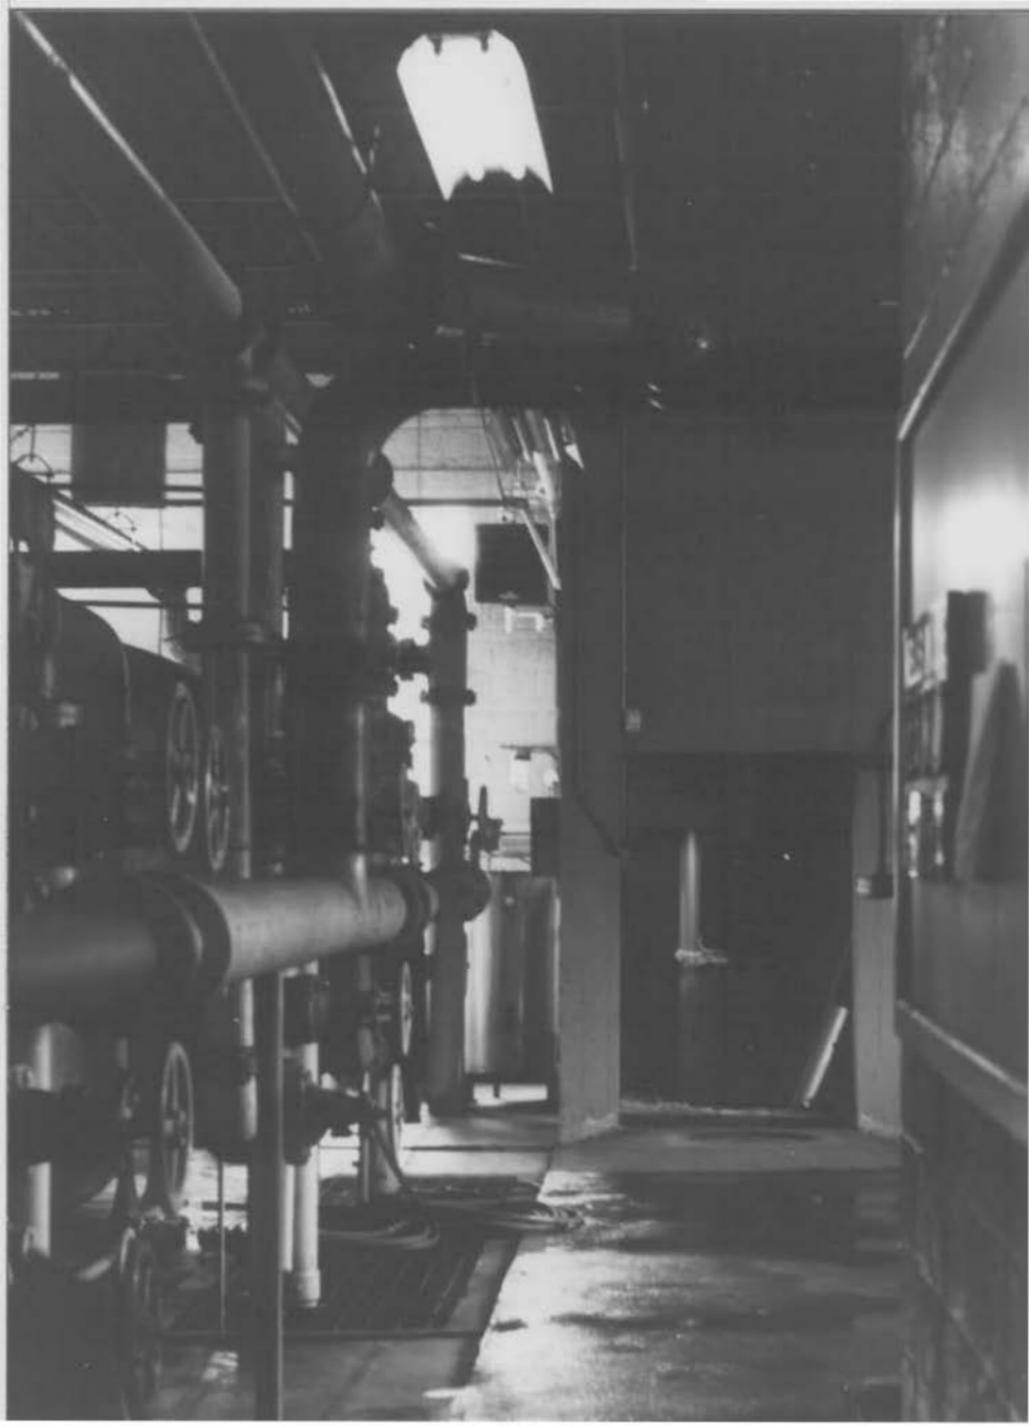
25/25

PG 61-23  
WATER SYSTEM BARC EAST  
PRINCE GEORGE, MARYLAND  
CAROL HOOPER, FEBRUARY 1996  
NEGATIVE AT MD SHPO  
INTERIOR VIEW, BUILDING 310

The water treatment facility is currently operational, as water is drawn into the building from the wells for treatment. It is then injected with chlorine to oxidize the iron, and sent through an aeration system to blow carbon dioxide and volatiles (e.g. radon) out into the atmosphere. It is then sent through a channel which adds soda ash to raise the Ph level and reduces corrosiveness. The plant has a 40,000 gallon reservoir underneath it. An electronic control system controls the pumps. The water is pumped through pressure filters to a distribution system to buildings and water towers at BARC.
