**CONTRIBUTING RESOURCE  
MARYLAND HISTORICAL TRUST  
INTERNAL NR-ELIGIBILITY REVIEW FORM**

Property Name: Maier House Bldg 531 Survey Number: P.G. #64-10

**The Maier House -- Building 531**

Beltsville Agricultural Research Center -- Beltsville, MD

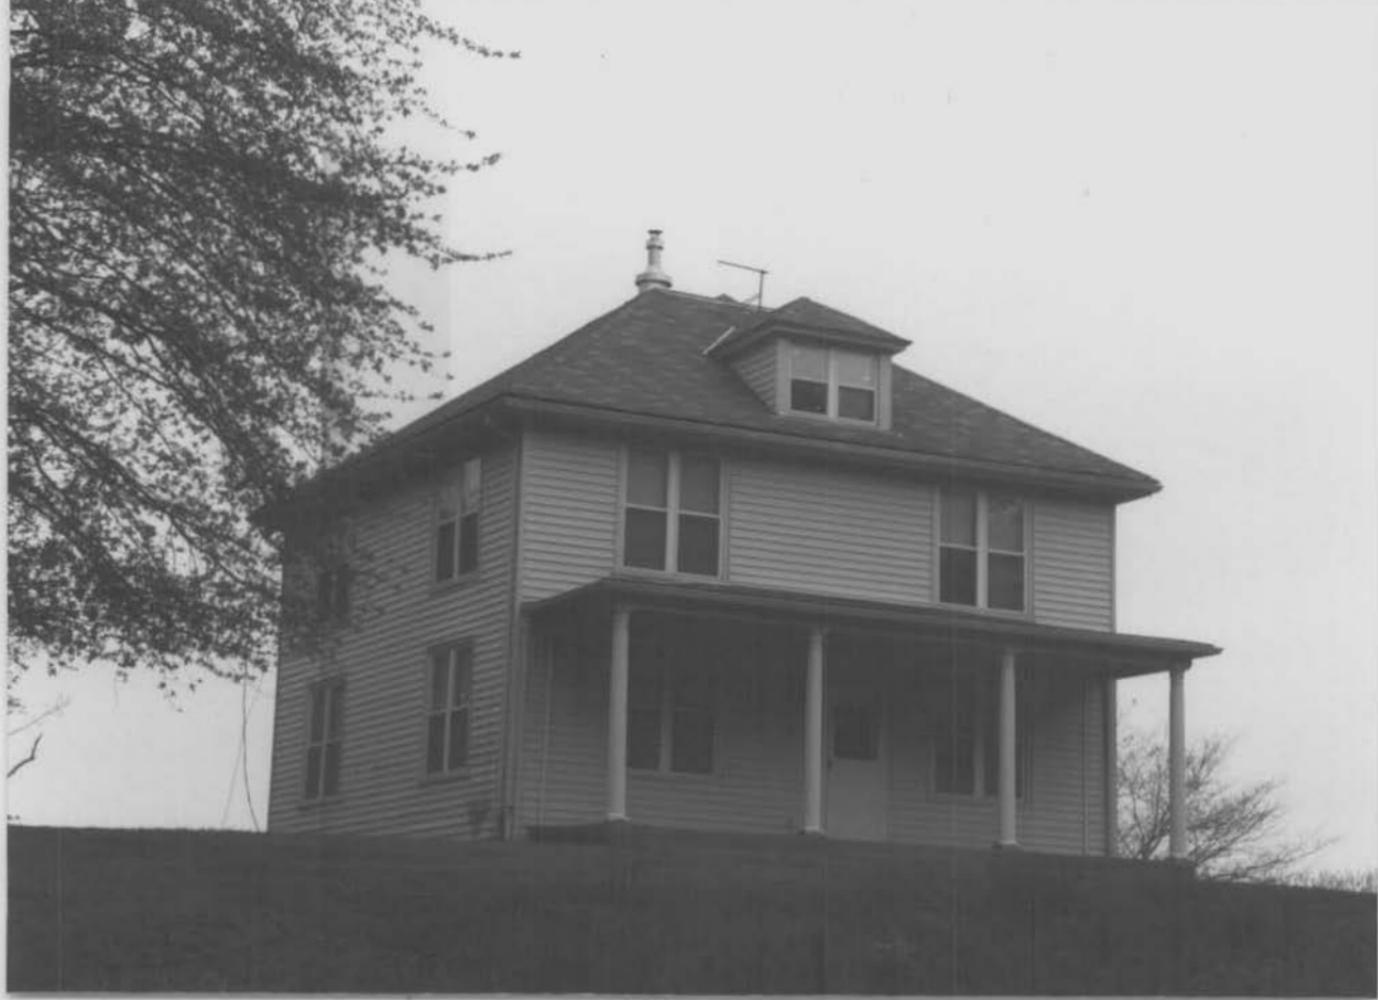
WEST FACADE, LOOKING EAST

The primary facade, which faces west, is three bays wide and features an entrance placed slightly off-center in the center bay. It consists of a small wooden door, with an exterior metal screen door. A one-story porch runs the width of this facade. Supported by four simple wood columns, the porch has a very gently sloping hipped roof. On the first story, in the outer bays, paired windows frame the central door. Likewise on the second floor, there is a paired window set in each outer bay, with no window in the center bay over the entrance door. Centered on the roofline is a projecting dormer with a pyramidal roof and paired one-over-one windows.

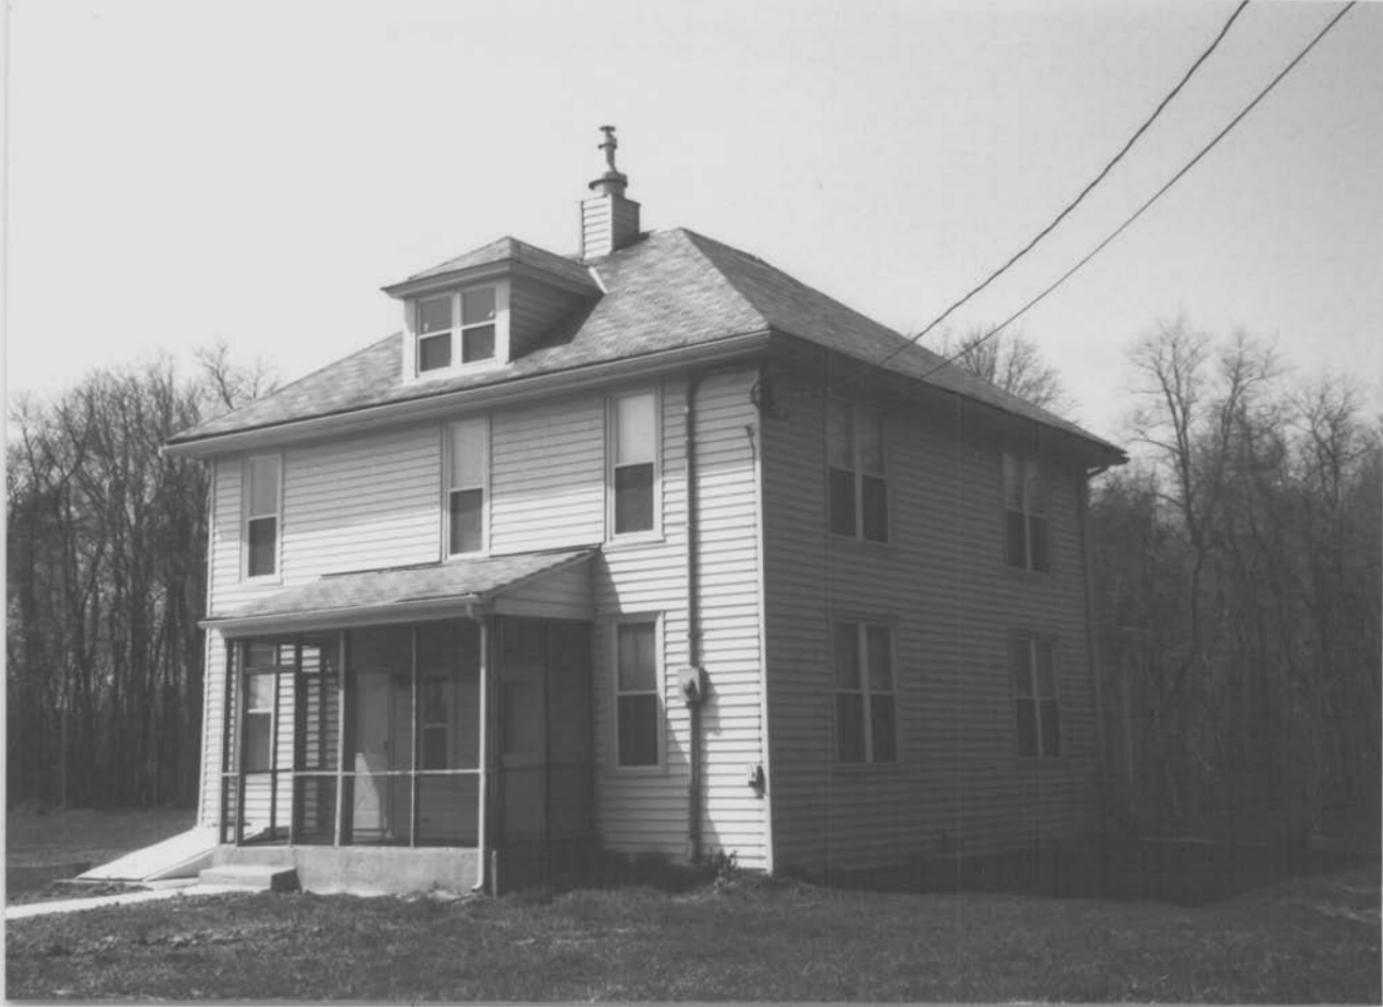
EAST + NORTH FAÇADES, LOOKING SOUTHWEST

The rear (or east) facade, which today provides primary access to the house, has two entrance doors in the central bay. Both are enclosed by a shed-roof screened porch, which sits on a raised concrete block. Between the two doors is a narrow one-over-one window. This facade, unlike the principal facade, does not have paired windows. In the outer bays, outside the screen porch, is a one-over-one window. The second floor features a single one-over-one window in each of the elevation's three bays. The center window appears slightly off center. In the center of the roofline is a projecting pyramidal-roofed dormer, with a paired one-over-one window, identical to the dormer of the west facade. At ground level, to the south of the porch, is located the entrance to the basement.

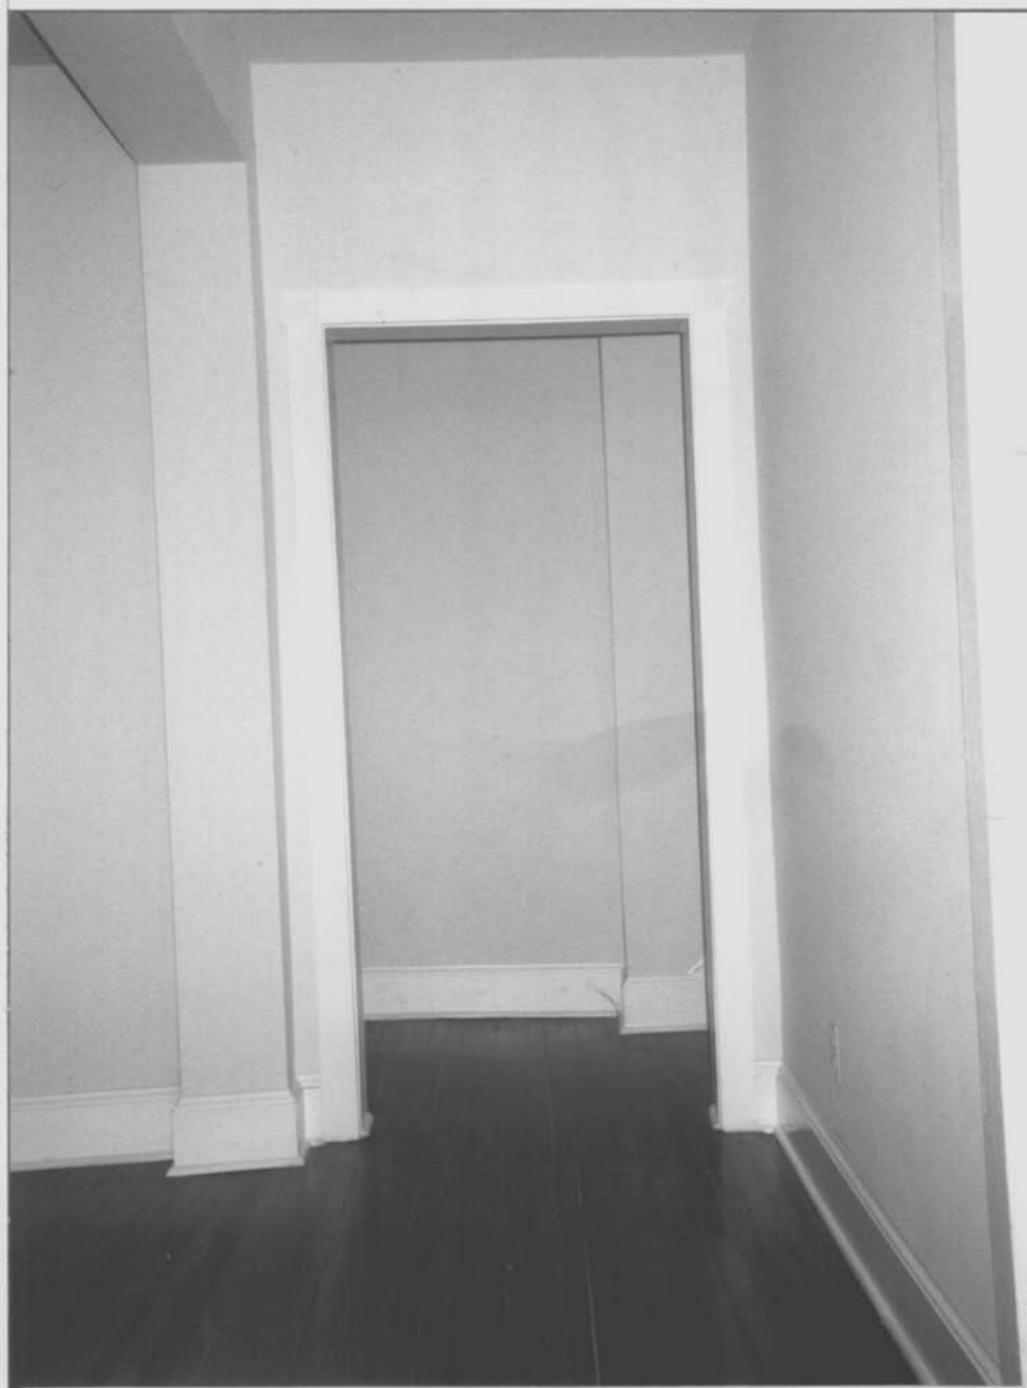
PG: 64-10

Building 531 has been extensively remodeled recently, a job that involved the replacement of all windows, a new roof and porch, and aluminum siding. The seven qualities of integrity observed by the National Park Service include location, design, setting, materials, workmanship, feeling, and association. While the house retains its integrity of location and design, most of the other criteria can no longer be met. The recent renovations have diminished the house's integrity of craftsmanship and materials. The integrity of setting, feeling, and association have also been altered by the renovations,
