Name: MD 320 (PINEY FRANCH RD) OVER NORTHWEST BR

MARYLAND INVENTORY OF HISTORIC BRIDGES
HISTORIC BRIDGE INVENTORY
MARYLAND STATE HIGHWAY ADMINISTRATION/
MARYLAND HISTORICAL TRUST

SHA Bridge No. 16065 Bridge name MD 320 (Piney Branch Road) over Northwest Branch

Bridge Type CONCRETE ARCH

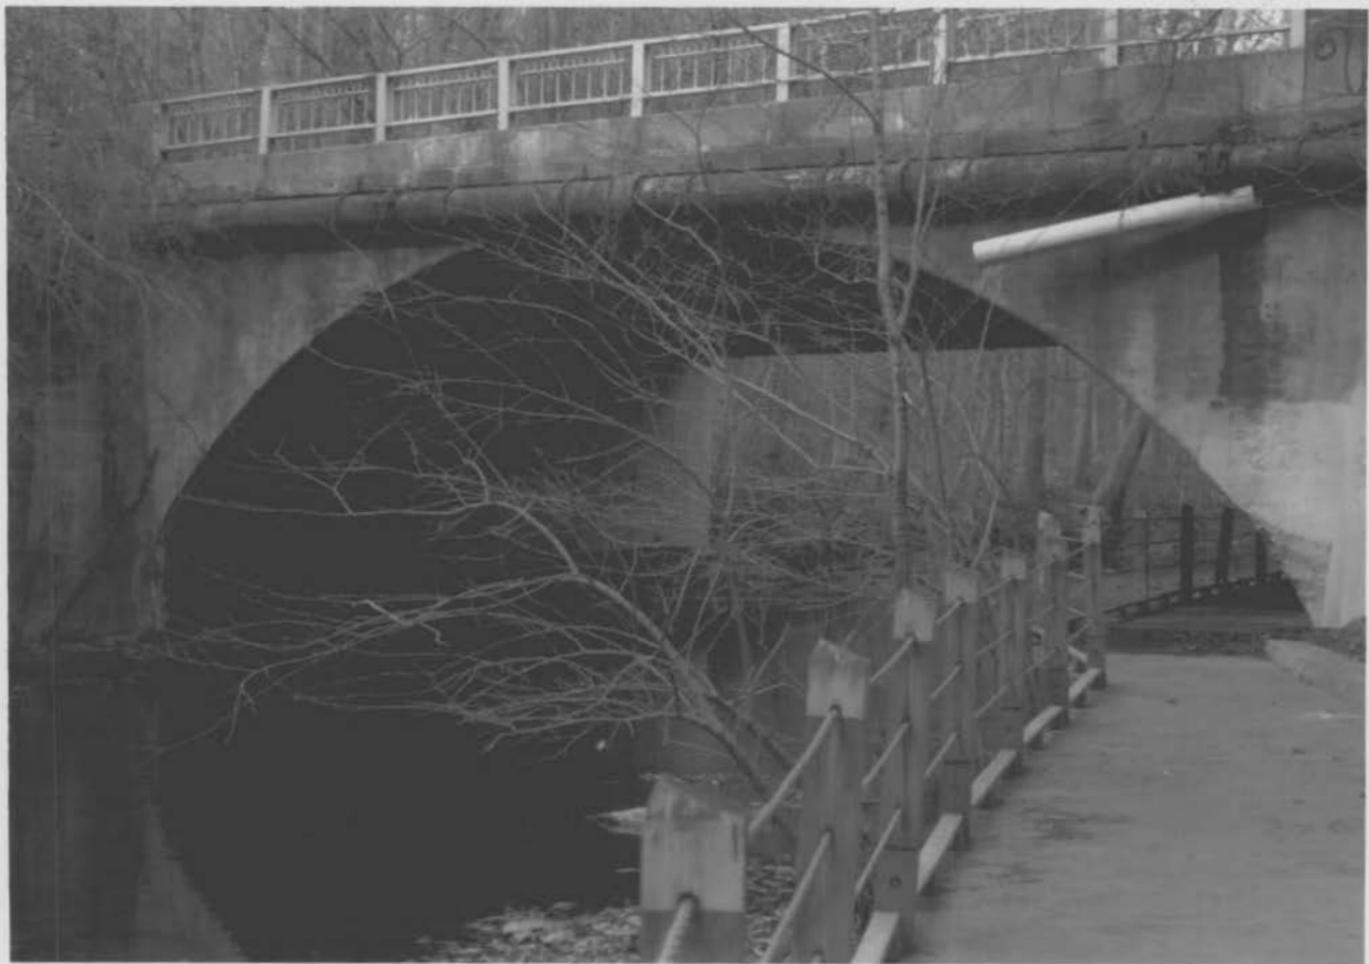
1. PG:65-23
2. MD 320 over Northwest Branch
3. Prince George's Co, MD
4. Wallace, Montgomery & Assoc.
5. 12/97
6. MD SHPO
7. Elevation looking upstream
8. 1 of 4

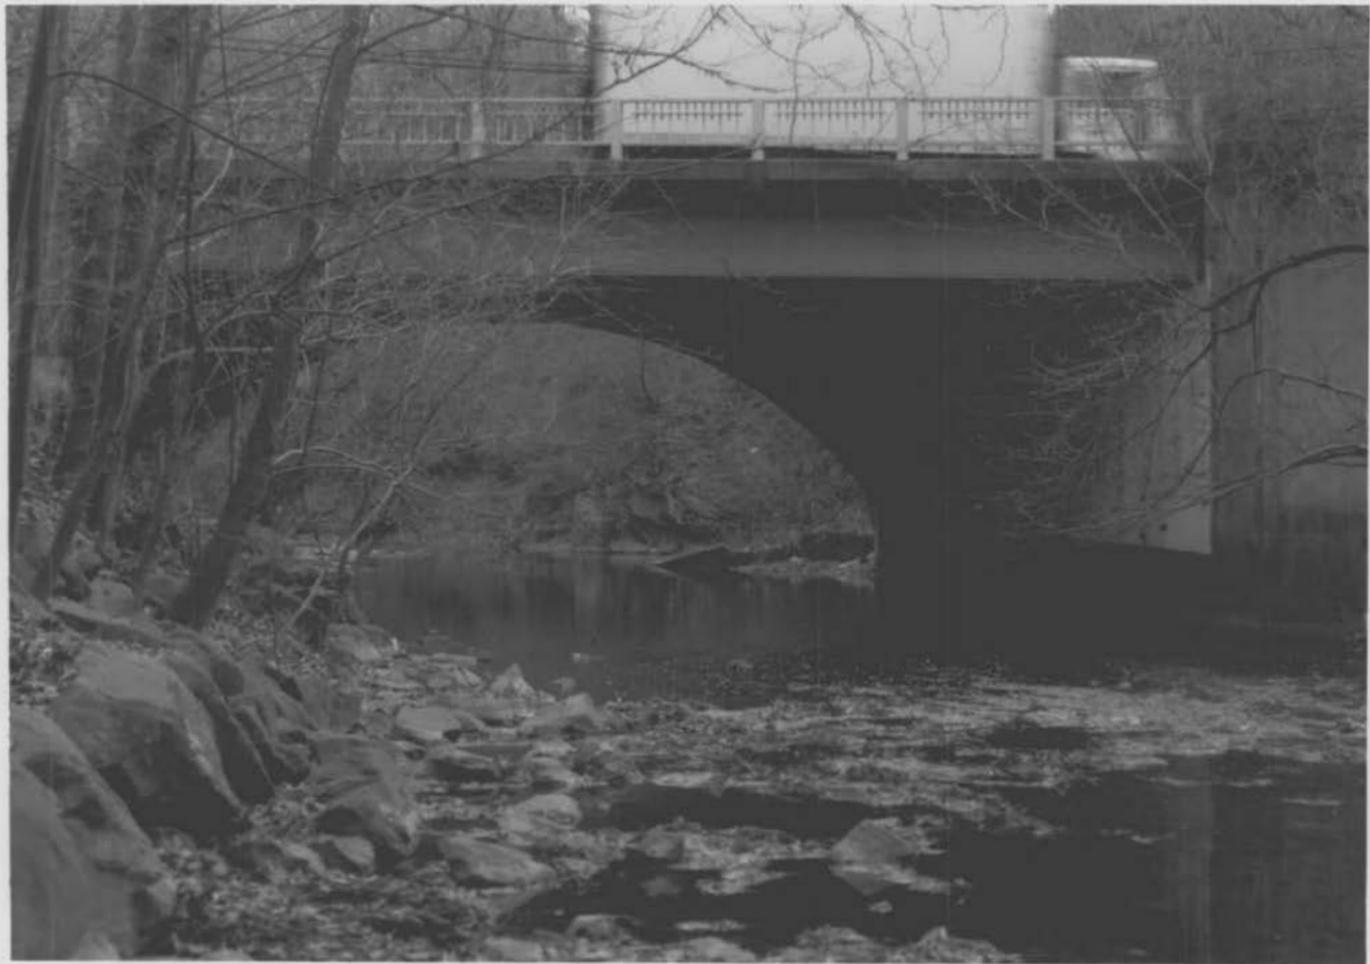
1. PG:65-23
2. MD 320 over Northwest Branch
3. Prince George's Co., MD
4. Wallace, Montgomery & Assoc.
5. 12/97
6. MD SHPO
7. Elevation looking downstream
8. 2 of 4

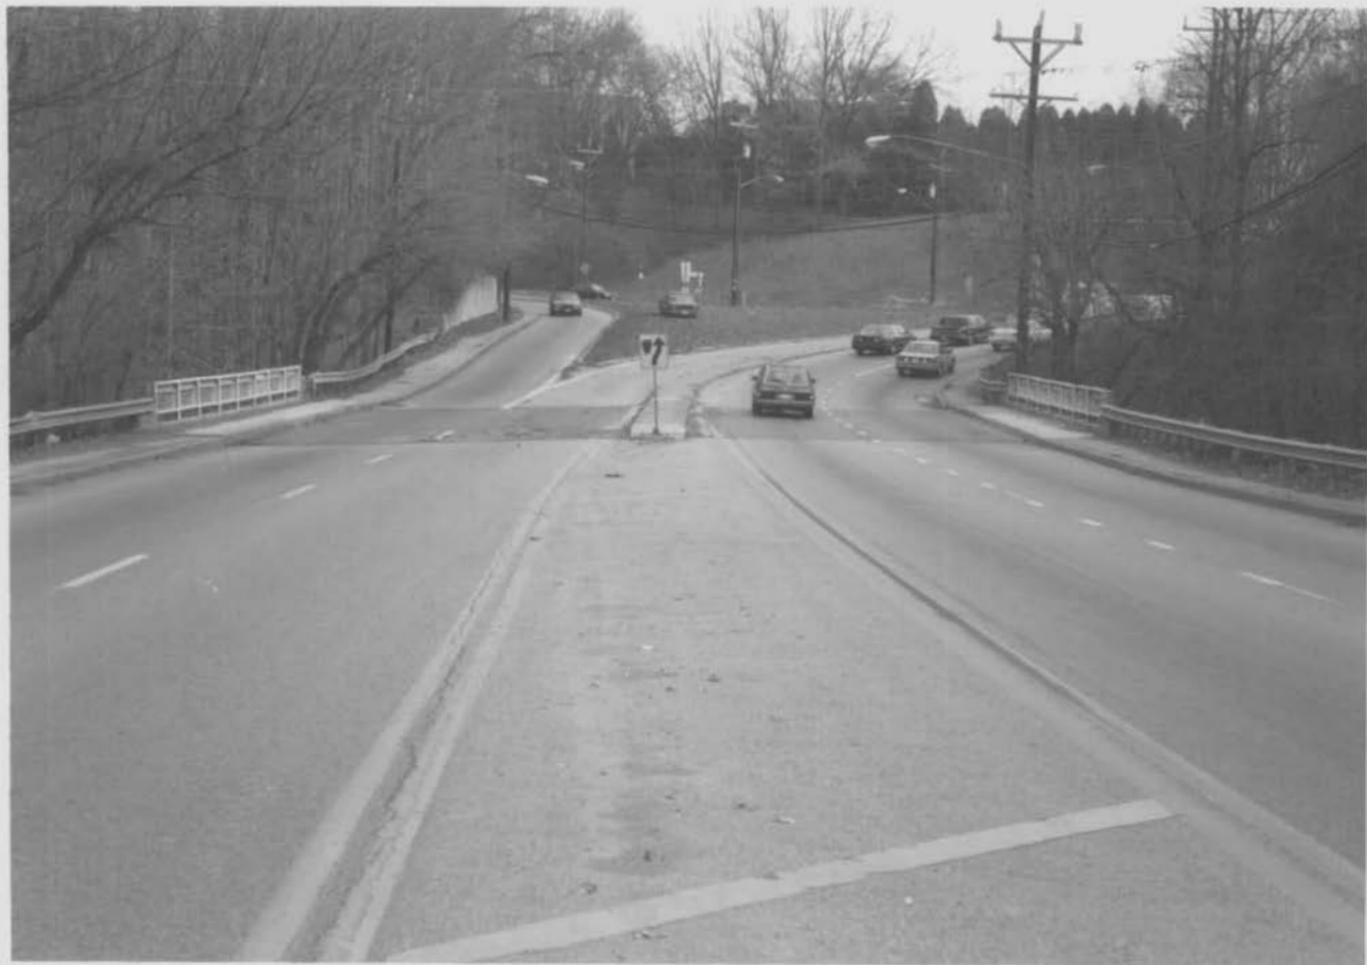
1. PG:65-23
2. MD 320 over Northwest Branch
3. Prince George's Co, MD
4. Wallace, Montgomery & Assoc,
5. 12/97
6. MD SHPO
7. Looking East
8. 3 of 4

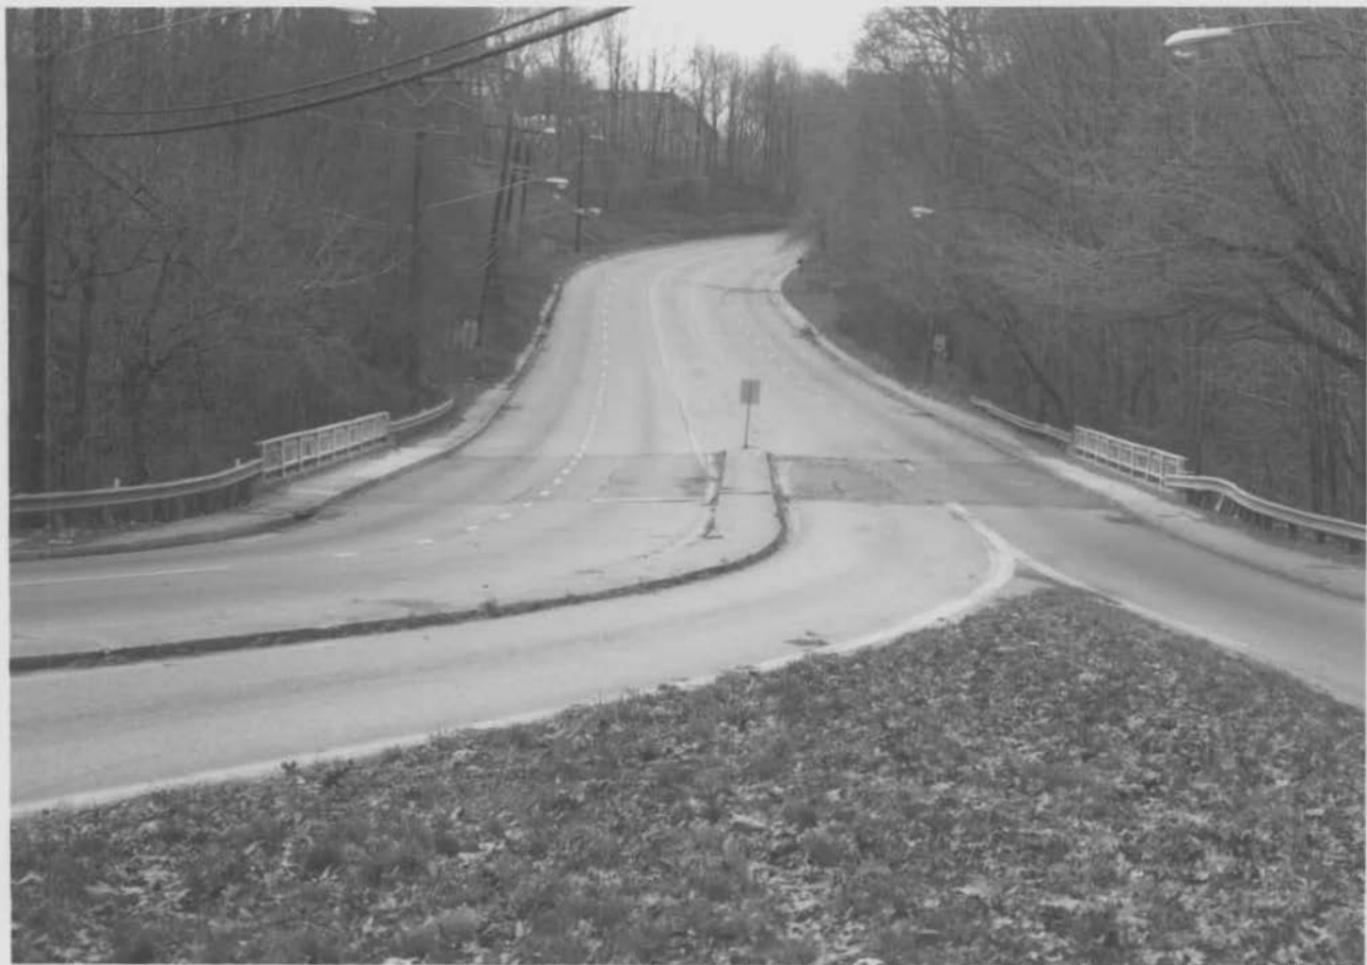
1. PG:65-23
2. MD 320 over Northwest Branch
3. Prince George's Co., MD
4. Wallace, Montgomery & Assoc,
5. 12/97
6. MD SHPO
7. Looking West
8. 4 of 4
