THE NUGENT HOUSE  
University of Maryland  
College Park Campus  
College Park, MD

# Maryland Historical Trust State Historic Sites Inventory Form

historic Nugent House (Preferred)

date October 7, 1986

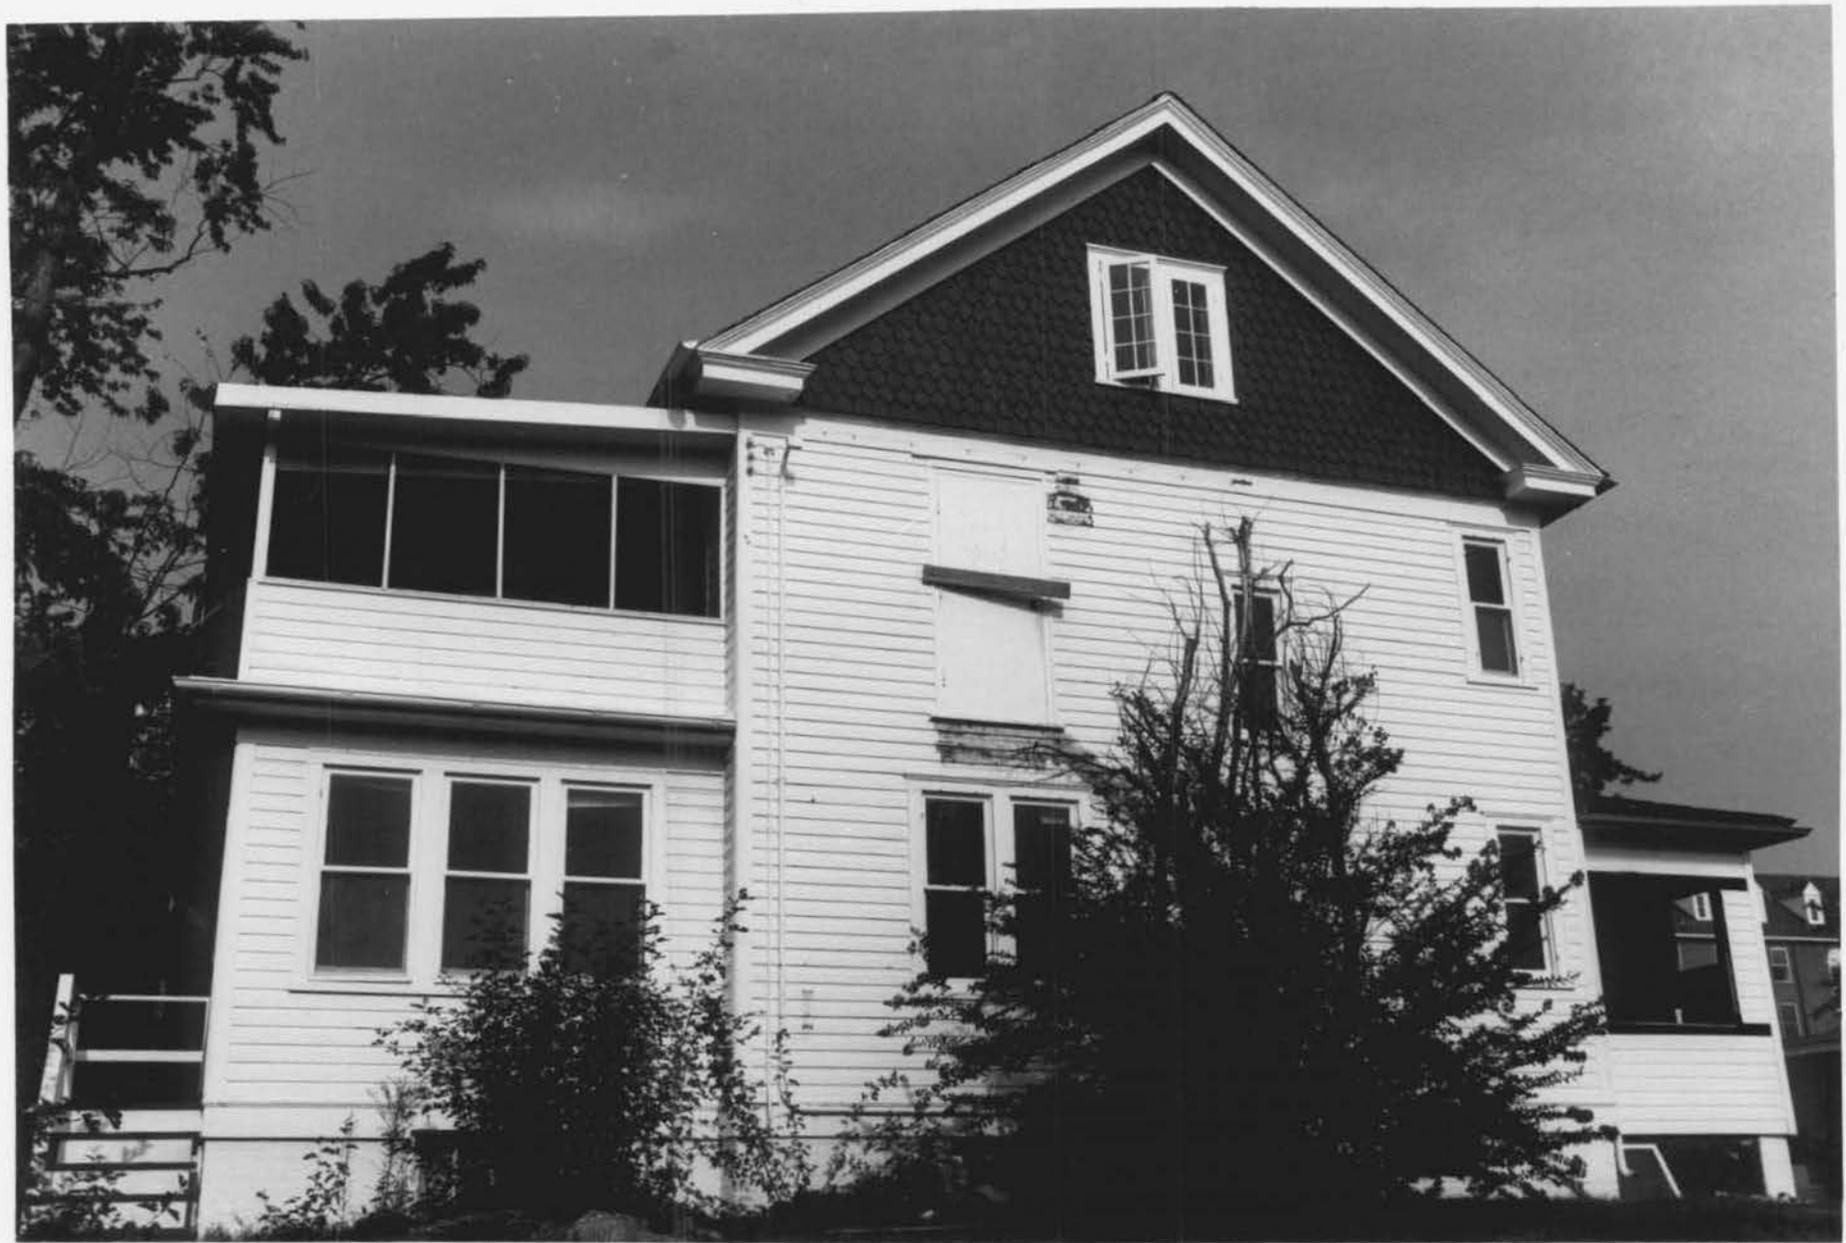
Photo Number: 5 of 23

Description: South side, 1st floor & 2nd floor porch

A wing, slightly narrower than the main block, projects from the south side of the house. This wing also stands on a brick foundation and appears to be original to the house on the first floor. However, an appraisal of the property made in 1965 states that this wing was a later addition. There is a doorway at the east end of the south side giving access to a small wooden deck with wooden steps and railing. In the center of the south side of the wing is a small one over one double hung sash window. A second floor porch above this wing is built of new materials and has a corrugated plastic shed roof. Screens and a half wall form the porch sides. There is a one over one double hung sash window on the second floor of the south wall of the main block.

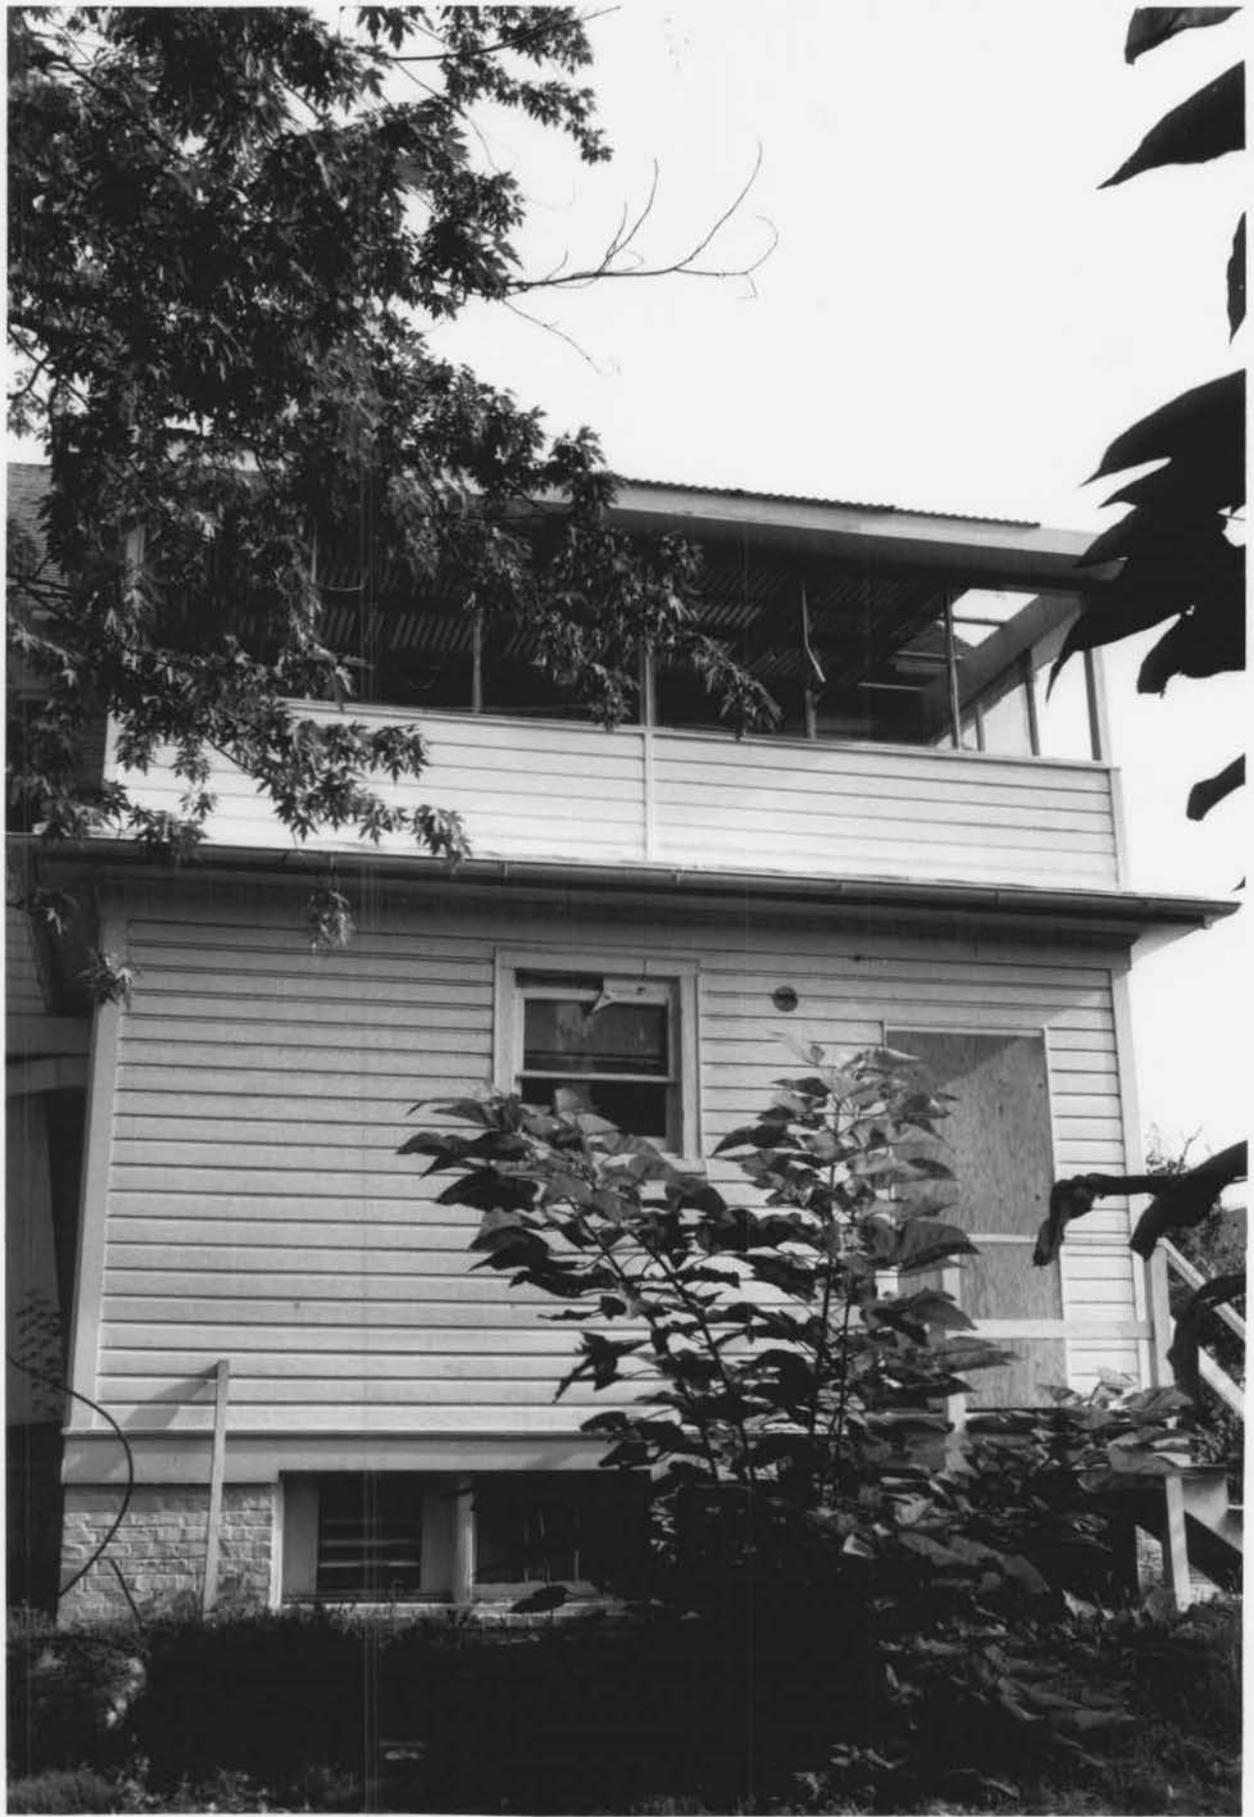
Photo Number: 6 of 23

Description: Wing on south side

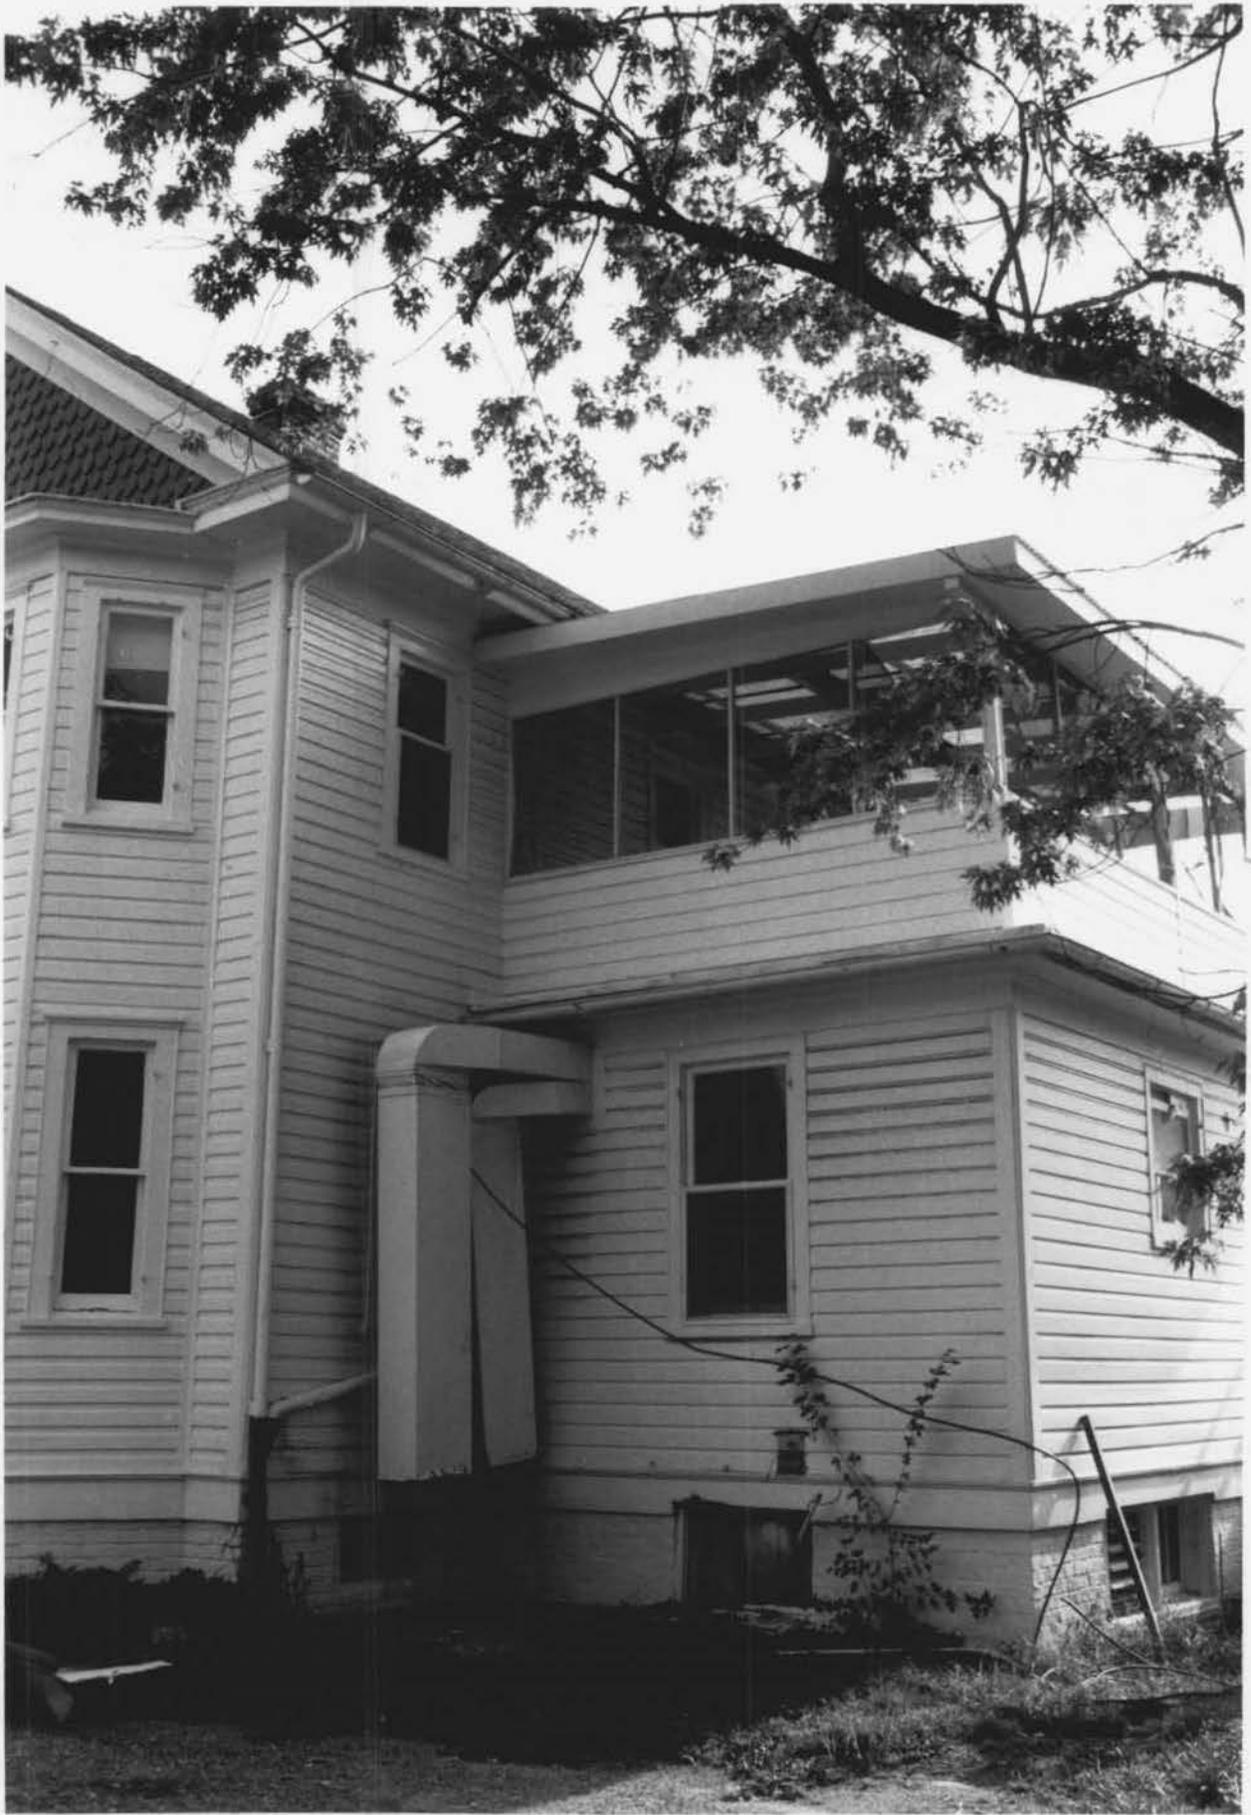
PG: 66-20  
Nugent House  
College Park, Prince George's County, Maryland  
Date of Photo: August 1986  
Photographer: Kristine Sharp  
Location of Negatives: Maryland Historical Trust  
Description: Main entrance, north side  
Photographer Facing: South  
Photo Number: 7 of 23

The north side of Nugent House is two bays wide and has a one story porch with hip roof. The porch roof is original to the house, but the porch itself has been enclosed to create an additional room. The original main entrance to the house was within the porch. Wood German siding covers this side of the house which has two pairs of one over one double hung sash windows on the second floor. A gable roofed dormer with wood cornice projects from the main roof. Fish scale shingle cover the walls of the dormer. It contains a one over one double hung sash window with a narrow window on each side.

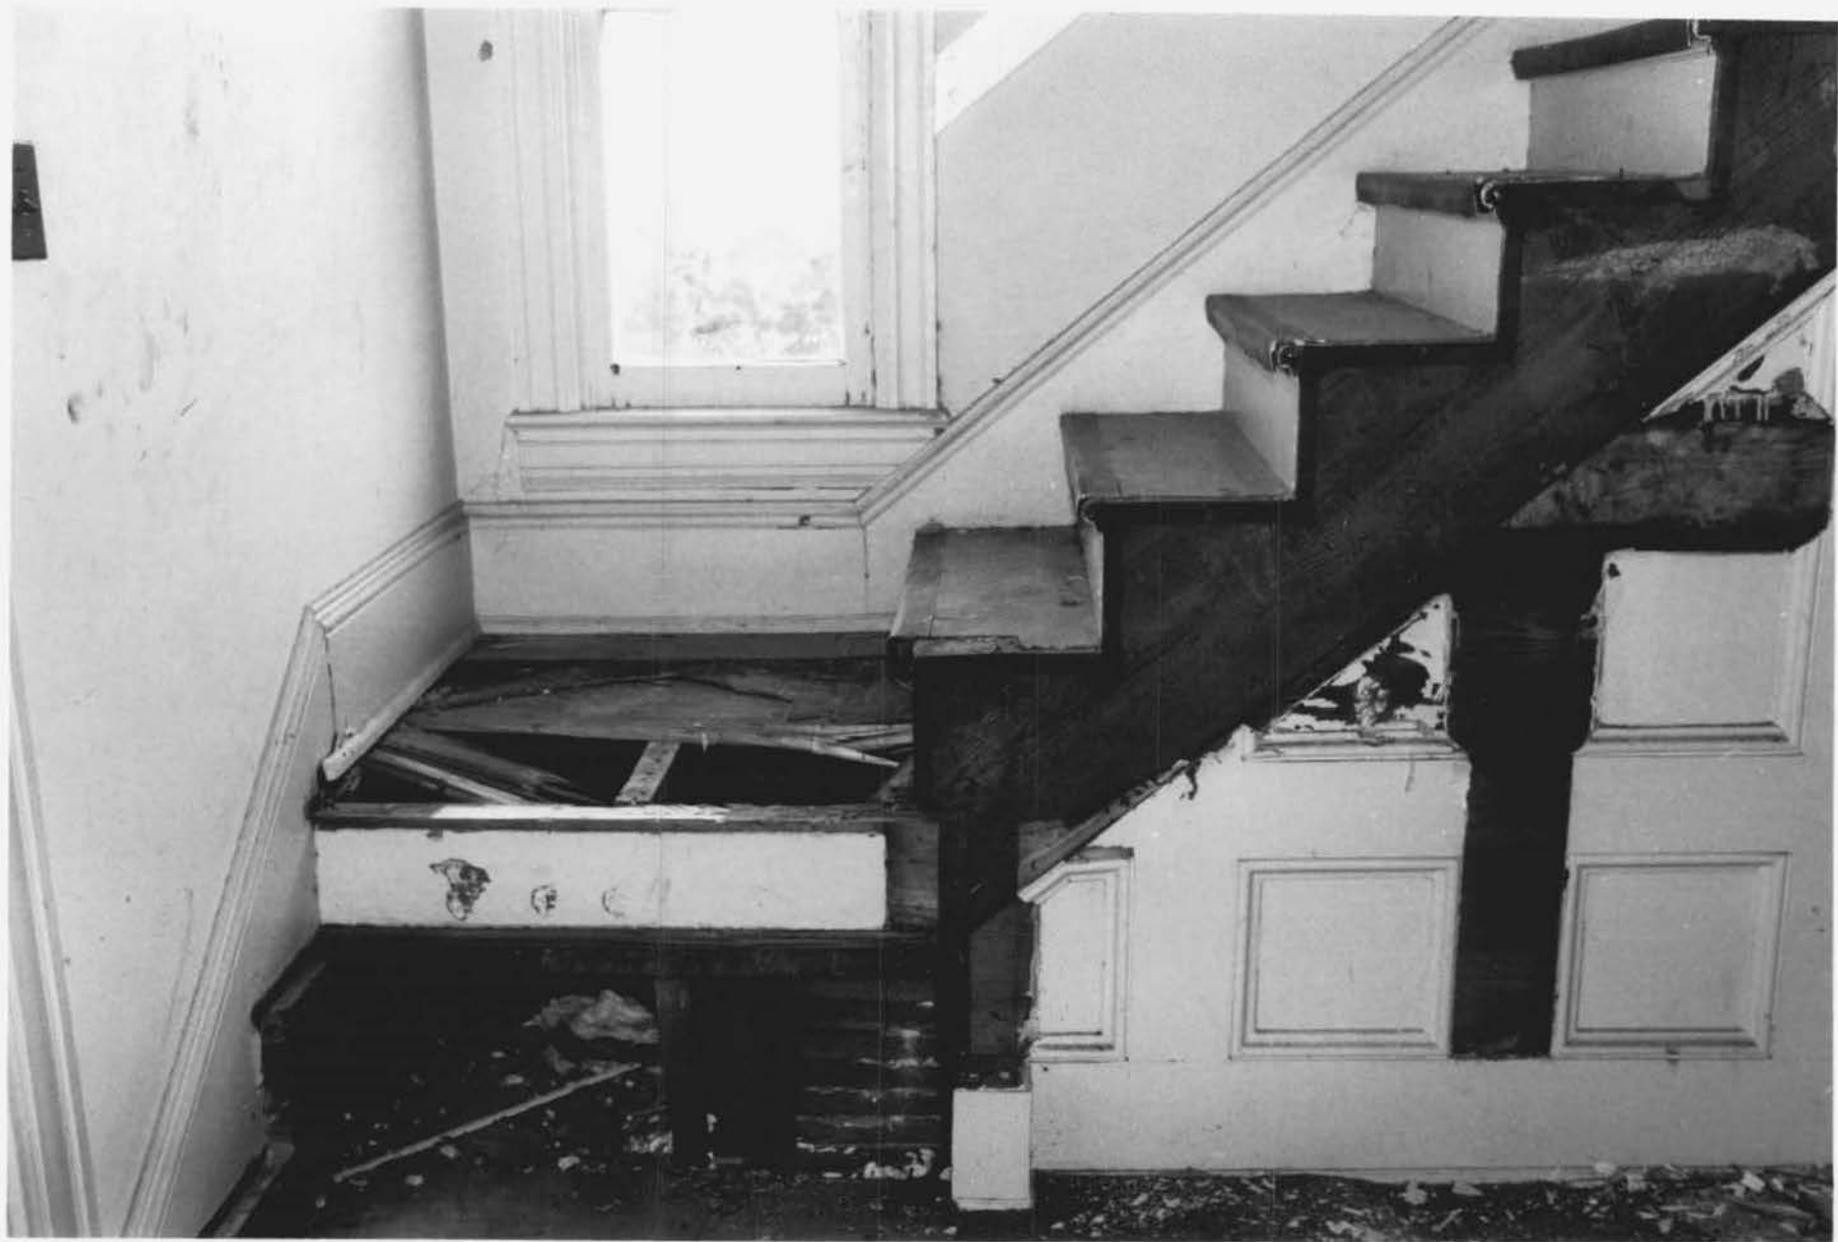
Photo Number: 8 of 23

Description: Stairs from 1st to 2nd floor

The main block of the house is nearly square and on the first floor it is now divided into three areas, although it was originally four rooms. The main entrance is in the north facade and leads to the east side of the house where stairs lead to the second floor. The stairs are now broken and the handrail, balusters, and newel posts are missing. Originally, three steps led to a landing from which the main run of the stairs followed the east wall of the house to the second floor. This is an open string stair. Wood with recessed panels encloses the area beneath the stairs on the first floor.

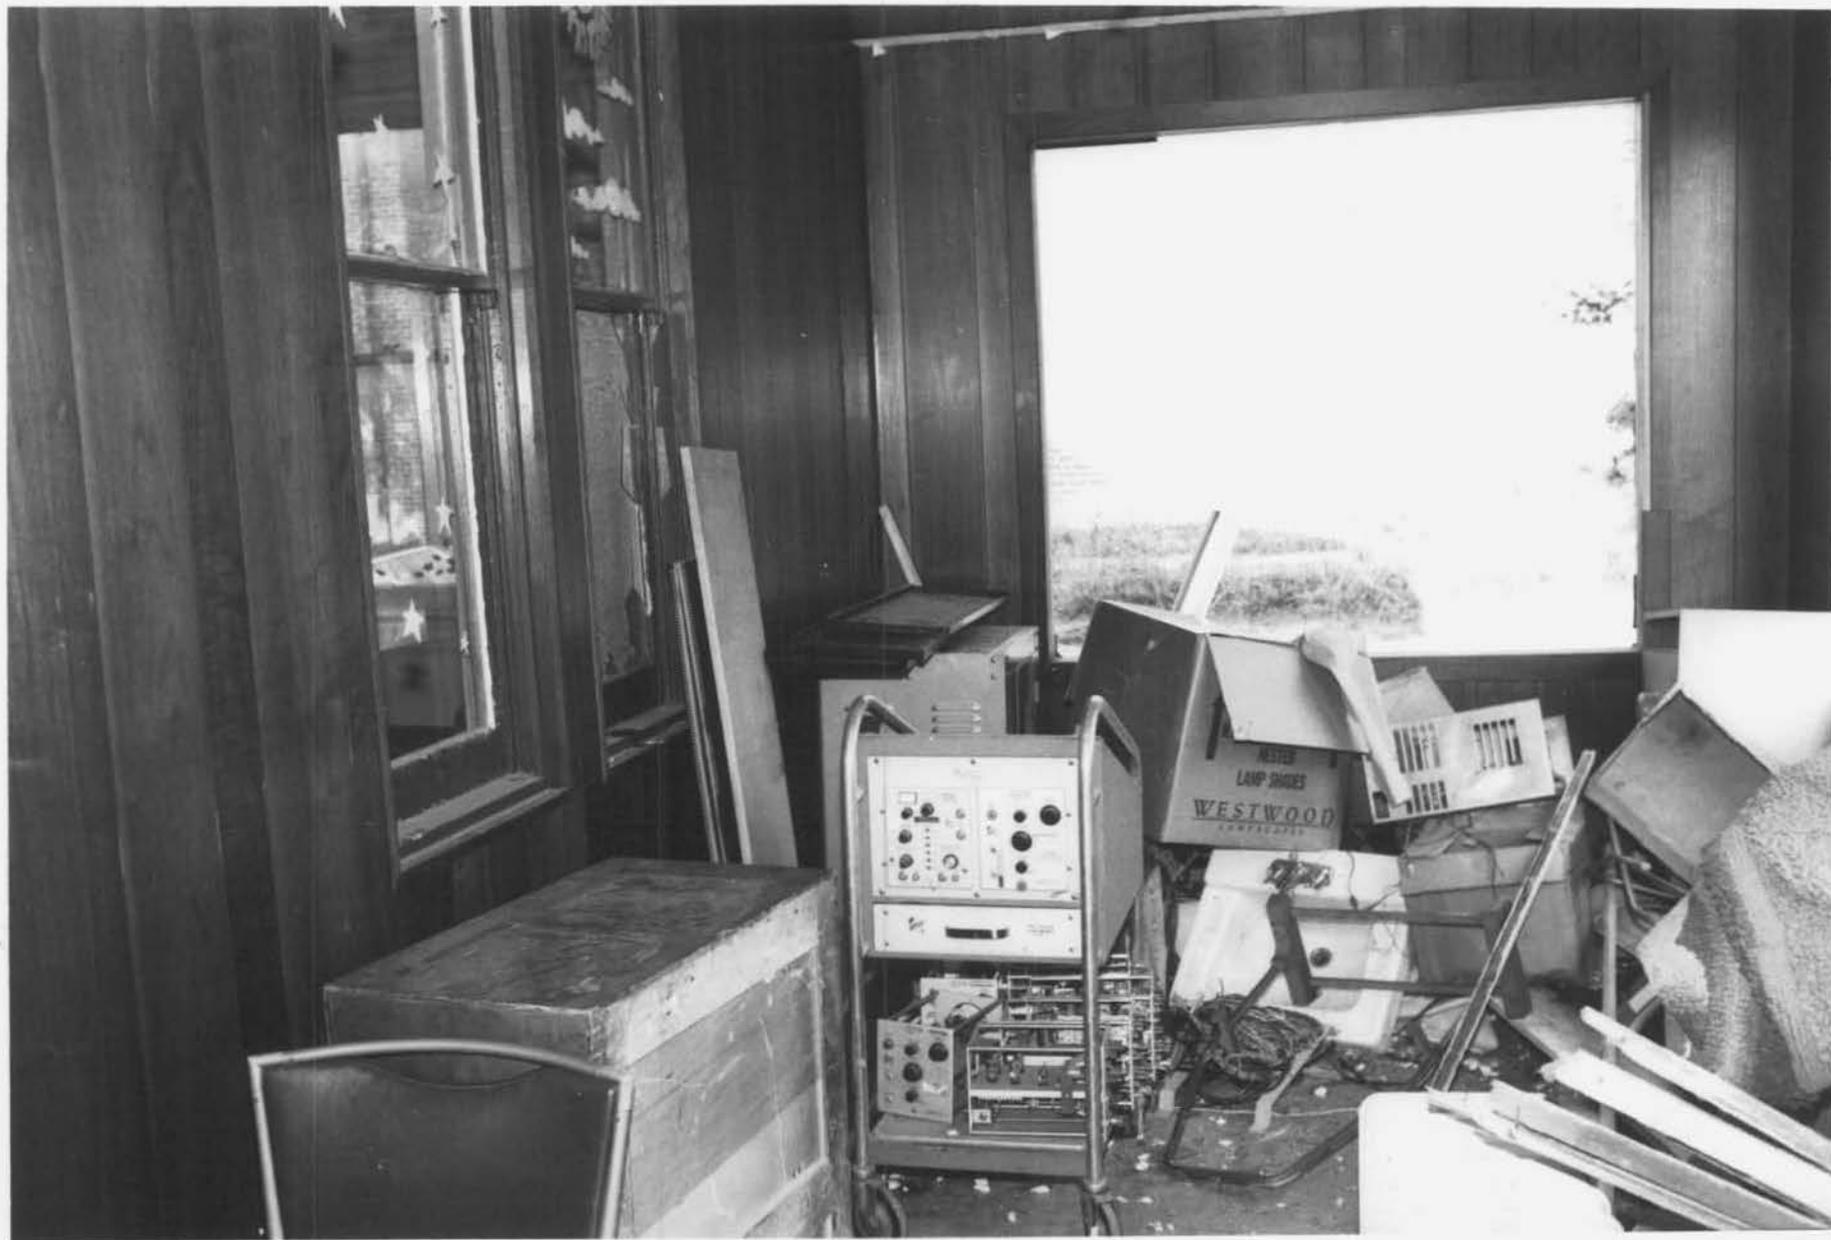
Photo Number: 10 of 23

Description: Inside front porch

The porch on the north side is now enclosed and panelled with wood and has an acoustical tile ceiling. This creates an additional room that was not a part of the original house. The rear wing may have contained the kitchen at one time. A door with glass in the upper half leads to the outdoors.

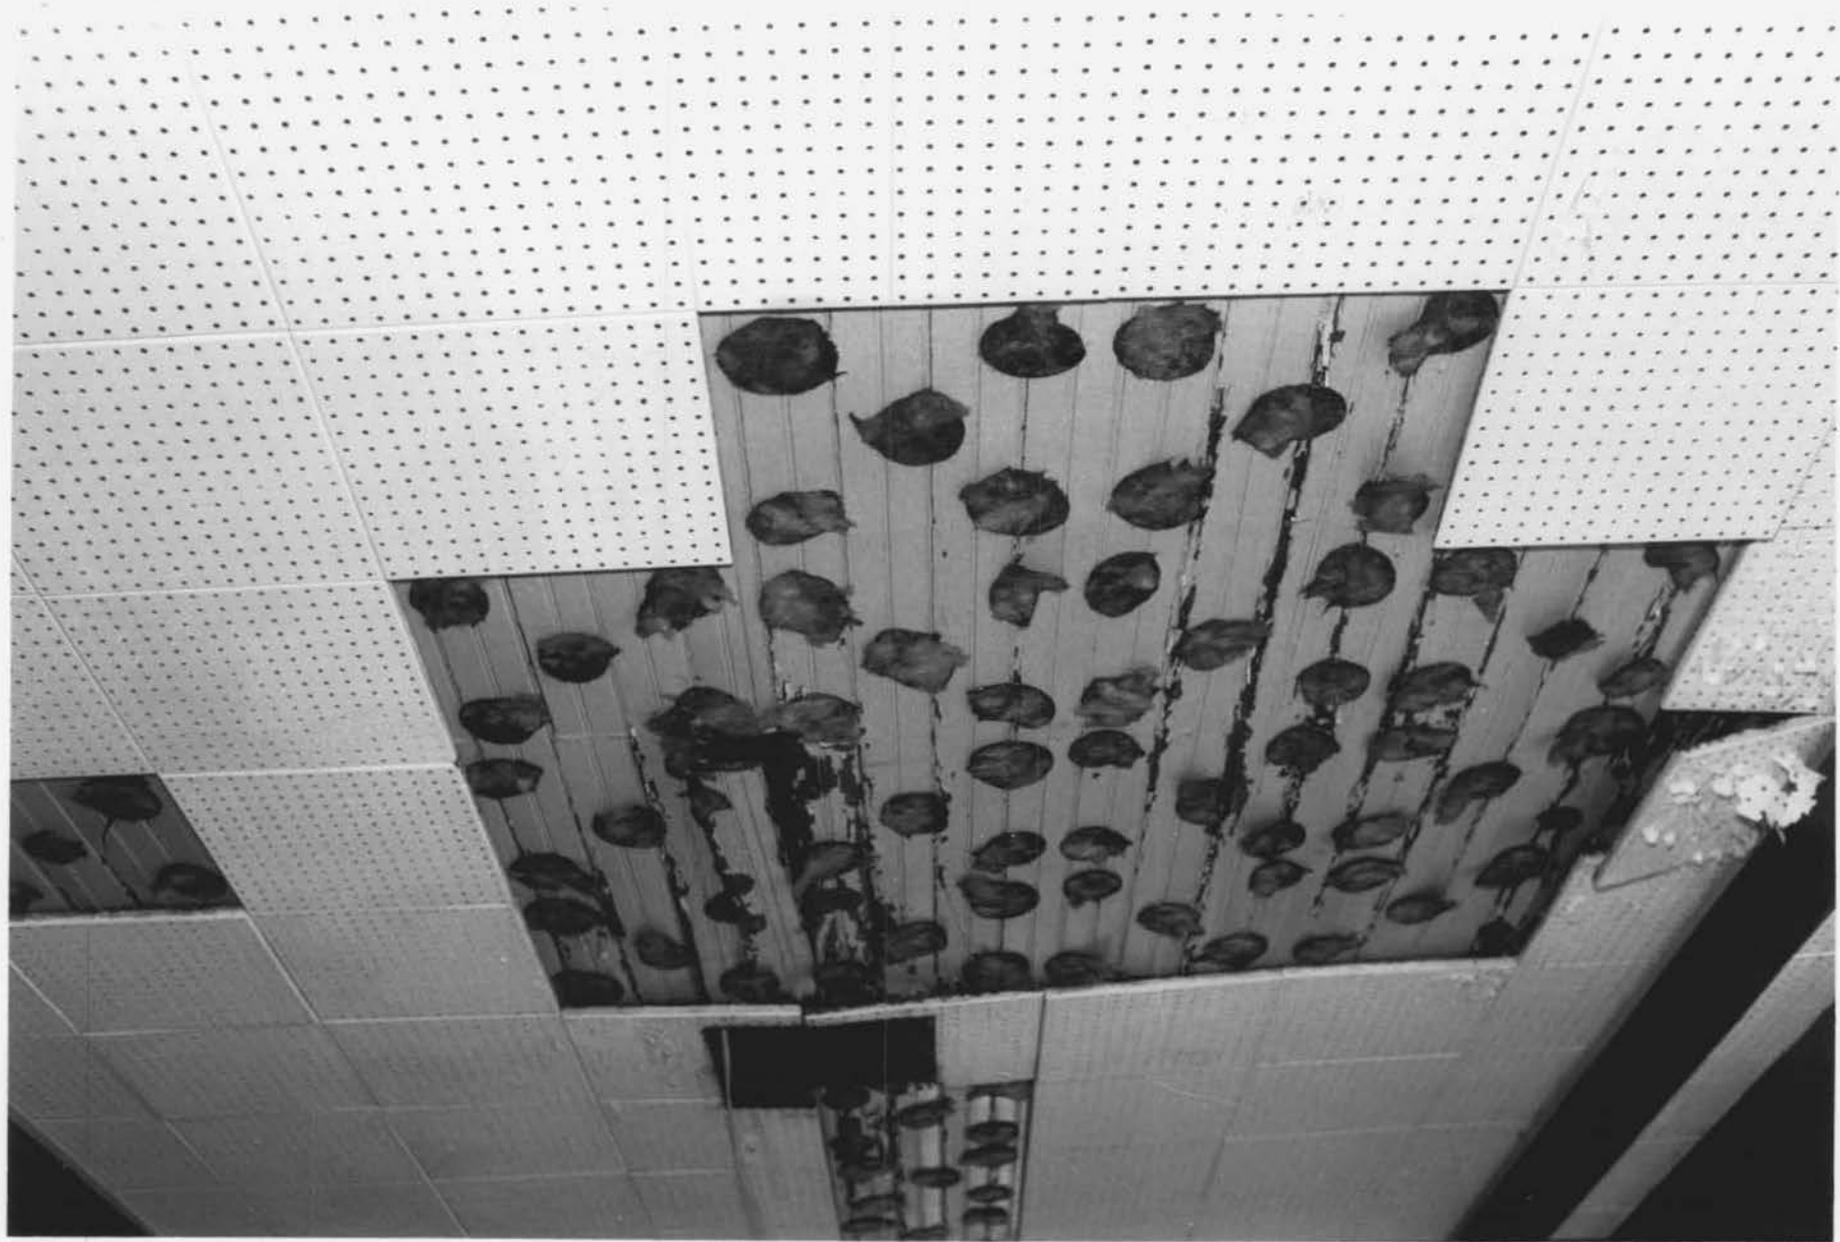
Photo Number: 11 of 23

Description: Porch ceiling

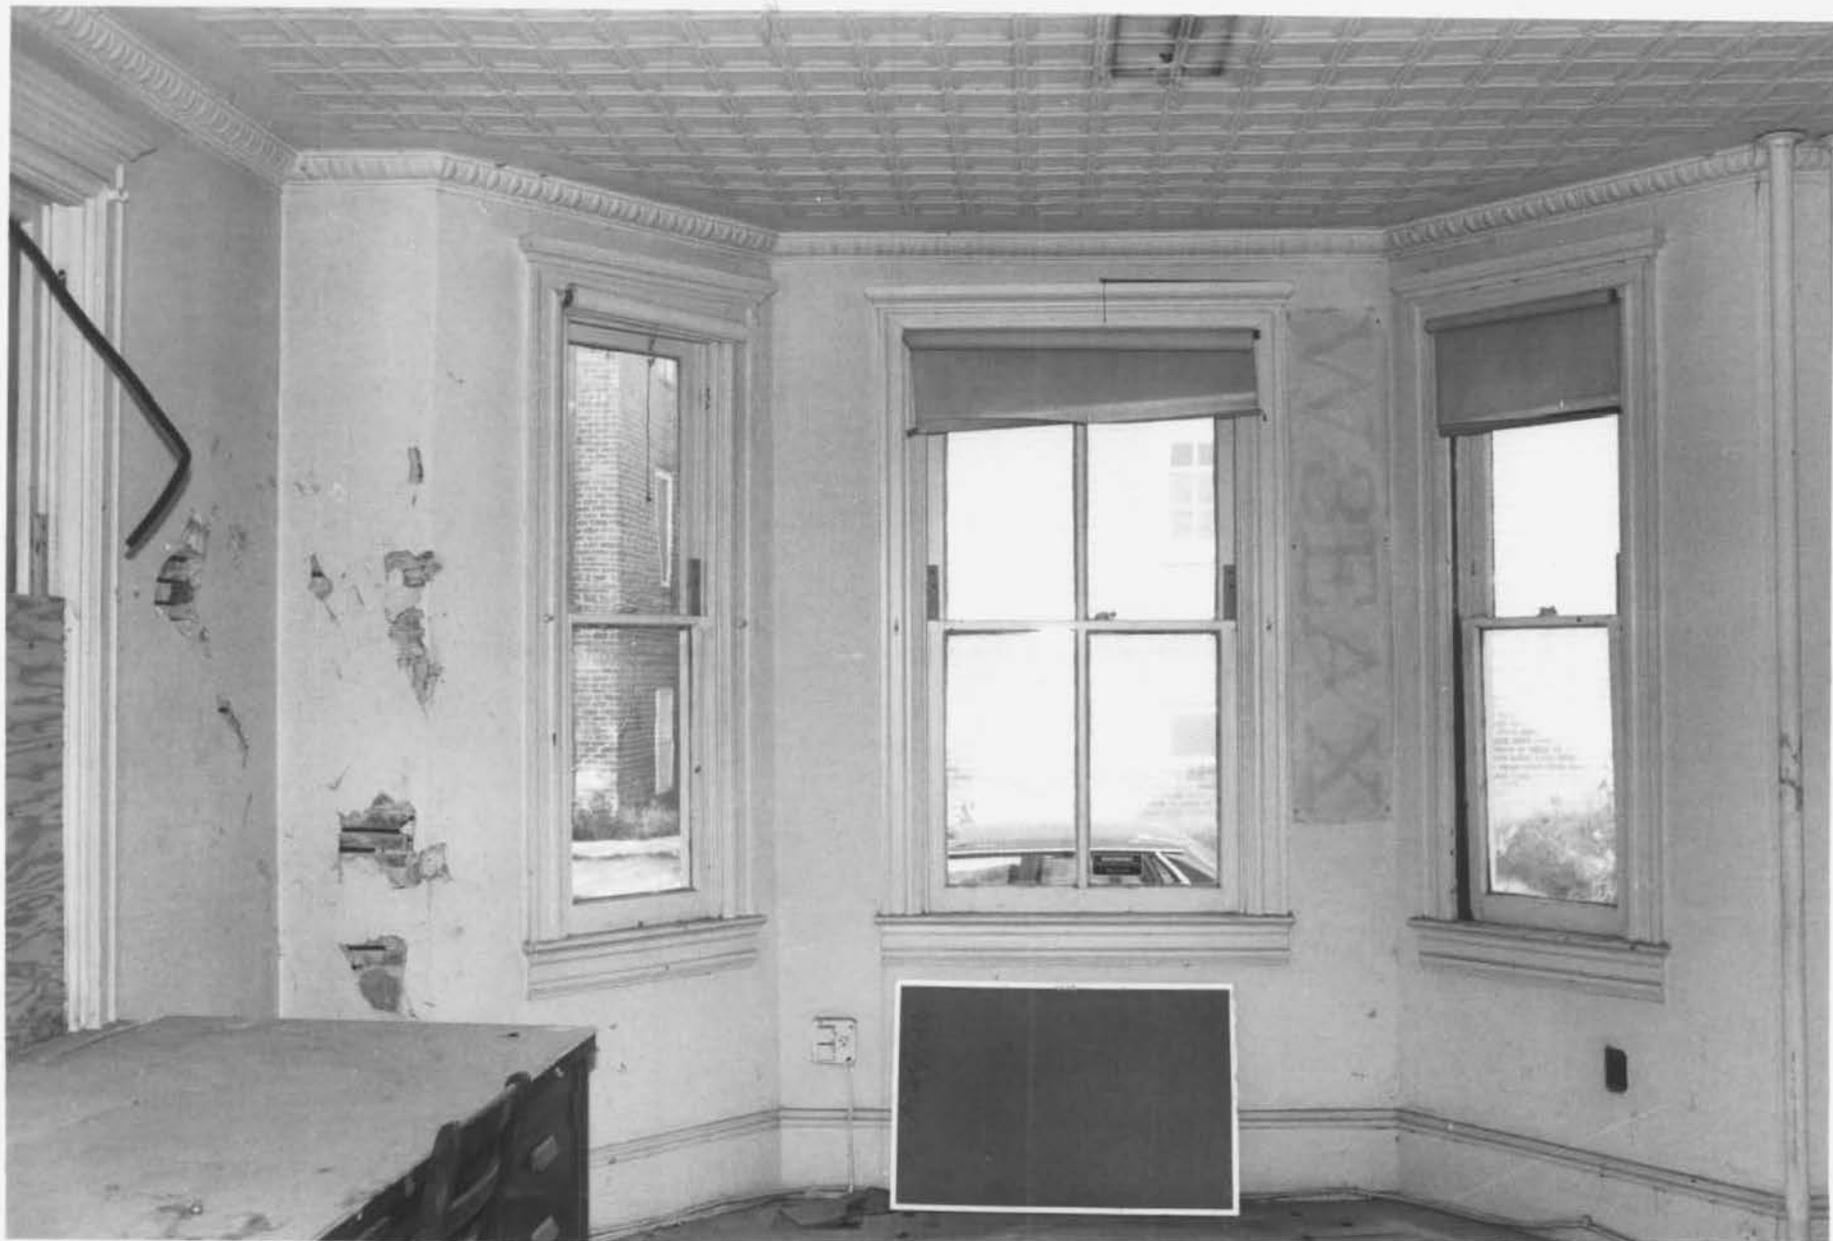
Photo Number: 12 of 23

Description: Bay window on west side of house

The west side profiles of the front and rear porches are similar to those on the east side. The main block also has similar siding on the first floor, and the gable pediment with fish scale shingles and casement window is identical to that on the east side. However, a two story bay window with flat roof rises on this side toward the rear of the house. The central section of the bay contains a two over two double hung wood window on each floor and there is a one over one double hung sash window in each of the angled sides of the bay. Toward the front of the house there is a pair of one over one double hung sash windows on the first floor and a two over two double hung sash window on the second floor. The foundation, as elsewhere on the house, is of brick with small basement windows.

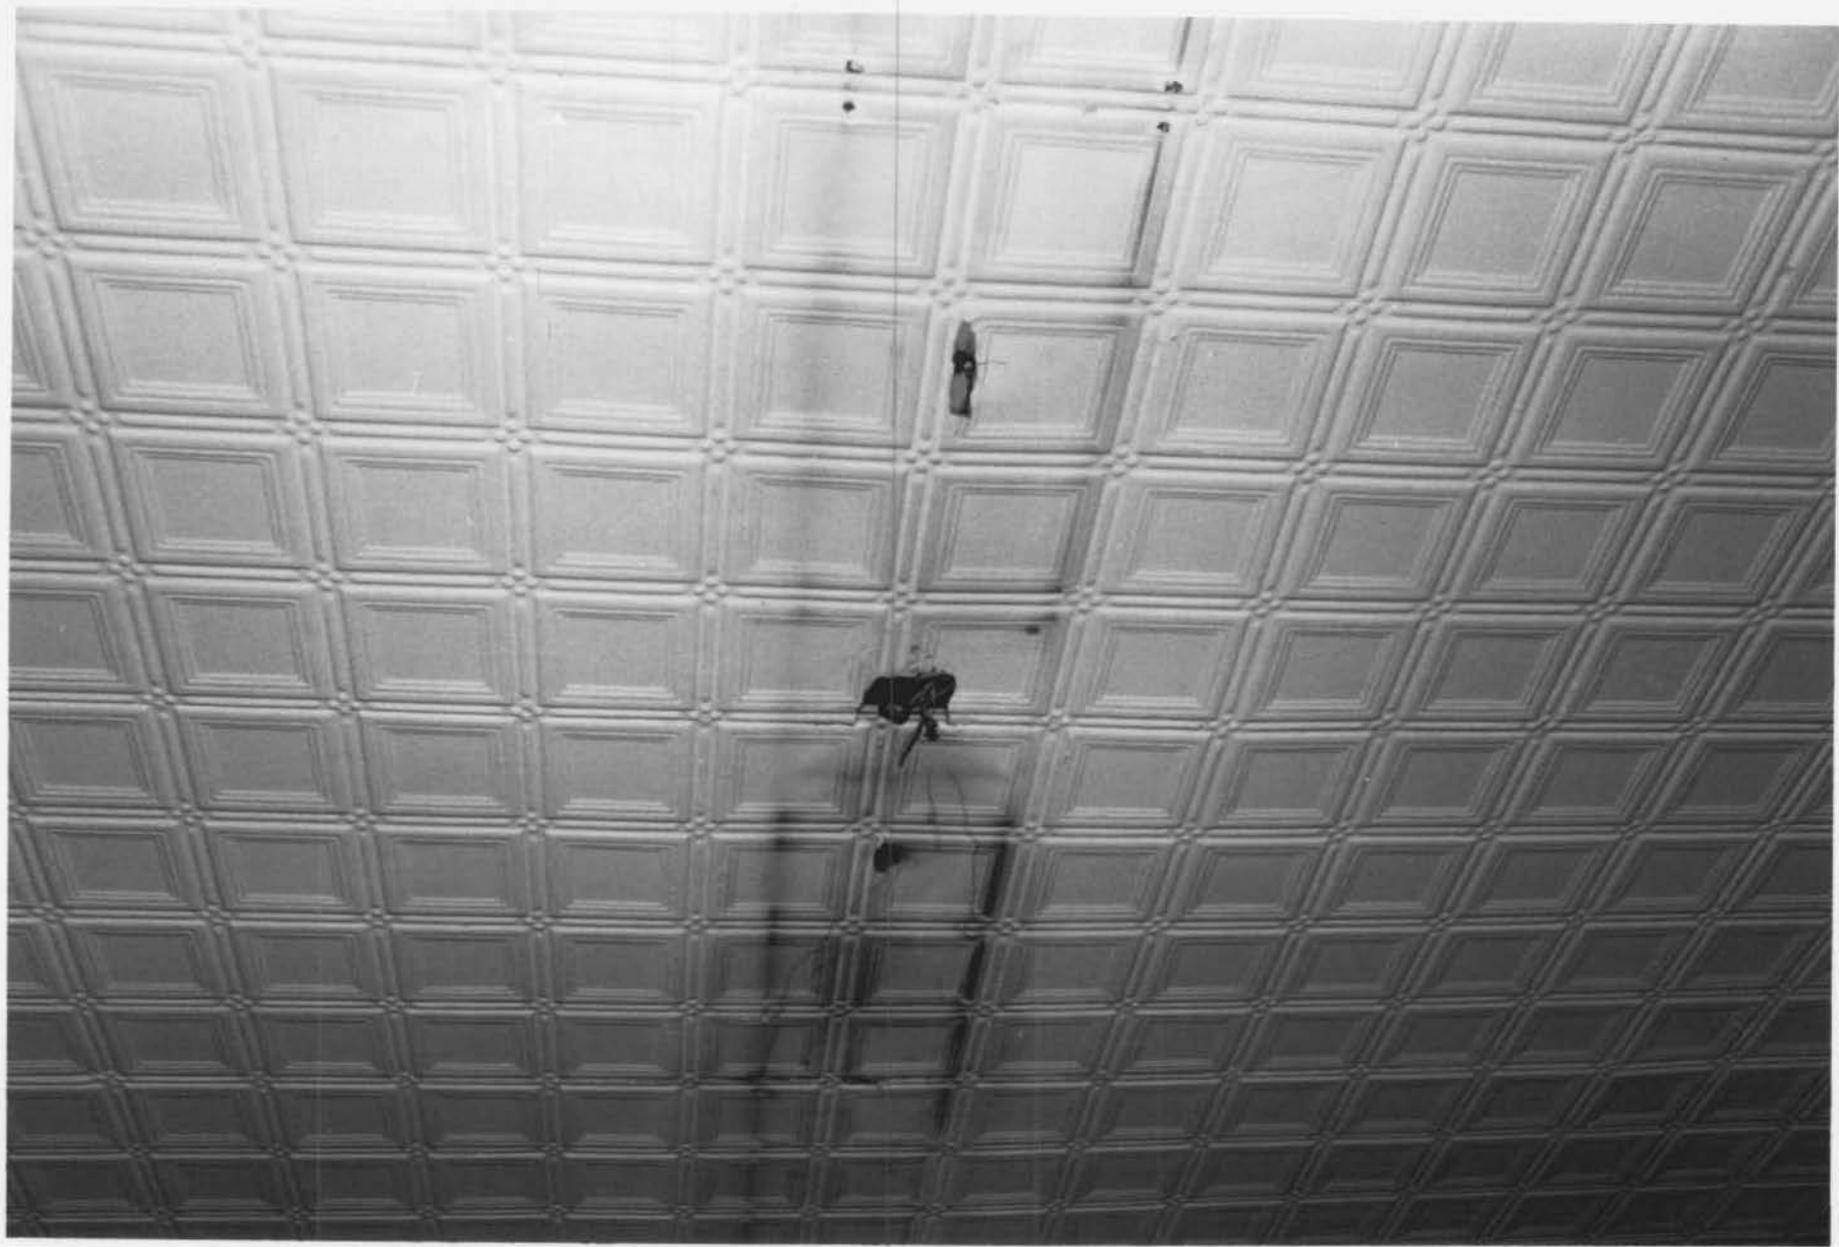
Photo Number: 14 of 23

Description: ceiling - 1st floor

Most of the first floor ceilings in the main block are of pressed tin in a square pattern with a narrow egg and dart cornice. The windows are double hung wooden sash as indicated in the description of the exterior. Some doors are missing and some have been replaced with modern doors. Some of the doors that appear to be original have four horizontal panels. Moulded wood trim with a small cornice surrounds most of the window and door openings. The baseboards are about eight inches high with a moulded cap. Plaster originally covered all the walls and much of it

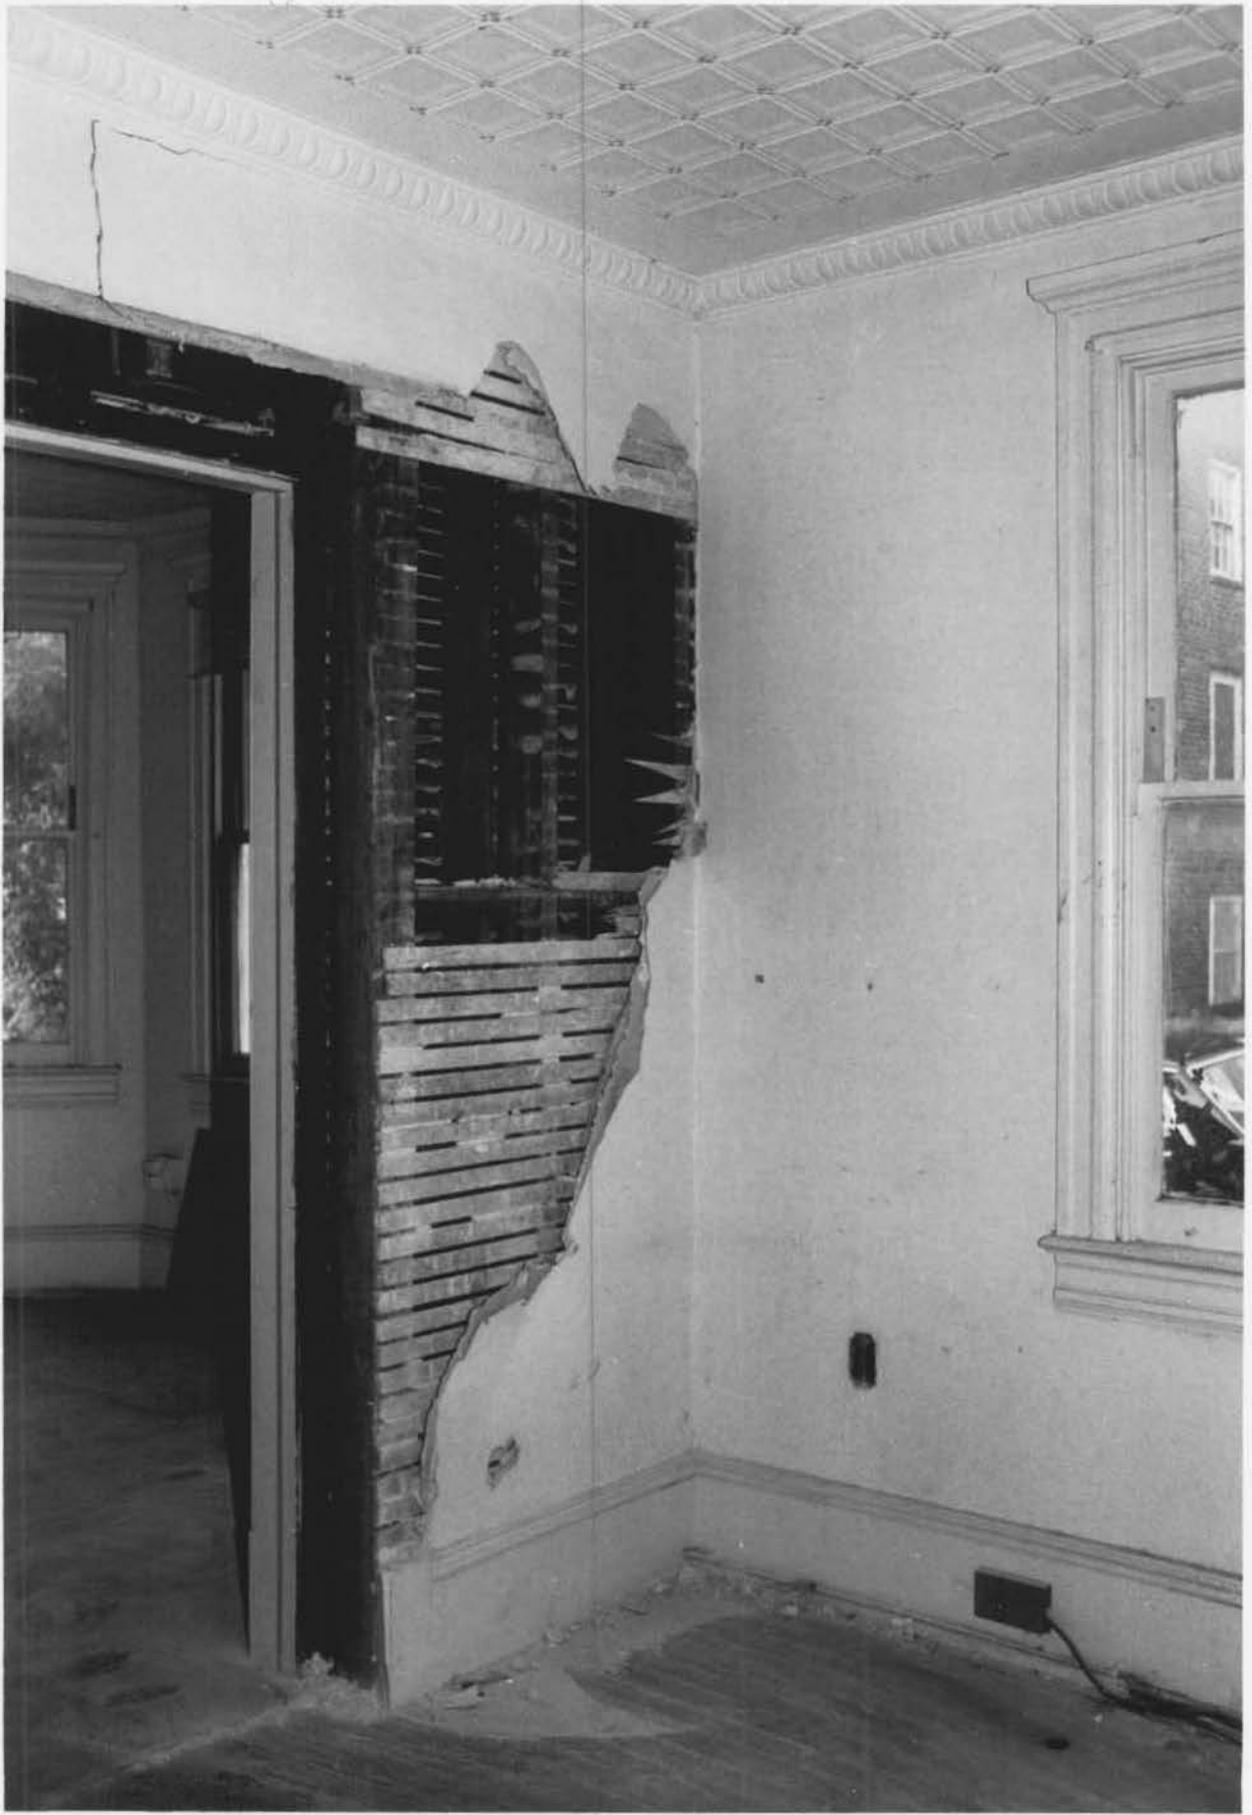
Photo Number: 15 of 23

Description: Rooms on 1st floor west side

The entry or stair hall continues through to the rear of the main block along the east side of the house. On the west side of the house are two rooms, one behind the other. The front room is nearly square and has a fireplace across the southeast corner. This room has doorways to the entry and to the room in the southwest corner of the house. The latter is similar in size, but has a three window bay window on the west wall. From it a large opening leads to the hallway. The original floors wood floors are in place, but modern material covers some of them.
