THE NUGENT HOUSE  
University of Maryland  
College Park Campus  
College Park, MD

# Maryland Historical Trust State Historic Sites Inventory Form

historic Nugent House (Preferred)

date October 7, 1986

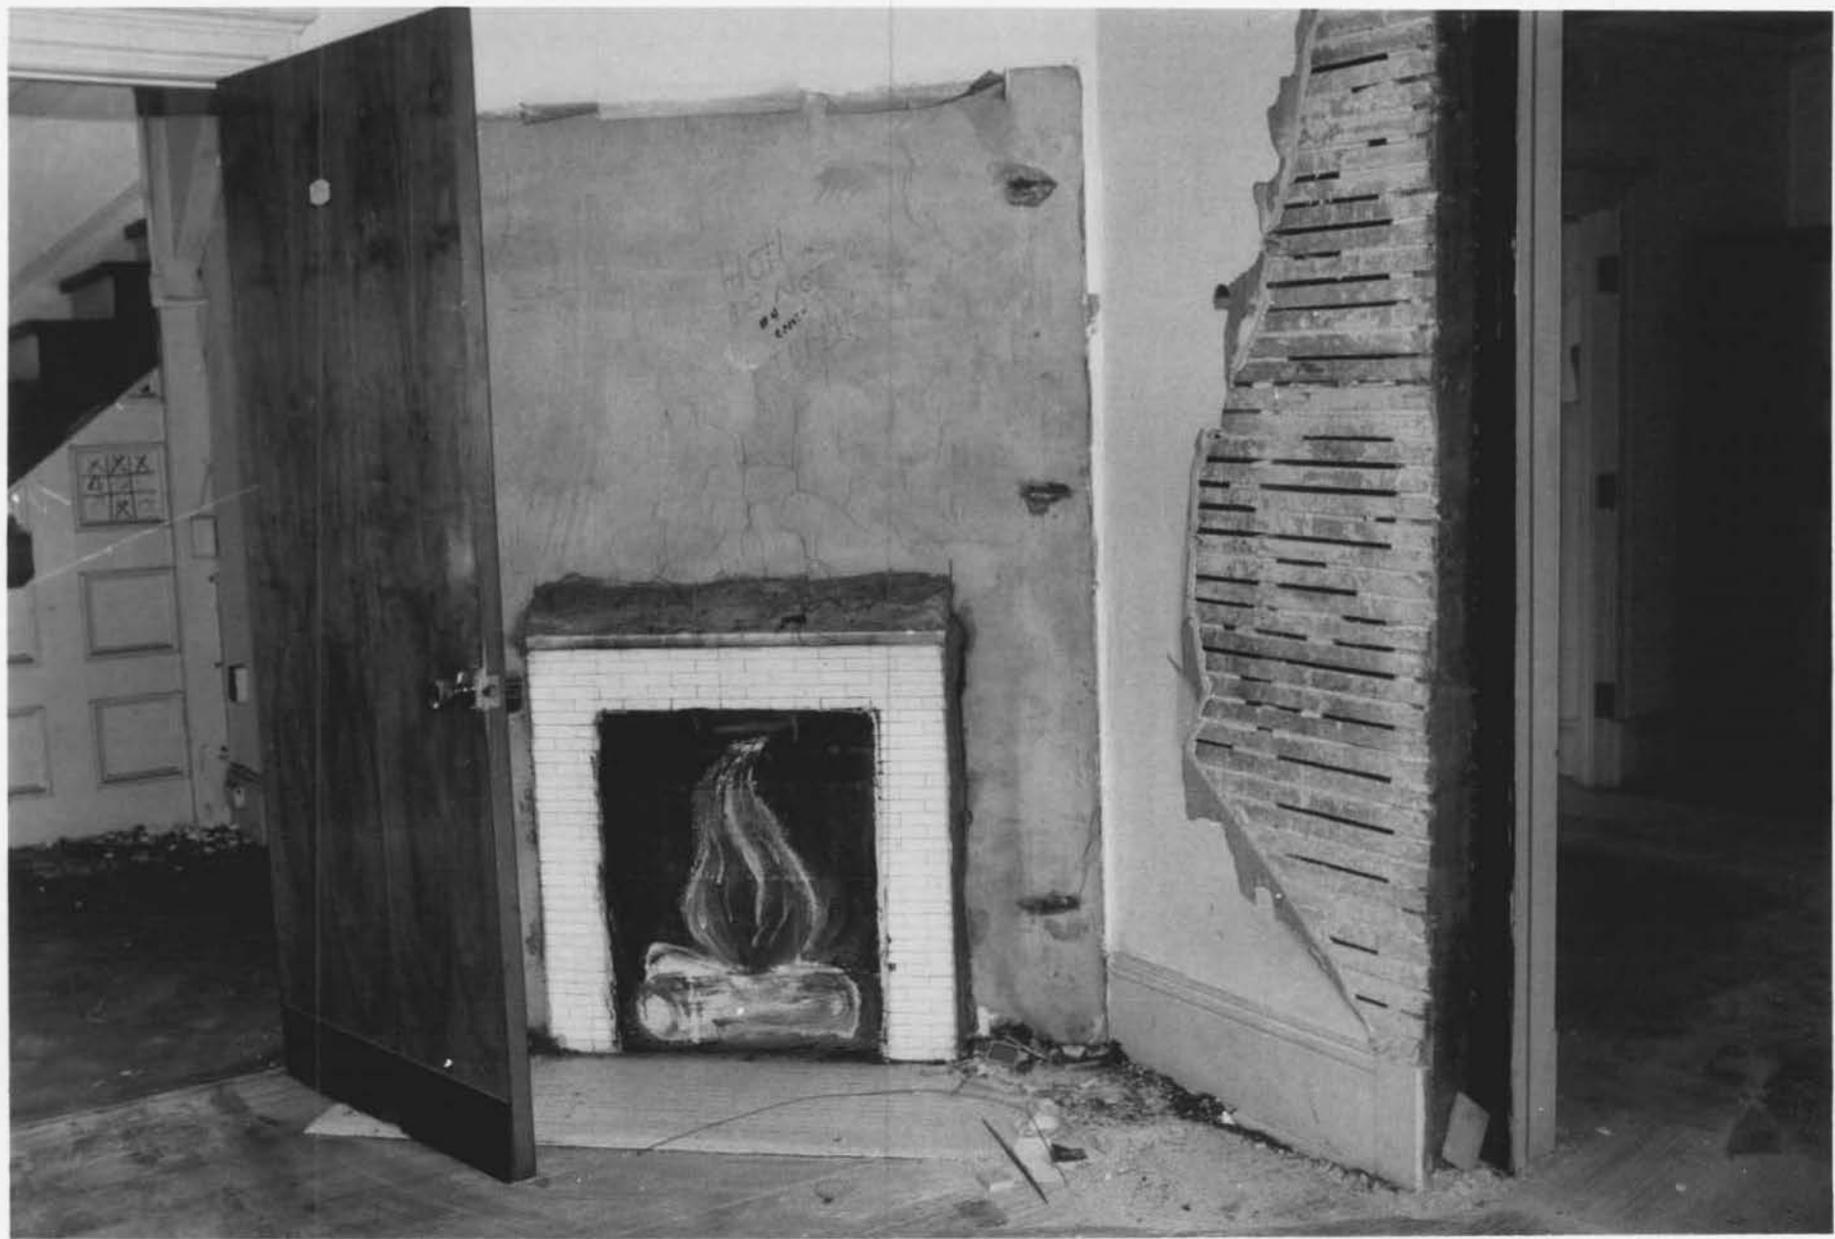
Photo Number: 16 of 23

Description: Chimney corner front room

The entry or stair hall continues through to the rear of the main block along the east side of the house. On the west side of the house are two rooms, one behind the other. The front room is nearly square and has a fireplace across the southeast corner. This room has doorways to the entry and to the room in the southwest corner of the house. The latter is similar in size, but has a three window bay window on the west wall. From it a large opening leads to the hallway. The original floors wood floors are in place, but modern material covers some of them.

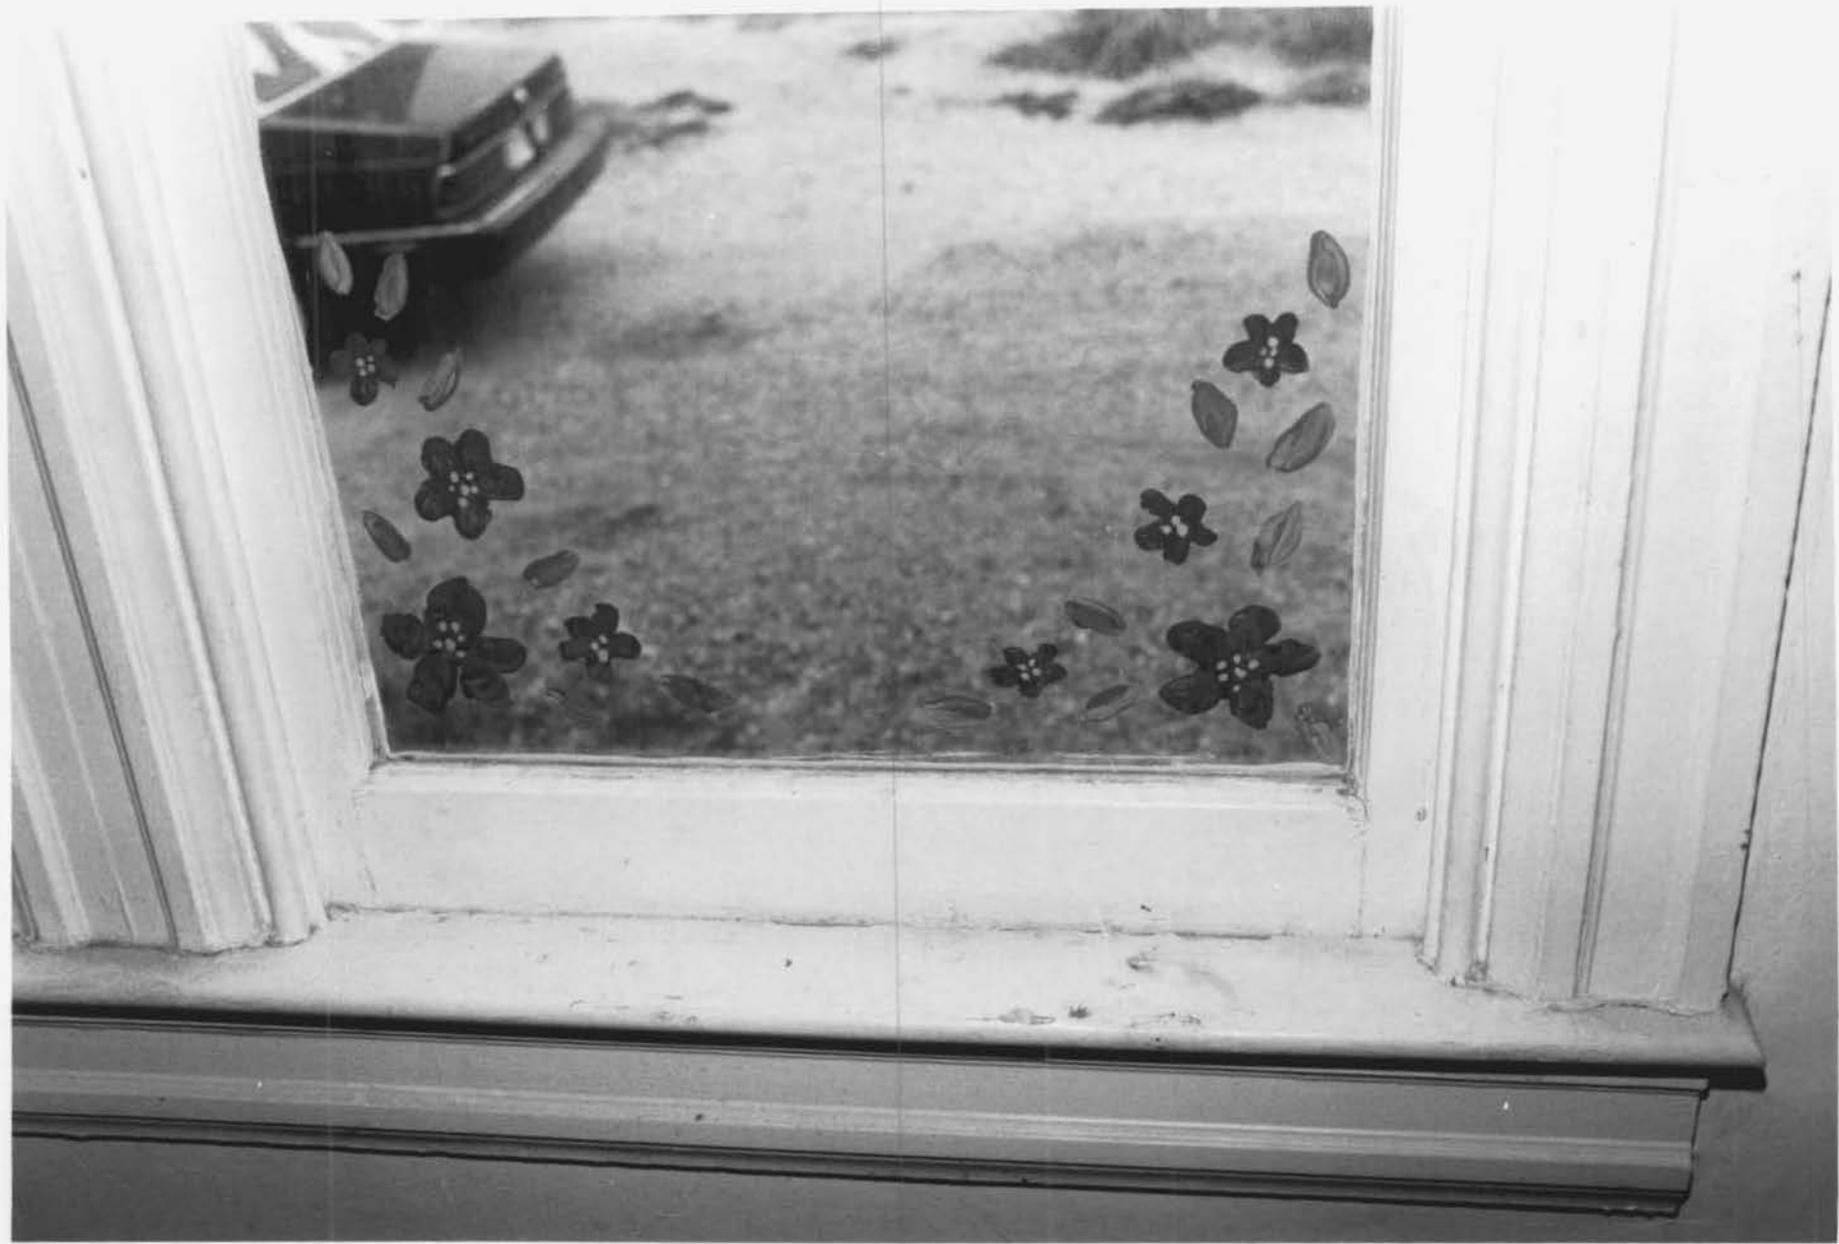
Photo Number: 17 of 23

Description: Window detail

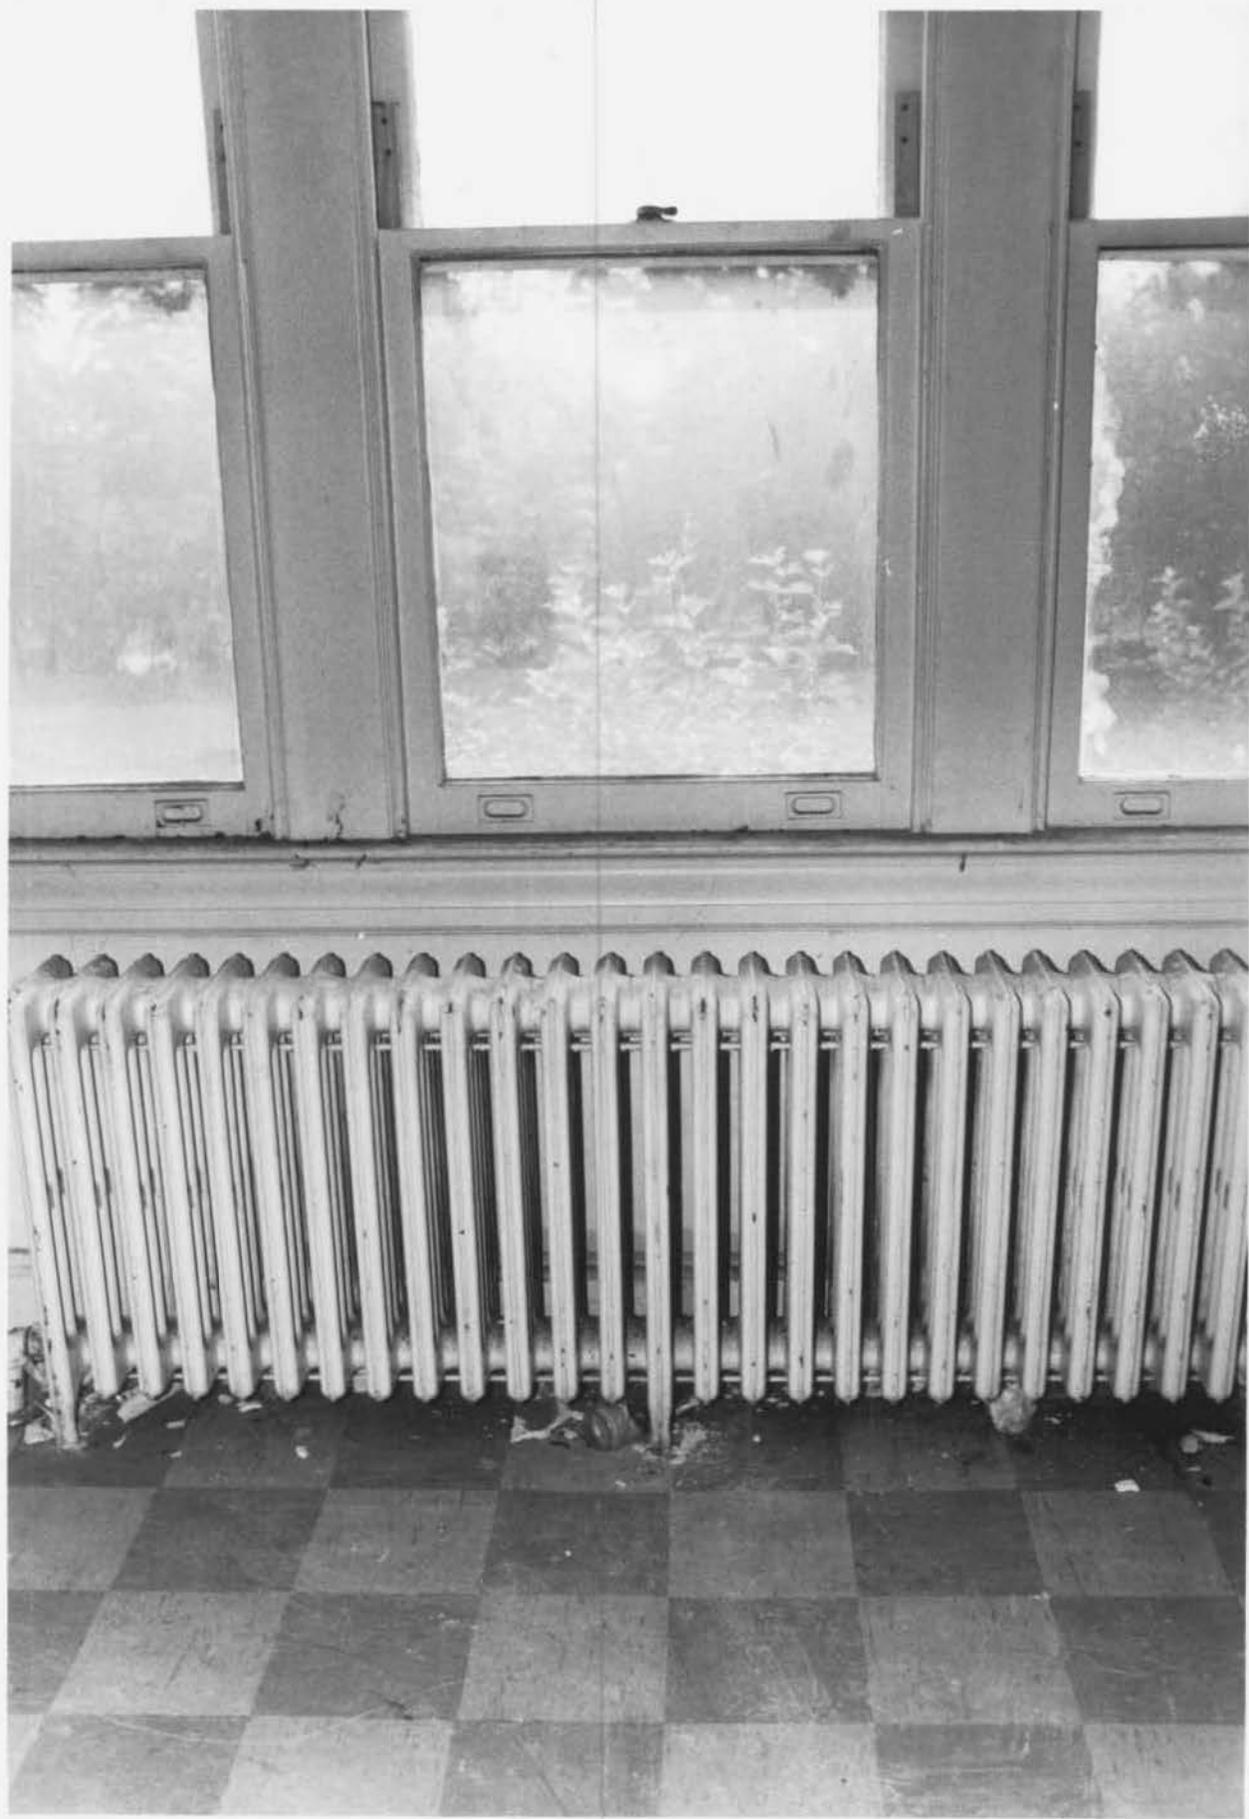
Photo Number: 18 of 23

Description: First floor porch, south side

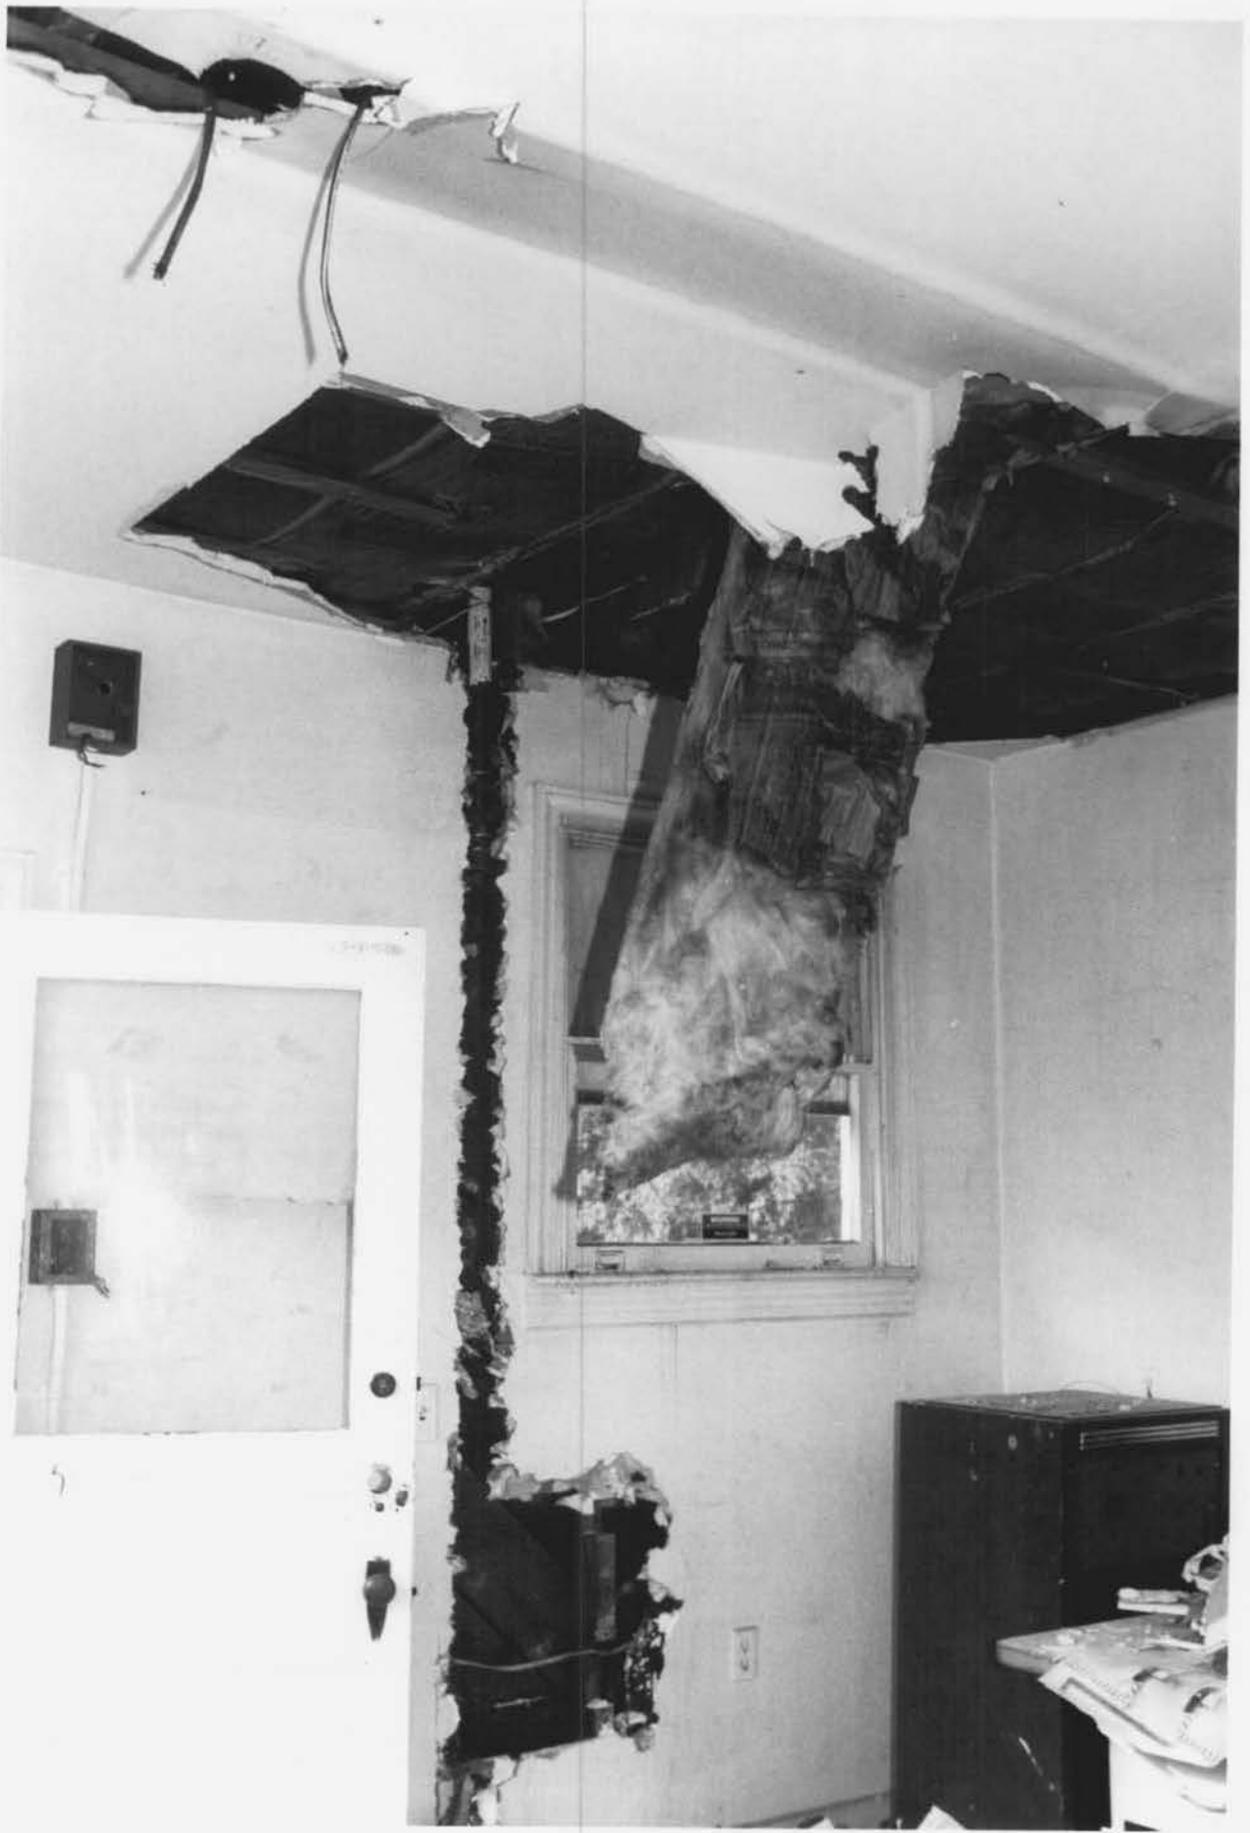
Photo Number: 19 of 23

Description: First floor porch south side

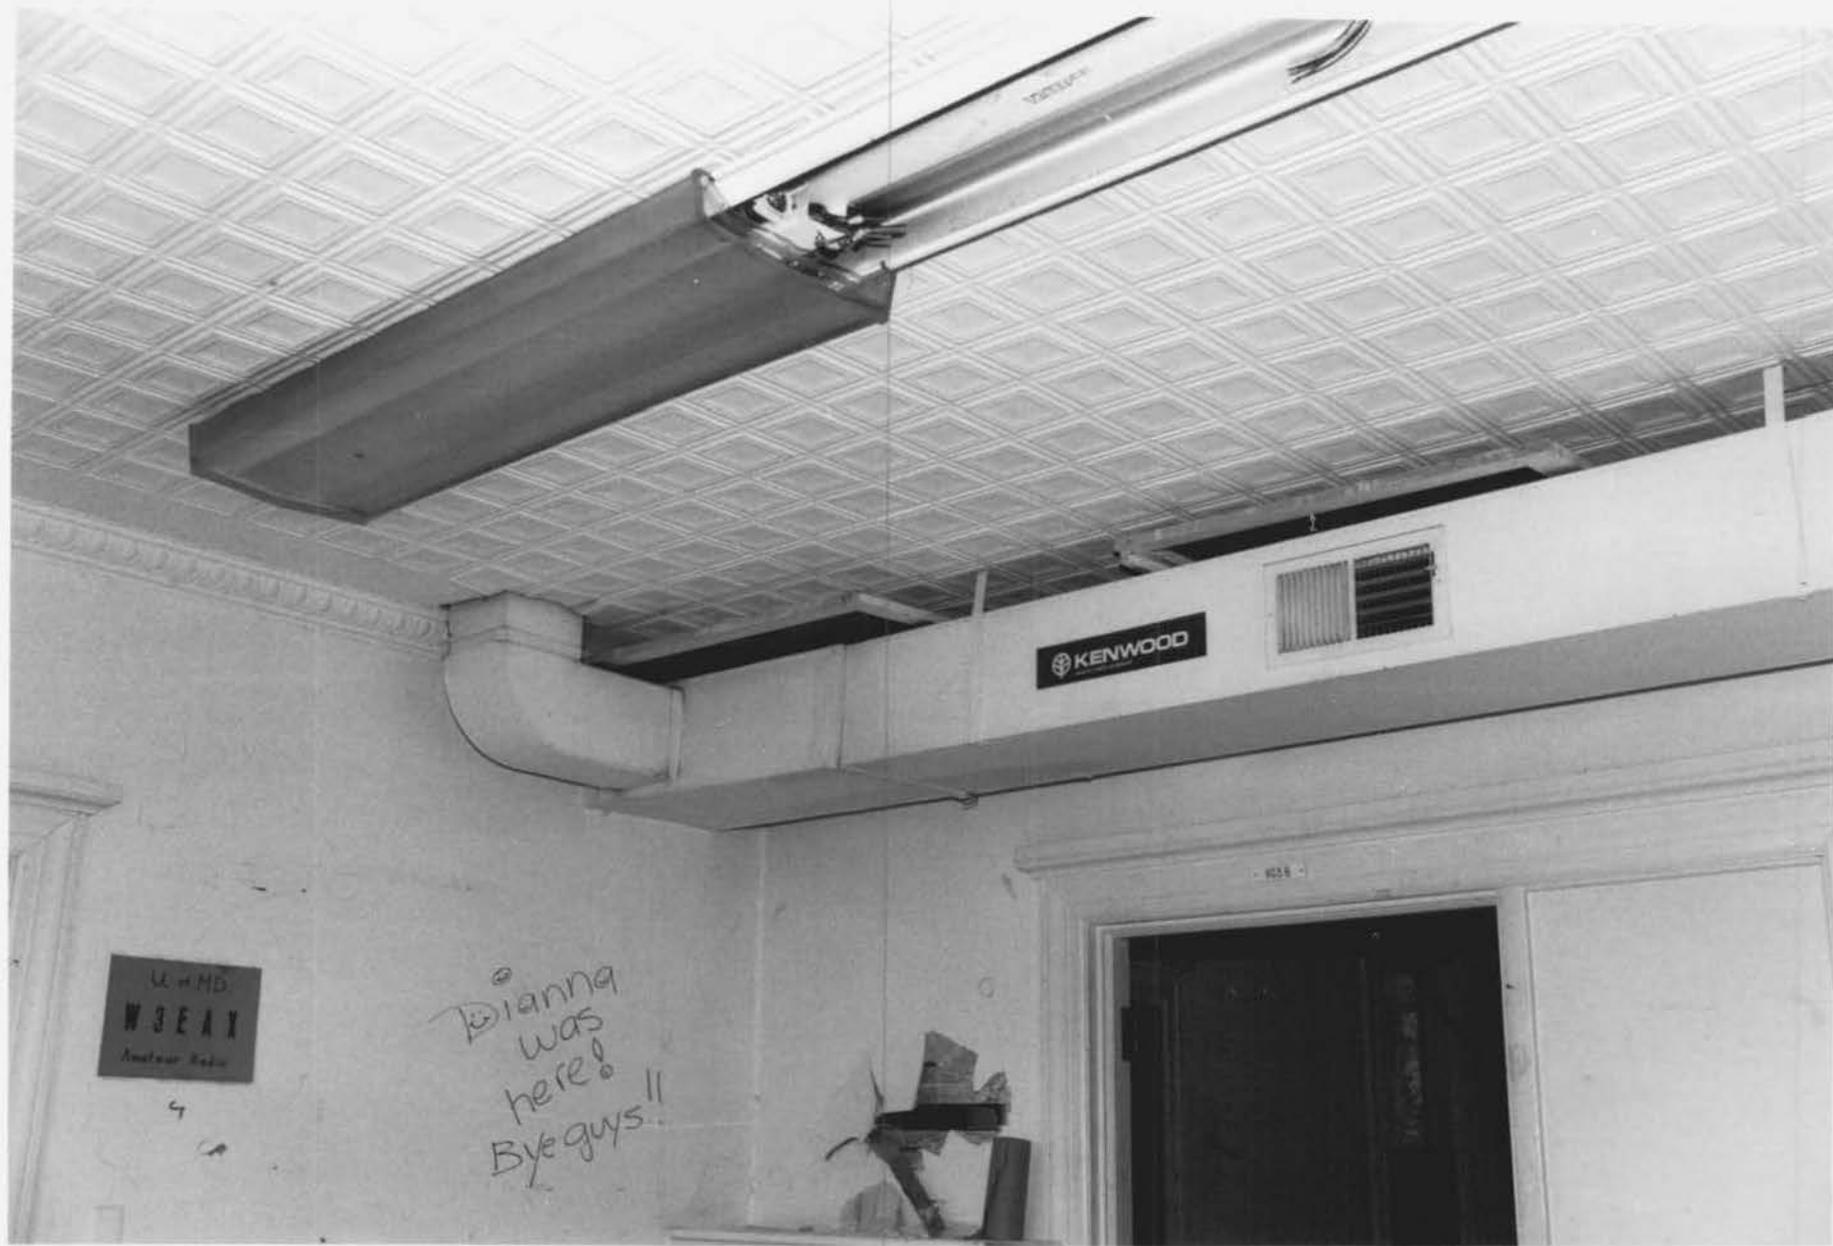
Photo Number: 20 of 23

Description: Ceiling & top of door to former LR

Most of the first floor ceilings in the main block are of pressed tin in a square pattern with a narrow egg and dart cornice. The windows are double hung wooden sash as indicated in the description of the exterior. Some doors are missing and some have been replaced with modern doors. Some of the doors that appear to be original have four horizontal panels. Moulded wood trim with a small cornice surrounds most of the window and door openings. The baseboards are about eight inches high with a moulded cap. Plaster originally covered all the walls and much of it

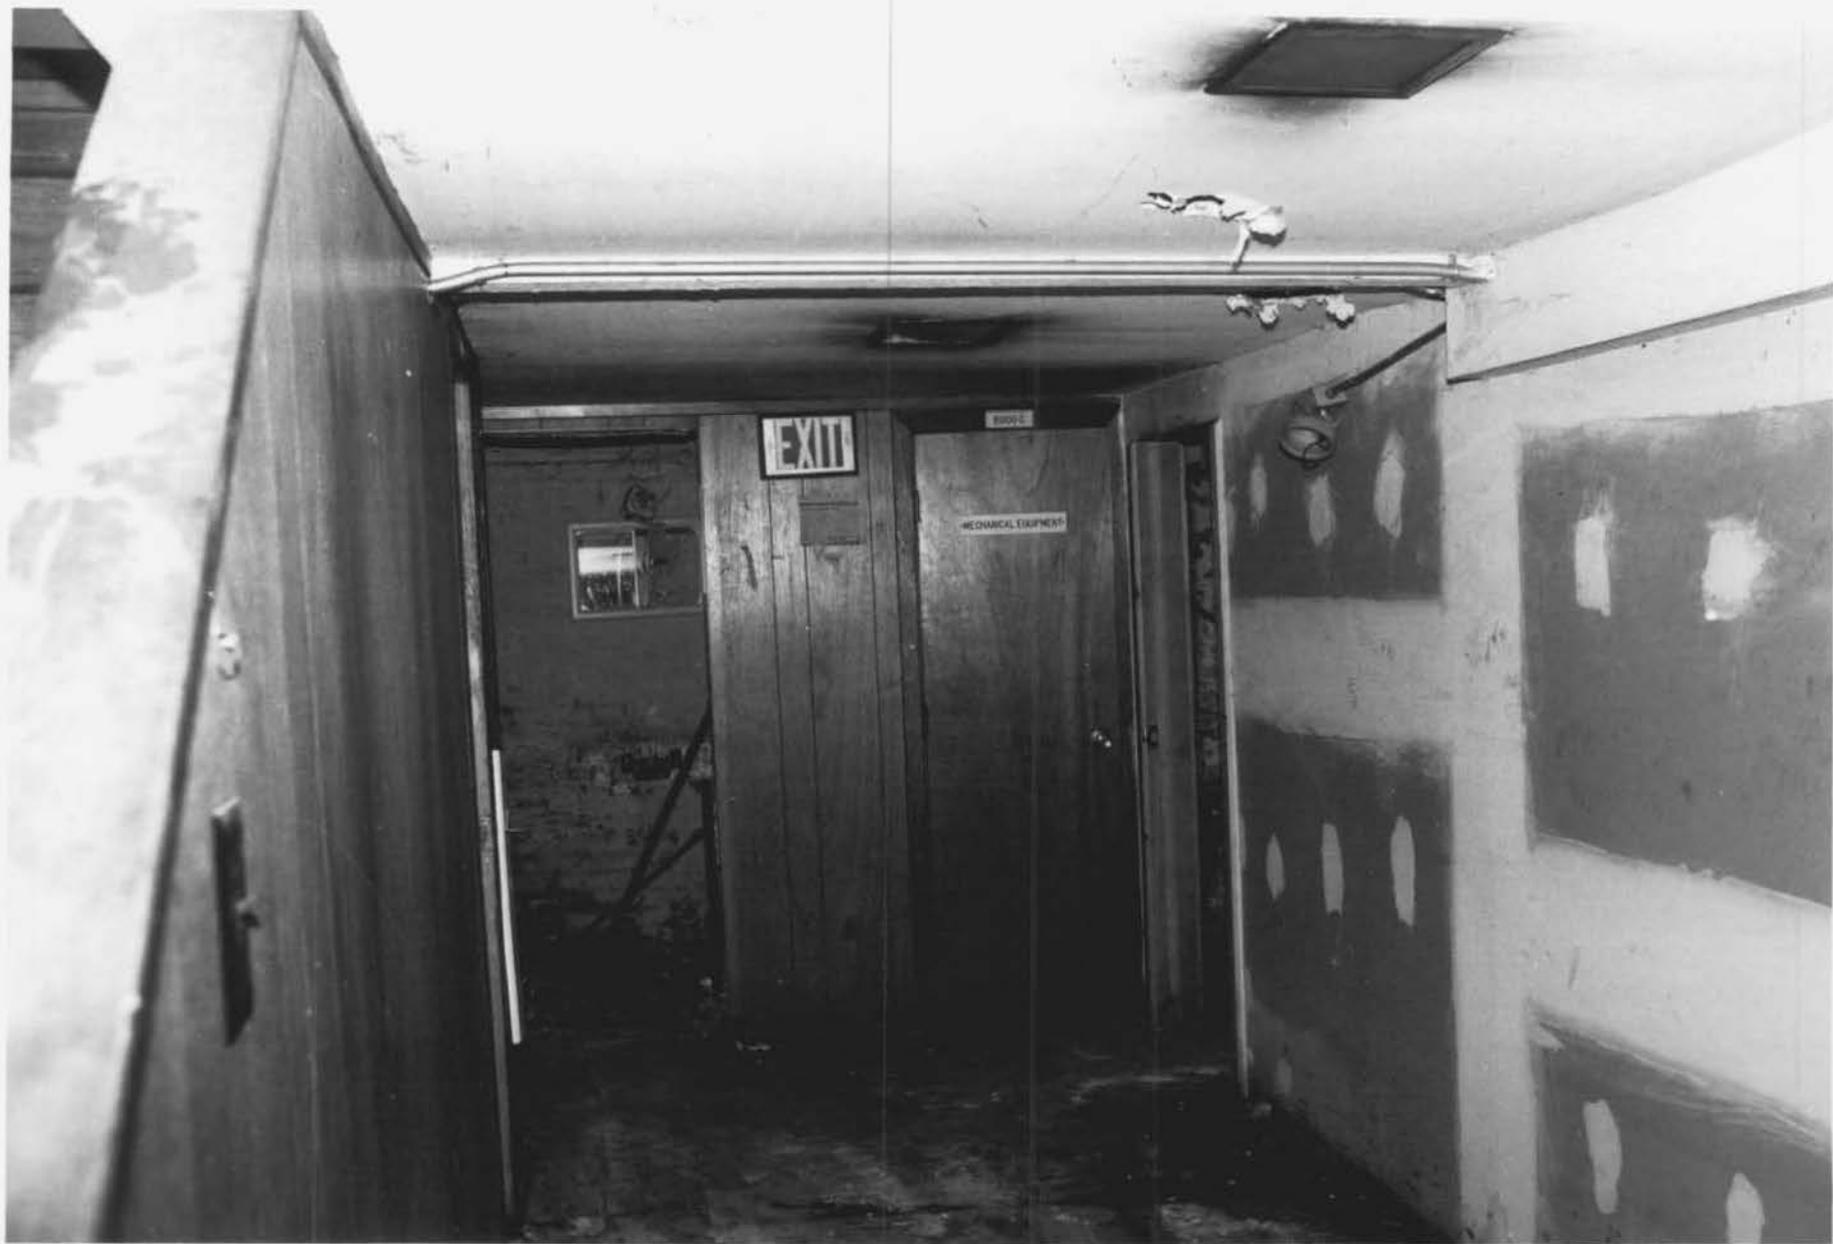
Photo Number: 21 of 23

Description: Basement

The basement walls are covered with modern panelling and the space is divided into three rooms.

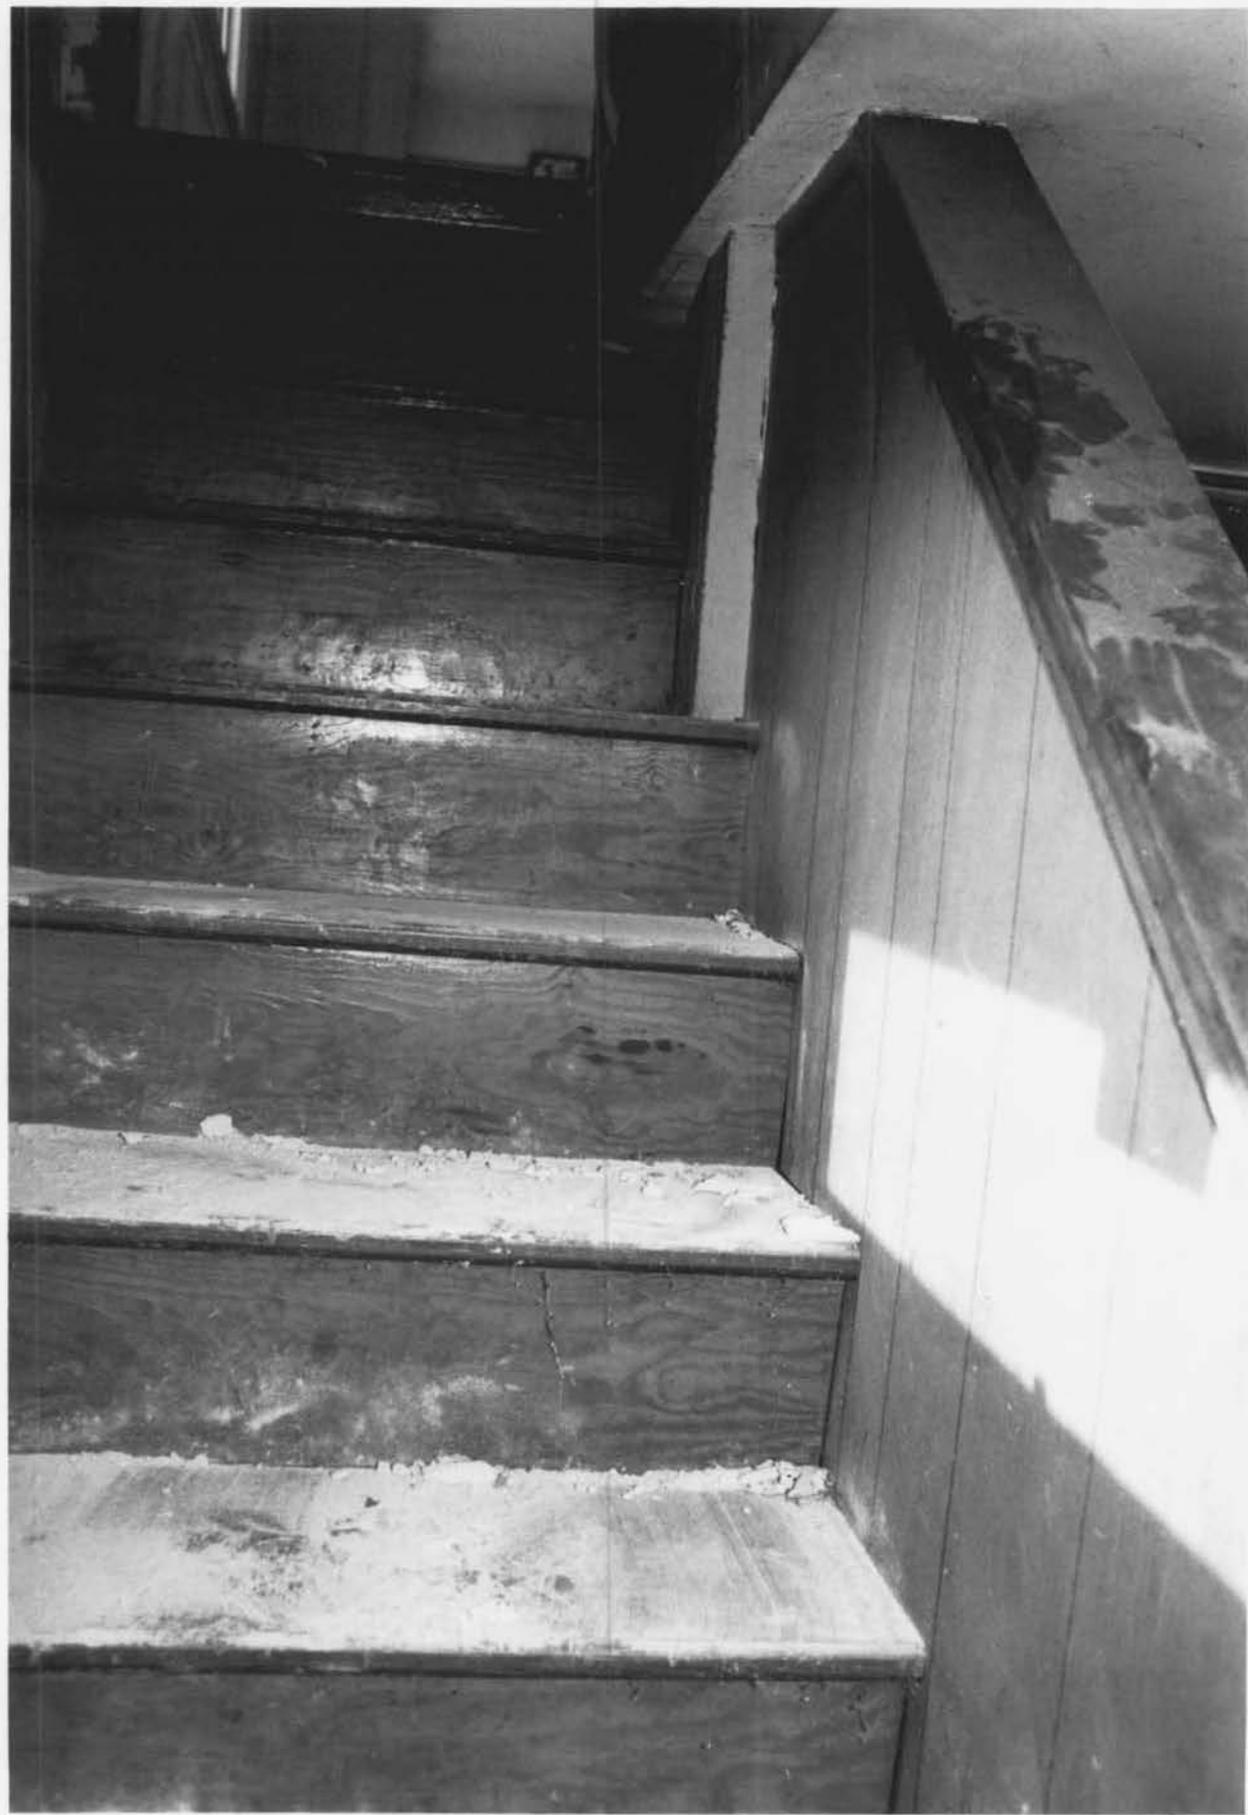
Photo Number: 22 of 23

Description: Stairs from basement to 1st floor

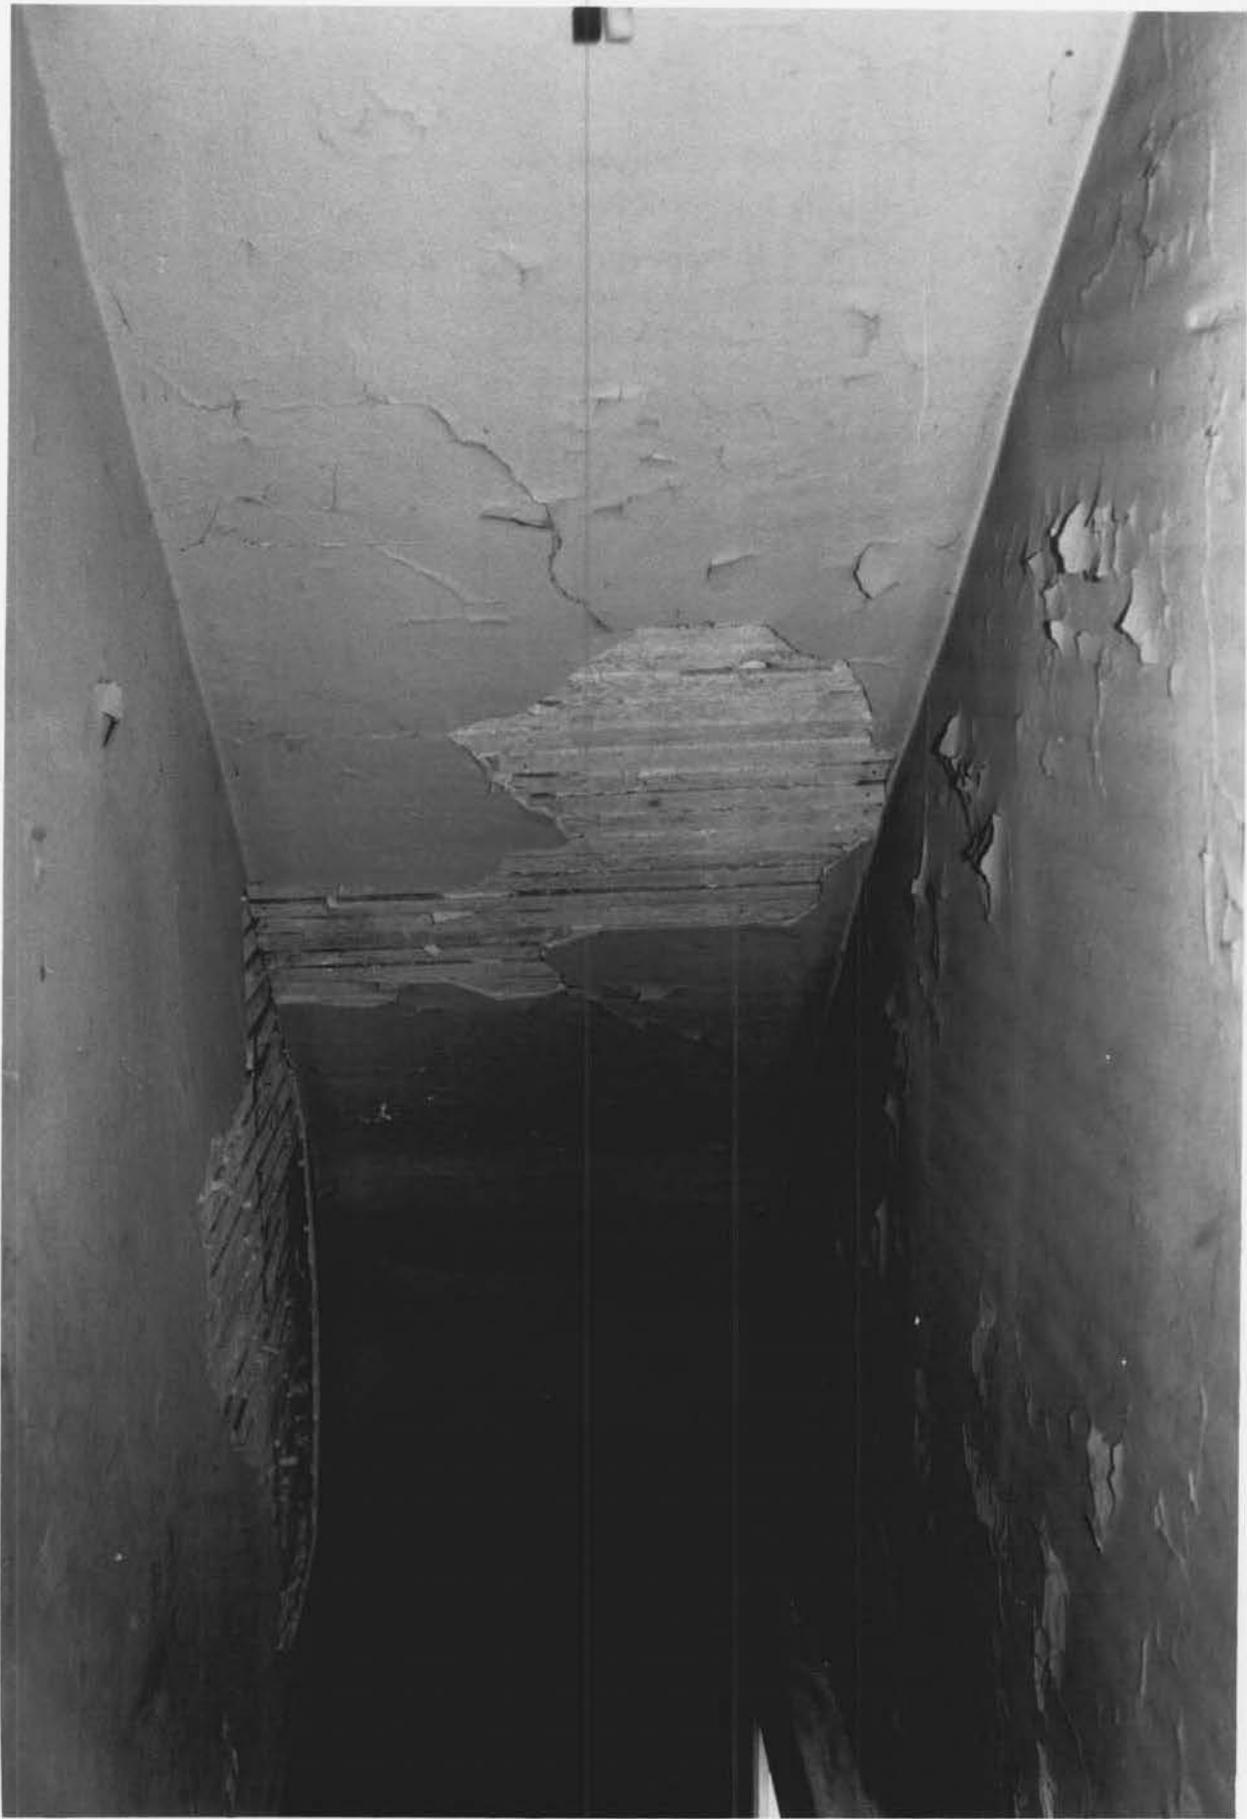
Photo Number: 23 of 23

Description: view down basement stairs
