PRINCE GEORGE'S COUNTY
HISTORIC SITE SUMMARY SHEET

Building Name: College Park Shopping Center

Location: 7415-7423 Baltimore Avenue, College Park, Maryland

**MARYLAND HISTORICAL TRUST
DETERMINATION OF ELIGIBILITY FORM**

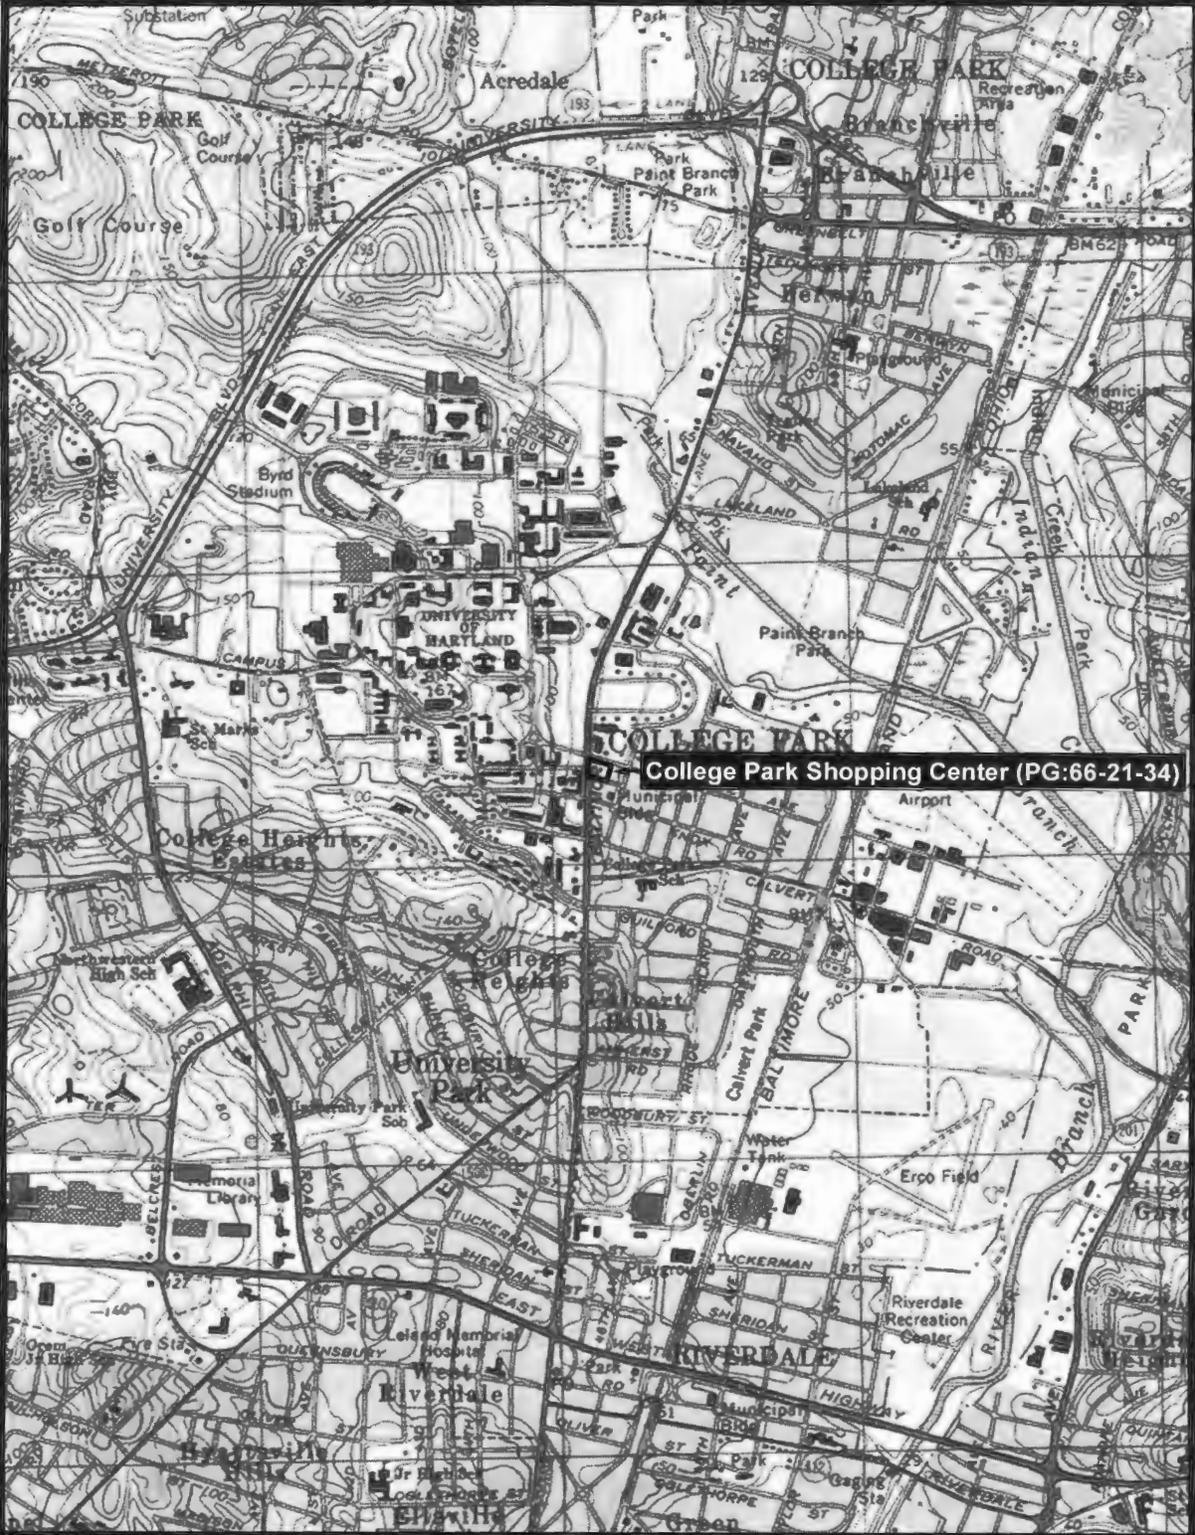
College Park Shopping Center (PG:66-21-34)
7415-7423 Baltimore Avenue (US 1)
College Park, Prince George's County, MD

Property Boundary

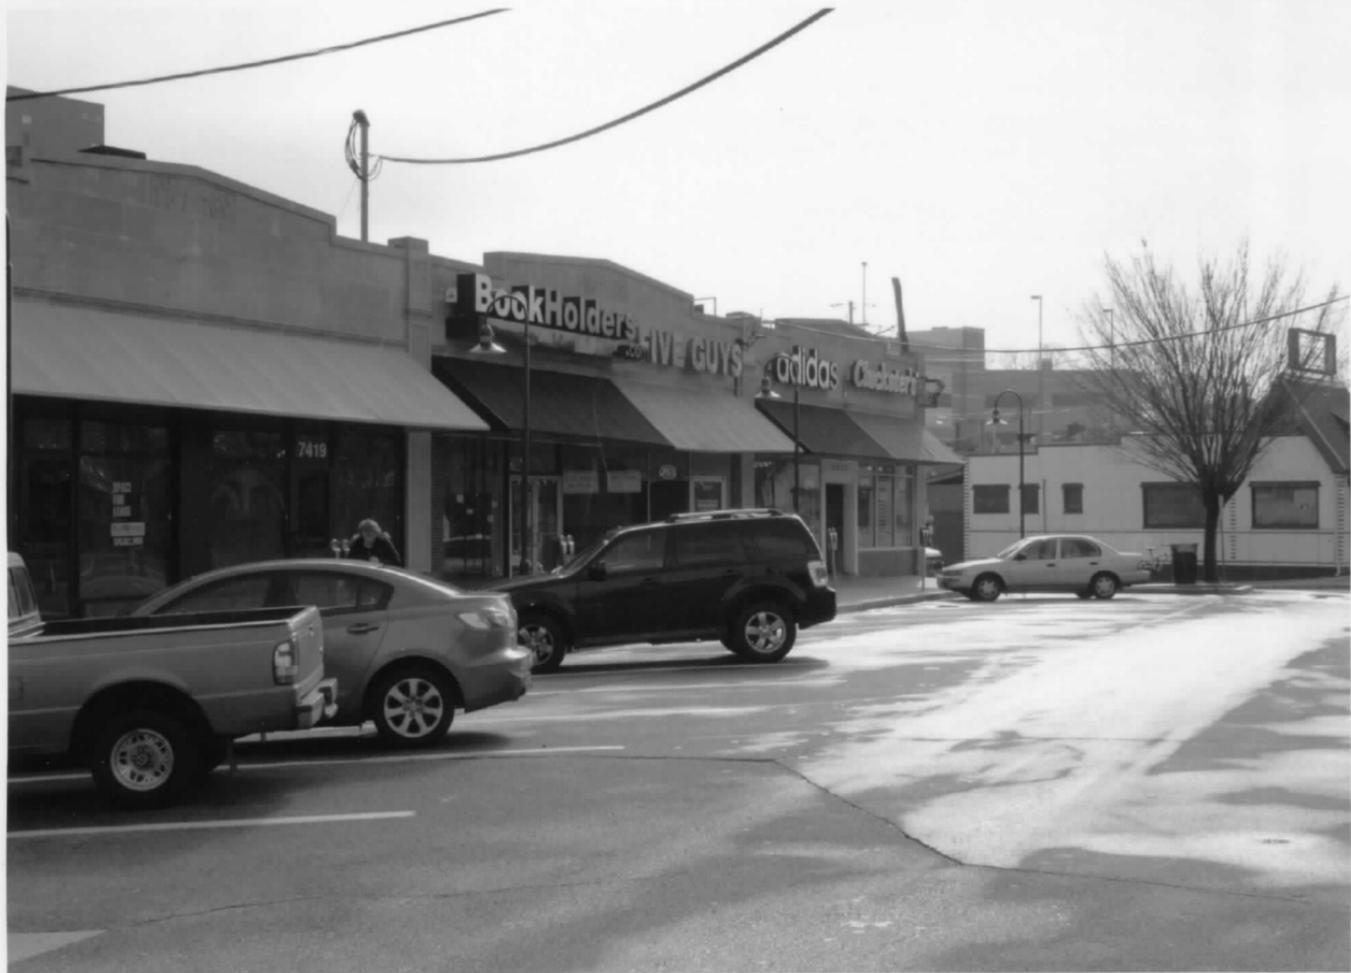
1/10

Looking south at the west facade of the College Park Shopping Center

LOOKING SOUTH AT WEST SIDE

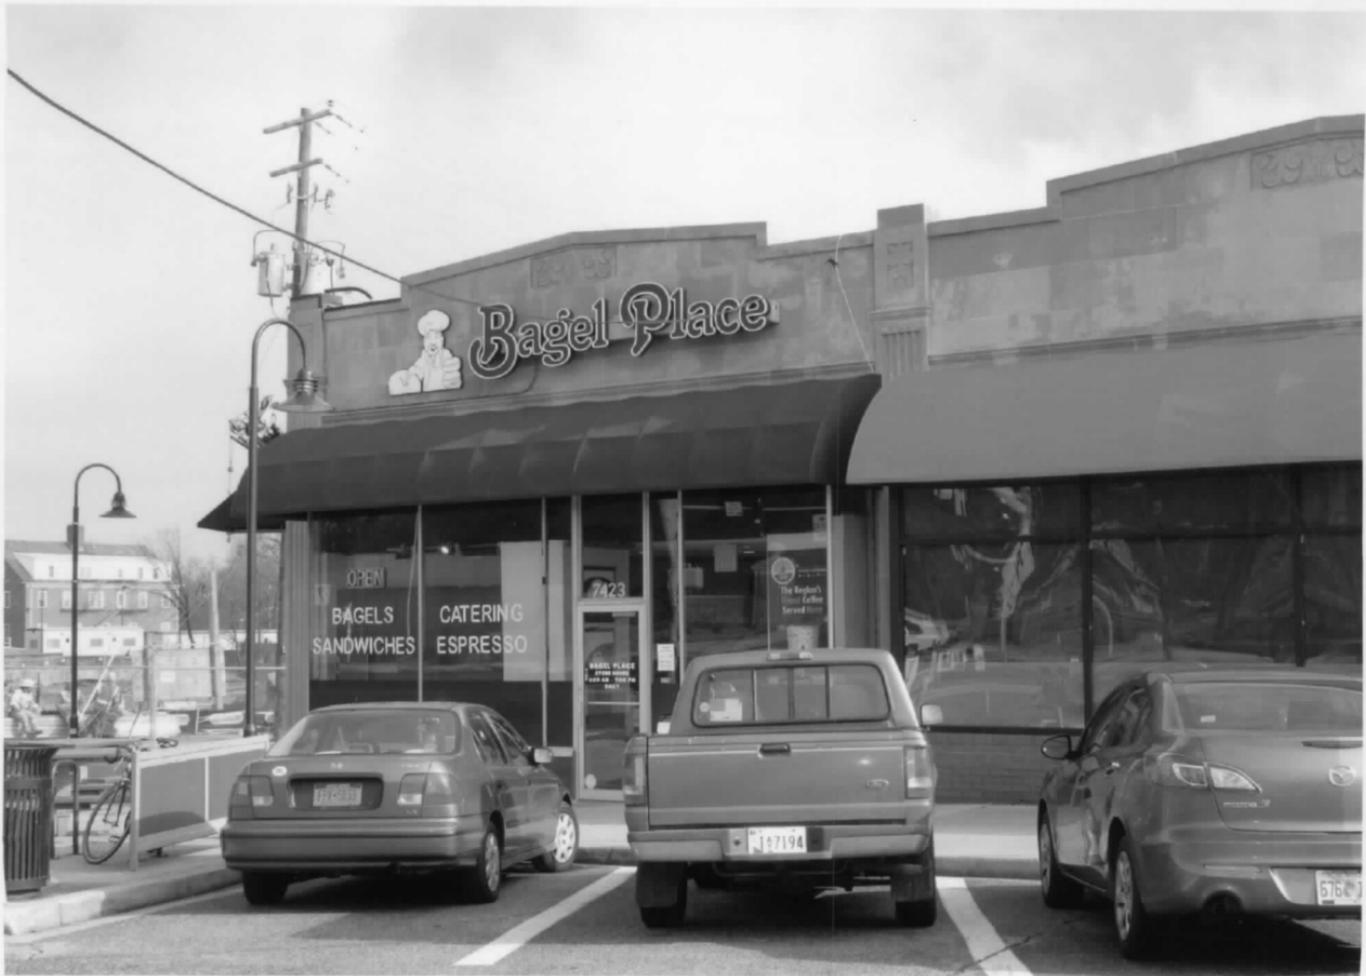
2/10

Looking east at the north end of the west facade of the College Park Shopping Center

LOOKING EAST AT NORTH END
OF WEST FACADE

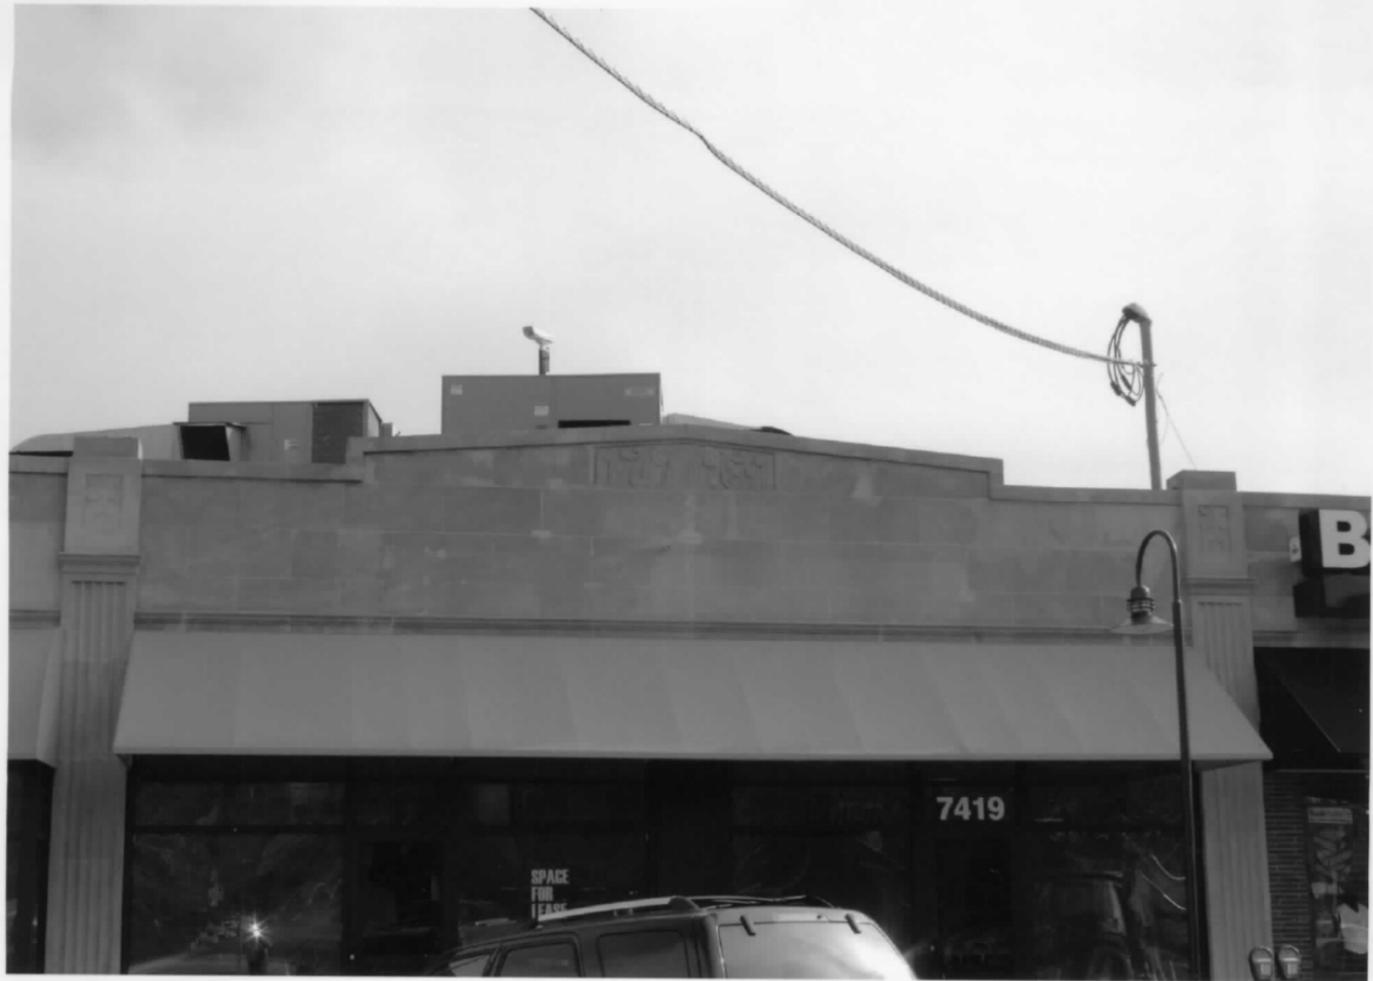
3/10

Looking east at the west center cornice

LOOKING EAST AT WEST SIDE

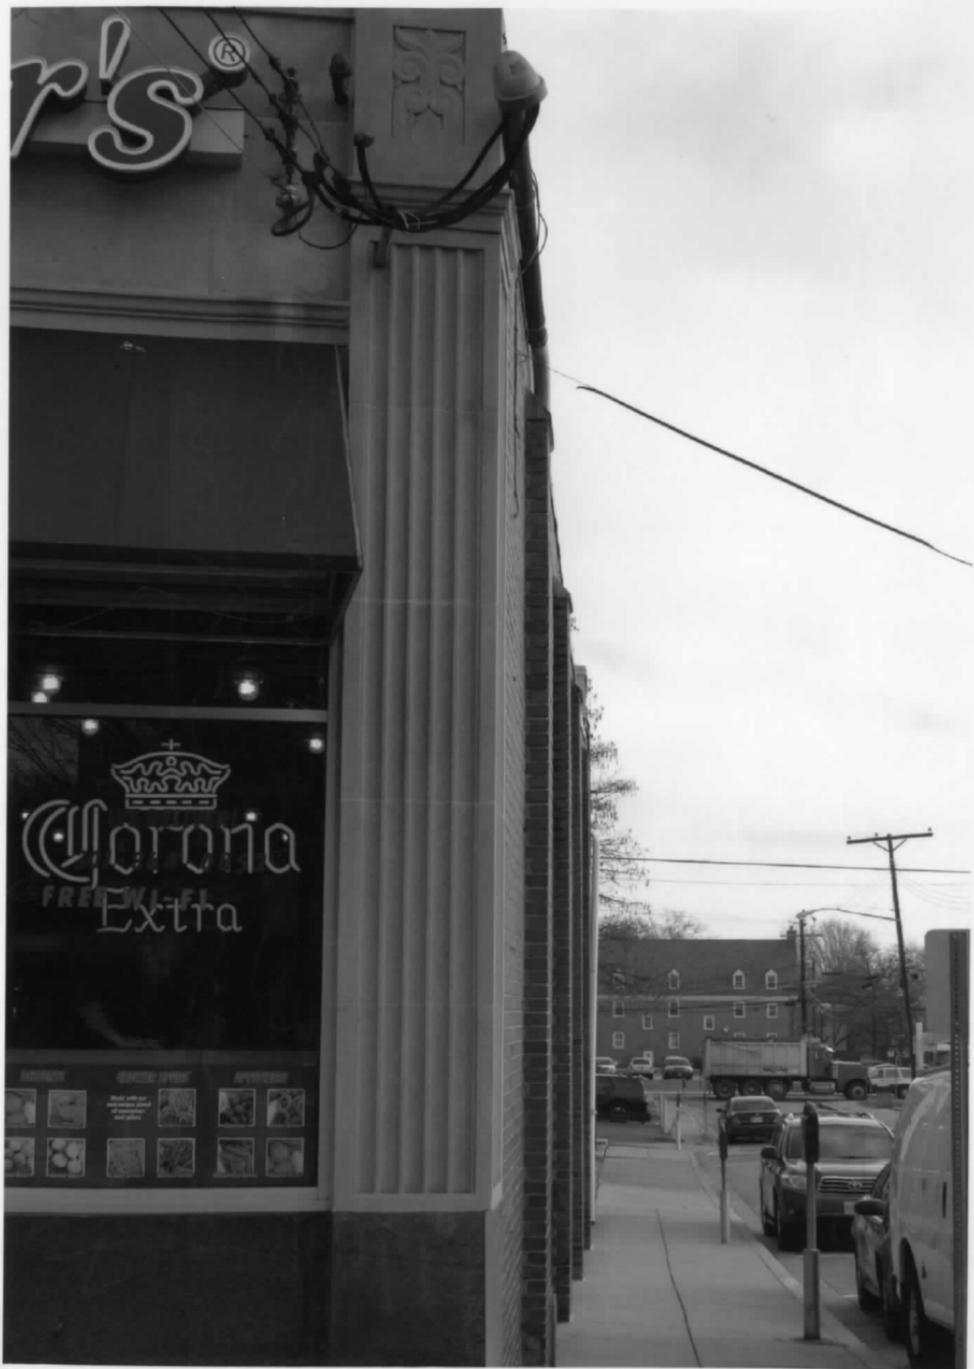
4/10

Looking east at the south end pilaster with marble base and decorative capital

LOOKING EAST AT SOUTHWEST
HILL SIDE WITH MARBLE PARKER
DECORATIVE CAPITAL.

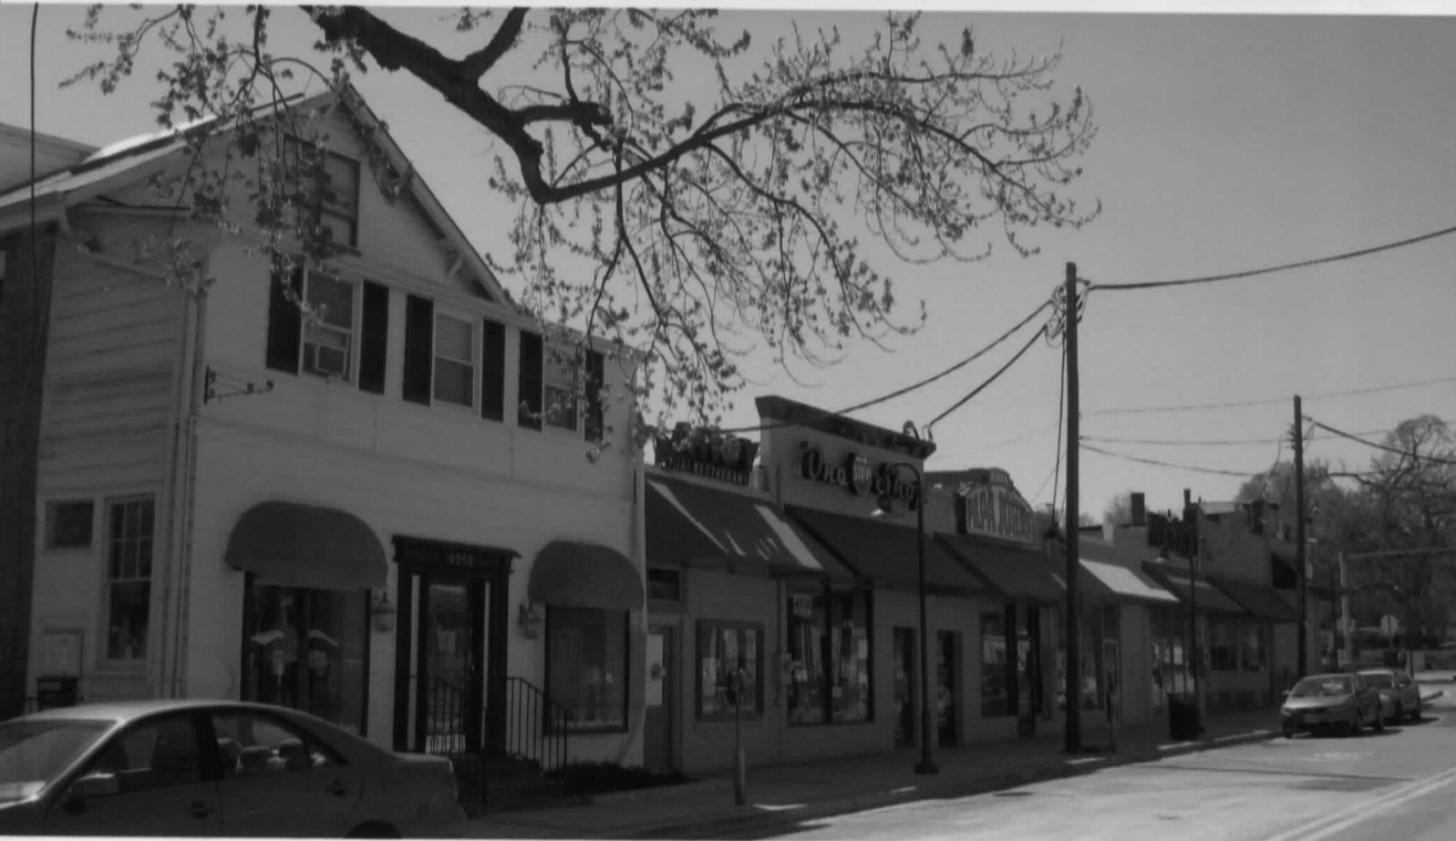
5/10

Shopping center addition and attached house; view to the southwest

Shopping center addition and attached
house; view to the southwest

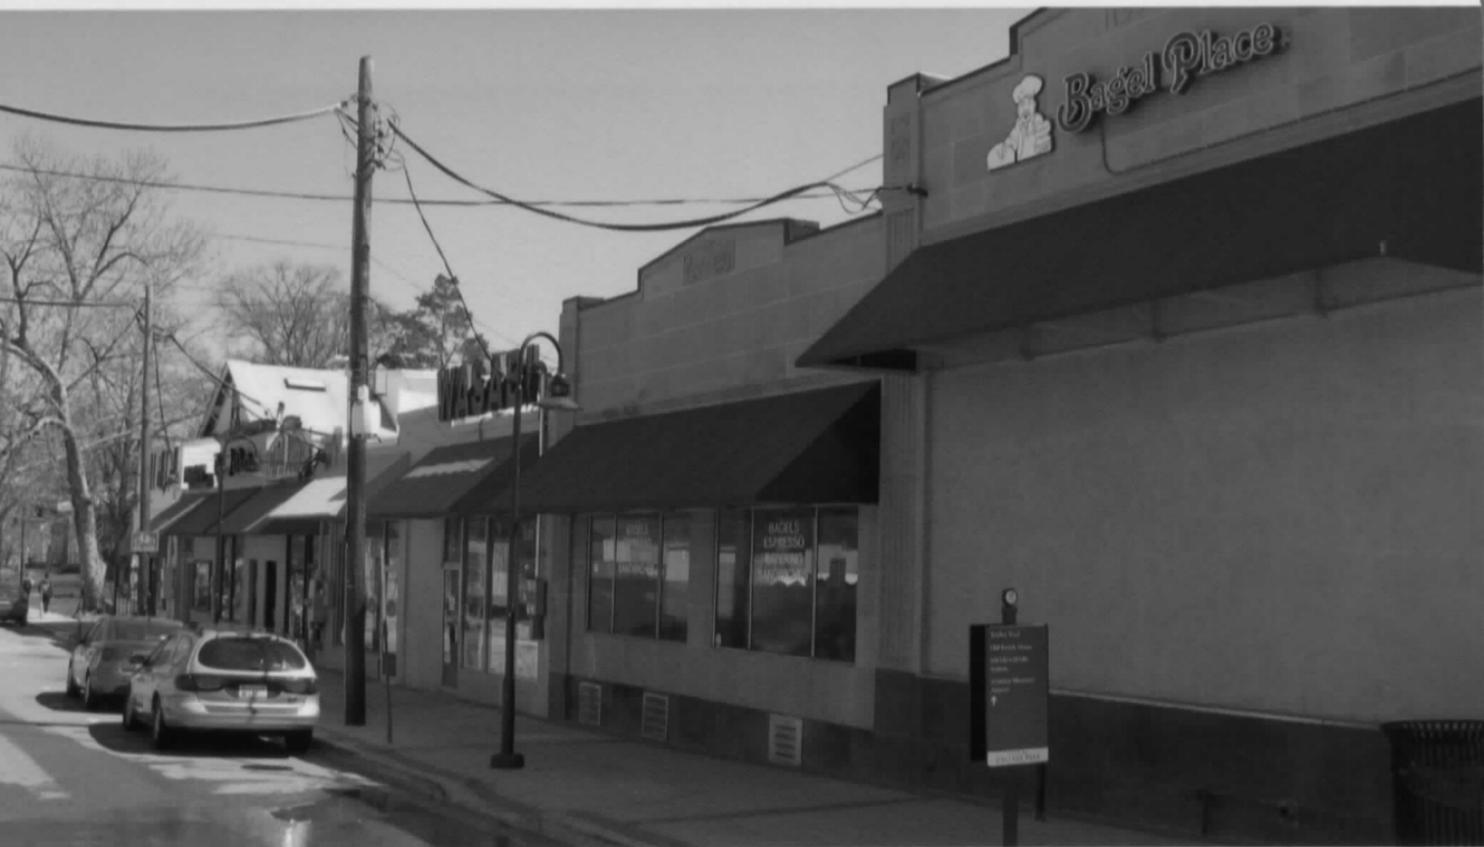
6/10

Original shopping center, addition, and attached house; view to the southeast

Original shopping center, addition, and
attached house; view to the southeast

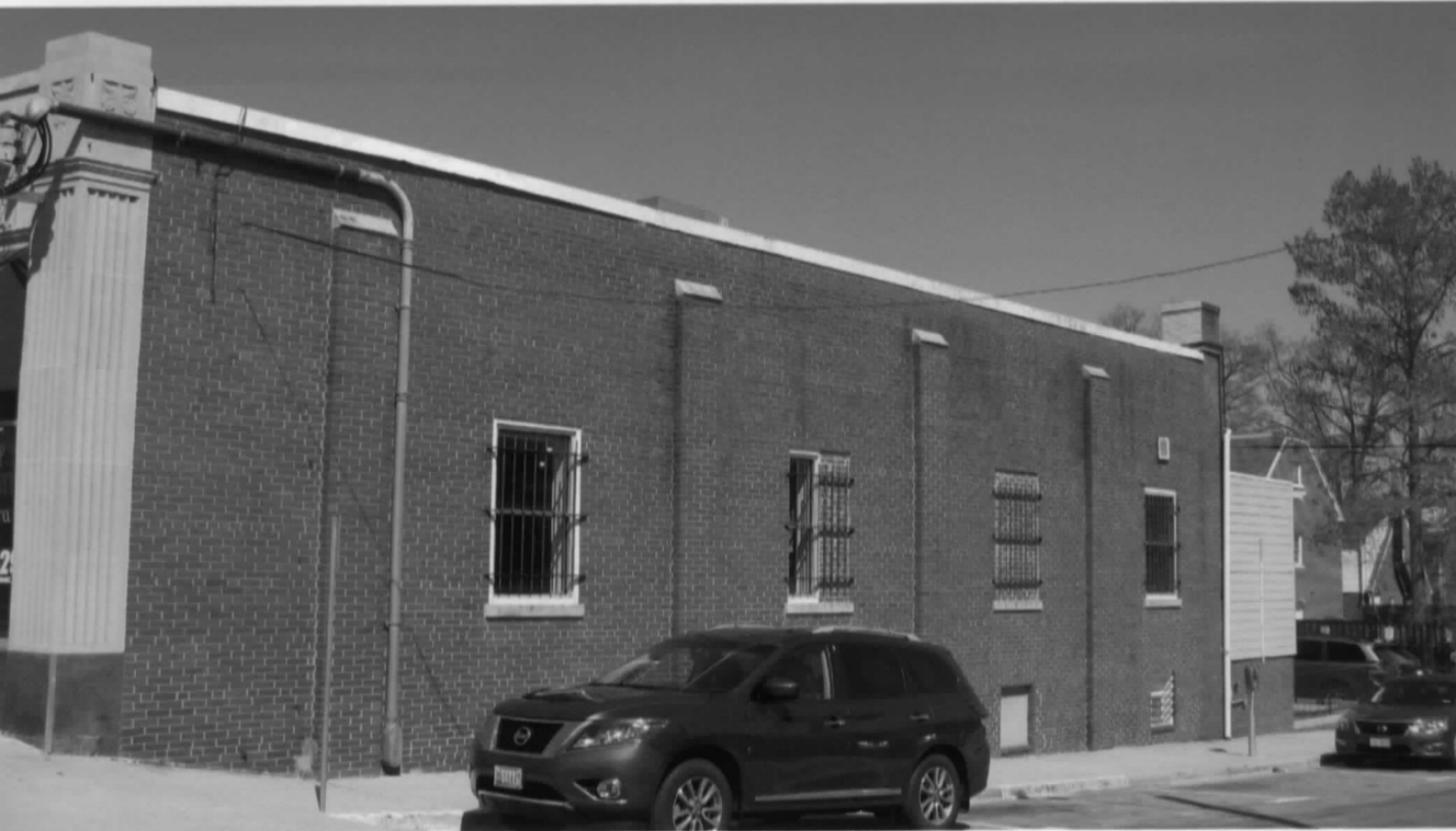
7/10

The circa 1924 building's side south elevation is oriented toward Lehigh Street. Here, the building's brick walls are exposed and brick pilasters divide the side elevation into five sections. The side south elevation contains four basement-level openings. Two are infilled with concrete stucco and two are partially infilled; one partially infilled opening contains louvers and the second contains a horizontal sliding window. The side elevation contains four evenly-spaced openings. These openings house one-over-one light, double-hung windows; metal bars cover each opening. A small louvered vent is located above the east-end opening.

South (side) elevation; view to the northeast

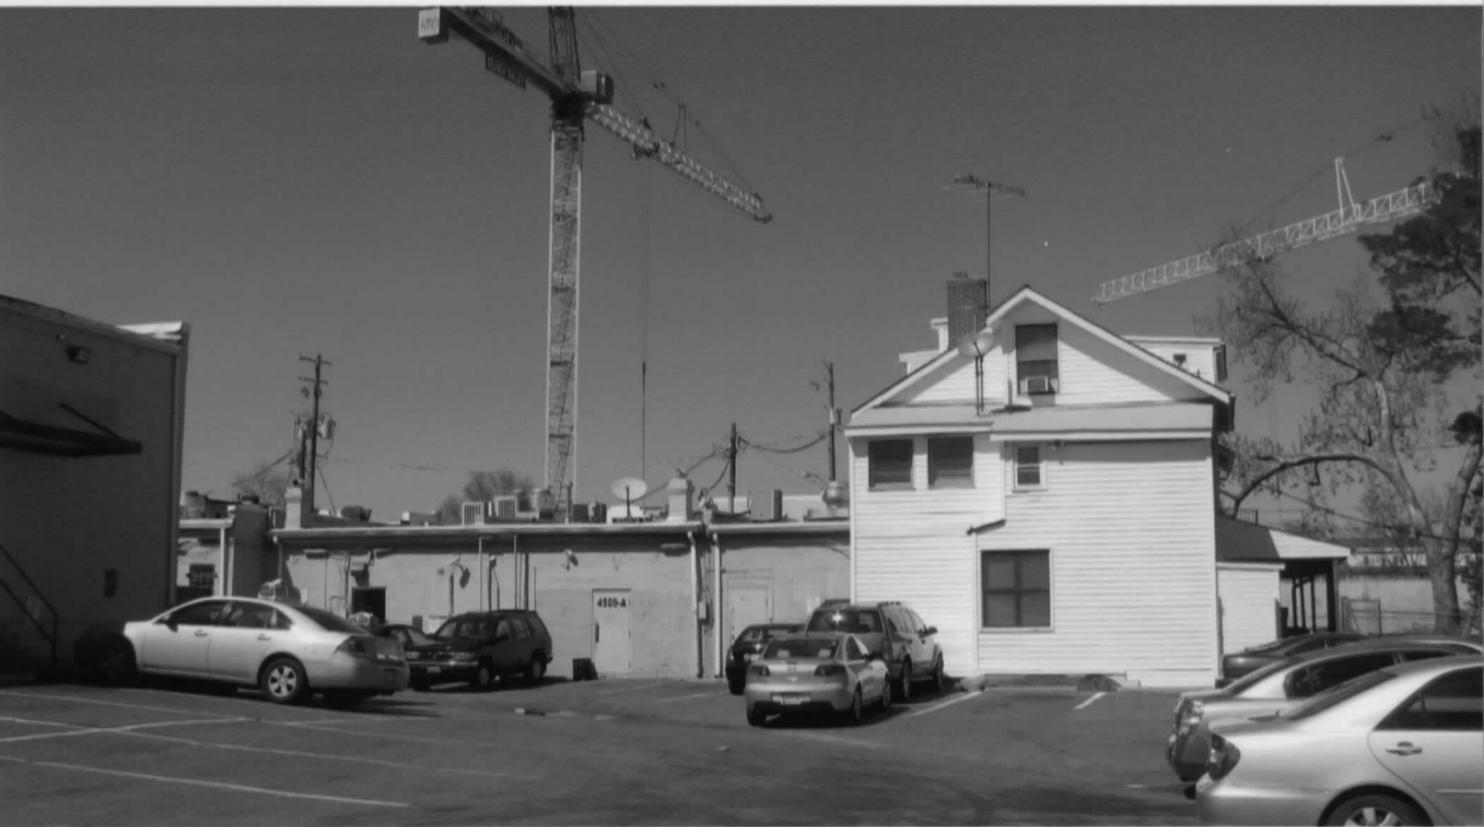
8/10

Rear elevation; view to the north

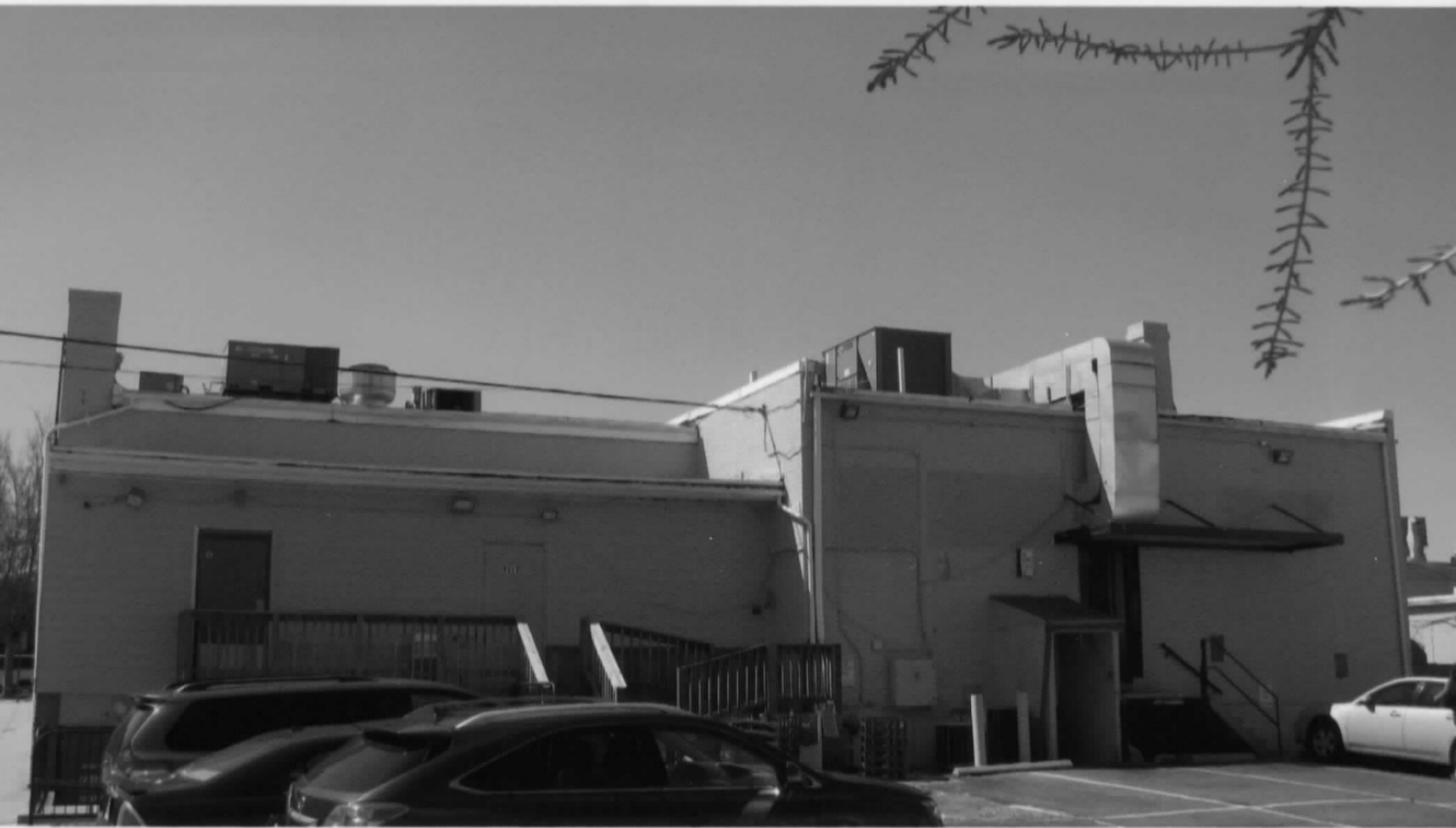
9/10

Rear elevation; view to the west

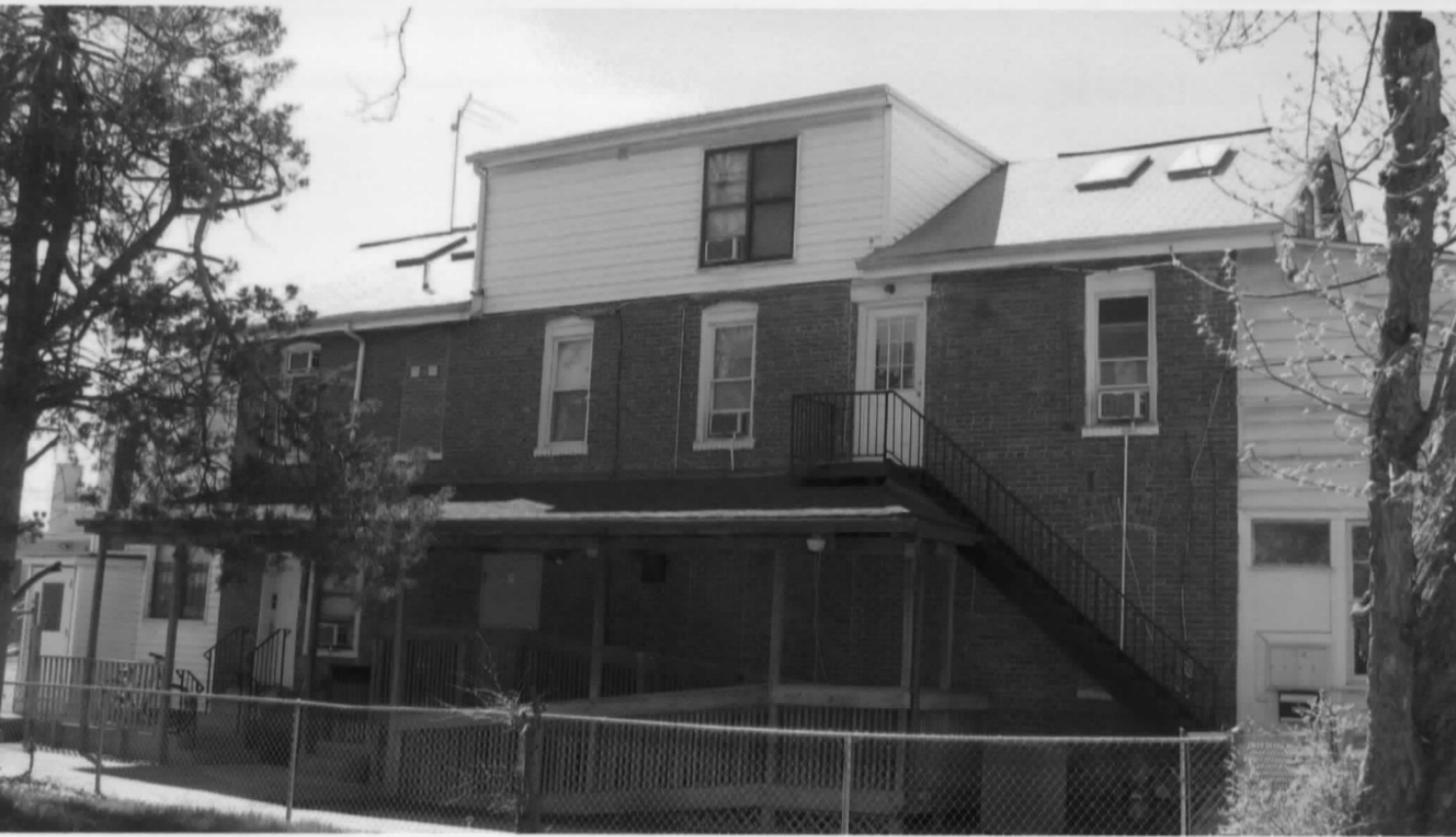
10/10

At the building's east side elevation, the original brick walls are visible. This elevation likely originally contained six evenly-spaced segmental-arch openings. At the side elevation's first story, five segmental-arch openings are infilled. A first-story non-original opening houses a metal door and opens onto a wooden porch approached by three wooden steps. A wooden ramp, which extends along the side elevation, is also attached to the porch. A segmental-arch opening contains a wooden door. Concrete steps, accessed by a concrete slab porch, approach the entrance. The concrete slab features a wooden railing. An opening, likely not original to the building, contains a multi-light replacement window. An asphalt-shingle clad hip-roof awning shelters the side elevation's first story, from the entrance to the ramp's termination. The awning is supported by wooden posts.

The original building's side east elevation's second story contains five openings. One segmental-arch opening is infilled. The north-end opening contains a one-over-one light, double-hung window. The opening's original segmental arch is infilled and a replacement door is present. Here the original segmental arch opening is not visible; the door opens onto a metal platform. The platform is connected to a staircase that provides access to the ground level and is attached to the building. The three remaining openings each contain one-over-one light, double-hung windows. Each opening's segmental arches are infilled.

East elevation of attached house; view to the west

East elevation of attached house; view to
the west
