PRINCE GEORGE'S COUNTY
HISTORIC SITE SUMMARY SHEET

Survey #: P.G. #68-33 Building Date: ca. 1899

Building Name: Buck-Catterton House

Location: 4211 Farragut Street, Hyattsville, Maryland

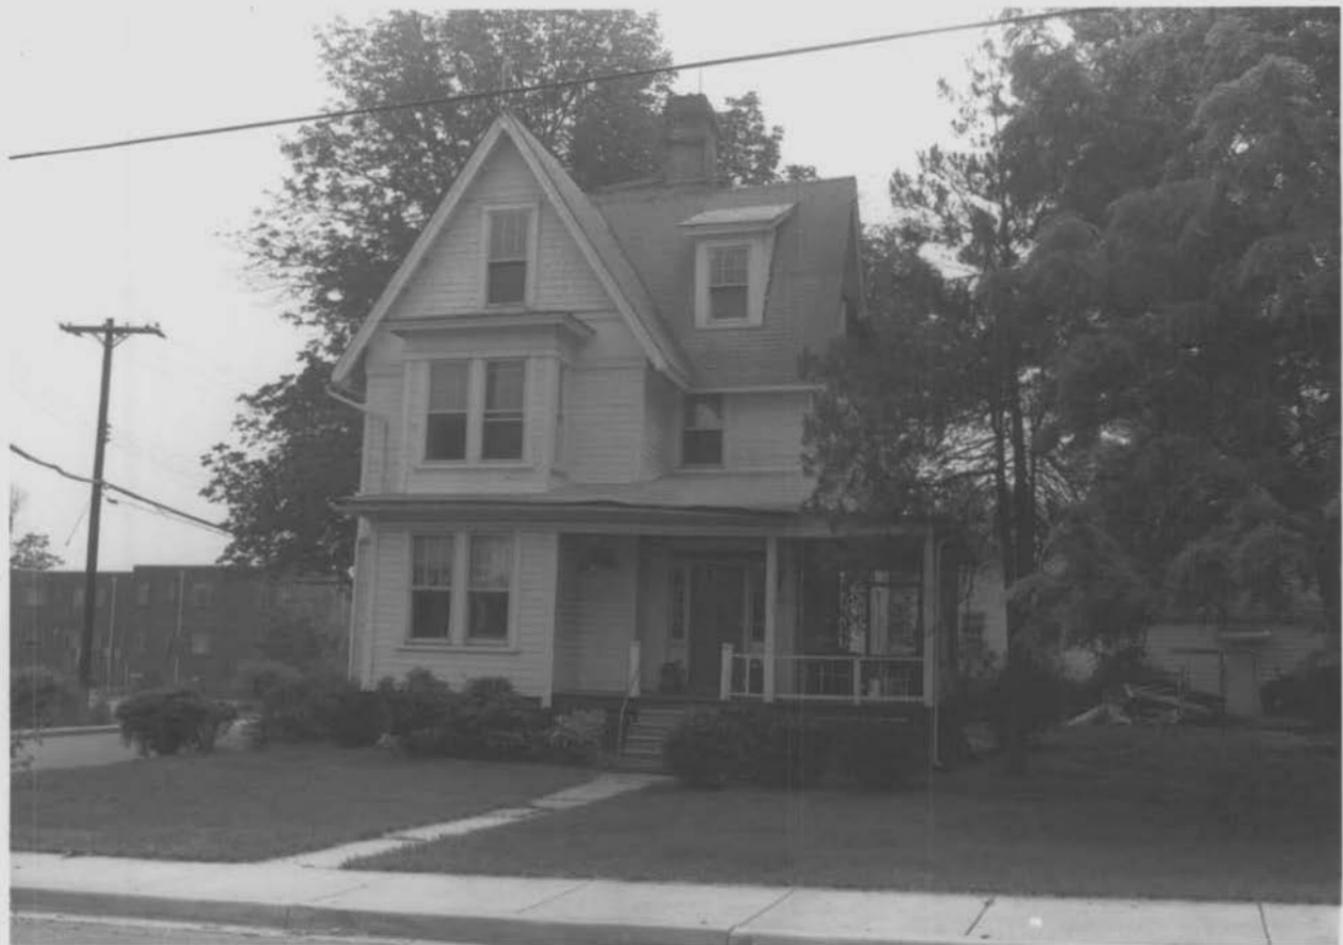
P.G. #68-33

Buck-Catterton House
Prince George's County, Maryland
Susan G. Pearl
May 1987
North elevation
Neg: Maryland Historical Trust
Annapolis, MD

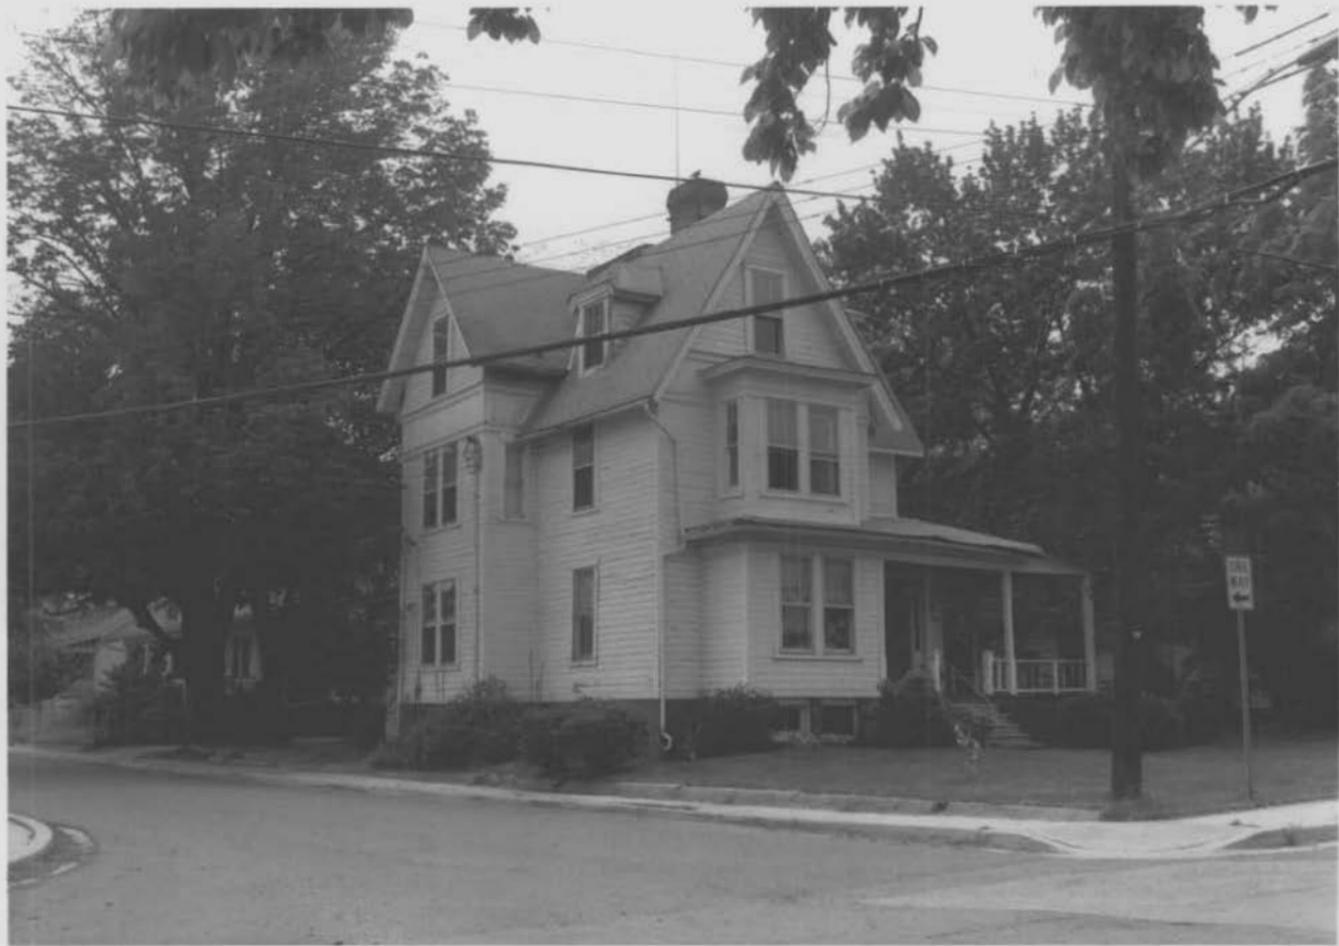
P.G. #68-33

Buck-Catterton House
Prince George's County, Maryland
Susan G. Pearl
May 1987
Northeast 3/4 elevation
Neg: Maryland Historical Trust
Annapolis, MD

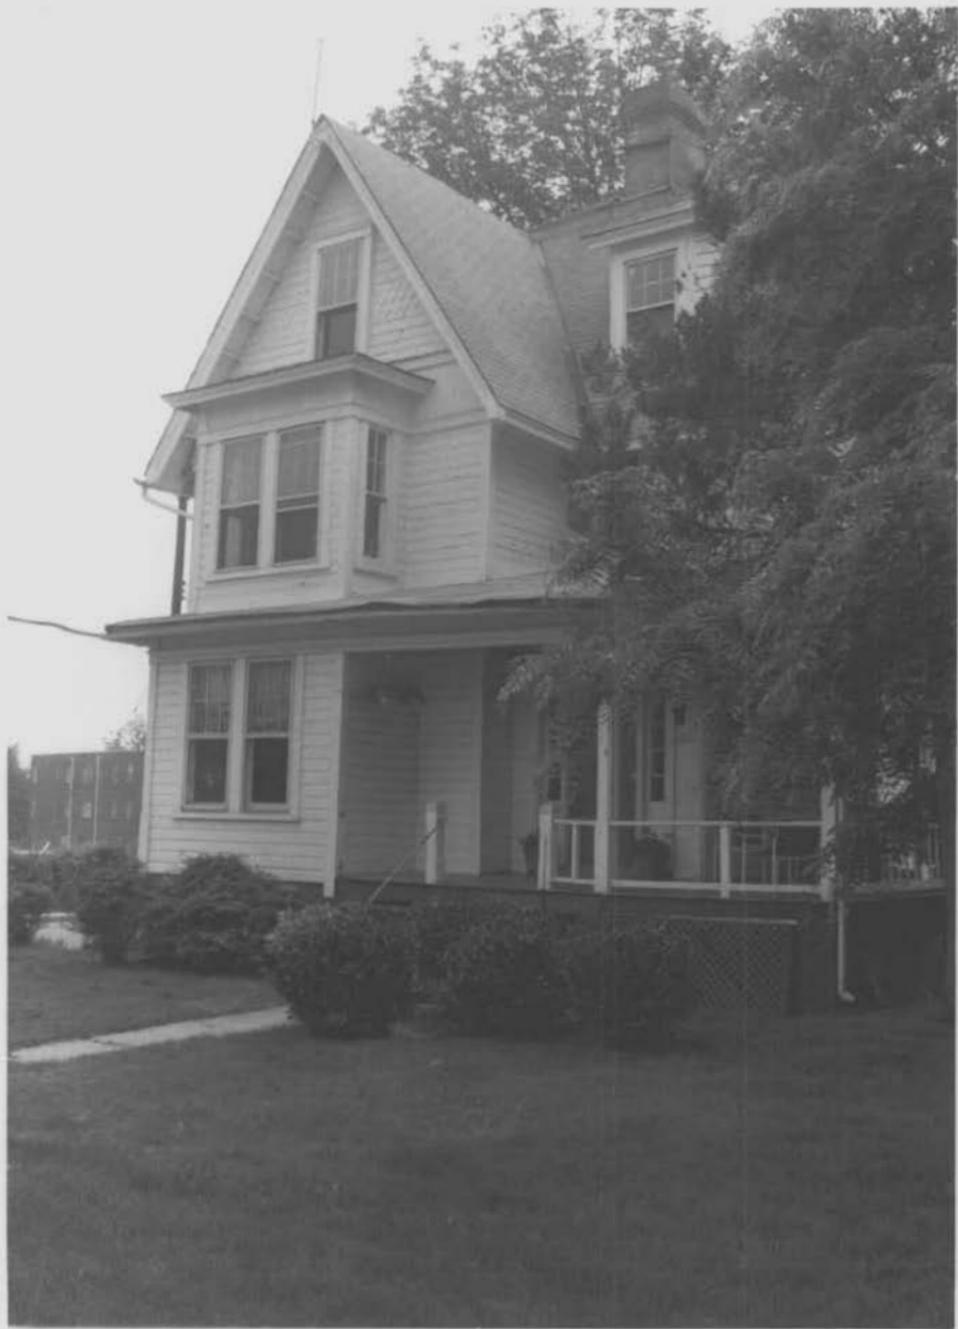
P.G. #68-33

Buck-Catterton House
Prince George's County, Maryland
Susan G. Pearl
May 1987
Northwest 3/4 elevation
Neg: Maryland Historical Trust
Annapolis, MD
