PRINCE GEORGE'S COUNTY  
HISTORIC SITE SUMMARY SHEET

Survey #: P.G. #68- 60 Building Date: 1905

Building Name: Bellman House

Location: 4012 33rd Street, Mt. Rainier

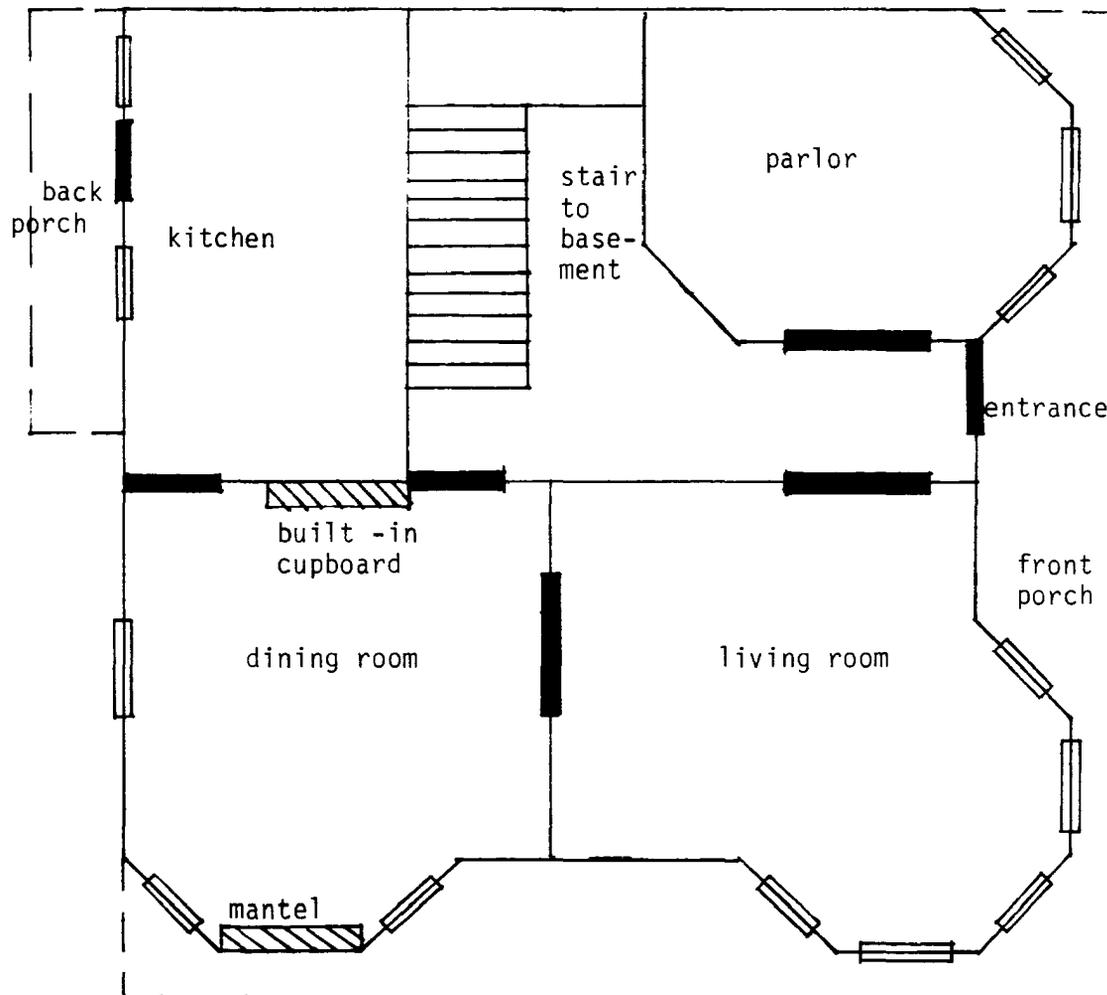
P.G.#68-60  
Bellman House  
November 1988  
Sketch Floorplan  
Not to Scale

The interior of the Bellman House has an "L" shaped central hallway, and a square plan, with two parlors flanking the hall at the front of the house and a dining room and kitchen at the rear. The parlors are irregularly shaped due to the projecting bays and octagonal tower.

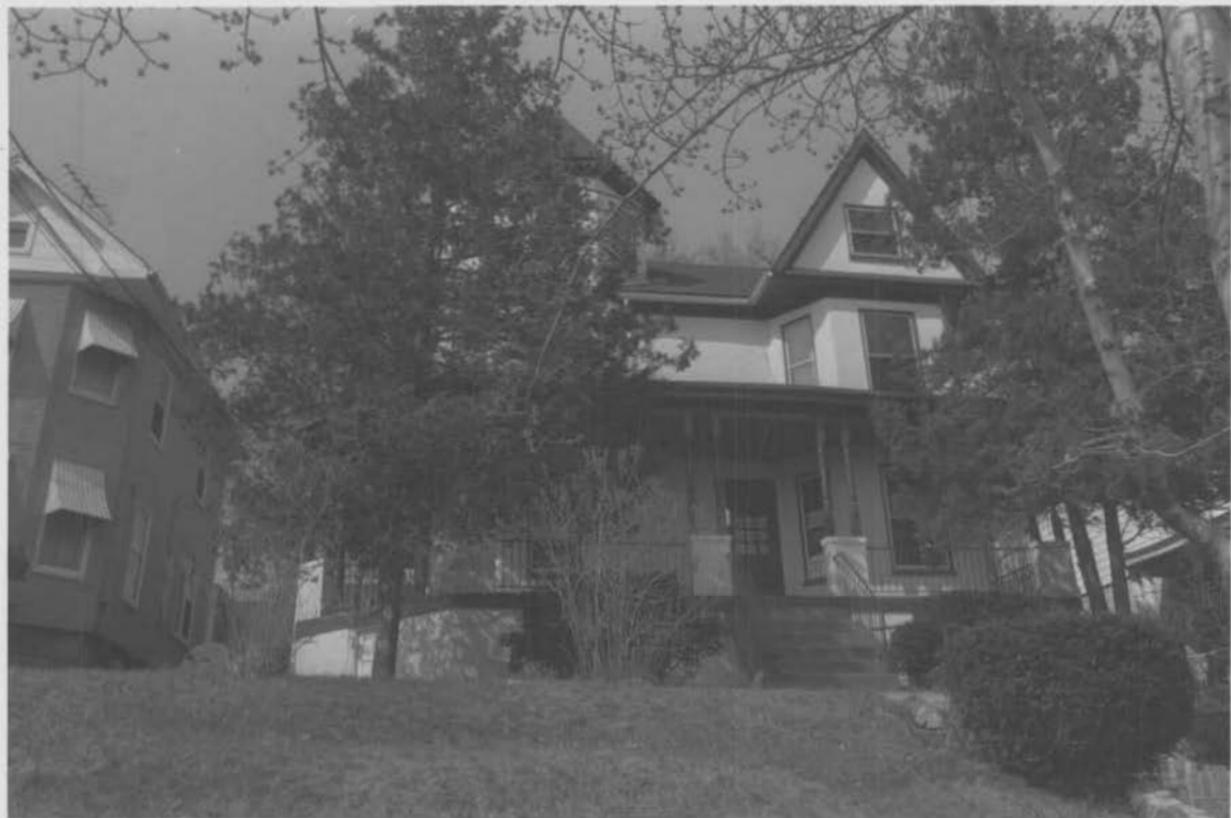
P.G. # 68-60

The three-bay east (main) facade is irregularly massed, due to the projecting octagonal tower at the southeast corner and a two-story semi-octagonal bay surmounted by a pediment as the northeast bay. The central entrance has a six-panel door with nine panes glazing the upper half. The door is surmounted by a narrow dentilled band, below a rectangular transom. The windows on first and second stories are 1/1 double-hung sash with narrow wood surrounds. The first story is sheltered by a hipped roof entrance porch which wraps around the south side of the building. The porch is set on a high parged concrete foundation and has a wooden floor, reached by a flight of six concrete steps. The turned and chamfered porch posts are arranged in pairs set on high stucco-covered concrete bases. The balustrade is a modern replacement metal balustrade. The posts support a roof with a plain frieze, and an overhanging boxed crown-molded cornice. There are foundation windows beneath the porch and a ground level entry to the basement beneath the southeast corner of the porch, reached by two steps down.

E main elevation

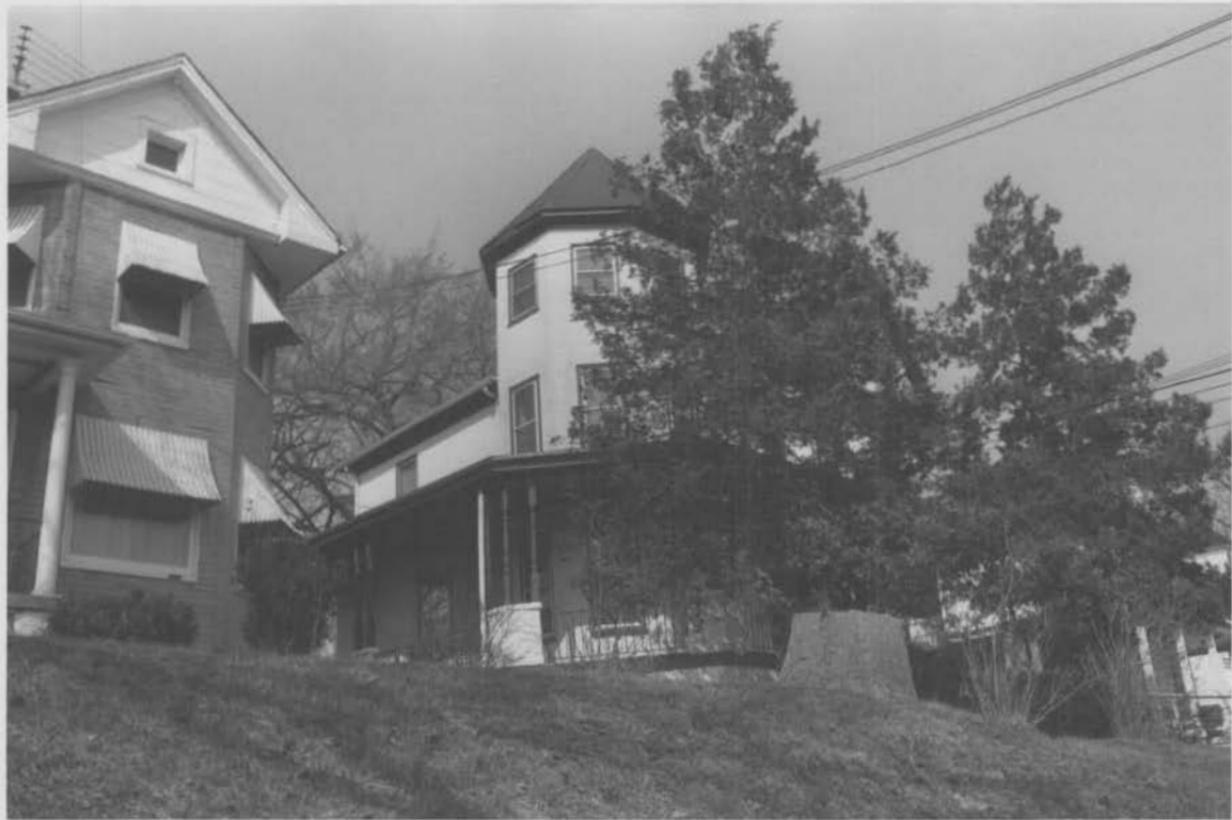
SE elevation

The two-bay south elevation is sheltered by the east entrance porch which wraps around the crosses the entire facade. There is a one-story semi-octagonal west bay. There are four windows on the facade. It appears that there may have been more originally.

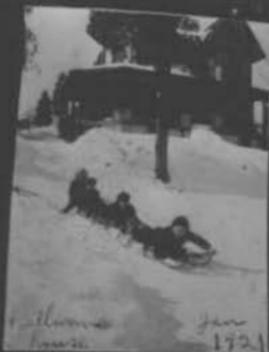
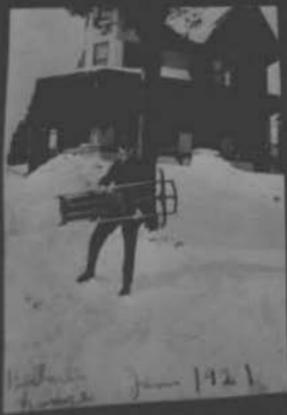
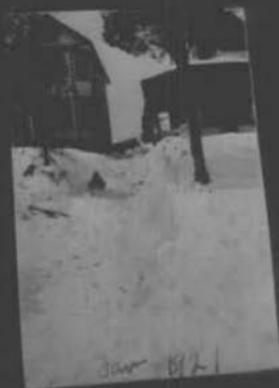
Views of Bellman House, ca. 1921

A ca. 1921 photograph shows the Bellman house substantially as it is today, with the same stucco wall treatment and front porch resting on the projecting basement story. A driveway visible along the south side of the lot has since been filled in.

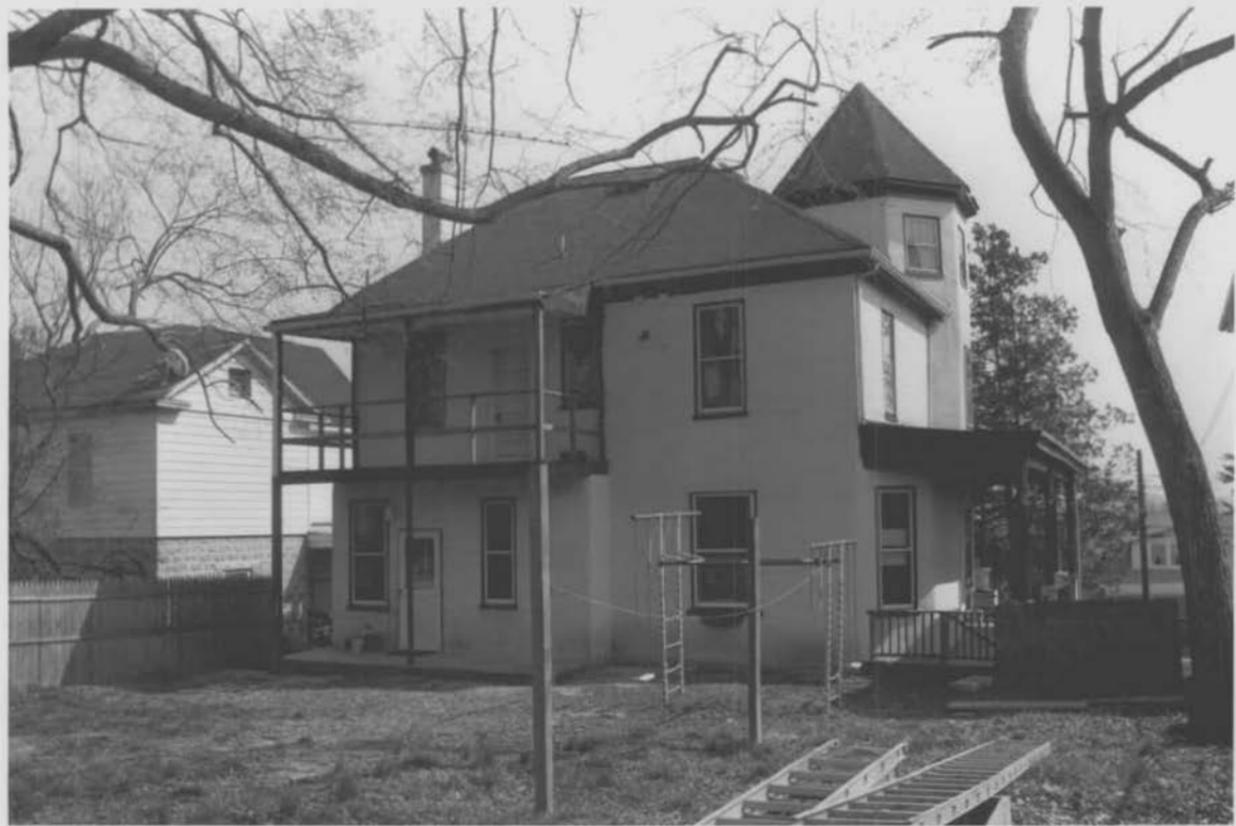
W elevation

The three-bay west (rear) elevation has a steep hipped roofline. An entry to the kitchen is in the northwest bay. It is sheltered by a two-bay, two-story shed roof porch supported on metal posts. There is an entry to the porch on the second story.

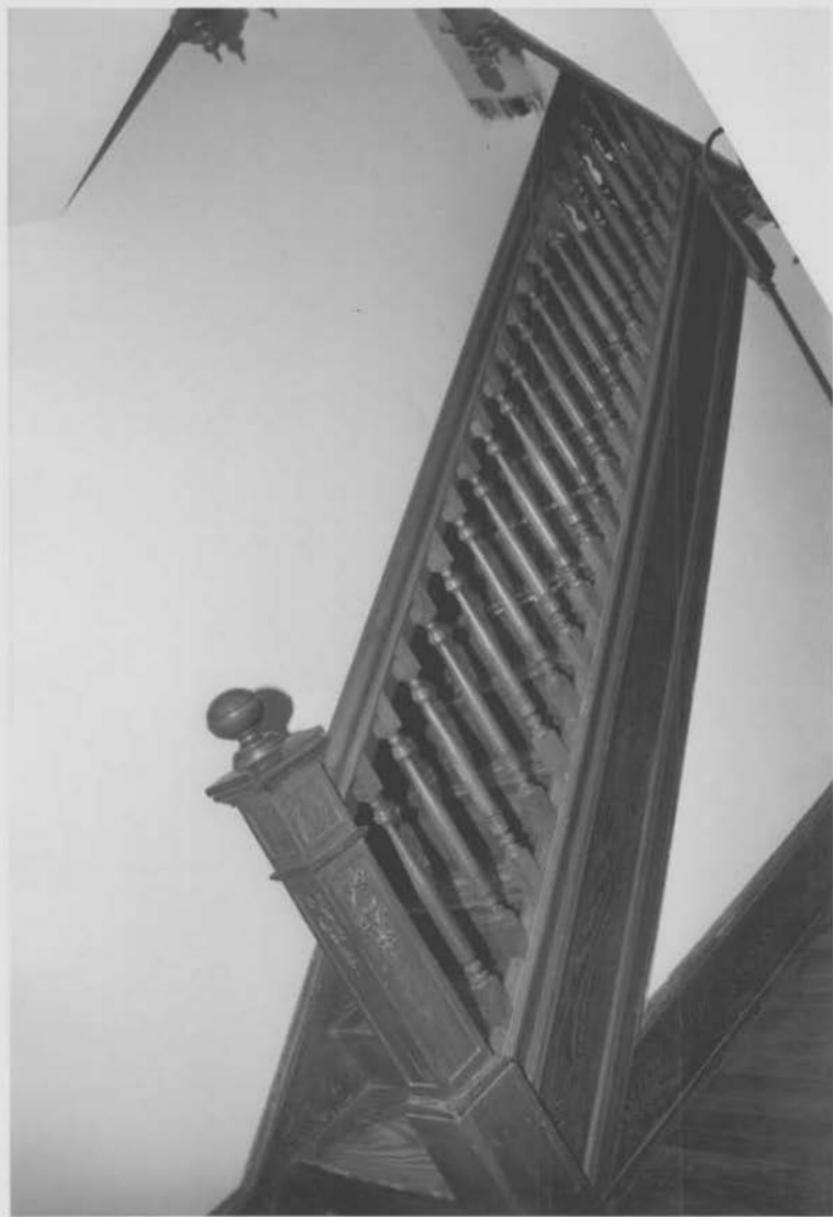
The entry hall runs west through the house and then turns at a right angle to the north. The closed-string stair raises along the west wall in this north section of the hall. It turns 90° at a landing lighted by a double 1/1 sash window, turns 90° once again and rises along an east wall to the second story. The balusters are turned, with upper and lower blocks. The square newel post has an applied floral design and is surmounted by a spherical knob. A doorway beneath the stair leads to the basement.

Bellman House  
Prince George's County, MD  
Marina King  
March 1988  
Stair - detail  
Negative - MD Historical  
Trust, Annapolis

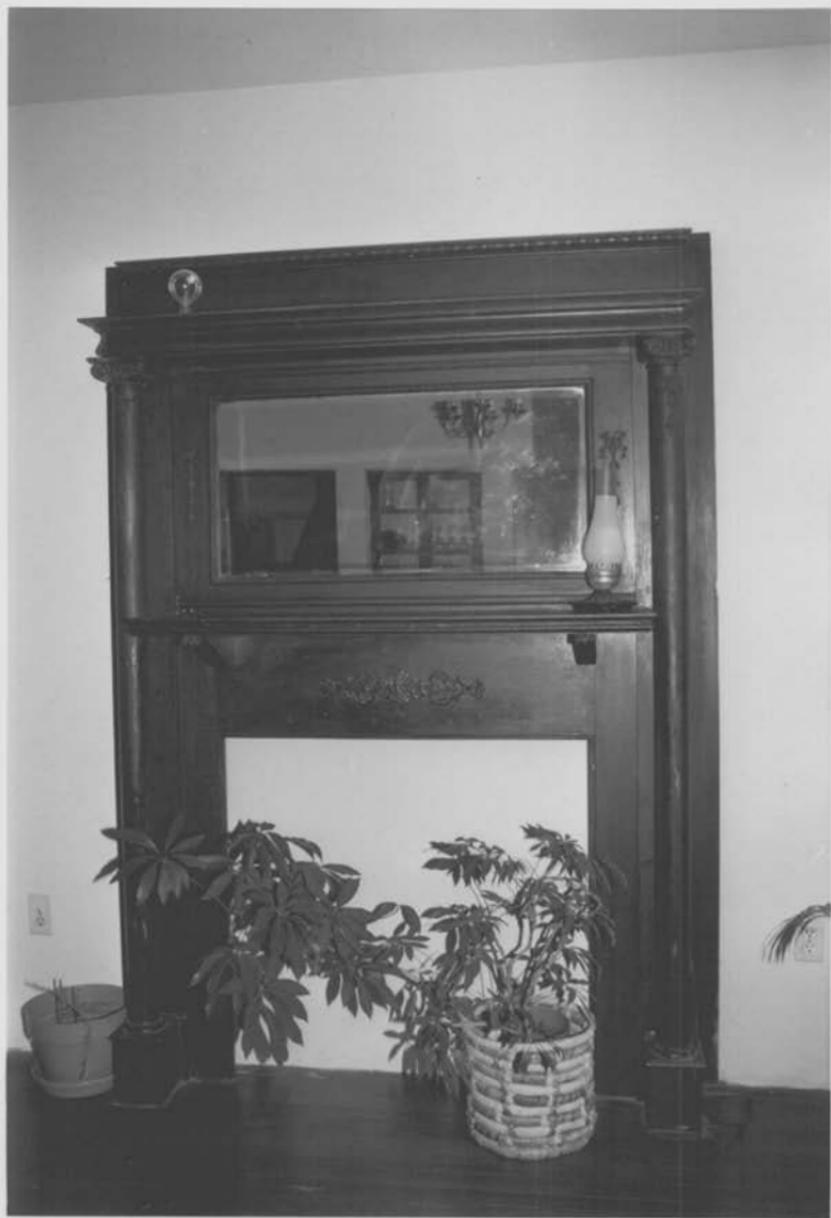
The flooring throughout the interior is original, of narrow uniform width boards. The high baseboard has an ogee cap. The dining room, at the southwest corner of the house, has a mantel centered on the south wall. The mantel is purely decorative, as there is no chimney behind it. It has a square hearth opening surmounted by oval an applied floral design centered in the frieze. Grooved brackets support the mantel shelf. There is a rectangular mirror in the over-mantel. The upper mantel shelf is supported by tapering ionic columns on base blocks, and is surmounted by a band of egg and dart molding. There is a built-in cupboard with glazed doors in the west wall of the room, between an entry to the kitchen and an entry to the stair hall.

Bellman House  
Prince Georges County, MD  
Marina King  
March 1988  
mantel - west parlor  
Negatives - MD Historical  
Trust, Annapolis
