PRINCE GEORGE'S COUNTY  
HISTORIC SITES SUMMARY SHEET

Building Name Melford

Location Md. Rte.#3, at #50, vicinity of Bowie, Maryland

RE: Melford; PG-71A-20  
Summary of field site visit September 9, 1986

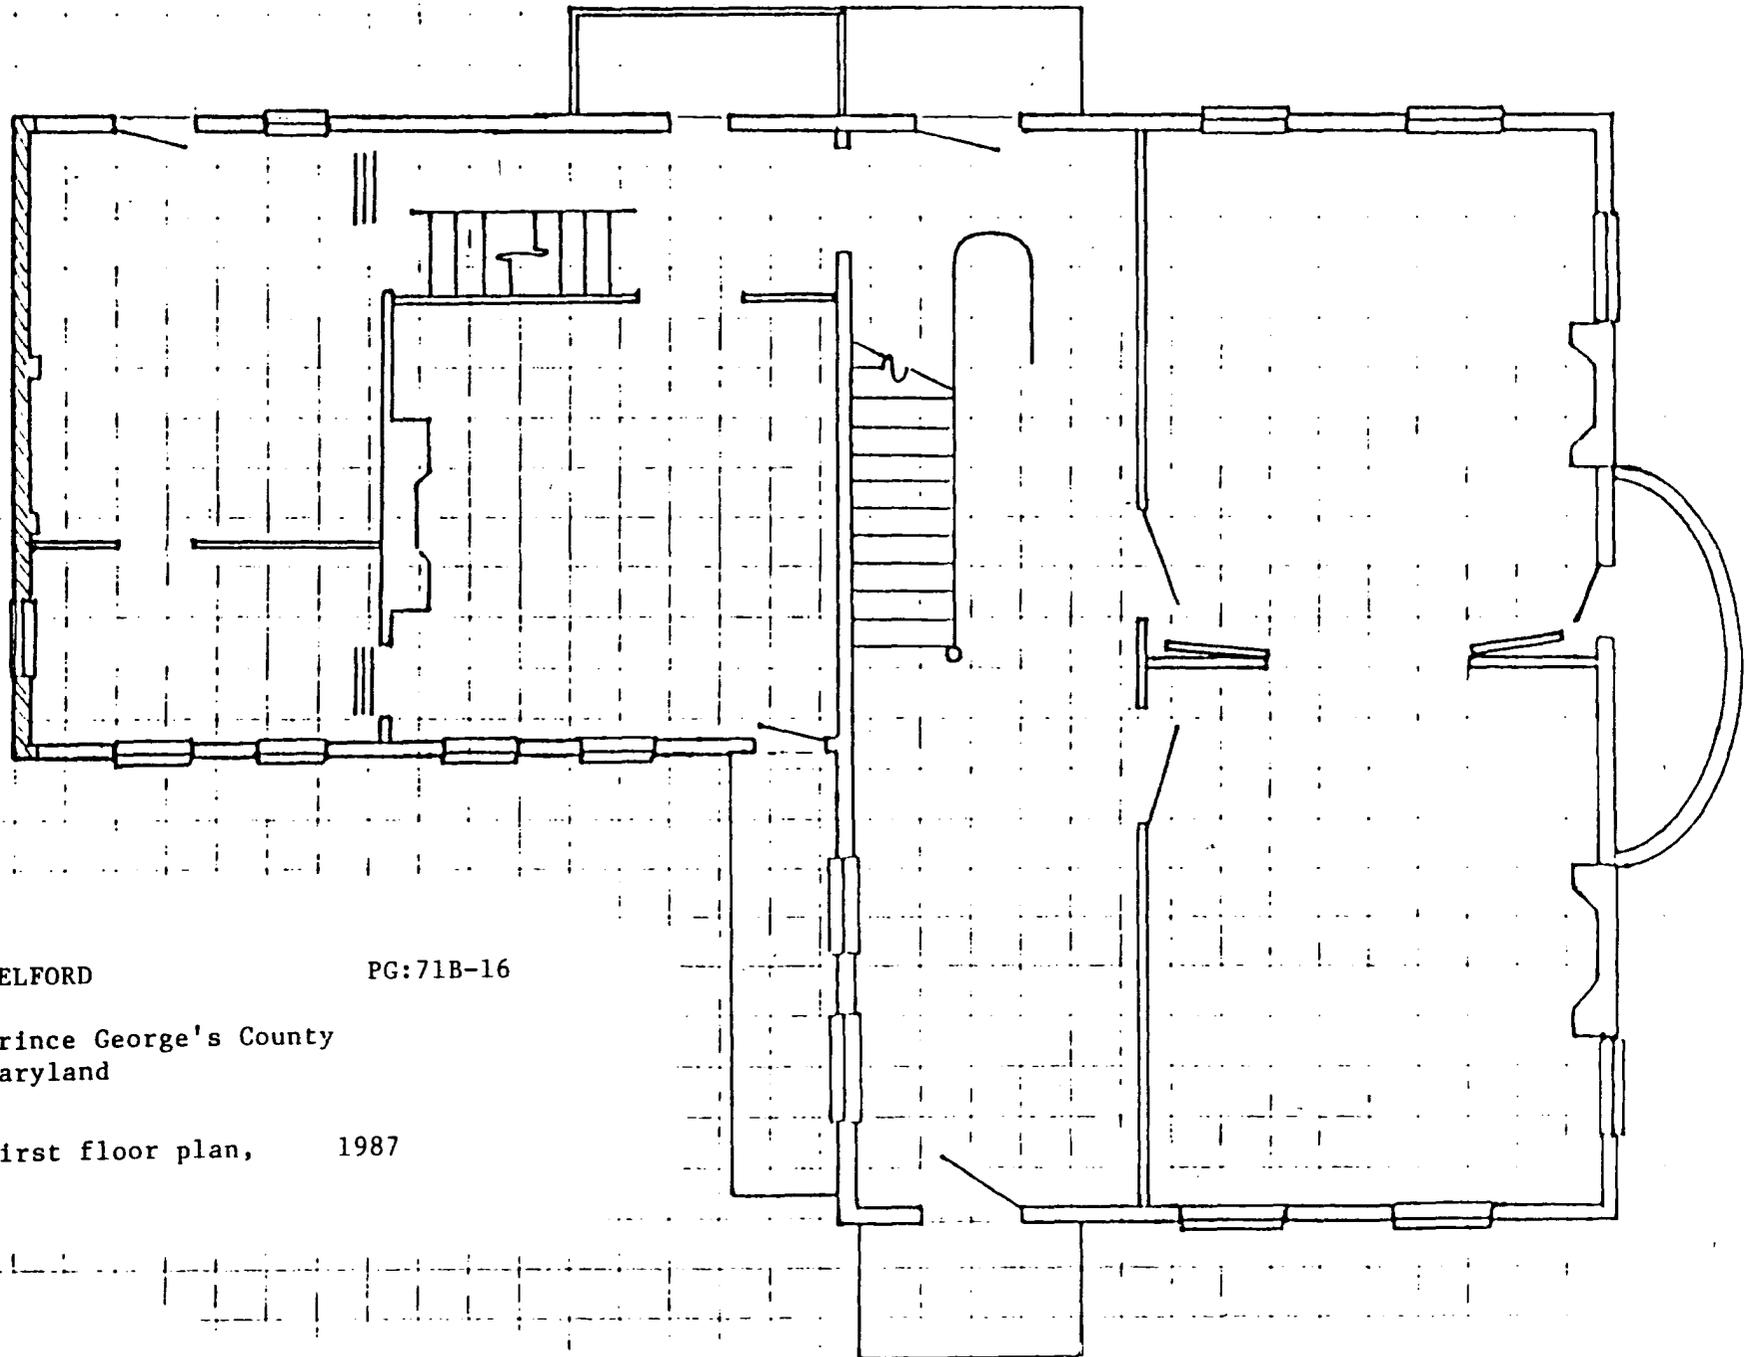
MELFORD

first floor plan, 1987

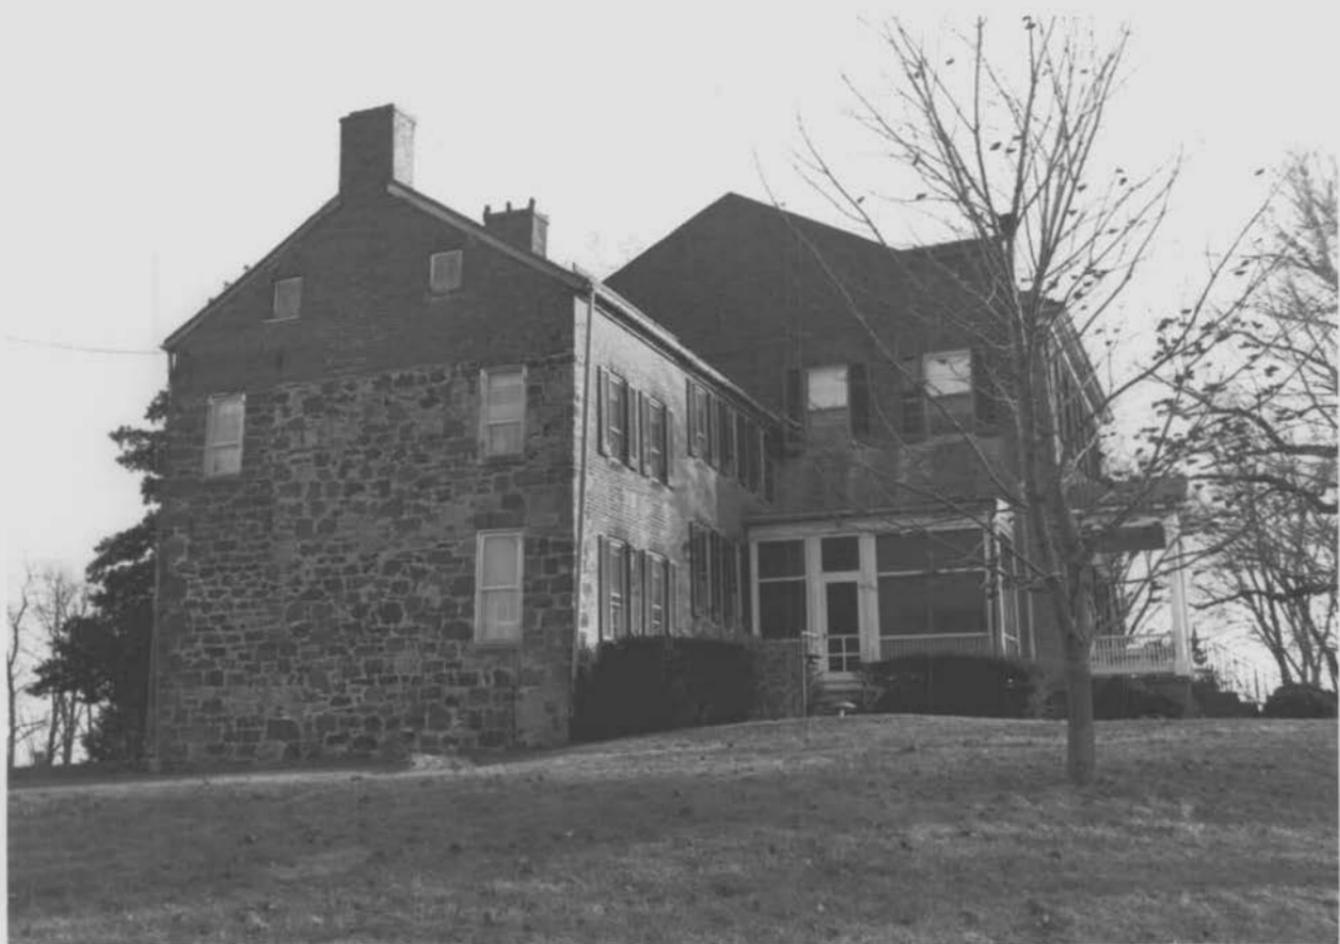
PG#71B-16

Melford  
Prince George's County, MD  
Susan G. Pearl  
December 1985  
North elevation  
Neg: Md. Hist. Trust, Annapolis, MD

- 2) There is no ready explanation for the contrasting brickwork in the upper gables of the main house. The overall character of the brickwork above and below the second story eaves lines is representative of the second quarter of the 19th century, and no obvious evidence

could be found to suggest any rebuilding of the roof and/or upper gable. This contrast might be a remnant of a whitewash finish on the two main stories, or perhaps a change in materials during construction. Perhaps a more careful analysis will suggest a more complex explanation.

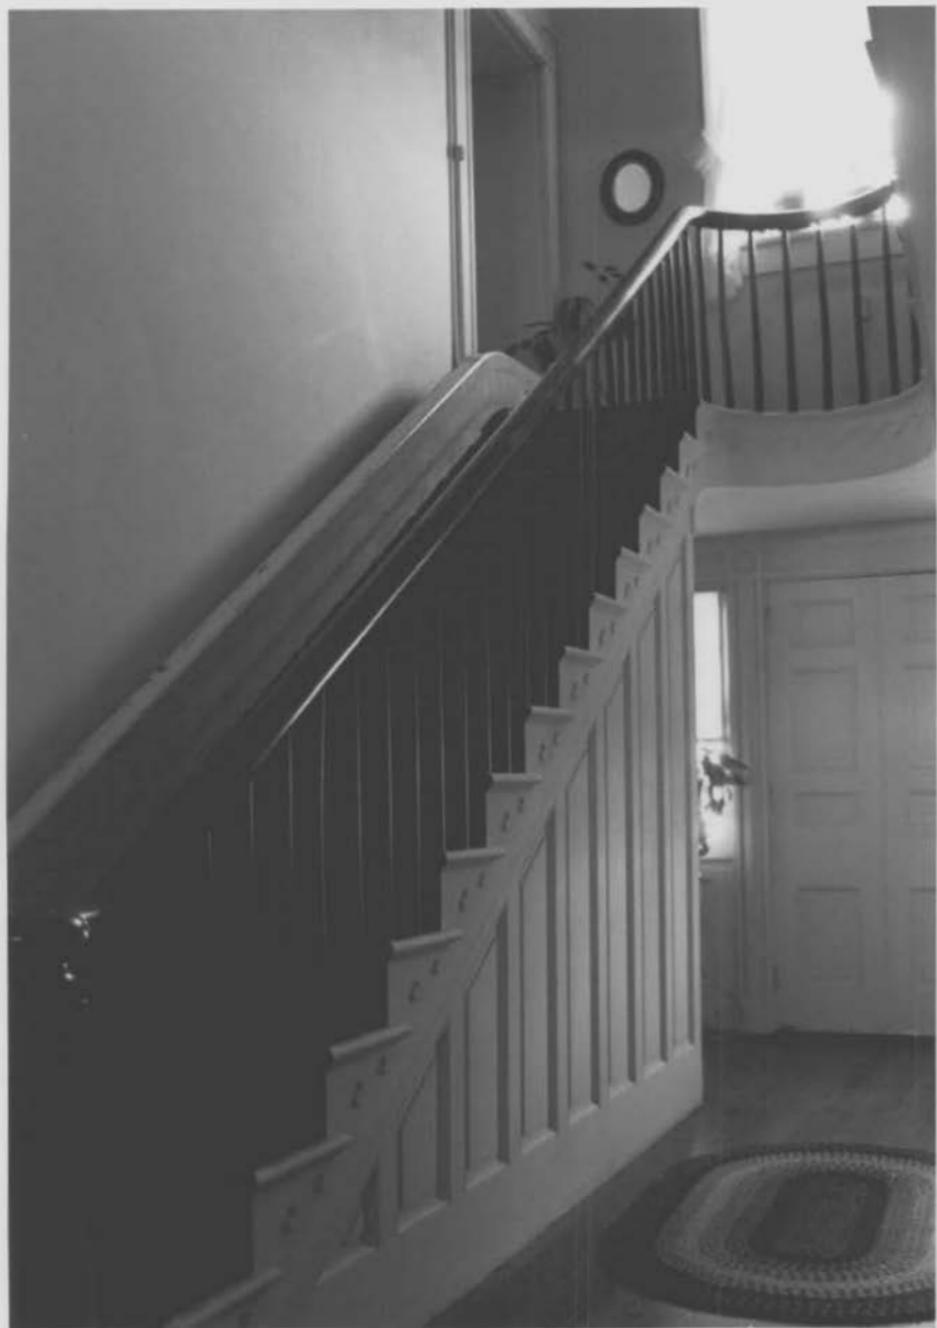
PG

Staircase

- b) The principal stair (in the main house) is an excellent example of a popular Greek Revival design in rural Maryland, consisting of an open-string dog-leg design with heavy turned walnut newel, simple walnut rail and tapered round tiger maple balusters; the design is consistent all the way to the third story.

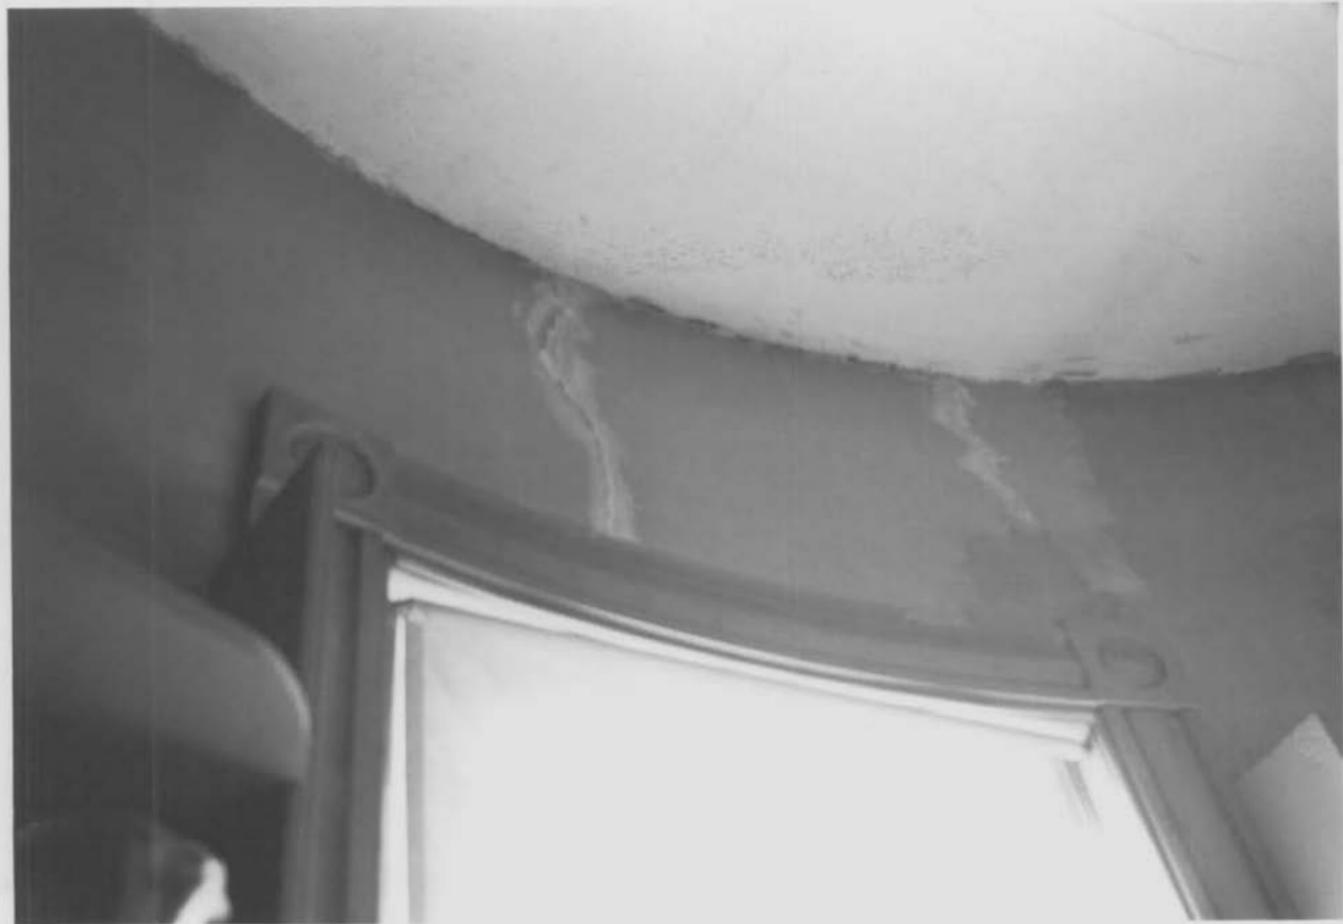
PG

Melford  
Prince George's County, MD  
Susan G. Pearl  
December 1985  
Inside semicircular bay, first story  
Neg: Md. Hist. Trust, Annapolis, MD

- 1) While it has been proposed that the semi-circular bay may have been added as late as the early 20th century, there is extensive evidence to conclude that this feature is original. The brickwork of the projecting bay perfectly matches the adjacent gable in color, size, texture and horizontal course alignment. The brick bonding pattern does vary from the adjacent gable walls, but the brickwork remains keyed together on the west side and the seam between the two sections seems clearly to be the result of repairs necessitated by settling of the bay rather than by a later construction. Note in particular the undisturbed area of the west seam and the visible broken key bricks in the upper wall where the patched seam has opened once again. Furthermore, the stone foundation of the bay matches the adjacent house foundation and the interior woodwork matches in every respect, including the Greek Revival architrave form, paneled doors and even the signed hinges and silver plated hardware. The first floor framing of the bay has been rebuilt and there is evidence of an altered opening in the foundation wall, both visible from a crawl space accessible through the floor of the first story closet.

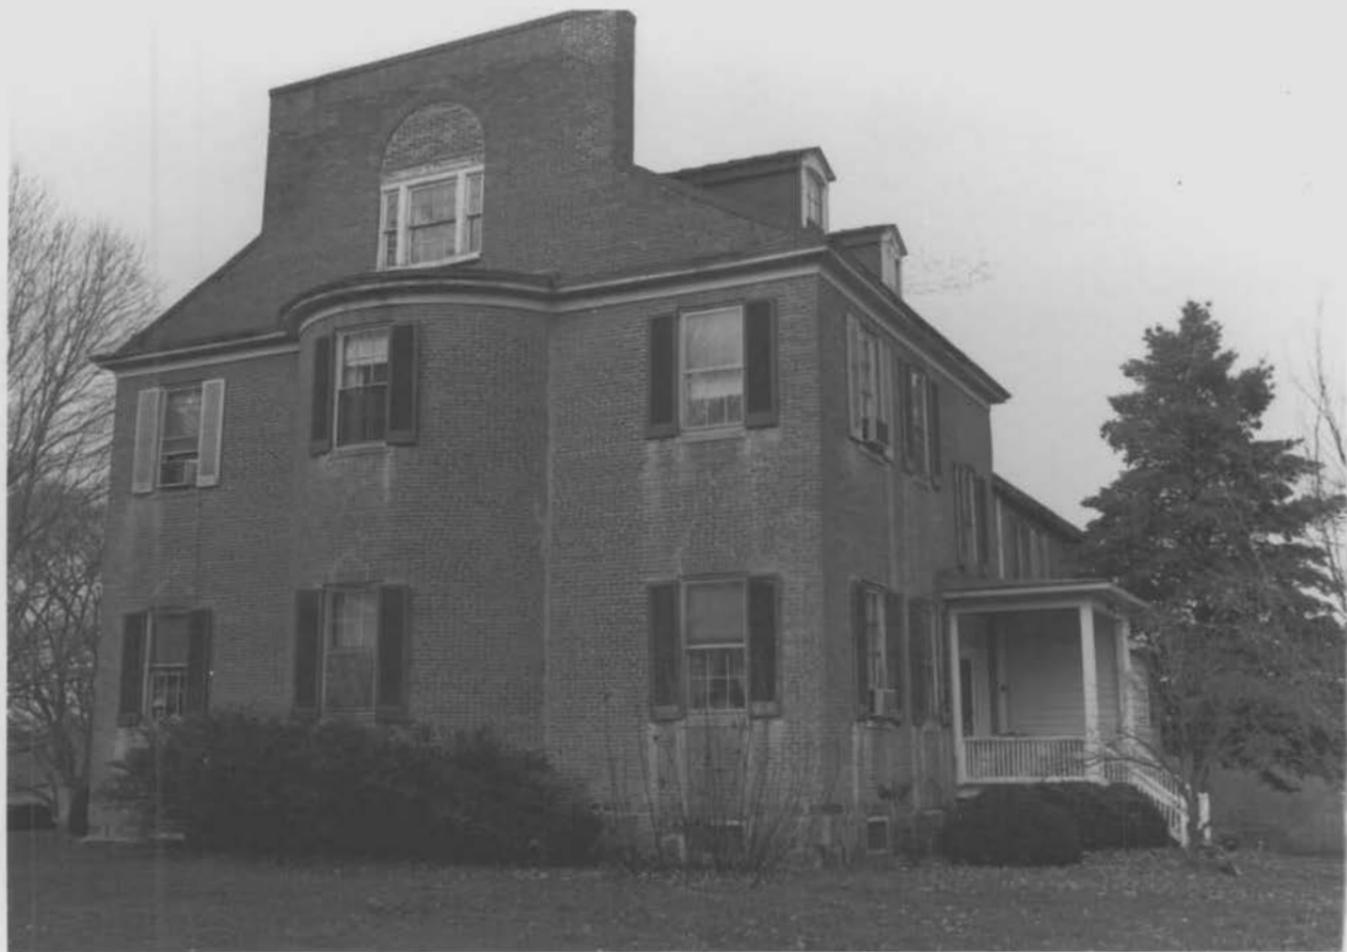
PG 71B-16

Melford  
Prince George's County, MD  
Susan G. Pearl  
January 1986  
Southeast 3/4 elevation  
Neg: Md. Hist. Trust, Annapolis, MD

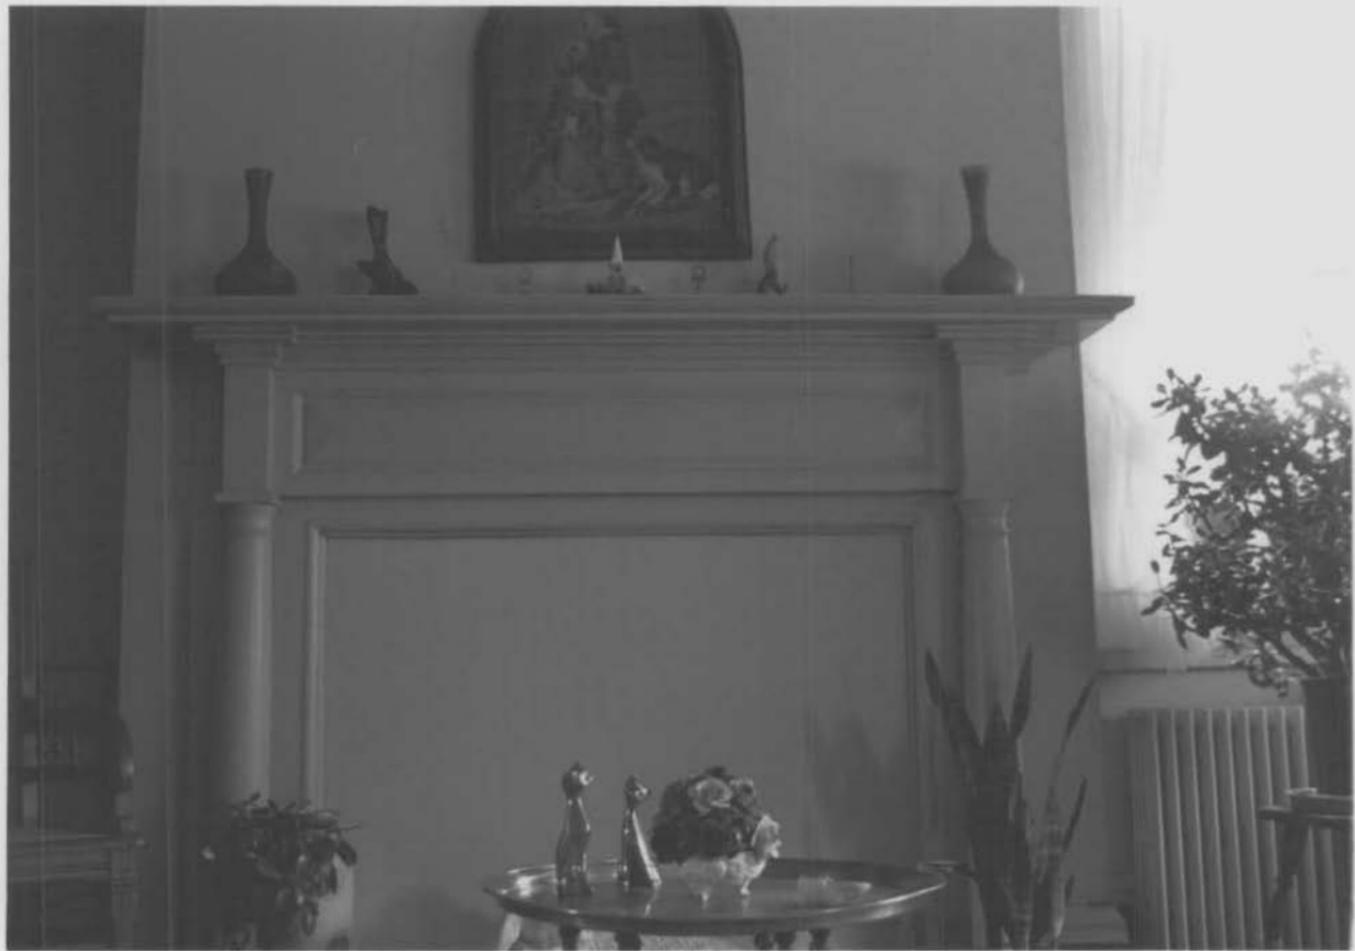
PG 71B-16

Melford  
Prince George's County, MD  
Susan G. Pearl  
January 1986  
Mantel, west parlor  
Neg: Md. Hist. Trust, Annapolis, MD

- a) The interior dates almost entirely to the Greek Revival period, most likely circa 1840-60. Architrave trim includes a standard profile most recognizable by the "peaked" center field flanked by standard routed and beaded components. Mantels on the first story have columns flanking the opening below side blocks flanking a plain frieze and surmounted by complex molded shelves with standard Greek molding components. Oral tradition regarding changes to the mantels in the main house seems to suggest that the two first floor parlor mantels were moved to the second story in the 19th century and replaced with Victorian marble mantels. About 1910, the marble mantels were removed, the Greek mantels were returned to the first floor, and the present Greek mantels were installed on the second story. This theory is highly conjectural, but is compatible with all evidence.

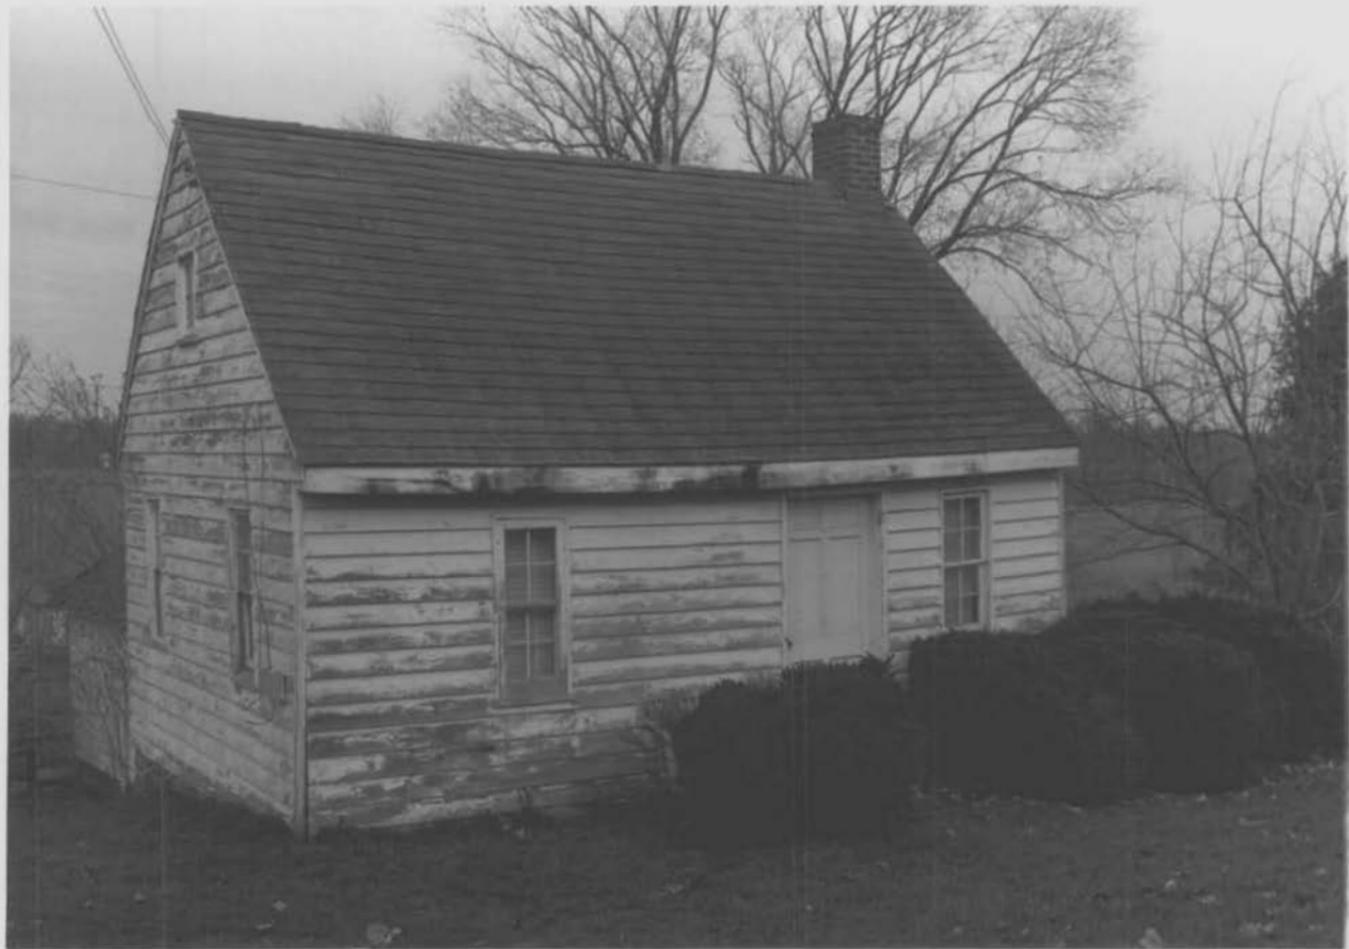
PG 71B-16

Melford  
Prince George's County, MD  
Susan G. Pearl  
January 1986  
Slave quarter, southwest  
Neg: Md. Hist. Trust, Annapolis, MD

Quarter: A one-story frame building to the northeast of the house is said to be a slave quarter. The size and materials of the building match an entry for a slave quarter in the

1798 Federal Direct Tax, but 20th century materials conceal virtually all potentially diagnostic features. A more detailed investigation should be able to establish a general date of construction and may provide further clues of the original function. It seems highly likely that the building dates to the same general period as the main house.

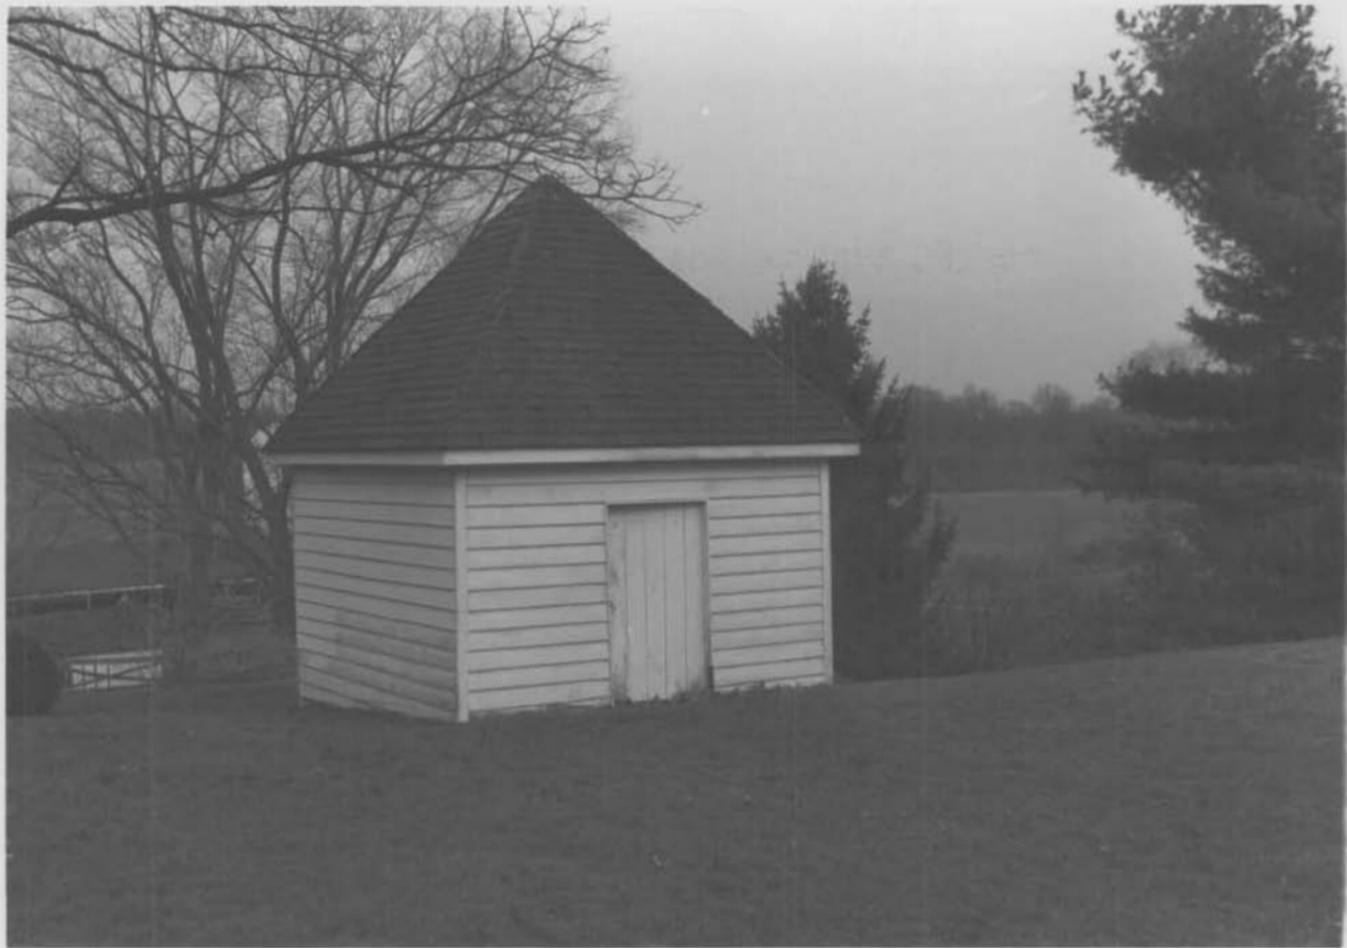
PG 71B-16

Melford  
Prince George's County, MD  
Susan G. Pearl  
January 1986  
Meat house, southwest  
Neg: Md. Hist. Trust, Annapolis, MD

Meat House: A frame meat house with pyramidal roof is located at the north side of the terraced east yard. Constructed with close-studding and a complex roof frame, the building is an excellent example of this building form and appears to be constructed with wrought nails, suggesting it may be earlier than the main house.

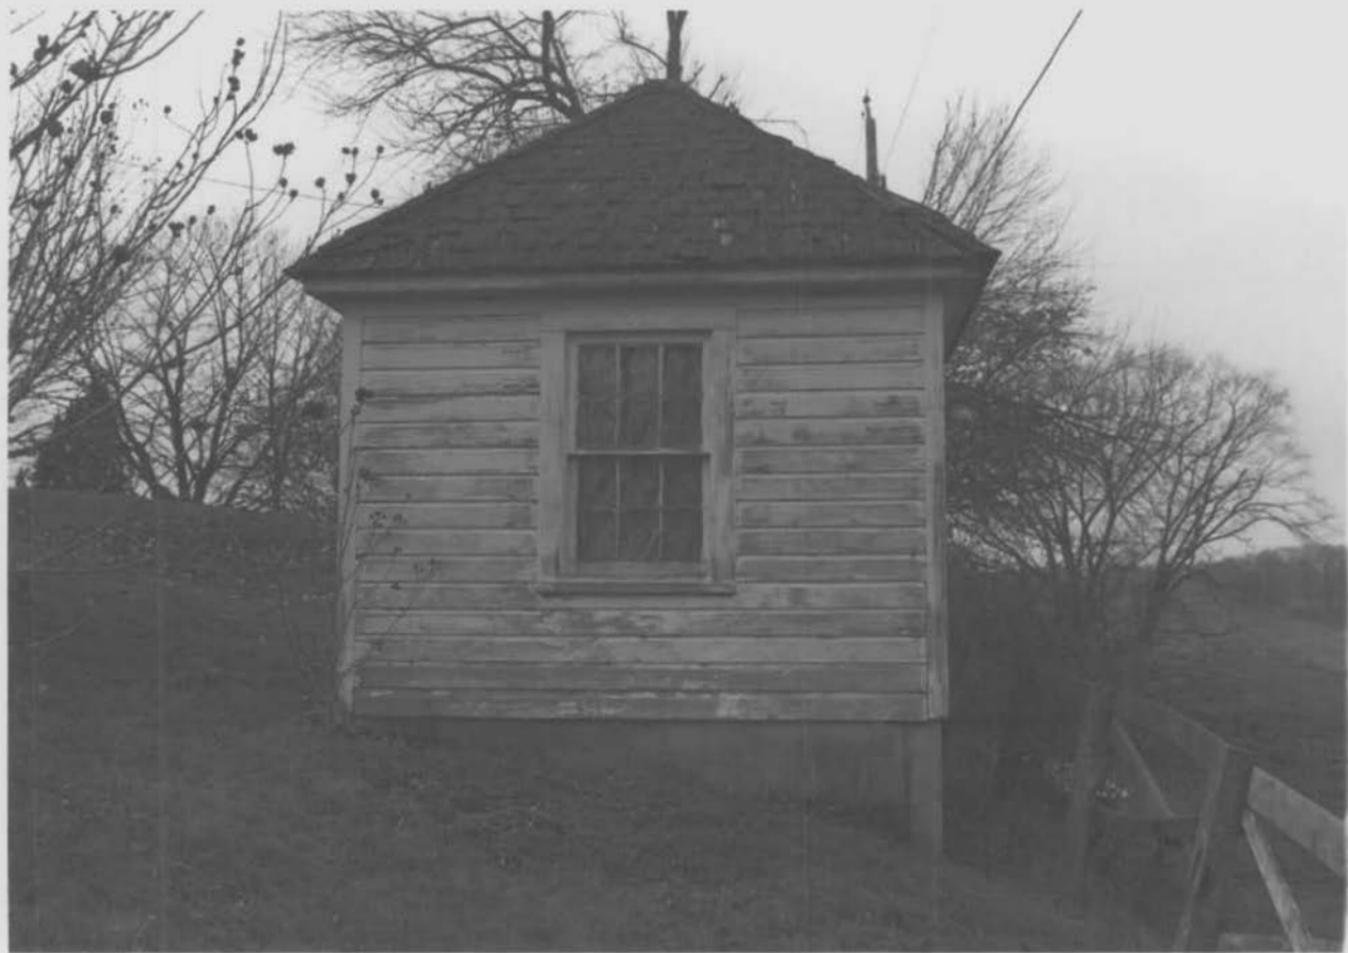
PG 71B-16

Melford  
Prince George's County, MD  
Susan G. Pearl  
January 1986  
Pumphouse, east elevation  
Neg: Md. Hist. Trust, Annapolis, MD

Pump House: A frame pump house to the north of the quarter incorporates a hand pump dated 1912, and it seems likely the pump house is of similar date.
