Maryland Historical Trust/ National Register of Historic Places Registration Form

historic name Oatland
 other names (Partnership)
Seton Belt Barn (at Oatland) (preferred)

street & number Church Road north of Central Avenue not for publication
 city, town Mitchellville vicinity Leeland
 state Maryland code _____ county Prince George's code _____ zip code _____

name of property: Seton Belt Barn

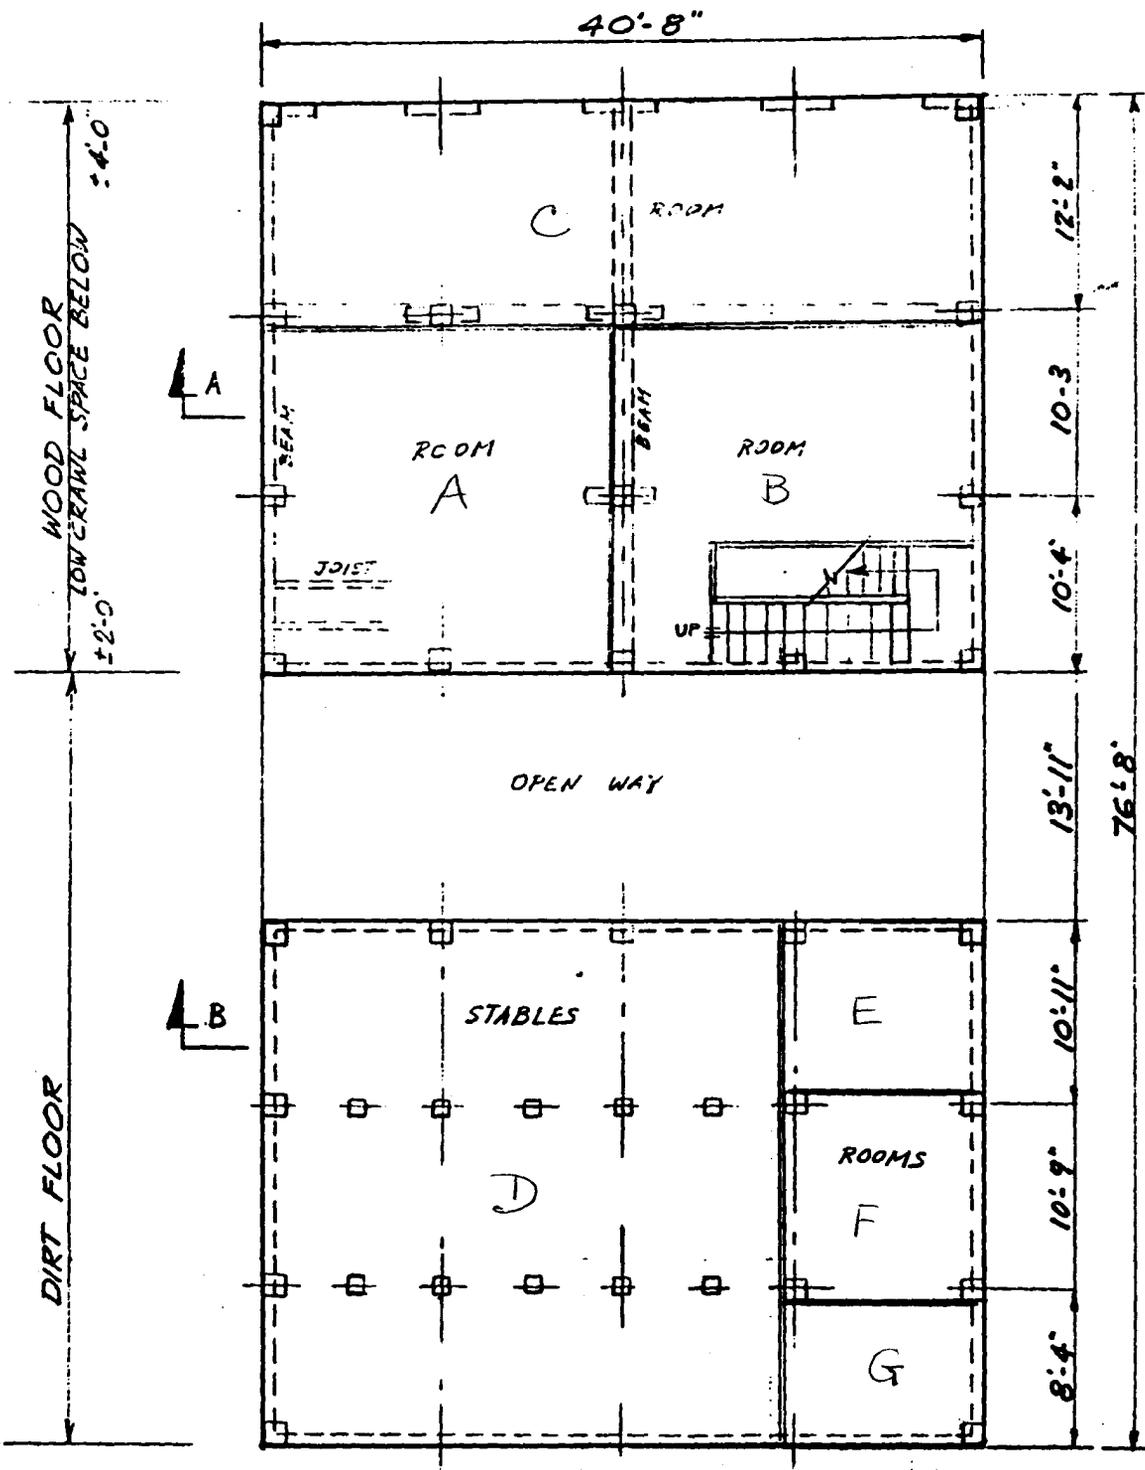
SK-1

This is a multi-use barn, built for livestock use, but adapted for the hanging of tobacco. The central aisle is 14 feet wide; in its ceiling is a large rectangular floor opening, used for loading and unloading crops. Accessible from the northwest part of the passage is an enclosed dog-leg staircase, which has wide treads, beveled rail, and is sheathed with board-and-batten siding. It rises toward the north, turns west at a landing, then rises southward to the second story. The west end of the barn has vertical-slat siding on the first story, and originally served as a corn crib and fodder storage area. Bounded by this corn crib, the staircase, and the central aisle, is a 21-foot square room. This square room (A) has fully finished walls of vertical board attached flush on the studs. In the north wall of this square space (A) is a vertical sliding door which connects with the space (B) just west of the staircase. The latter (northwest) space (B), unlike the square space immediately to the south (A), does not have finished walls. Both spaces have a finished floor of 7/8-inch tongue-and-groove boards supported by the beam and joist frame. Stored in the northerly space (B) are several sections of decorative wooden fencing: square posts cut to pyramidal points at the top, and set at an angle into a horizontal molded base. There is a variation in the height of the posts, giving the fence a curved upper profile.

The westmost section of the barn (C) is a corn crib, sided with vertical slats. This space has the same tongue-and-groove floor as the other two spaces. Below the corn crib is a low crawl space; the floor is supported by brick piers which rest (at the northwest and southwest corners) on concrete blocks.

All of the structure to the east of the central passage is devoted to use as a stable (D) with three small rooms (E,F,G) along the north wall. The westmost of the small rooms (E) serves as a small passageway with entrances into both the central passage and the stable area. Next to it on the east (F) is a storage room with a wooden manger; this space opens only into the stable area. The eastmost of these small spaces (G) is a tack room, and opens into the stable area.

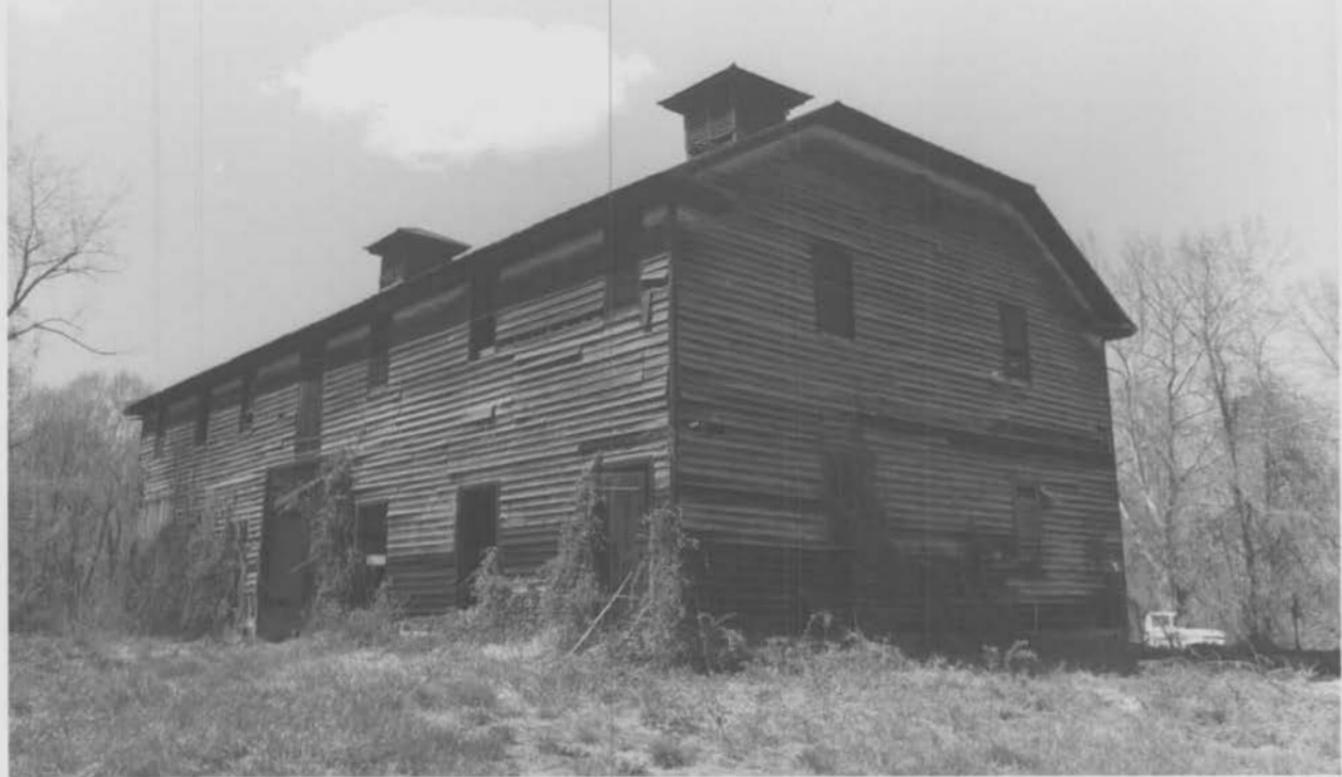
1 of 13

Seton Bell Barn
Prince George's Co., MD
Susan H. Pearl
April 1988
Southwest $\frac{3}{4}$ elevation
Neg: Md. West Trust,
Annapolis, MD

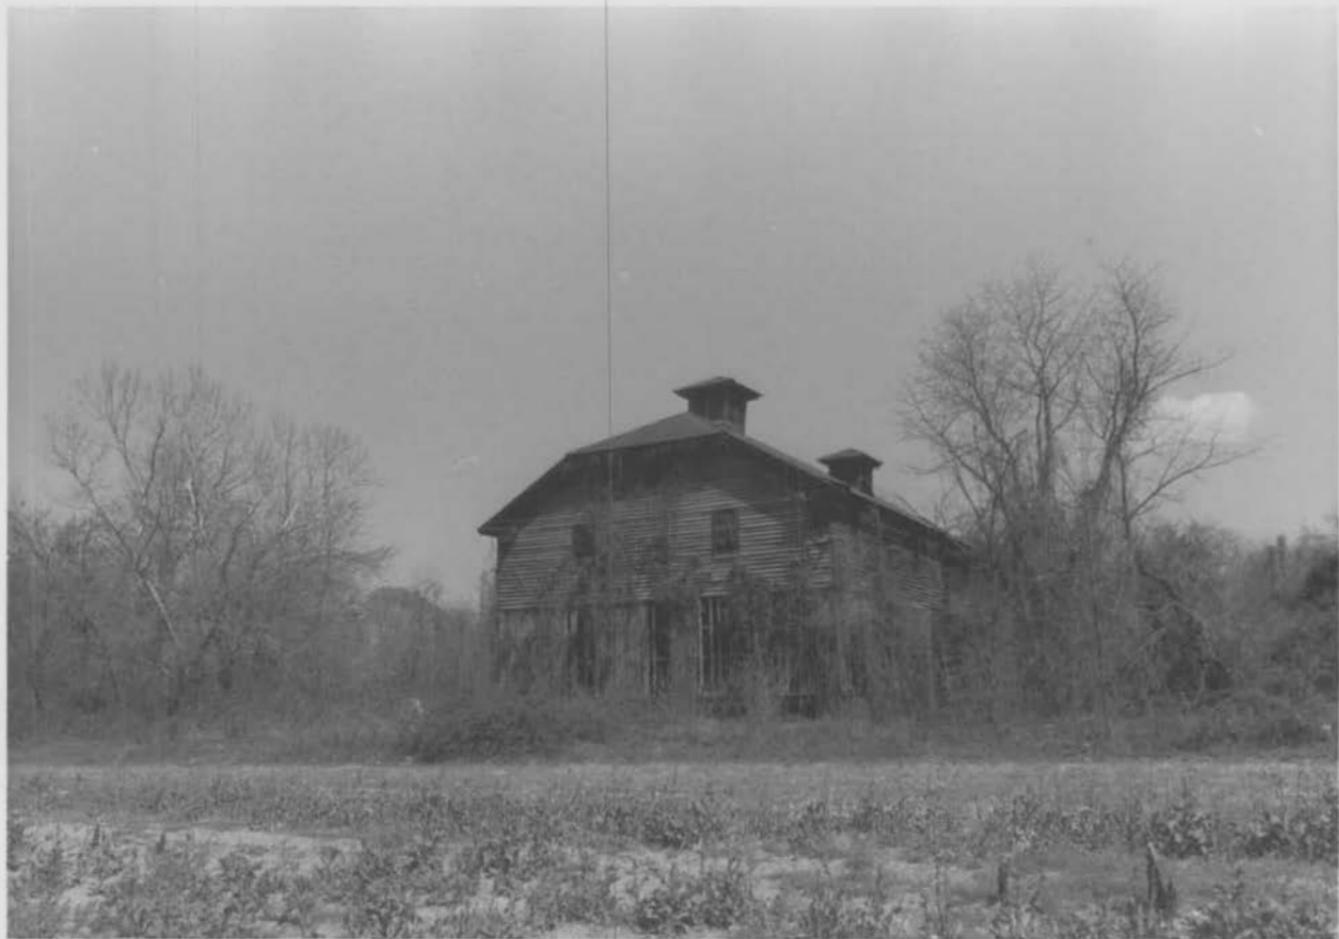
3 of 13

Seton Belt Barn
Prince Georges Co. MD
Susan H. Pearl
April 1988
Northeast 3/4 elevation
Neg: Md. Hist. Trust,
Annapolis, MD

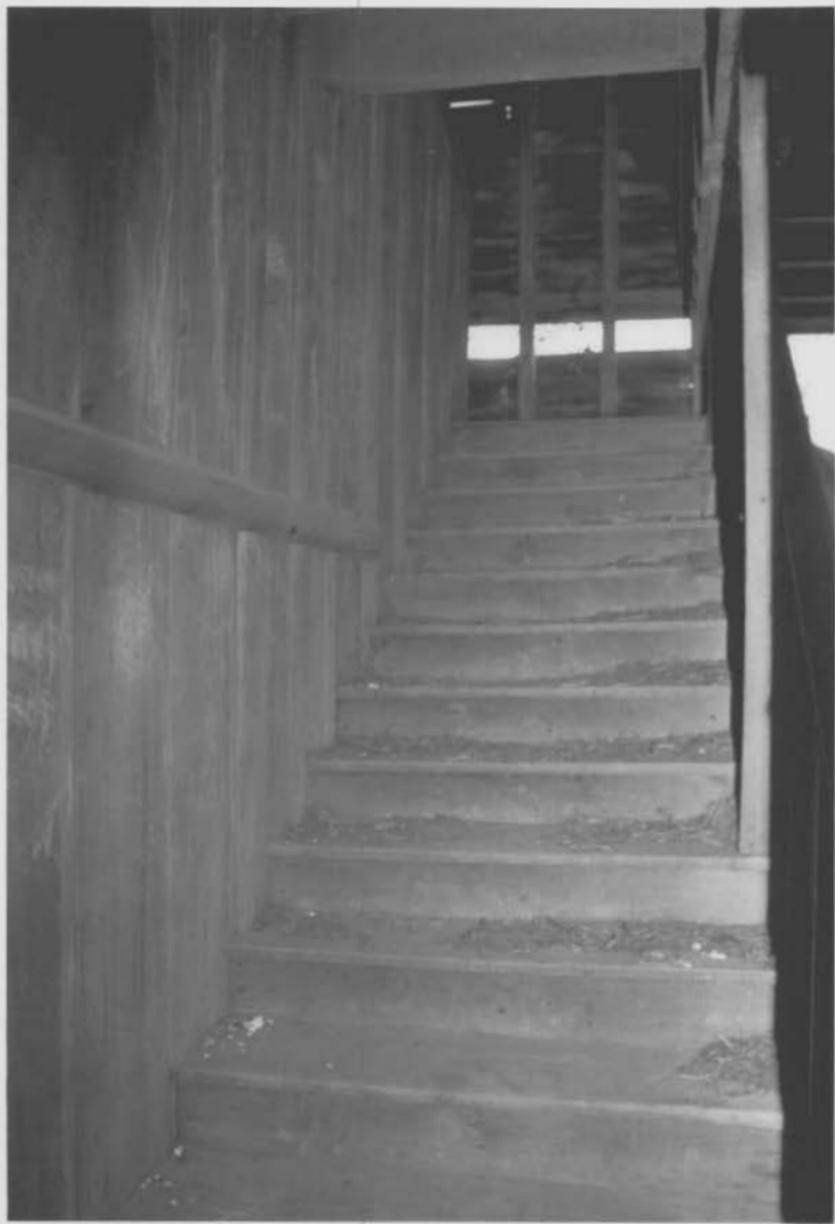
9 of 13

view up staircase, to N

The two-run partially-enclosed stair leads to the second story, which consists of a large area converted into tobacco-hanging space. A partition above the west wall of the first-story passage divides this large area into two unequal spaces. The floor of the second story is of 7/8-inch tongue-and-groove boards. Periodic posts support the frame of the roof, and the metal roof is nailed to 3" by 5" rafters. Between these posts are many non-structural (new) posts for the hanging of tobacco. Nearly centered in the second story floor is the large rectangular opening which allows unloading of crops into the passage below. Nearly centered in the east section (above the stable) is a chute, enclosed with finished wide vertical boards, which allows passage of fodder into the stable area below.
