Re: **PG:74A-37**  
**Beall House**

MARYLAND HISTORICAL TRUST  
SHORT FORM FOR INELIGIBLE PROPERTIES

# Maryland Historical Trust Maryland Inventory of Historic Properties Form

historic Beall House  
 other Beall Family Homesite

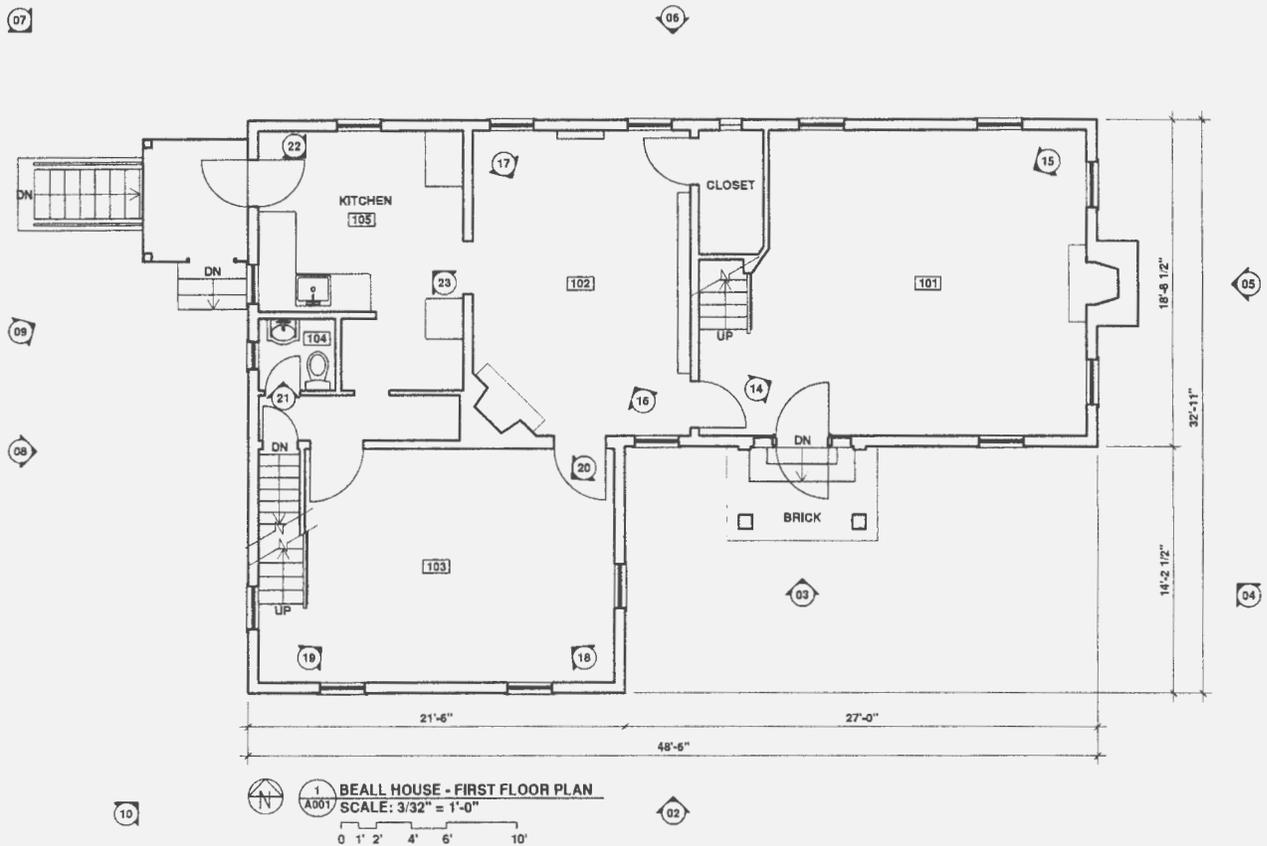
Number 7 Page 2

<b>ENCORE</b> SUSTAINABLE DESIGN ARCHITECTURE   PRESERVATION	<b>BEALL HOUSE</b> 13600 OAK GROVE ROAD UPPER MARLBORO, MD 20772	<b>ARCHITECT</b> ENCORE SUSTAINABLE DESIGN 2822 SOLOMONS ISLAND RD, SUITE 201, ANNAPOLIS, MD 21037  <b>OWNER</b> WOODLAWN DEVELOPMENT GROUP 11700 PLAZA AMERICA DR, SUITE 310, RESTON, VA 20190	FIRST FLOOR PLAN
			SCALE: 3/32" = 1'
			DRAWING ISSUE DATES
			01 02.09.16 MIHP

The Beall House is a two-story, clapboard house with an L-shaped footprint. The main entrance is located asymmetrically on the south side of the 3-bay east wing. A secondary entrance to the kitchen is located near the north end of the 4-bay west façade. The wood double hung windows are typically six-over-six and some are decorated with plastic shutters. There is a half round fanlight at the attic level of the south end of the west wing and a small round window in the middle of the north façade. There are two four-over-four bathroom windows in the middle of the west façade. There is an exterior brick chimney with running bond and hard mortar on the east end of the house and a central brick chimney in the middle of the west wing.

The evolution of the house is difficult to discern as the rectangular space enclosed by the stone foundation, including the central chimney base, does not correspond with the plan of the rooms above. It seems likely that the original house block was extended to the east in two steps, once with a stone foundation and later, after the major fire in 1890, with a brick foundation. It appears that the floor plan was radically changed at that time of the second extension that included Room 101, the closet with the little round window, and Rooms 204 and 205 above. The changes included removal of the central stone chimney and replacement with an angled brick chimney, and installation of a second stair and main entrance in Room 101. Note the remains of fireplace trim on the north wall of Room 103 in photograph number 19 and the peculiar space behind the wall on the first floor plan. It seems likely that the west porch was a late 19<sup>th</sup> century addition while the basement steps were installed in the second quarter of the 20<sup>th</sup> century. Further plan changes to second floor bathrooms and closets, and possibly the east bedrooms, appear to have been made in the 21<sup>st</sup> century.

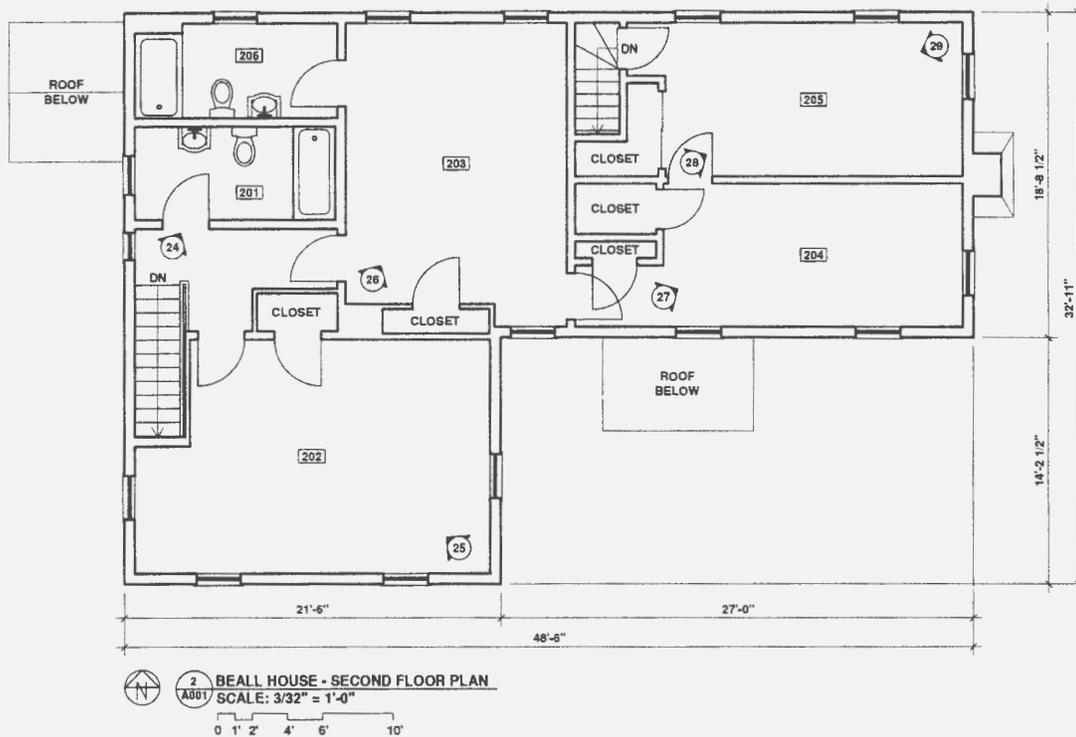
Number 7 Page 3

<b>ENCORE</b> SUSTAINABLE DESIGN ARCHITECTURE   PRESERVATION	<b>BEALL HOUSE</b> 13600 OAK GROVE ROAD UPPER MARLBORO, MD 20772	<b>ARCHITECT</b> ENCORE SUSTAINABLE DESIGN 2822 SOLOMONS ISLAND RD, SUITE 201, ANNAPOLIS, MD 21037  <b>OWNER</b> WOODLAWN DEVELOPMENT GROUP 11700 PLAZA AMERICA DR, SUITE 310, RESTON, VA 20190	SECOND FLOOR PLAN
			SCALE: $\frac{3}{32}'' = 1'$
			DRAWING ISSUE DATES
			01 02.09.16 MIHP

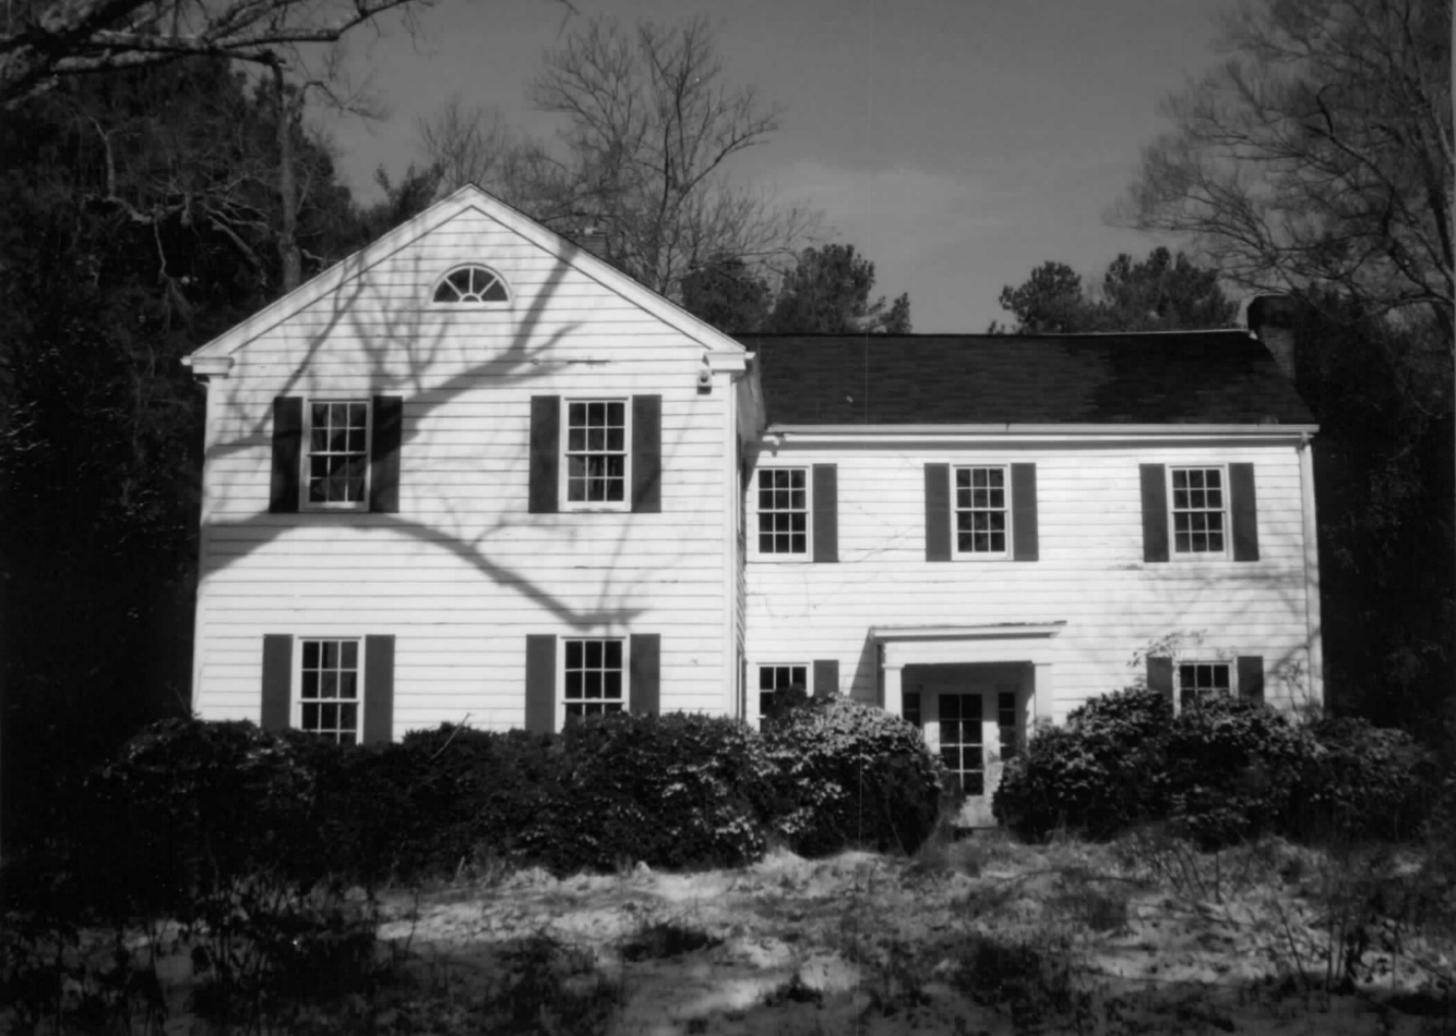
PG:74A-37  
Beall House  
Prince George's Co., MD  
Ward Bucher  
21 Jan. 2016  
MD SHPO  
South Facade  
#2 of 30

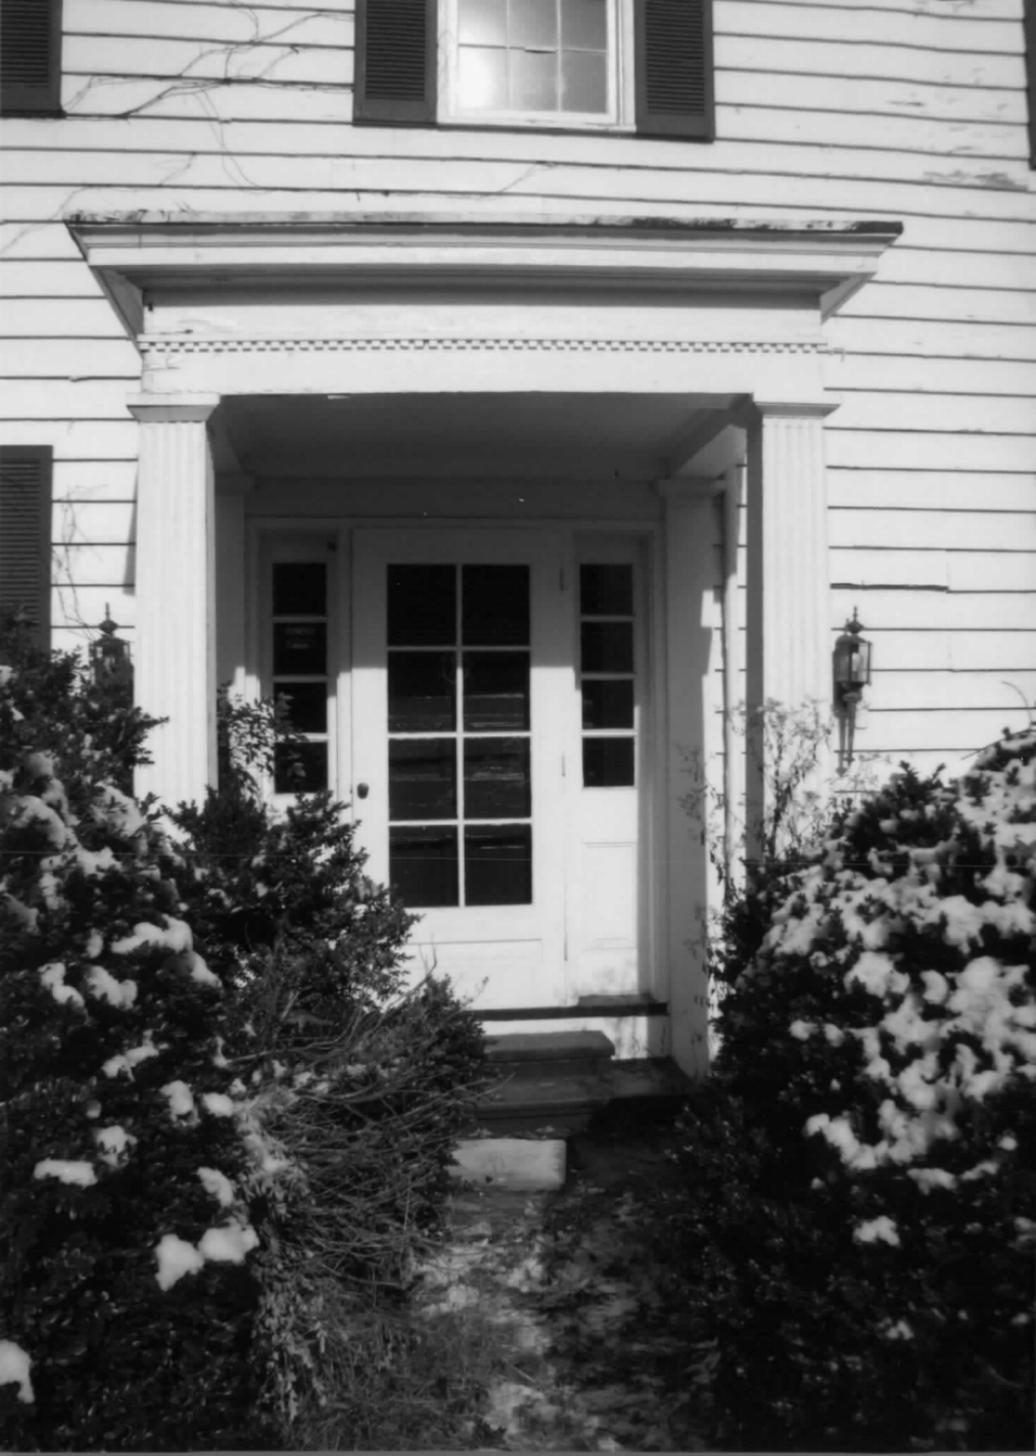
# 3 of 30

Main Entrance, camera facing N

The main entrance is covered with a flat roofed open porch with a pair of fluted square columns and a dentiled architrave. The front door is a wide eight panel door with recessed sidelights and raised panels. The west entrance has the remains of a small screened porch with a gable roof supported by a pair of granite piers and turned columns, and a beaded board wainscot. The kitchen door has five horizontal panels. Concrete steps lead down to a basement entrance below the west porch.

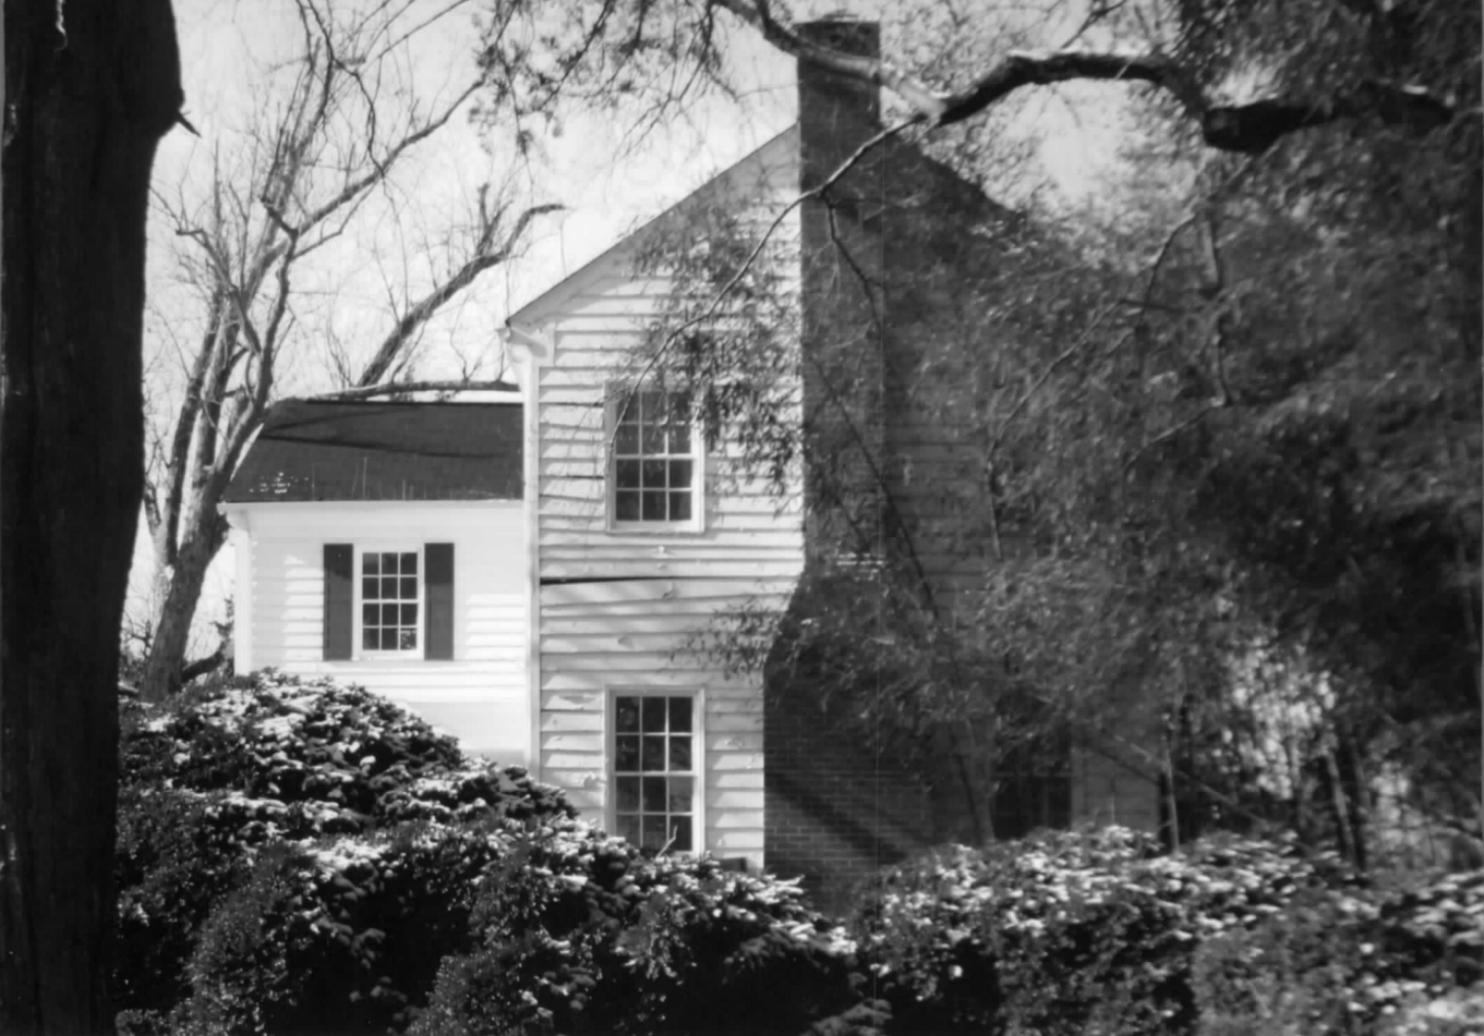
PG: 74A-37  
Beall House  
Prince George's Co., MD  
Ward Bucher  
21 Jan. 2016  
MD SHPO  
East Facade  
#5 of 30

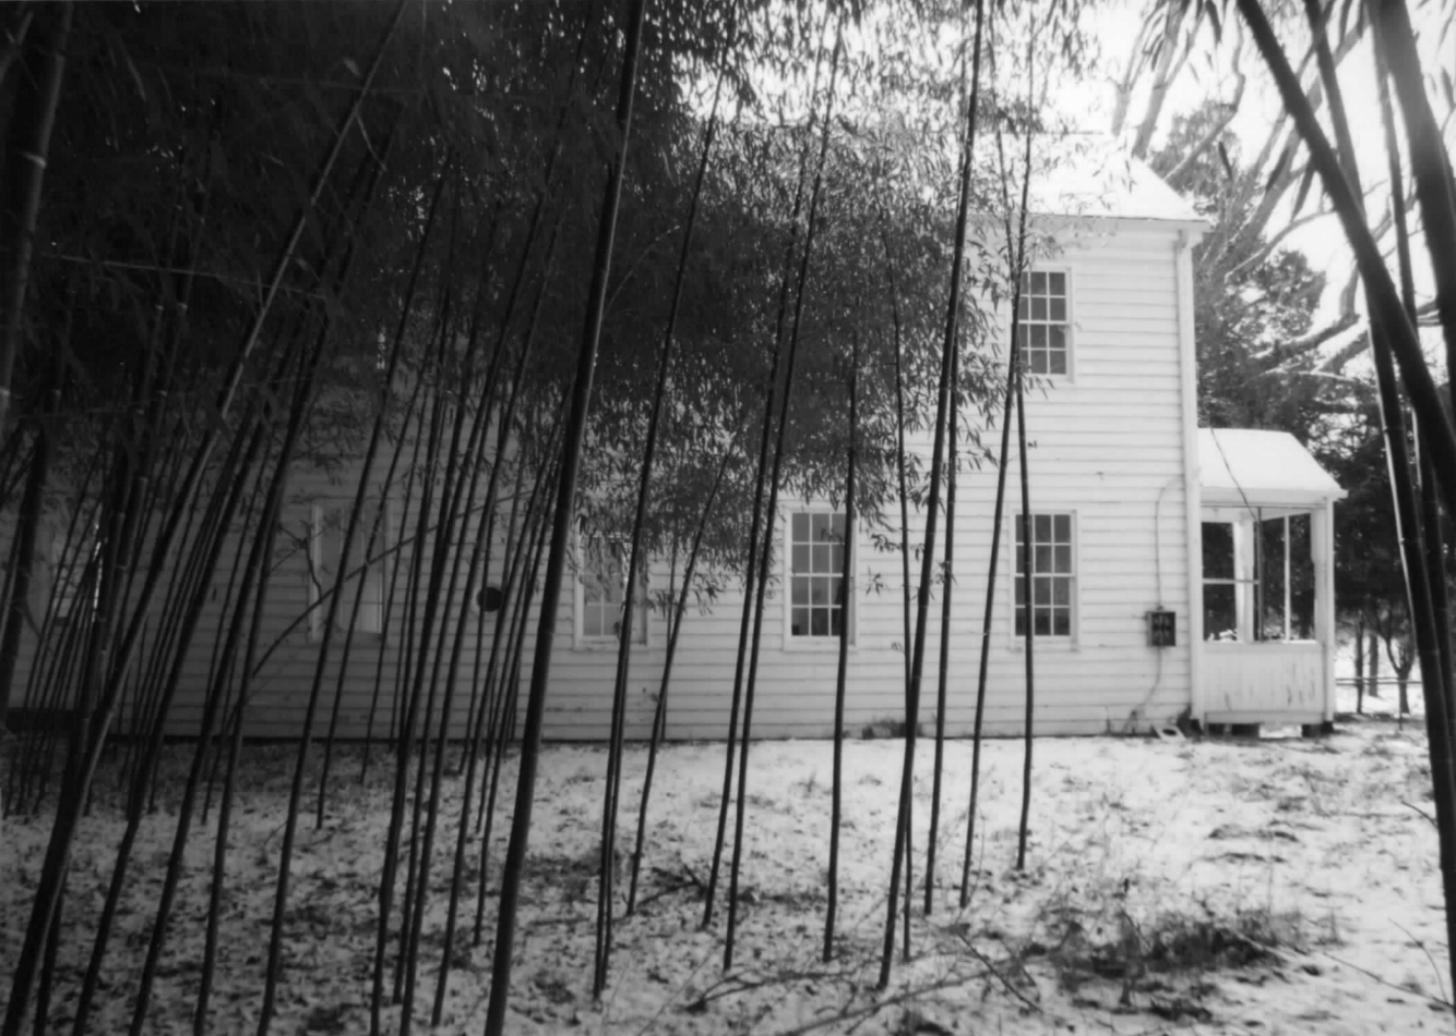
PG: 74A-37  
Beall House  
Prince George's Co., MD  
Ward Bucher  
21 Jan. 2016  
MD SHPO  
North Facade  
# 6 of 30

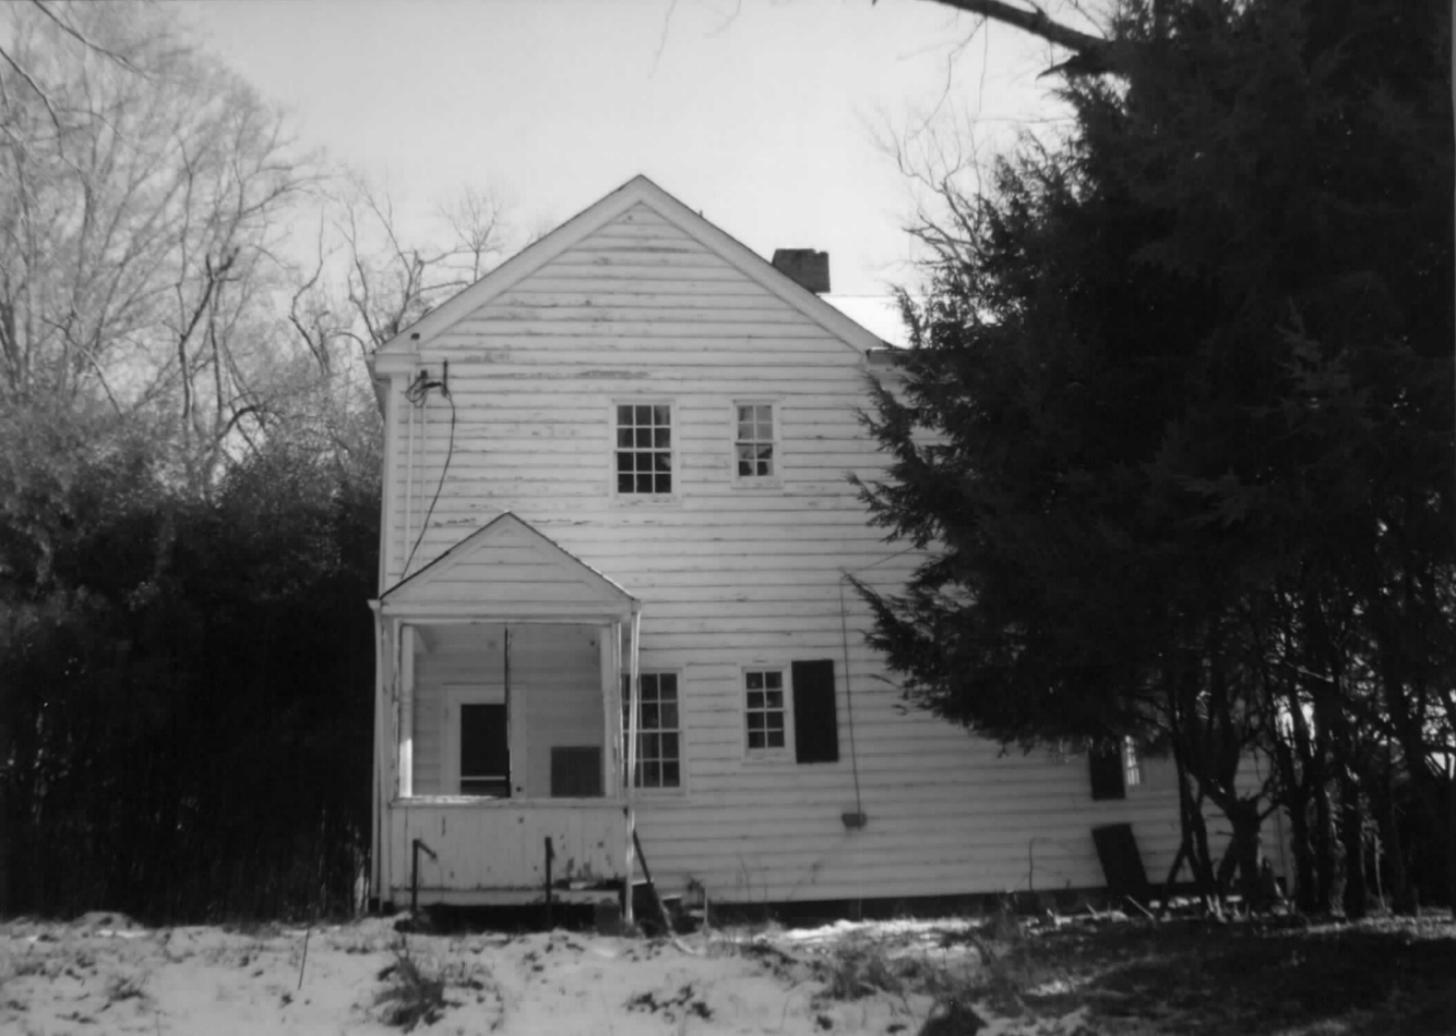
PG: 74A-37  
Beall House  
Prince George's Co., MD  
Ward Bucher  
21 Jan. 2016  
MD SHPO  
West Facade  
# 8 of 30

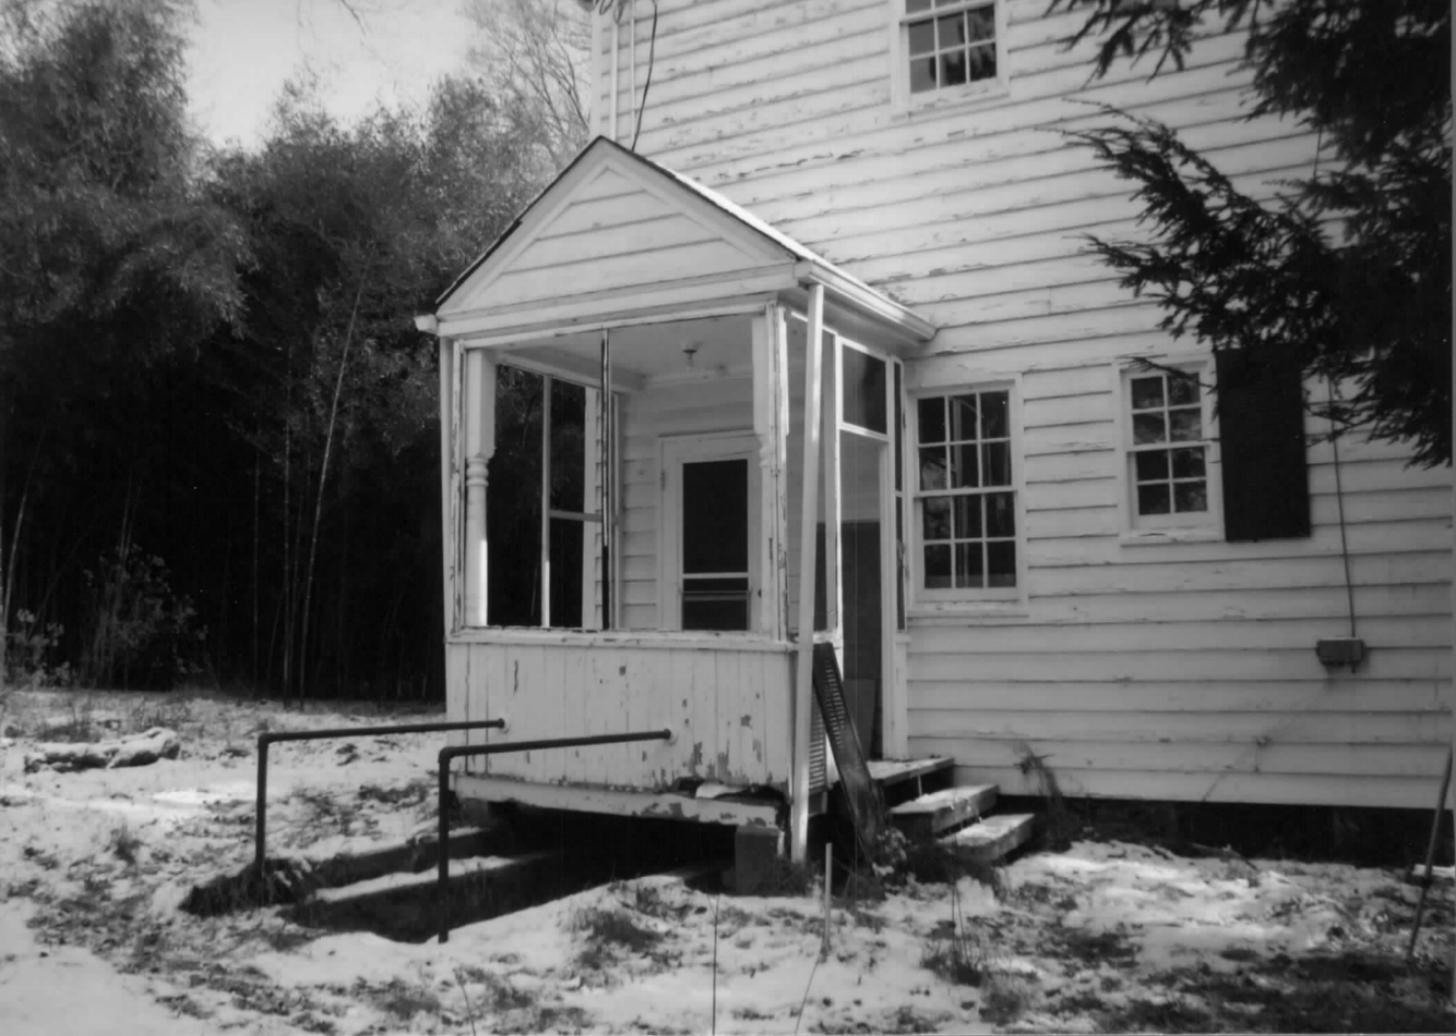
# 9 of 30

Side Porch & Entrance / Stair to Basement, camera facing NE

A small porch on the west side is screened in and has turned columns resting on its wood floor, that is supported by a foundation of two granite piers. The one-story front portico is located on the south side of the east wing and has a pair of fluted, square Doric style columns and an entablature with dentils.

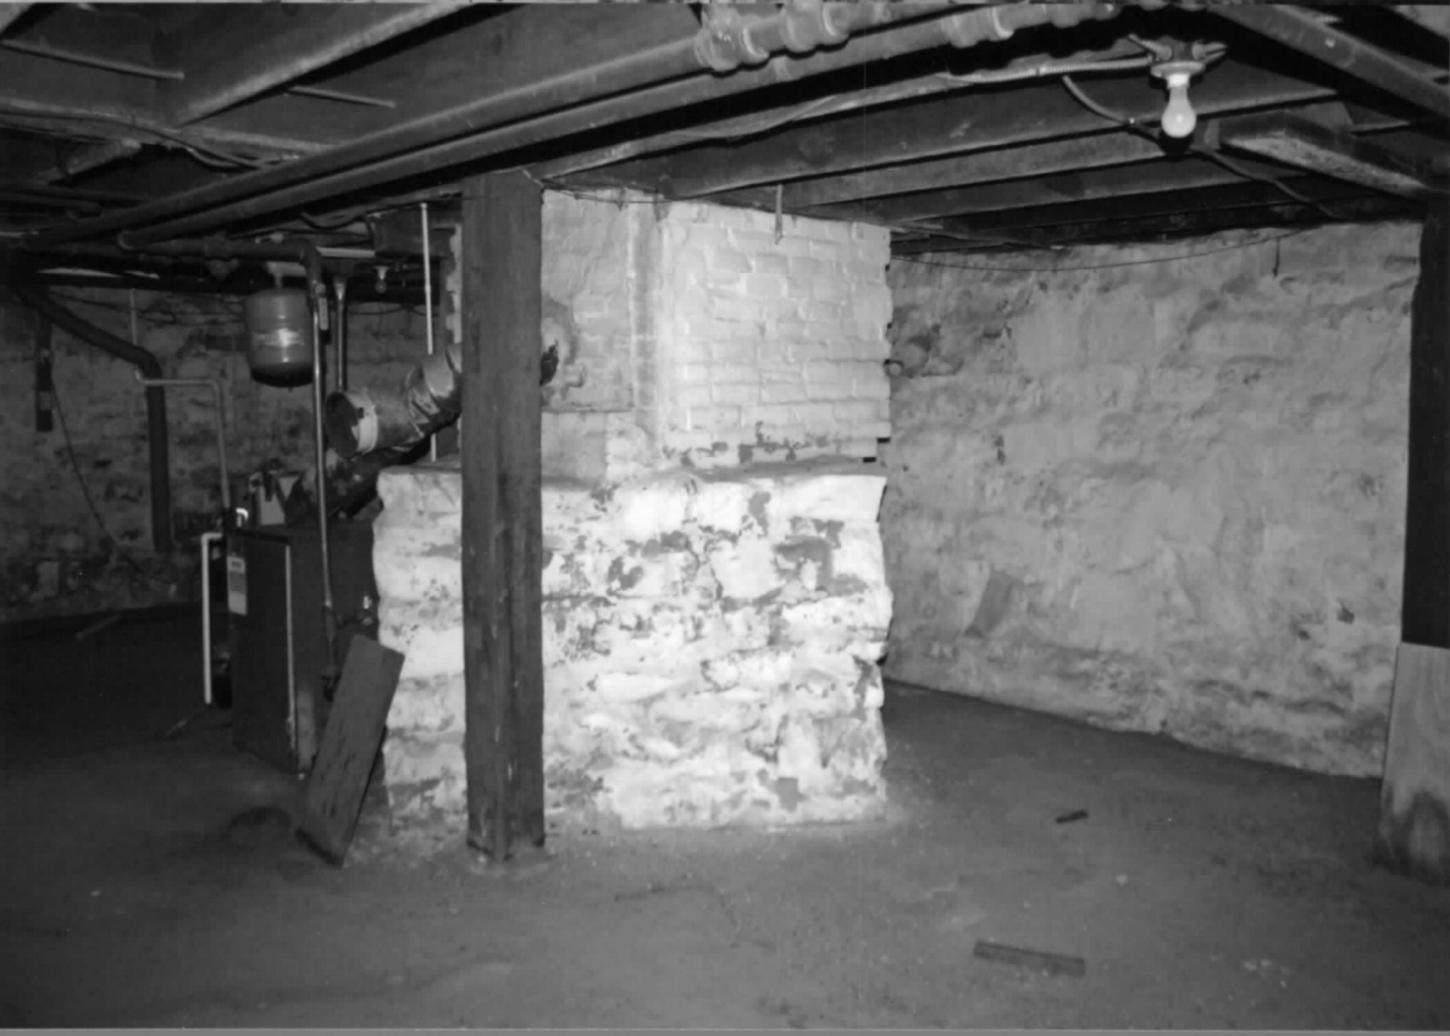
# 11 of 30

Basement, chimney foundation, camera facing NE

The western block has a roughly coursed rubble stone foundation and the eastern ell has a brick foundation with running bond. Below the east wing a brick retaining wall reduces the height of the east end to a crawl space. At this point the perimeter foundation transitions from stone to brick. The circular sawn joists in the western block run north-south to an east-west summer beam. The east ell joists span north-south. The joists below the east end of the east wing are of a different color than the other joists indicating a later construction date.

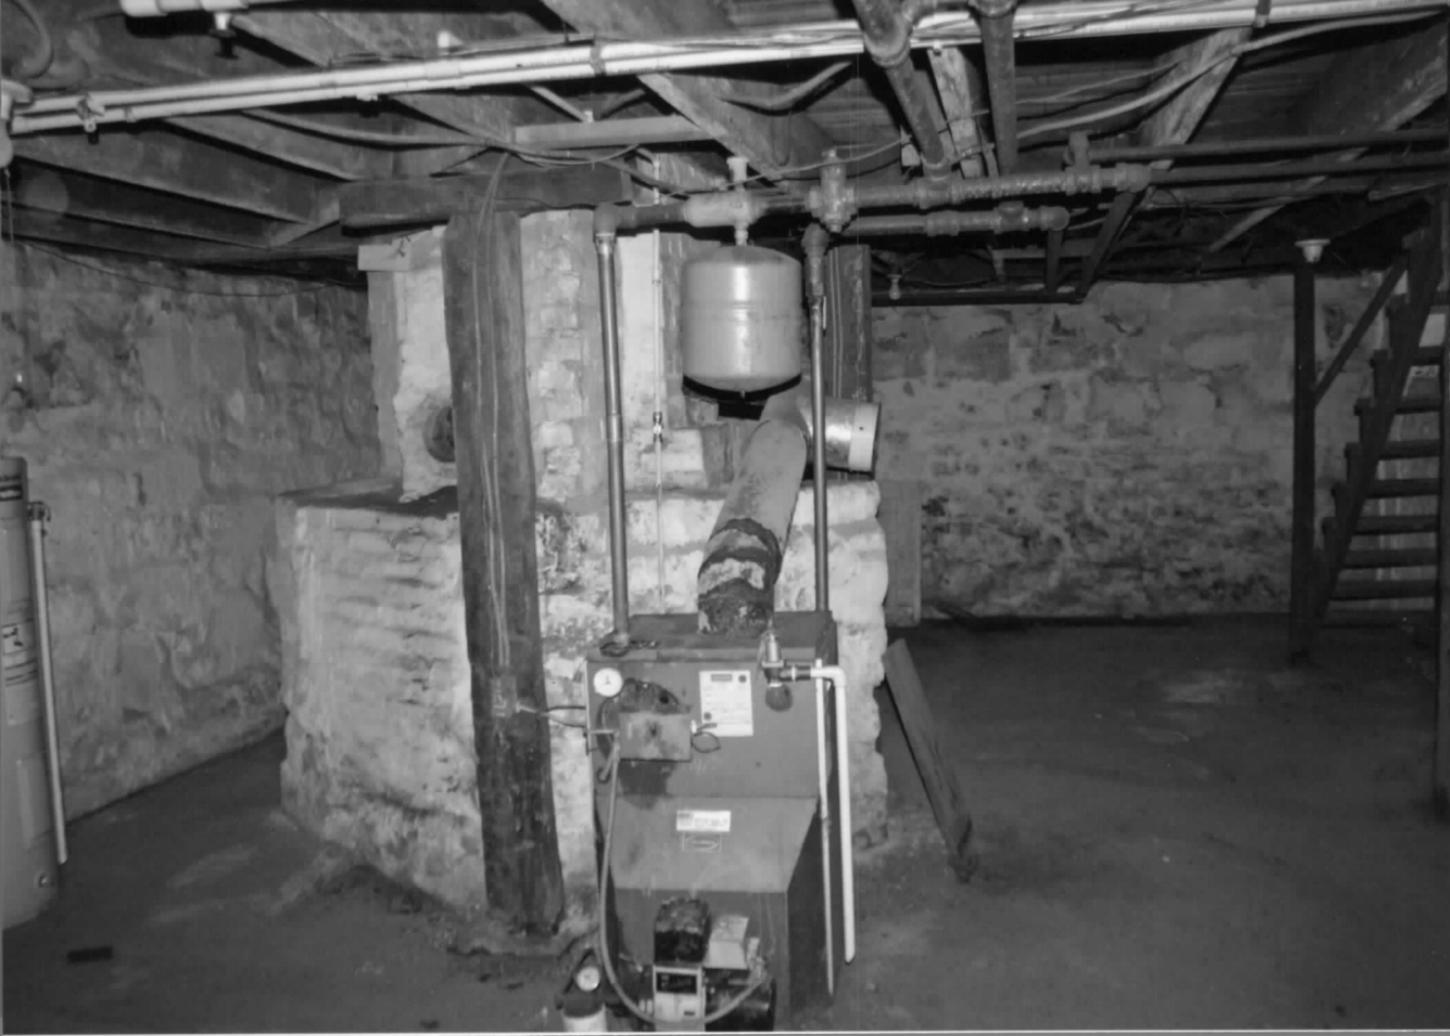
PG:74A-37  
Beall House  
Prince George's Co., MD  
Ward Bucher  
21 Jan. 2016  
MD SHPO  
Basement, chimney foundation, camera facing S  
#12 of 30

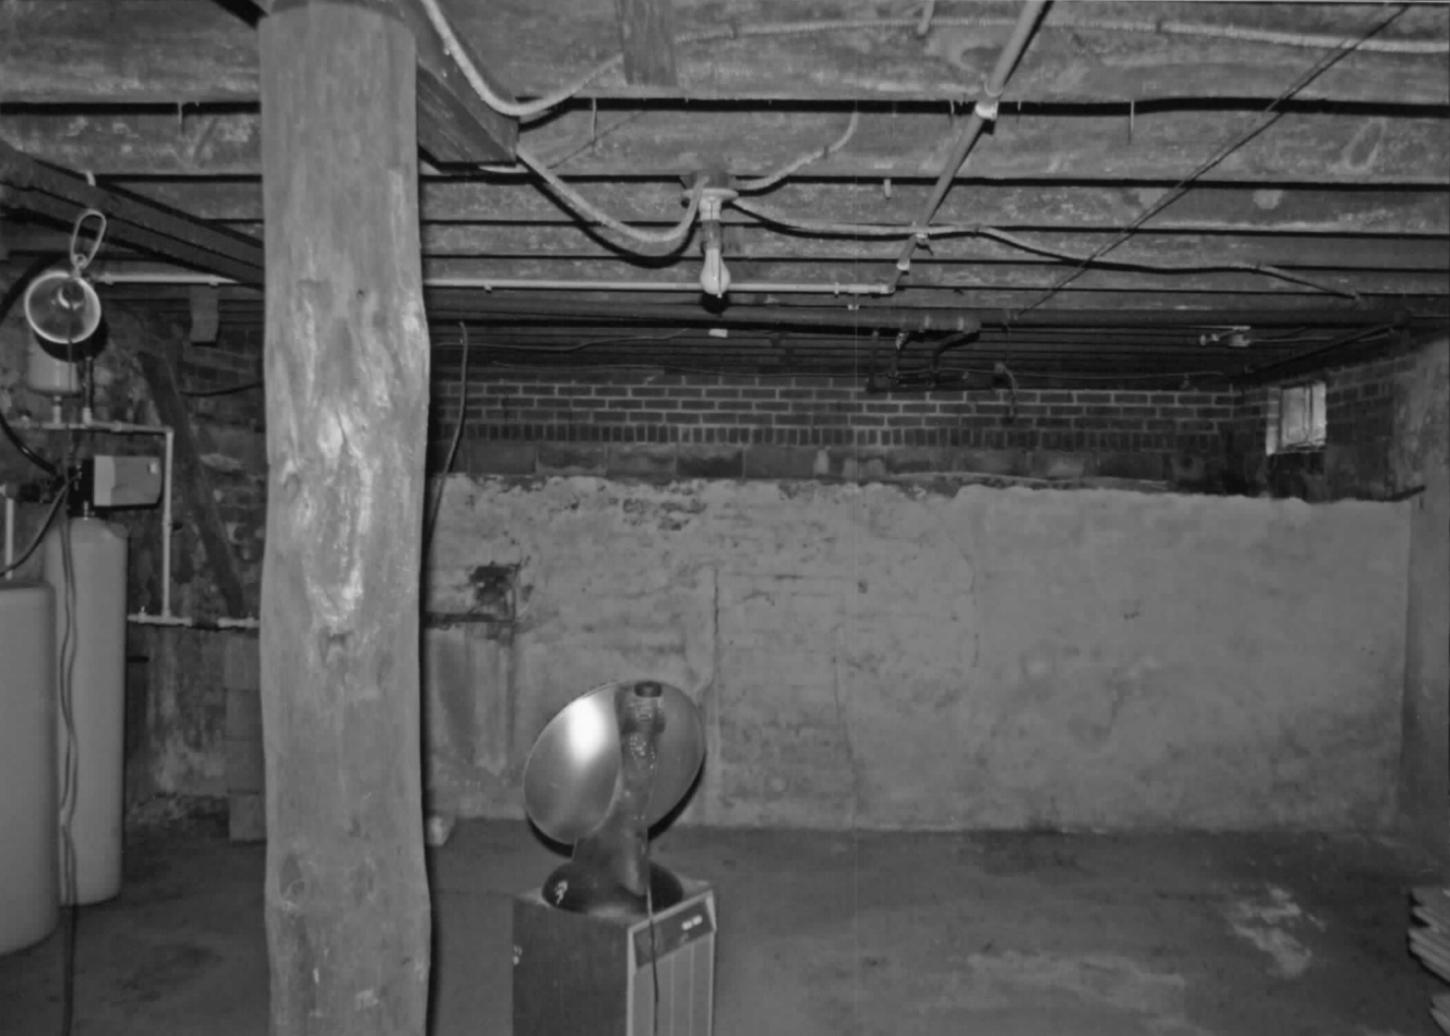
PG:74A-37  
Beall House  
Prince George's Co., MD  
Ward Bucher  
21 Jan. 2016  
MD SHPO  
Basement, camera facing E  
# 13 of 30

The basement floor is a concrete slab. Upper level floors are typically wide pine finished with a varnish stain. The kitchen and baths are finished with sheet vinyl. All bathroom finishes and fixtures, and the kitchen cabinets appear to date from the early 21<sup>st</sup> century.

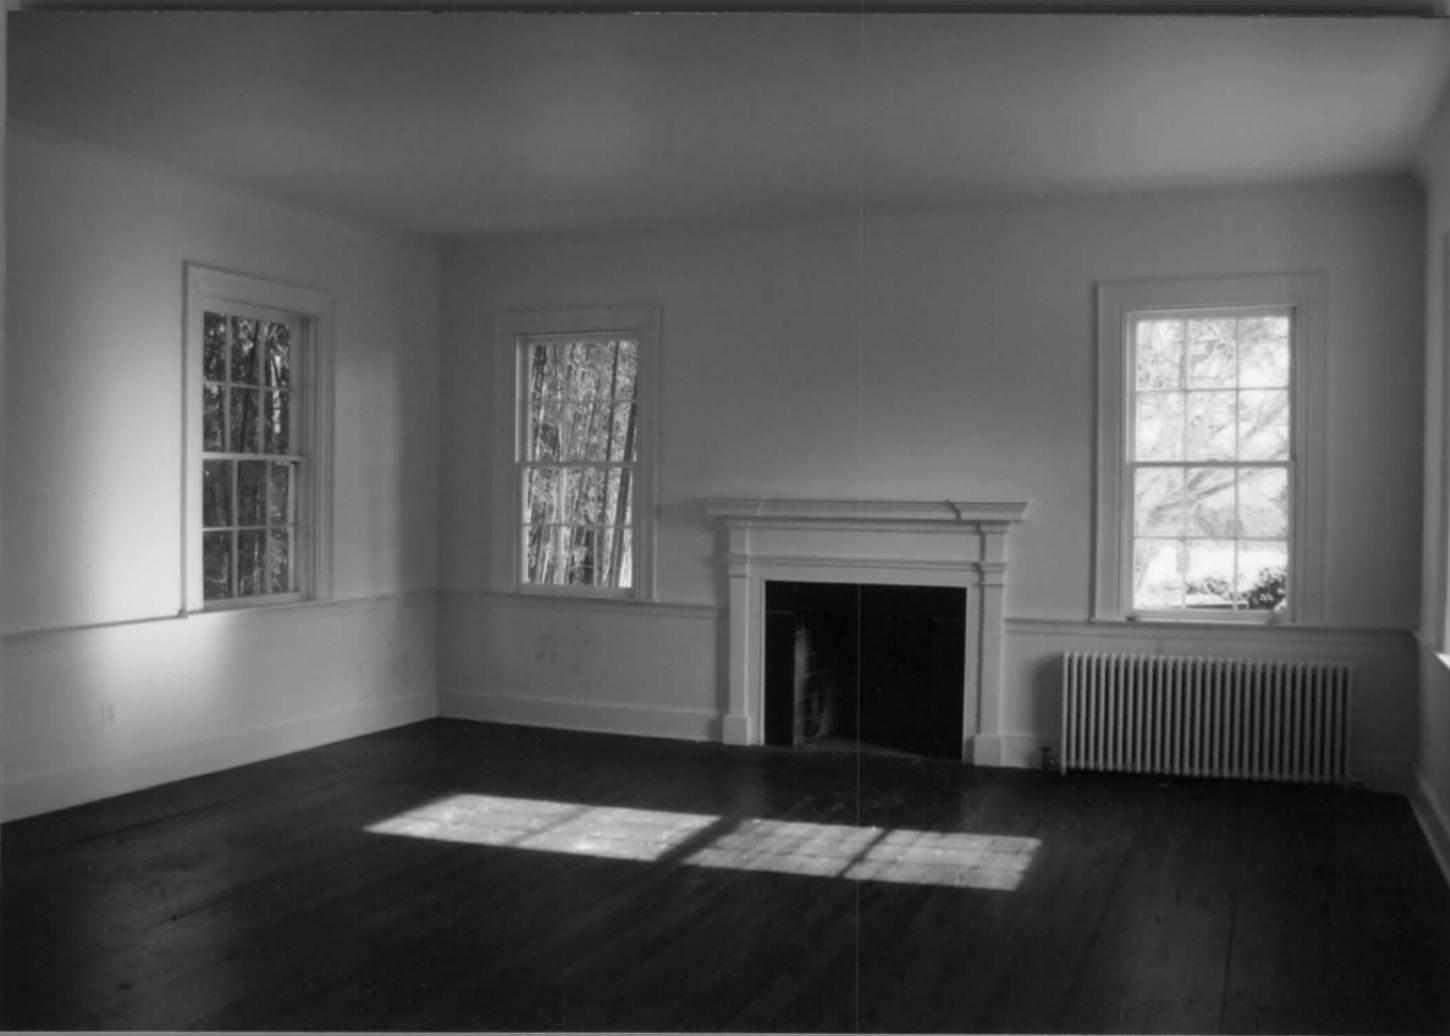
# 14 of 30

Room 101, fireplace mantel, camera facing E

Typical trim includes a three part base, chair rail, and reeded casings. Door casings are supported by plinth blocks. The first floor rooms typically have a cyma recta crown mold. Typical doors are six panel. Built-in shelves are located in Room 102 and in closets.

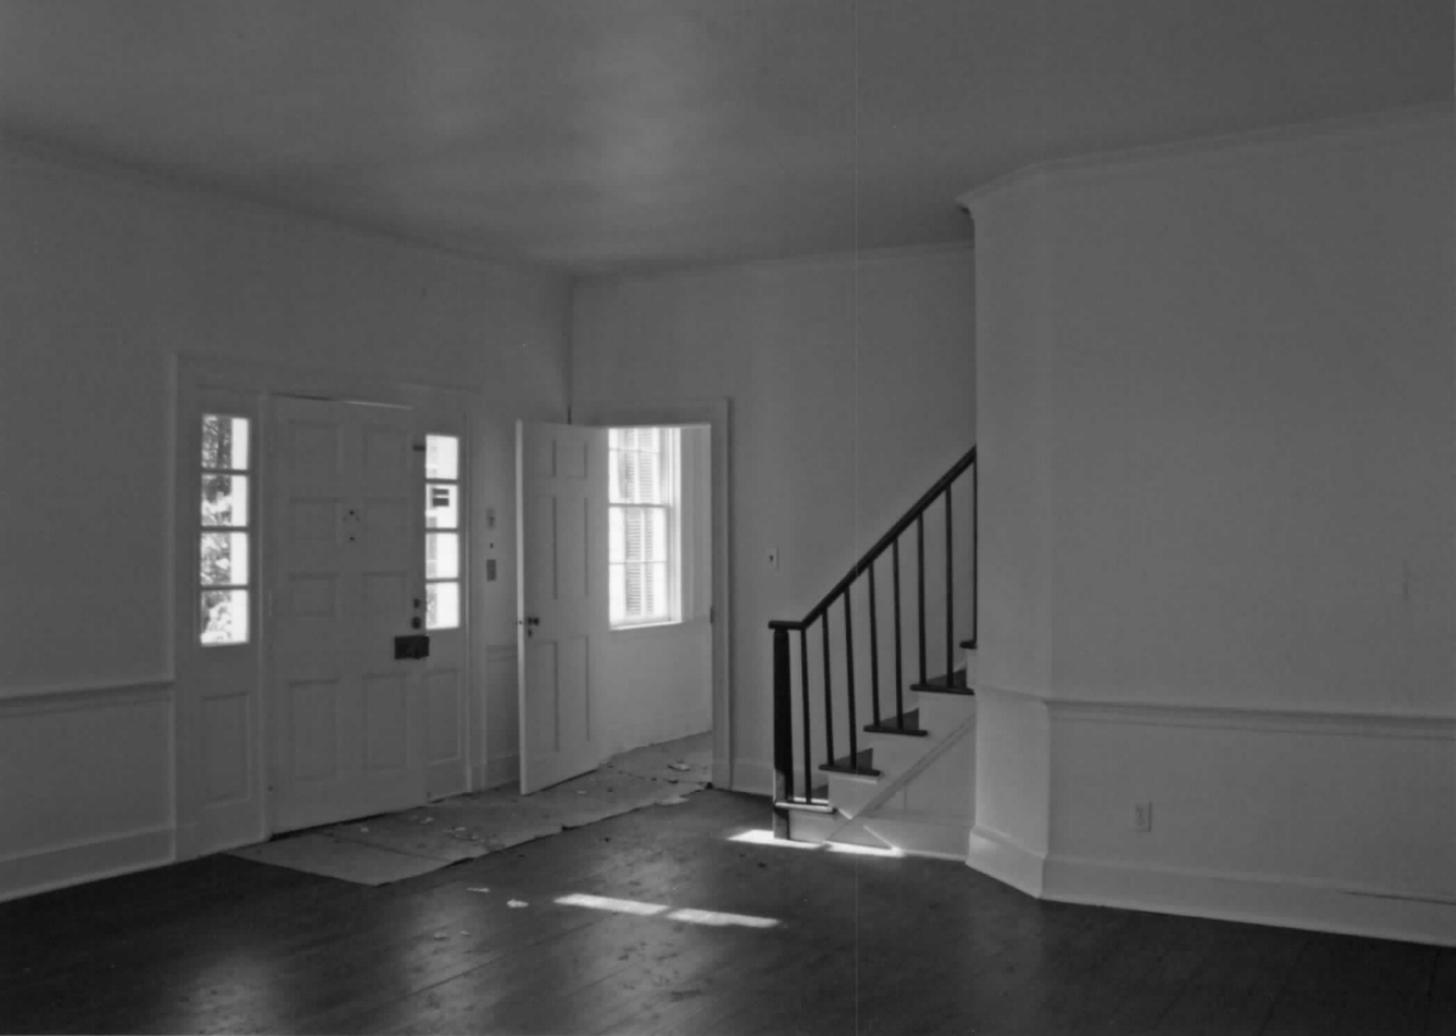
# 15 of 30

Room 101, main entrance/staircase, camera facing SE

Two open sided stairs connect the first and second floors. The early colonial style balustrades appear to be a recent addition. An open riser stair without balustrade leads down to the basement.

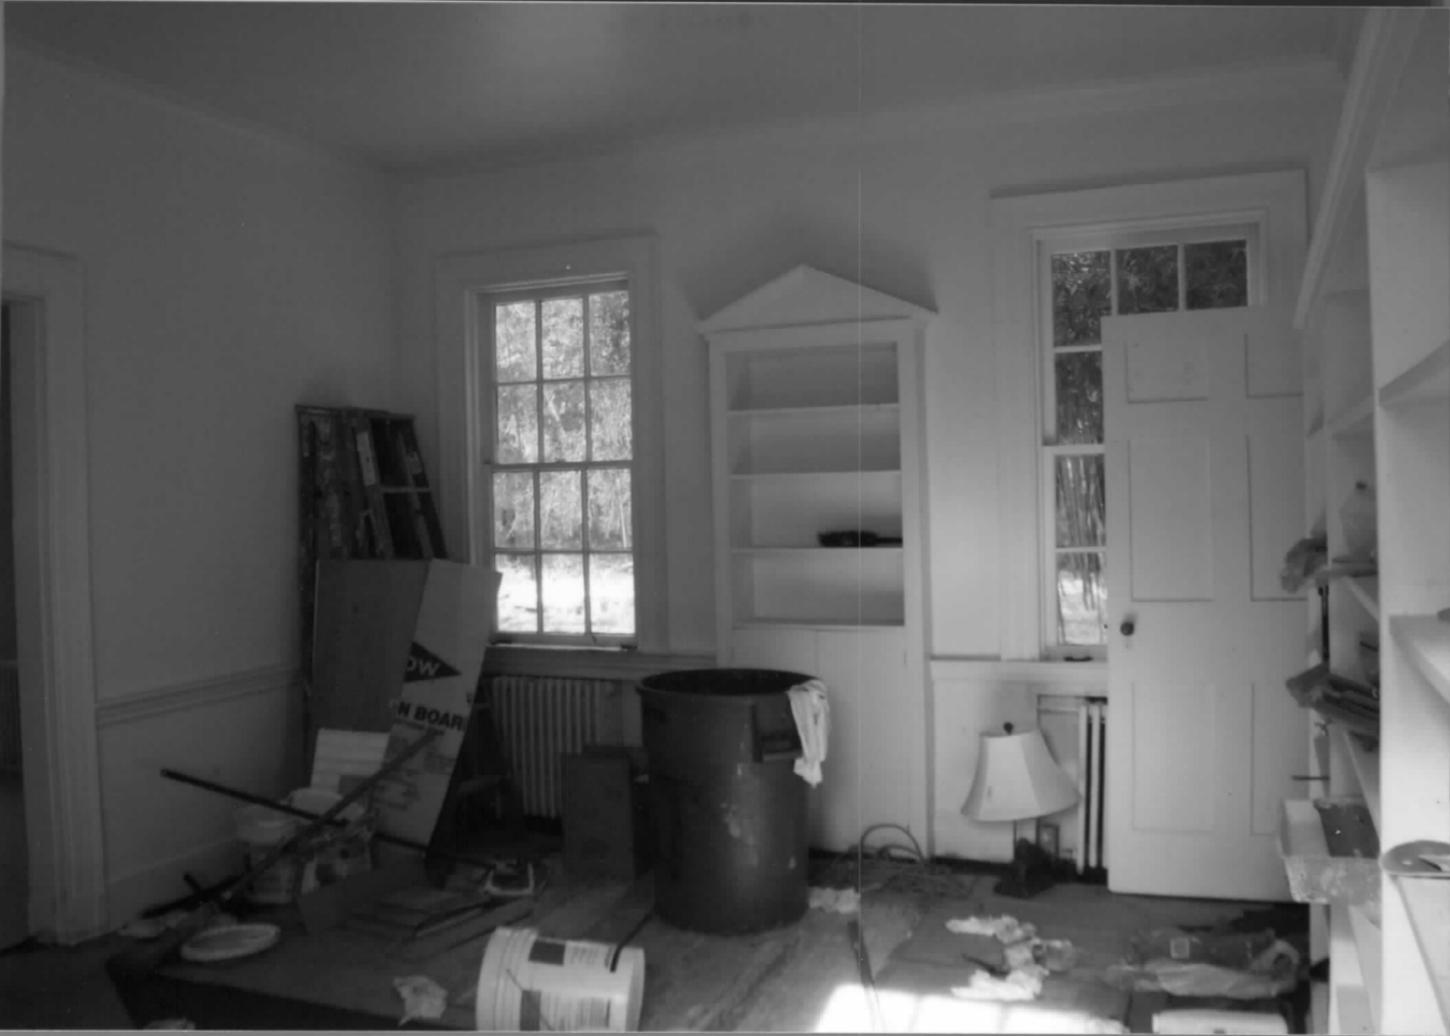
#16 of 30

Room 102, built in shelving, camera facing N

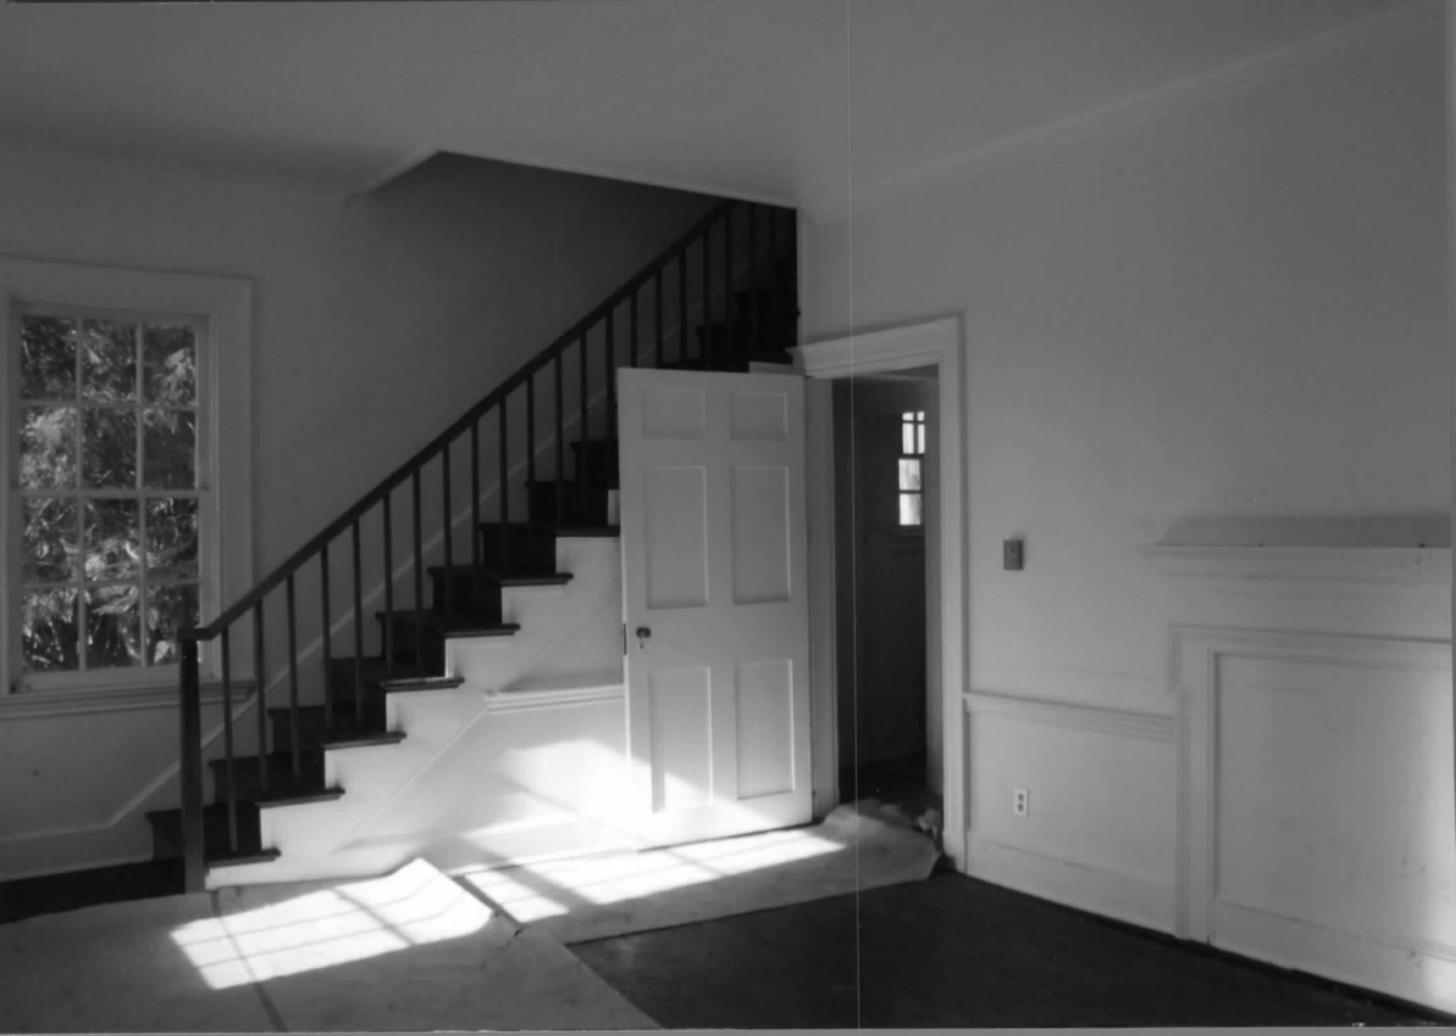
# 18 of 30

Room 103, staircase, camera facing NW
