Re: **PG:74A-37**  
**Beall House**

MARYLAND HISTORICAL TRUST  
SHORT FORM FOR INELIGIBLE PROPERTIES

# Maryland Historical Trust Maryland Inventory of Historic Properties Form

historic Beall House  
 other Beall Family Homesite

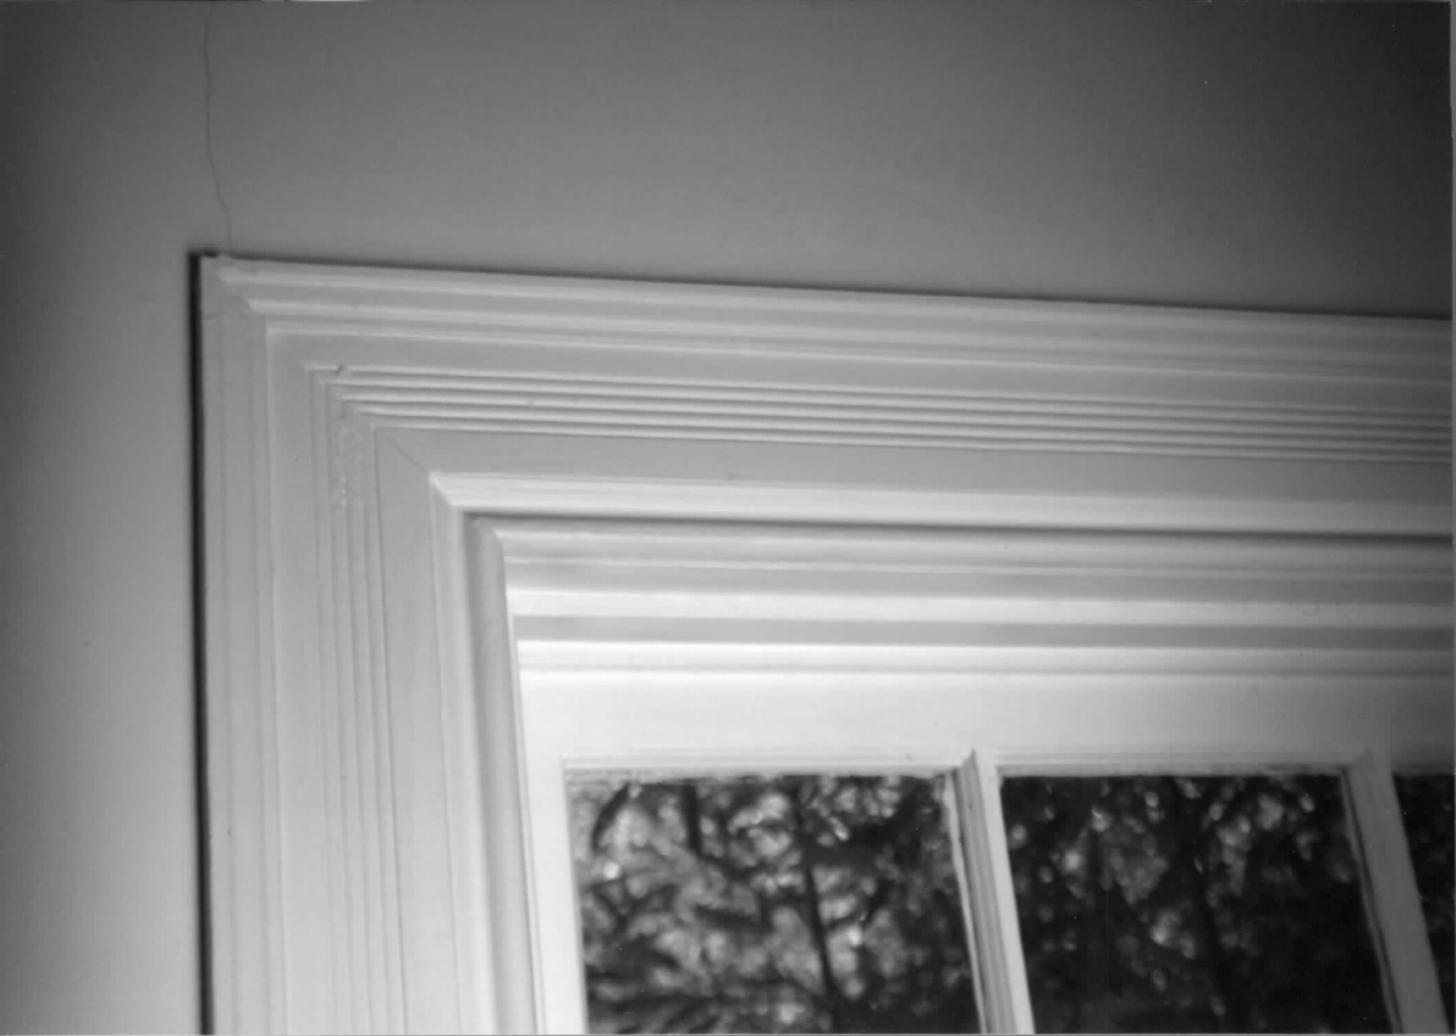
PG:74A-37  
Beall House  
Prince George's Co., MD  
Ward Bucher  
21 Jan. 2016  
MD SHPO  
Detail of window trim  
# 30 of 30

Typical trim includes a three part base, chair rail, and reeded casings. Door casings are supported by plinth blocks. The first floor rooms typically have a cyma recta crown mold. Typical doors are six panel. Built-in shelves are located in Room 102 and in closets.
