**MARYLAND HISTORICAL TRUST  
DETERMINATION OF ELIGIBILITY FORM**

Property Name: Tobacco Barns at W.W.W. Bowie House (site) Inventory Number: PG: 74B-2  
 Address: 17501 Governor's Bridge Road (new) City: Bowie Zip Code: 20716  
 County: Prince George's USGS Topographic Map: Bowie  
 Owner: Maryland National Capital Park & Planning Commission Is the property being evaluated a district? \_\_\_yes  
 56 A#&  
 Tax Parcel Number: 06&21 Tax Map Number: 55E3 Tax Account ID Number: 0796979 & 0801191  
 Project: Green Branch Athletic Complex Bond Bill Agency: Maryland National Capital Park & Planning Commission  
 Site visit by MHT Staff: X no \_\_\_yes Name: \_\_\_\_\_ Date: \_\_\_\_\_  
 Is the property located within a historic district? \_\_\_yes X no

MARYLAND HISTORICAL TRUST  
NR-ELIBILITY REVIEW FORM

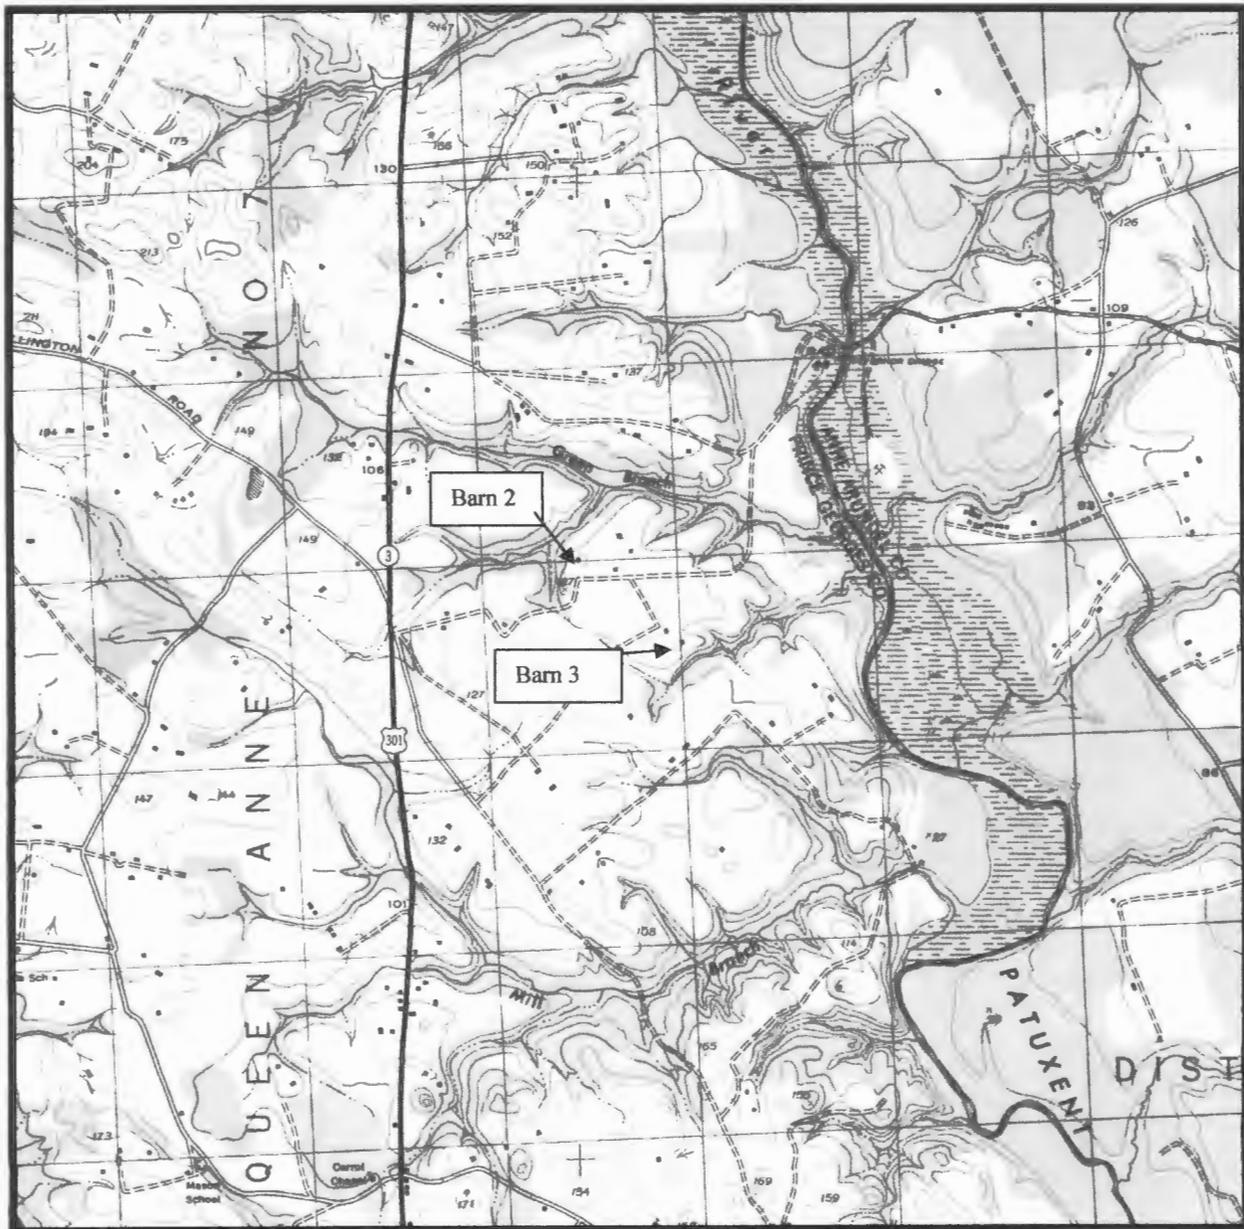
Figure 3: This 1944 USGS map show the presence of numerous now lost buildings and a different farm road network than exists at present. Barns #1, #4 and #5 are not shown on this map, and Barn #2 appears smaller.  
Source: USGS Map (Quad Bowie, 1944).

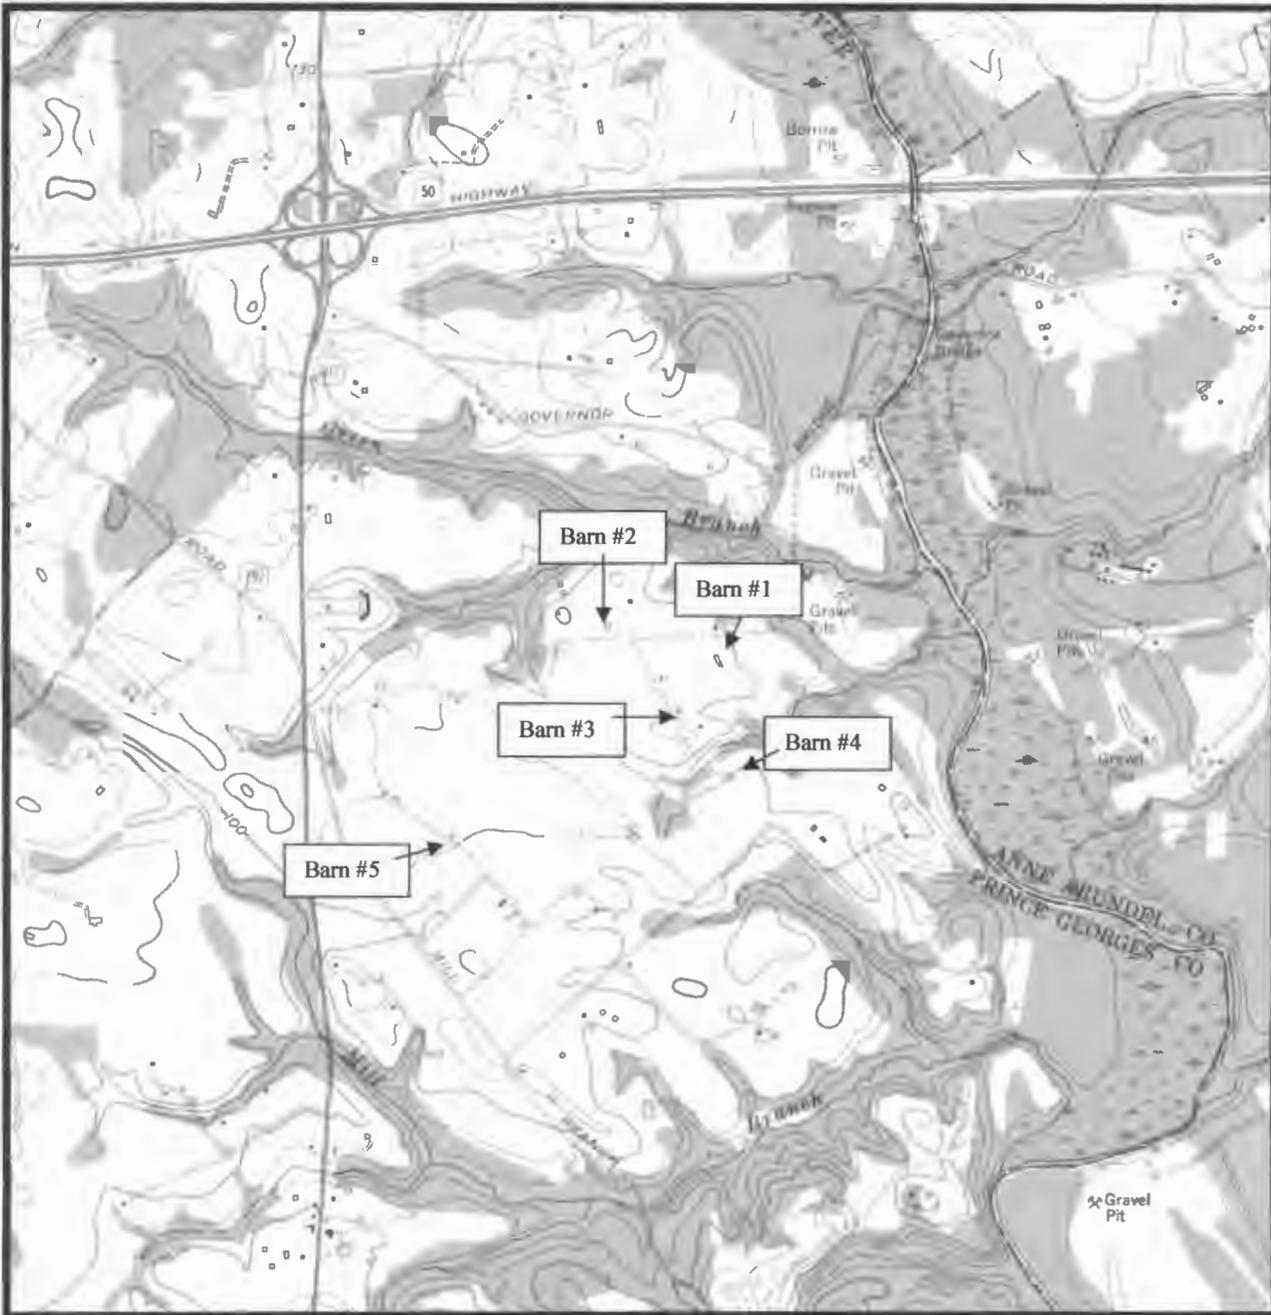
Figure 4: All of the barns examined in this report appear to be in place by the time this 1957 USGS map was published. Source: USGS Map (Bowie Quad, 1957). Note the change in size of Barn #2 and the change in road patterns in response to the new barns.

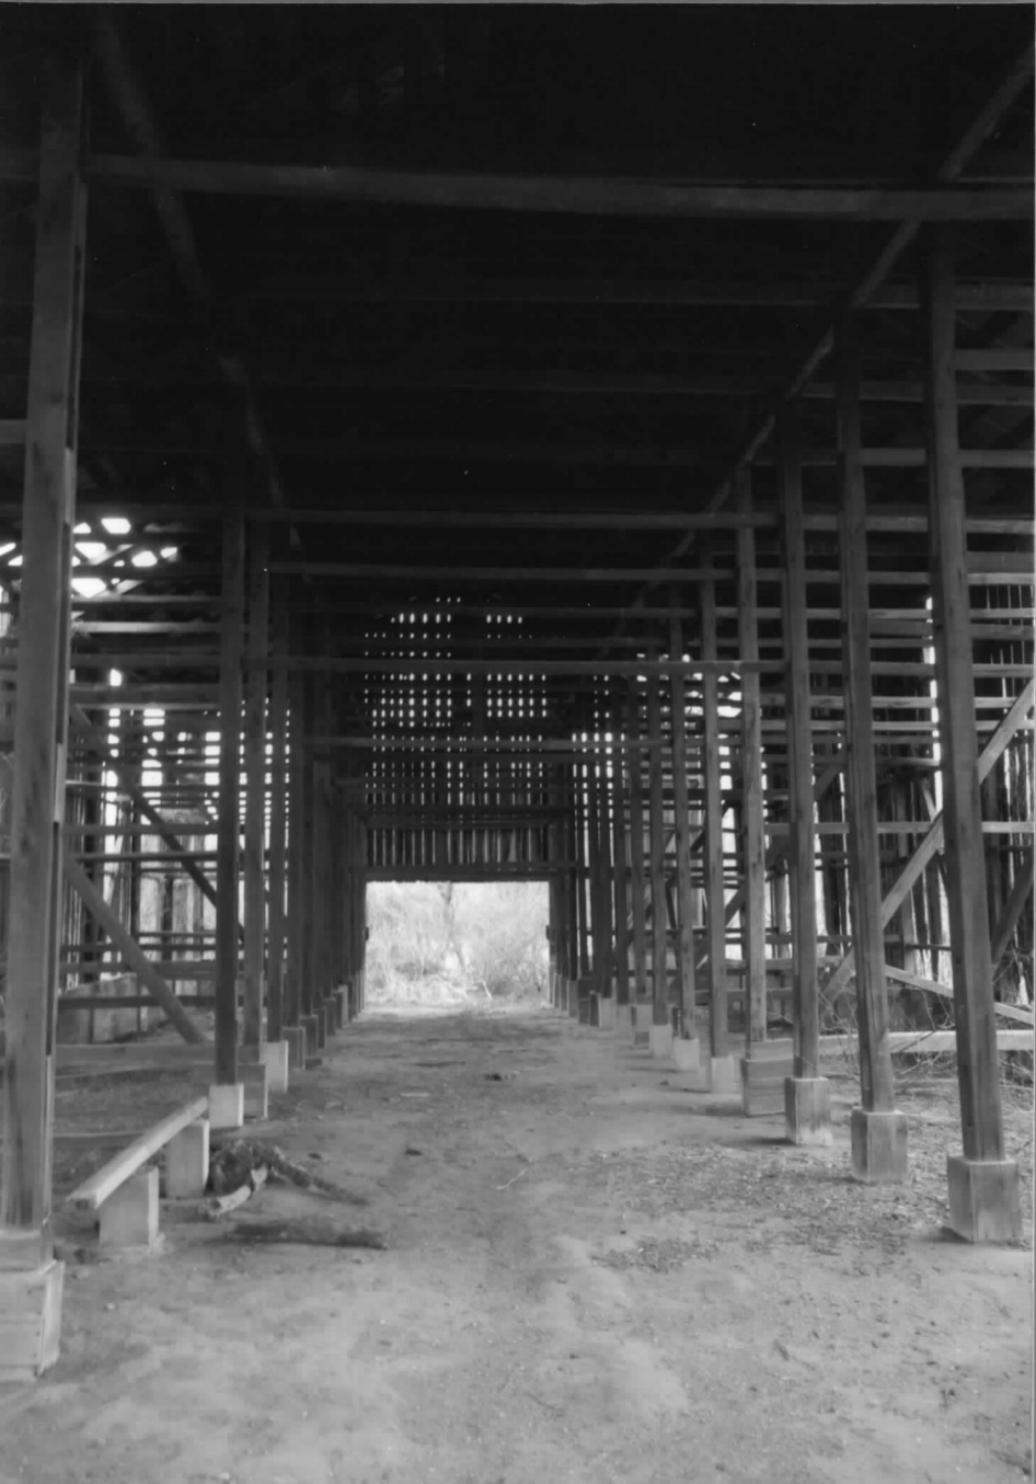
3 of 28

Interior Tobacco Barn #1, facing North  
(ILFORD), (Freeze True B&W), 04/09/14

Built between 1944 and 1957, this drive-through, center-aisle-plan barn measures 100' x 40'. The ridge line of the badly damaged, standing-seam- metal-clad roof runs north to south. The balloon-framed walls rest on a pier foundation infilled with concrete blocks. Wall sheathing is random-width vertical board siding measuring between 6" and 1'. Siding is fixed to interior 4" x 2.5" horizontal rails with wire nails. An approximately 3/4" gap between vertical boards allows for ventilation. Approximately 50% of the siding is missing. The doors are also missing. Encroaching vines, trees and brush surround much of the structure.

The barn is divided into four, 20' bays with each bay containing four, 5' rooms. The bays and rooms are 16' wide and separated on each side by a 14' center aisle. Each bay begins and ends with a toe-nailed downbrace that extends from the sill to above the fifth tier pole. The barn is 8 tiers high. Common rafters rest on a thin false plate. Despite the long length of this barn, there are no upper level wind braces. The absence of windbraces is at least a contributing reason for the condition of the siding and roof.

All building material is light circular-sawn material, attached with wire nails. Interior posts are 6" square, formed by assembling two, 2"x 6" pieces of lumber. These are separated by a 2" gap used to receive tier poles. Interior posts rest on a 2'-tall concrete piers. Sills measure 8"x 6", segments of which are lap-joined and nailed together. Framing associated with three of the former rooms is removed, and approximately 15% of the tiers poles are also gone, but the majority of the interior framing remains intact and only beginning to exhibit damage from the extensive siding loss.

**Barn #1** is not eligible for National Register listing due to its deteriorated condition. About half of the exterior siding has been lost, the doors are missing, the roof is damaged and the structure partially overgrown with vines and brush. In addition, the stripping room has been demolished. It has greatly diminished integrity of materials, workmanship and feeling.

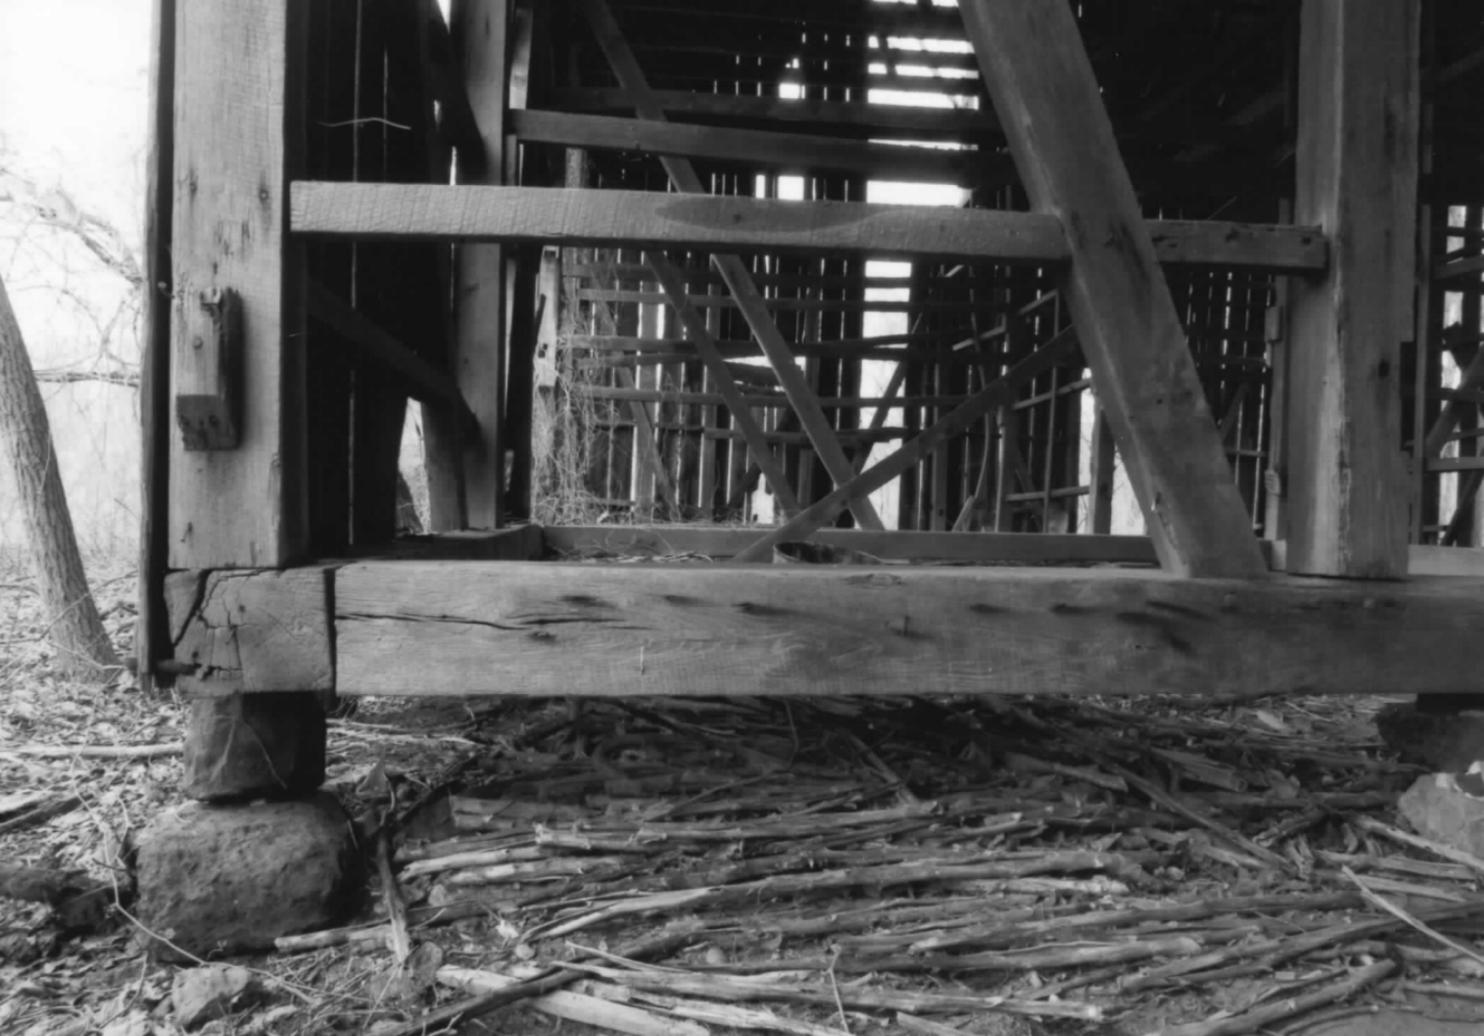
<ILFORD>, (Framex True B&W), 04/09/14  
TOBACCO BARN #2, Interior aisle  
FRAMING DETAIL, facing NORTH  
Photo 10 of 28

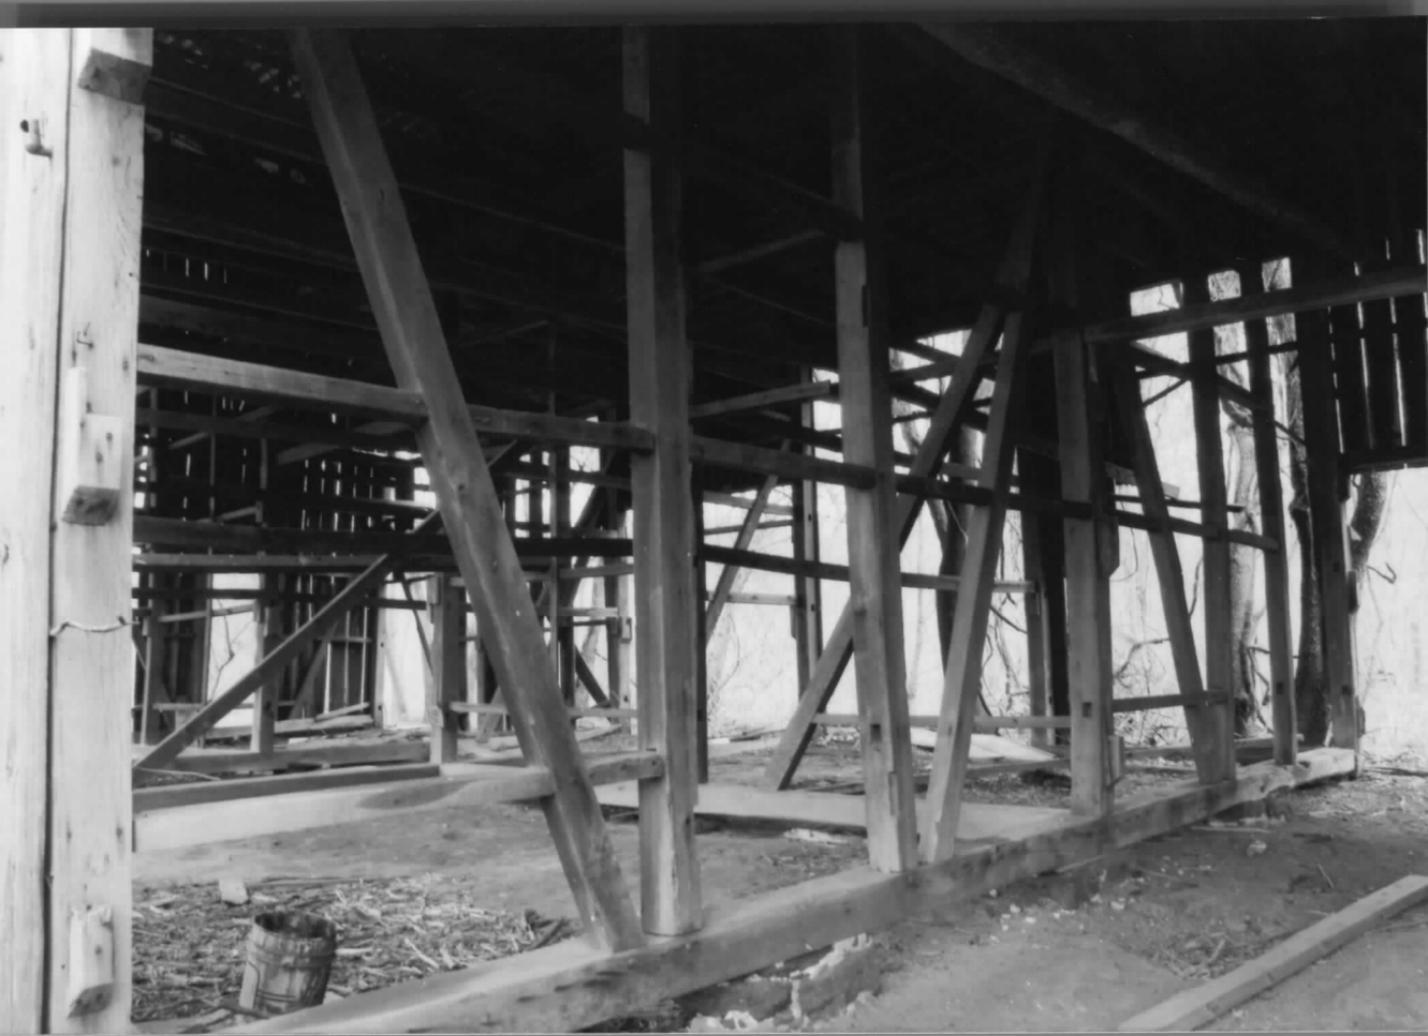
Photo 11 of 28

Detail, facing south towards period  
2 section

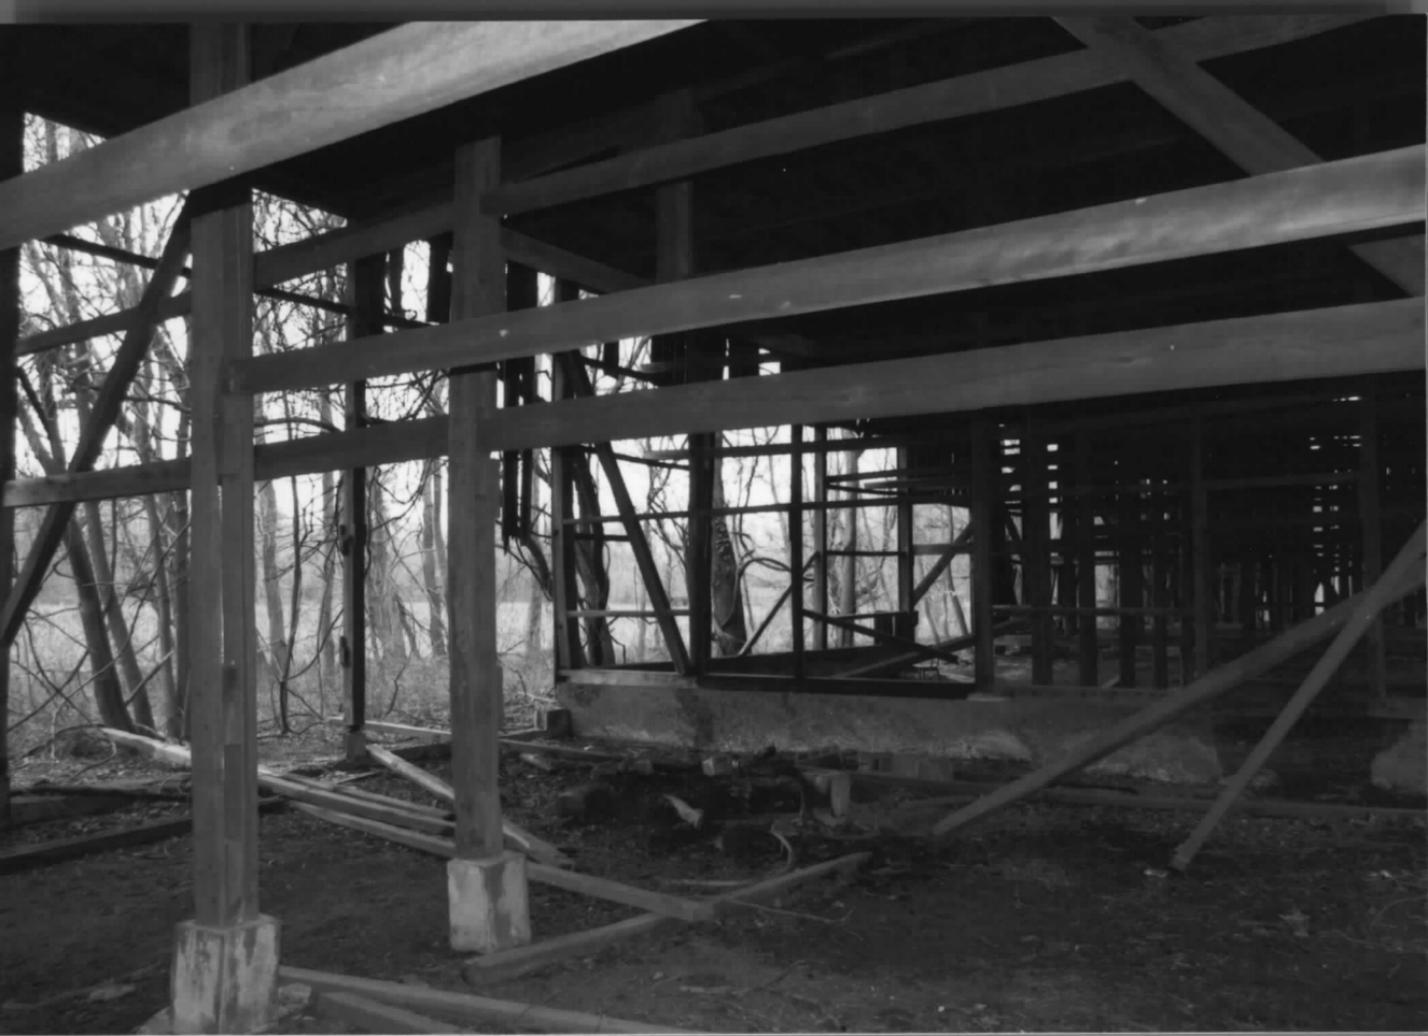
Photo 12 of 28

FIRE DAMAGE IN PERIOD I section  
FACING NORTH East

The period 2 and 3 sections reflect changing building practices in response to the use of tractors and other motorized vehicles. For example, the absence of ground sills inside in this part of the structure allowed vehicle ingress/egress, and facilitated ease of movement around barn's interior. The construction methods used in these sections are typical for the period, but again are not a good example of their type due to deterioration and arson.

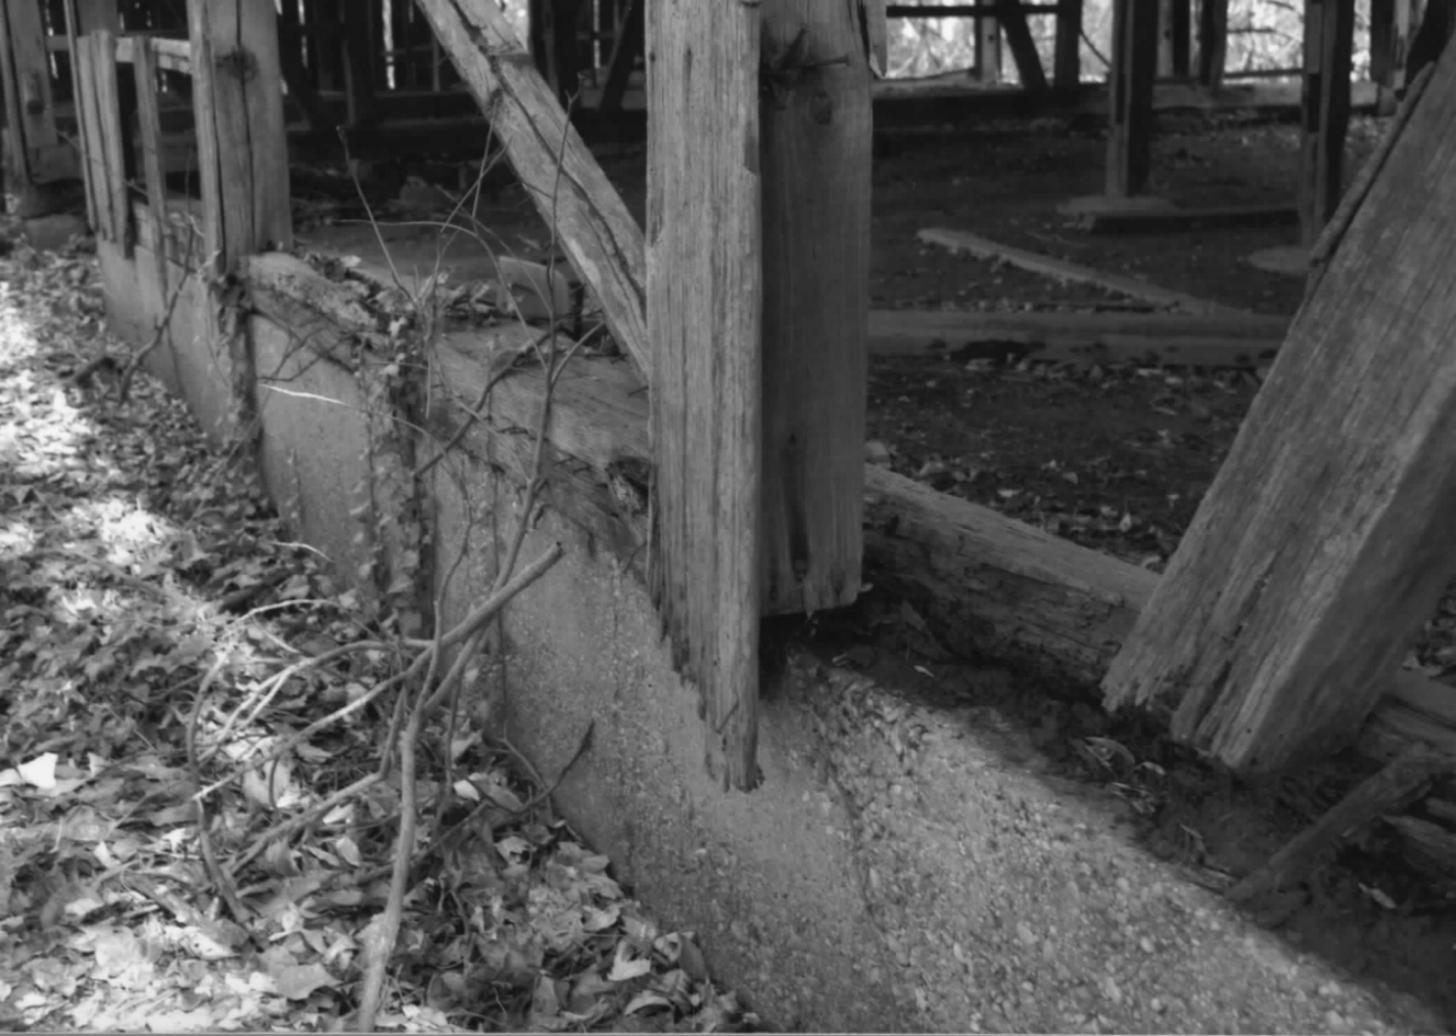
Photo 14 of 28

PERIOD TWO FOUNDATION Detail of  
BARN #2

The center, period 2 section of the barn, measures 40' x 34'. Map evidence indicates this section, and the period 3 structure, were both built between 1944 and 1957. Here the balloon-framed walls rest on a 2'-tall, coarsely textured, poured concrete foundation. The interrupted wall sills measure 7.5" x 6", with the 5" x 6" wall posts resting directly on the foundation. The gaps between sill and posts has allowed for moisture penetration. As a result of this poor craftsmanship, the framing of this section, which may be nearly a century later than the Period 1 barn, is in much worse condition.

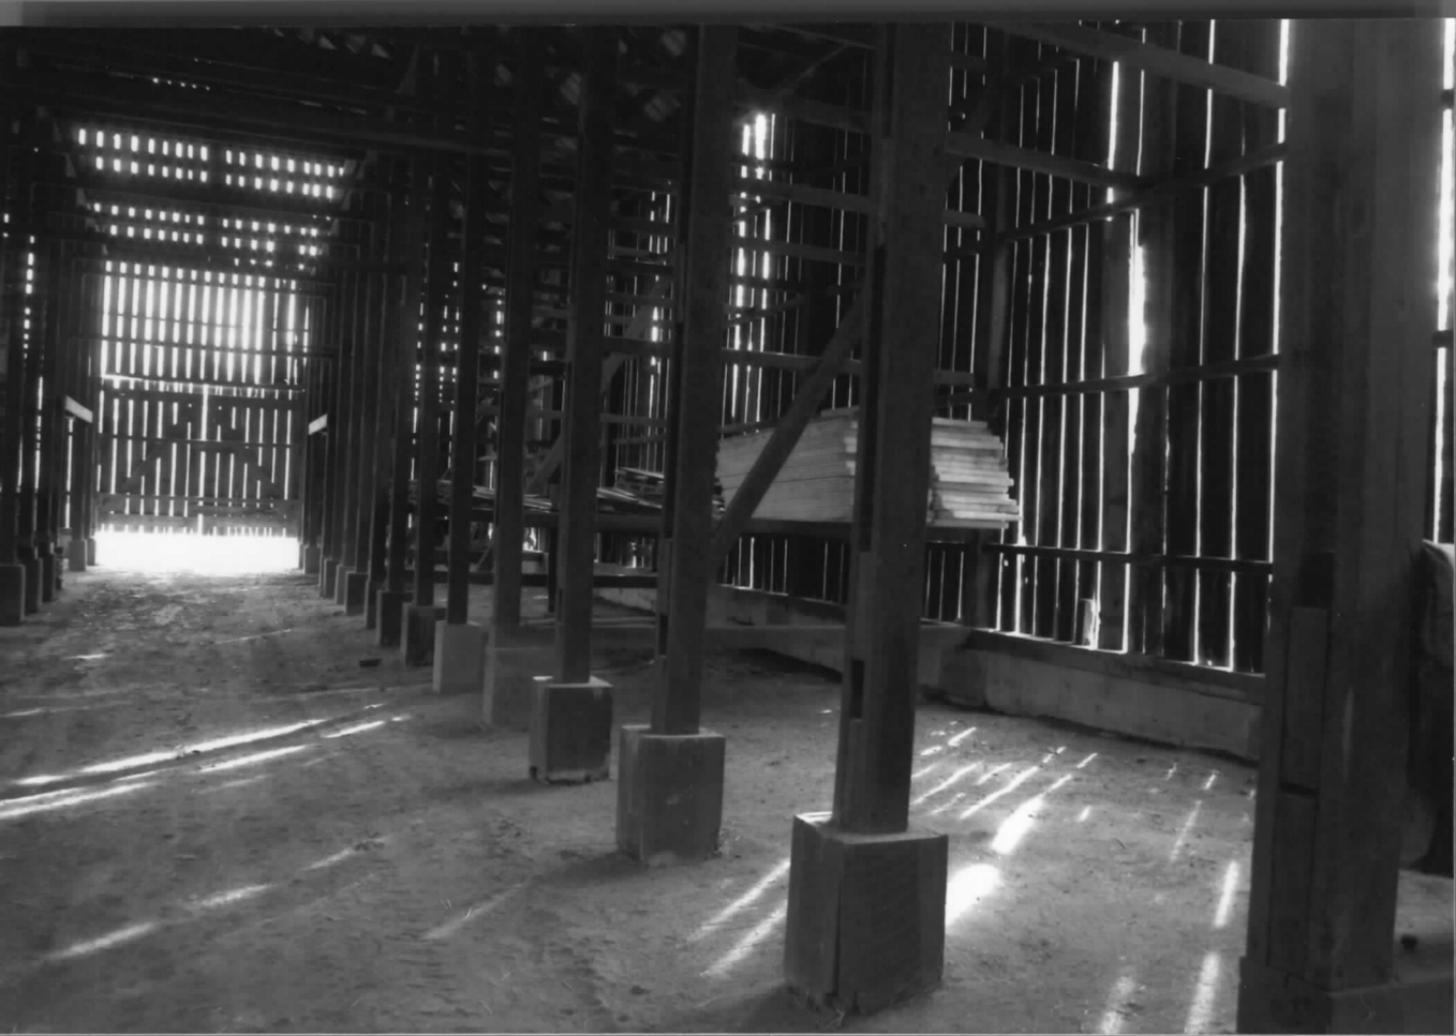
Photo 19 of 28

INTERIOR FRAMING DETAIL  
FACING SOUTH/SOUTH WEST

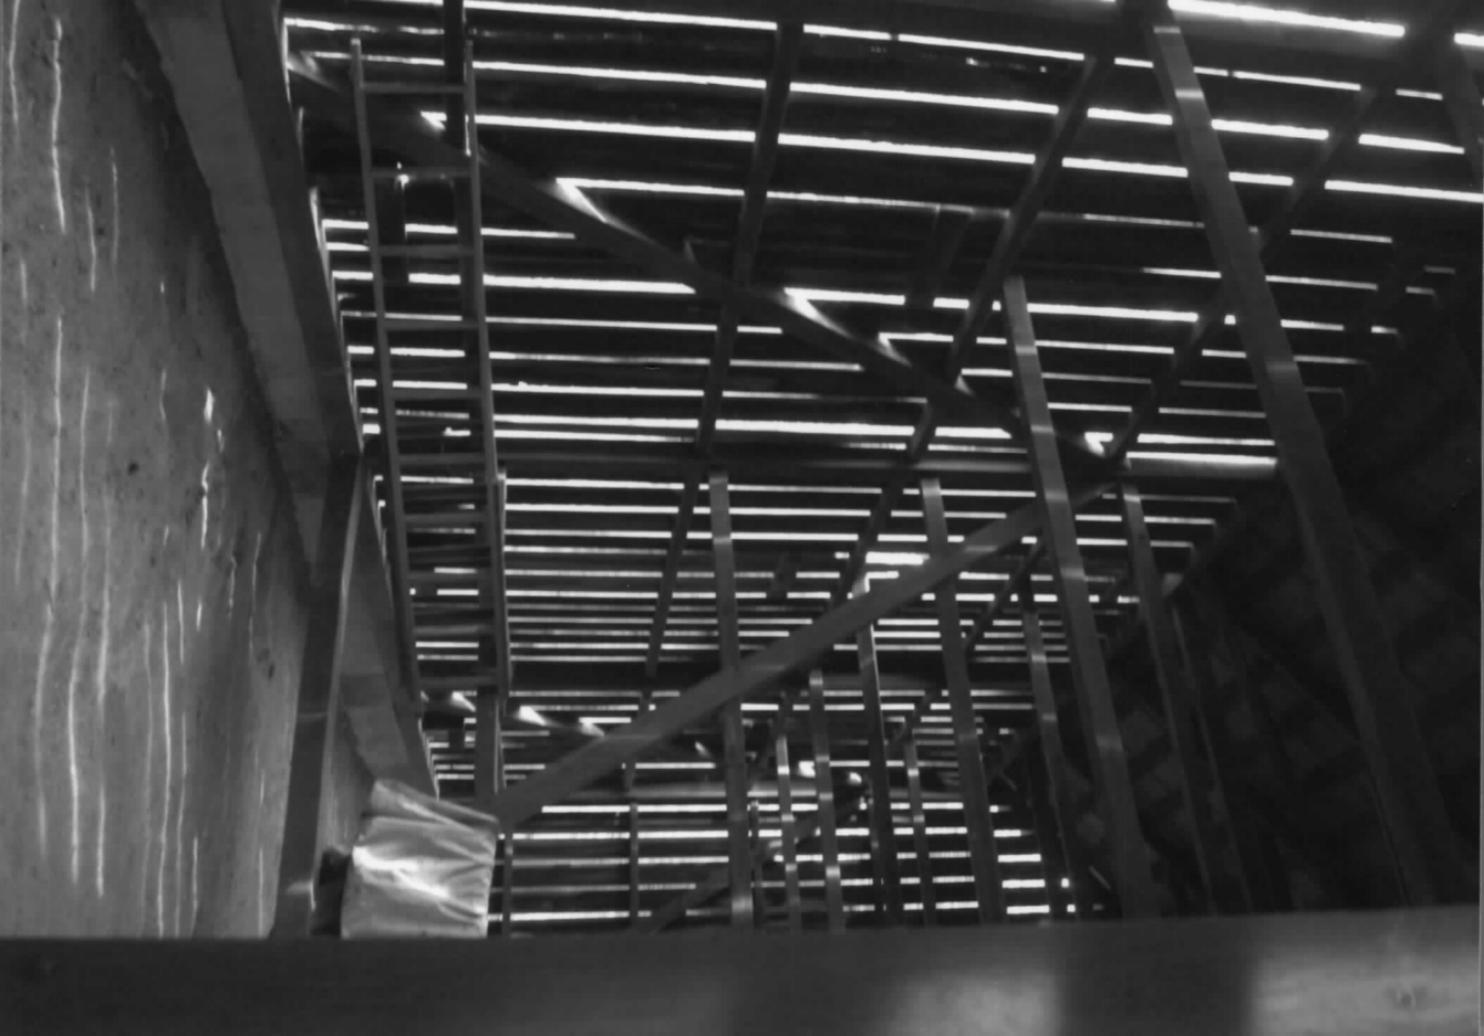
Photo 20 of 28

FRAMING DETAIL

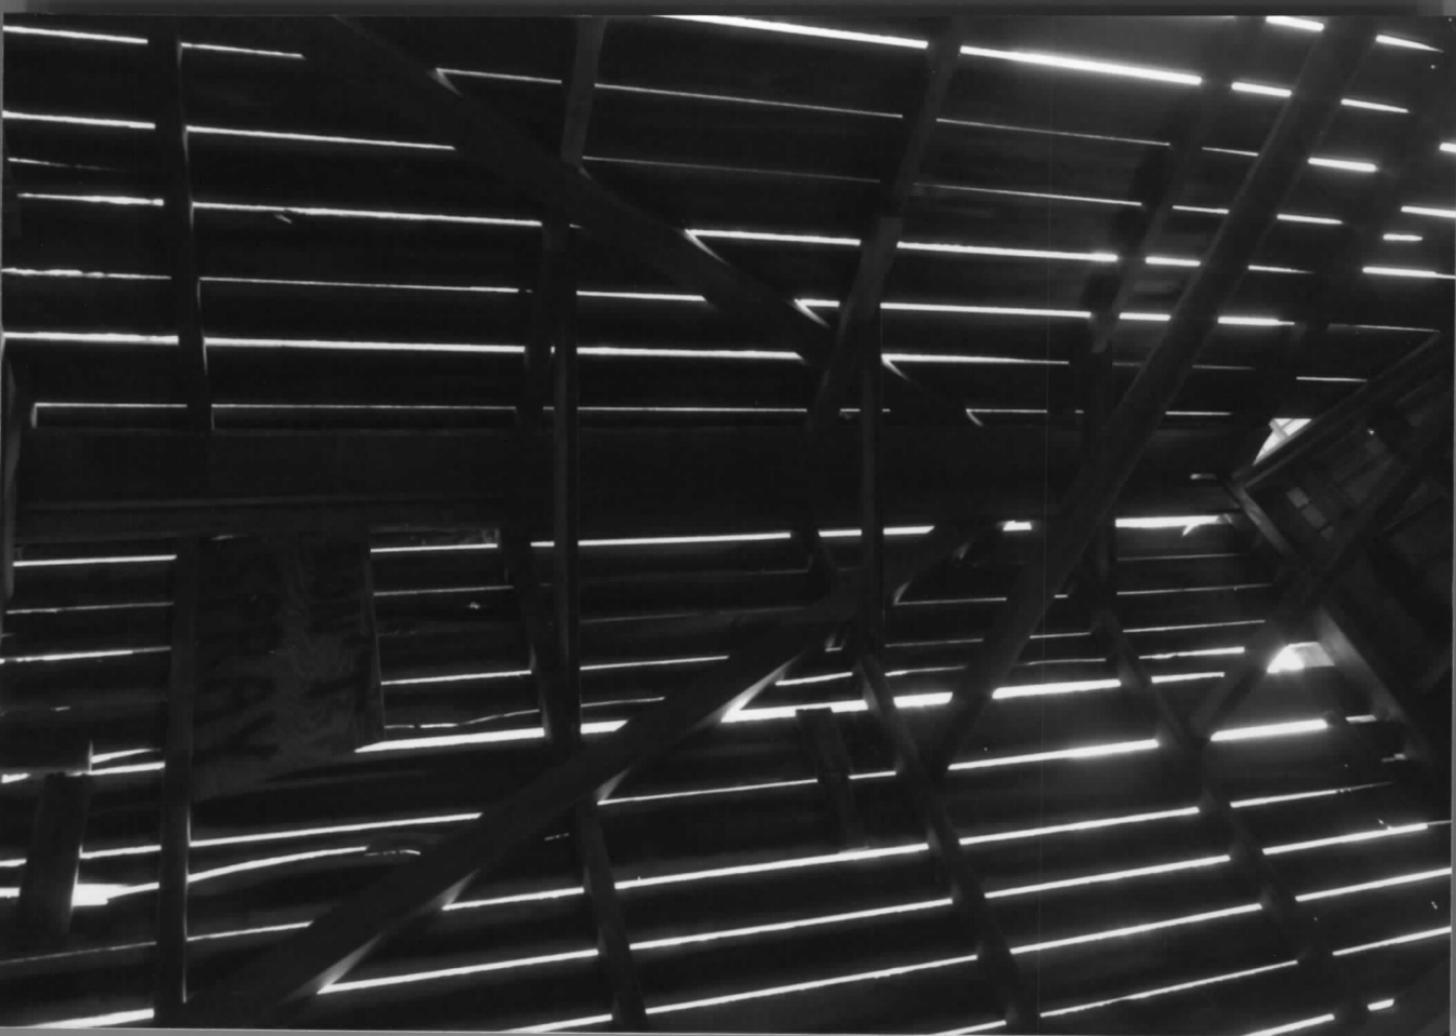
Photo 21 of 28

CORNER FRAMING DETAIL

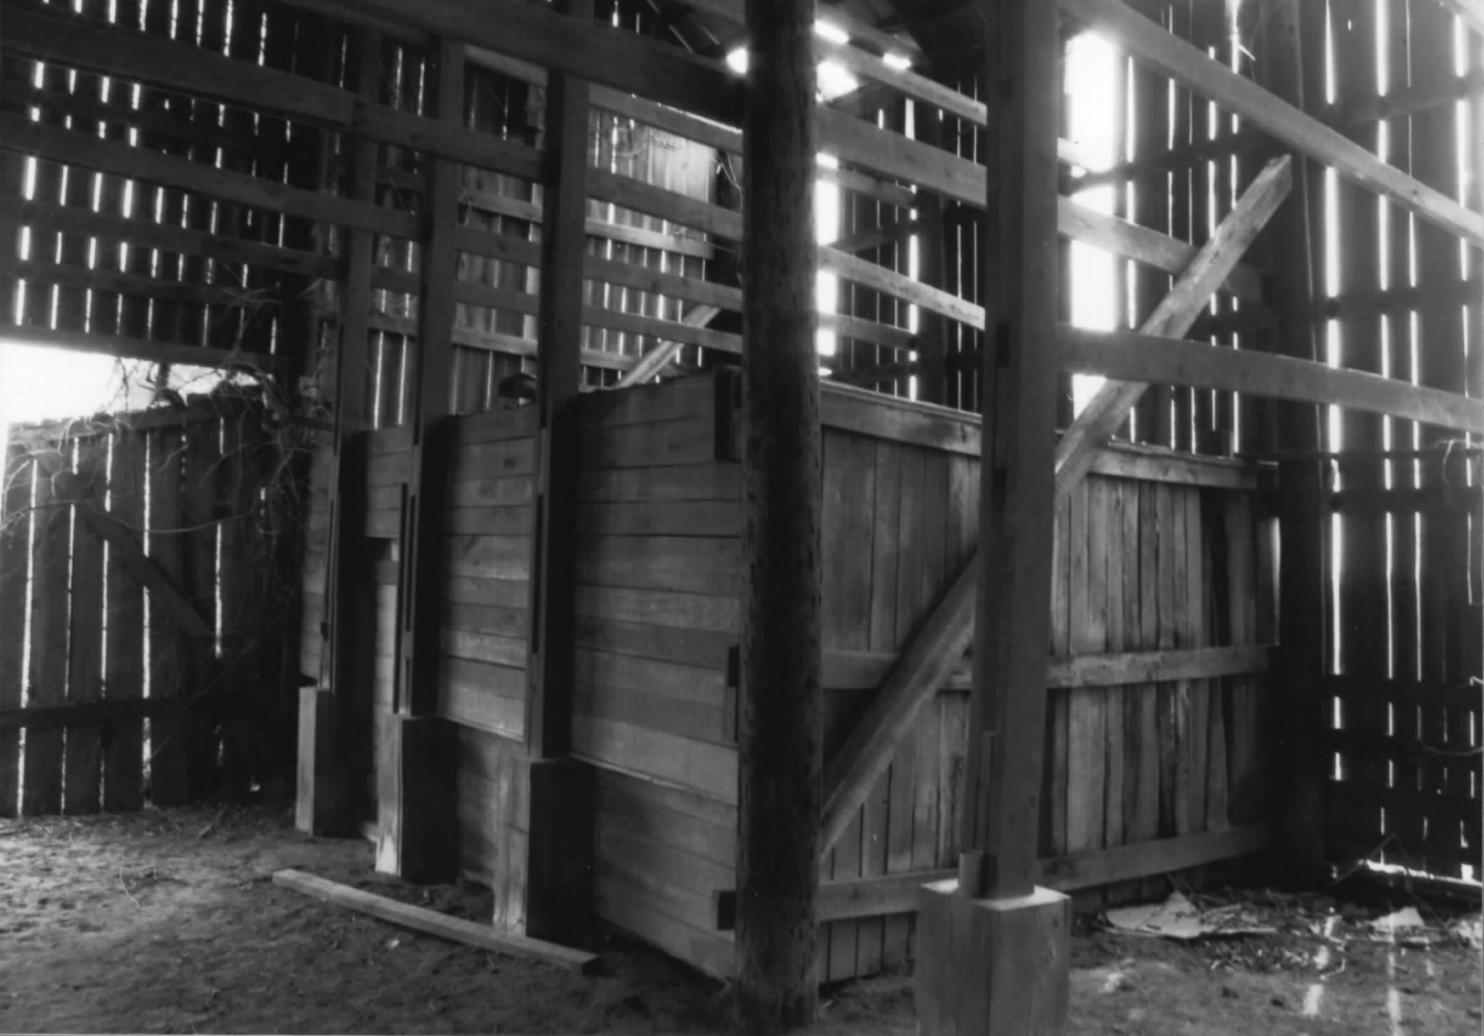
Photo 26 of 28

Stripping shed located in BARN5  
Southwest CORNER

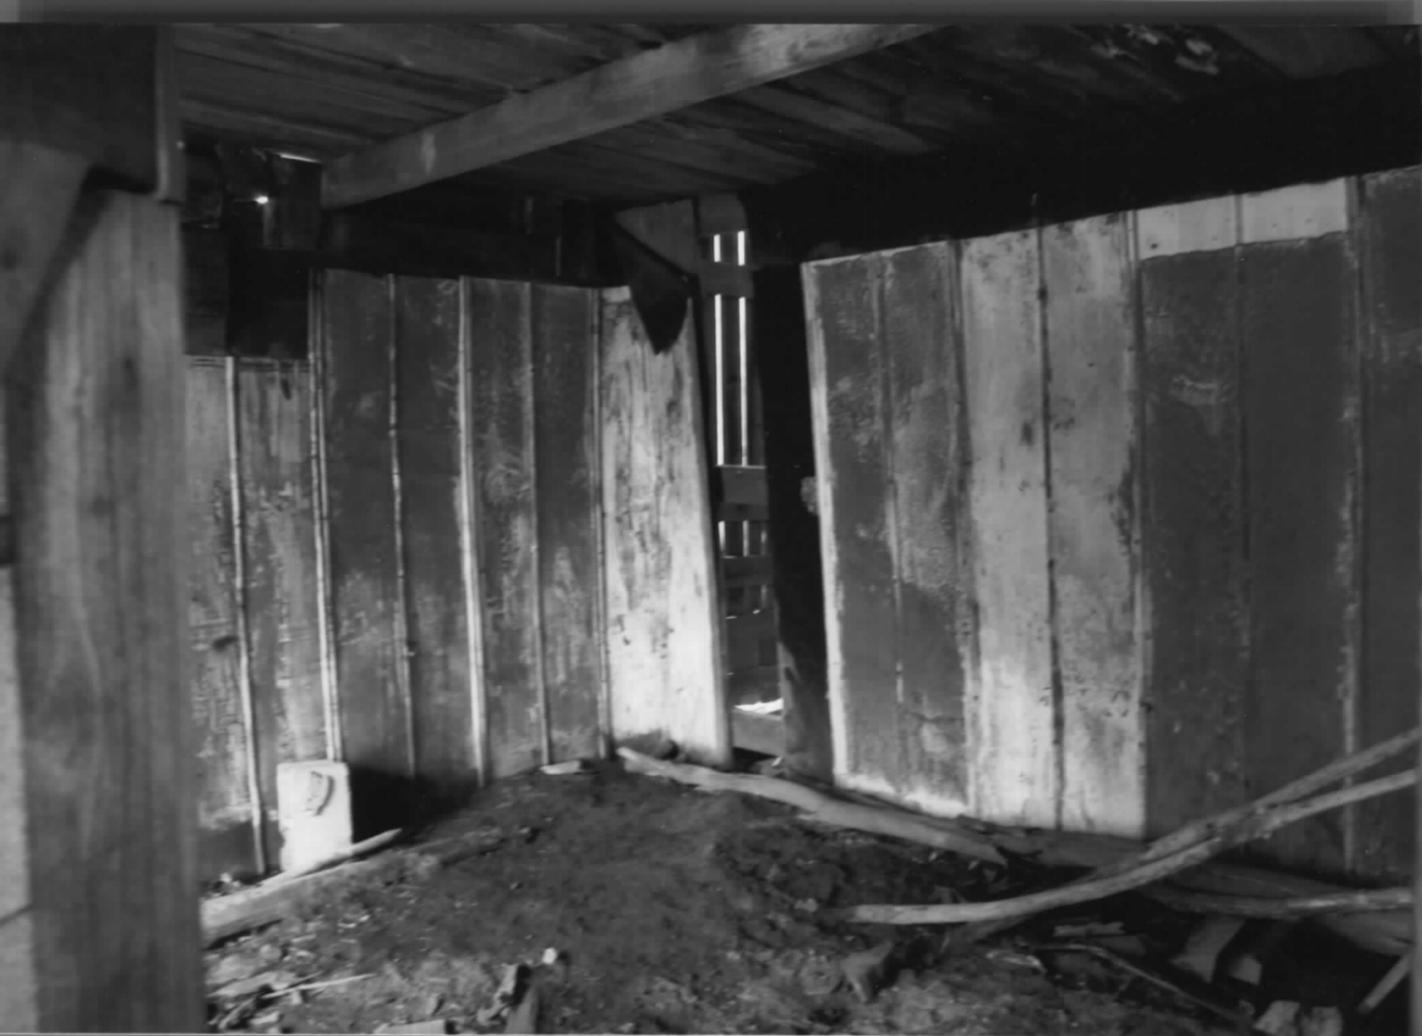
Photo 27 of 28

Stripping shed interior

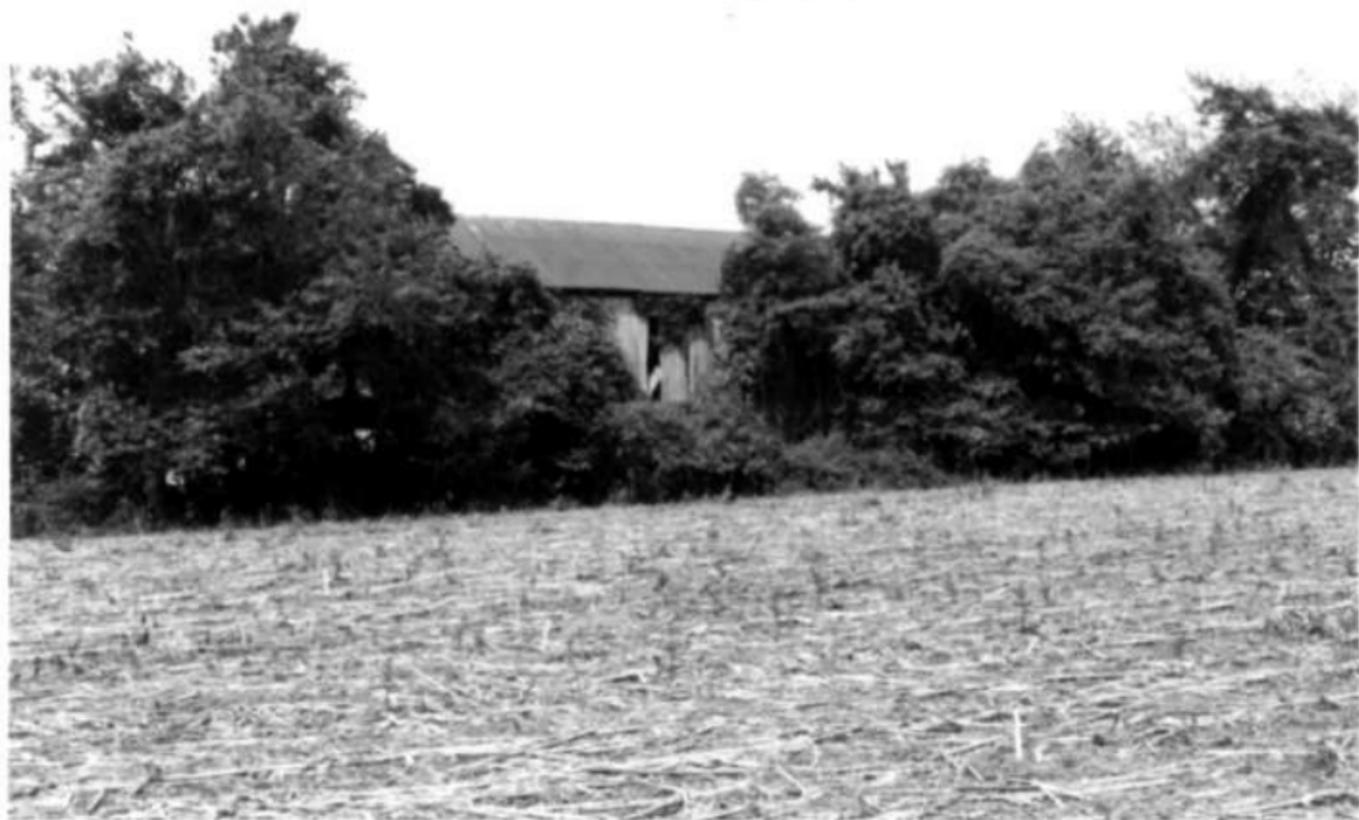
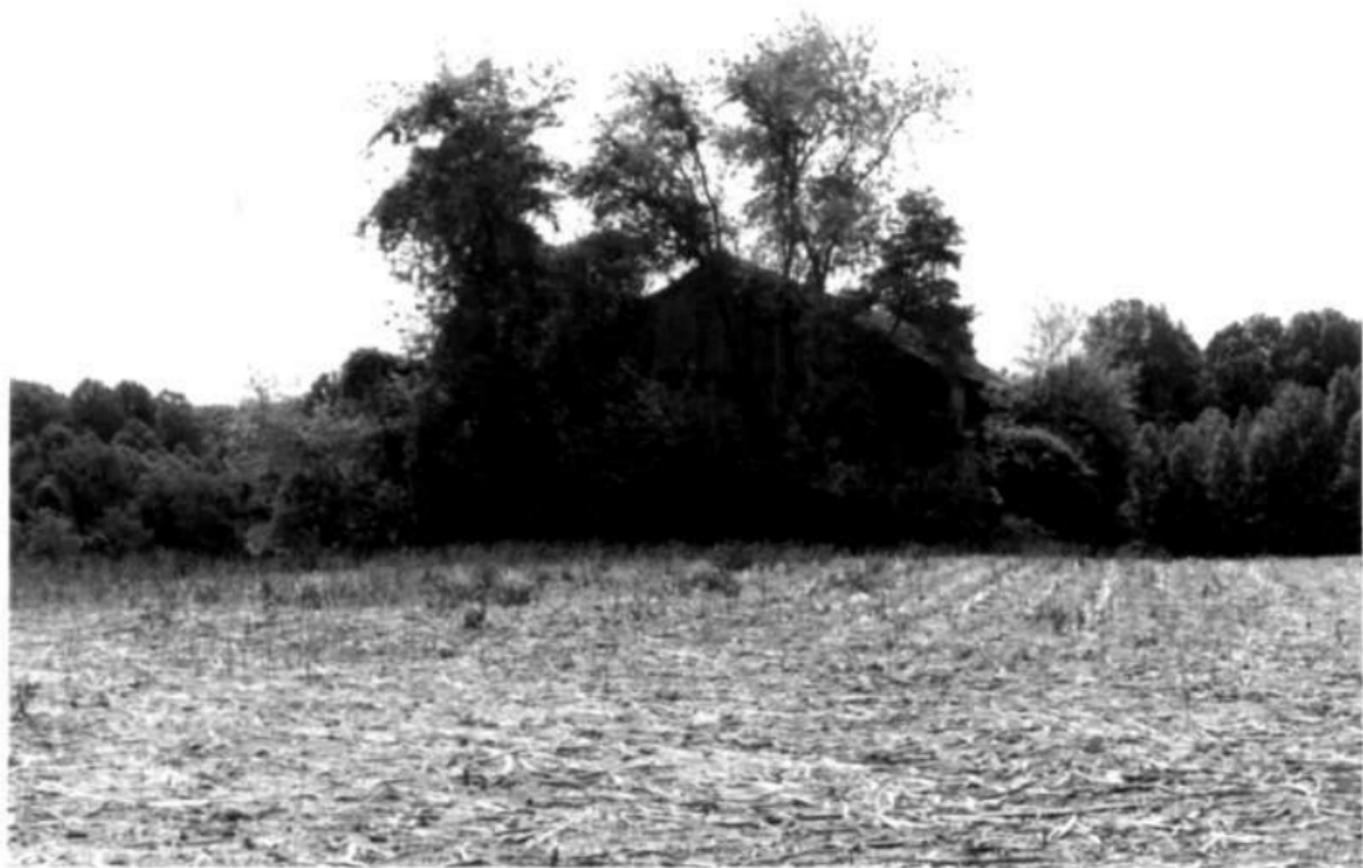
PG: 74B2  
Structure 1 Tobacco Barn  
May 2001 DK. Creveling

Structure 1 is an early to mid twentieth century tobacco barn. It is located in the center of an agricultural field and is overgrown with trees. The barn is 100 by 40 feet and rests on a cinder block foundation. The interior supports rest on poured concrete piers. All lumber is circular sawn and is fastened with wire nails. There is a collapsed cinder block stripping shed attached to the south elevation of the barn.
