**MARYLAND HISTORICAL TRUST  
DETERMINATION OF ELIGIBILITY FORM**

Property Name: Tobacco Barns at W.W.W. Bowie House (site) Inventory Number: PG: 74B-2  
 Address: 17501 Governor's Bridge Road (new) City: Bowie Zip Code: 20716  
 County: Prince George's USGS Topographic Map: Bowie  
 Owner: Maryland National Capital Park & Planning Commission Is the property being evaluated a district? \_\_\_yes  
 56 A#&  
 Tax Parcel Number: 06&21 Tax Map Number: 55E3 Tax Account ID Number: 0796979 & 0801191  
 Project: Green Branch Athletic Complex Bond Bill Agency: Maryland National Capital Park & Planning Commission  
 Site visit by MHT Staff: X no \_\_\_yes Name: \_\_\_\_\_ Date: \_\_\_\_\_  
 Is the property located within a historic district? \_\_\_yes X no

MARYLAND HISTORICAL TRUST  
NR-ELIBILITY REVIEW FORM

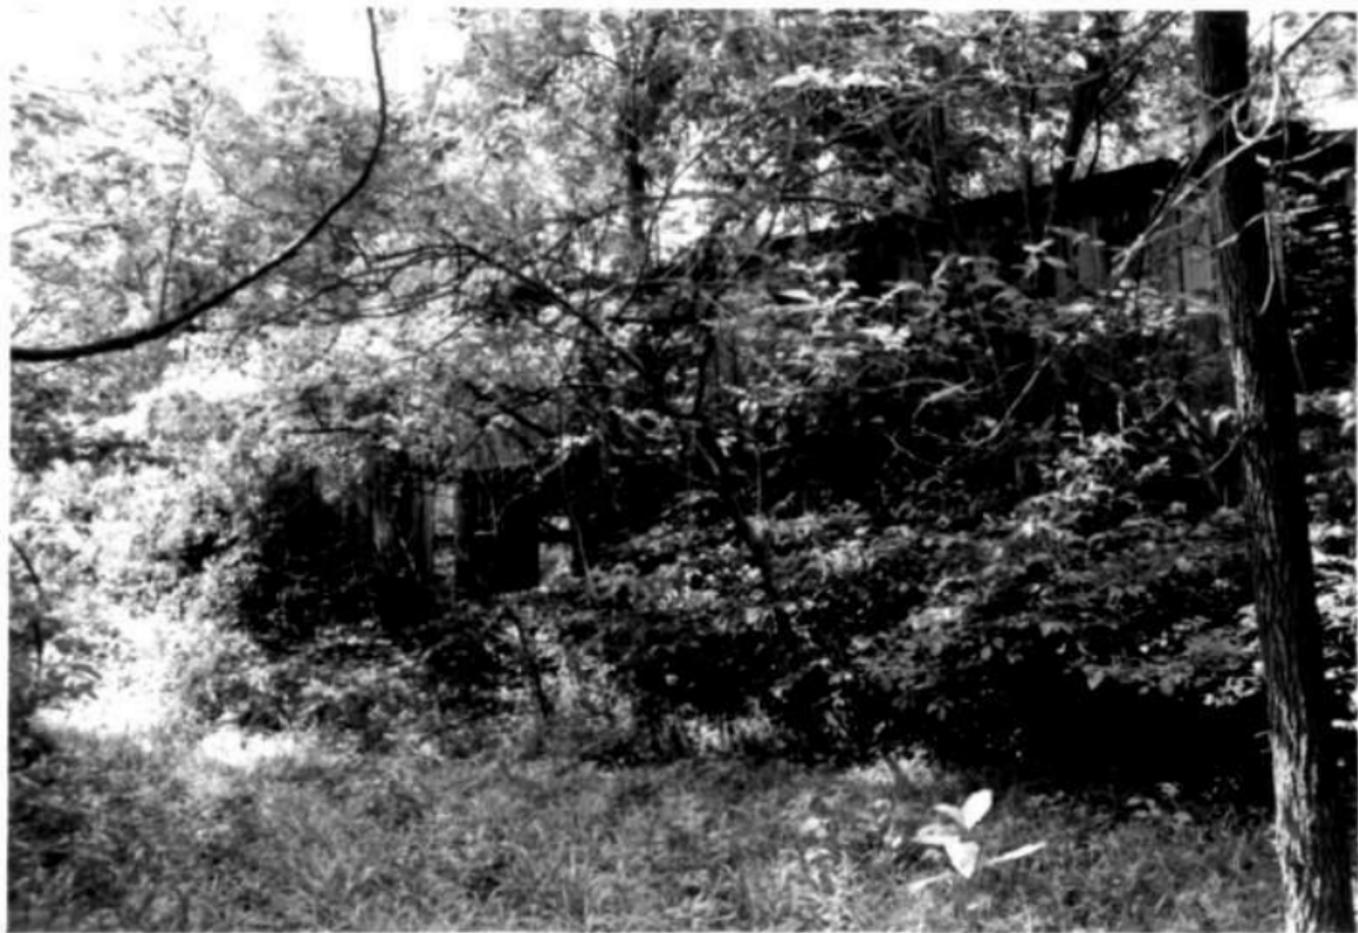
Structure 2 Tobacco Barn

Structure 2 is a mid twentieth century tobacco barn. It is overgrown by trees and is located in a wooded area. It is 60 by 40 feet and rests on a cinder block foundation. The interior supports rest on poured concrete piers. All lumber is circular sawn and is fastened with wire nails.

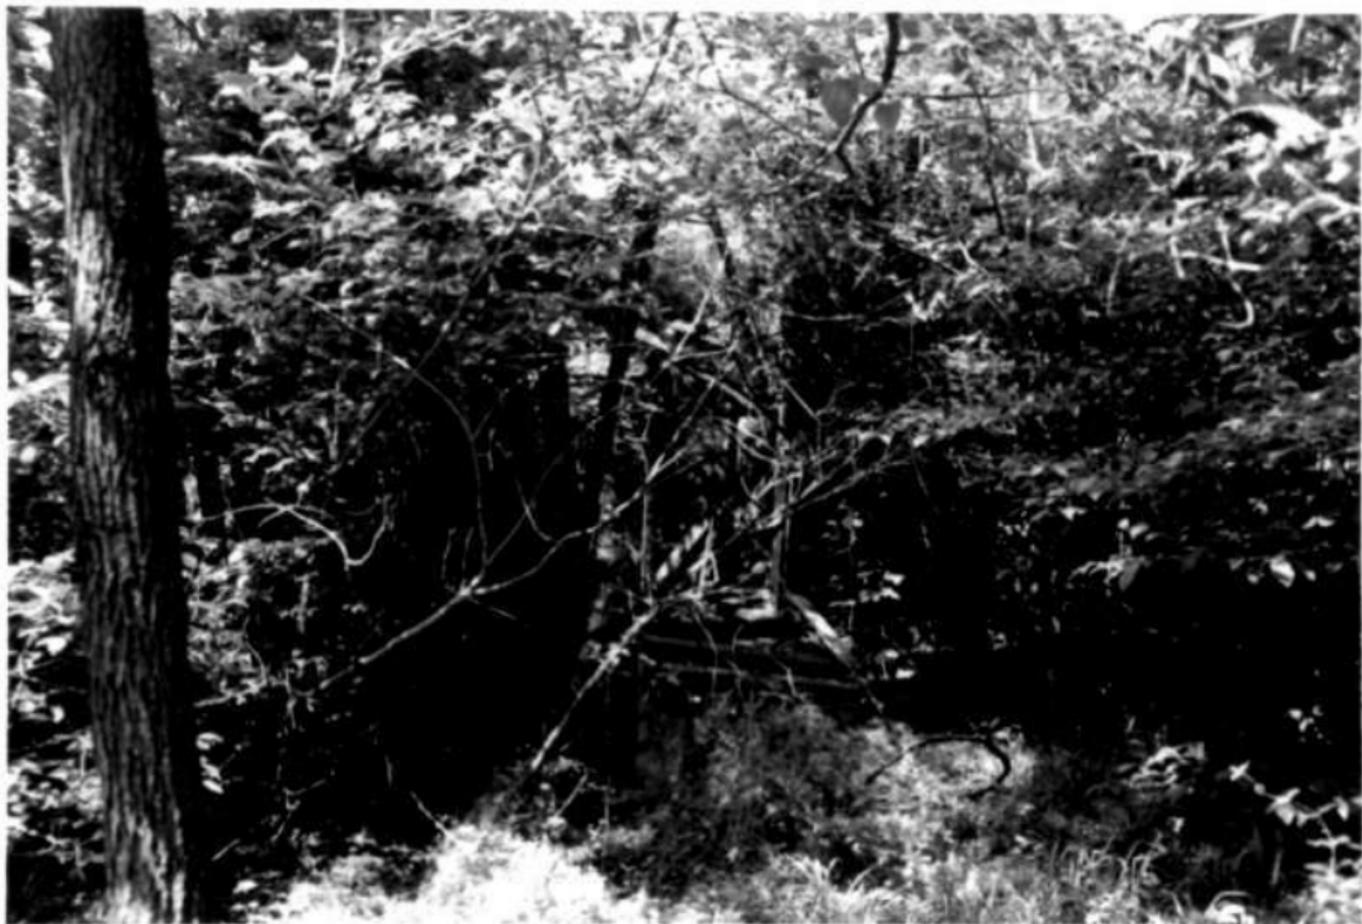
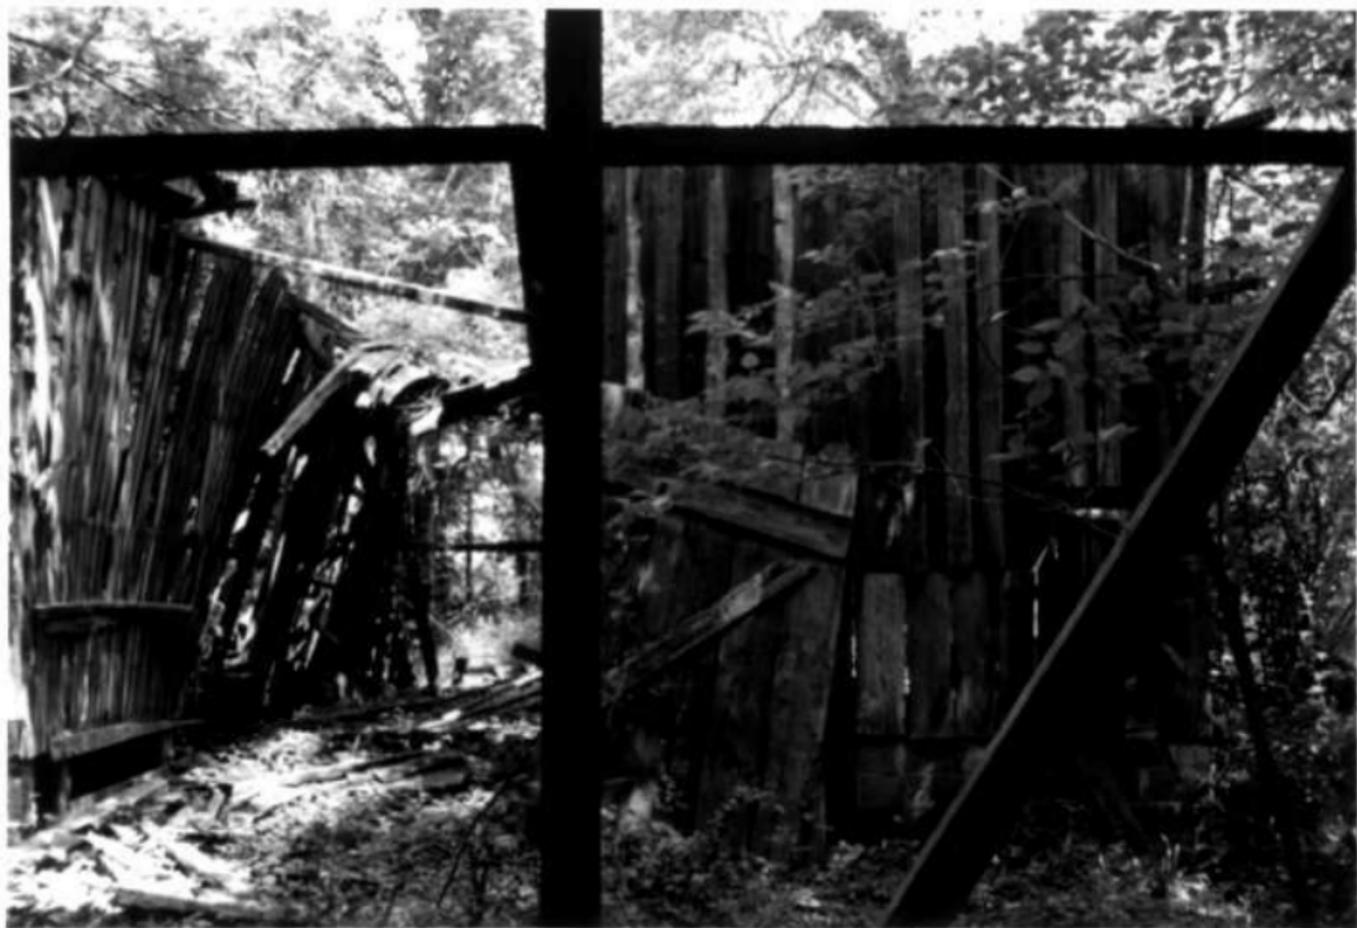
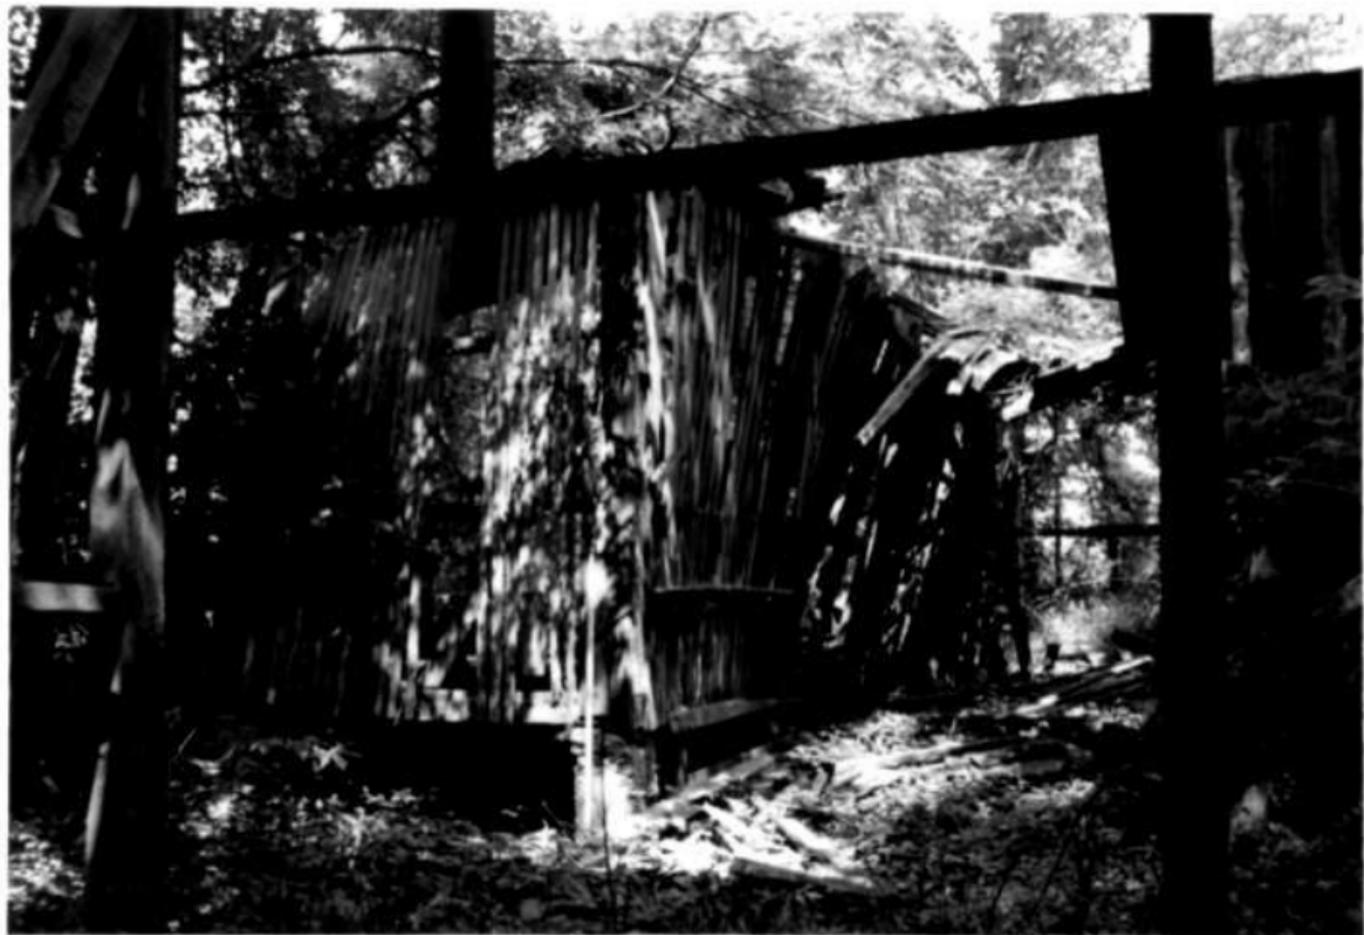
Structure 3 Corn house

Structure 3 appears to be a corn house that has been altered and repaired several times. It is 32 by 24 feet. There is a ten foot wide opening in each gable end. The interior foundation of the north half of the structure is two feet tall and is constructed of limonite (ironstone). The rest of the structure rests on concrete piers and cinder block. There is some hand worked lumber, however, the majority of the lumber is circular sawn. The roof is collapsed and the structure is very unstable.

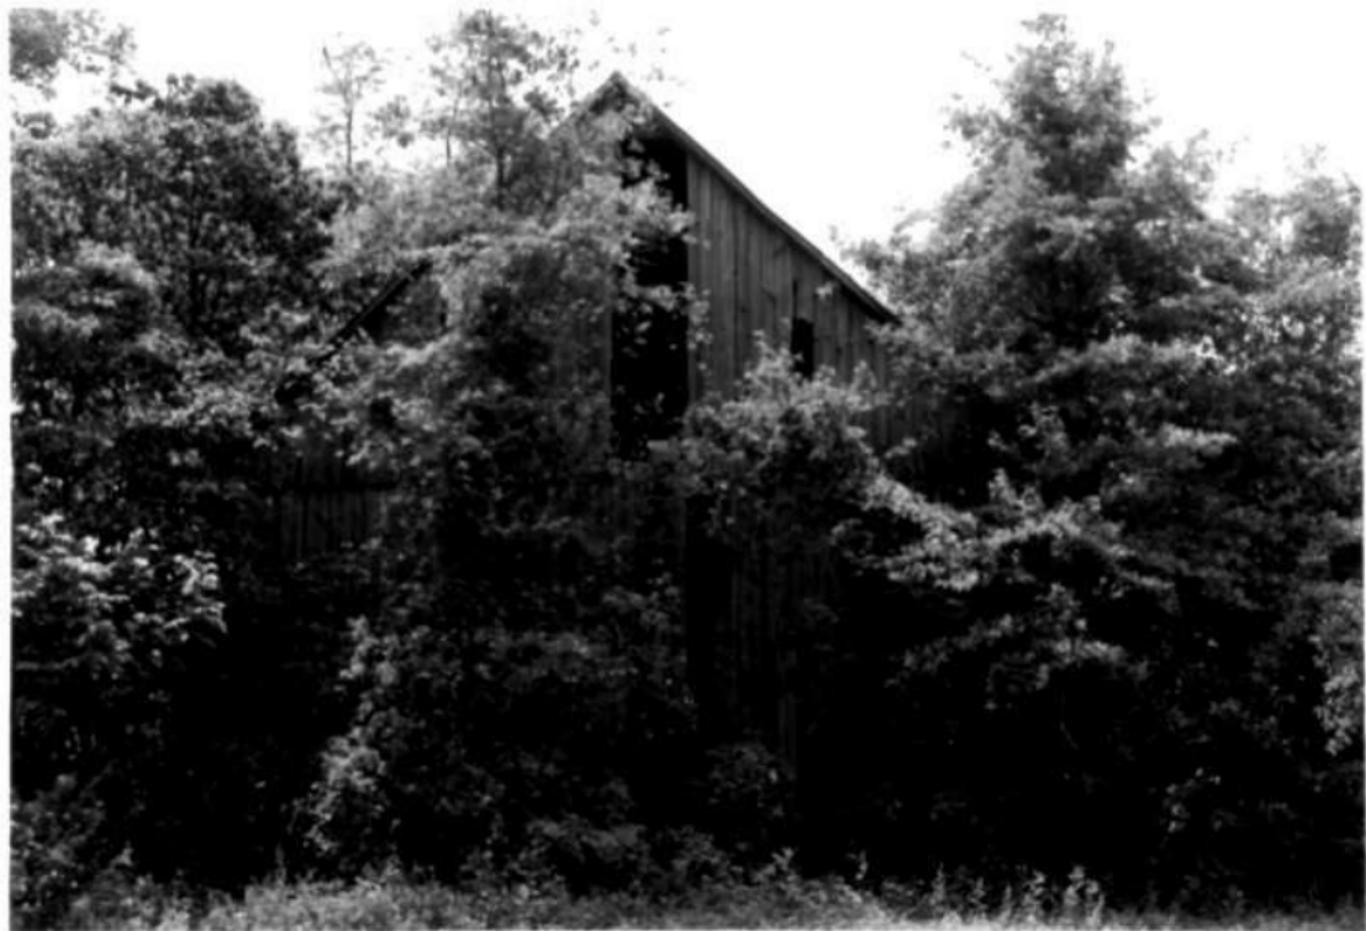
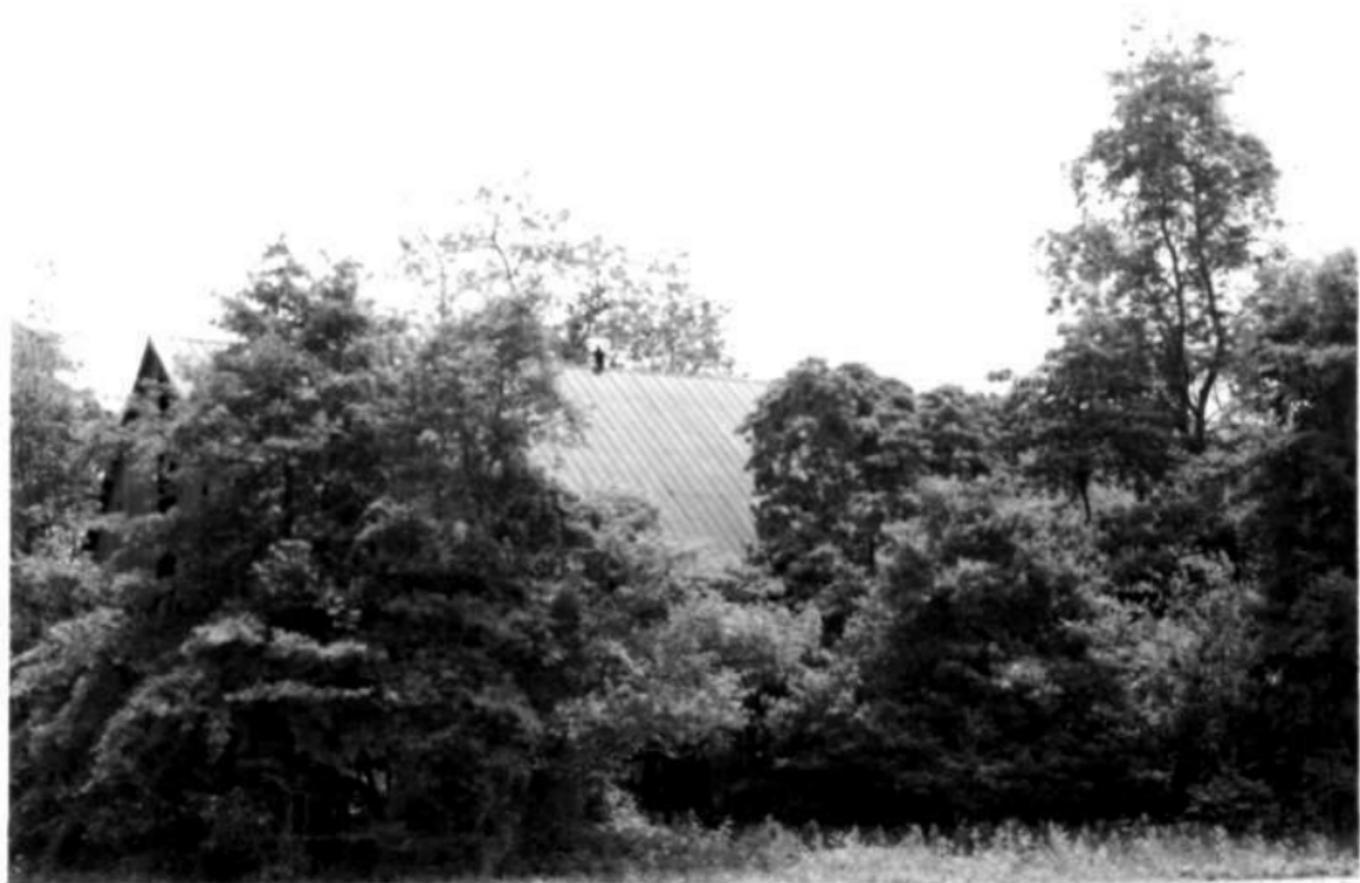
Structure 4 Tobacco Barn

Structure 4 is a mid-twentieth century tobacco barn that appears to have been built in three sections. It is 140 by 40 feet. The barn rests on both poured concrete and cinder block foundations. The interior supports rest on poured concrete piers, cinder blocks, and blocks of limonite. There is a 30 by 20 foot collapsed stripping house attached to the east side of the barn.

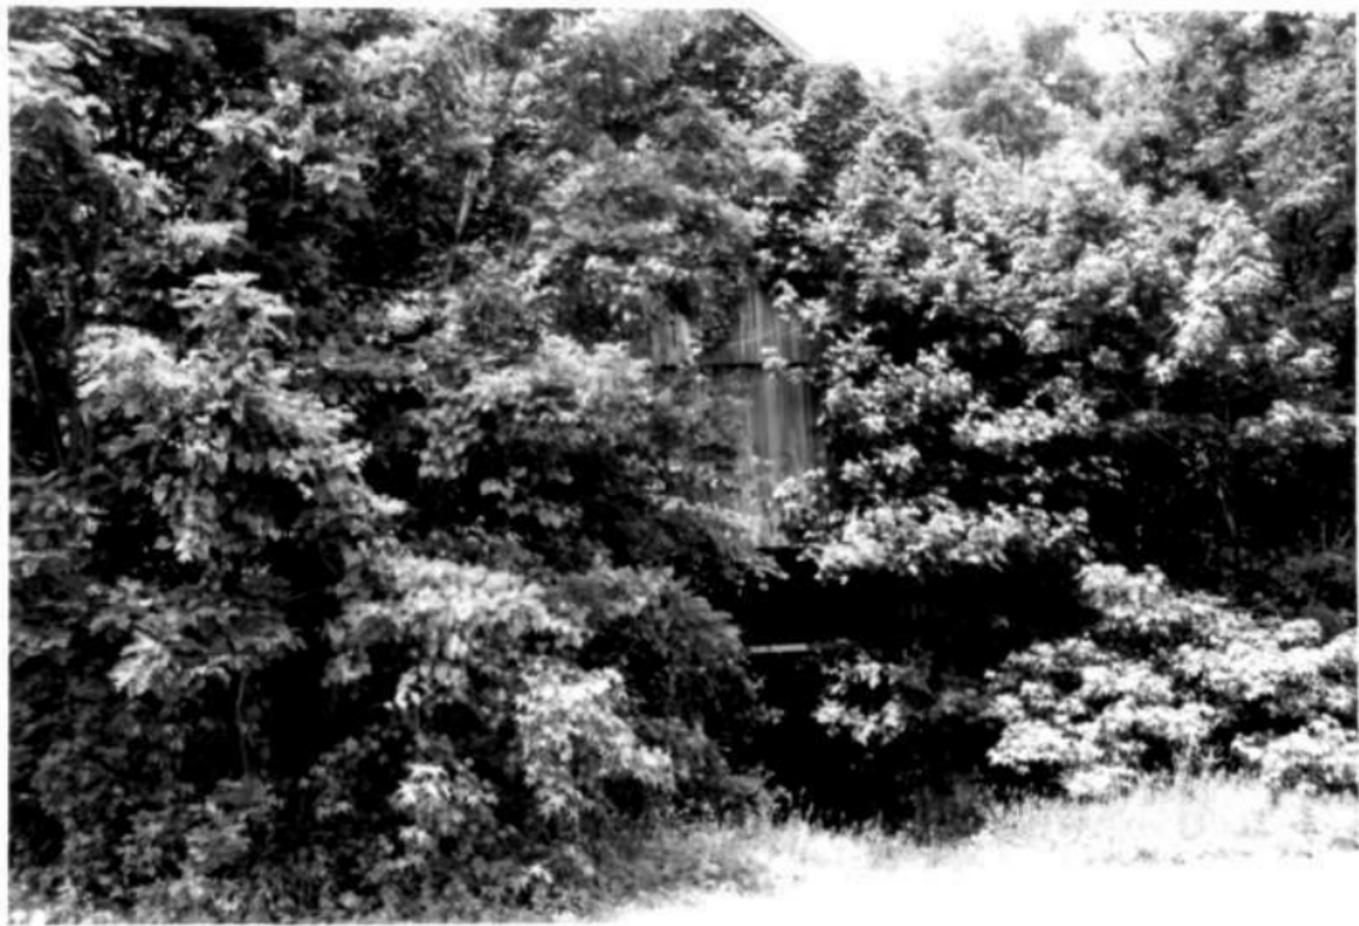
Structure 7 Tobacco Barn

Structure 7 is a mid twentieth century tobacco barn. It is 100 by 36 feet. The barn rests on a cinder block foundation. The interior support posts rest on poured concrete piers. All lumber is circular sawn and is fastened with wire nails.
