**MARYLAND HISTORICAL TRUST
DETERMINATION OF ELIGIBILITY FORM**

Property Name: Walter & Emma Entzian Farm Inventory Number: PG: 74B-62
 Address: 18509 Central Avenue (MD 214) Historic district: yes no
 City: Upper Marlboro Zip Code: 20774 County: Prince Georges
 USGS Quadrangle(s): Bowie
 Property Owner: City of Bowie Tax Account ID Number: multiple
 Tax Map Parcel Number(s): multiple Tax Map Number: 71
 Project: Intercounty Connector, REF-21 Agency: SHA
 Agency Prepared By: ICC Team
 Preparer's Name: Elizabeth Roman Date Prepared: 3/22/2011
 Documentation is presented in: _____
 Preparer's Eligibility Recommendation: Eligibility recommended Eligibility not recommended
 Criteria: A B C D Considerations: A B C D E F G
Complete if the property is a contributing or non-contributing resource to a NR district/property:
 Name of the District/Property: _____
 Inventory Number: _____ Eligible: yes Listed: yes
 Site visit by MHT Staff yes no Name: _____ Date: _____

Walter & Emma Entzian Farm, MIHP No. PG:74B-62
18509 Central Avenue, Upper Marlboro, Prince George's County

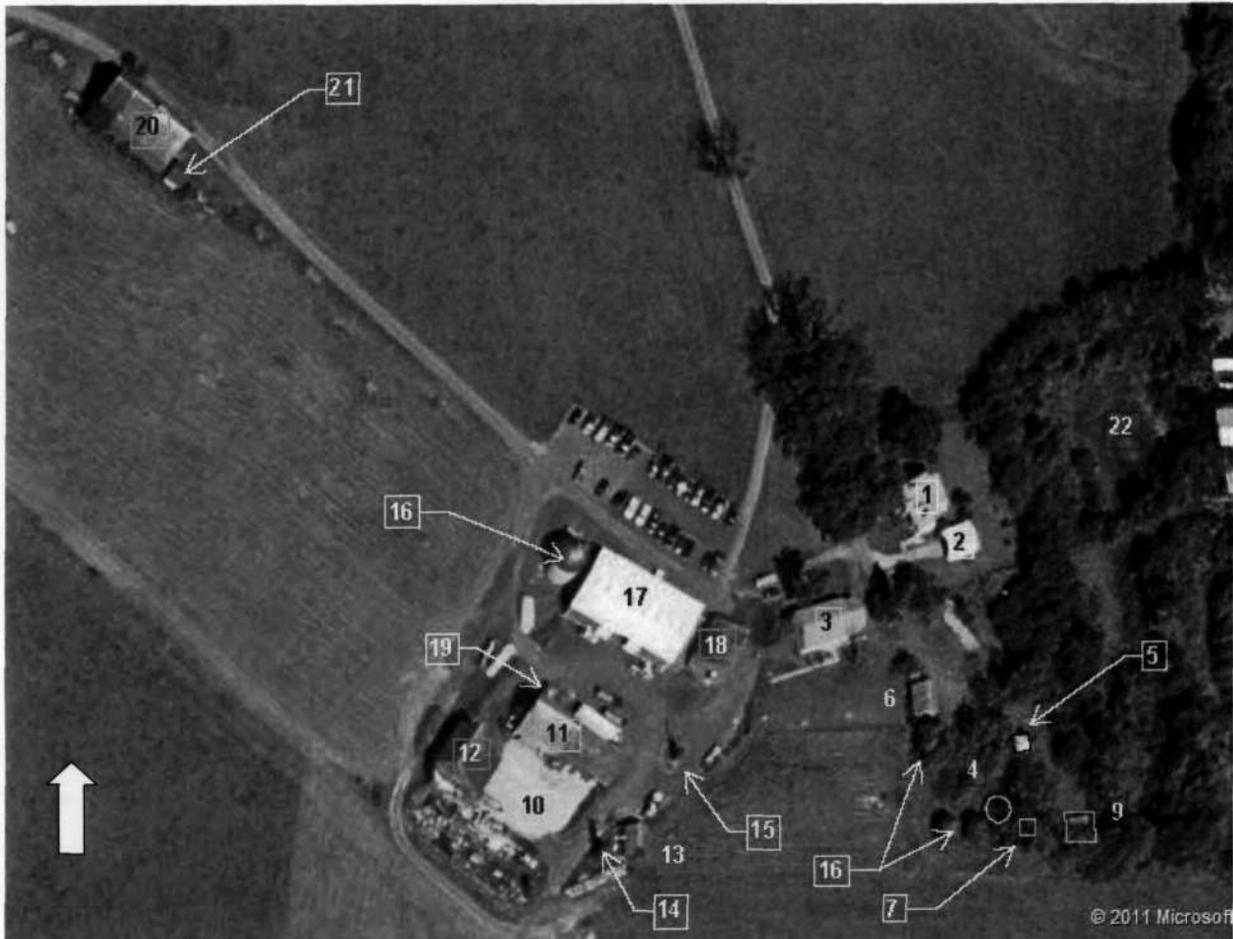
Site Plan

The farmstead is situated along the east property line, several hundred yards south of Central Avenue. The farmstead (Photo 1) contains two dwellings, six domestic outbuildings, two barns, ten agricultural outbuildings and structures, three modern storage buildings, and a farm pond in two adjoining clusters. A tobacco barn and stripping shed are located north of the farmstead. The property is accessed by a farm lane that runs south from the road, past the tobacco barn, through the farmstead, and into the fields to its south. The original farm lane extends north from the two dwellings, but has been cut-off from Central Avenue.

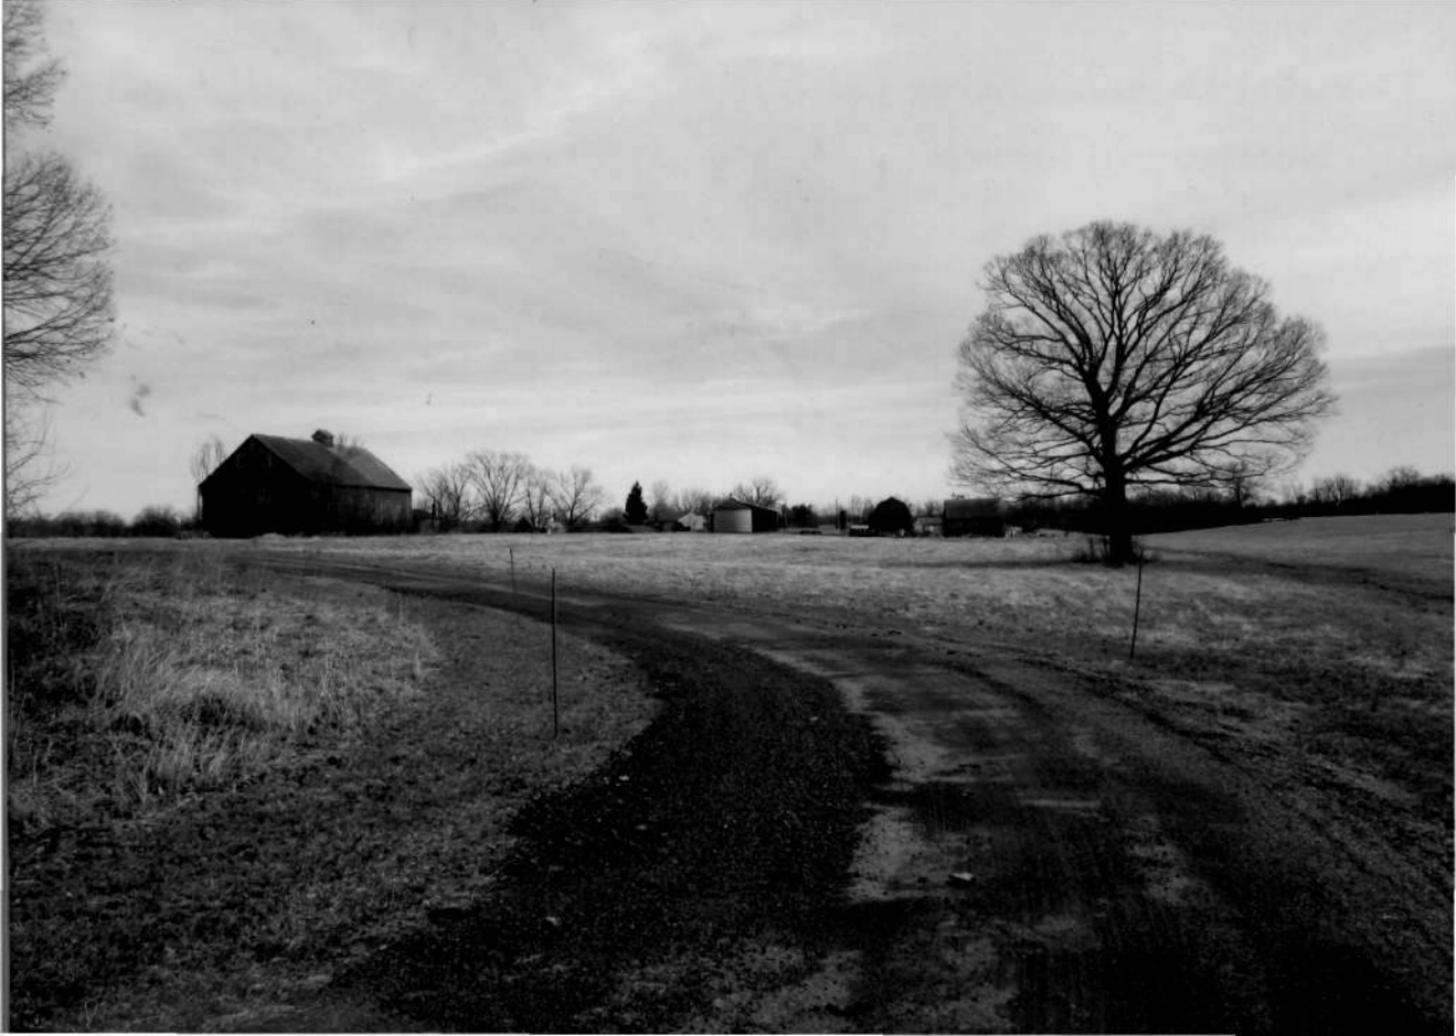
PG-74B-62-2011-3-9-01

View facing south from farm lane towards the farmstead.
PG-74B-62_2011-3-9_01

View facing South from farm lane towards
the farmstead

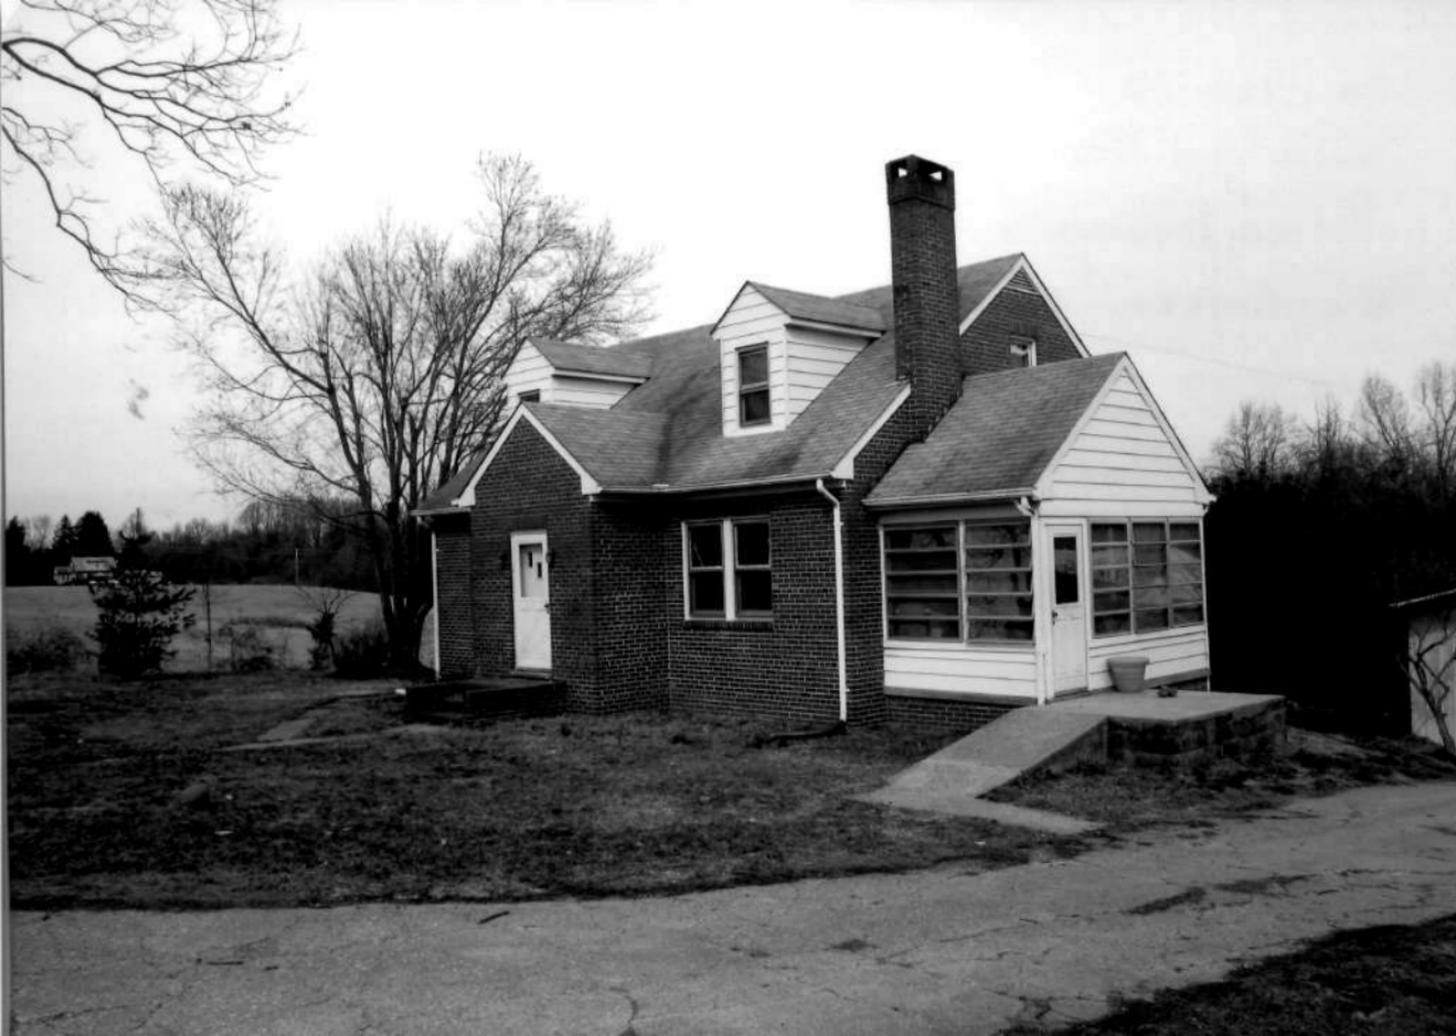
buildings. With the exception of the two dwellings, all the buildings and structures in this cluster are in a ruinous condition and overgrown with vegetation due to years of abandonment. Dwelling 1 (Photo 2) is a Cape Cod of brick construction built in 1949 (Tax Records). It faces southeast across the farm lane towards the barn complex. The 1-1/2 story building measures three bays wide by two rooms deep. It has an asphalt-shingled side gable roof with two gabled front dormers and full-width shed rear dormer. It has double-hung wooden windows, flush wood entrance doors, and wrapped plain trim. A gable-roofed sun porch with aluminum siding and jalousie windows extends off the southeast elevation. An exterior brick chimney is also found on the southeast elevation. A front-gable two-car Garage (Photo 3) of frame construction on a slab foundation with steel siding and roofing is located off the southeast rear corner of Dwelling 1.

Cape Cod Dwelling, west (façade) and south elevations. View faces northeast.
PG-74B-62_2011-3-9_02

Cape Cod Dwelling, West & South Elevations

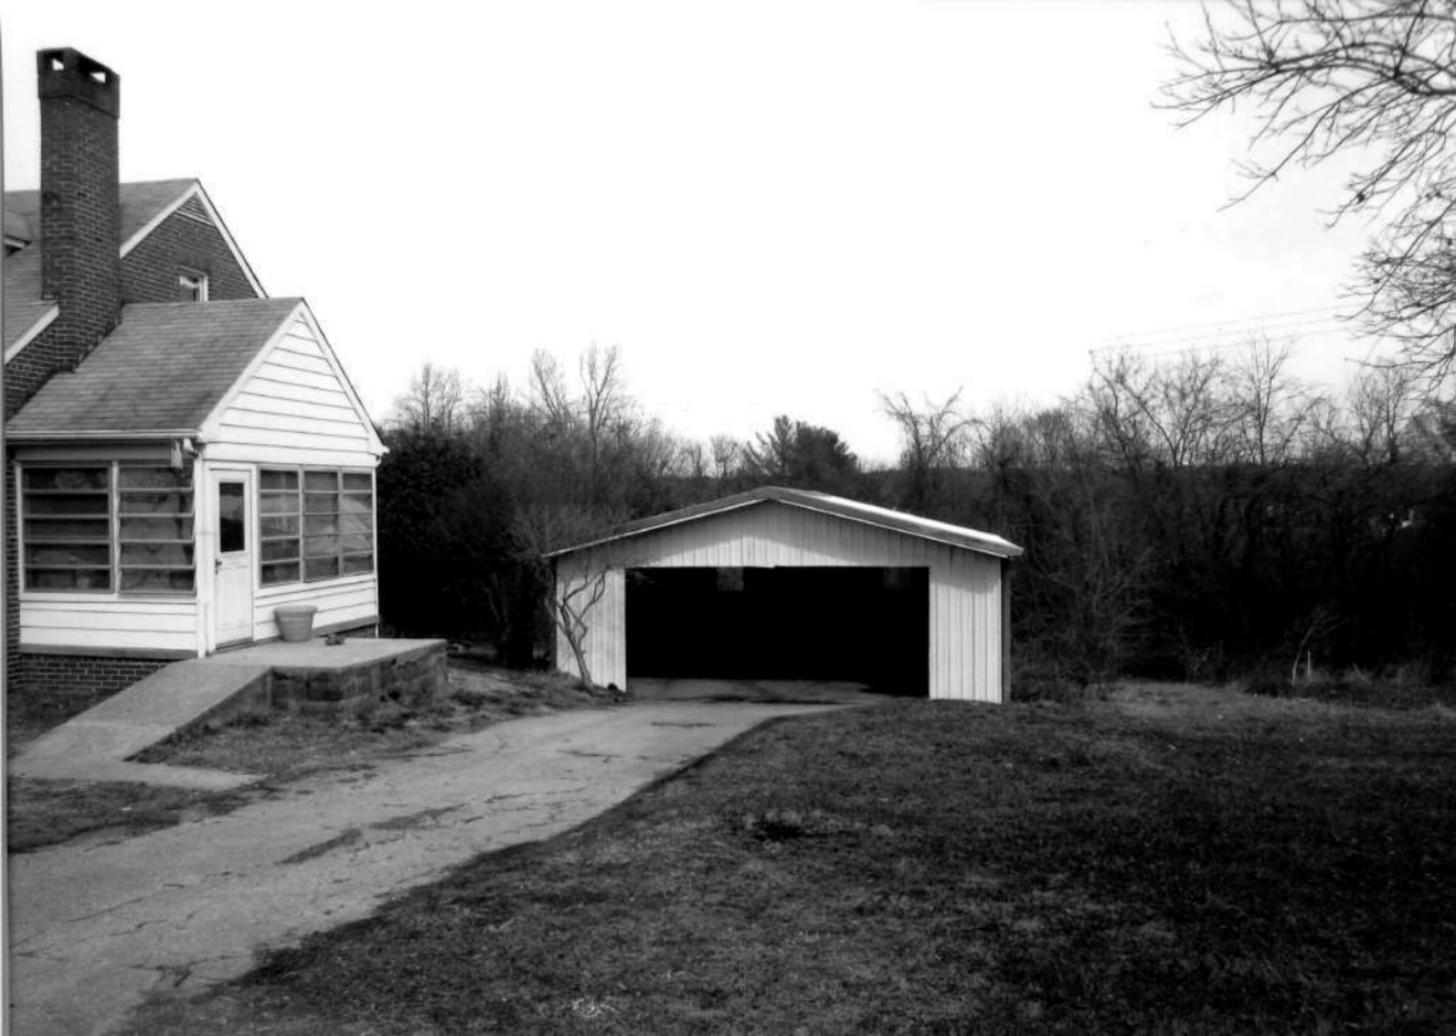
PG-74B-62 - 2011-3-9 - 03

Garage, west (façade) elevation. View faces east.
PG-74B-62_2011-3-9_03

Garage, west elevation

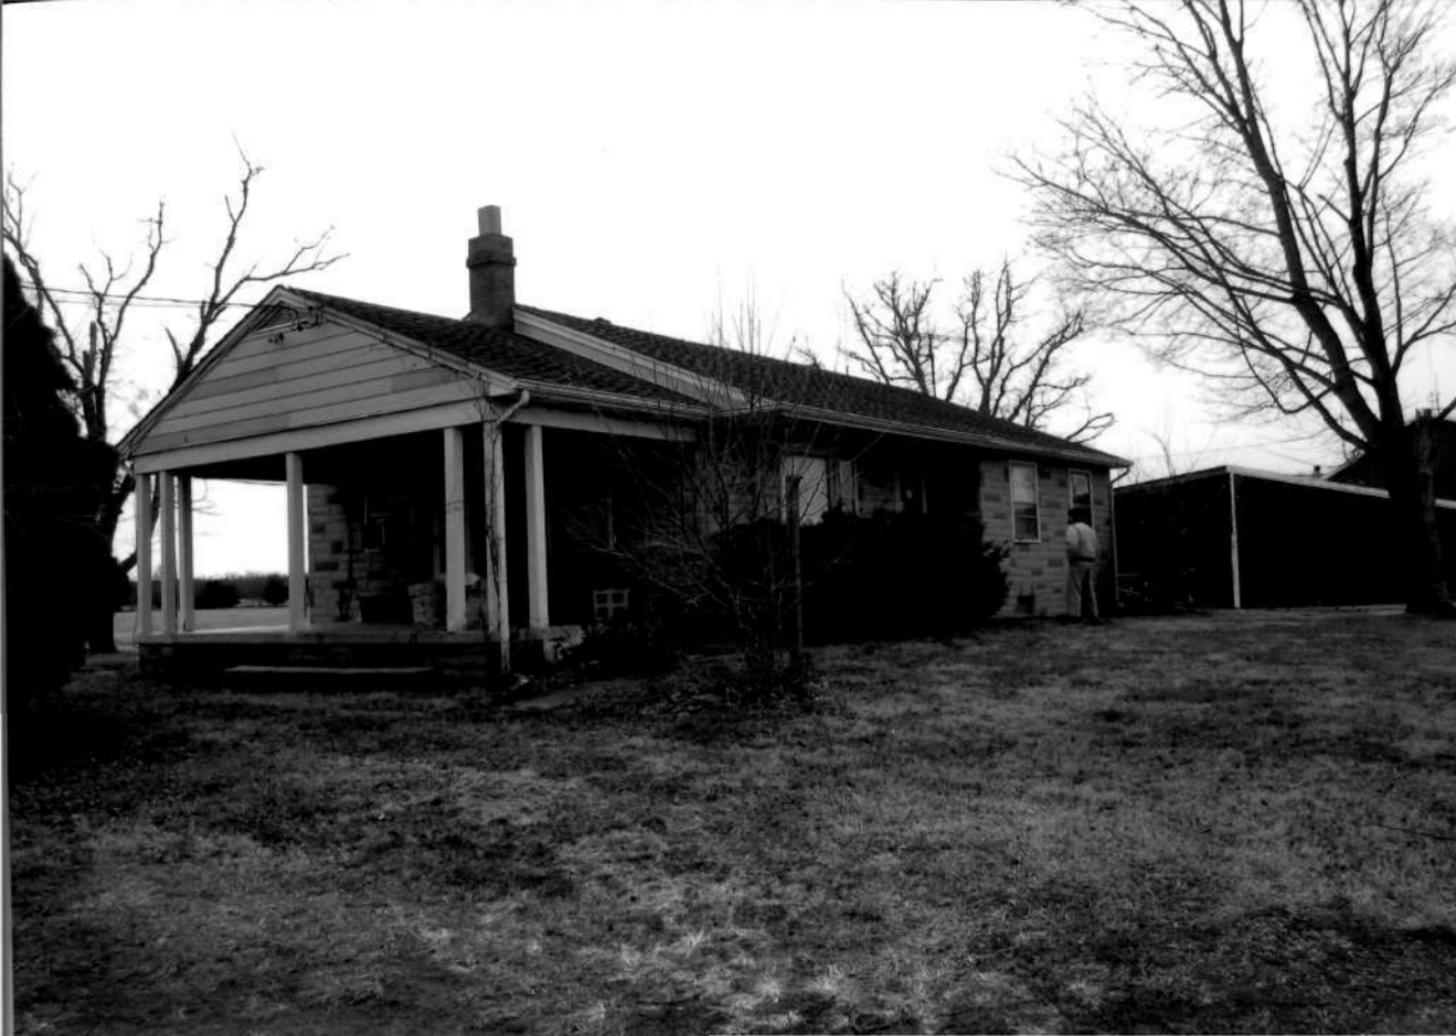
PG-74B-62-2011-3-9-04

Dwelling 2 (Photo 4) is located to the southwest of the Cape Cod facing northwest up the original farm lane. This Ranch style dwelling was built in 1962 (Deeds and Tax Records) of masonry construction with stone veneer. The 1-story building measures four bays wide by two rooms deep. It has a low pitched side gable roof with asphalt shingles and closed cornice. It has horizontal 2/2 double hung wood windows, flush wood entrance doors, wrapped trim, and exterior brick chimney. It has a Chicago style window and centered entrance with slate stoop on the northwest-facing façade. A gable-roofed porch with square columns and slab floor extends off the northeast elevation.

Ranch Dwelling, east and north (façade) elevations. View faces southwest.
PG-74B-62_2011-3-9_04

Ranch Dwelling, east & north elevations

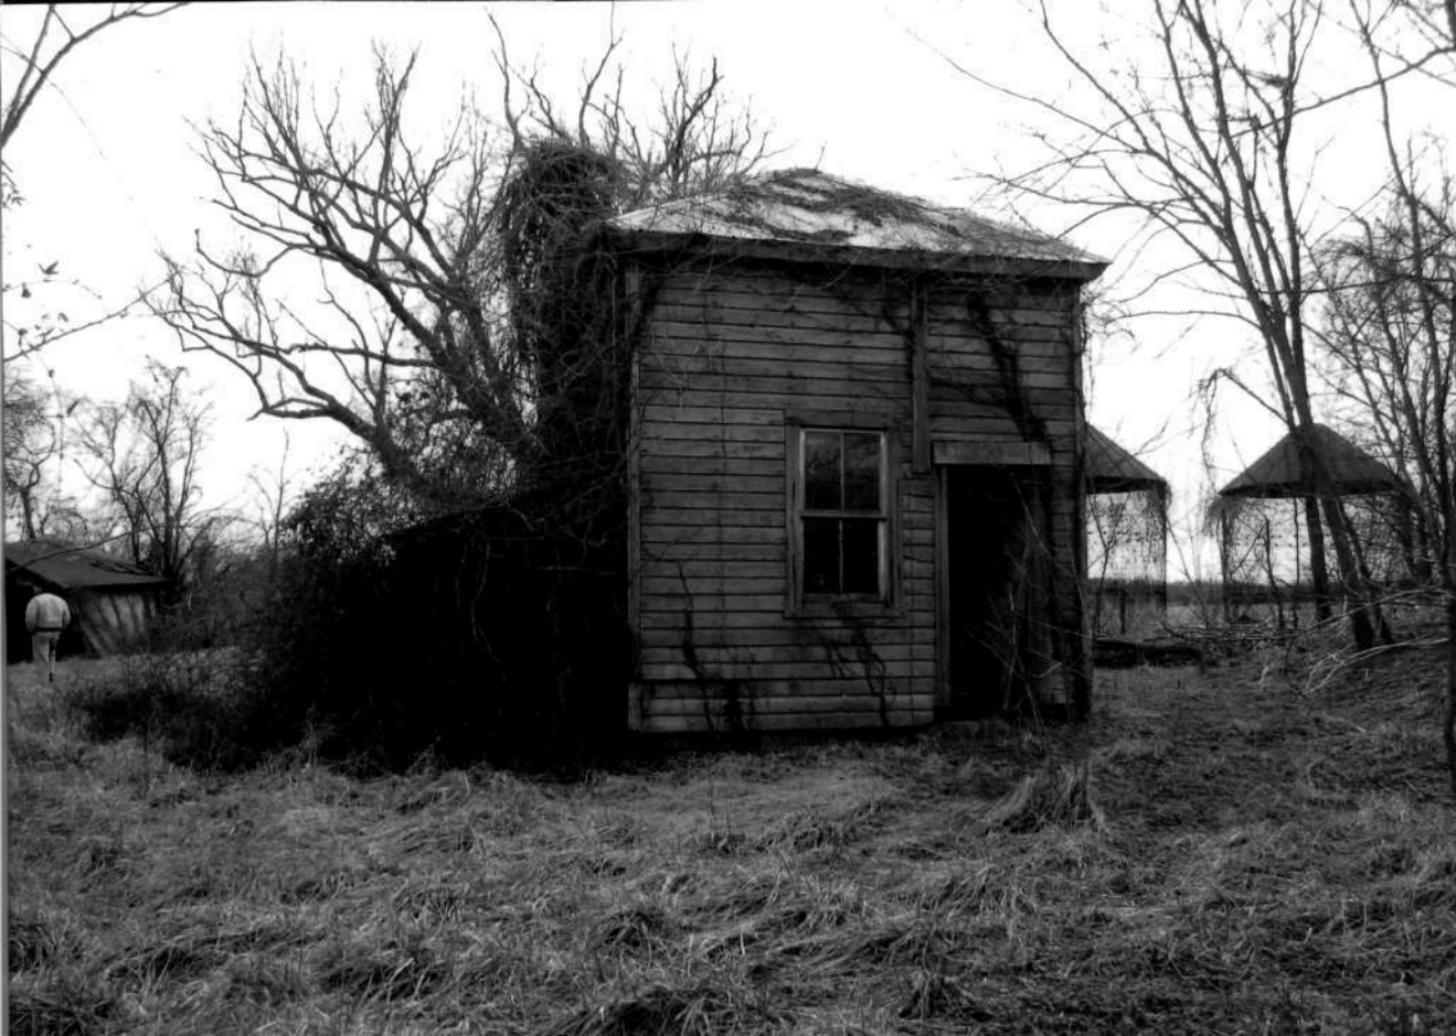
Summer Kitchen, east and north (façade) elevations. View faces south-southwest.
PG-74B-62_2011-3-9_06

Summer Kitchen, east & north elevations

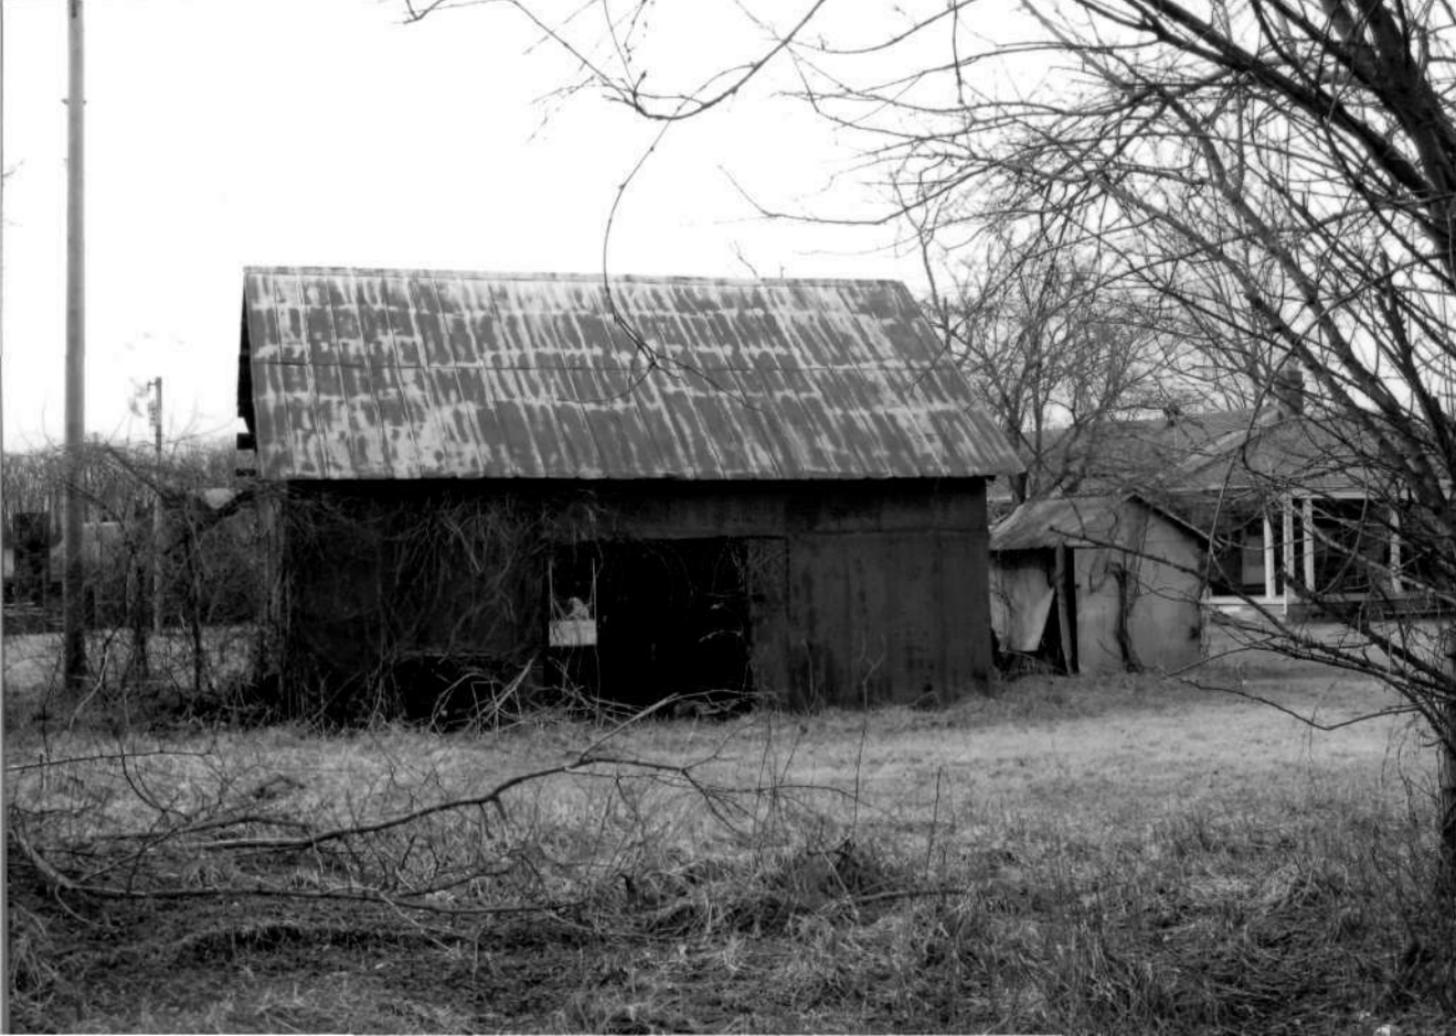
PG-74B-62-2011-3-9_07

Between the Cellar and Dwelling 2 are the Wood Shed and Smokehouse (Photo 7), both built circa 1950s. The Wood Shed is a single pen 1-story side-gable building of frame construction with plywood siding, and standing seam metal roofing. Resting on the ground surface, it has open entrance centered on its east elevation. The Smokehouse is a small single pen building of frame construction resting on a concrete slab. It has sheet metal for its siding and roofing and also lining its interior walls. A single door enters from the east elevation.

Wood Shed and Smokehouse, south and east (façade) elevations. View faces west-northwest.
PG-74B-62_2011-3-9_07

Wood Shed and Smokehouse, south & east elevations

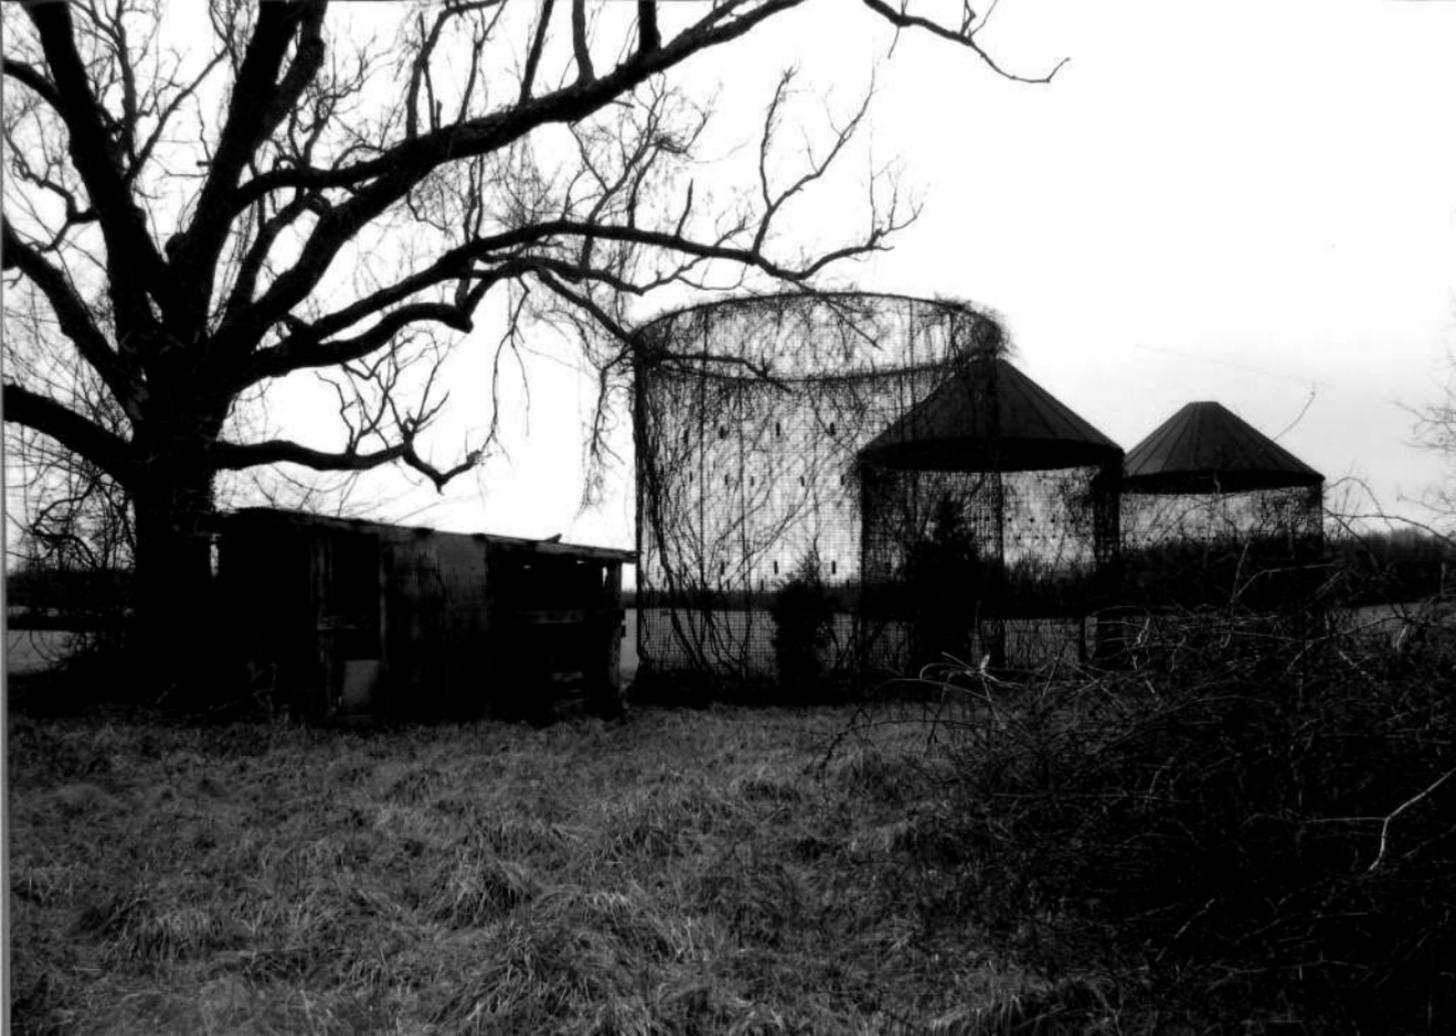
A row of structures are situated south of the Cellar, Wood Shed and Smokehouse, along the north edge of the fields at the south of the property. These include: a frame Shed (Photo 9) with plywood sheathing and roof; four wire Corn Cribs (Photo 9); and a front-gable Tractor Shed (Photo 10) of frame construction with corrugated metal siding and roofing. All these structures date from the 1950s and early 1960s, as they appear on the 1965 aerial of the region.

Shed and Corn Cribs. View faces southwest.
PG-74B-62_2011-3-9_09

Shed and Corn Cribs, facing southwest

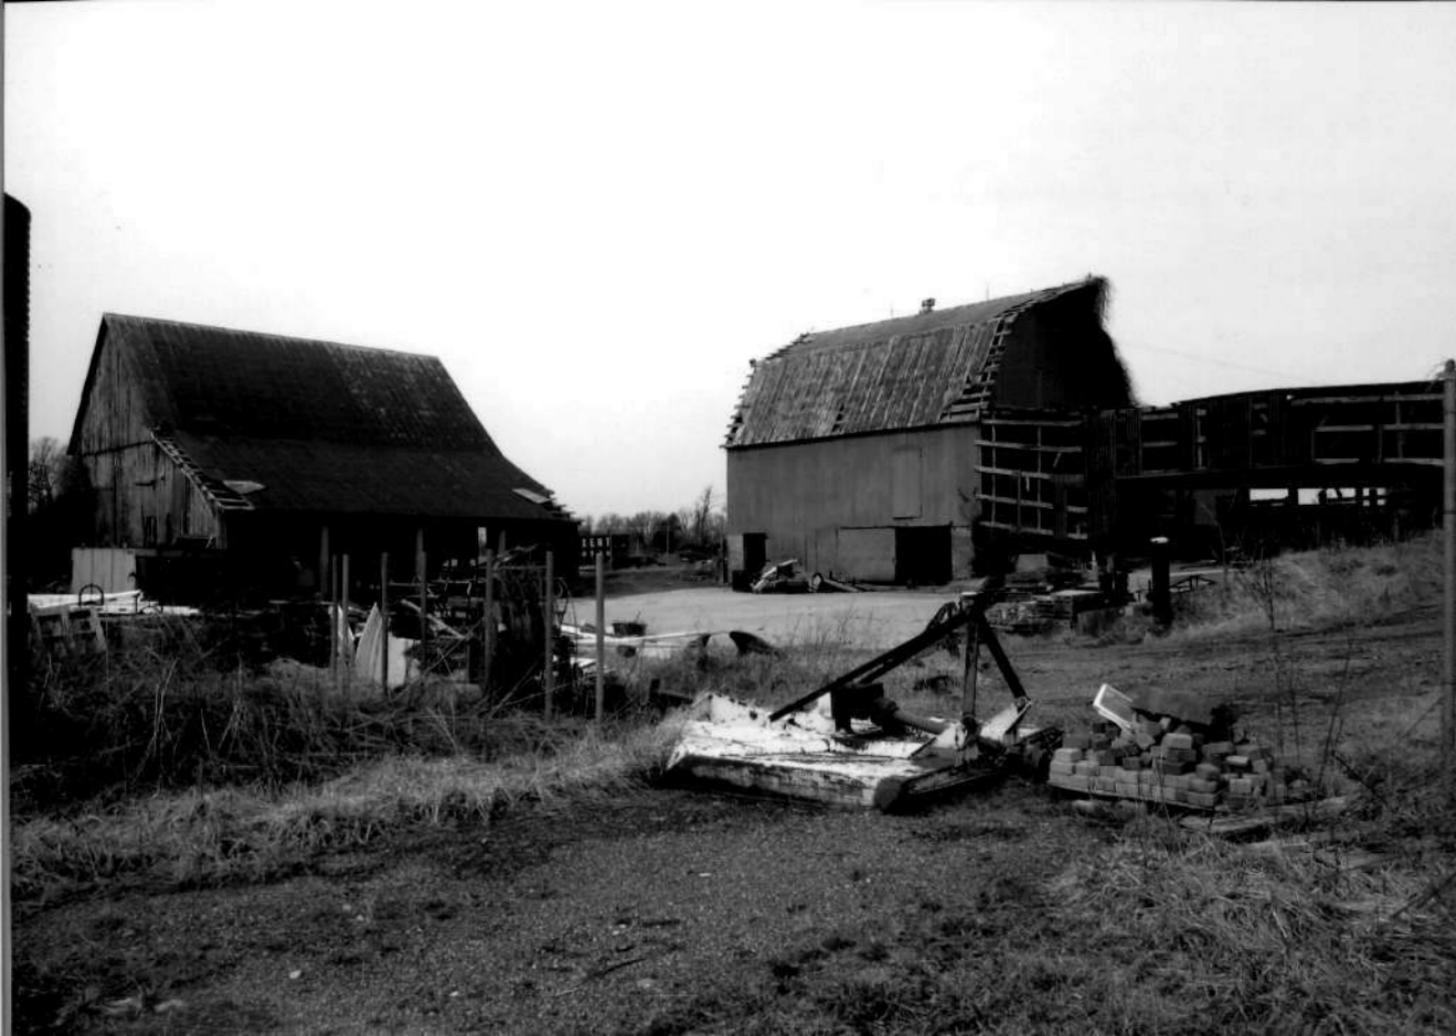
PG-74B-62-2011-3-9-10

View of Barnyard, Barn/Stable and Bank Barn, facing northeast.
PG-74B-62_2011-3-9_10

View of Barnyard, Barn/Stable and Bank Barn,
facing northeast

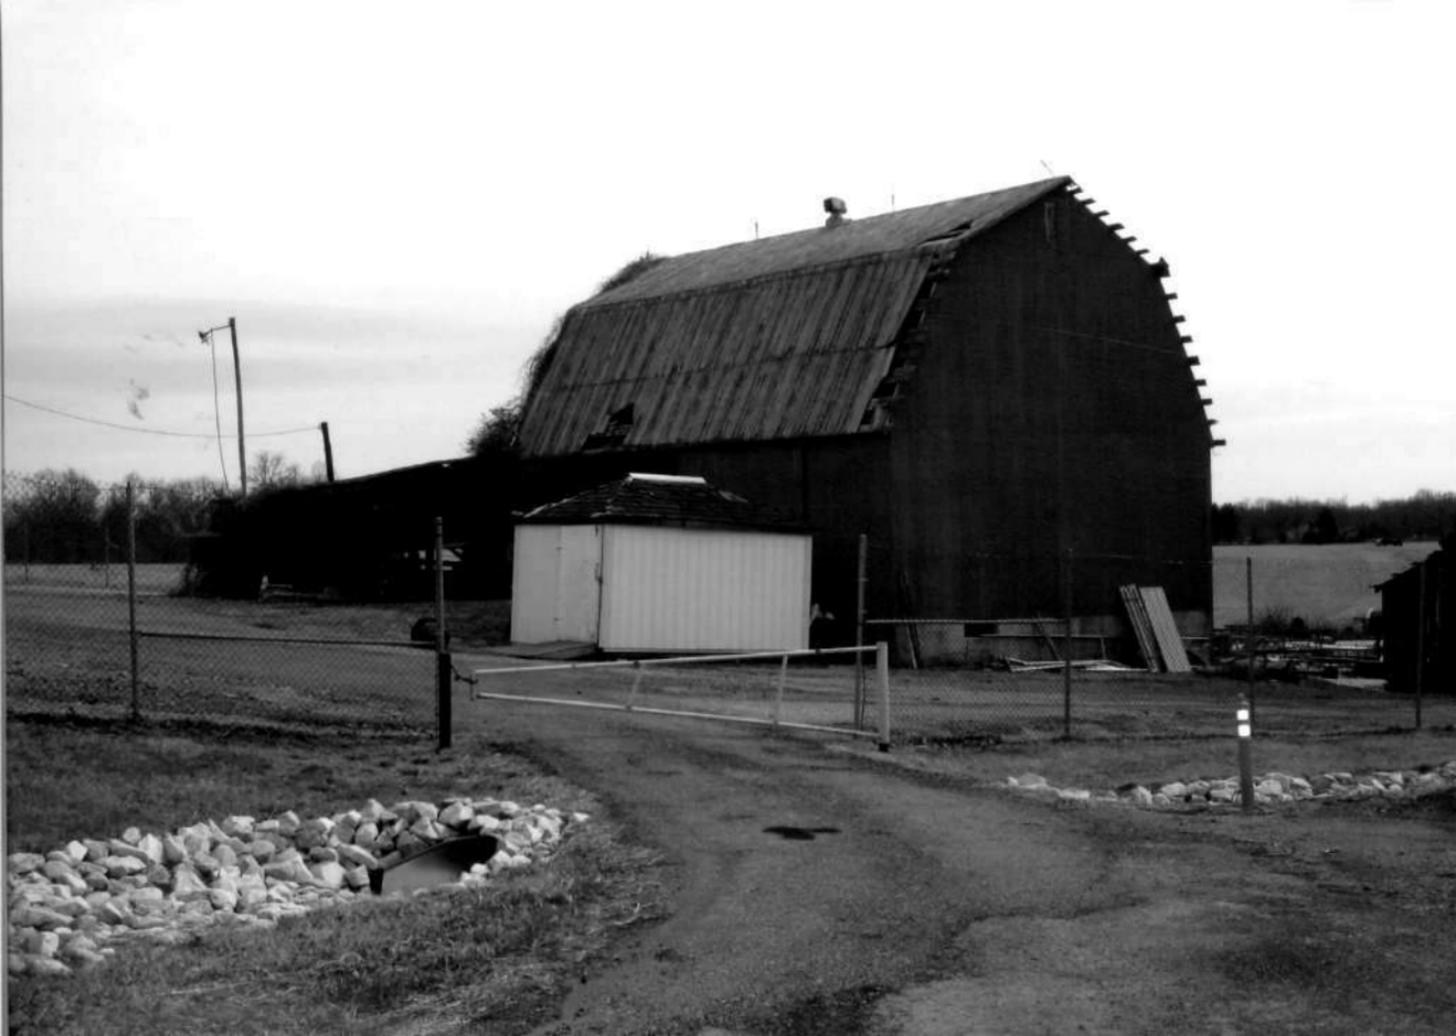
PG-74B-62 - 2011-3-9 - 11

The two circa 1950s barns are located east of the dwellings, facing into a former concreted barnyard (Photo 10). The complex dates from circa 1950s (Deeds; PG County Aerials). The Bank Barn (Photo 11) is a three-bay timber frame structure on a concrete foundation with a gambrel roof. It faces southwest onto the barnyard, with its cellar level exposed along that elevation. It has vertical board siding and corrugated metal roofing. Double sliding doors enter the upper level from a shallow ramp on the northeast elevation. The cellar is separated into stalls for livestock, with the south half concreted for dairy cattle. A Straw Shed addition of frame and plywood construction on a poured concrete foundation extends off the southeast end of the Bank Barn. Located along the northwest edge of the barnyard is the Barn/Stable (Photo 12). This is a transverse barn of light frame

Bank Barn with Straw Shed and Prefab Shed, northeast and northwest elevations. View faces south.
PG-74B-62_2011-3-9_11

Bank Barn with Straw Shed and Prefab Shed,
Northwest & northeast elevations

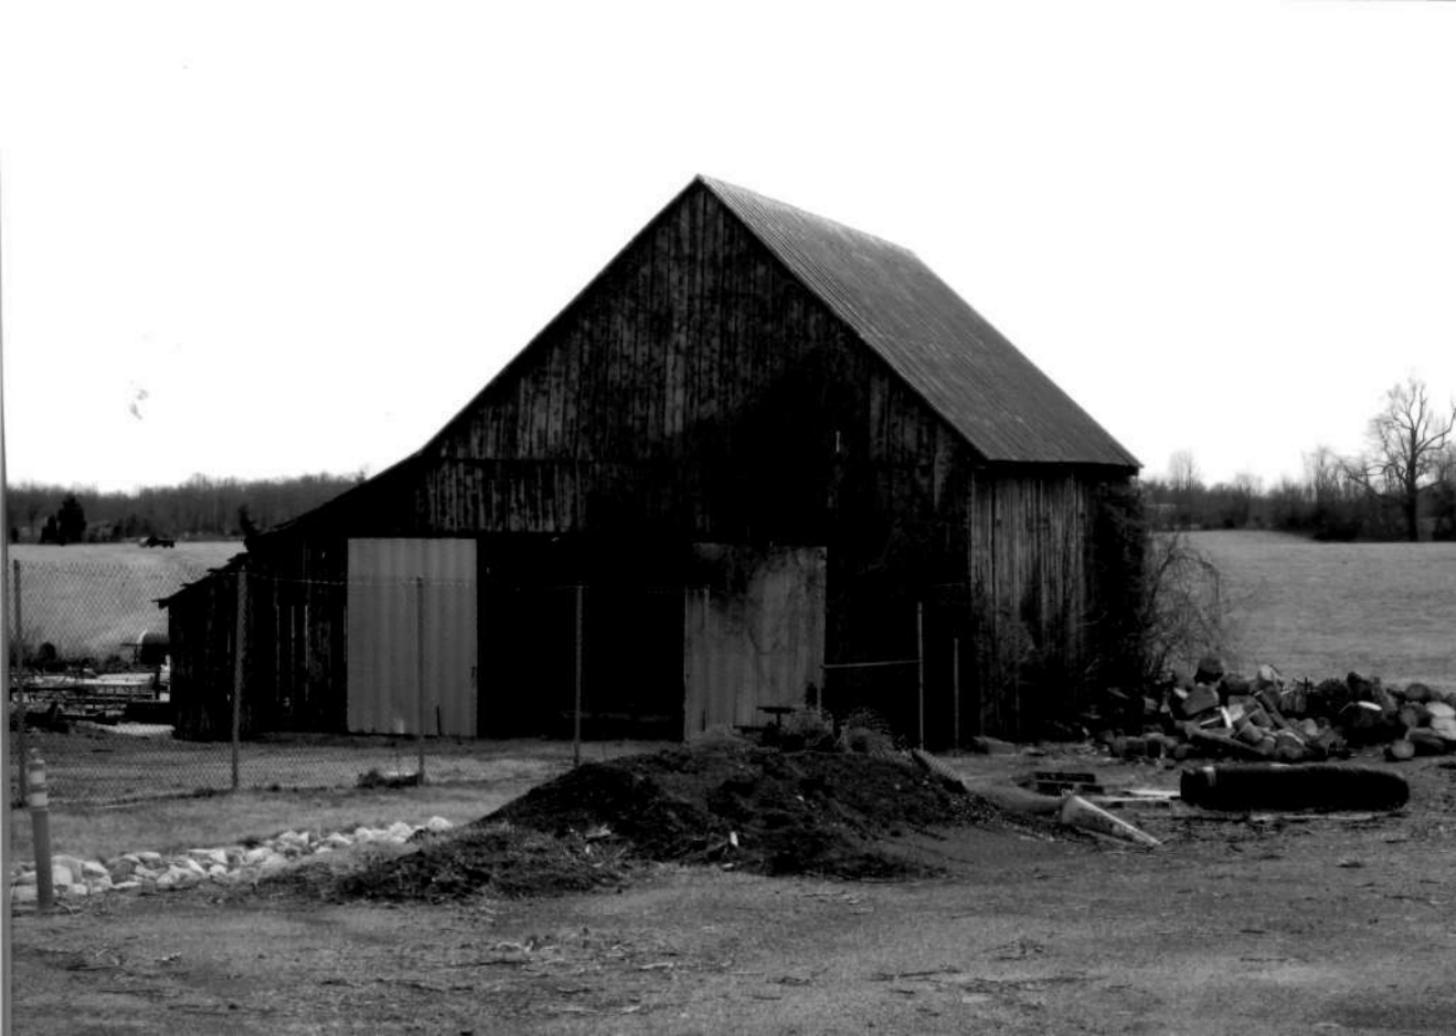
construction with a front facing gable roof and side shed. It has hinged doors that enter the northeast and southwest elevations. Other structures near the barnyard include: a second Garage (Photo 13) of concrete block construction on a slab foundation with corrugated metal front-facing gable roof and plywood gable ends; a steel Windmill, and a steel elevated Water Tank.

Barn/Stable, northeast and northwest elevations. View faces south.
PG-74B-62_2011-3-9_12

Barn/stable, northeast & northwest elevations

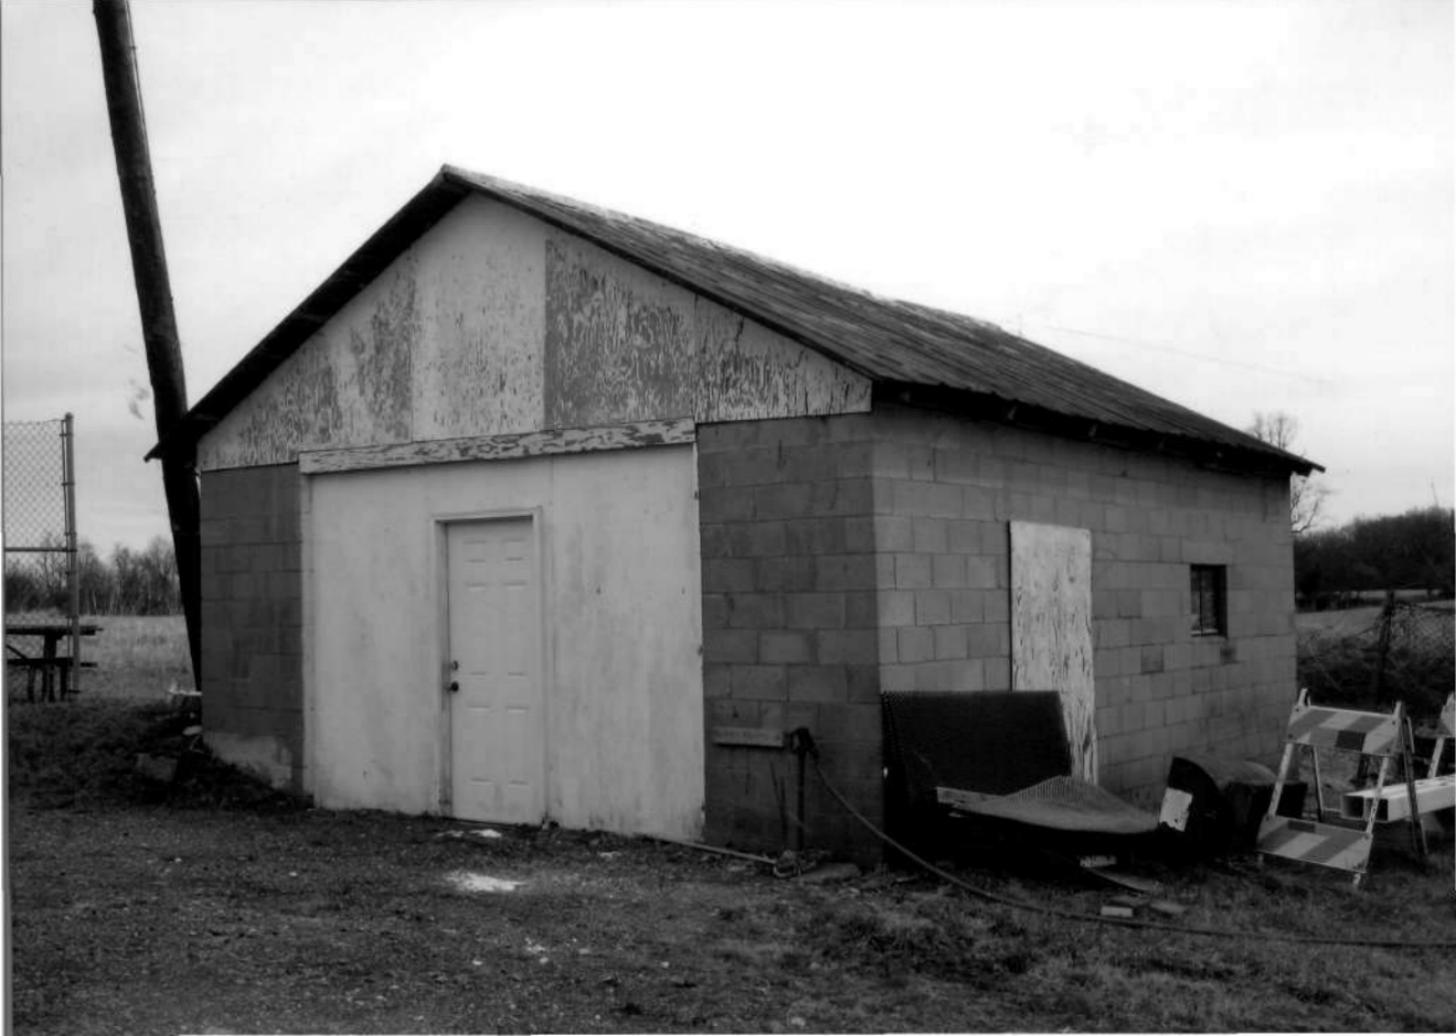
PG: 74B-62-2011-3-9-15

Garage, north (façade) and west elevations. View faces southeast.
PG-74B-62_2011-3-9_13

Garage, north and west elevations

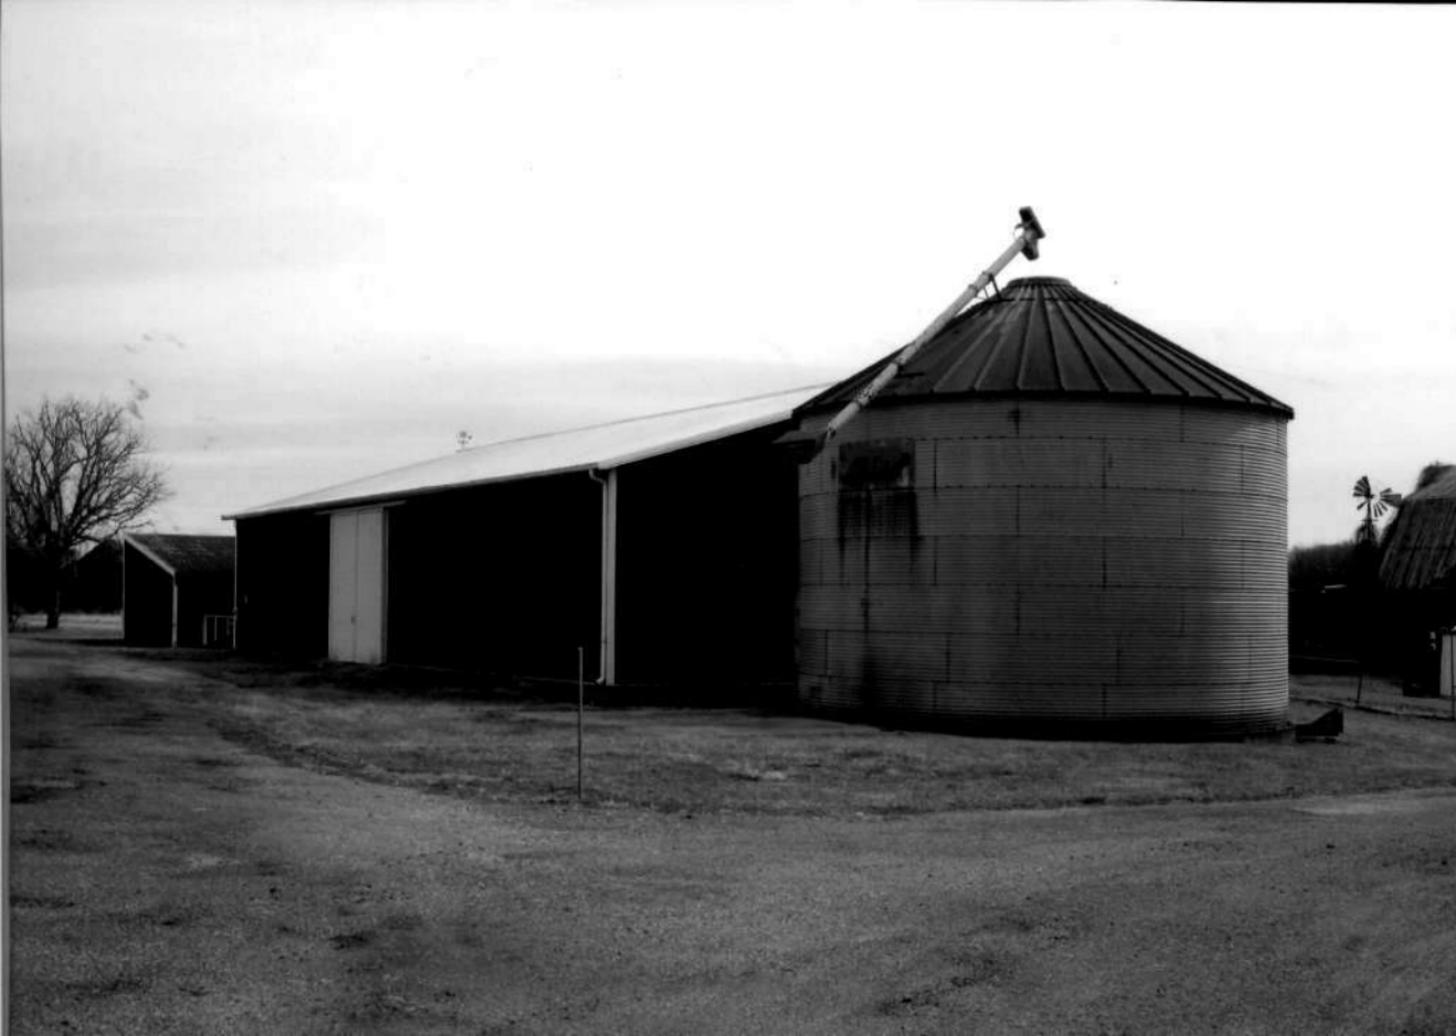
PG-74B-62-2011-3-9-14

Along the farm lane east of the barn complex is a row of three storage structures (Photo 14). At the north end is a steel stave Silo with conical standing seam metal roof constructed circa 1960 (PG County Aerial 1965) The Storage Barn and Machine Shed were constructed after the City of Bowie acquired the property. Both are of pole construction on poured concrete slab foundations with steel siding and roofing. The Storage Barn is located at the site of the original circa 1914 barn on the property, which no longer extant by 1965 (PG County Aerial). Also installed by the City of Bowie since 1988 is the pre-fabricated plywood Shed located near the Bank Barn (Photo 11).

Machine Shed, Storage Barn, and Silo, northeast and northwest elevations. View faces south.
PG-74B-62_2011-3-9_14

Machine Shed, Storage Barn, and Silo,
northeast & northwest elevations
