**MARYLAND HISTORICAL TRUST
DETERMINATION OF ELIGIBILITY FORM**

Property Name: Walter & Emma Entzian Farm Inventory Number: PG: 74B-62
 Address: 18509 Central Avenue (MD 214) Historic district: yes no
 City: Upper Marlboro Zip Code: 20774 County: Prince Georges
 USGS Quadrangle(s): Bowie
 Property Owner: City of Bowie Tax Account ID Number: multiple
 Tax Map Parcel Number(s): multiple Tax Map Number: 71
 Project: Intercounty Connector, REF-21 Agency: SHA
 Agency Prepared By: ICC Team
 Preparer's Name: Elizabeth Roman Date Prepared: 3/22/2011
 Documentation is presented in: _____
 Preparer's Eligibility Recommendation: Eligibility recommended Eligibility not recommended
 Criteria: A B C D Considerations: A B C D E F G
Complete if the property is a contributing or non-contributing resource to a NR district/property:
 Name of the District/Property: _____
 Inventory Number: _____ Eligible: yes Listed: yes
 Site visit by MHT Staff yes no Name: _____ Date: _____

Walter & Emma Entzian Farm, MIHP No. PG:74B-62
18509 Central Avenue, Upper Marlboro, Prince George's County

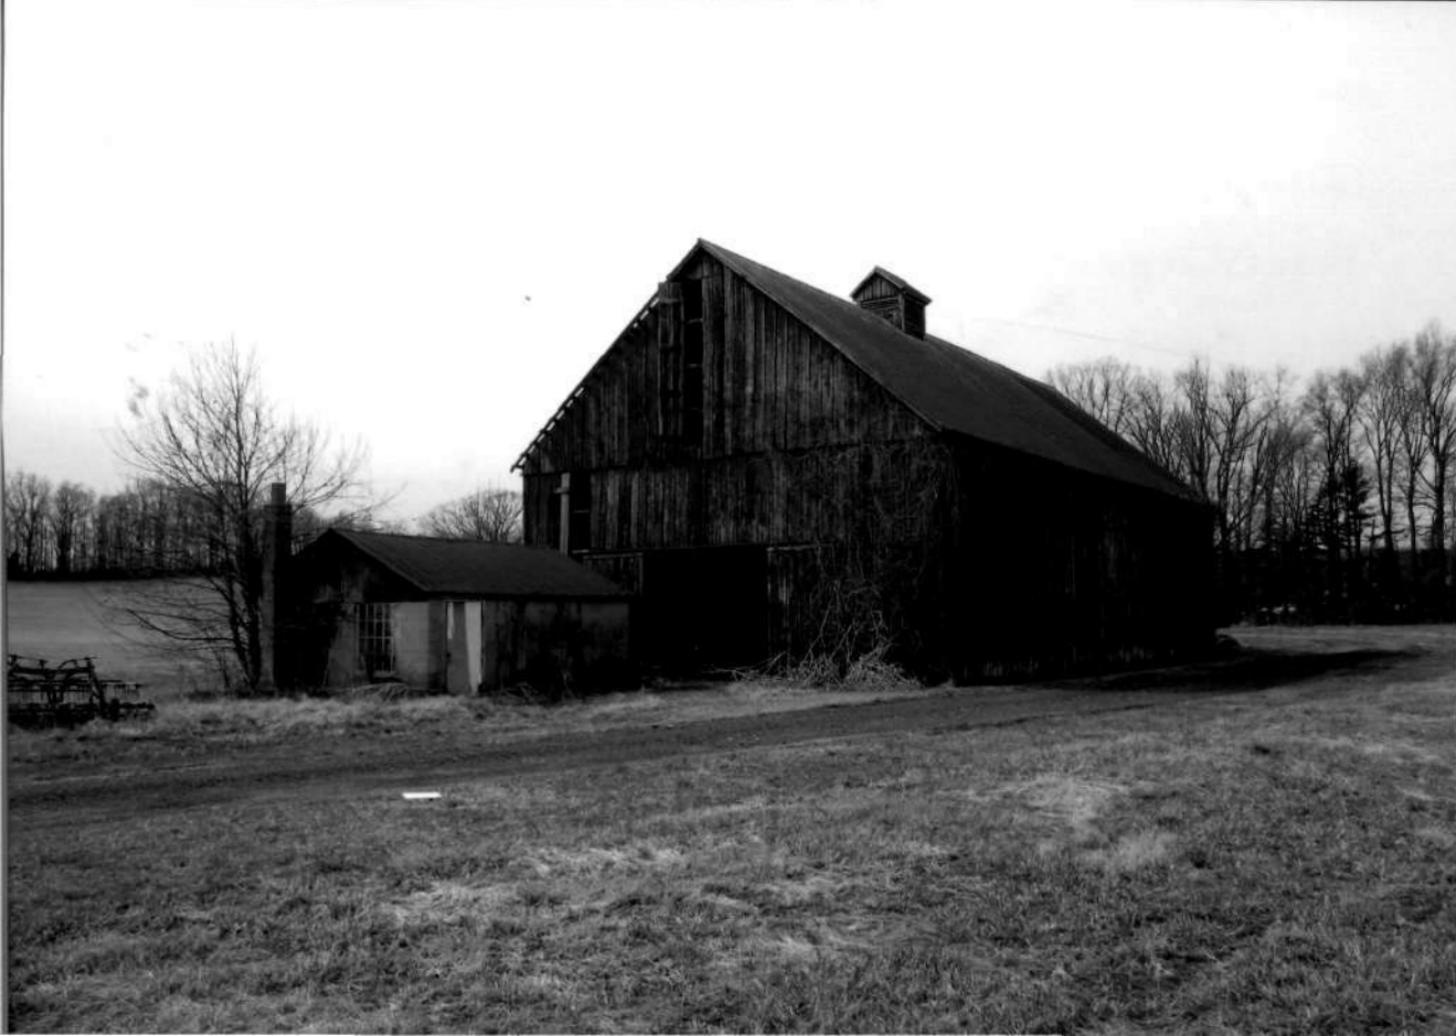
PG-74B-62 - 2011-3-9 - 15

Located along the farm lane north of the farmstead are the Tobacco Barn and Stripping Shed (Photo 15). The Tobacco Barn is a transverse barn of timber frame construction on a concrete pier foundation. It has a gable roof with open cornice and corrugated metal roofing. It has hinged vertical board siding and a gabled cupola to provide ventilation during drying of the tobacco. Hinged doors enter the center aisle from each end of the building (southeast and northwest elevations) of the building. The Tobacco Barn dates from the 1930s as it appears on the 1938 aerial of the area. Off its south corner is the Stripping Shed built circa 1950s. This concrete block single pen building has a side gable roof covered with corrugated metal, concrete slab foundation, and block chimney stack. It is lit by multi-pane steel sash set into the block walls. A modern hollow core steel door enters the building on its northeast elevation.

Stripping Shed and Tobacco Barn, southeast and northeast elevations. View faces north.
PG-74B-62_2011-3-9_15

stripping Shed and Tobacco Barn, southeast
& northeast elevations

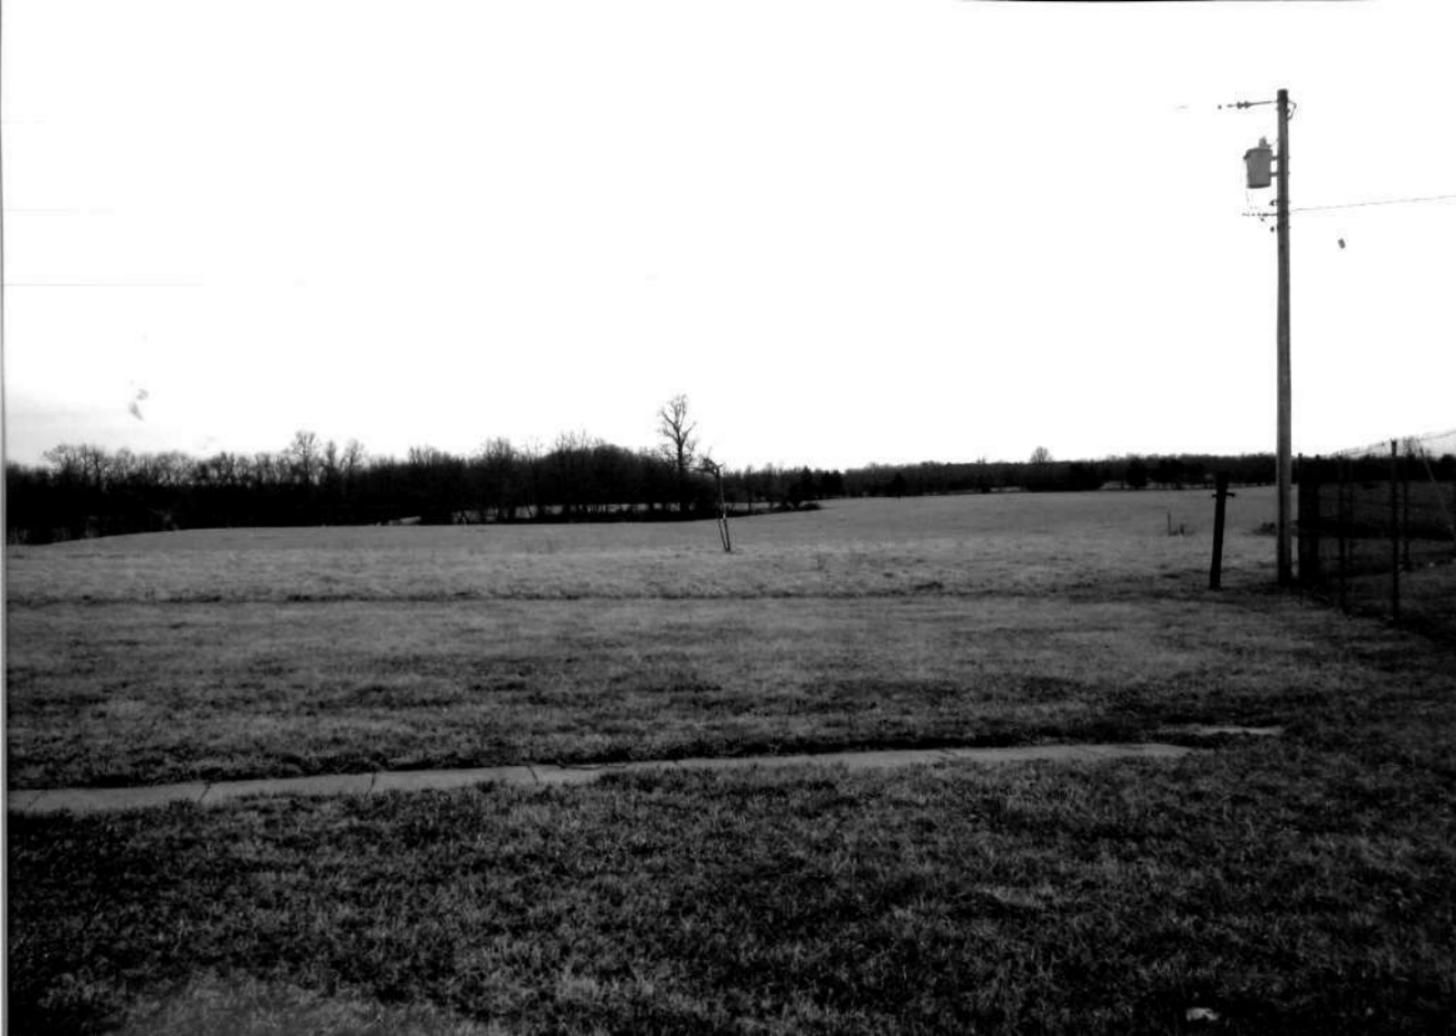
PG-74B-62 - 2011-3-9-16

The topography of the property is gently undulating with Honey Branch along the eastern edge of the property. Mature forest demarcates the edges of the property, separating it from the adjoining properties. Open fields extend across the property (Photo 16). These former agricultural fields are planted in grasses that are cut for hay by a local farmer. A mid-twentieth century Farm Pond (Photo 17) is located east of the dwelling again the Homey Branch. No pastures are found on the property. Wire fencing is found only in the area of the original farmhouse yard and around the farm pond. No field edge fencing is present. A review of the 1938 and 1965 aerial photographs of the area reveal that the open areas of the farm were cut into multiple crop fields, with pasture in the field to the south of the farmhouse. Multiple farm lanes that are no longer present once connected these fields to the farmstead.

View of fallow cropland, facing south from farmstead complex.
PG-74B-62_2011-3-9_16

View of fallow cropland, facing south from
farmstead complex

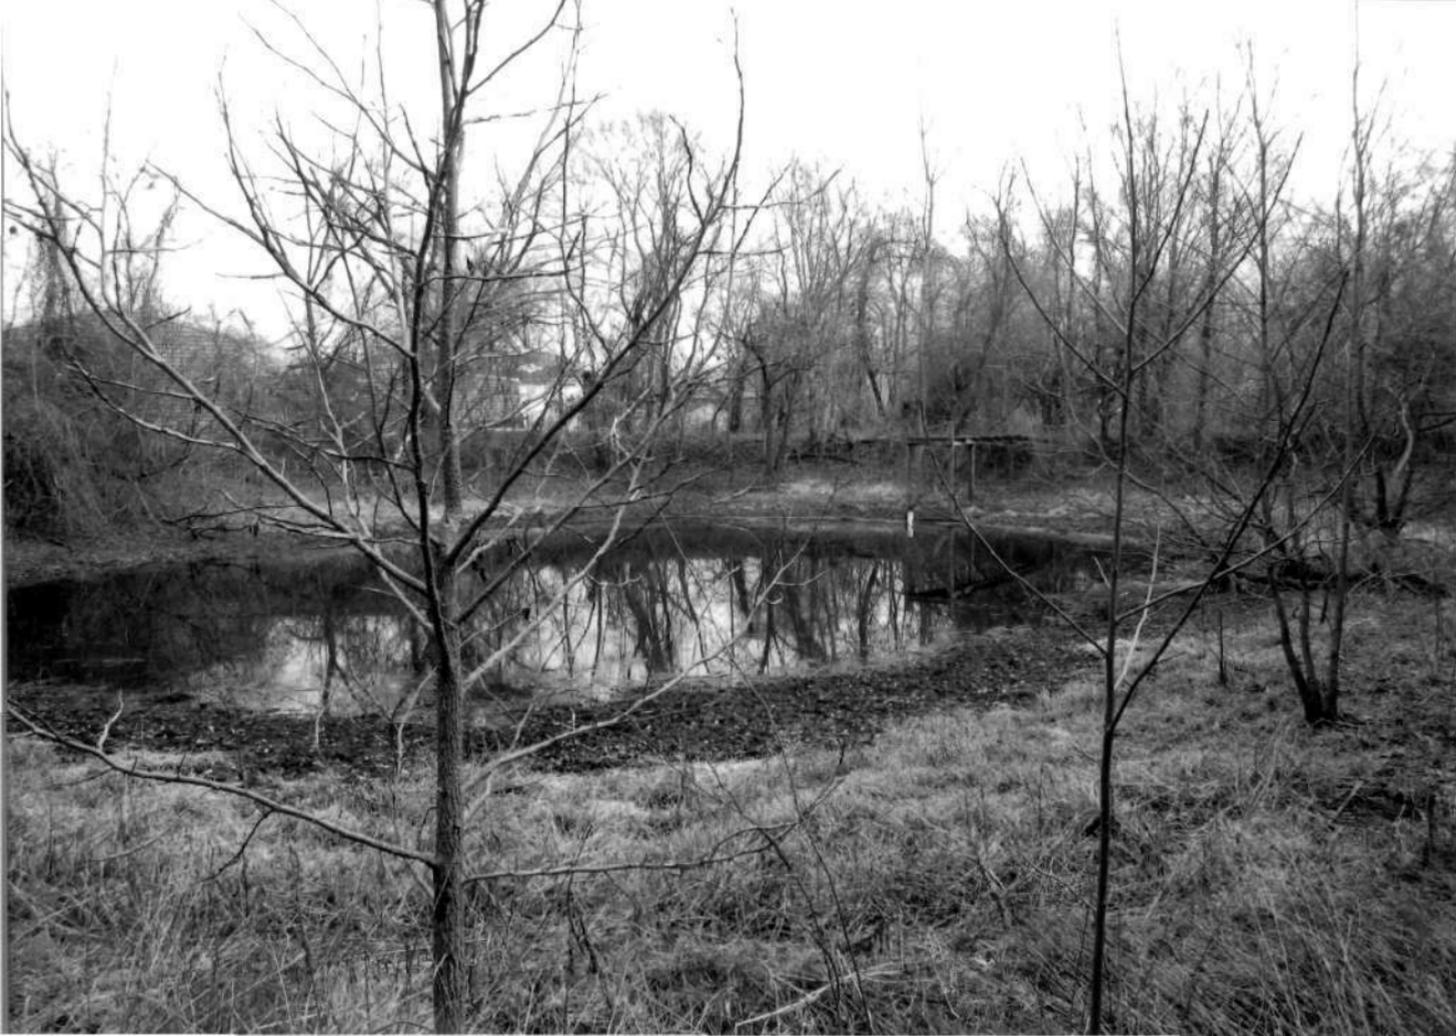
PG-74B-62-2011-3-9-17

Farm Pond. View faces southeast.
PG-74B-62_2011-3-9_17

Farm Pond. View faces Southeast
