historic name Oxon Cove Farm, Godding Croft, Mount Welby
other names/site number Oxon Hill Children's Farm/ P.G. 76A-13

street & number Government Farm Road not for publication
city or town Oxon Hill vicinity _____
state Maryland code MD county Prince George's code 033
zip code 20745

OXON COVE FARM	
DATE: JULY, 1993	PAGE 1 OF 2
R. Christopher Goodwin & Associates, Inc. 337 East Third Street Frederick, Maryland 21701 Drawn By: Bethany M. Usher

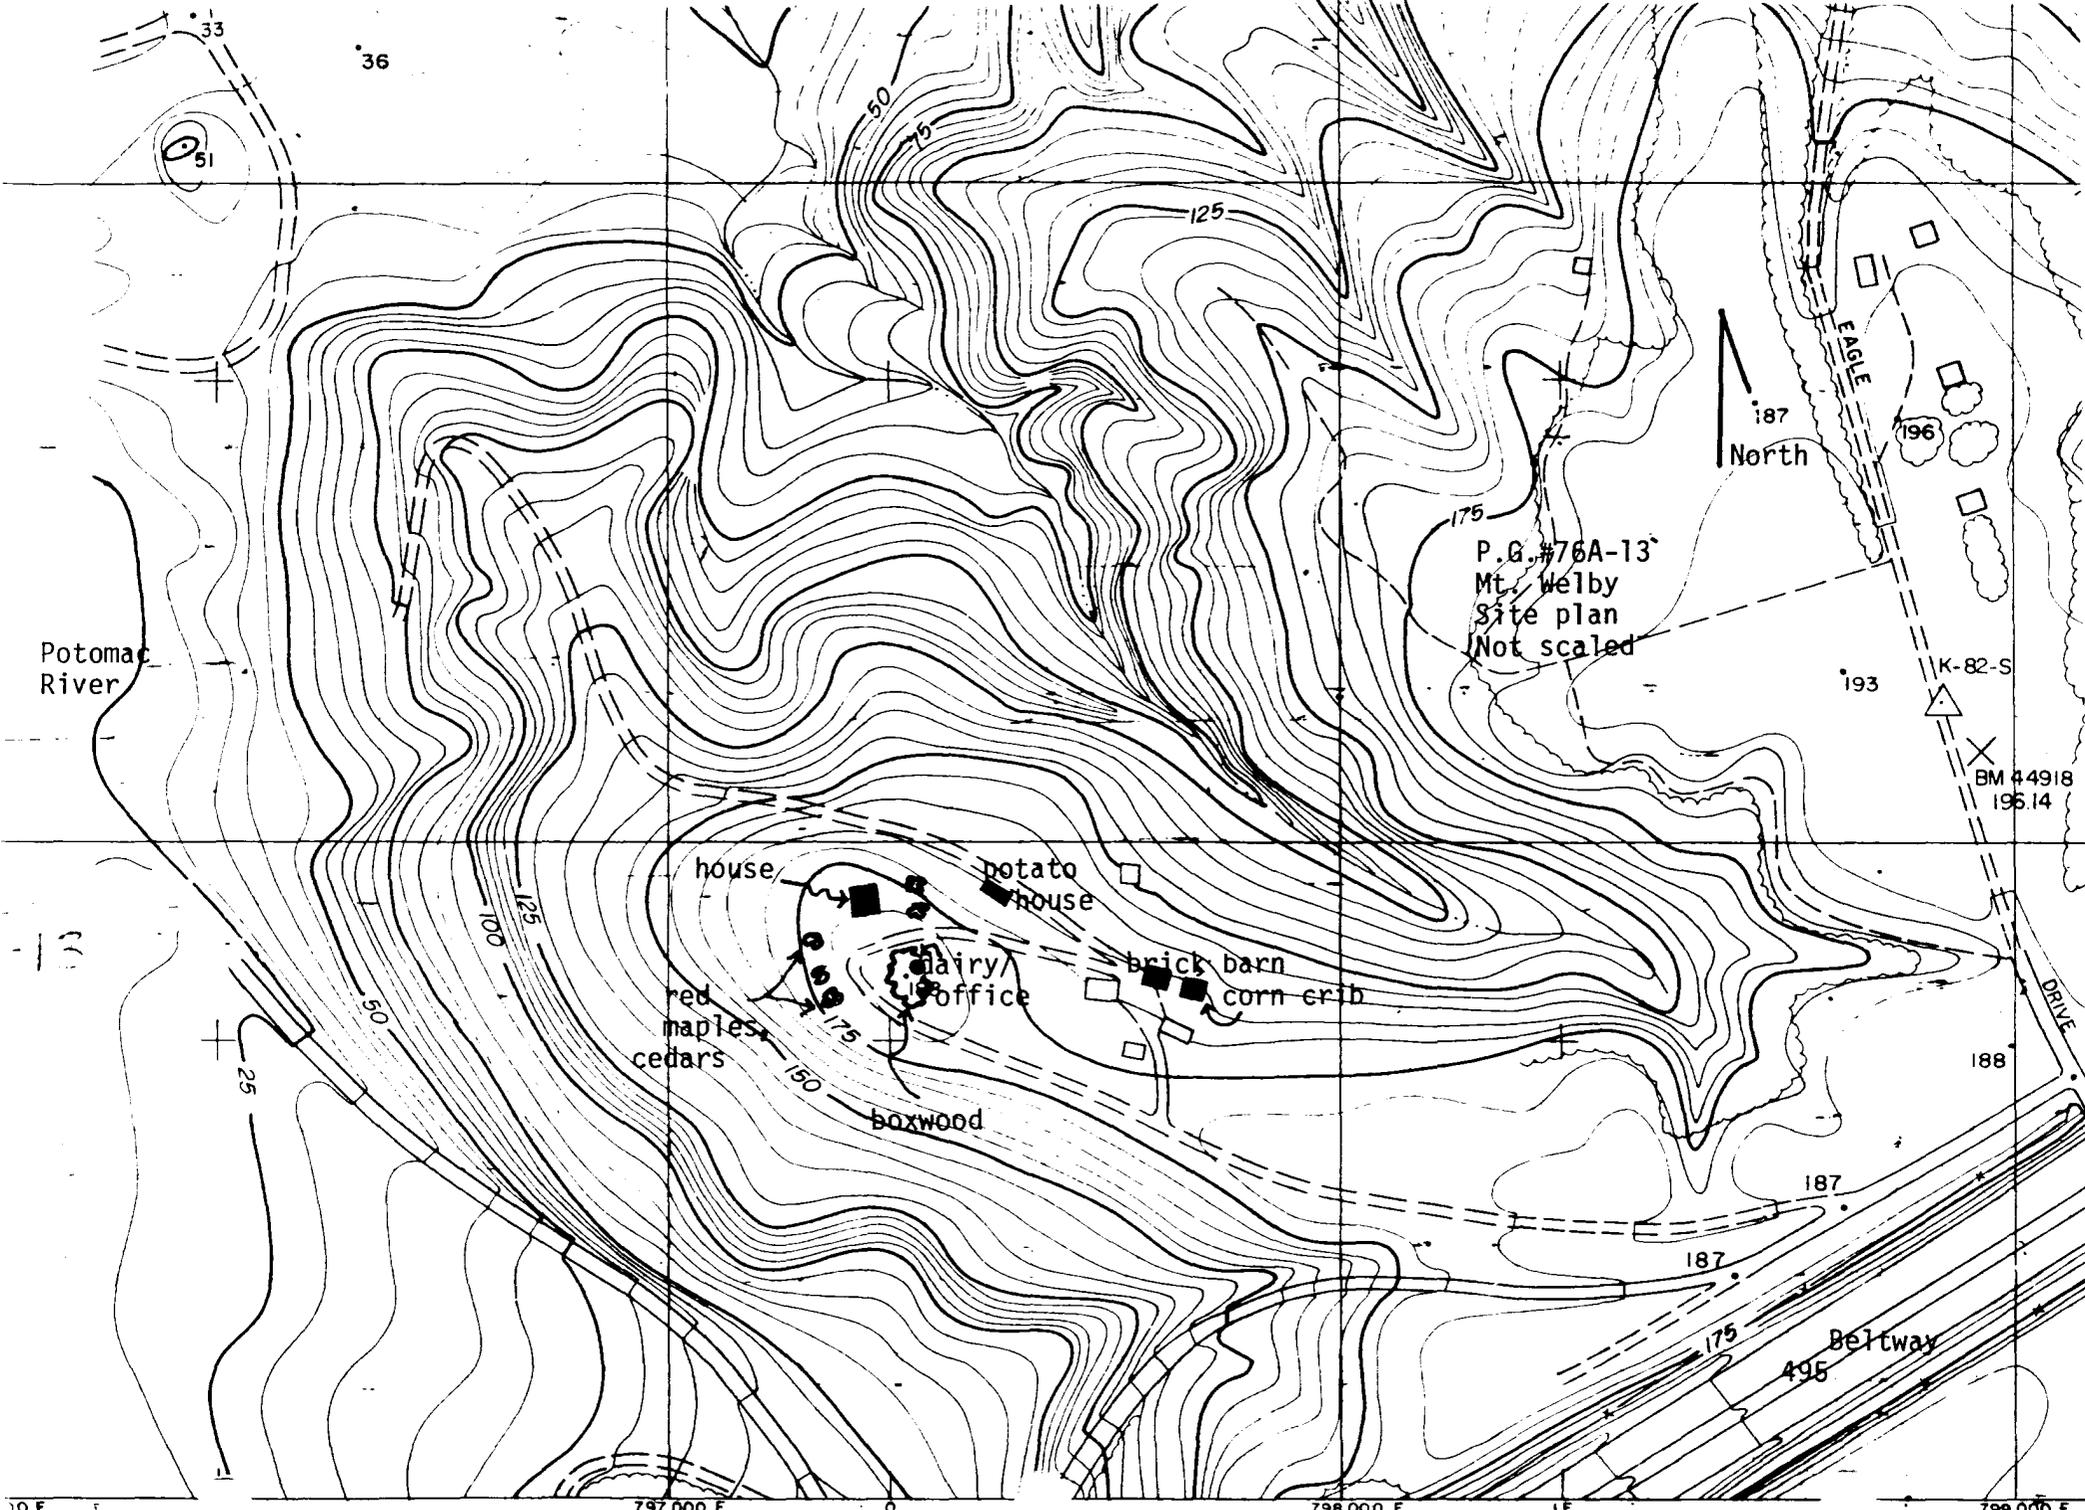
P.G. #76A-13
Mt. Welby
Site plan
(Not scaled)

house
potato house
dairy/office
brick barn
corn crib
red maples cedars
boxwood

The agricultural complex east of the house is centered around an antebellum two-story brick stable. The buildings are arranged in an open cluster form commonly found in the Chesapeake. Buildings with related functions such as the stable, corn crib, hay barn and implement shed are in close proximity. Buildings with domestic functions such as the dairy/office are located closer to the house.⁹ The number and variety of the buildings and their relationship to the house provides important information on the functioning of a late 19th-early 20th century farm. The brick stable/barn, which may be contemporary with the house, is a significant example of a building type rarely seen in Southern Maryland.¹⁰

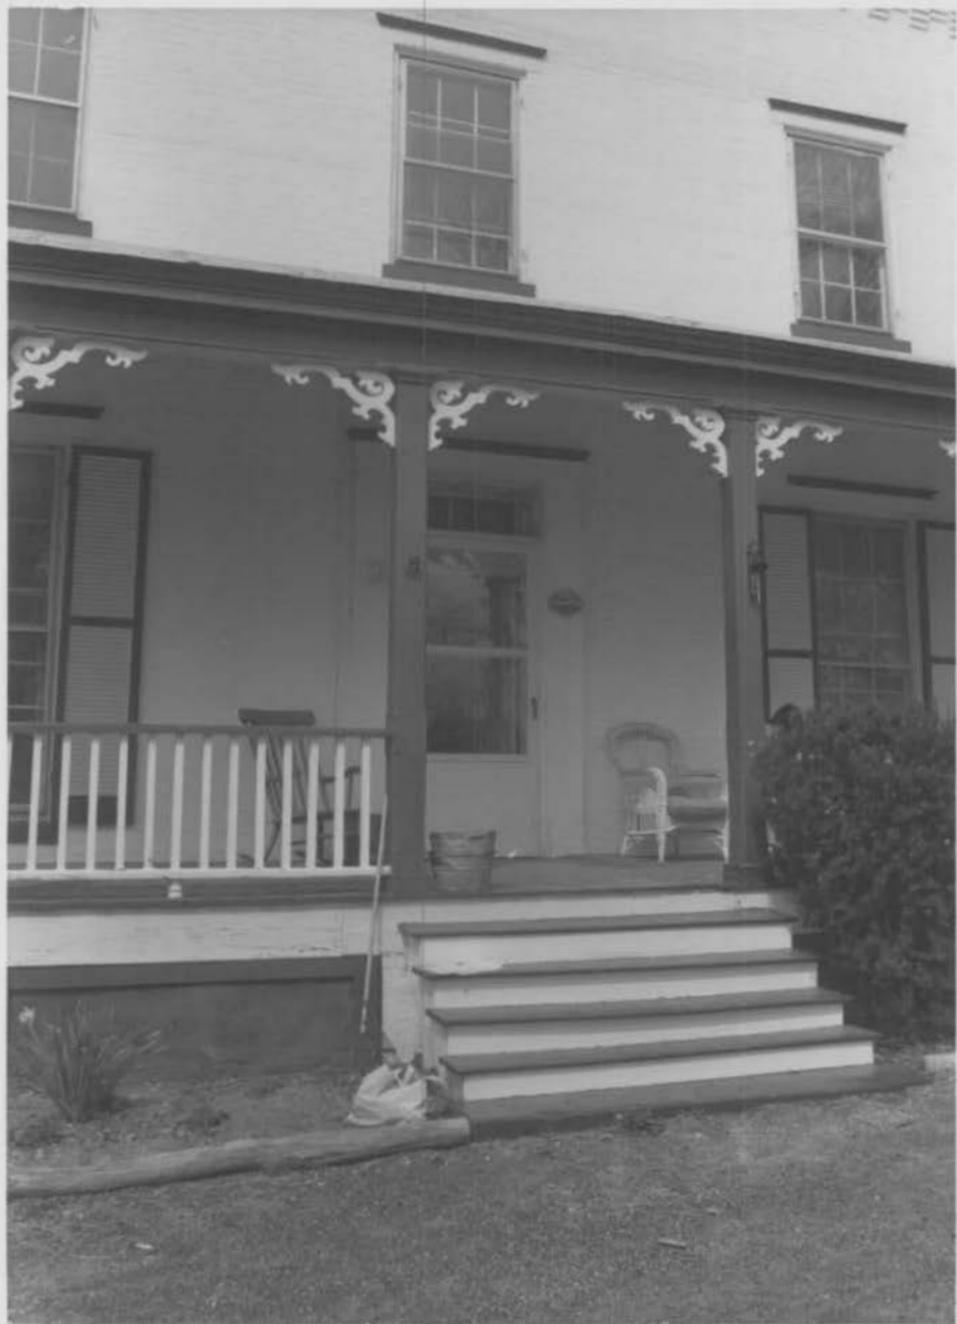
S porch detail

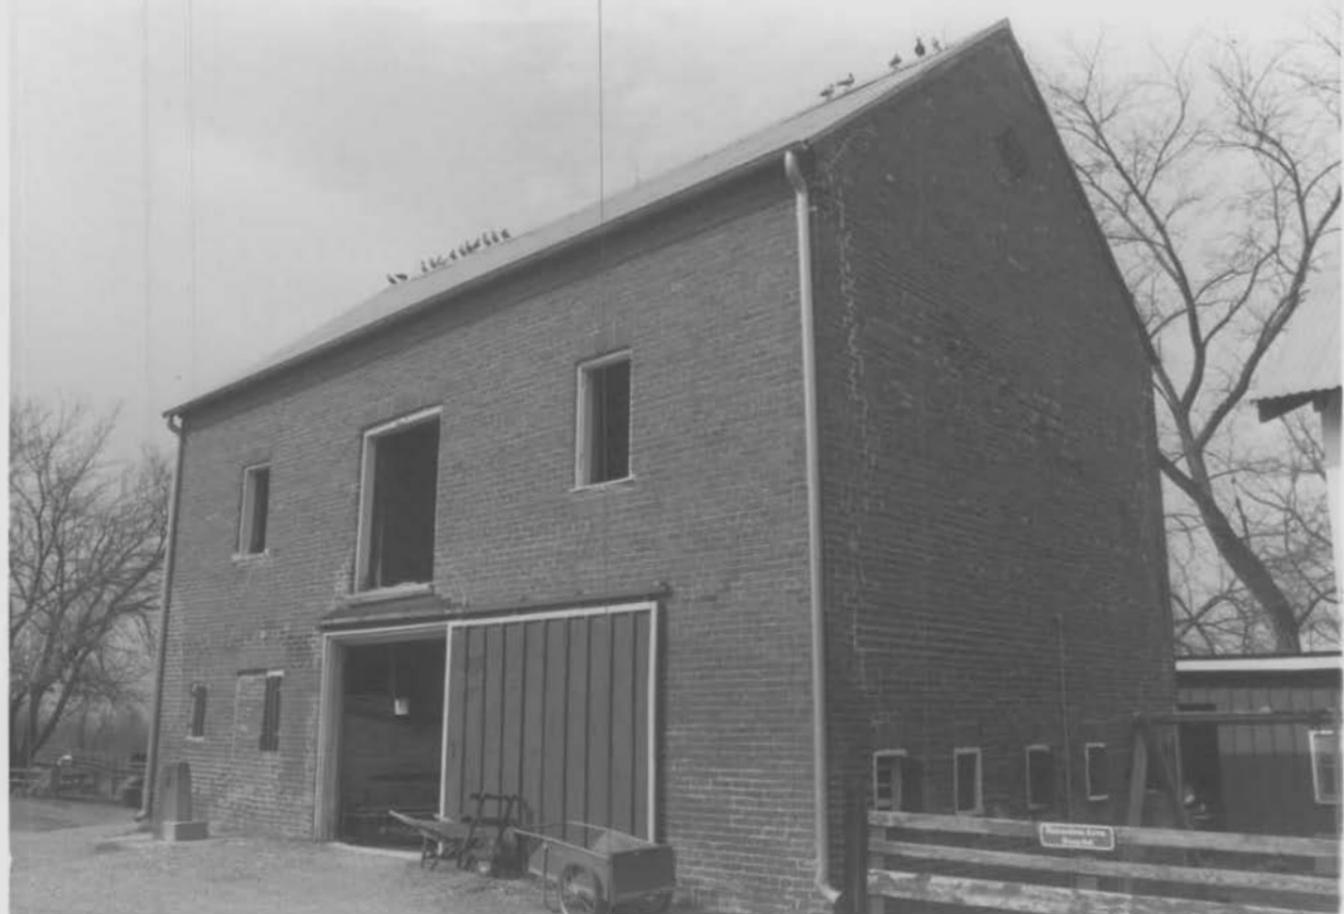
Mt. Welby
Prince George's County, MD
Marina King
March 1988
Stable, SE
Neg: MD Historical Trust
Annapolis, MD

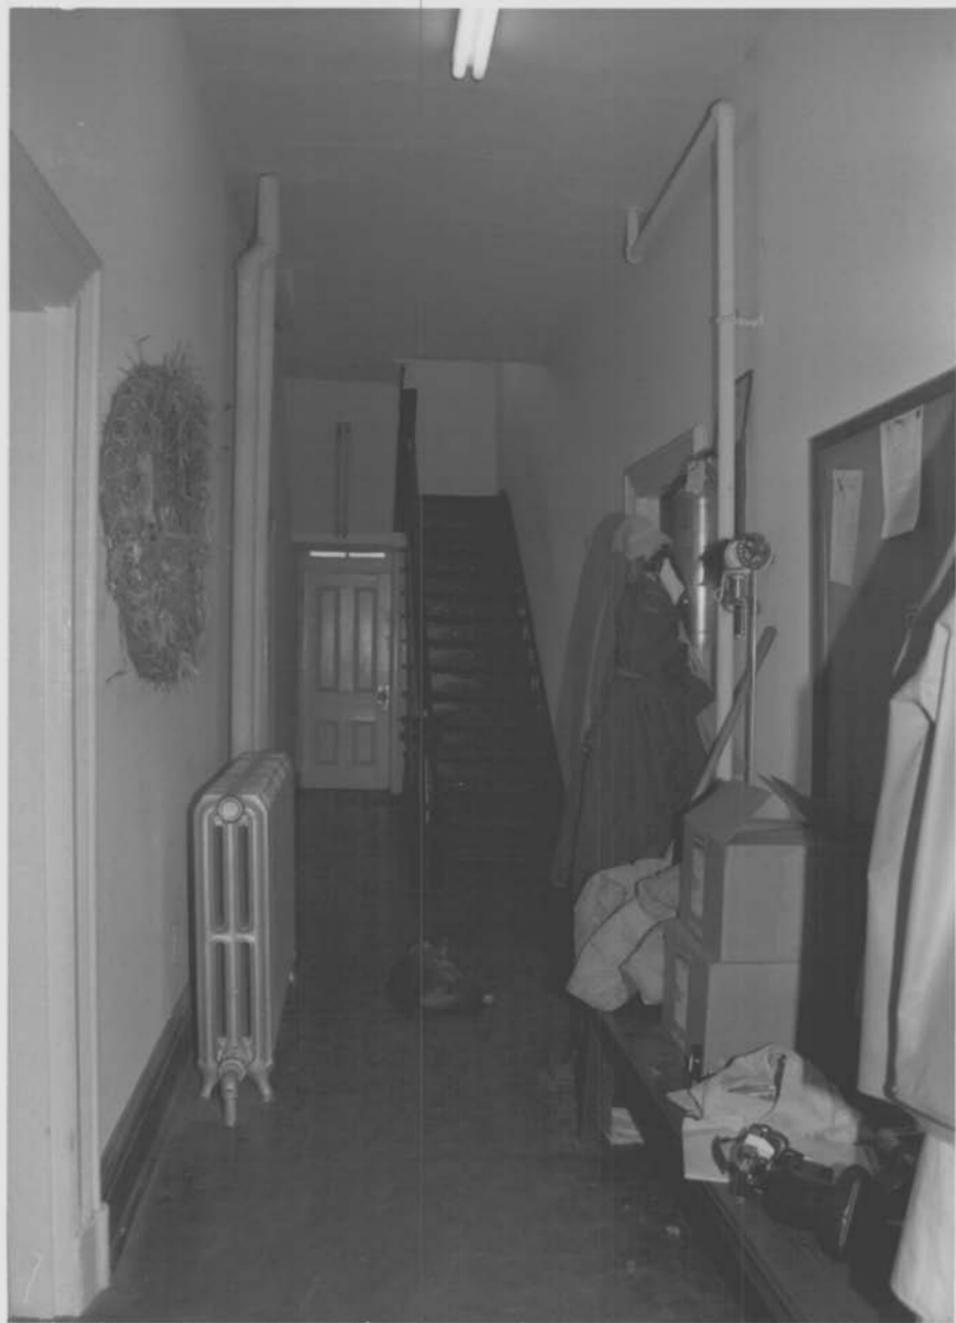
Hall, looking N

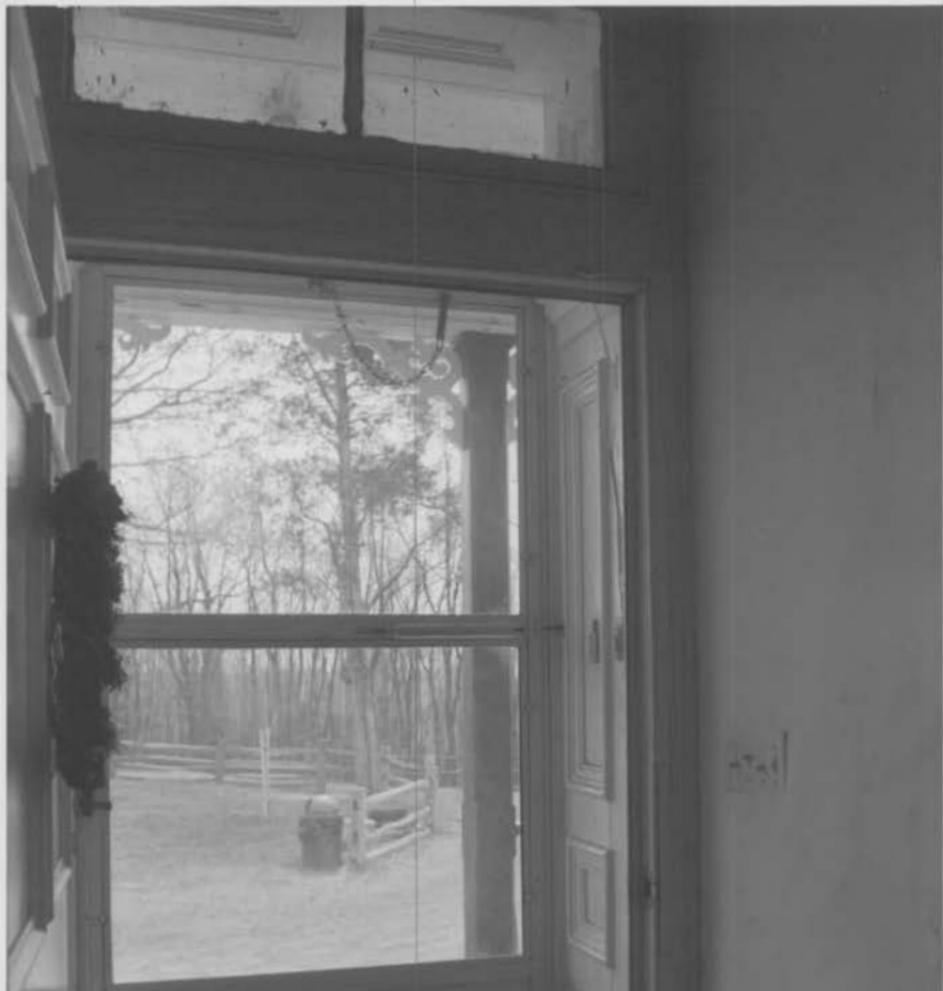
S entrance
