**MARYLAND HISTORICAL TRUST
NR-ELIGIBILITY REVIEW FORM**

Property Name: Building 4691 Andrews AFB Inventory Number: PG: 77-85

Maryland Inventory of Historic Properties Form

historic Farmhouse
 other Andrews AFB Building 4691 (preferred)

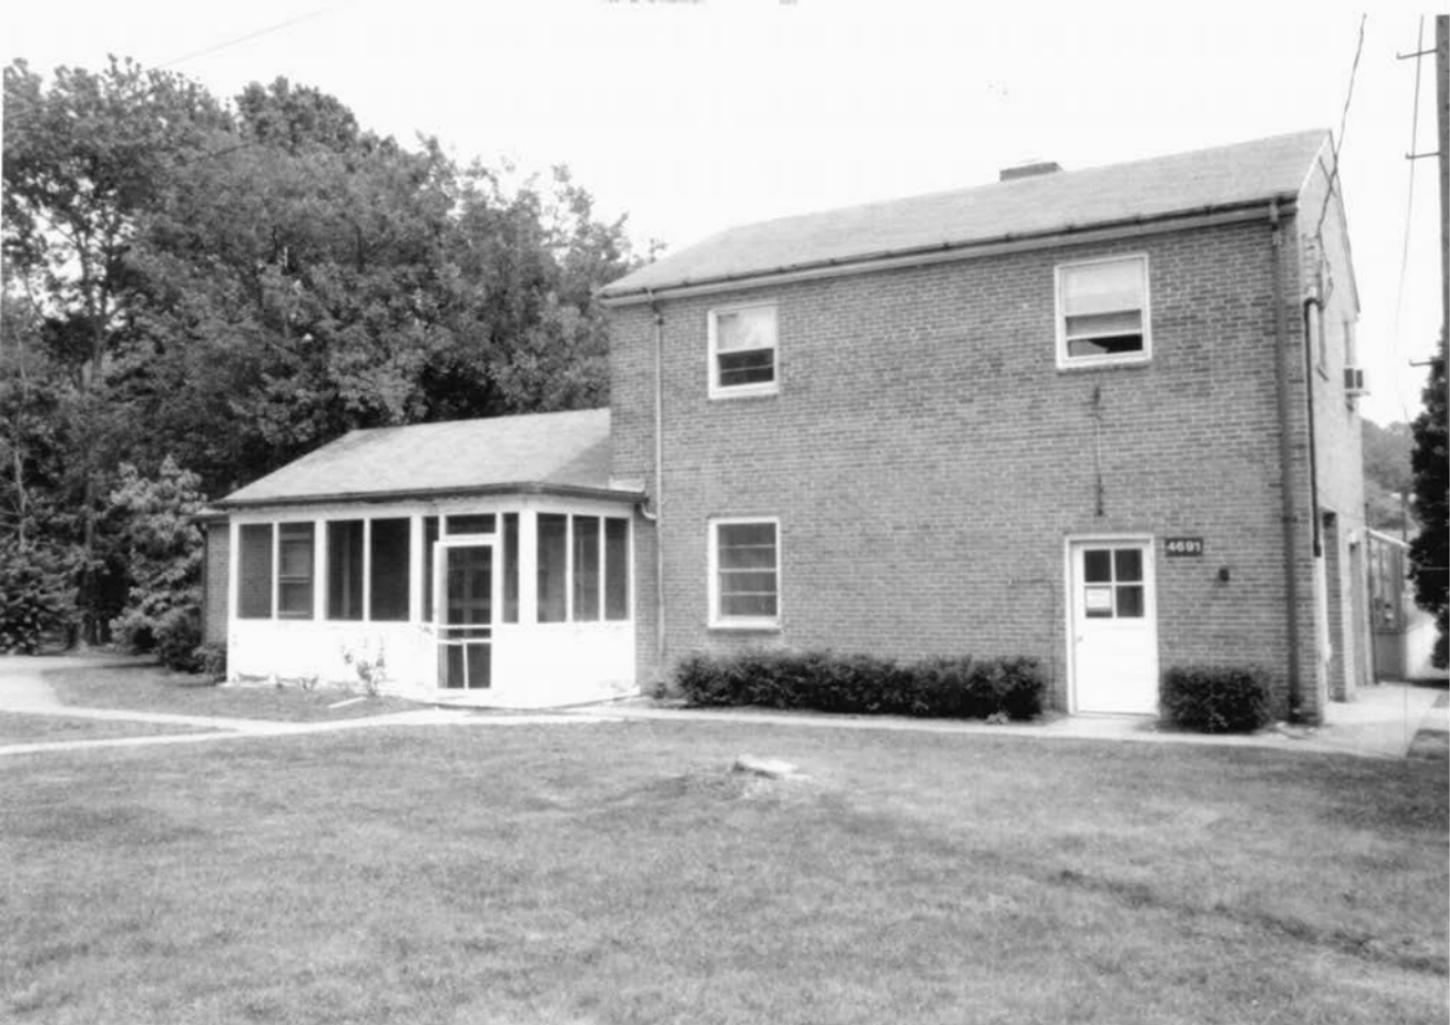
#1/4

Building 4691 is a single-family residence known as "the farmhouse." The two-story, two-bay, double-pile main block is constructed of stretcher-bond brick and has a rectangular footprint. Two, one-story rectangular wings telescope to the east from the east gable end. The long axis of the house is oriented roughly east-west, parallel to Georgia Avenue. The front elevation of the main block faces Georgia Avenue to the north. The two-bay front elevation has two symmetrical window openings on the second-story level, and a window and a door opening on the first-story level. The front door opening is located in the west bay and has a single half-glass, paneled wood door with four lights that opens into an interior garage space. The windows on the main block are two-over-two, double-hung wood sash.

N elev.

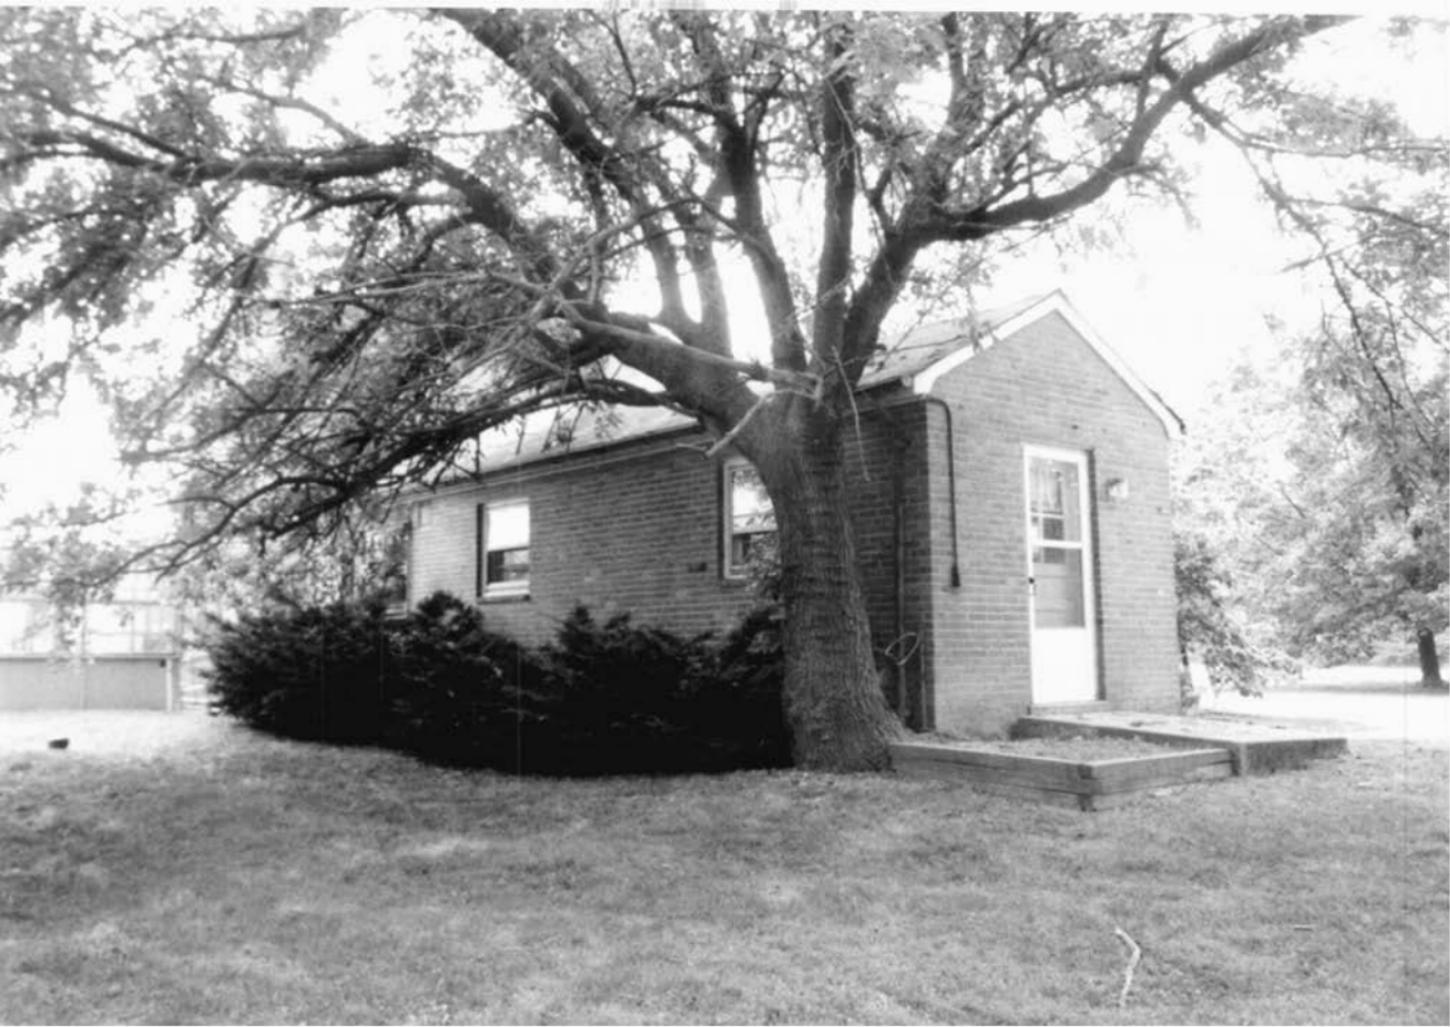
2/4

The second wing contains a kitchen with a door on the east gable end from the adjacent concrete patio in the side yard. The door opening has an aluminum exterior screen door and a paneled wood door with four lights. The south elevation has a pair of two-over-two wood sash. The north elevation is an unbroken brick wall.

SE corner, far E wing

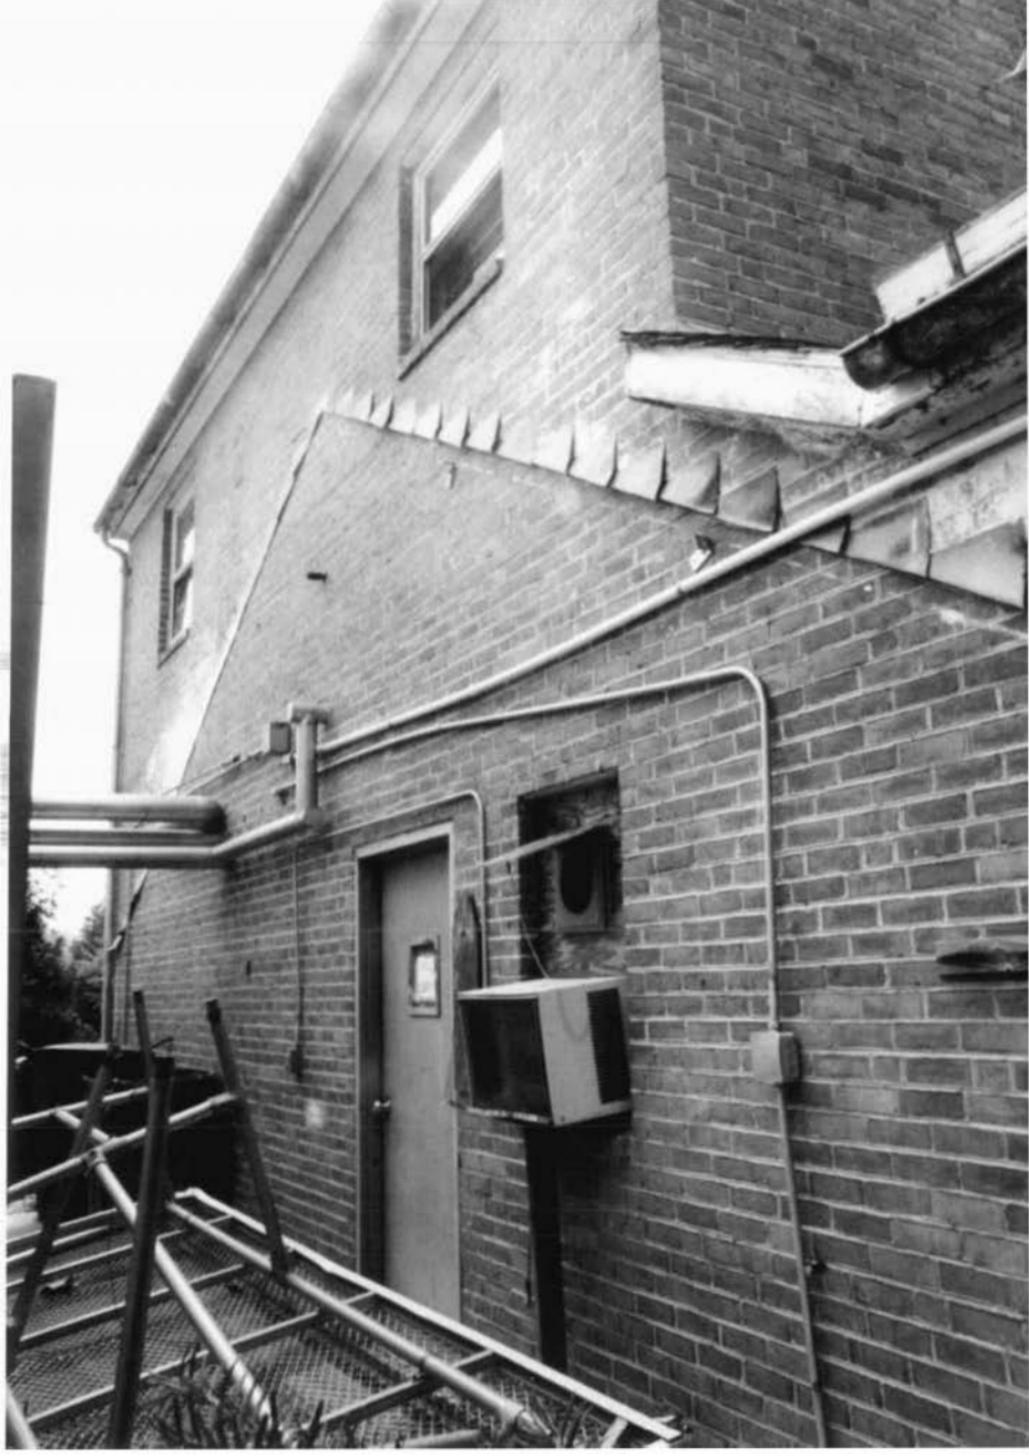
3/4

The west side elevation (gable end) of the main block contains an overhead metal single garage door in the north bay and a pair of flat metal doors in the south bay. The south elevation was formerly attached to a greenhouse which has been moved several feet to the south. Metal pipes connect the house to the greenhouse, and flashing is still attached to the house where the gable roof of the greenhouse once abutted. A door opening containing a flat metal door with a single light faces south toward the greenhouse, with a window opening to the right. The opening contains an air conditioner in the bottom half and plywood with a metal vent in the upper half.

Selev, w/2

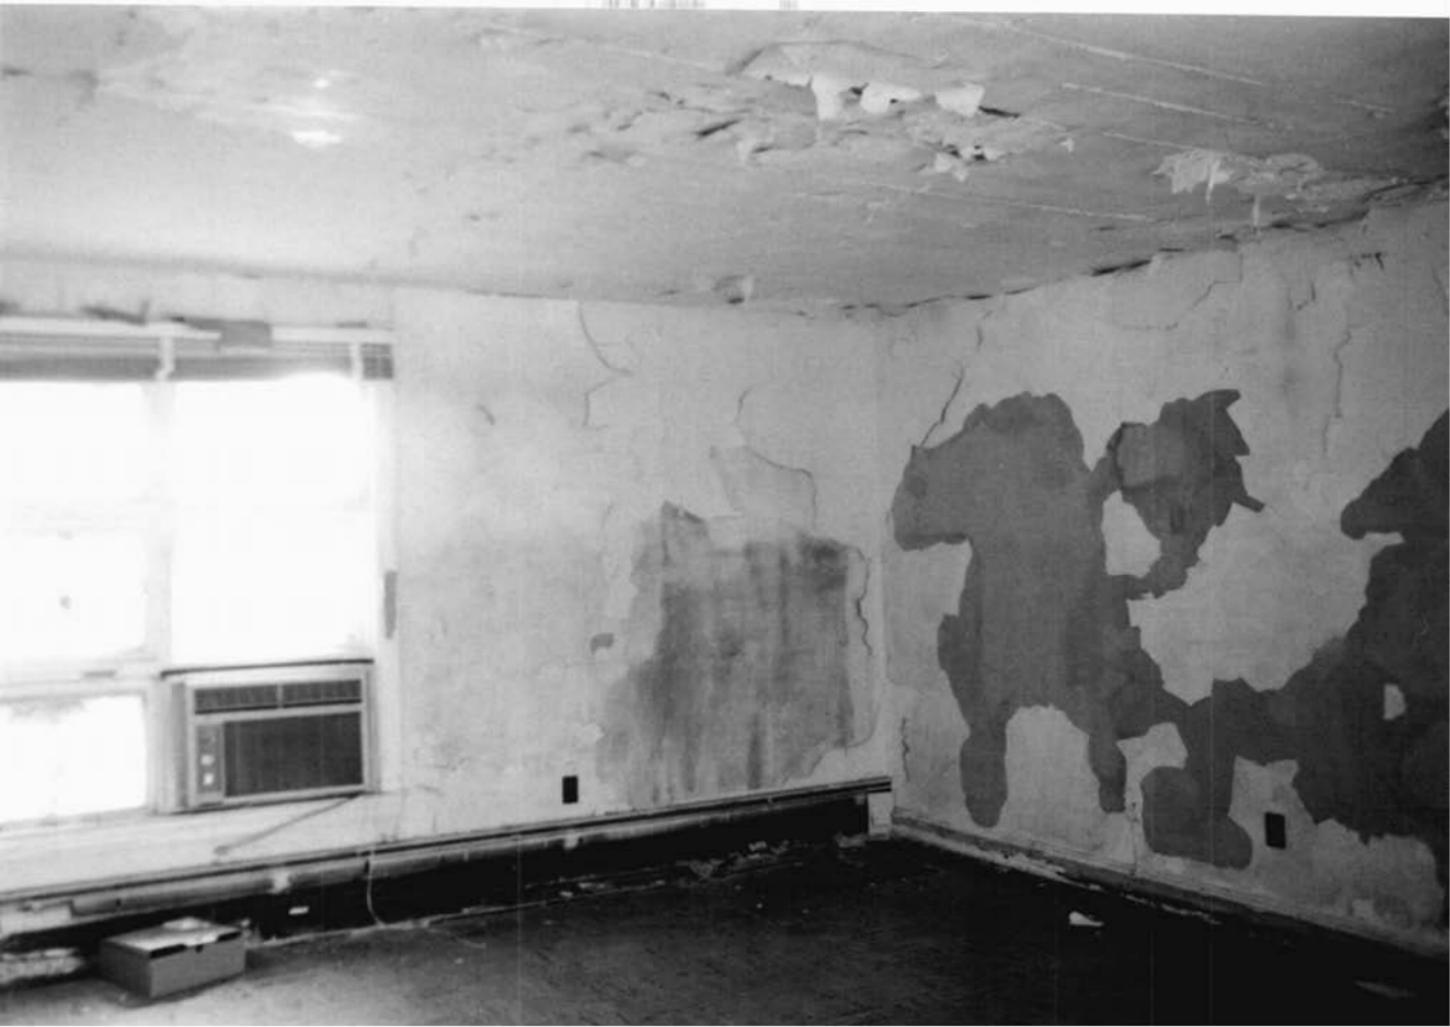
4/4

No one has lived in the house in the last ten years, and the building is used for military training exercises. There were plans to convert the building into office space, but the ceiling collapsed, revealing the poor condition of the plaster. The interior of the house has been deteriorating for a number of years. Plaster and paint have fallen or are peeling away from the walls and ceilings of the main floor rooms. The training exercises have reportedly added some of the holes in the walls. The second floor was not examined due to the instability of the building.

on the east end of the main block. The living room is in the west half of the first addition. A dining room occupies the east half of the first wing. The second wing contains a renovated kitchen.

Interior of near E wing, living
room, facing SW
