PRINCE GEORGE'S COUNTY
HISTORIC SITES SUMMARY SHEET

P.G. County Survey # 80-16 Date 1809-1824
Building Name Fort Washington
Location Fort Washington Road, Oxon Hill
Open to Public yes no

National Register of Historic Places Inventory—Nomination Form

Historic Fort Washington also Fort Warburton

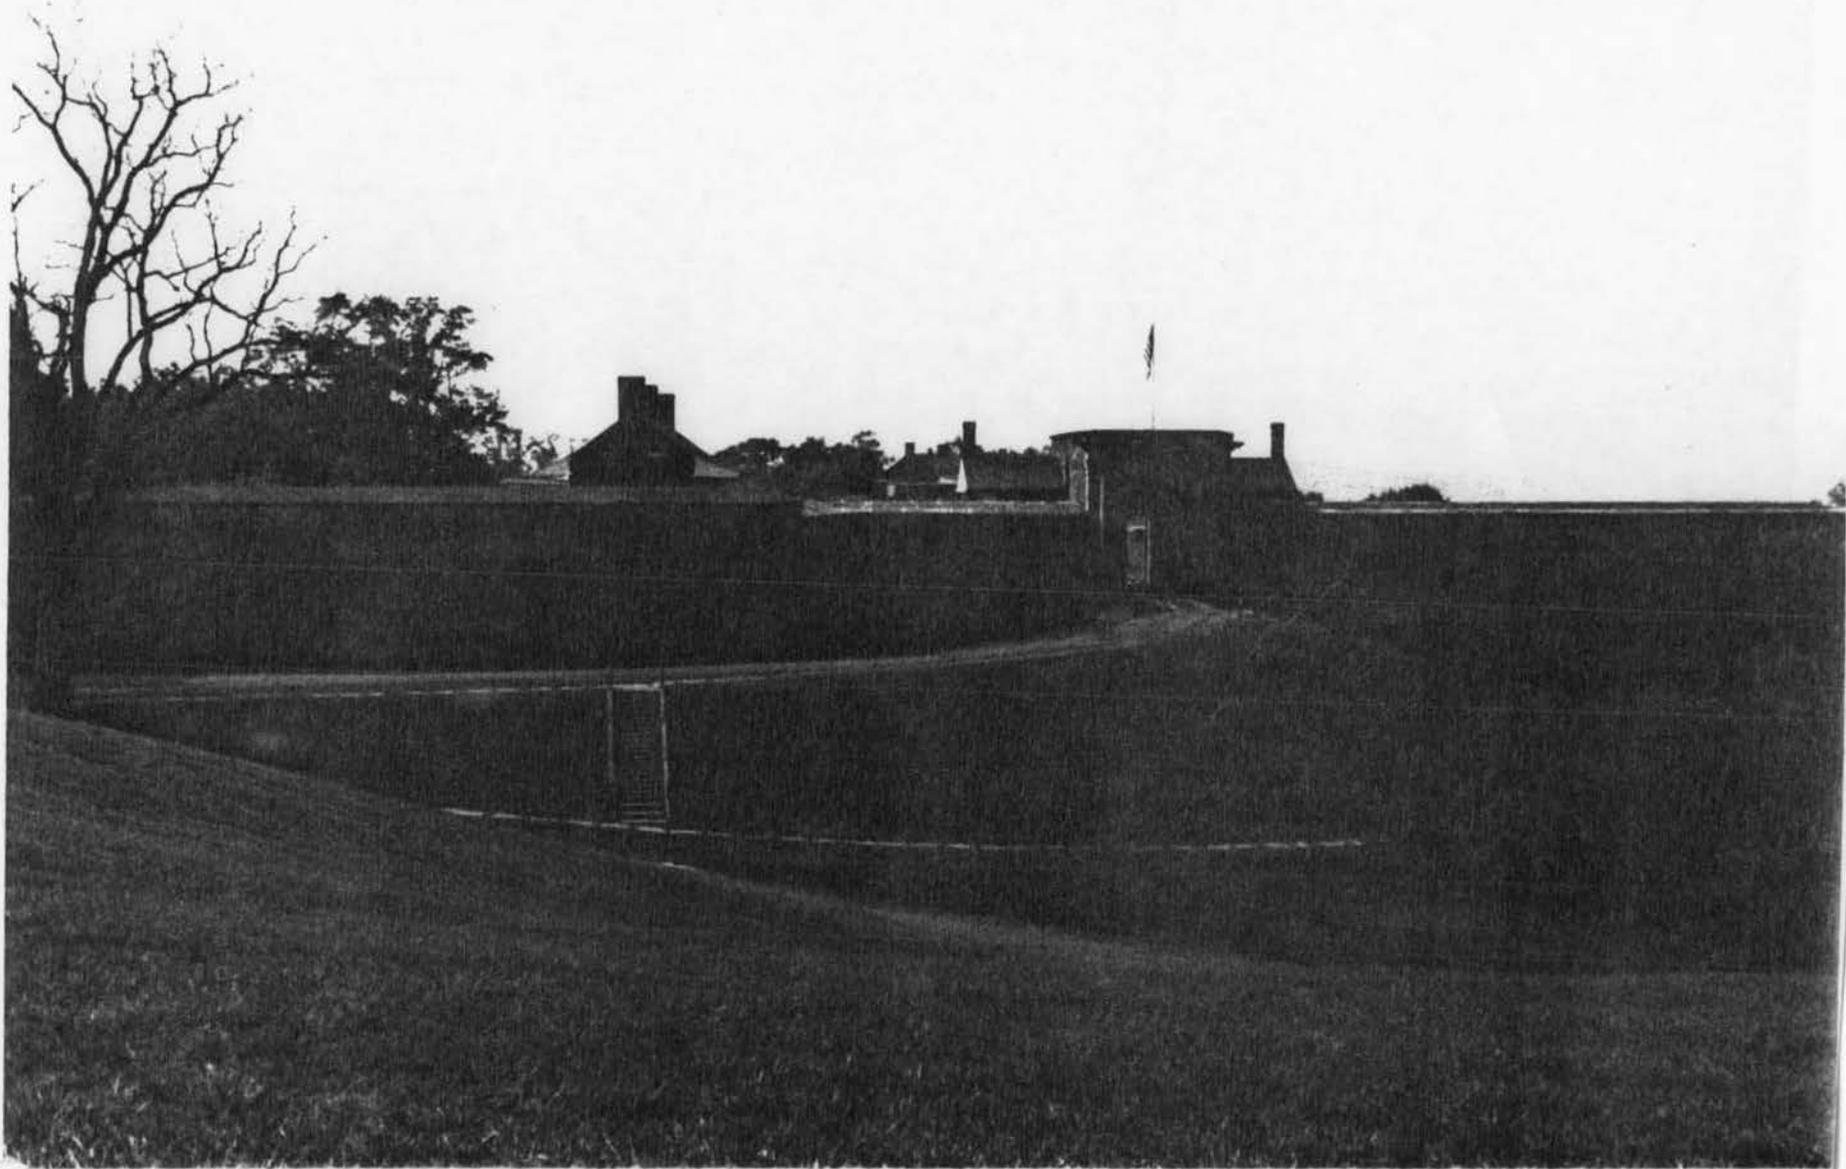
1. Gate House and North Wall of Fort

The main entrance to the fort proper consists of three parts; a monumental masonry entrance passage, an imposing archway with oversize decorative keystone and a heavy overhanging cornice, supported on each face by a pair of columns. The entire face, up to the level of the flanking wings, is rusticated, including the four columns. The ashlar decoration of the walls continues about 20 feet to either side of the opening on the outside where the stone projects into a pier-like terminus decorated with a Wall-of-Troy moulding. The interior of the gateway features handsome and striking brick vaults, one groin vault, one barrel vault. It also contains the remains of a set of old gears used at one time to hoist the drawbridge which spanned the dry moat. The bridge has now been replaced by a stationary one.

Flanking the masonry-faced centerpiece are a pair of brick wings, each of two storeys. They are open to the public and contain such interesting rooms as a guard-room and a solitary confinement cell. The two brick wings were restored 1957 to 1958, and are in excellent condition.

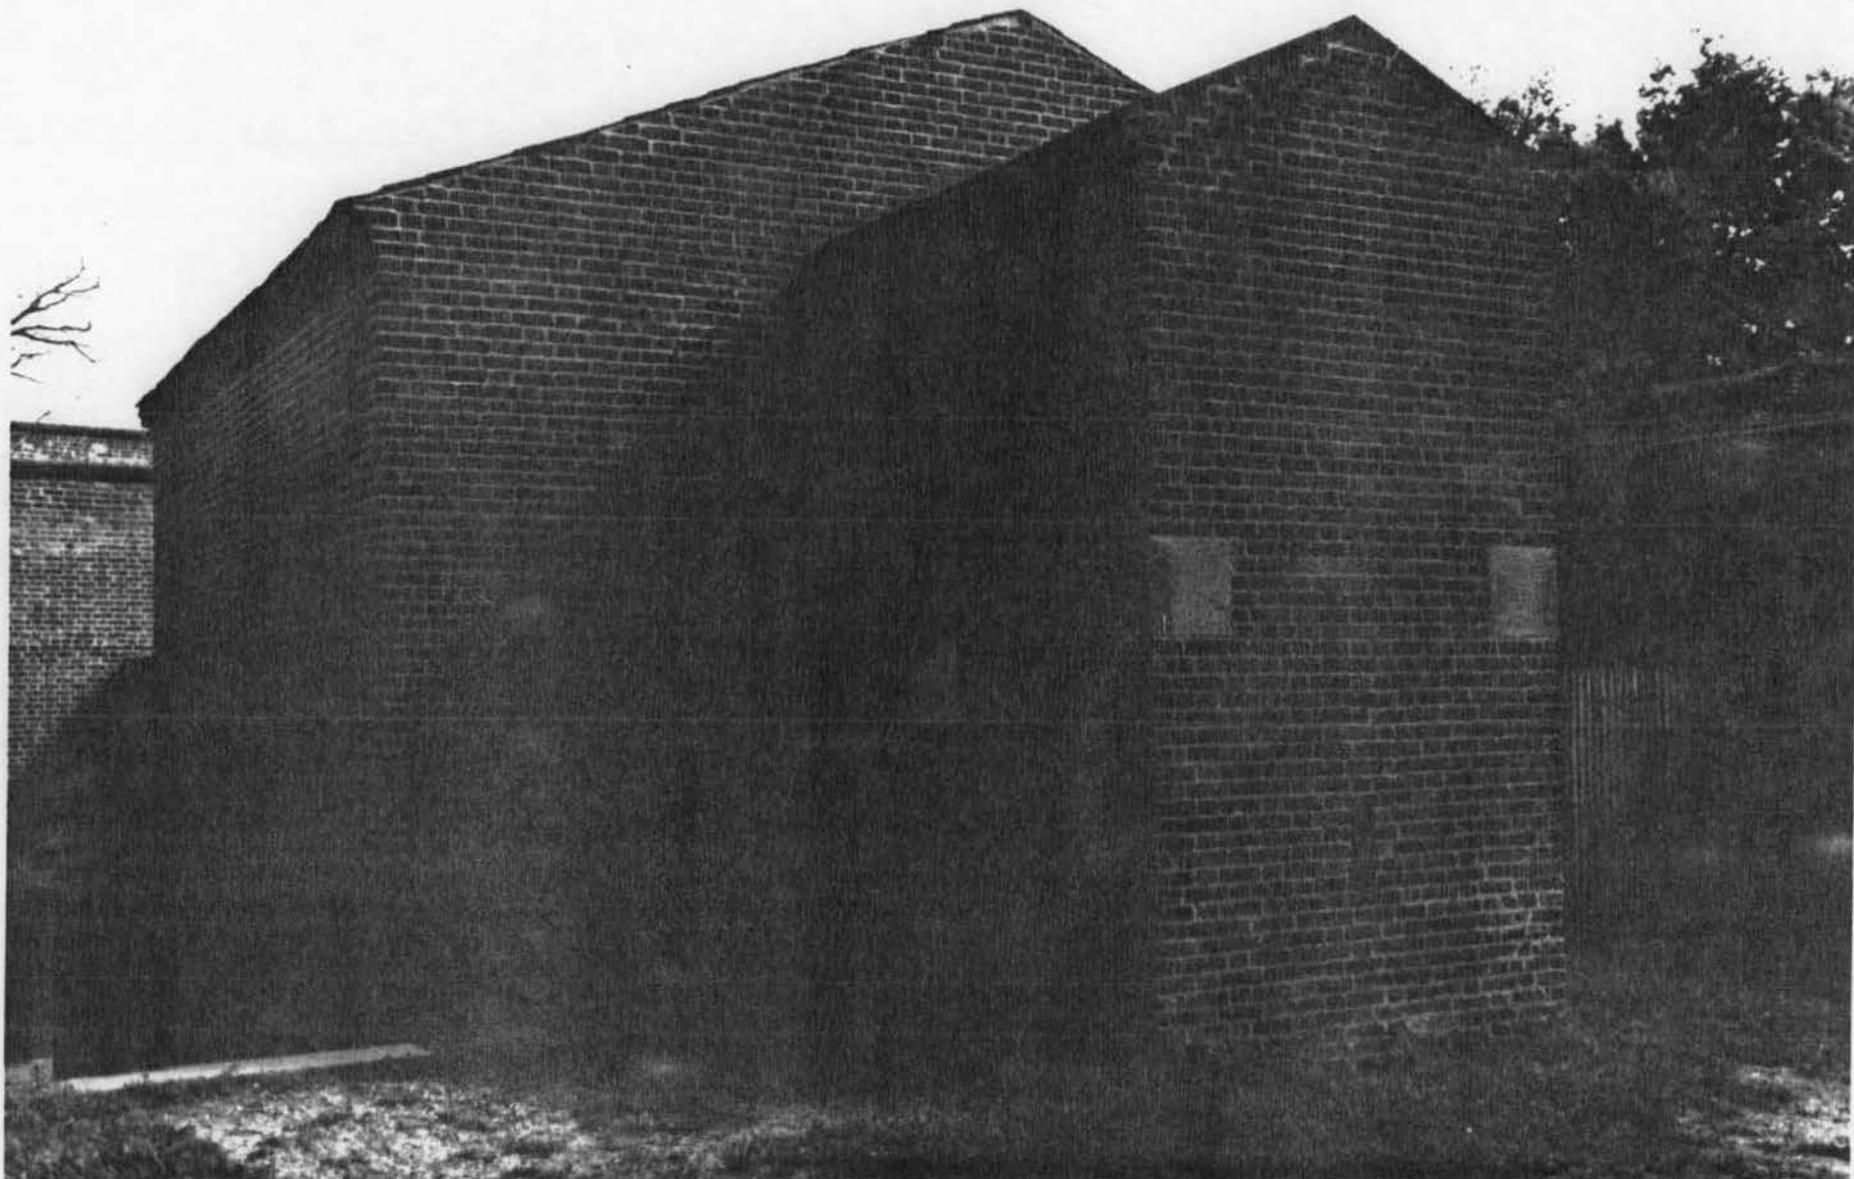
1. North Powder Magazine in Fort

The exterior brickwork of both magazines is in good condition, and the 1841 increase in height is clearly visible. The additional brickwork is approximately 2'-6" measured perpendicular to the roof slope. The brickwork is Flemish bond; the mortar is generally in good condition although some contemporary repointing resulted in joints being too wide. Stone impost blocks at the blindage wall arches have some surface erosion but are not in need of replacement at the present time.

Minor repairs are needed for the north magazine roof: replacement of broken slates on the main roof, complete new slating for the blindage roof, and installation of ridge caps, gutters and downspouts.

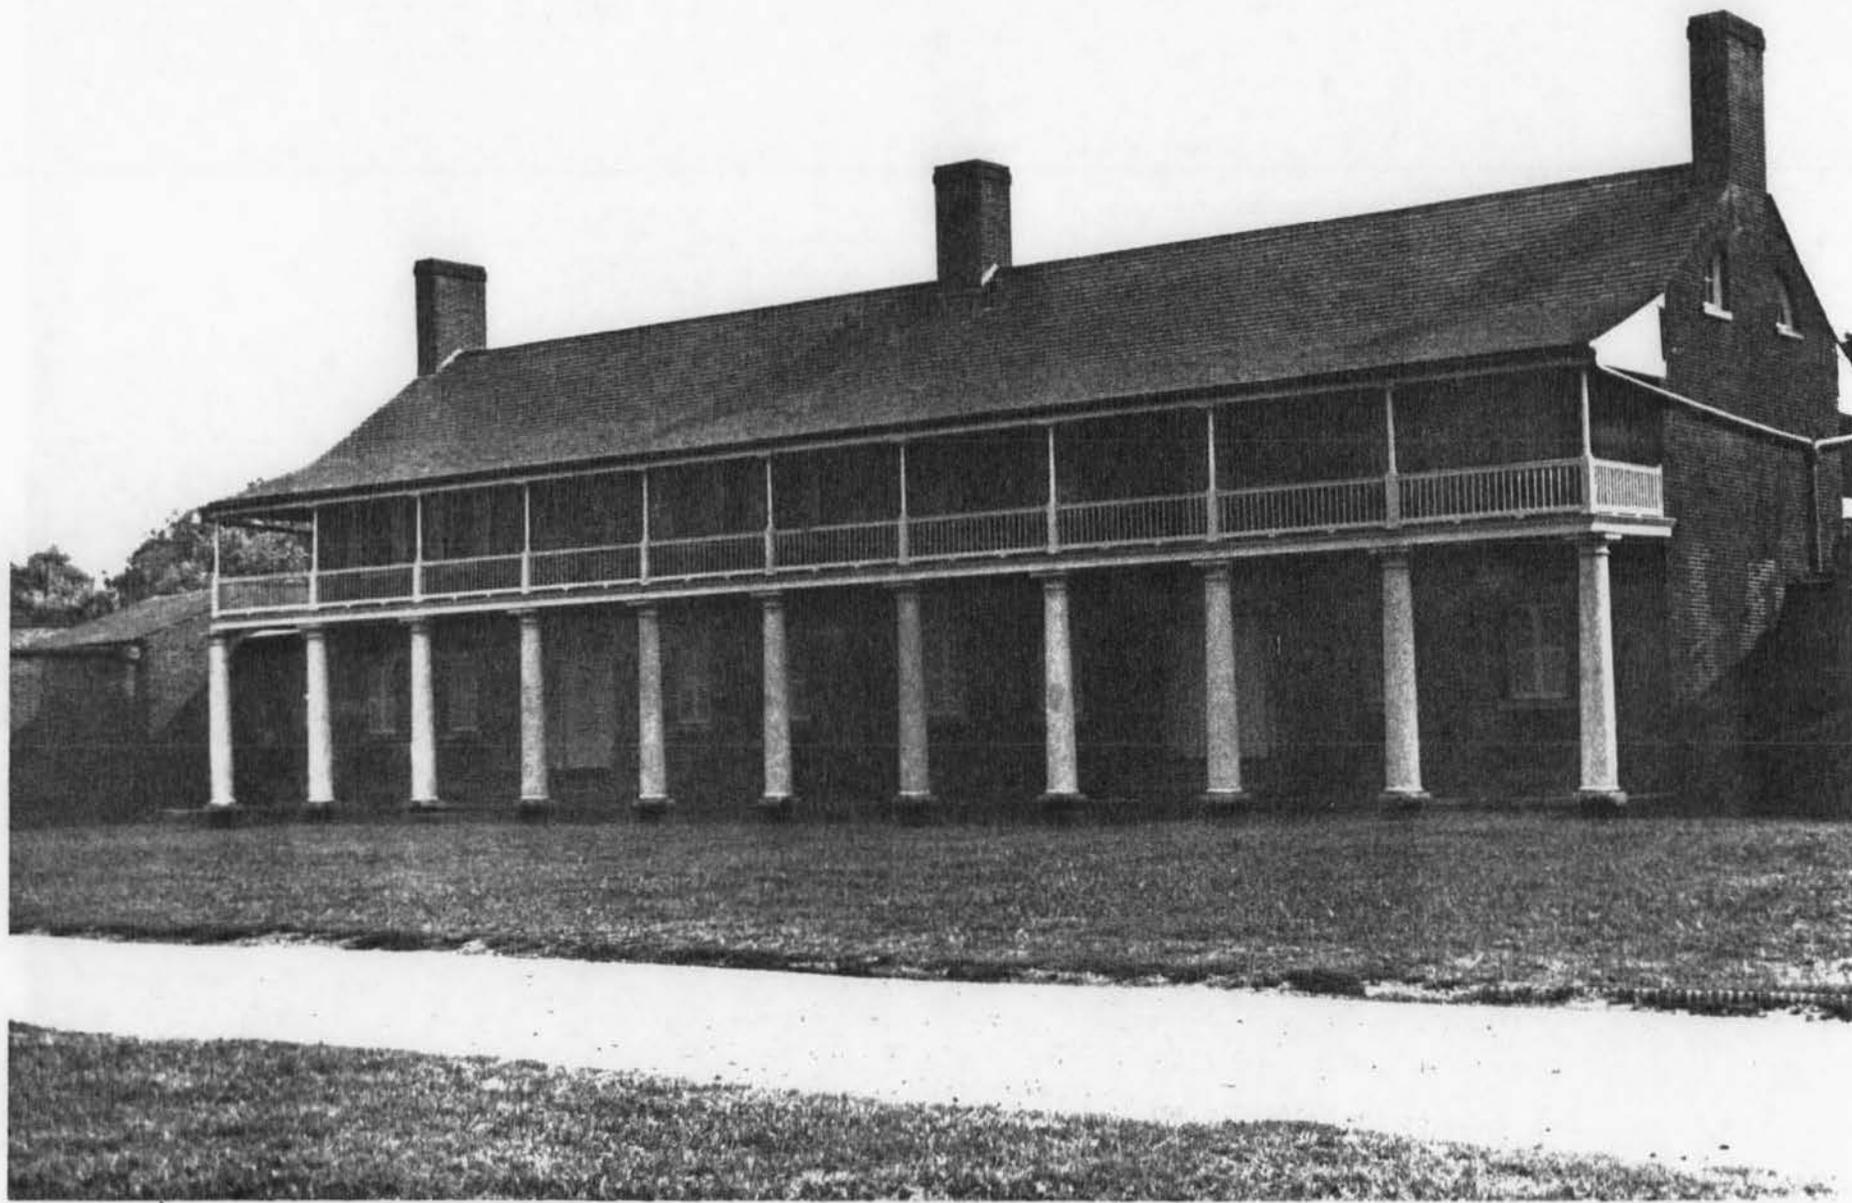
1. Officers' Quarters in Fort

The officers' quarters building is located inside the main walls of the fort, and faces west, paralleling the Potomac which is about 300 yards to the west. It is a long and narrow two-storey brick building with two end chimneys and one center chimney. The two principal entrances are at the west side, the northern one being a graceful exercise in federal style detail, with an elliptical fanlight, and sidelights flanking panelled doors. The south entrance on the west side was almost certainly a match, but now has its glazing replaced with boards.

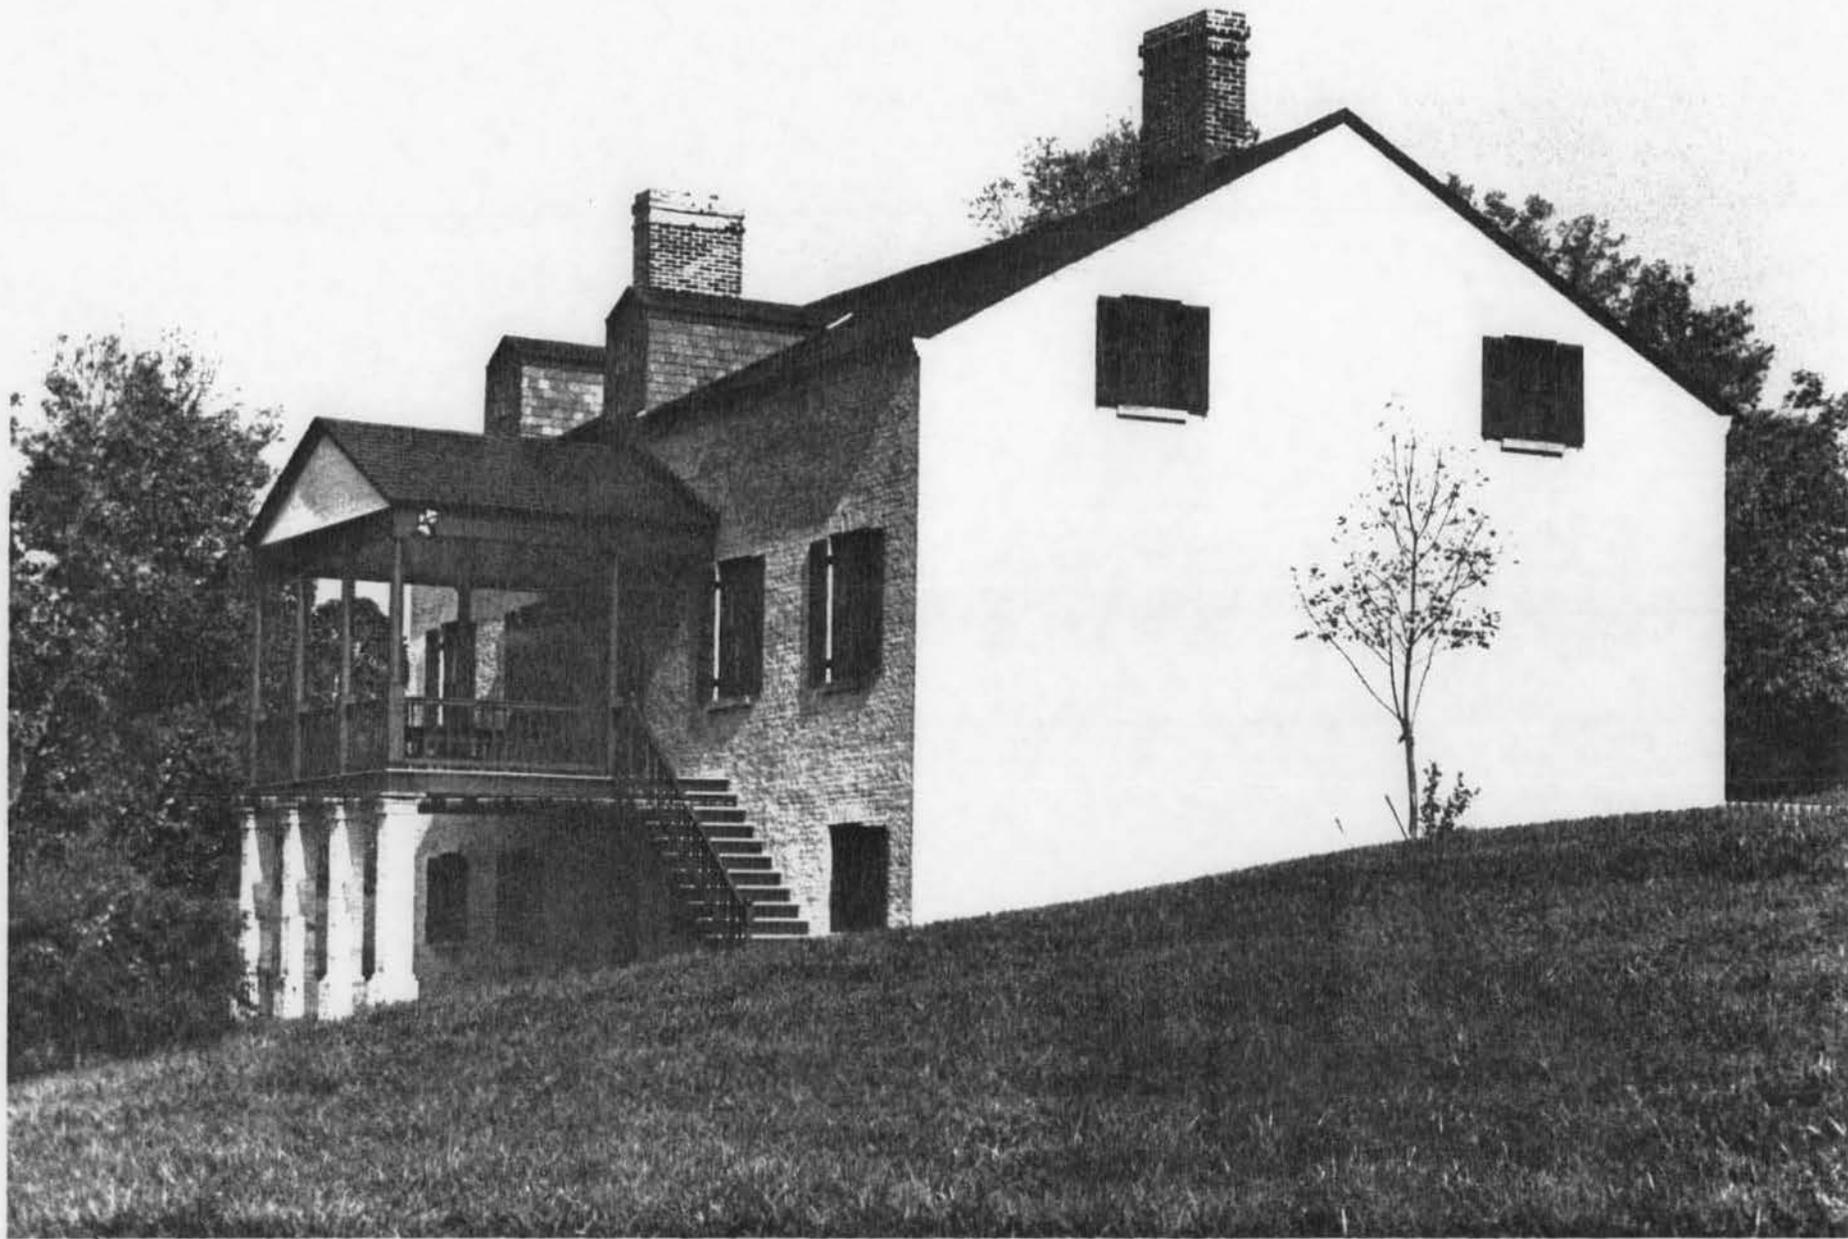
1. Commandant's House

As the quarters for the principal official at the Fort, the commandant's house was the largest, as well as the most finely-detailed. It has been adaptively restored as a Visitors' Center for the fort. The restoration included replacement of both porches and the three historic dormers.

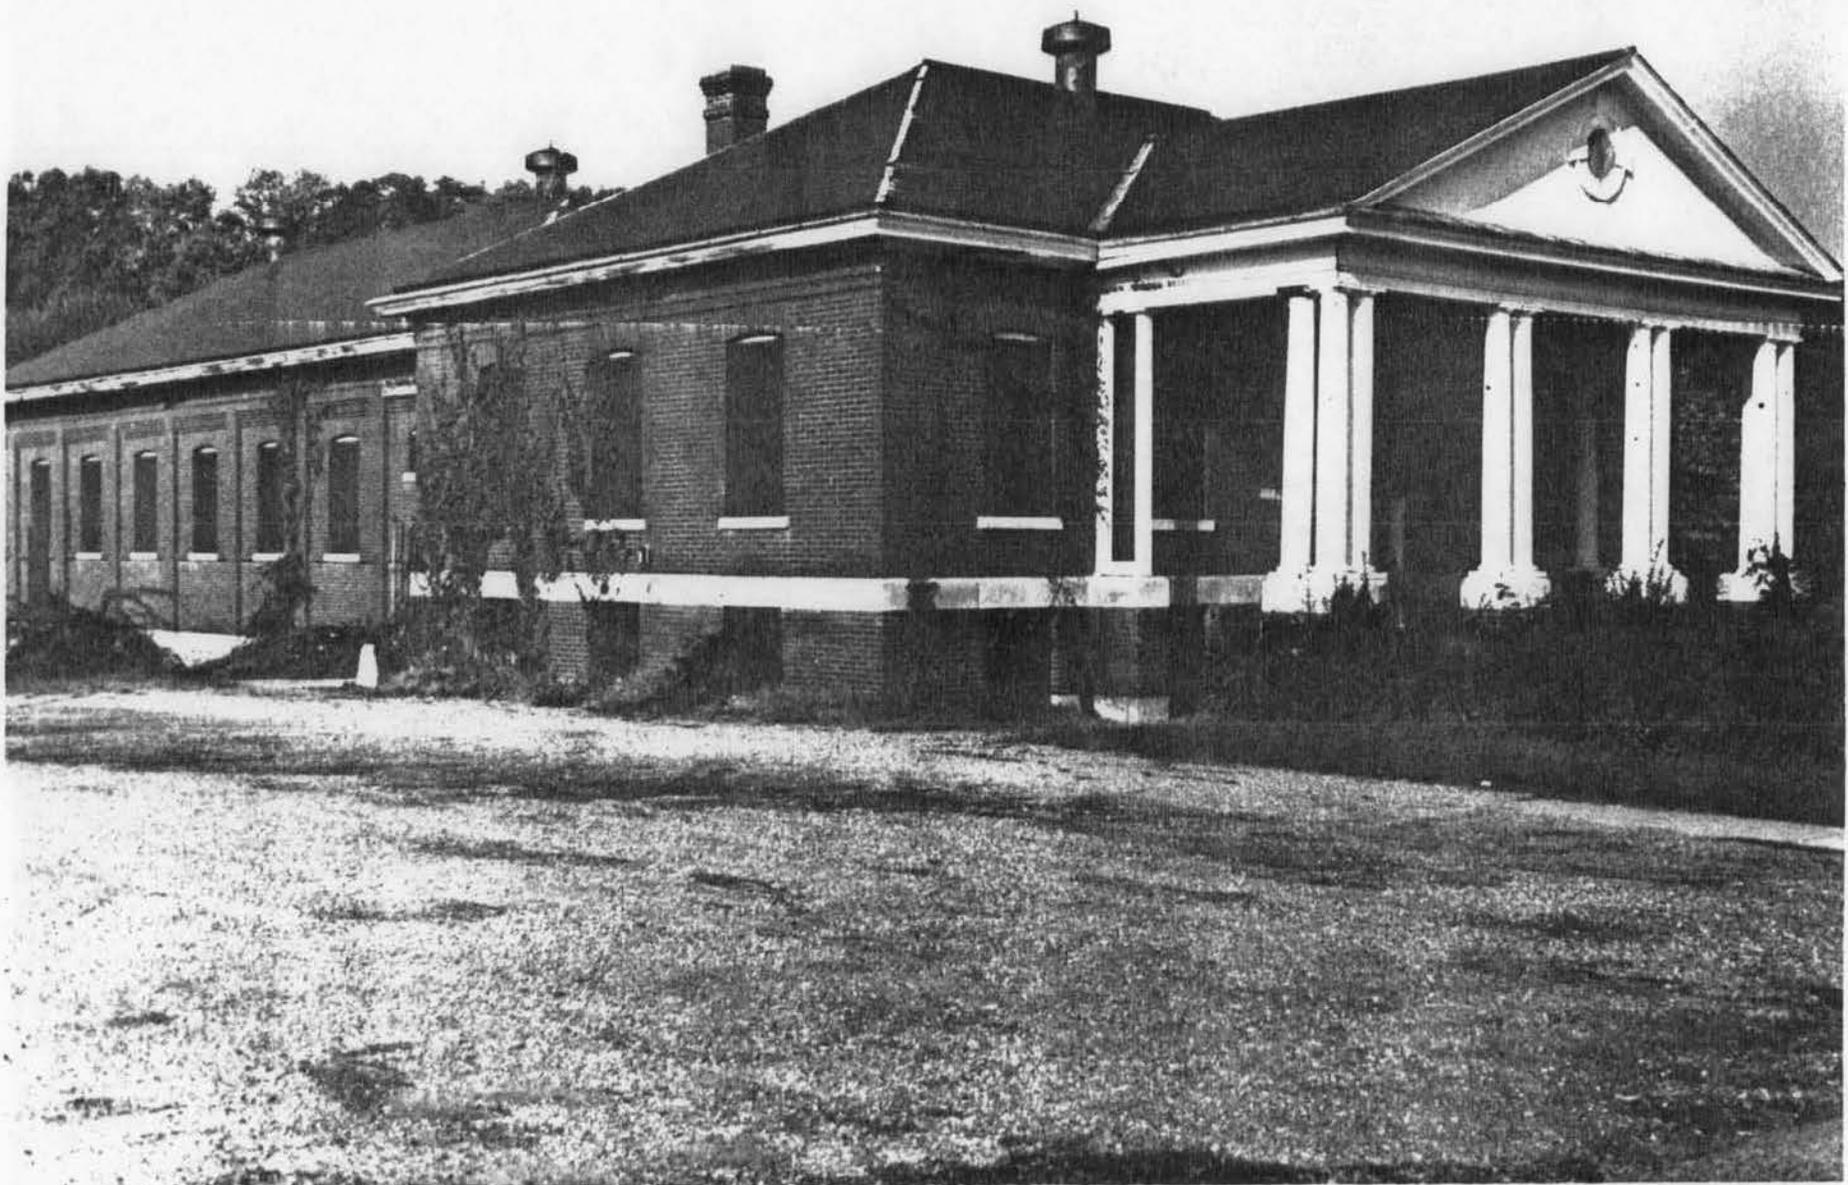
1. Pa. Building

This is the largest of the remaining buildings outside the fort walls and is located in the center of the park close to the eastern boundary. It was constructed at a cost of \$24,444 and completed in June 1906. This structure, brick on a stone foundation with slate roof, measures 103' x 51' and contains 6344 square ft. The front winged portion, 51' x 37', has two floors with twelve rooms. The rear portion is one large room, 34' x 75', which housed the gym. In 1933 the structure was remodeled and a portion was used as a school. During World War II the structure became the post headquarters building.

To date, the structure is essentially intact; some exterior brick and stone have fallen out and the wooden classical portico over the main entrance is in disrepair. The interior shows a great deal of deterioration.

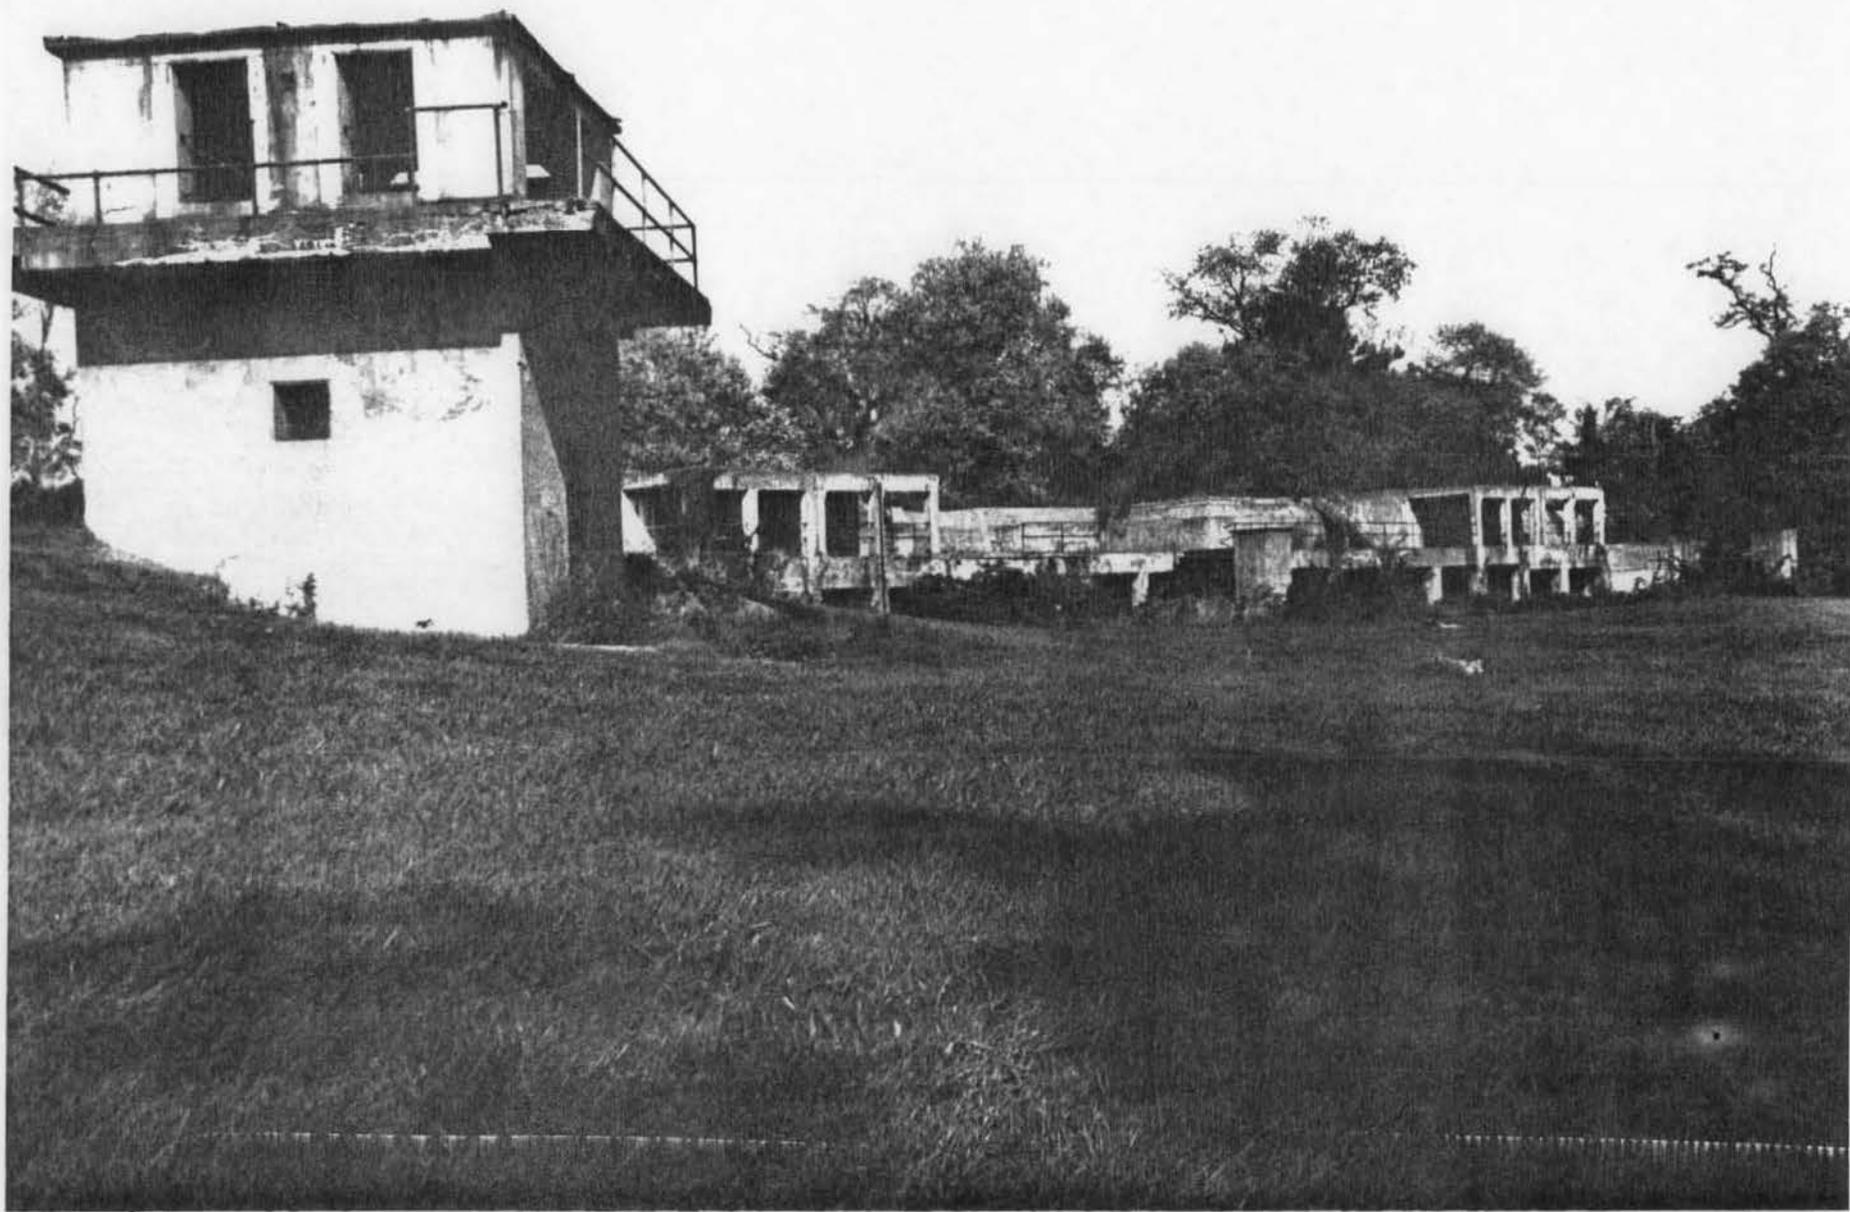
1. Control Tower and Battery Decatur

It is approximately 330' x 90' and designed for two 10" disappearing rifles. Battery Decatur is located immediately to the north of Fort Washington and is named for Commodore Stephen Decatur, U.S. Navy 1798-1816. The emplacements consist of each rifle mounted behind an 8' high protective concrete wall above a circular passageway system immediately beneath the gun pit. At this Battery the storage areas are double level below the guns and are protected by a 3' thick reinforced suspended slab. The general appearance of the Battery shows considerable cracking and leaching of the East spandrel beam supporting the upper platform and also considerable leaching of the upper protective roofs above the ammunition handling areas. The lower walls of the storage areas show considerable water infiltration and are wet and the upper walls surrounding the gun emplacements themselves show a great deal of spalling of the concrete surface, as if the surfaces were refinished at some time subsequent to the initial construction and this finishing layer is deteriorating now and spalling away from the walls.

The physical condition of the battery varies from section to section. Some areas are in good condition while others show erosion of the concrete up to 1 1/2" in depth. Some I-beams are badly rusted due to water infiltration. The battery is fenced in and closed to the public.

This is one of the two battery commander stations at Fort Washington, whose function was to provide an elevated but safe lookout for the men directing fire from the batteries. Consequently, the building's design is highly defensive. A brick and concrete two-story tower with a platform walkaround about 15'-20' above the sloping ground. On the water sides, the space through which to observe is barely a slit, while on the land side, the opening is much larger. Entrance doorway is at the east (land) side. Some deterioration, and probably some safety hazard. Stairway has been removed and is presently stored inside Battery Decatur for safety purposes. Constructed c. 1905.
