CAPSULE SUMMARY
Rosaryville State Park
MIHP # PG 82A-51
Upper Marlboro Vicinity
Prince George's County
Park – 1973
Public

Maryland Inventory of Historic Properties Form

Name Rosaryville State Park
Continuation Sheet

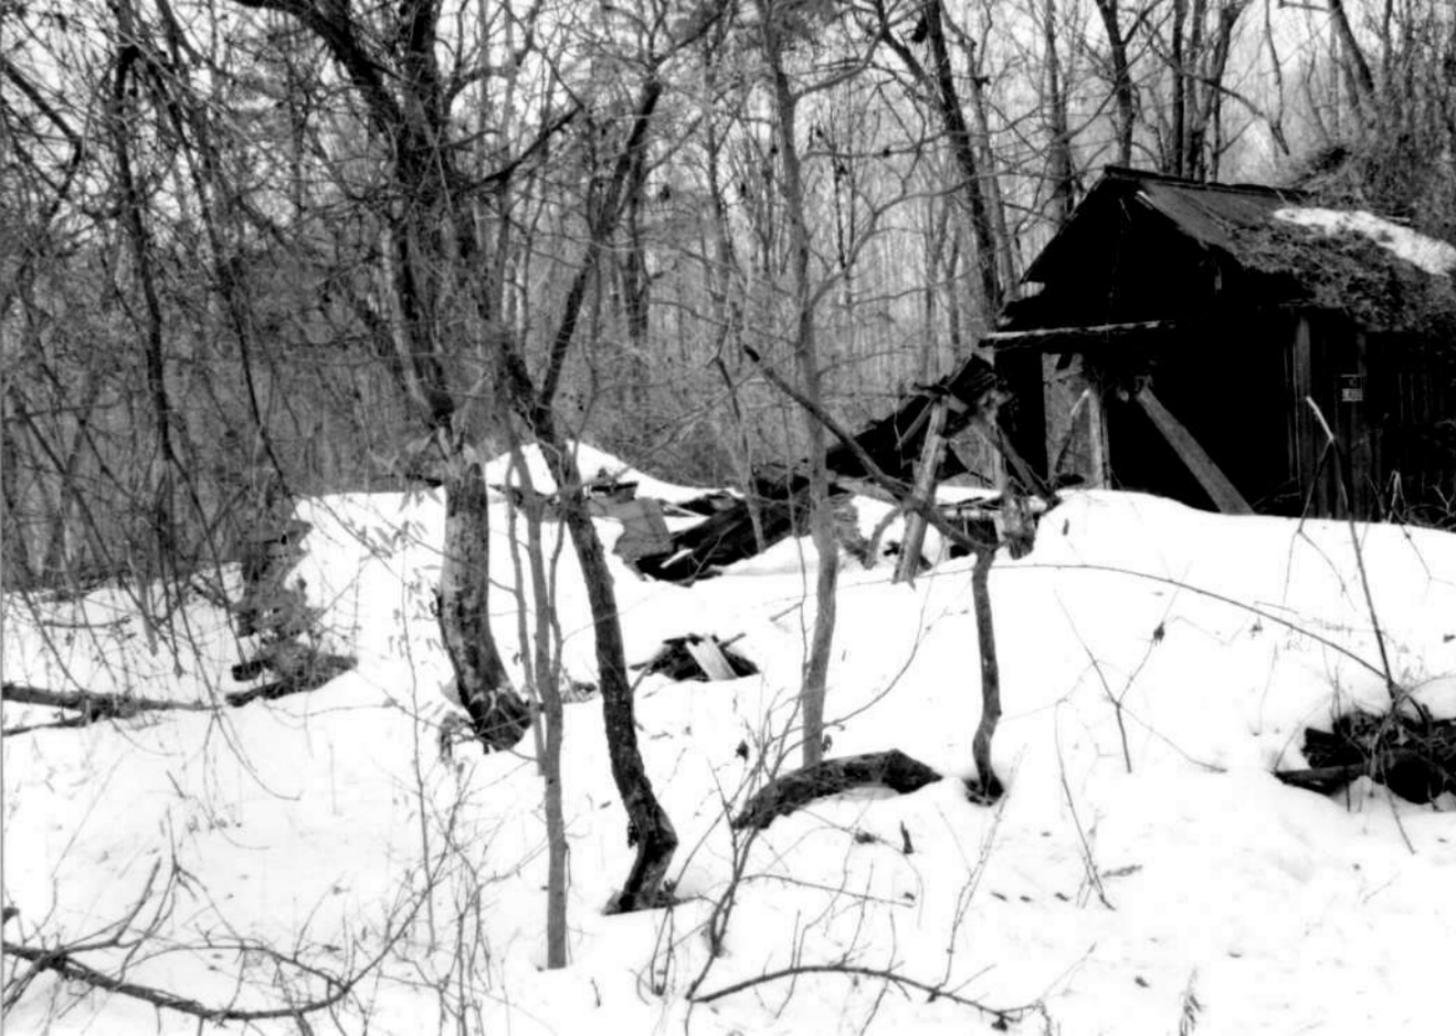
The remains of a former TENANT HOUSE, constructed ca. 1950, were found in the woods west of the Smith tenant houses in the Mount Airy section of the park. The building is not visible from park's main access road and is accessible only by foot. The building is in ruinous condition. Nearly the entire wood-frame building had collapsed; the kitchen was the only section of the building that remained standing. The kitchen is clad in board-and-batten wood siding. The gable roof is clad in corrugated metal. An interior, gable end brick chimney was present. An eighteen-light, fixed sash wood window and a four-paneled wood door were noted. Snow covered the collapsed section of the building, thereby precluding visual assessment of the rest of the dwelling.

HHP # PG 82A-51
Rosaryville SP
PG Co. MD
RCA, Inc
1-2/2003
MD SHPO
Former tenant hse - W elevation
14/26

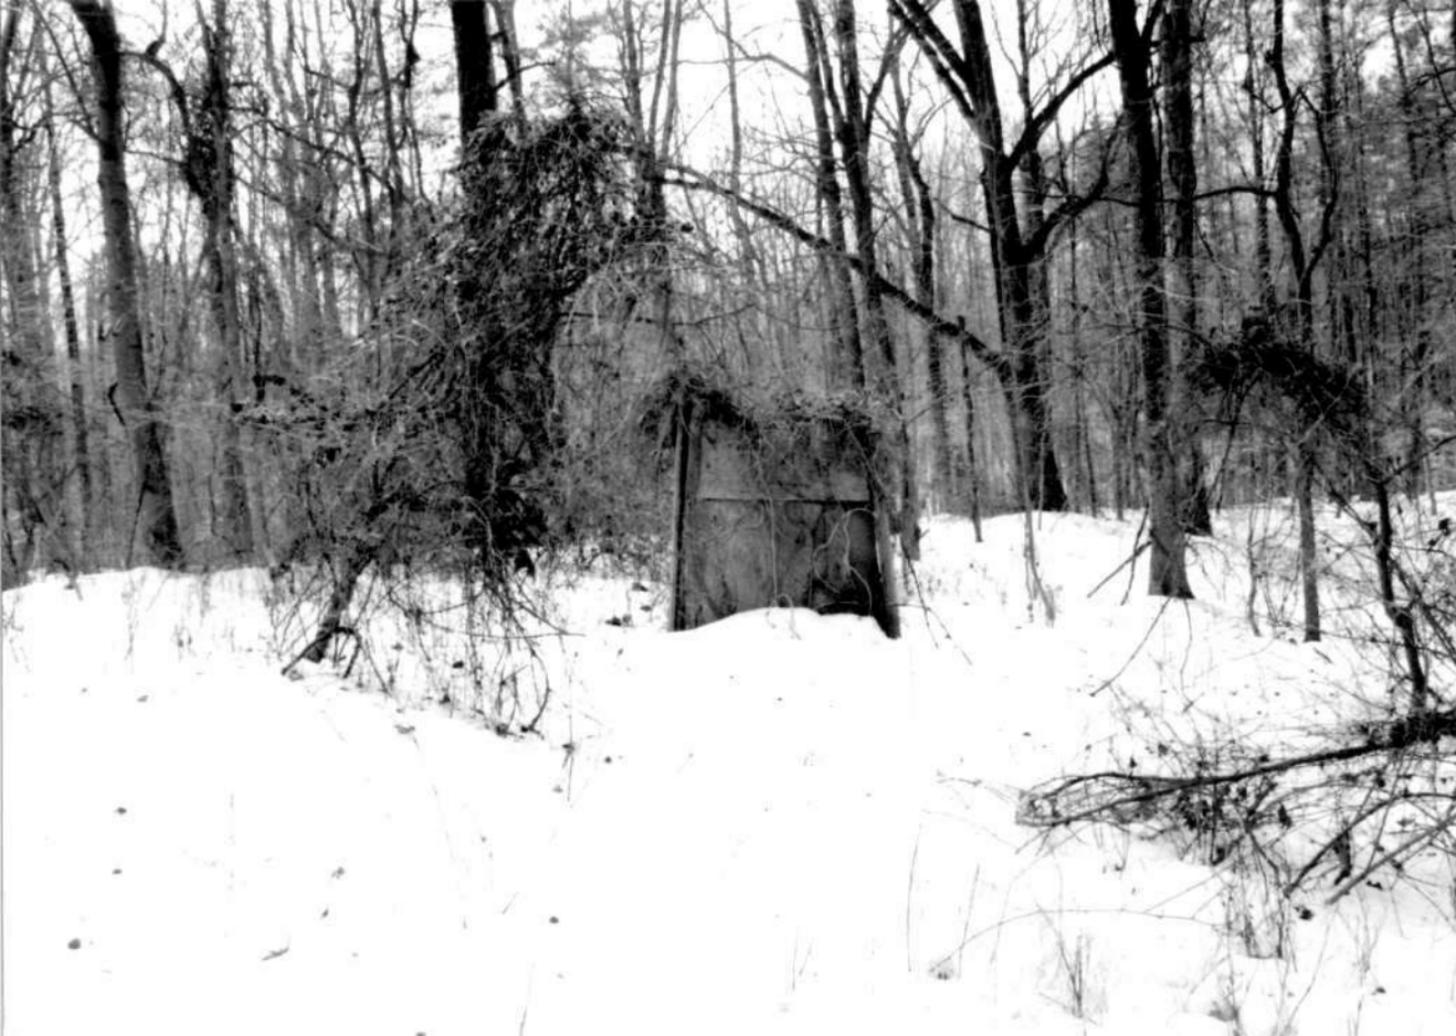
MHP # PG 82A-51
Rosaryville SP
PG Co. MD
REGA, INC.
1-2/2003
MD SHPo
Former tenant hse outlse - N elevation
15/26

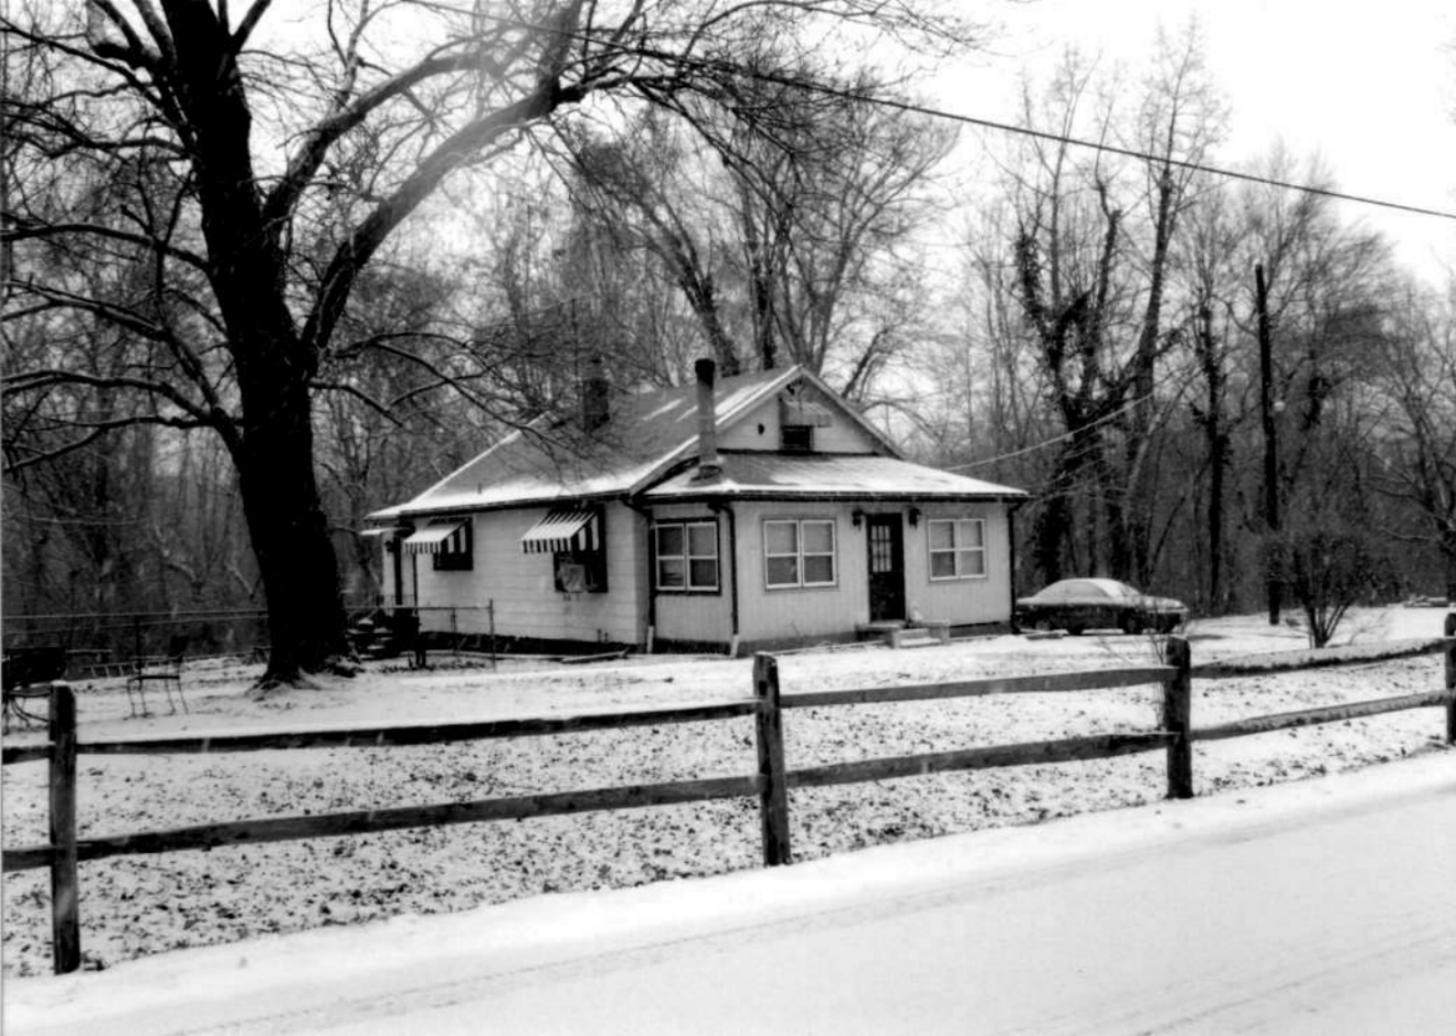
The former LEDMAN HOUSE, constructed ca. 1953, is located on Marlton Road, which serves as the park's access road to the day use area. The building is located immediately inside the park gate. The one-story, wood-frame residence rests on a concrete-block foundation. The building terminates in a front gable roof sheathed in asphalt shingles. A brick chimney is found at the north end of the west elevation, at the ridge of the roof. A metal stovepipe is located on the southwest corner of the enclosed front porch. An enclosed porch spans the front elevation of the dwelling. The enclosed front porch is clad in T1-11 and terminates in a truncated-hipped roof. The primary entrance is centered in the enclosed porch and contains a nine-light wood door. The building is clad in asbestos shingles. Windows consist of double-hung, six-over-six-light, wood-sash units on the principal block; metal awnings are located above the windows. Windows on the enclosed porch consist of one-over-one-light, vinyl-sash units on the front (south) elevation, and six-over-one-light, vinyl-sash units on the east and west elevations. A small, enclosed porch, with shed roof, is located on the rear of the house. The building is in good condition.

MIHP # PG 82A-51
Rosaryville SP
PG Co. MD
RCSA, Inc.
1-2/2003
MD SHPO
Former ledman hse - s + w elevations
16/26

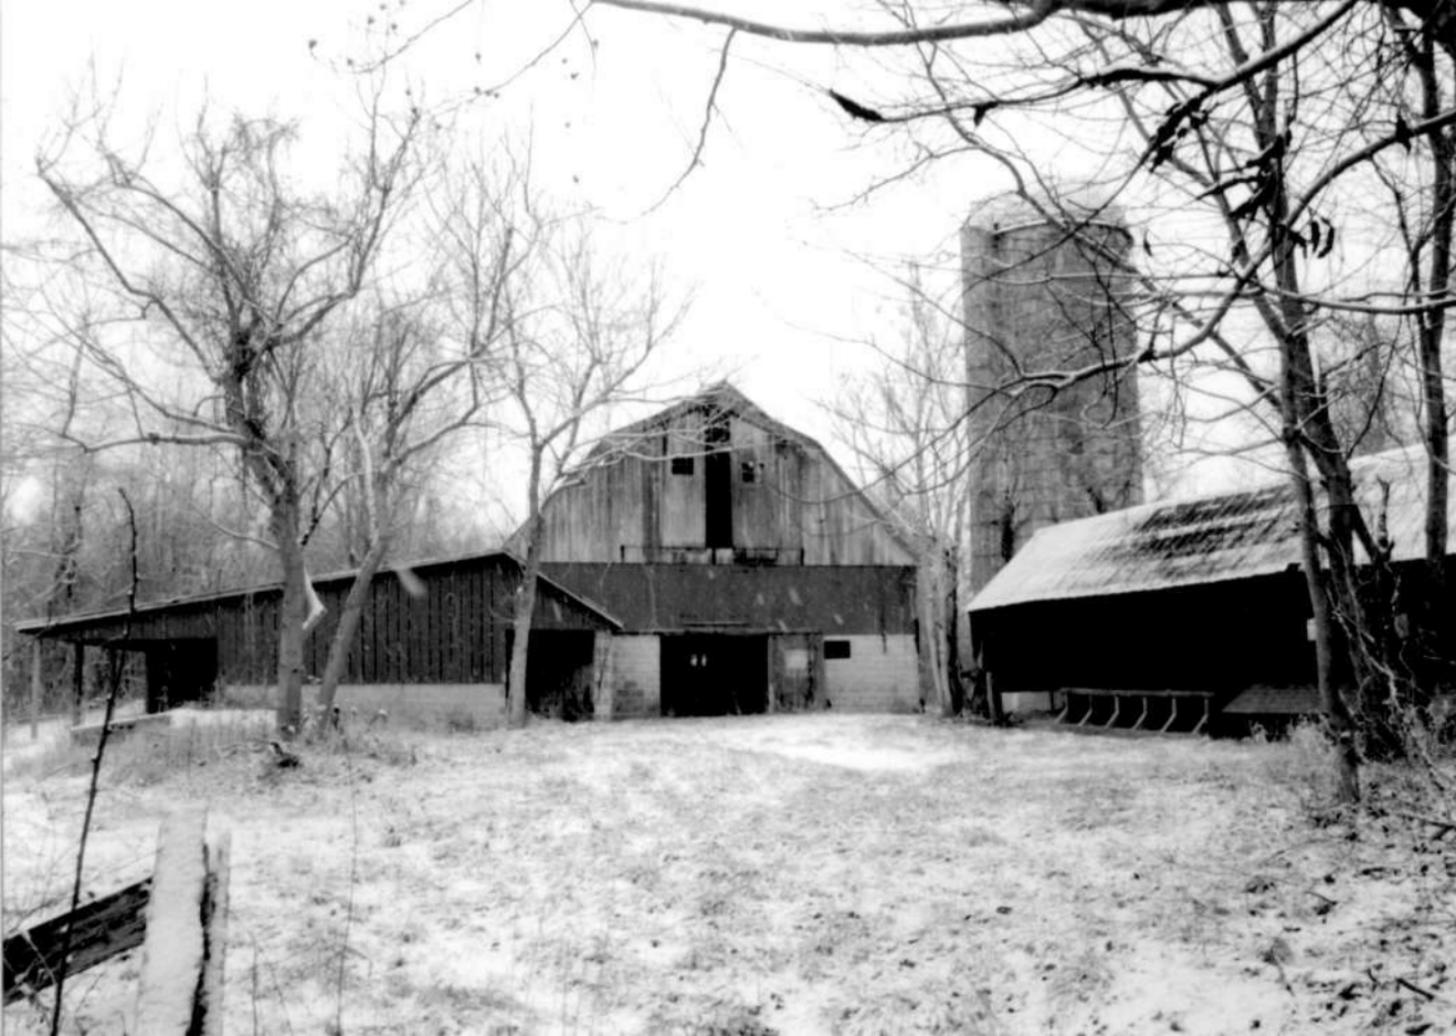
The former DUVALL DAIRY BARN (ca. 1940) (MIHP # PG:82A-27) is located off the park's access road and is part of a complex of agricultural outbuildings. The entire complex is recessed from the road; trees screen the buildings. Open fields are located between the trees and the road. The barn faces east. The first story is constructed of rusticated concrete block. Metal hopper windows are located on the side (north and south) elevations. The upper wood-frame loft is clad with vertical board wood siding. The gambrel roof has projecting eaves and is sheathed in standing seam metal. Hopper windows also flank the first floor entrance, which is centered in the elevation. On both the east and west elevations, double, sliding wood track doors are located on the first floor and double doors on the loft level. Fixed, single-light, wood-sash windows are located on both loft doors. On the interior, the barn has eleven bays on each side of a central corridor.

MHP # PG 82A-51
Rosaryville SP
PG Co. MD
RCA, Inc.
1-2/2003
MD SHPO
Duvall dairy barn, sib, equipment shed - W elevation
21/26

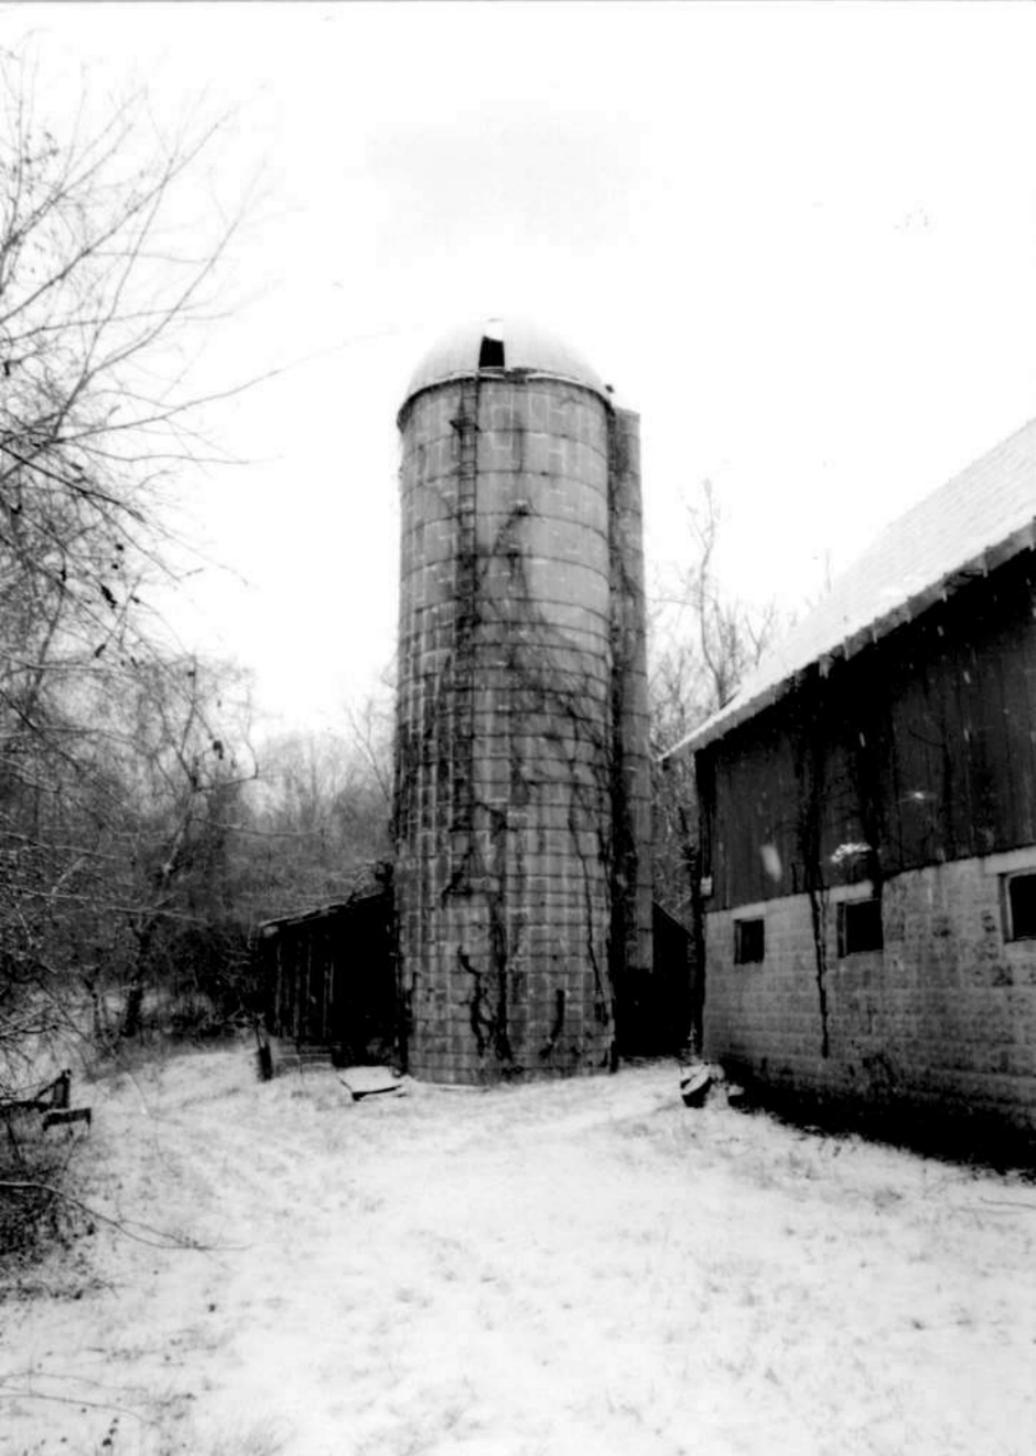
The former DUVALL SILO, constructed ca. 1942, is located west of the dairy barn. The concrete-block structure occupies a round plan and has a round roof clad in standing seam metal. The silo is in fair condition. Some of the roof's metal panels are missing.

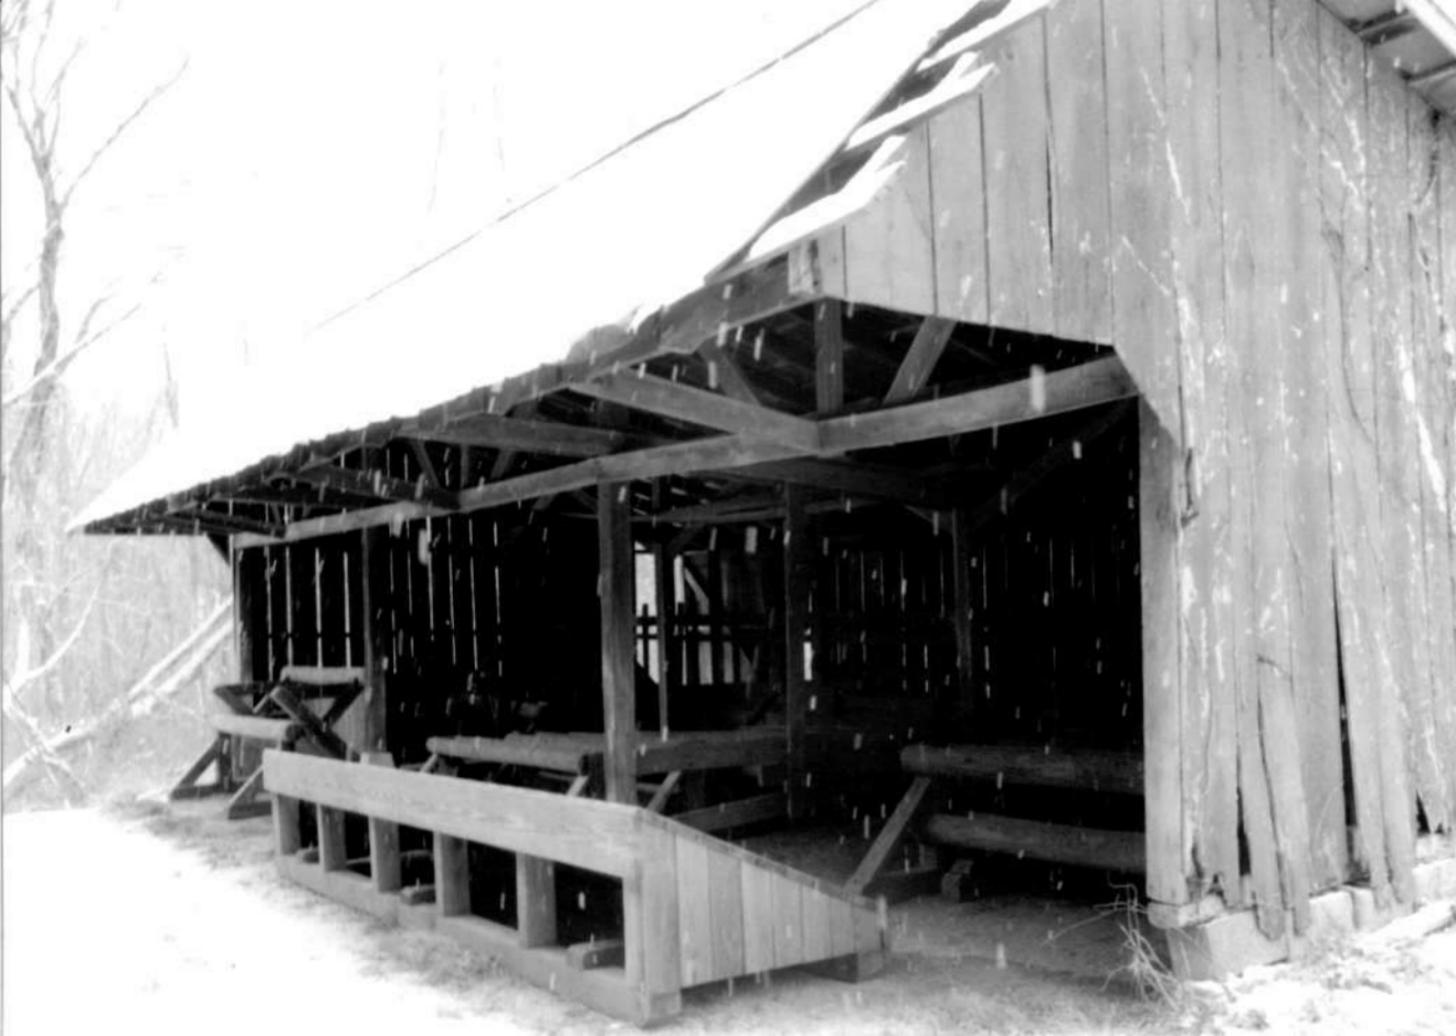
The former DUVALL IMPLEMENT SHED, constructed ca. 1940, is located east of the dairy barn and faces west. The one-story, two-bay, wood-frame building rests on a concrete-block foundation. The building is clad in vertical board wood siding. The building terminates in a gable roof sheathed in standing seam metal. The west elevation is partially open, exposing the wood posts that support the roof. Wood doors are located on the north and south elevations. The building is in fair condition. There was evidence of rot and loose vertical siding. Additionally, some of the roof's metal panels are missing, exposing the rafters to weather.

MD SHPO
Duvall implement shed - w elevation
24/20

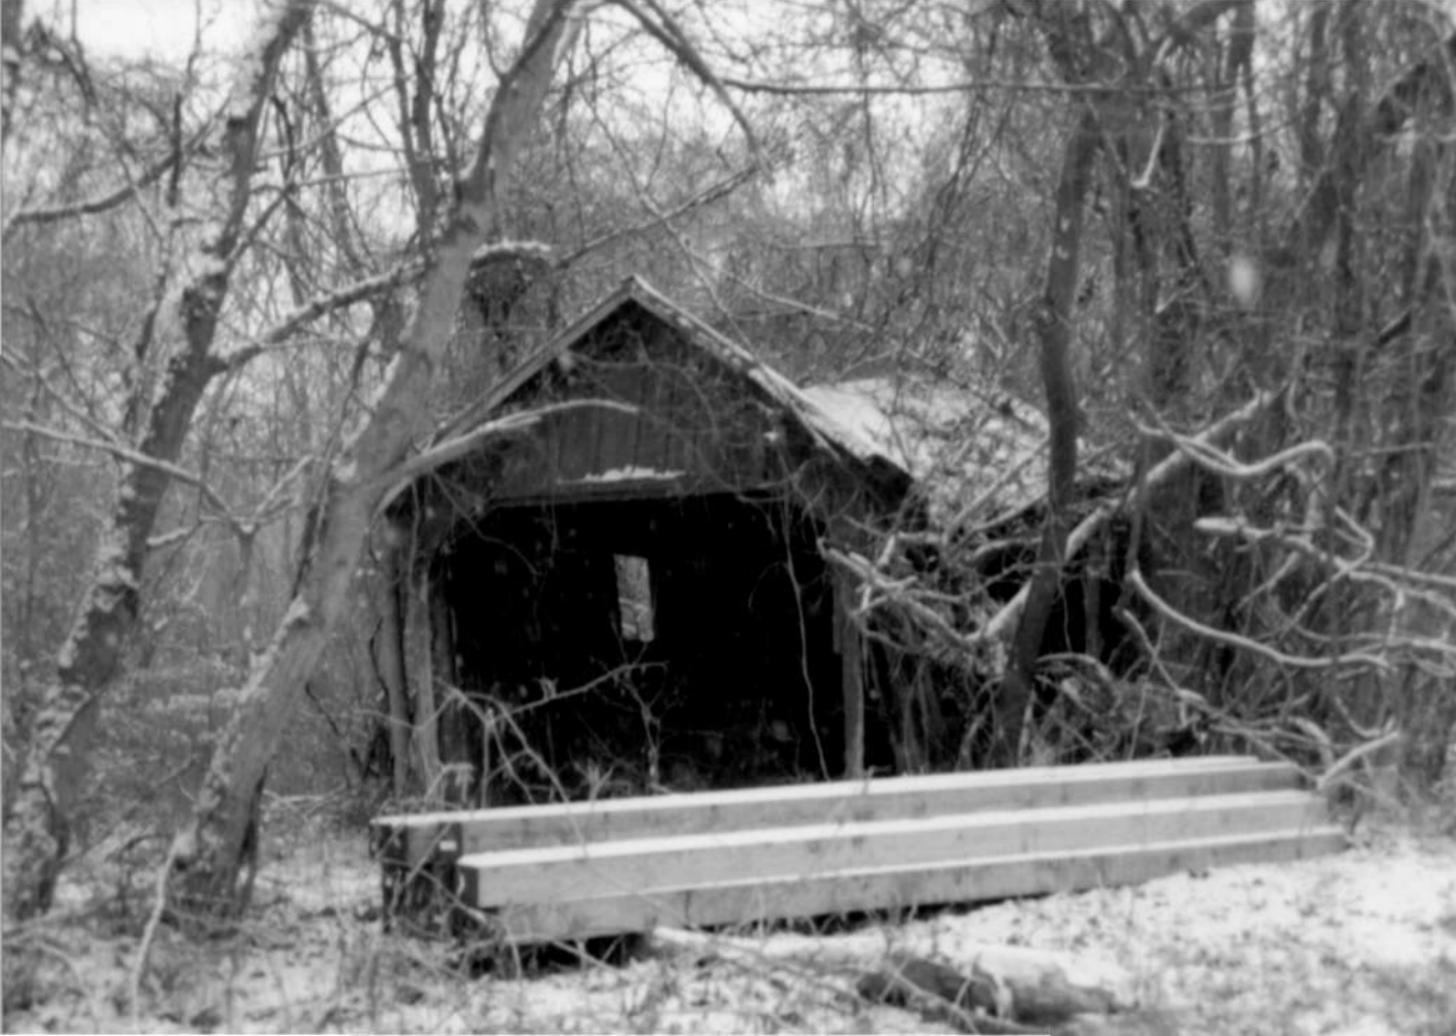
25/26

The former DUVALL GARAGE, constructed ca. 1930, is located east of the dairy barn, some distance from the other agricultural outbuildings. The one-story, wood-frame, mortise-and-tenon building occupies a rectangular plan and rests on an earthfast foundation. The front gable roof is clad in corrugated metal. The south elevation has a projecting eave. The building has one window opening; the sash is missing. A large, entrance is centered on the west elevation. No doors were present. The building is in poor condition. Loose and missing siding was noted. The roof has partially collapsed on the south elevation. The building also was leaning, suggesting evidence of structural failure.

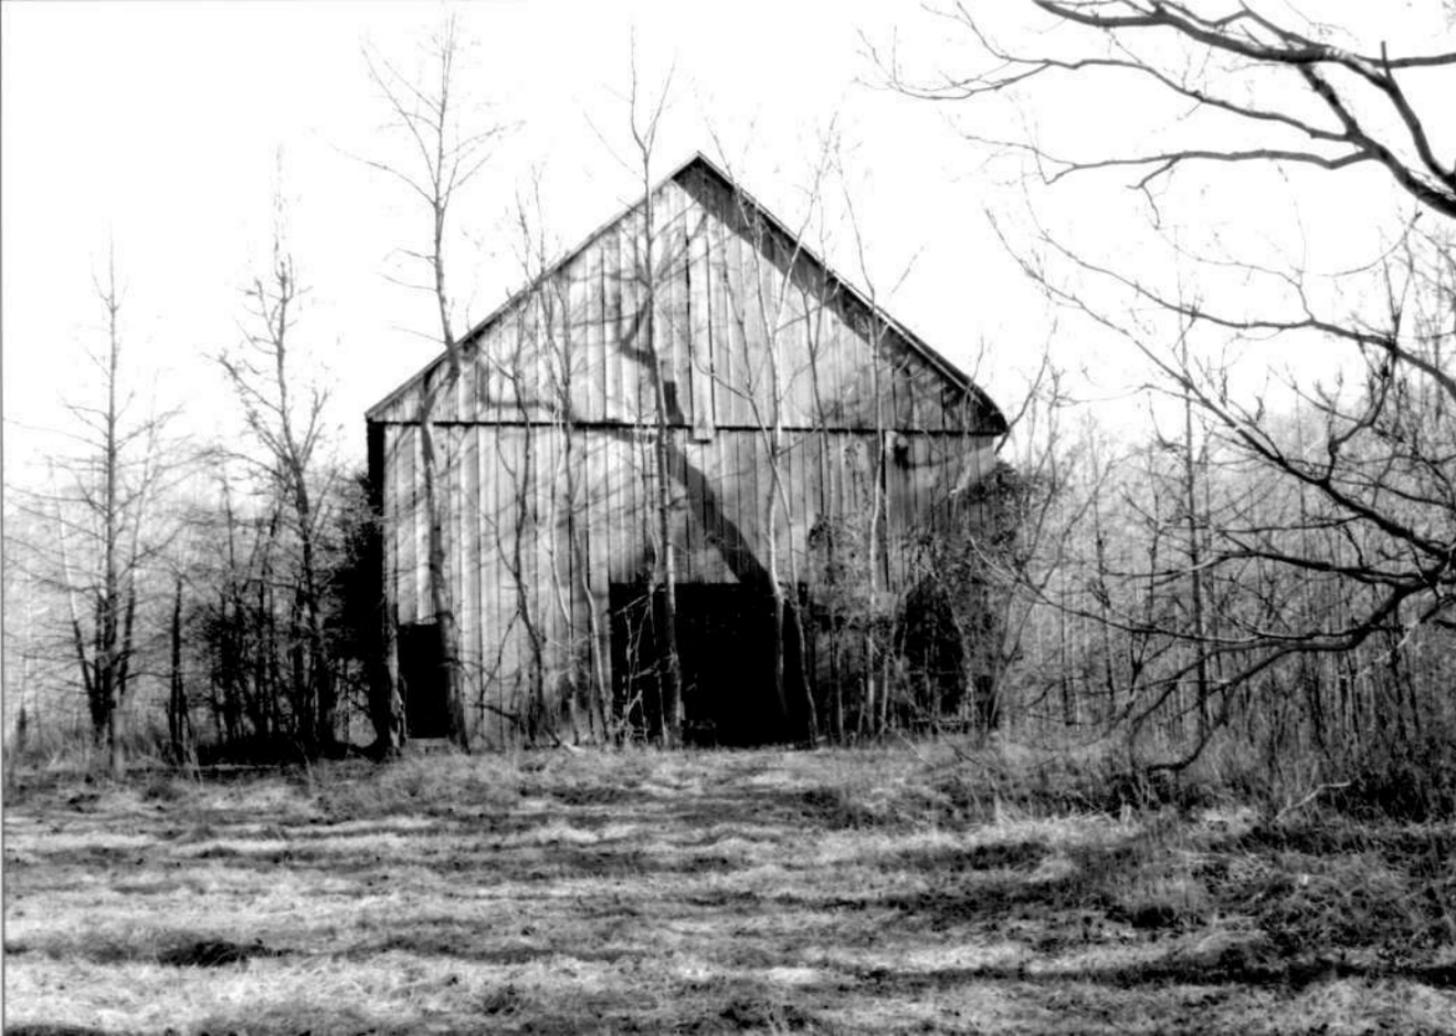
MIHP # PG 82A-51
Rosaryville SP
PG Co. MD
QCSA, INC.
1-2/2003
MD SHPO
Magruder retail barn - s elevation
26/26
