Maryland Inventory of Historic Properties number: PG: 81-24.  
Name: P410/GARDNER RD. OVER MATAWOMAN CREEK

U.S. 301 South Corridor  
Transportation Study

MARYLAND INVENTORY OF HISTORIC BRIDGES  
HISTORIC BRIDGE INVENTORY  
MARYLAND STATE HIGHWAY ADMINISTRATION/  
MARYLAND HISTORICAL TRUST

SHA Bridge No. P410 Bridge name Gardner Road over Mattawoman Creek

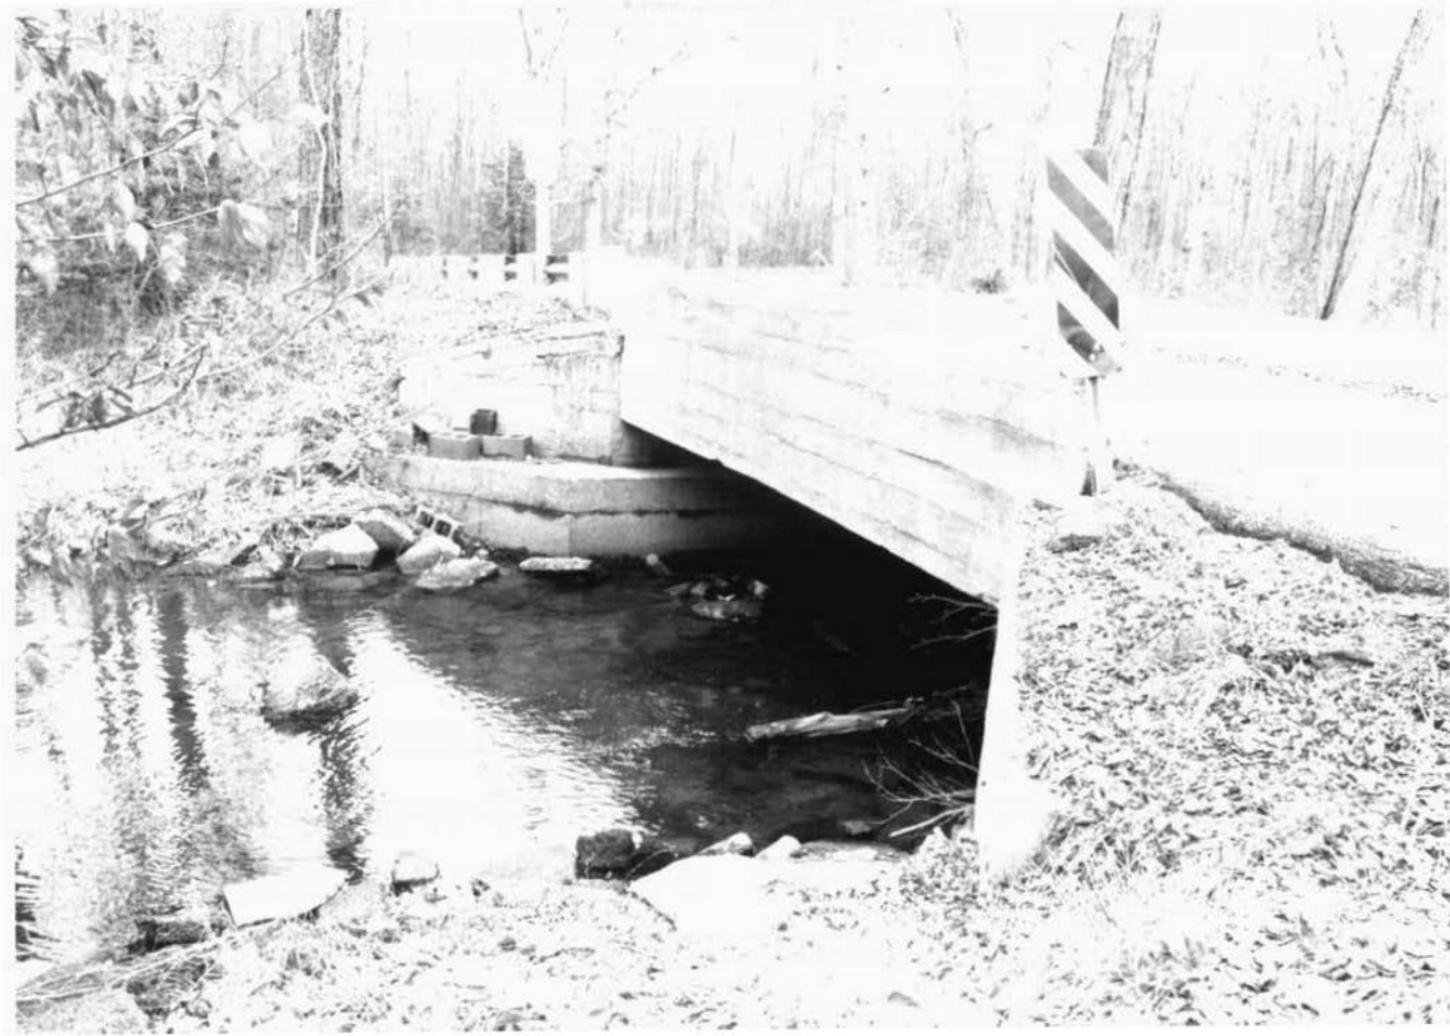
- 1) PG: 84-24
- 2) Gardner Road over Mattawoman Creek
- 3) Prince Georges County - Charles Co line, MD
- 4) Julie Darsie
- 5) 1-99
- 6) MD SHPO
- 7) W elevation - View NE
- 8) 1 of 4

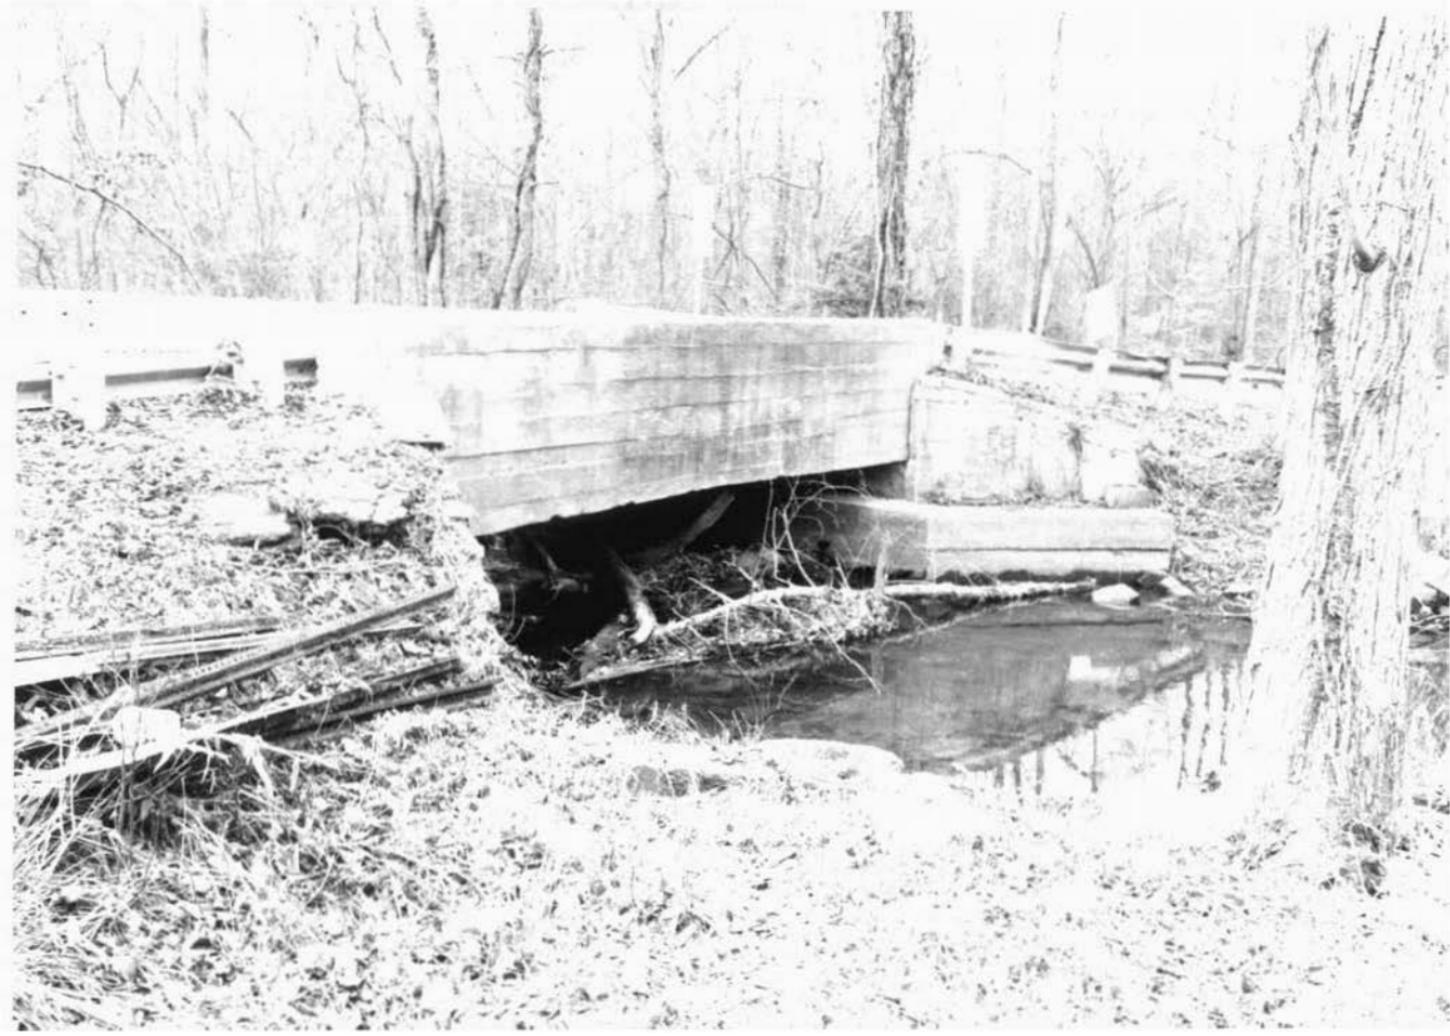
D PG: 84.24

- e) Gardner Rd over Mattawoman Creek
- f) Prince George's Co - Charles Co Line, MD
- 4) Julie Darsie
- 5) 1-99
- 6) MD SHPO
- 7) East elevation - View NW
- 8) 2 of 4

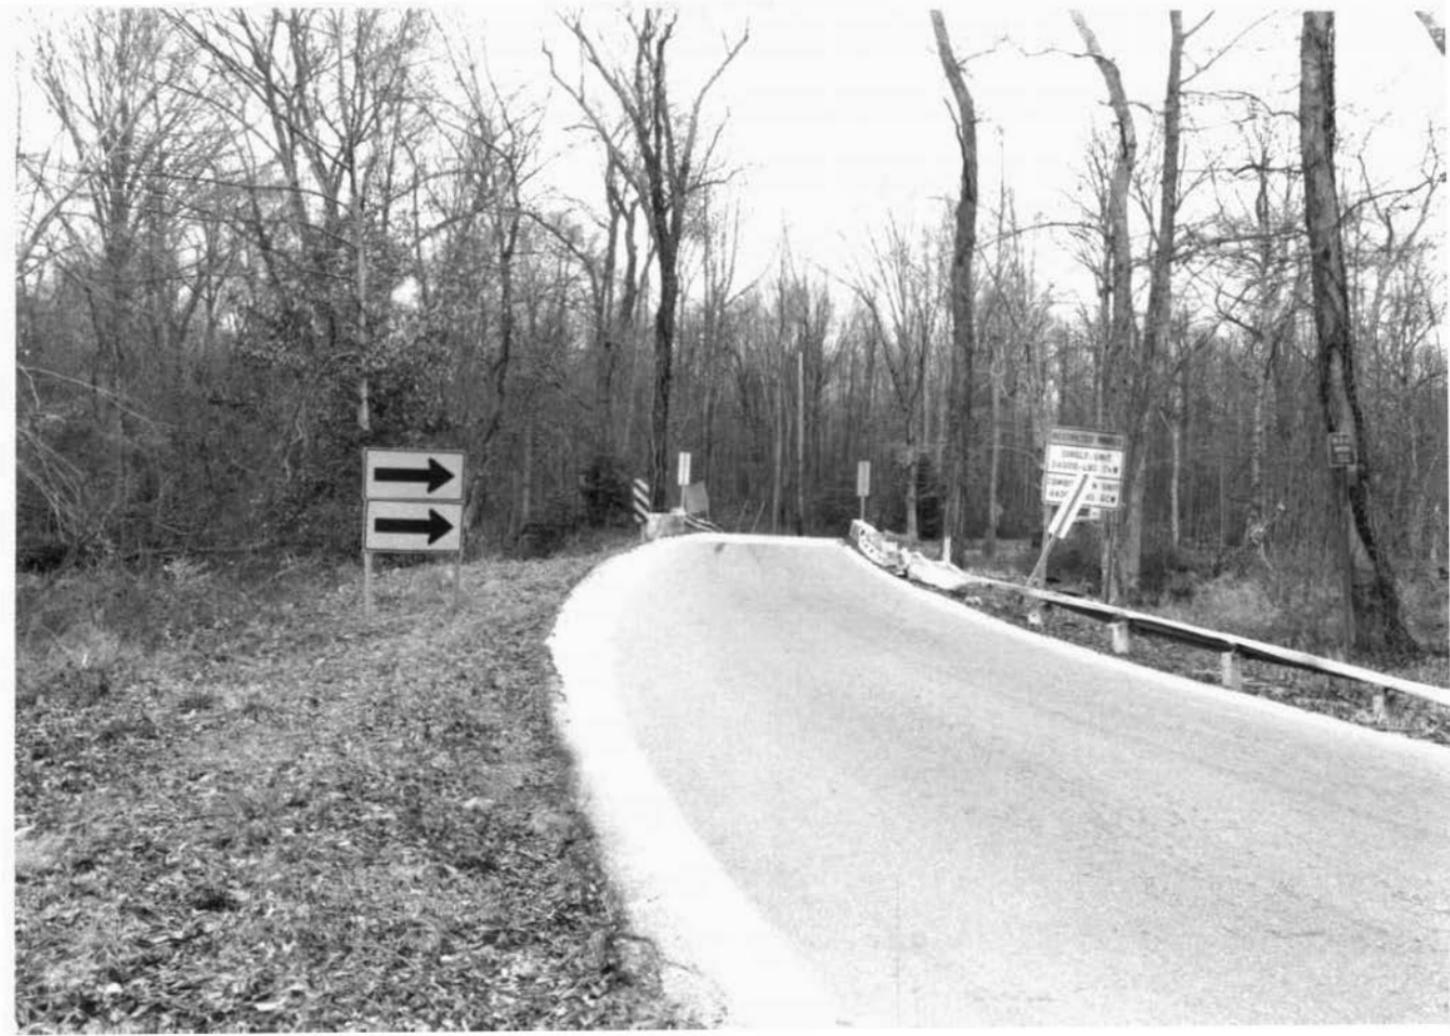
- 1) PG: 84-24
- 2) Gardner Rd. over Mattawoman Creek
- 3) Prince Georges Co - Charles Co Line, MD
- 4) Julie Darsie
- 5) 1-99
- 6) MD SHPO
- 7) South approach - View N
- 8) 3 of 4

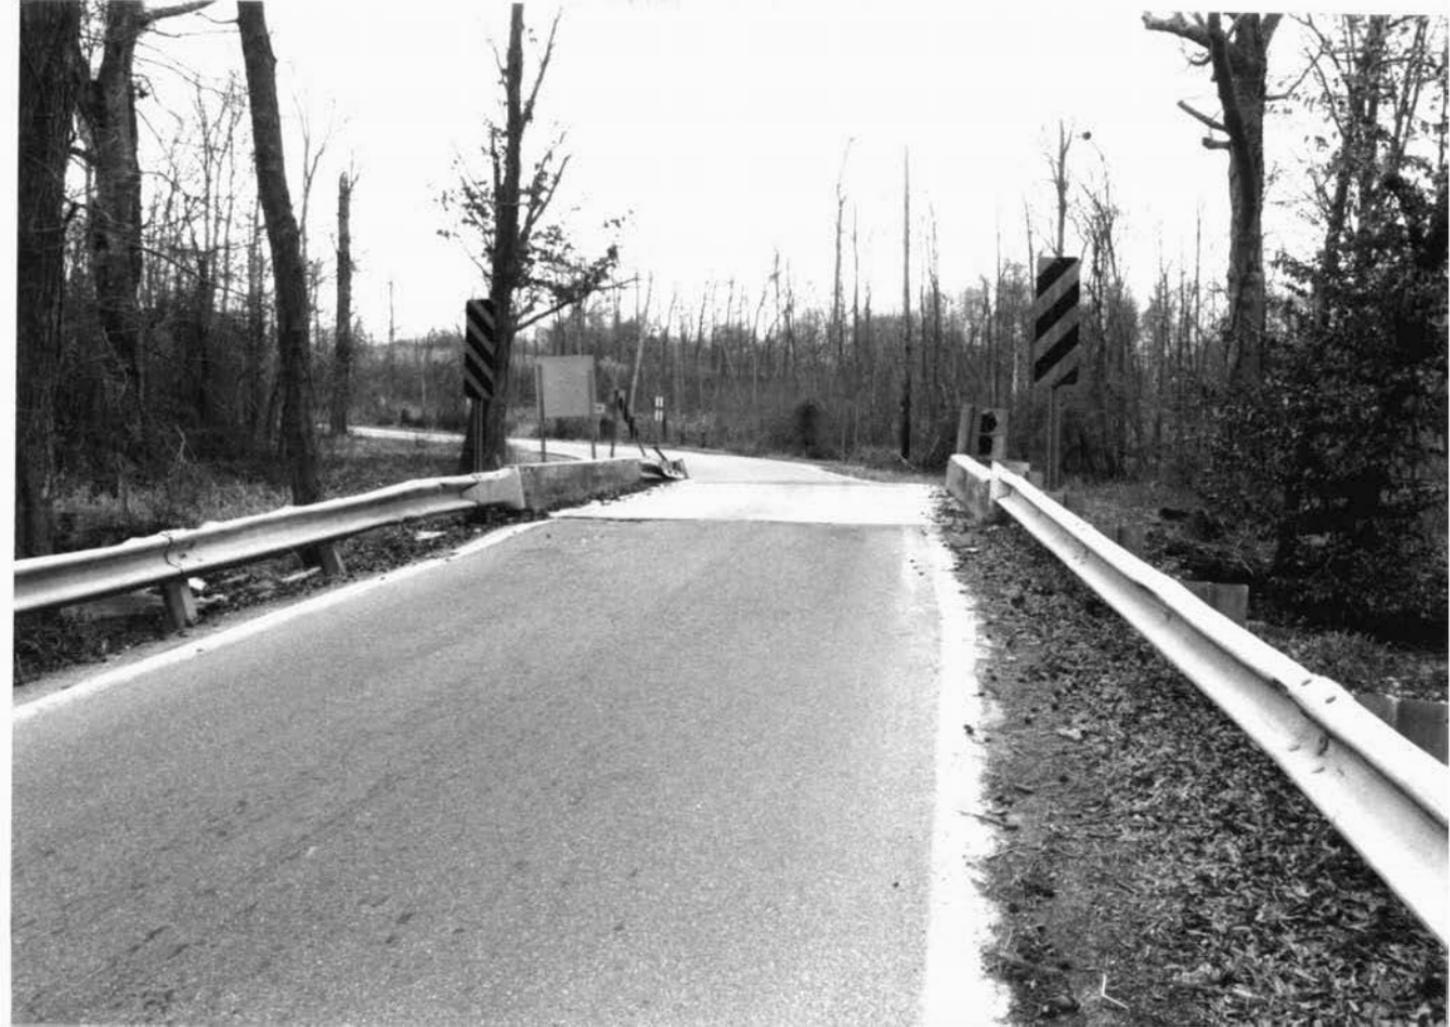
- 1) PG: 84-24
- 2) Gardner Rd over Mattawoman Creek
- 3) Prince George's Co - Charles Co Line, MD
- 4) Julie Darsie
- 5) 1-99
- 6) MD STPO
- 7) North approach - Views
- 8) 4 of 4

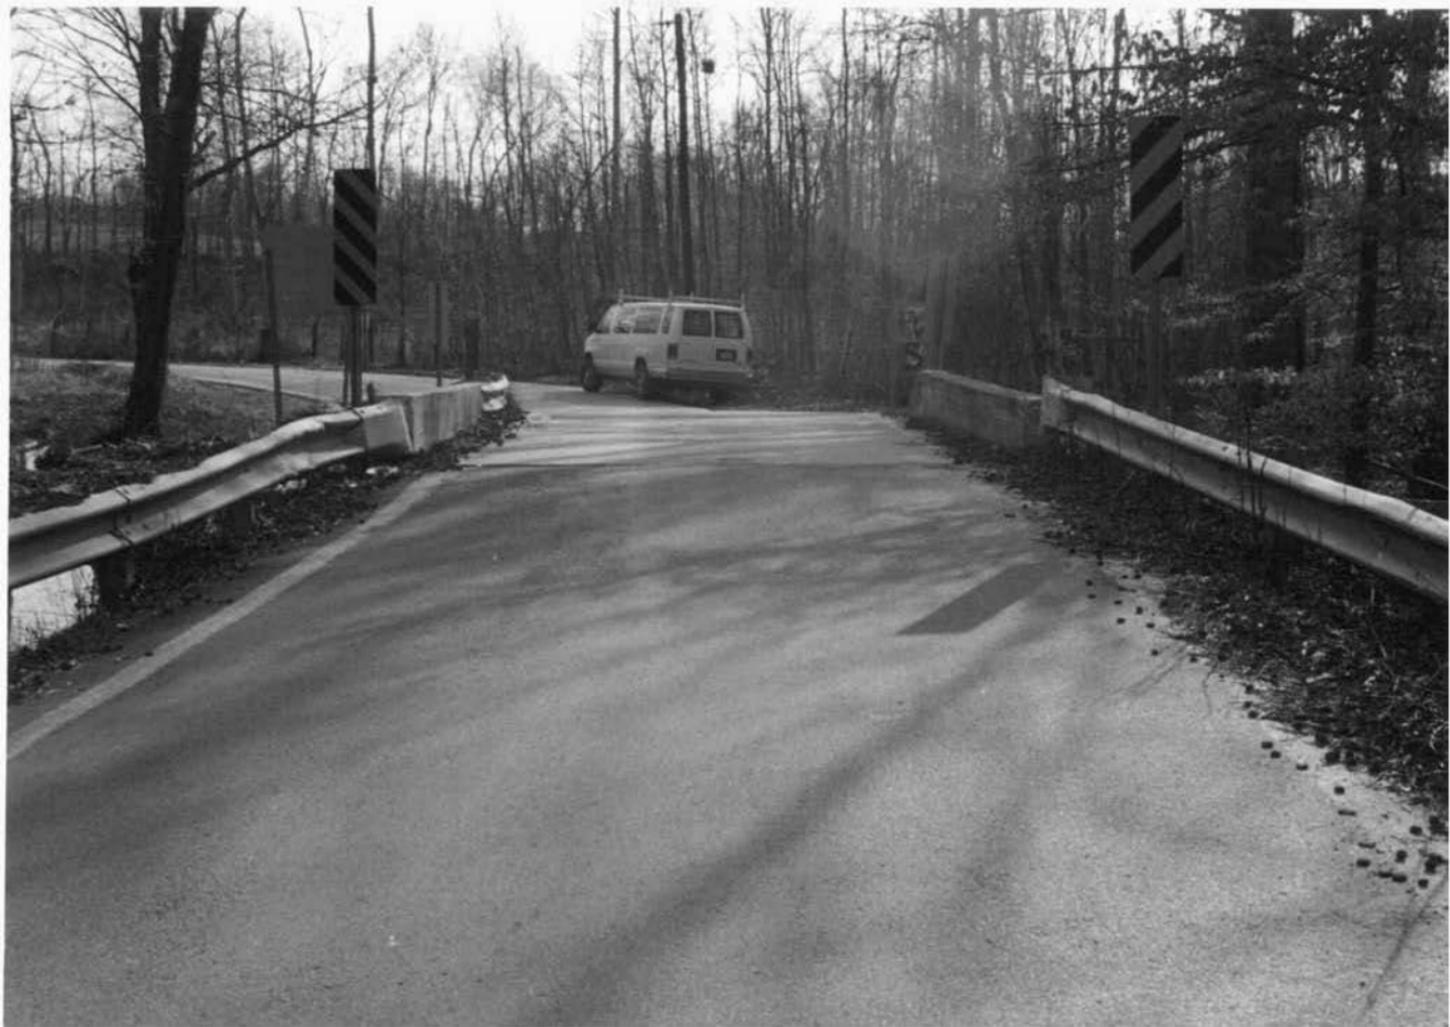
Number 28 of 4

Description NORTH APPROACH LOOKING SOUTH

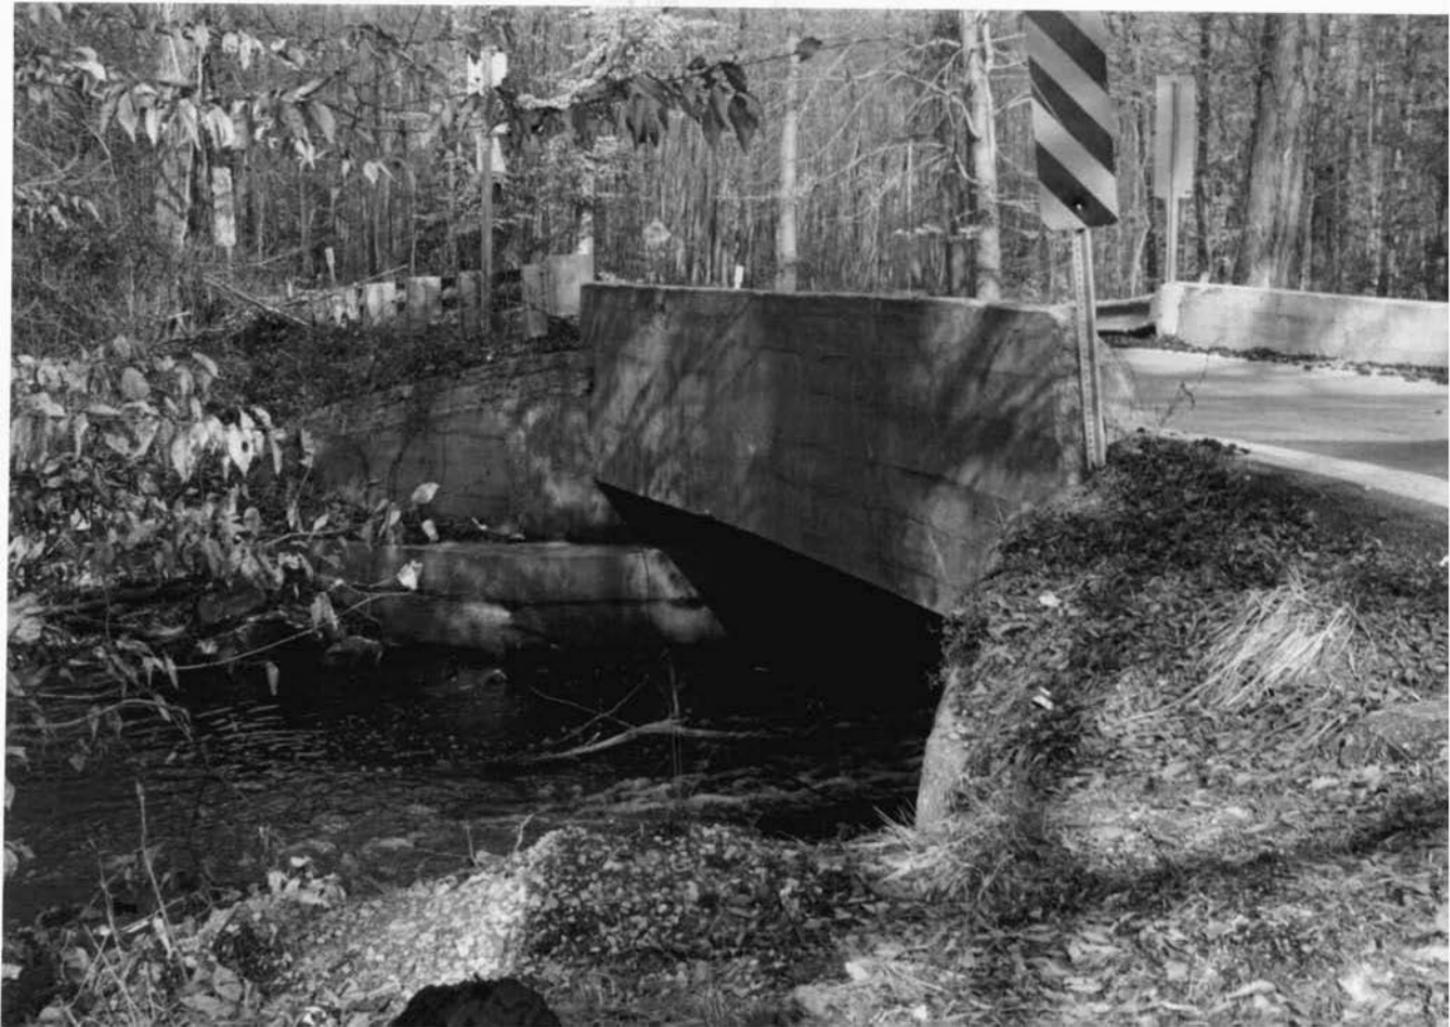
Number 4 of 9  
~~10~~ of ~~24~~

Description WEST ELEVATION  
\_\_\_\_\_  
\_\_\_\_\_
