**MARYLAND HISTORICAL TRUST
DETERMINATION OF ELIGIBILITY FORM**

Property Name: Stephen's Crossing at Brandywine (current name) Inventory Number: PG-85A-84
 Address: 13801 Missouri Ave. City: Brandywine Zip Code: 20613
 County: Prince George's USGS Topographic Map: 1956 Brandywine
 Owner: Route 301 IND CPI LTD PARTNERSHIP Is the property being evaluated a district? yes
 Tax Parcel Number: 10 Tax Map Number: 145 Tax Account ID Number: 3713880
 Project: _____ Agency: _____
 Site visit by MHT Staff: no yes Name: _____ Date: _____
 Is the property located within a historic district? yes no

PG-85A-84

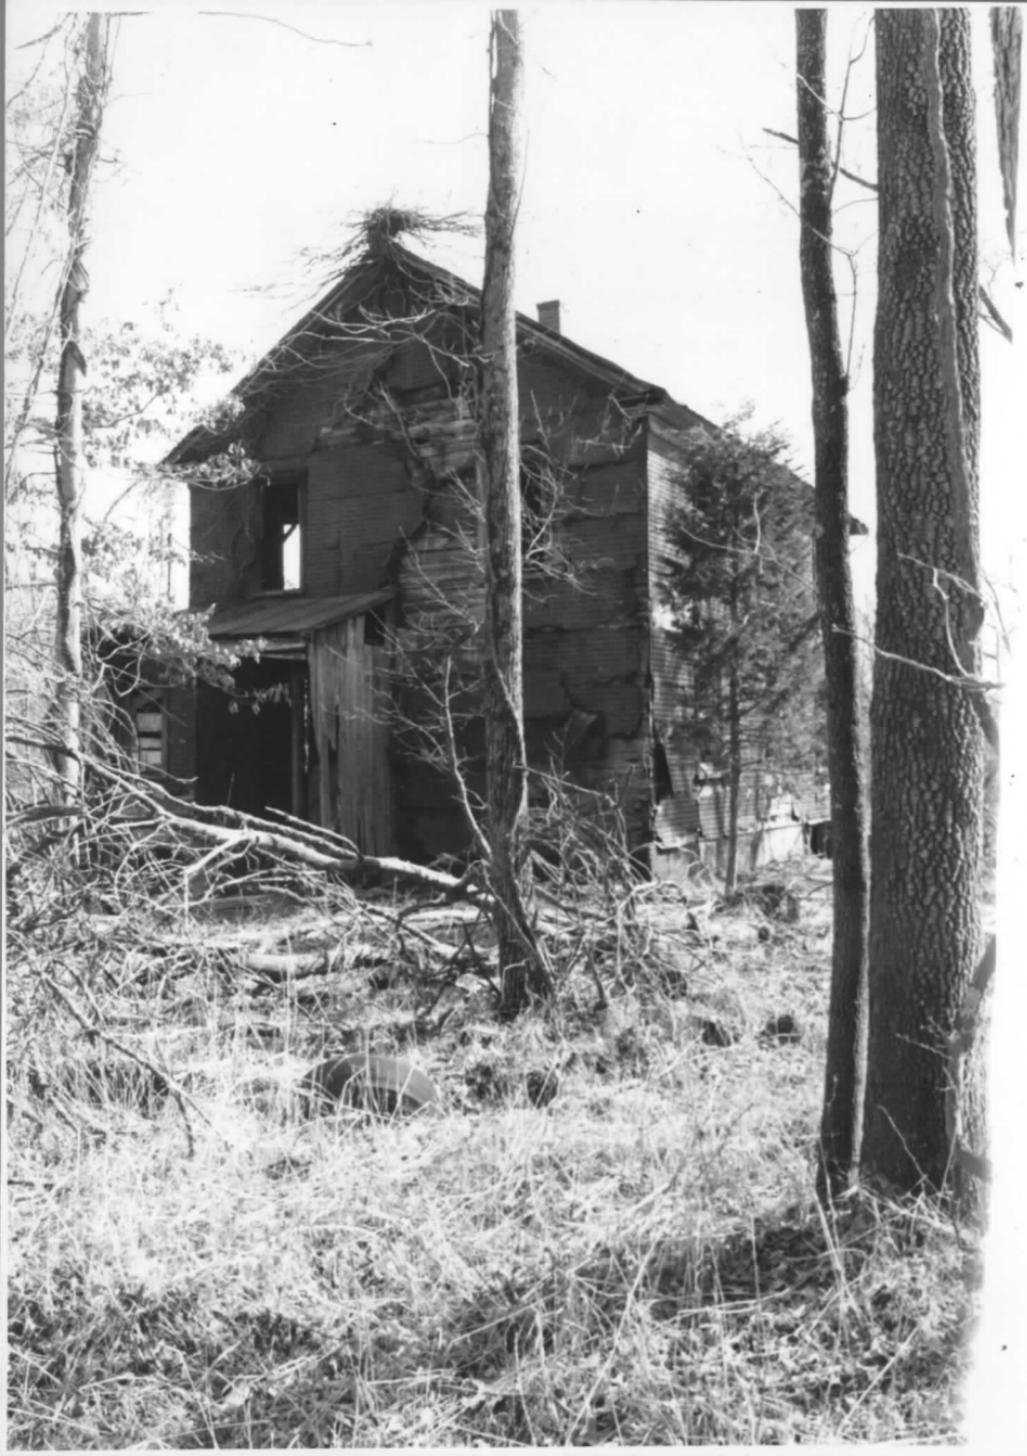
1/9

BILL LEBOVICH
MARCH 13, 2011
MD SHPO
FRONT (NORTH) AND
SIDE (WEST)
OF TENANT
FARM HOUSE

The tenant house is two stories, with gable roof and central brick chimney, and remnants of cornice returns at the north and south ends. It is a wood frame house, with wood sheathing partially covered in pressed metal ceiling panels and corrugated panels. The house sits on a poured concrete foundation with a crawl space and short poured concrete piers supporting floor beams in the front half of the houses. The rear of the house has a full height basement, with a thin concrete floor. On the northwest side, a below ground poured concrete open enclosure with concrete steps leads to a basement entrance. The house's foundation is cracked along this west side and the floor beams for the front of the house have snapped at the concrete piers and are collapsed. The concrete foundations are two feet above ground and run 24 feet on the front (north) and rear, and (SEE CONTINUATION SHEET)

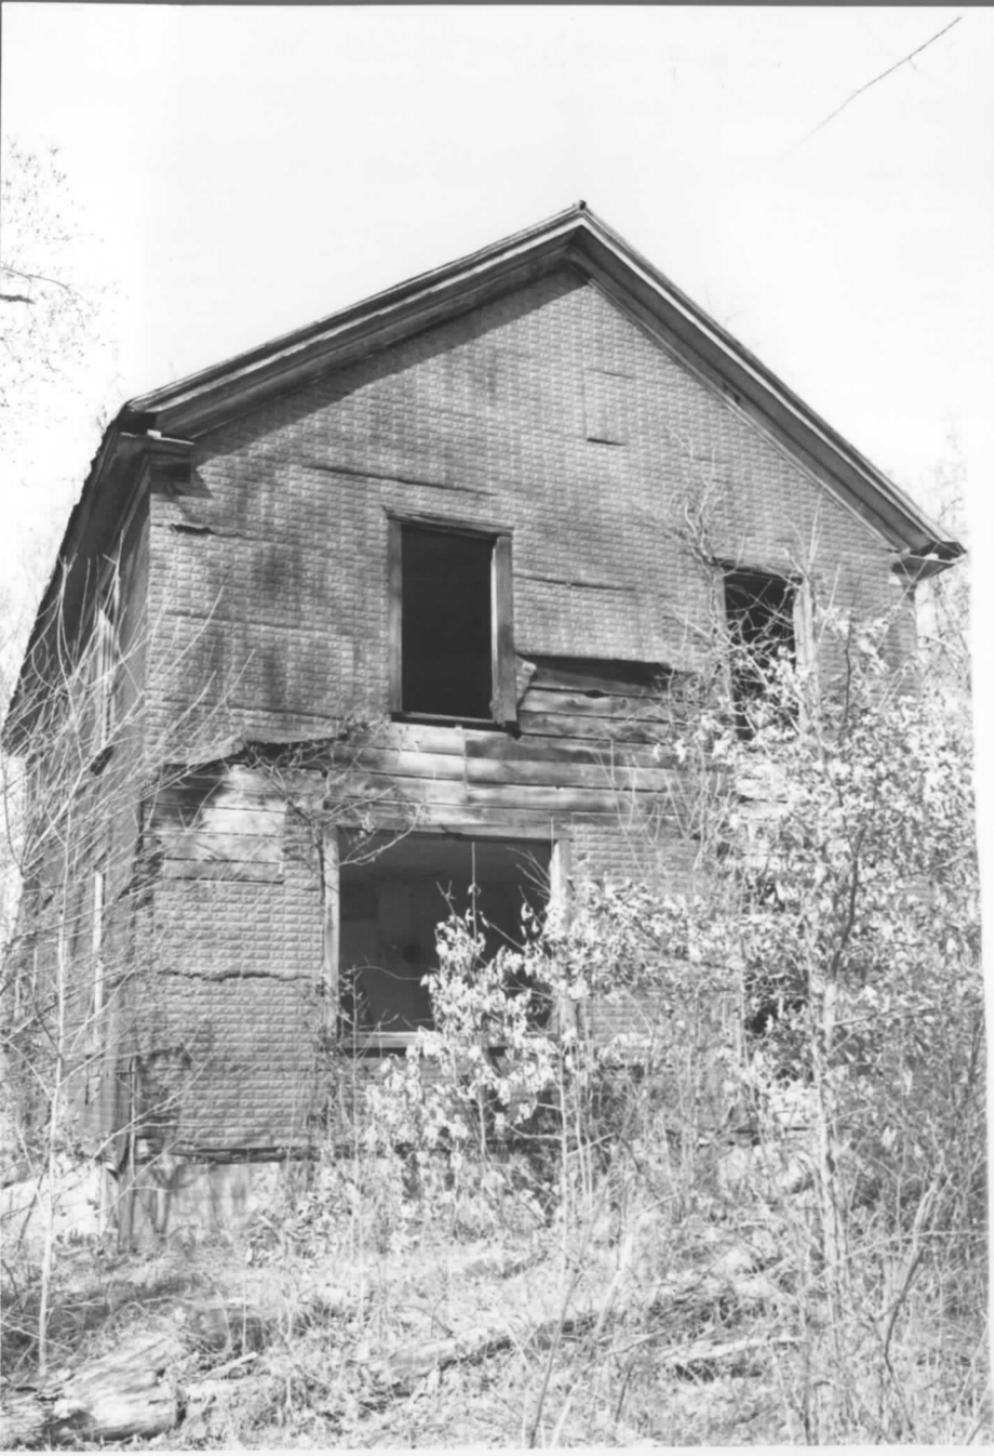
2/9

PG-85A-84
13801 MISSOURI AVE,
BOSZANOWICZ WINE
PRINCE GEORGE'S
6, MD
BILL LEBOVICH
MARCH 13, 2011
MD SK00
REAR (SOUTH)
SIDE

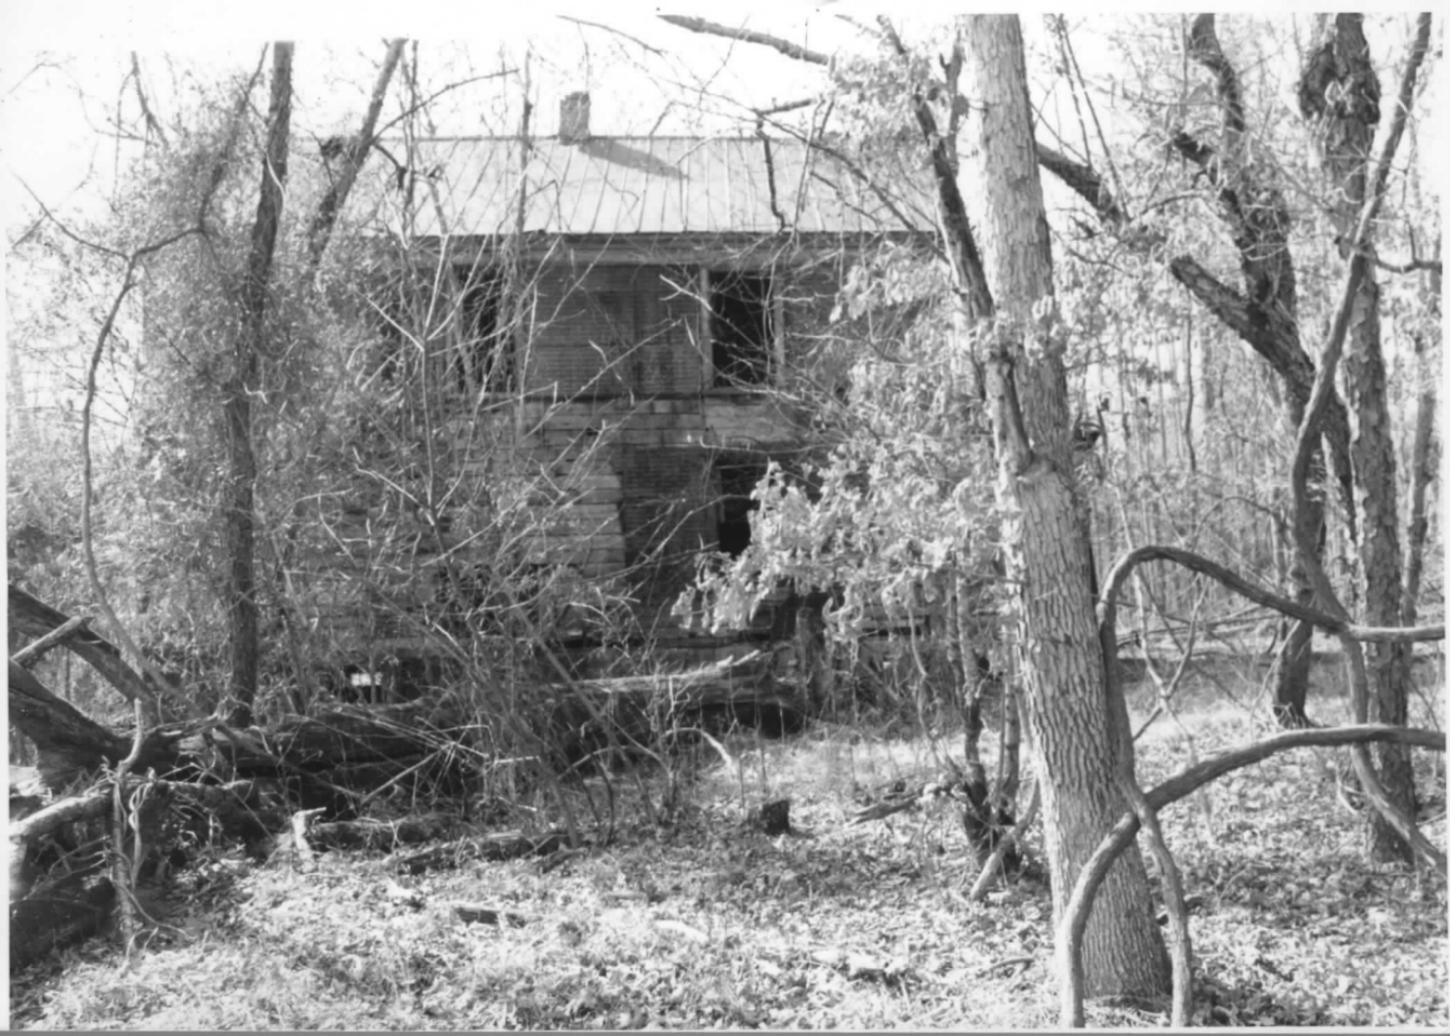
3/9

BILL LEBONICH
MARCH 13, 2011
MD SHPO
EAST SIDE

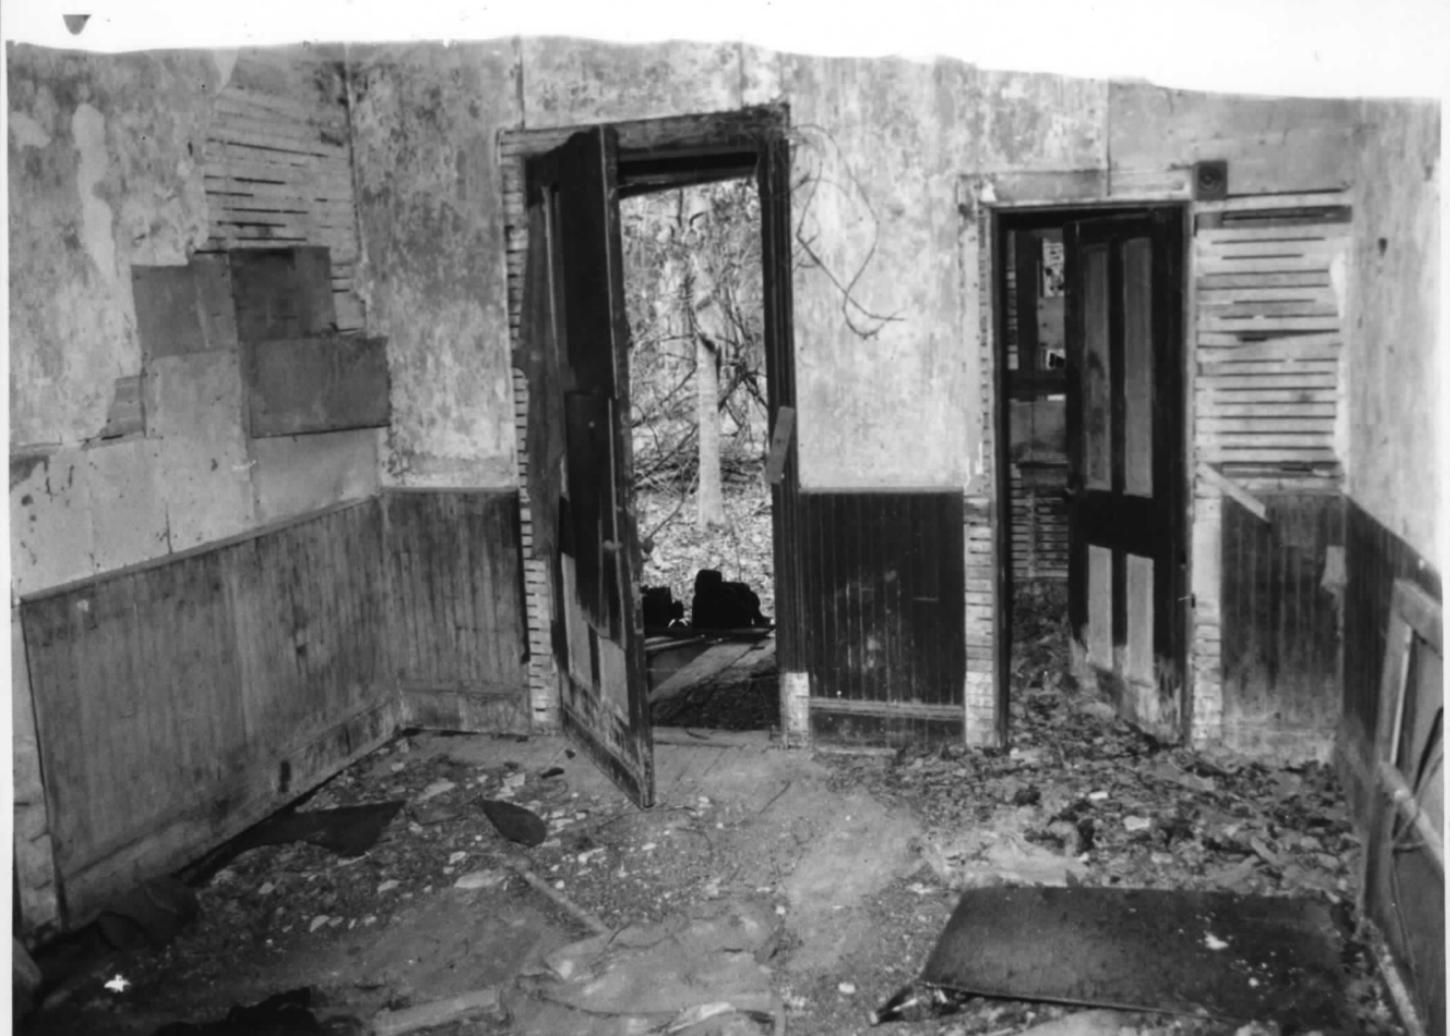
4/9

BILL LEBOVICH
MARCH 13, 2011
MD SMPD
PARLOR, LOOKING
NORTH

The first floor has two rooms in front and two in the rear with at least three of the rooms showing round openings in the inside wall for a pipe running from the central chimney flue to a free-standing stove in at least three of the rooms. A partial stairs in the rear (south east) room leads up to the second floor, where there are also four rooms and a small corridor.

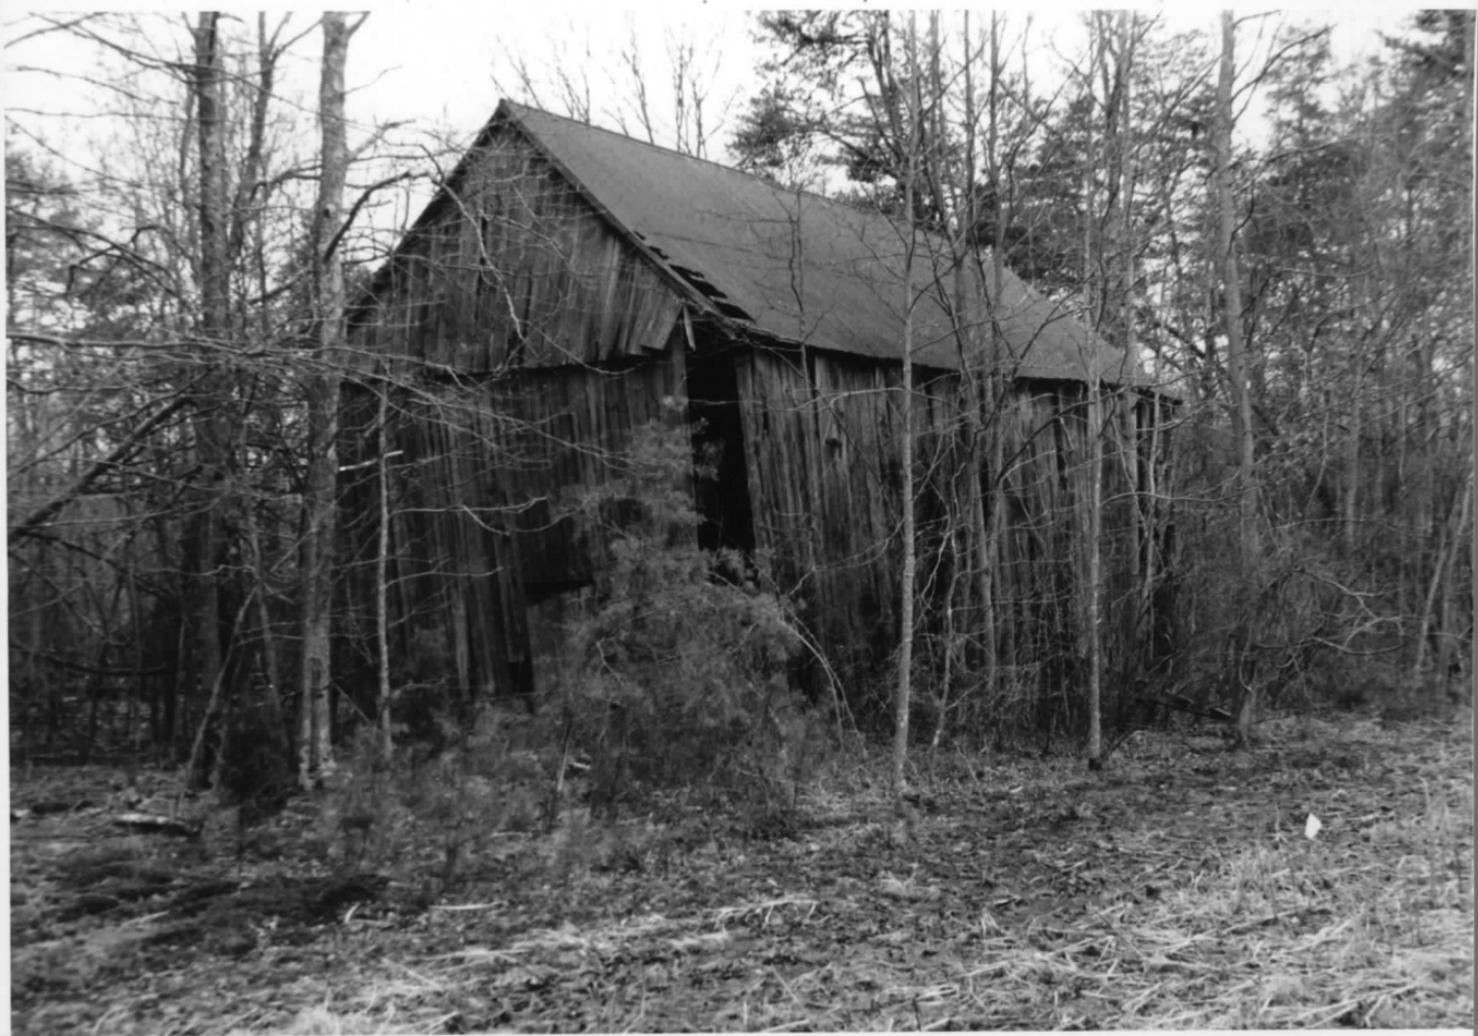
5/9

EAST AND NORTH
SIDES

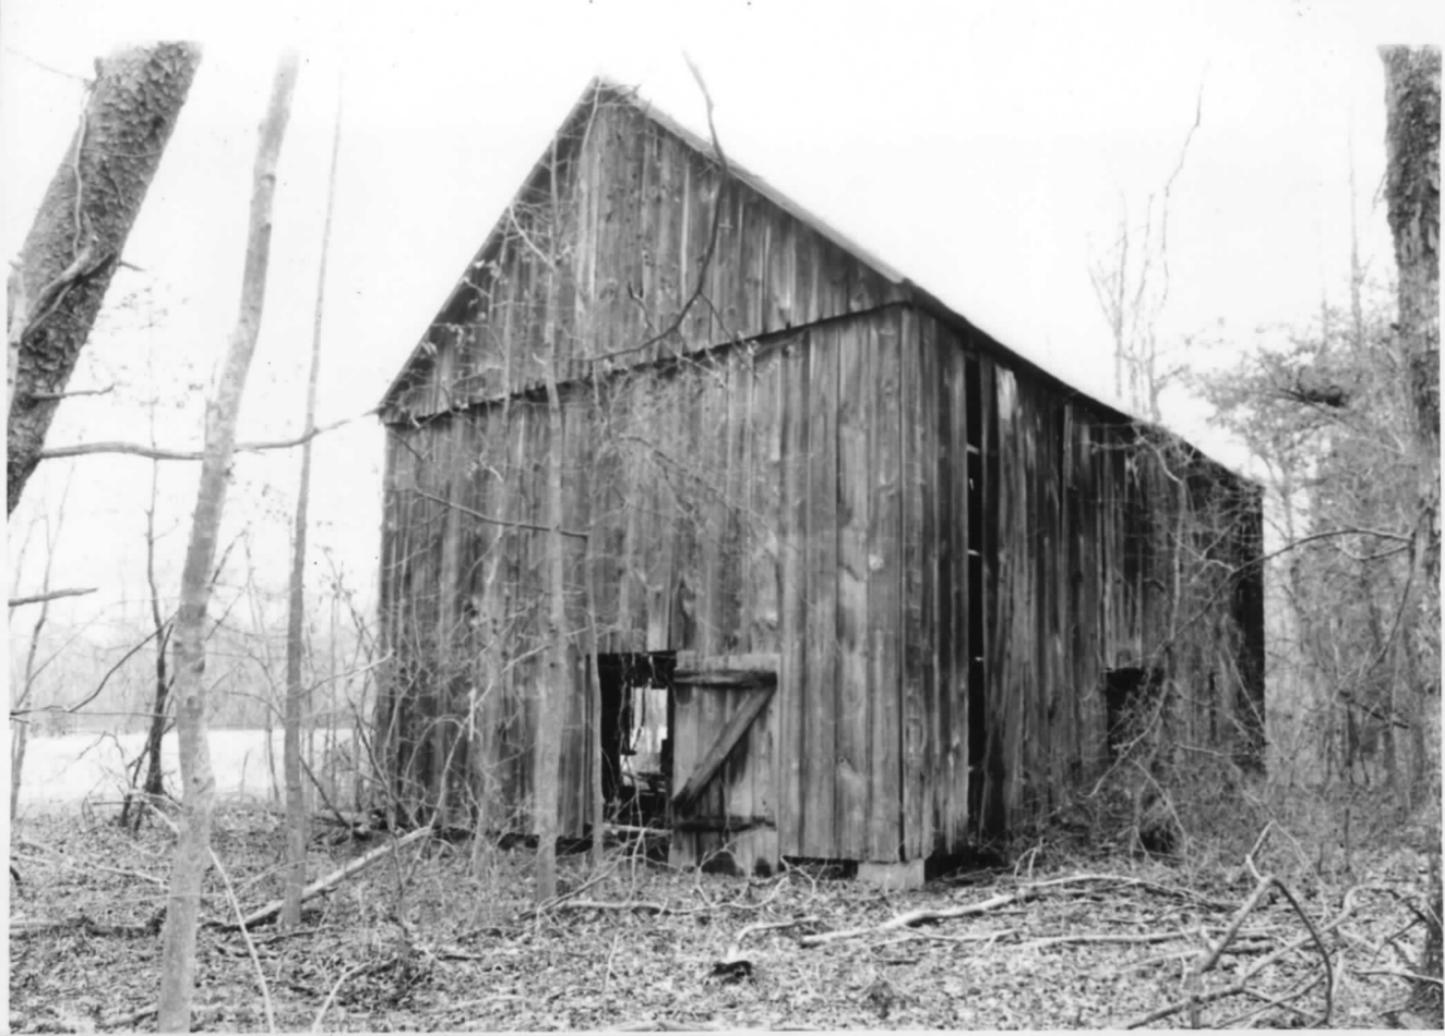
6/9

WEST AND SOUTH
SIDES

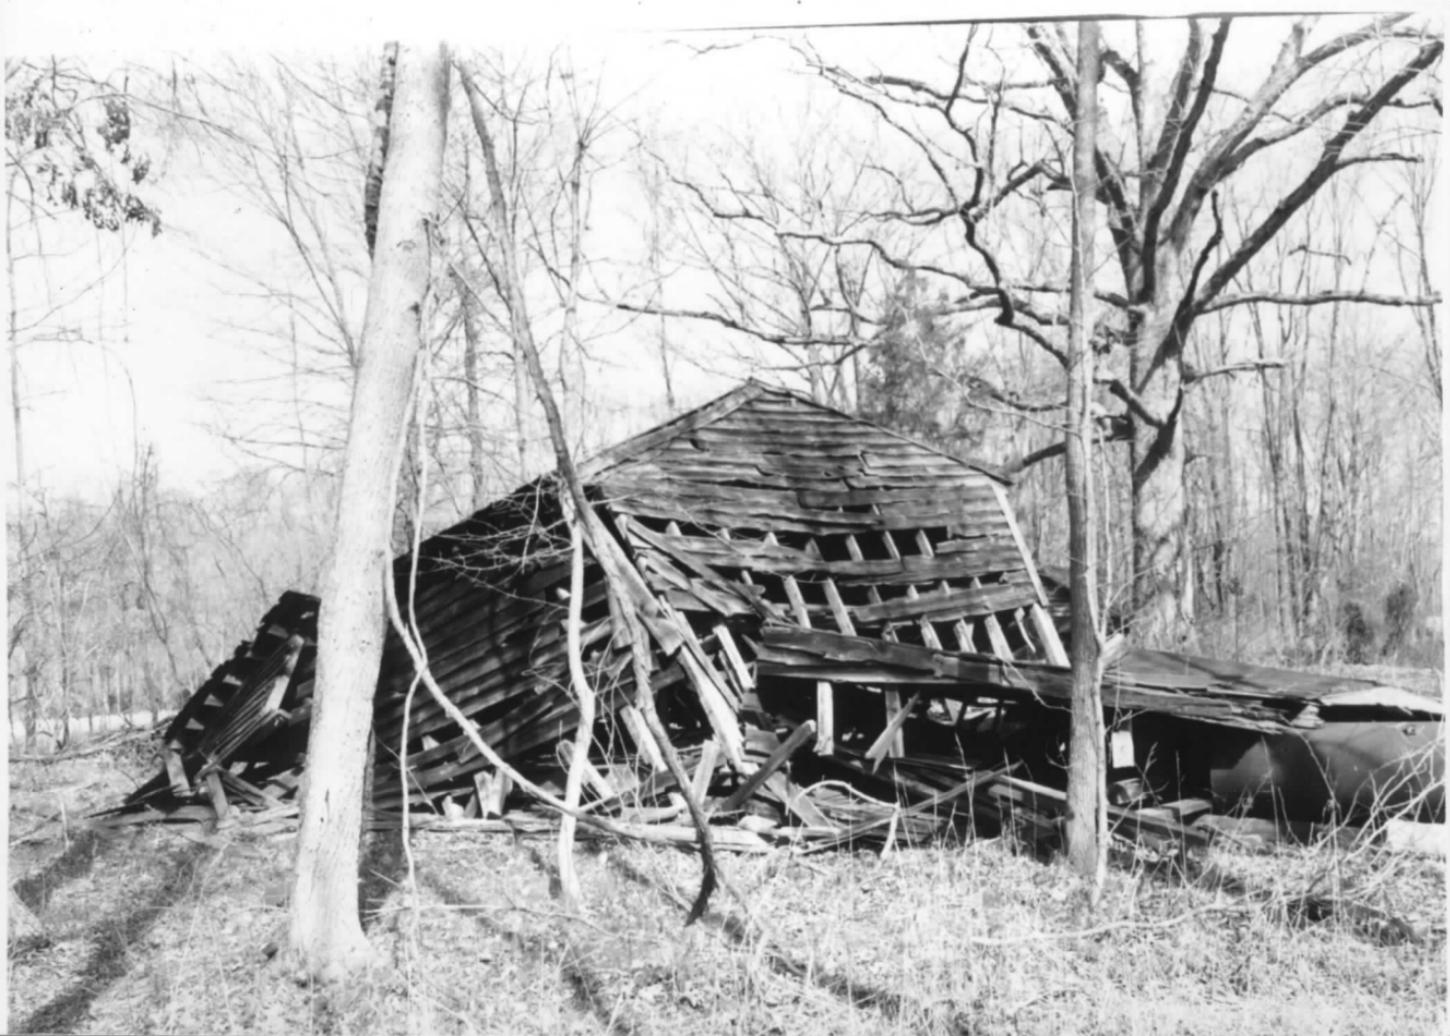
BILL LEBOVICH
MARCH 13, 2011
MD SHOO
COLLAPSED
BAR, LOOKING
NORTH
8/9

The collapsed barn closest to the house had an attached shed on the south end. It was impossible to measure to building or see if there was any evidence of foundations. Directly east of the collapsed barn there is a coop, twelve feet and eighteen and half feet, in fair condition. North of the coop are concrete foundations, twenty feet at east and west, thirty feet at north and south. In the vicinity of these foundations are scattered, half buried concrete blocks of undetermined number.

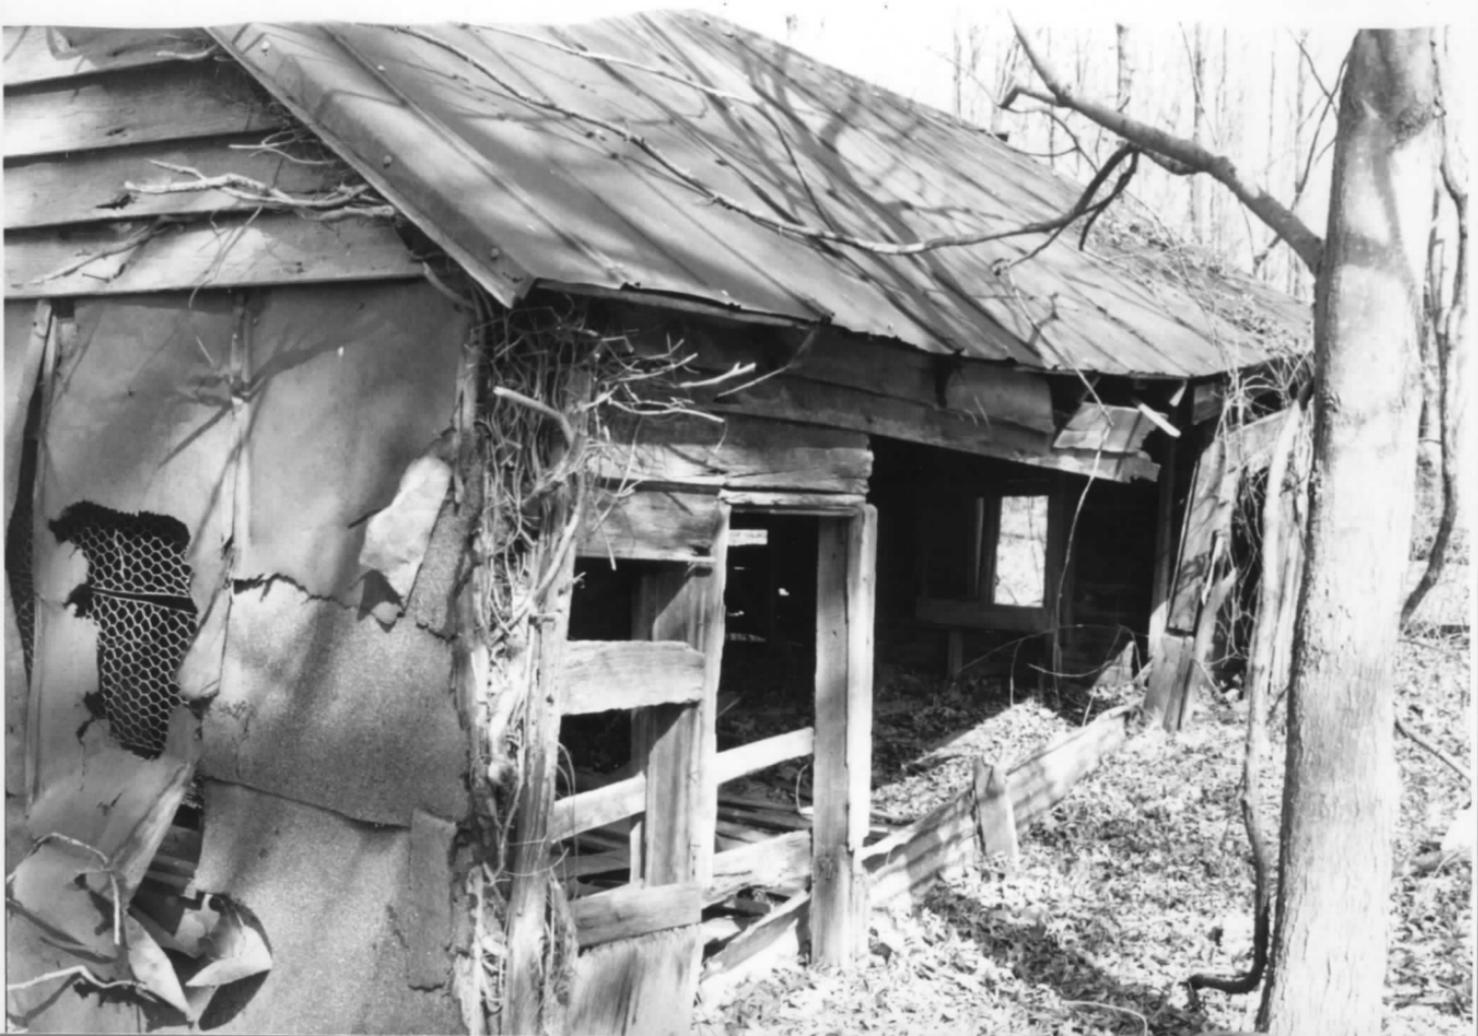
COOP, LOOKING NE
9/9
