PRINCE GEORGE'S COUNTY
HISTORIC SITE SUMMARY SHEET

Building Name William R. Barker House

Location 22600 Aquasco Road, Aquasco

Maryland Historical Trust State Historic Sites Inventory Form

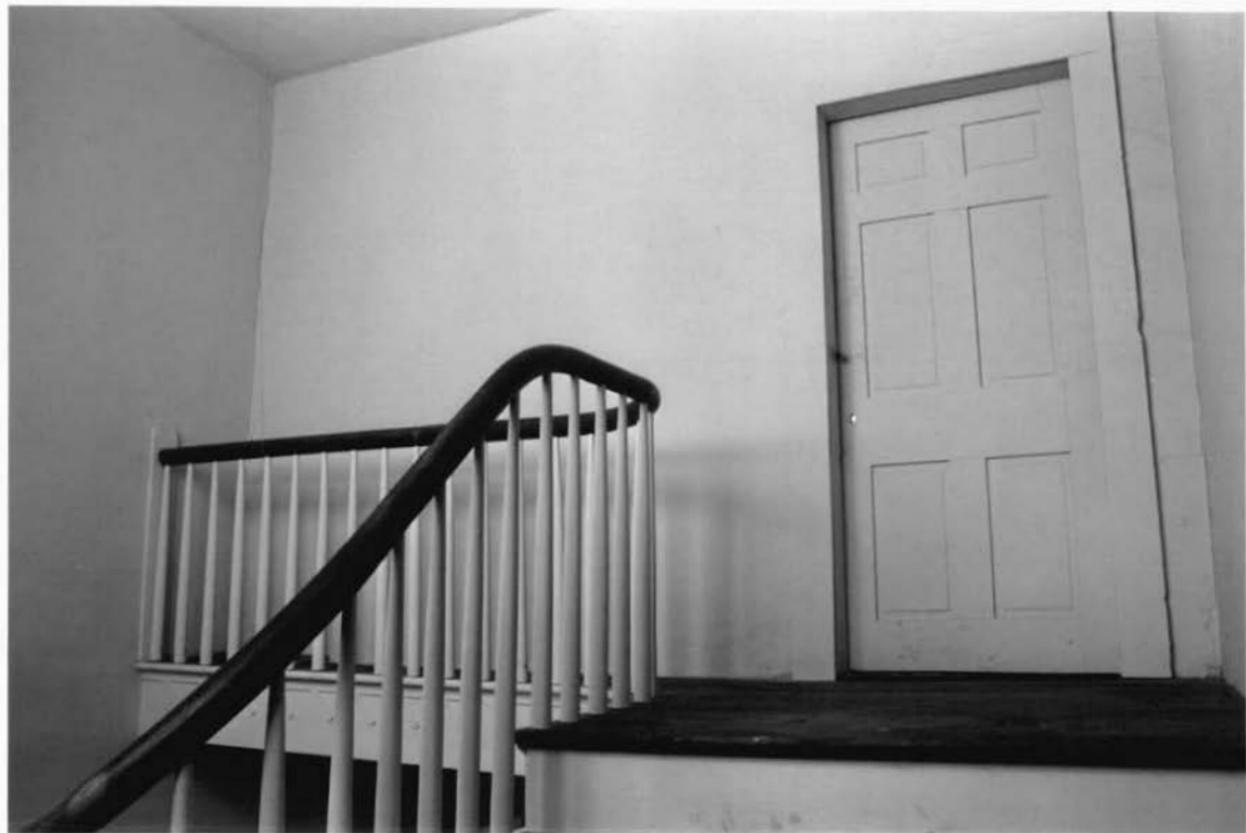
3rd story, door to attic

The main staircase is finished to the third story level. The landing to the third story is lighted by the upper half of the second story window, and by the large central dormer above the east elevation. A plaster wall with a six-panel door is at the top of the staircase and blocks entry to the attic. The attic is unfinished and is divided into a north and a south room by a wall of vertical boards. A beaded, vertical board door gives access from one room to the other. The rafters are regular in shape and bear the marks of a machine-driven saw. There is a barrel-like cistern in the south room that provided running water to the household during the 20th century. The cistern dates to 1936. The system was first installed during the 1920's.

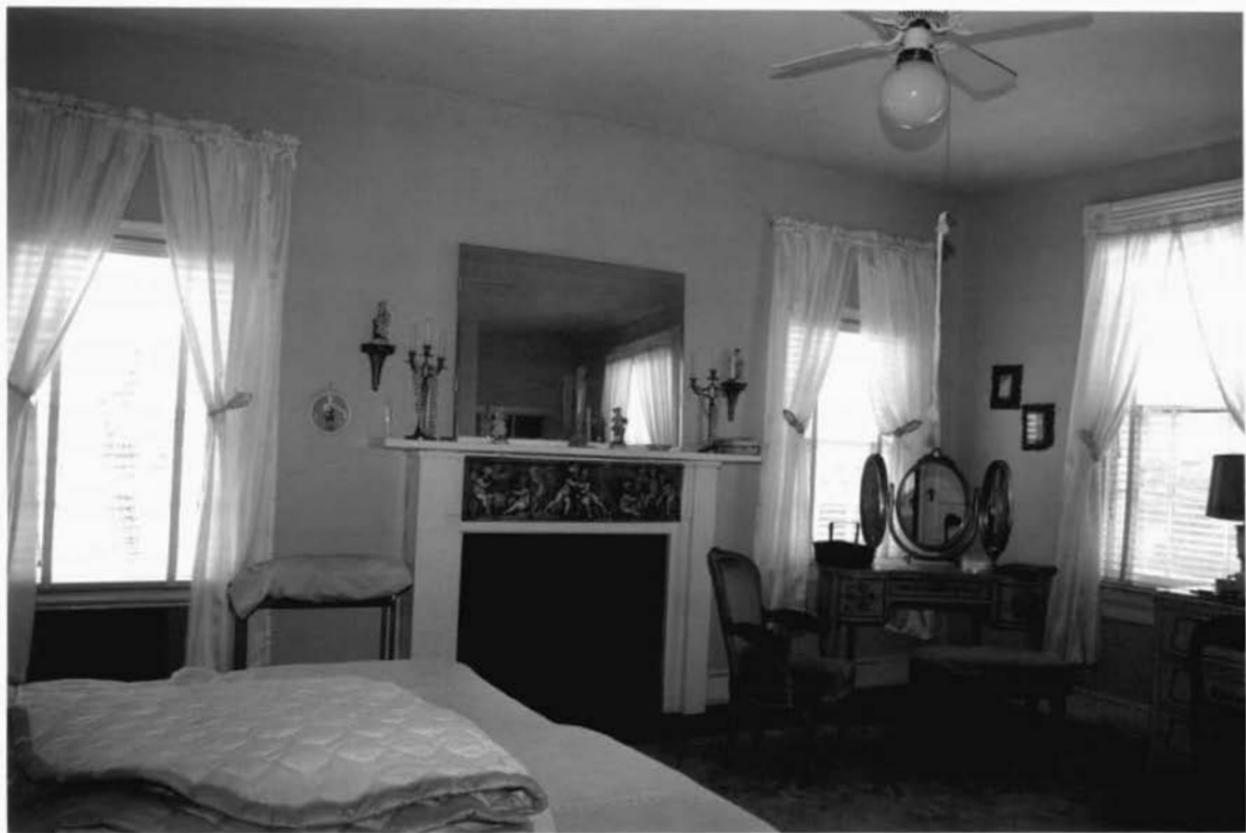
William Barker House
Prince Georges Co.
Marina King
Feb 1989
Southwest bedroom
Neg. MHT, Annapolis

The southwest bedroom has two entry doors off of the hall. The north wall, between the entry doors has been enclosed for a closet. The room is warmed by a fireplace in the south wall. The very plain wooden mantel has a rectangular firebox opening and mantel shelf. There is a ceramic bas-relief panel with a motif of grouped cherubs set into the frieze. The two south windows flanking the fireplace are smaller than those in the west wall, their heads being lower. The window surrounds are a narrow one-step molding with three shallow bands. The west windows have the same molding as those throughout the house.

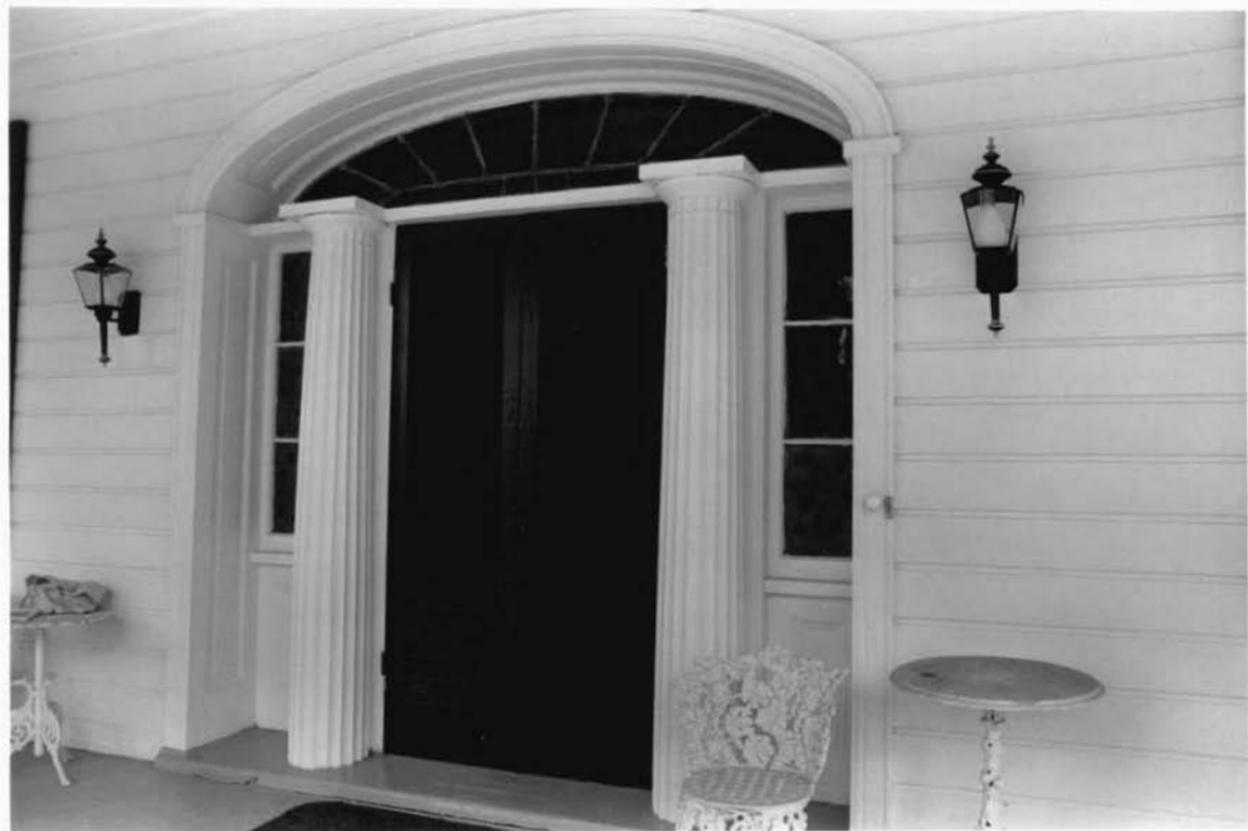
William Barker House
Prince Georges Co.
Marina King
Feb. 1989
West entrance detail
Neg: MHT, Annajohn

The five-bay west (main) facade has central entrance through double louvered outer doors protecting the double entrance door beneath. The doorway is flanked by two heavy, tapering fluted Doric columns of wood. The three-light sidelights are of glass etched with grapevine and floral designs, set above a wainscot panel. The elliptical fanlight is of multi-paned leaded glass, the lead muntins having a fleur-de-lis at the upper and lower ends. The reveal is paneled with long, rectangular panels. The door surround is a flat molding with an inner bead and two rectangular channels. It forms two flat pilasters flanking the sidelights, with horizontal cap molding at the height of the transom bar. The architrave arches over the elliptical fanlight.

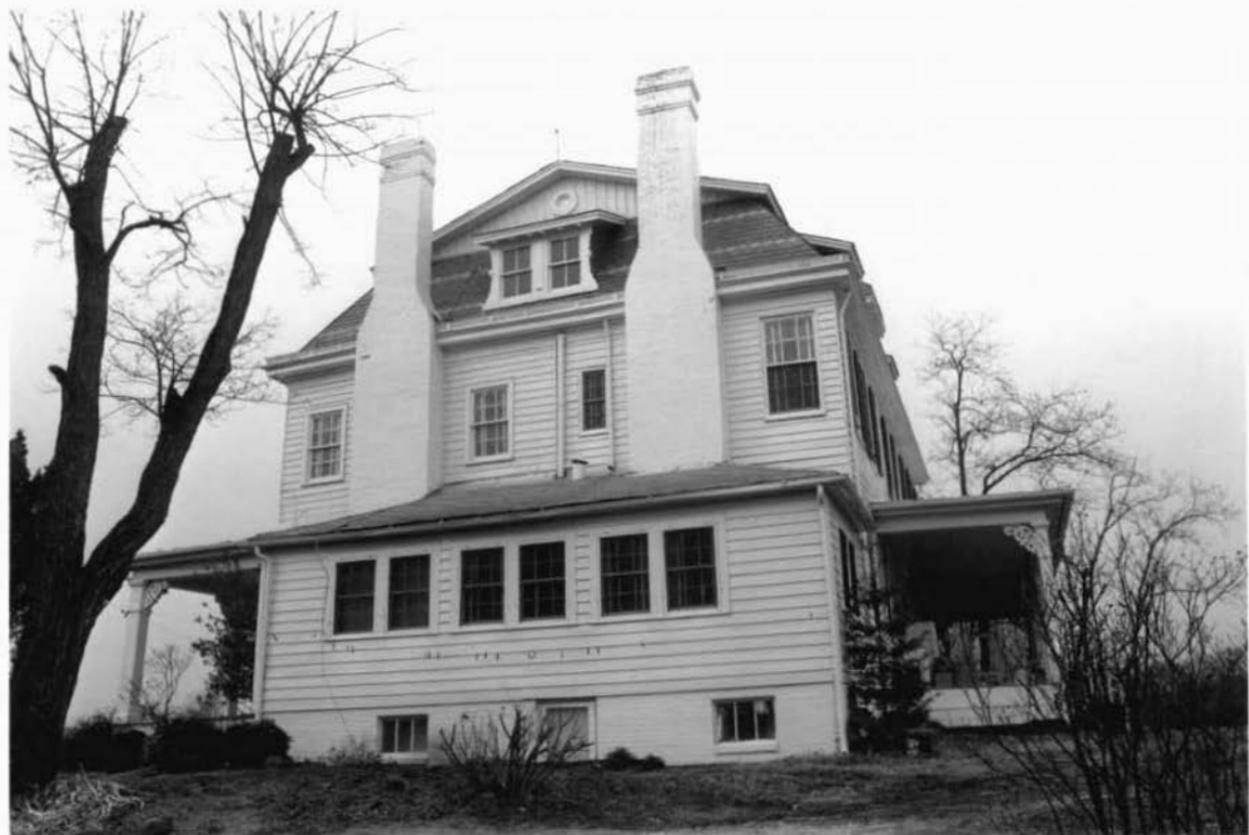
South gable end

The four-bay south gable end is similar to the north gable end. Two exterior chimneys flank a central dormer below the pediment of the shallow gable roof. Three of the windows at

second story level are smaller than those on the rest of the house. There are no shutters on this elevation. The first story is covered by an enclosed hipped roof porch resting on a high brick foundation with a central entrance below grade, reached by a flight of concrete stairs. A band of three double 6/6 windows with plain board surrounds crosses the facade. The porch was added during the ownership of the Chichester family, 1919-1945. A two story south wing containing servants quarters and the kitchen was removed at that time due to its deteriorated condition. the porch was enclosed and a basement dug beneath it during the late 1940's.

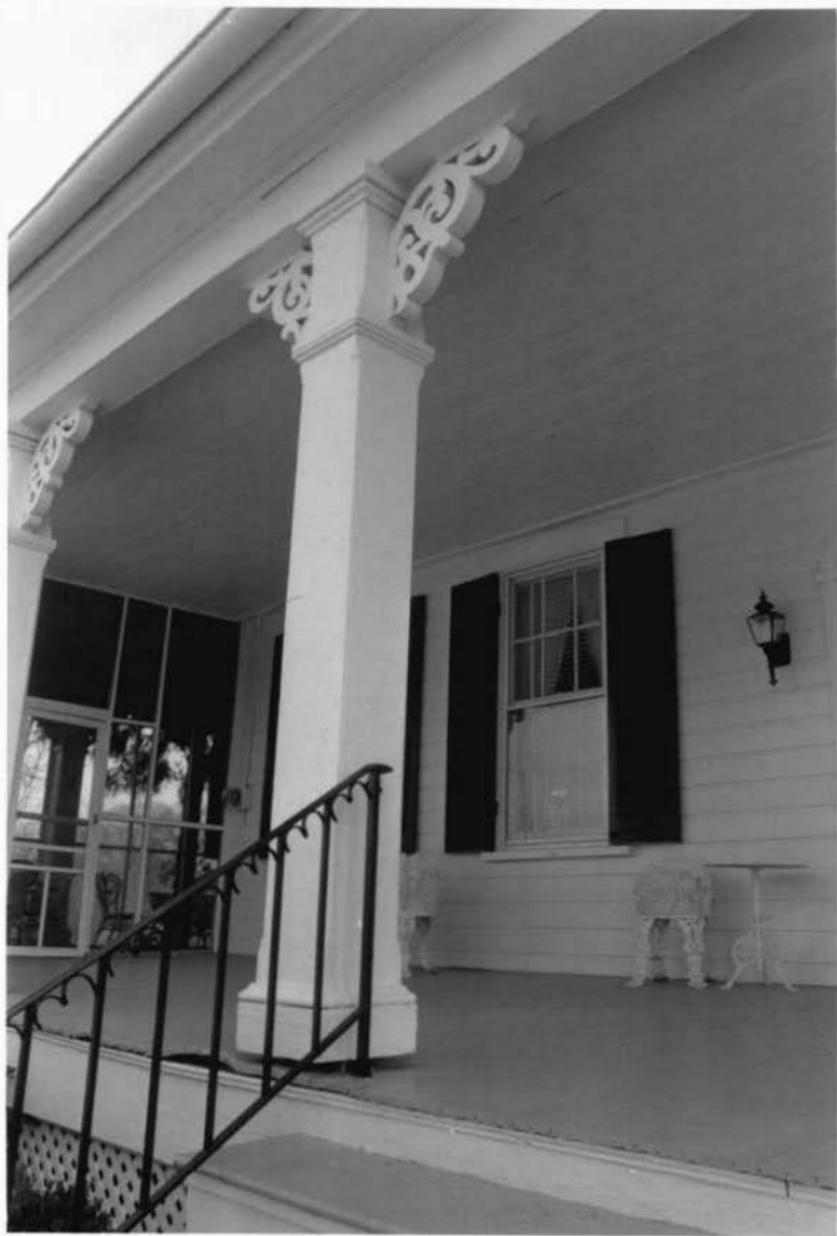
William Parker House
Prince Georges Co
Marina King
Feb. 1987
West porch detail
Neg. MAT, Annapolis

The six-bay west entrance porch is reached by a central flight of four wooden steps with a wrought-iron balustrade. The wooden porch floor is supported on brick piers interspaced with wood lattice. The shallow hipped roof is supported on heavy rectangular chamfered posts with base and capital molding and large, thick jig-sawn brackets. The posts meet a boxed frieze and there is a deep overhang beneath the cornice.

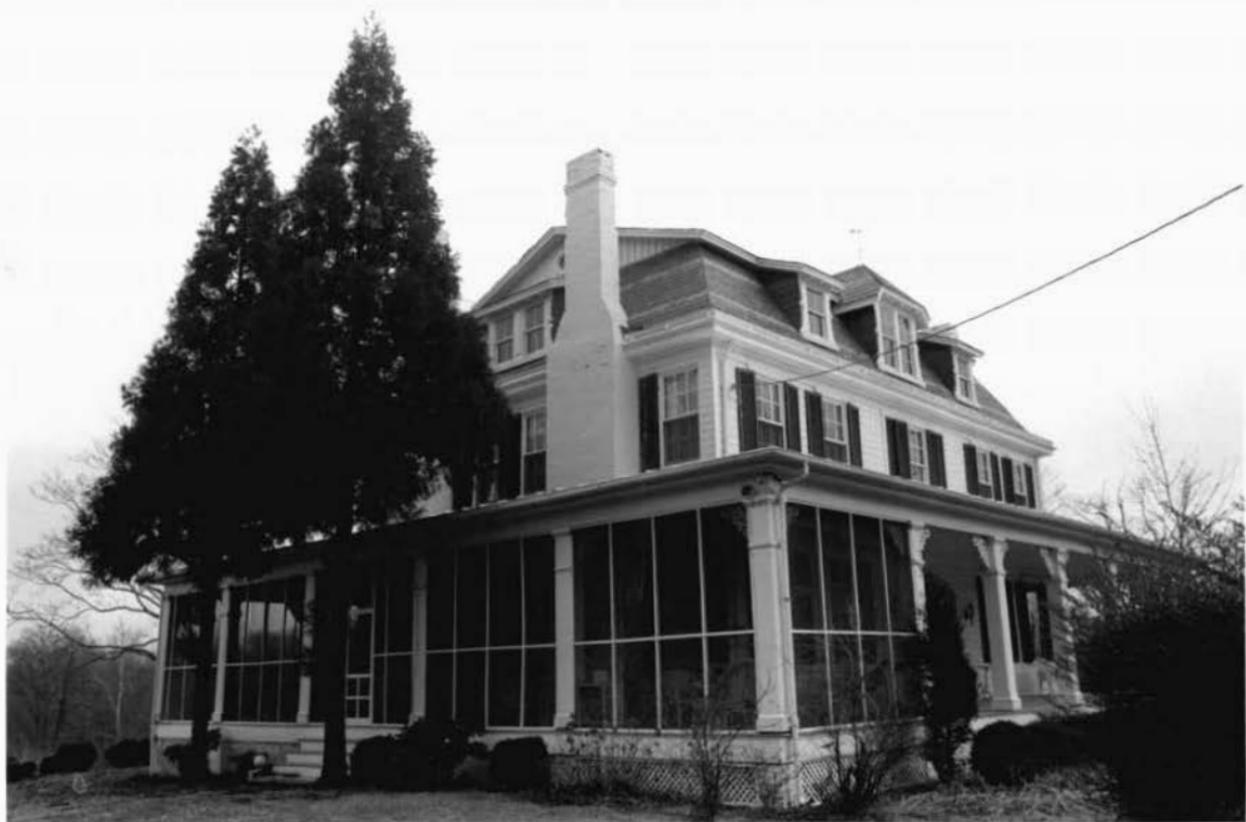
William Barker House
Prince Georges Co.
Marina King
Feb. 1989
Northwest
Neg: MHT, Annapolis

The four-bay north gable end is regularly fenestrated, with two central windows flanked by the exterior brick chimneys with corbelled weathering and corbelled caps. Two windows flank the outer side of the chimneys, on both the first and second story. Windows on this elevation have a narrow wood surround with an inner bead, a rectangular backband and a central groove. There is no lintel treatment. The entrance porch wraps around the north elevation and crosses it with five bays. This section of the porch is screened and entry is gained through a central screen door, reached by three wooden steps up from the lawn. Centered above the cornice line is a shed roofed dormer with double 2/2 sash windows and the same decorative treatment as the dormers on the main elevation. The shallow, sloped gable end rises above the mansard roof slope. The narrow pediment is covered with board-and-batten siding and has a central bull's-eye window.

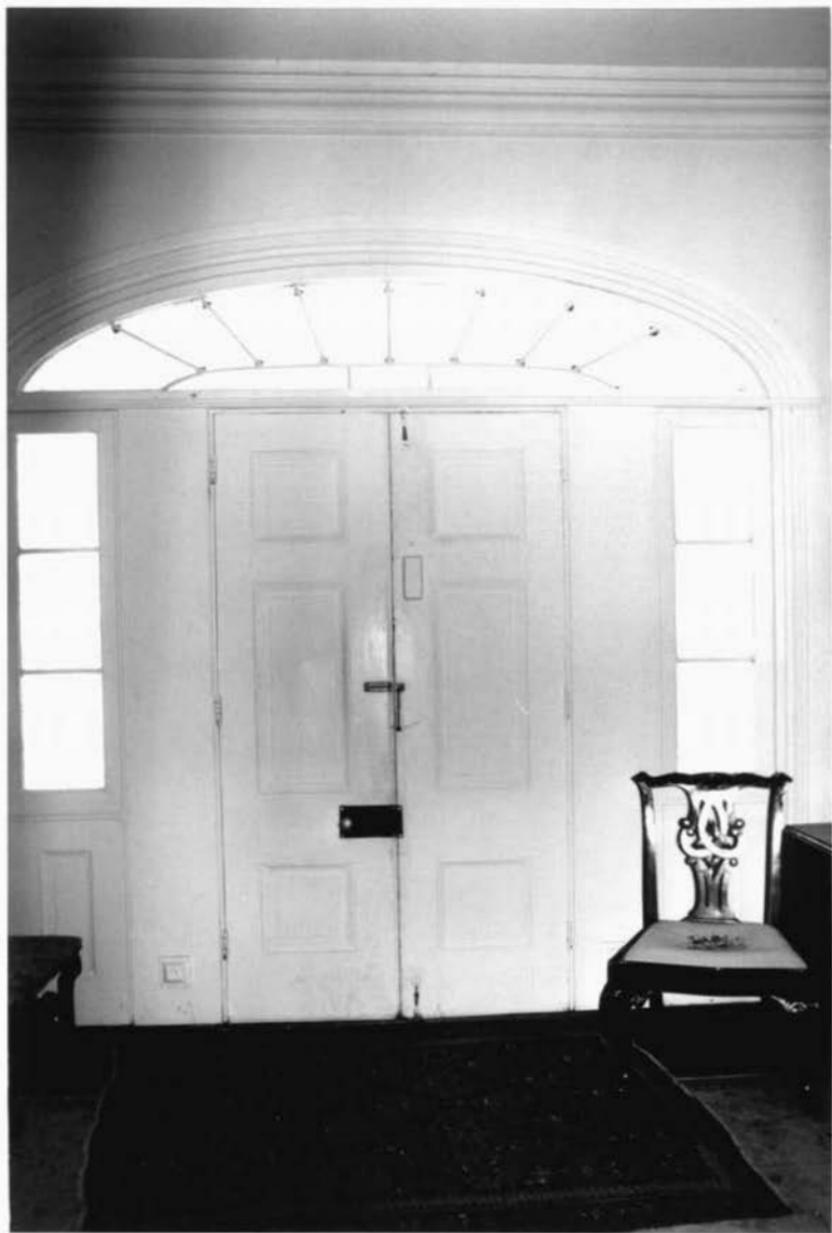
Main entrance door

The main entrance has double doors, of three panels each, and a large iron box lock with a brass handle. The sidelights are of frosted glass, with cut designs of floral sprays. The north lights have a thistle and daisy design, the south have a grapes and daisy design. The elliptical fanlight forms a wide arch over the door and the sidelights. The door surround, forming pilasters on the outer sides of the sidelights and arching over the fanlight, is a wide molding composed of a rectangular inner and outer band, and an inner and outer ogee molding flanking a central raised rectangular band. The eight-panel doors giving access off of the hall have the same surround, surmounted by bull's-eye corner blocks. The 1 1/2 inch high baseboard has a double cap of a rectangular surmounted by an ogee molding.

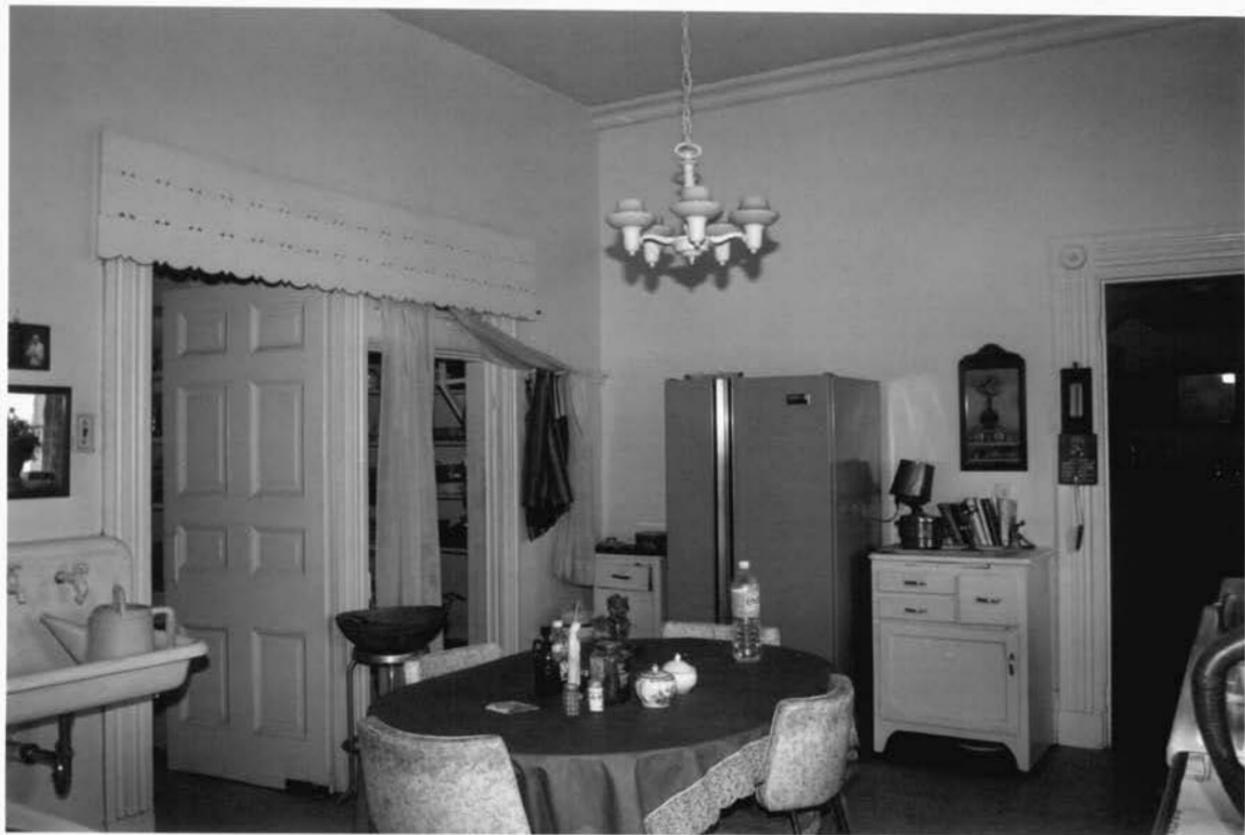
Kitchen, northwest and west walls

The kitchen has a plain coved cornice along the north, south and east walls. The doors and door surrounds are the same as those in the rest of the first floor. A door in the northeast corner of the room leads to the main stair hall, beneath the stairs. A door in the southeast corner leads to the sun porch.

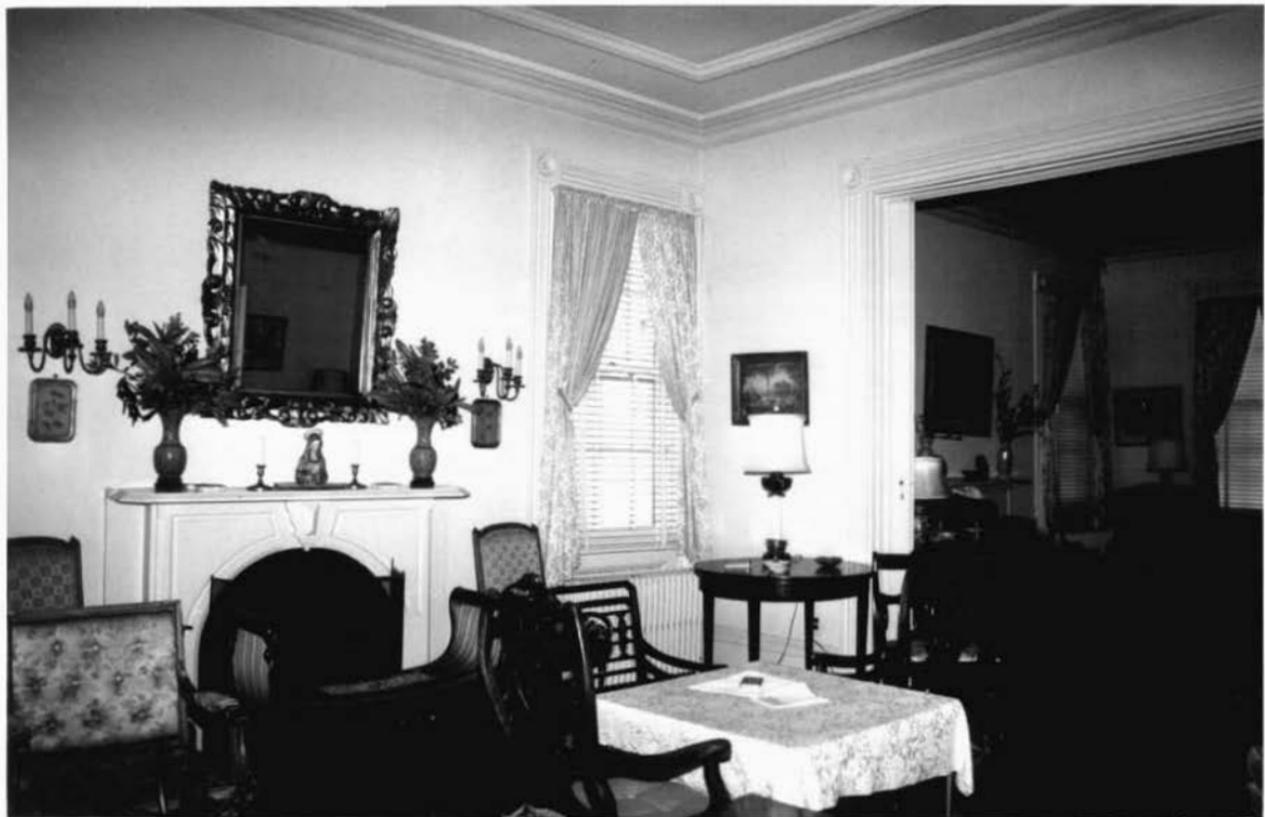
William Barker House
Prince Georges Co
Marina King
Feb 1989
Northwest parlor
neg: MHT, Annapolis

There are two north parlors, reached through entrances off of the stair hall. The northwest parlor has a multi-band plaster cornice and a large rectangular ceiling panel defined by a wood or plaster molding. A square plaster medallion centered within the panel is composed of a central square of four acanthus leaves surrounded by a bead-and-reel molding and an outer band of acanthus leaves with a small daisy defining the four corners. There is an outer molding of banded papyrus leaves. A fireplace is centered in the north wall of the parlor. The white-painted stone mantel has chamfered corners and a round-arch fire box opening surmounted by an ornate keystone. Cut channels or grooves in the stone define panels flanking the keystone. The rectangular mantel shelf has a molded edge and clipped outer corners.

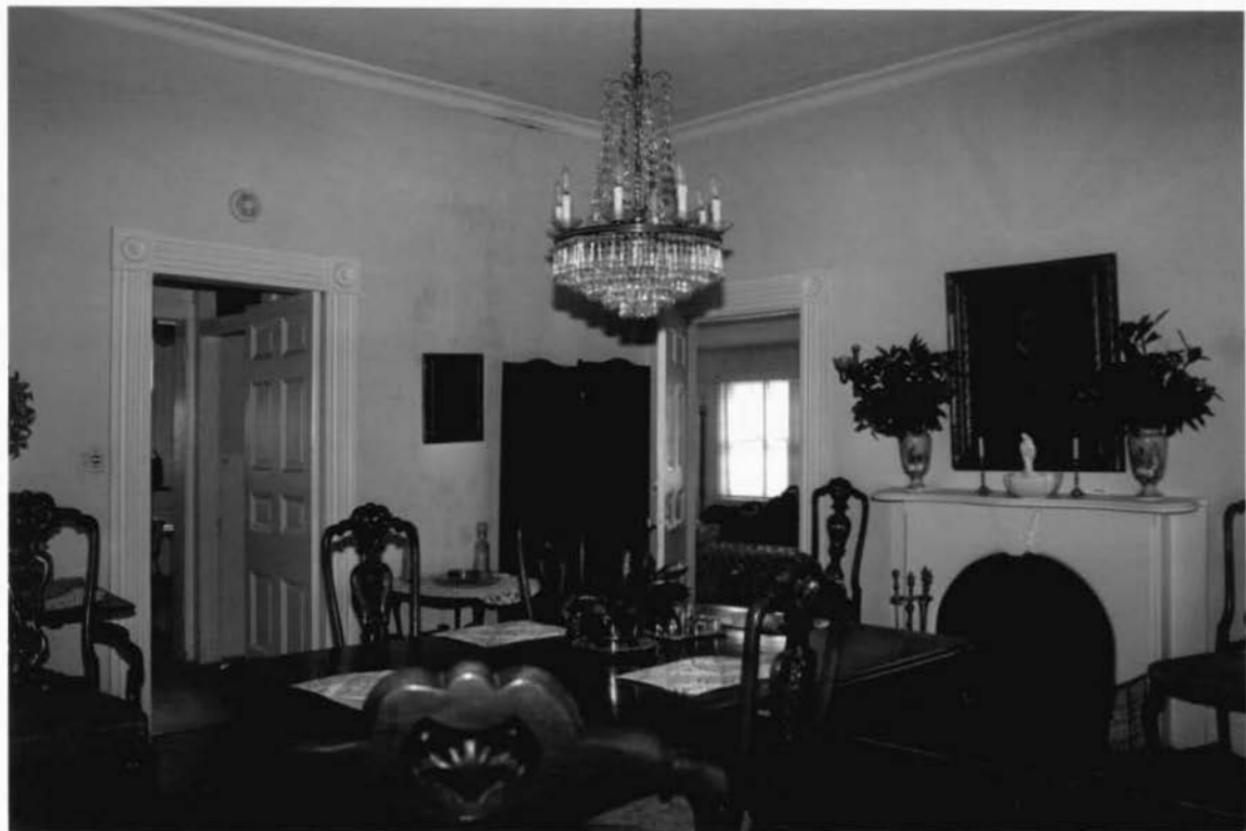
Dining Room

The dining room is located in the southwest quadrant of the first floor plan, reached through a door in the south wall of the main hallway. The flooring in the dining room is narrower than the random three-to-five inch boards of the hallway, and is of uniform approximately two inch widths. There is a simple, coved plaster ceiling cornice. The fireplace centered in the south wall has a painted stone mantel with chamfered outer edges and a chamfered, round-arch fire box opening surmounted by a large flat keystone. Incised lines form geometric designs in the frieze. The mantel shelf has a curvilinear profile. The 6/6 sash window to the right of the fireplace is smaller than the other windows on the first story, having the same sill height but a lower head. A door to the left of the mantel leads to the enclosed porch or sunroom on the south end of the house.

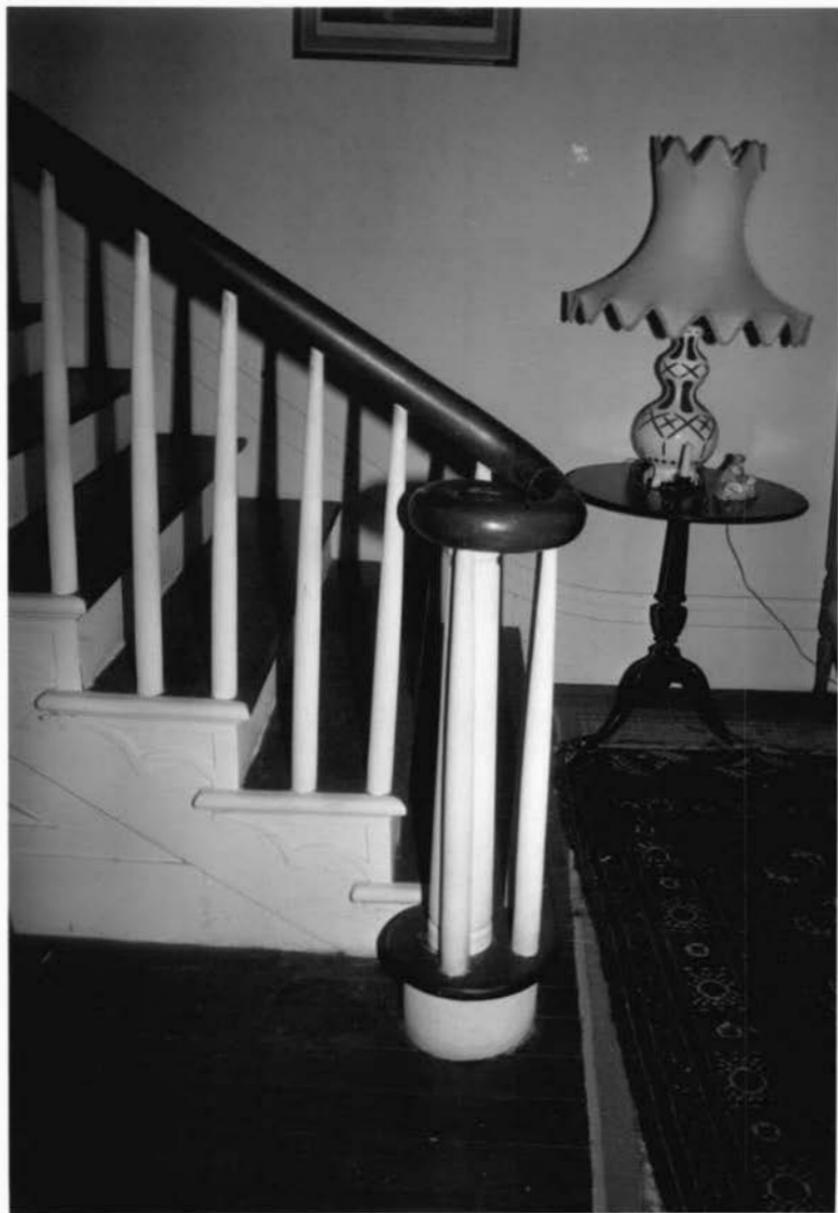
William Parker House
Prince Georges Co.
Marina King
Feb 1989
Main Stair, newel post
Neg: M47, Annapolis

The open-string stair rises along the south wall of the stair hall, turns 90 degrees at a landing, turns 90 degrees once again and rises along the north wall to the second story. There is scalloped bracketing in the stair ends. The white-painted balusters are smooth and tapering. The newel post stands on the curved projecting end of the lowest step. It is a tapering post around which two of the balusters are set. The handrail has a

circular cross-section, and forms a coil on top of the newel post. The spandrel is paneled with vertical rectangular wainscotting.

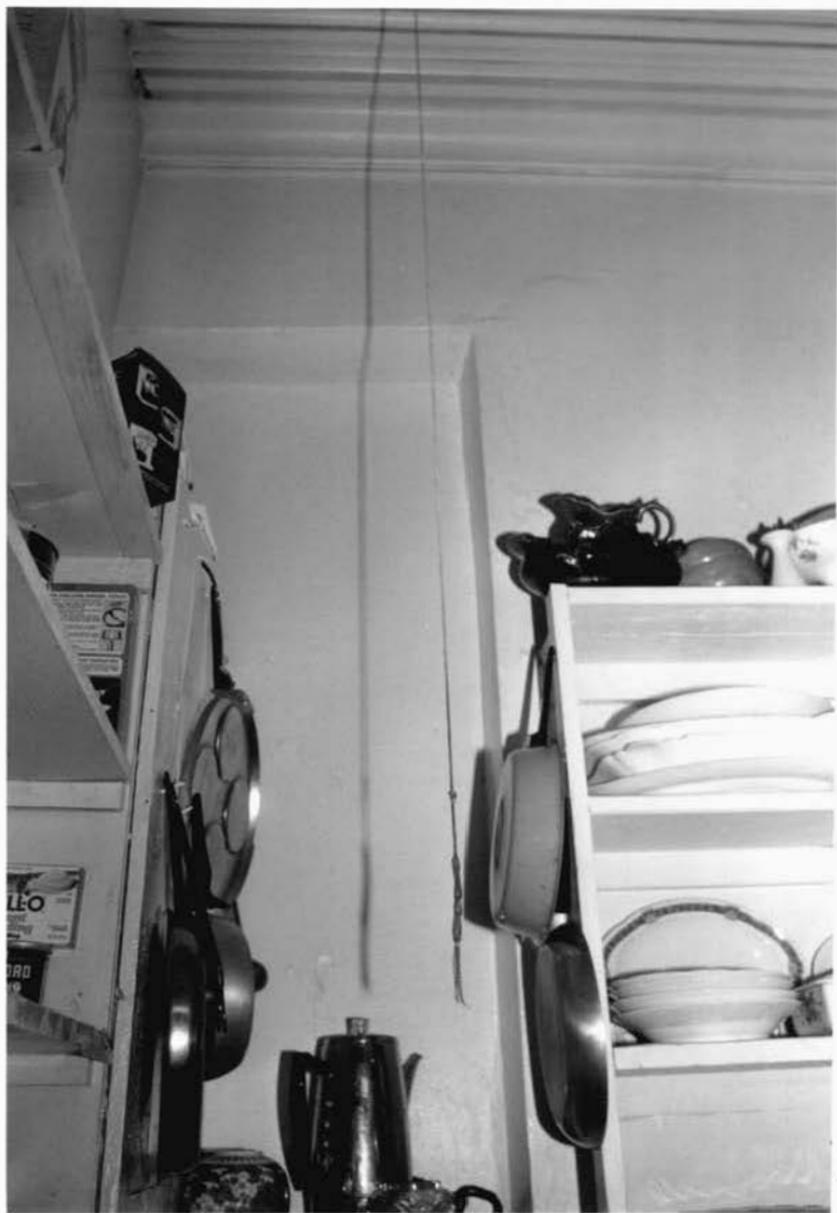
William Barker House
Prince Georges Co.
Marina King
Feb 1989
Kitchen pantry, corner
and blocked doorway
Neg. MHT, Annapolis

A central door in the east wall of the dining room enters a shallow hall leading into the kitchen. The hall is flanked by a pantry to the north and a bathroom to the south. The bath is entered off of the hall, the pantry is entered from the kitchen. The hallway and both small rooms have ornate plaster cornice molding similar to that in the main entry hall, along the west wall or the wall adjoining the dining room. Both rooms also have evidence of a high doorway, now blocked off, in the wall adjoining the dining room. This indicates that the room now serving as the kitchen once had a wide rectangular opening similar to that between the north parlors, connecting it to the dining room. It also had the same ornate plaster cornice as the main hallway. The arrangement of kitchen, bathroom and pantry are an alteration to the original floor plan, probably completed when the south wing was removed, during the 1920's or 30's.

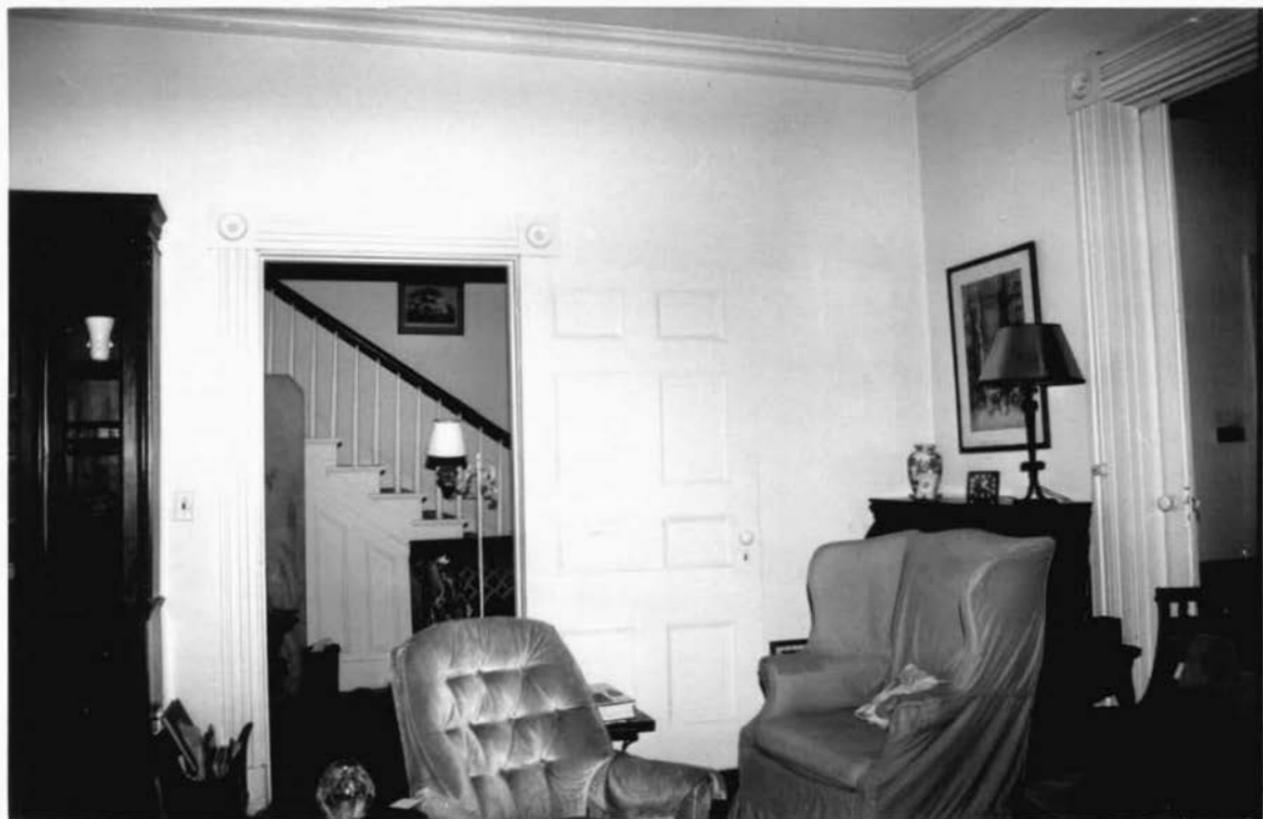
Northeast parlor look south
toward main staircase

A wide opening with pocket doors connects the northwest and northeast parlors. The northeast parlor has a fireplace in the north wall with a mantel identical to that in the adjoining parlor. The room has a multi-band plaster cornice but no other ceiling decoration.

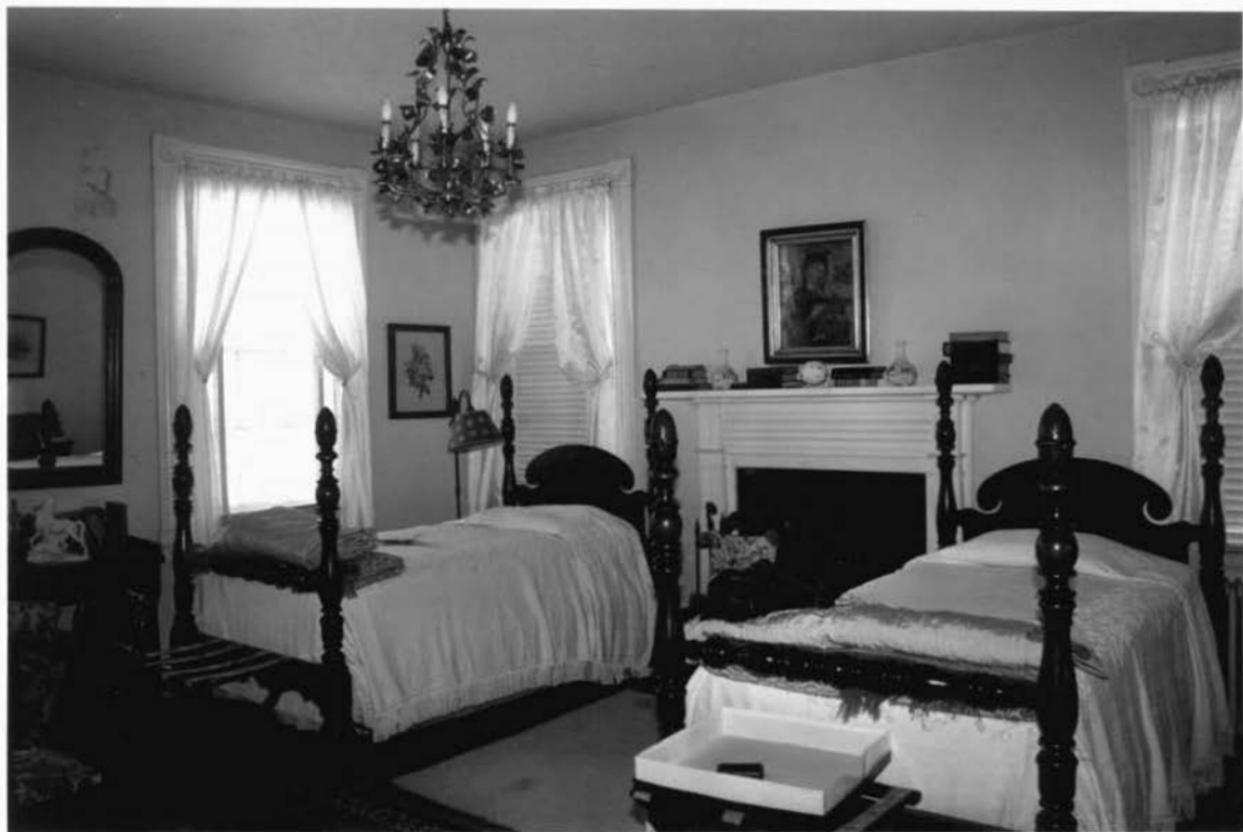
William Barker House
Prince Georges Co
Marina Key
Feb. 1989
Northwest bedroom
Neg: MHT, Annapolis

The two north bedrooms are both warmed by a fireplace in the north wall. The wooden mantels are identical, having a rectangular firebox opening flanked by flat pilasters, each with a vertical rectangular inset panel. The wide frieze has horizontal fluting. The pilasters are surmounted by a capital with an inset oval panel. There is an ogee molding beneath the rectangular mantel shelf. Both rooms are made smaller by the enclosure of closets on the south wall. The northeast bedroom has two windows looking east, overlooking the rear porch roof. The southeast window has two wainscot panels beneath it with a central division. The panels open like a door and when the window is raised it functions as a doorway. The baseboards in the north bedrooms have a plain, sloping cap.

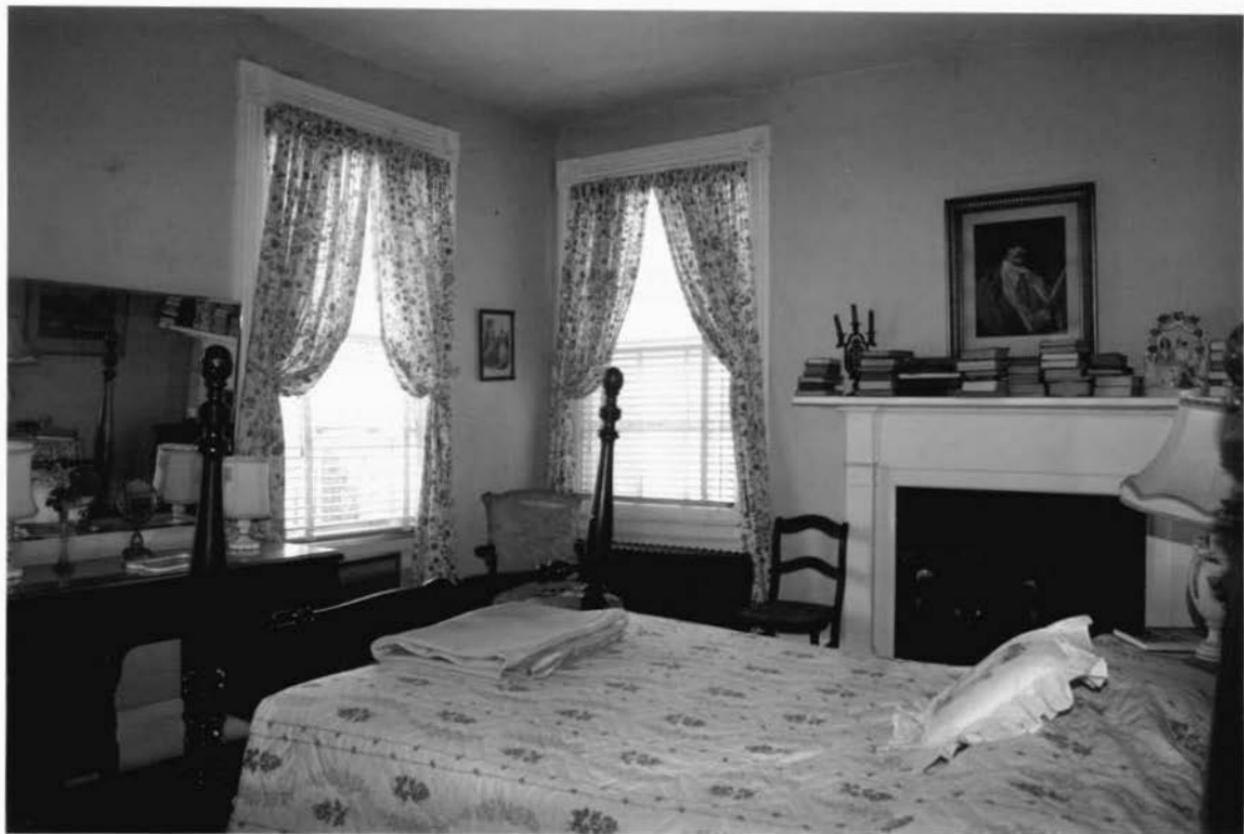
William Barker House
Prince Georges Co
Marion King
Feb 1981
Southeast bedroom
Neg: M45, Amnigobes

The southeast bedroom is made smaller by the enclosure of the west end to form a small entry vestibule with a closet and a bathroom. The bathroom has a small 4/4 sash window looking south. The moldings in the bathroom are varied, and there is a wooden, two-step cornice molding at ceiling level. The bedroom is warmed by a fireplace in the south wall. The wooden mantel has a rectangular firebox opening flanked by plain, flat pilasters with a simple raised molding defining the capital. The frieze is plain and there is a convex molding beneath the rectangular mantel shelf. The firebox is filled with concrete, leaving a circular opening for a stove pipe. There is a small iron Cinderella Franklin stove with ceramic medallions flanking the stove door. The northeast window, overlooking the east porch, has the same wainscot panel treatment as the window in the hall and the northeast bedroom.

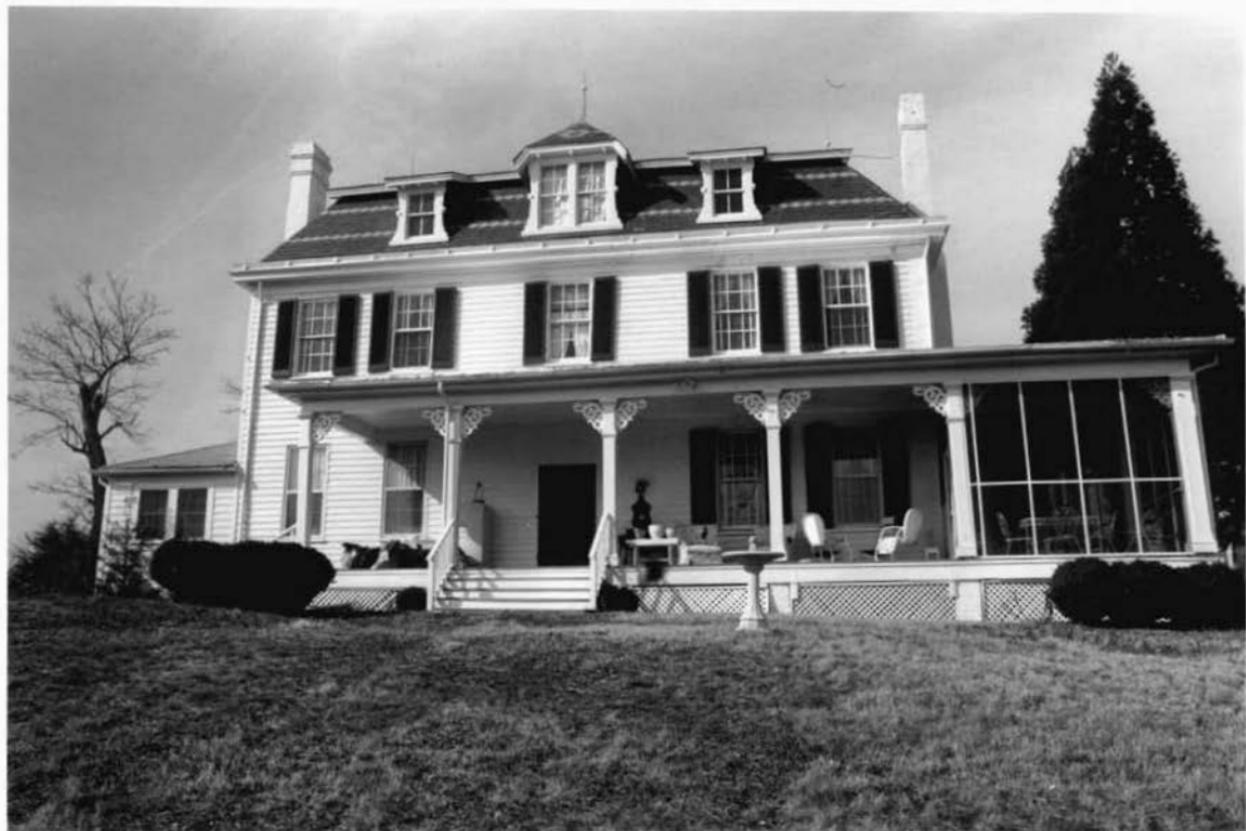
William Barker House
Prince Georges Co
Marina King
Feb 1989
East Location
Neg M47, Annapolis

The five-bay east elevation is very similar to the west main facade. The central rear entrance is covered by double louvered outer doors. The windows have narrow surrounds and no lintel decoration. The porch wraps-around this elevation for five bays and has the same detail as the main facade. There are four wooden steps up to the porch from the lawn, flanked by simple wooden balustrades. The south bay of the elevation is not sheltered by the wrap-around porch.

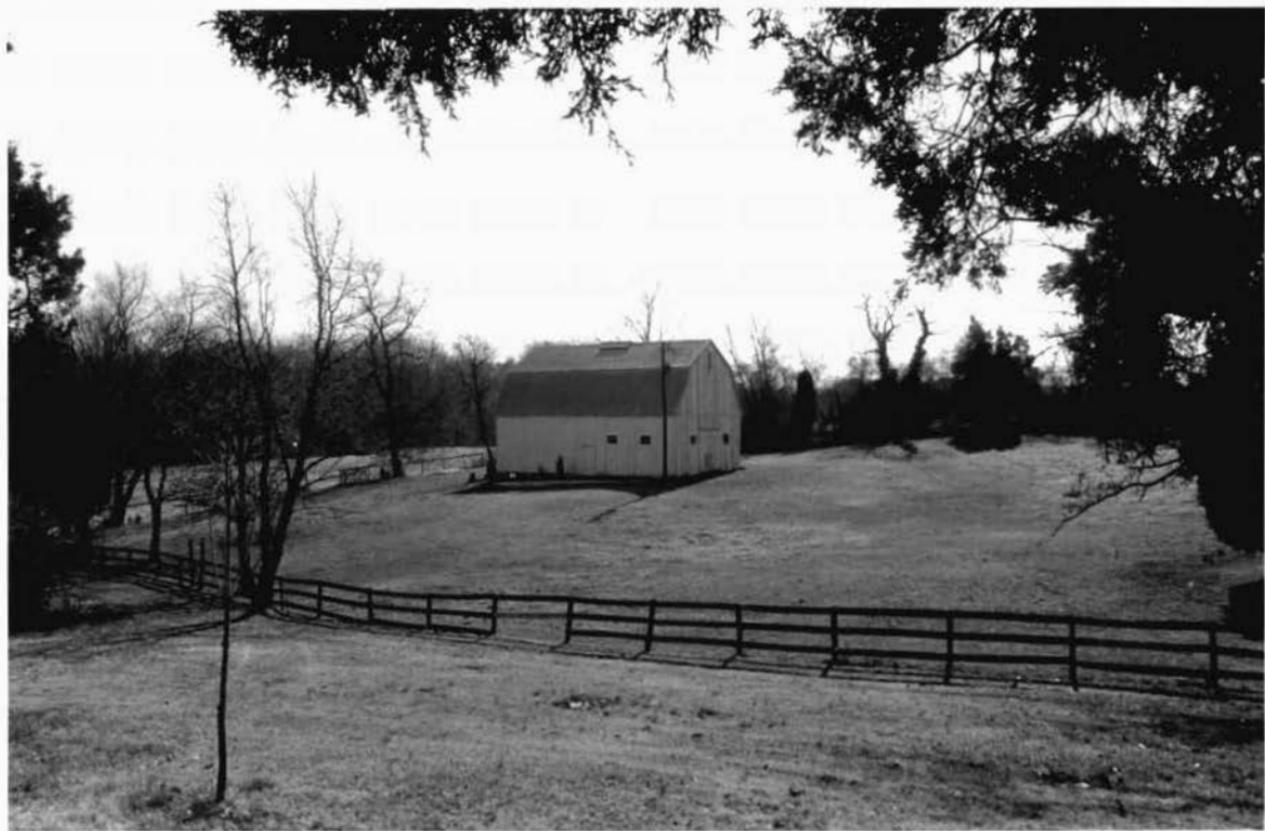
barn, southeast of house

At the foot of the knoll at the east or rear of the house is a small grove of fruit trees. South of the house is a field encircled with a three-board fence. At the east side of the field is a gambrel roof frame barn, dating to the 1930's, with a standing-seam metal roof and vertical board siding, standing on concrete piers. The central double west door has iron strap hinges. Cedar trees follow the fenceline, which starts at Aquasco Road, just south of the entry drive to the house. A stable and corncrib southeast of the house, constructed in 1877 for the Mercers, burned after 1949 during the ownership of the present owner.
