QA-103  
Fishingham  
Centreville vicinity  
Private

## INVENTORY FORM FOR STATE HISTORIC SITES SURVEY

Fishingham

Orlando Ridout V, Historic Sites Surveyor

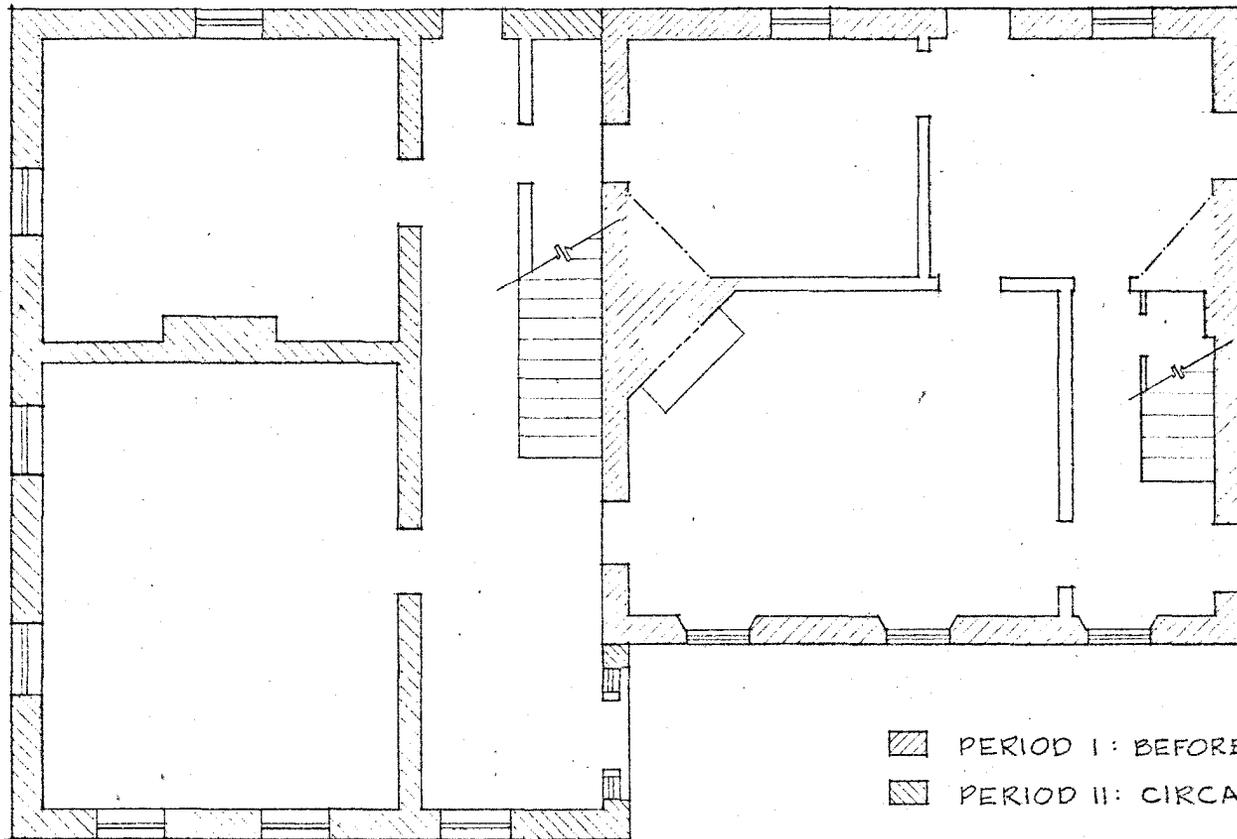
FISHINGHAM  
CENTREVILLE, MARYLAND

PERIOD I: BEFORE 1798

PERIOD II: CIRCA 1860's

SCALE: 1/8" = 1'-0"

The interior is arranged in an unusual four room plan, with two unequal sized rooms on each facade. The center door in the east facade and the east door on the south gable both lead into a nearly square room that now serves as a dining area as well as an entrance hall. Interior doors lead from this room to a similar sized room in the northeast quadrant of the house, a larger rectangular room in the northwest quadrant, and a small stair hall in the southwest quadrant. The northeast room now serves as a kitchen, but originally had a corner fireplace and probably served as a parlour or a sleeping chamber. The northwest room was undoubtedly a parlour, and still

In the third quarter of the 19th century, a large addition was made adjoining the north gable wall of the original house. This addition is actually a self-contained house, with concessions in the plan to make it compatible with the earlier dwelling. The new building is also brick, two stories high and three bays wide with a hip roof. The plan of this section is a side hall-double parlour, with the hall running along the wall that connects the two sections of the house. This allows the hall to serve both the new addition and the original house.

The interior of the 19th century house is arranged in a side hall double parlour plan, with the stair rising along the south wall of the hall, and two doors on each floor leading to the north rooms in the earlier house. The stair has an open-string carriage, with heavy Victorian newel posts, turned
